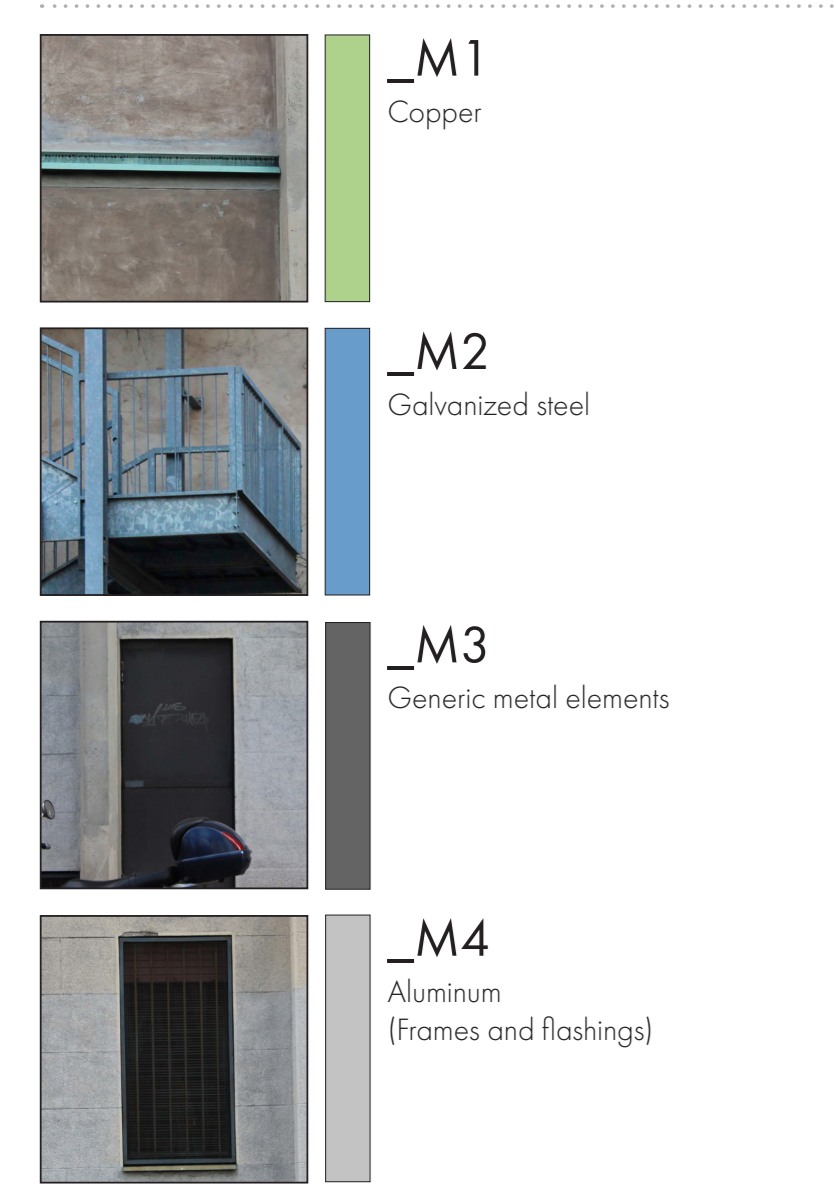
DECAYS

CONCRETE

GLASS

PLASTIC ELEMENTS

FINISHINGS

METAL CARPENTRY

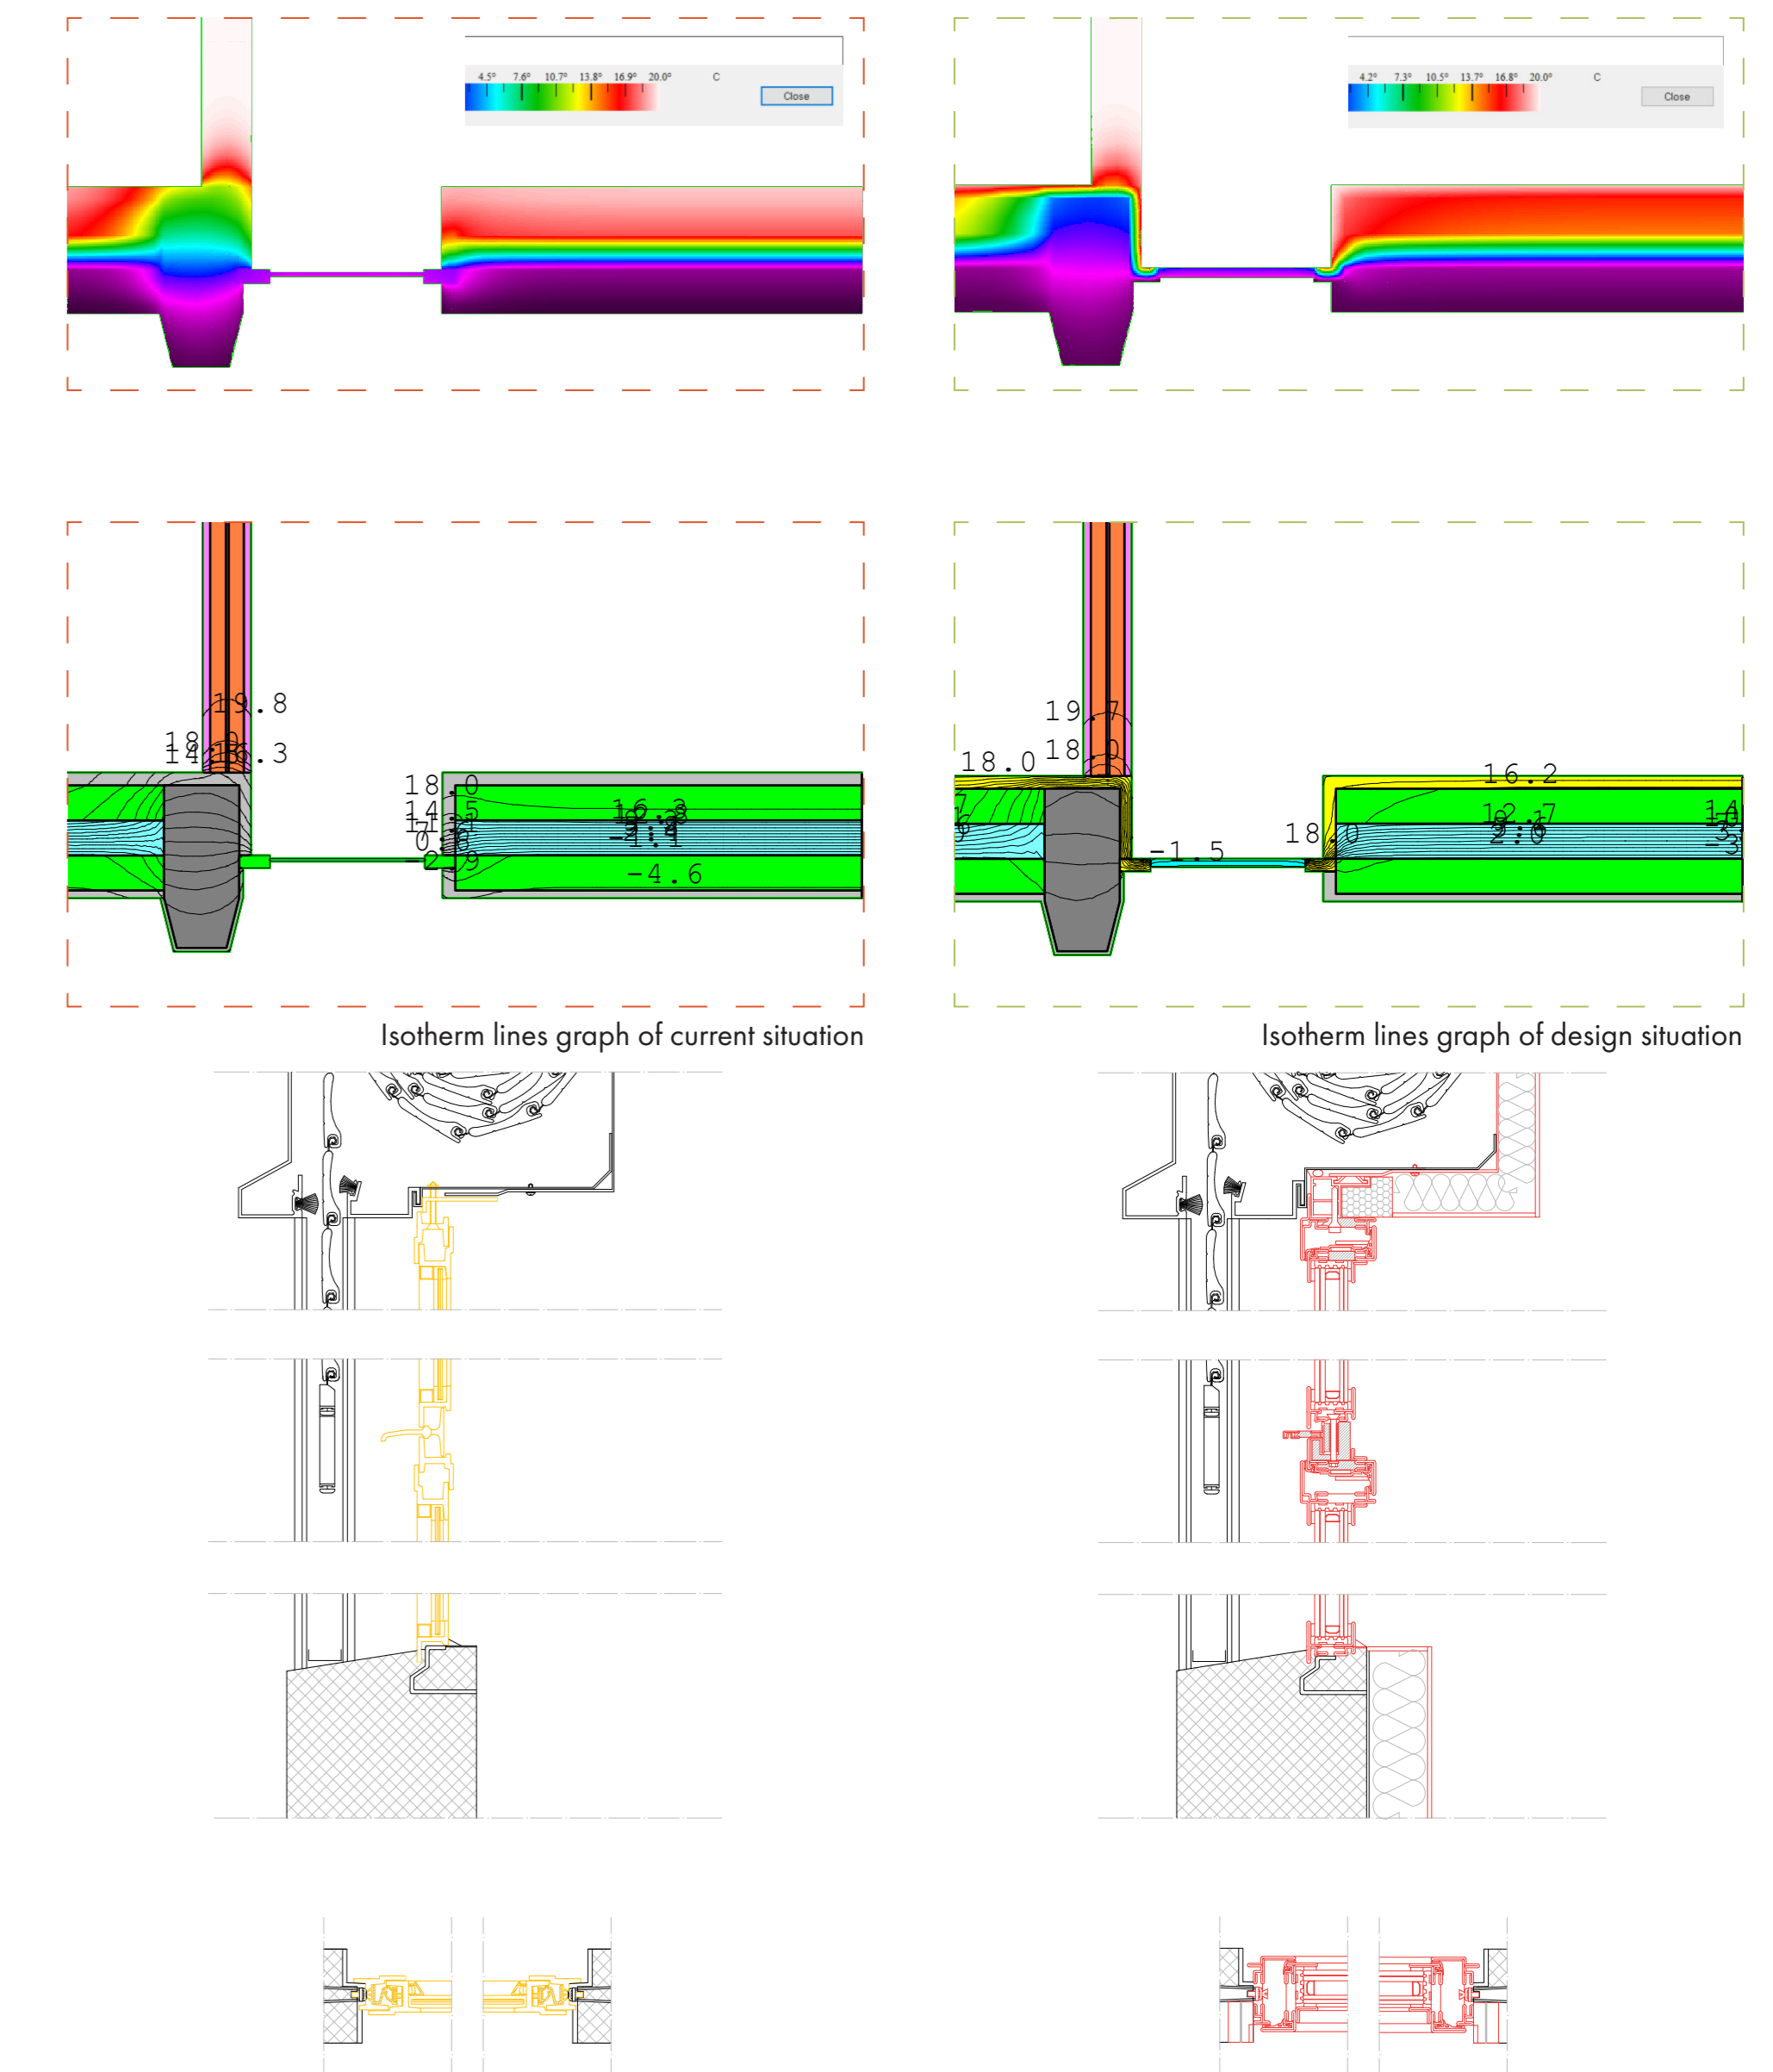
Existing window frames
SCALE 1:5

Substitution of the window frames
SCALE 1:5

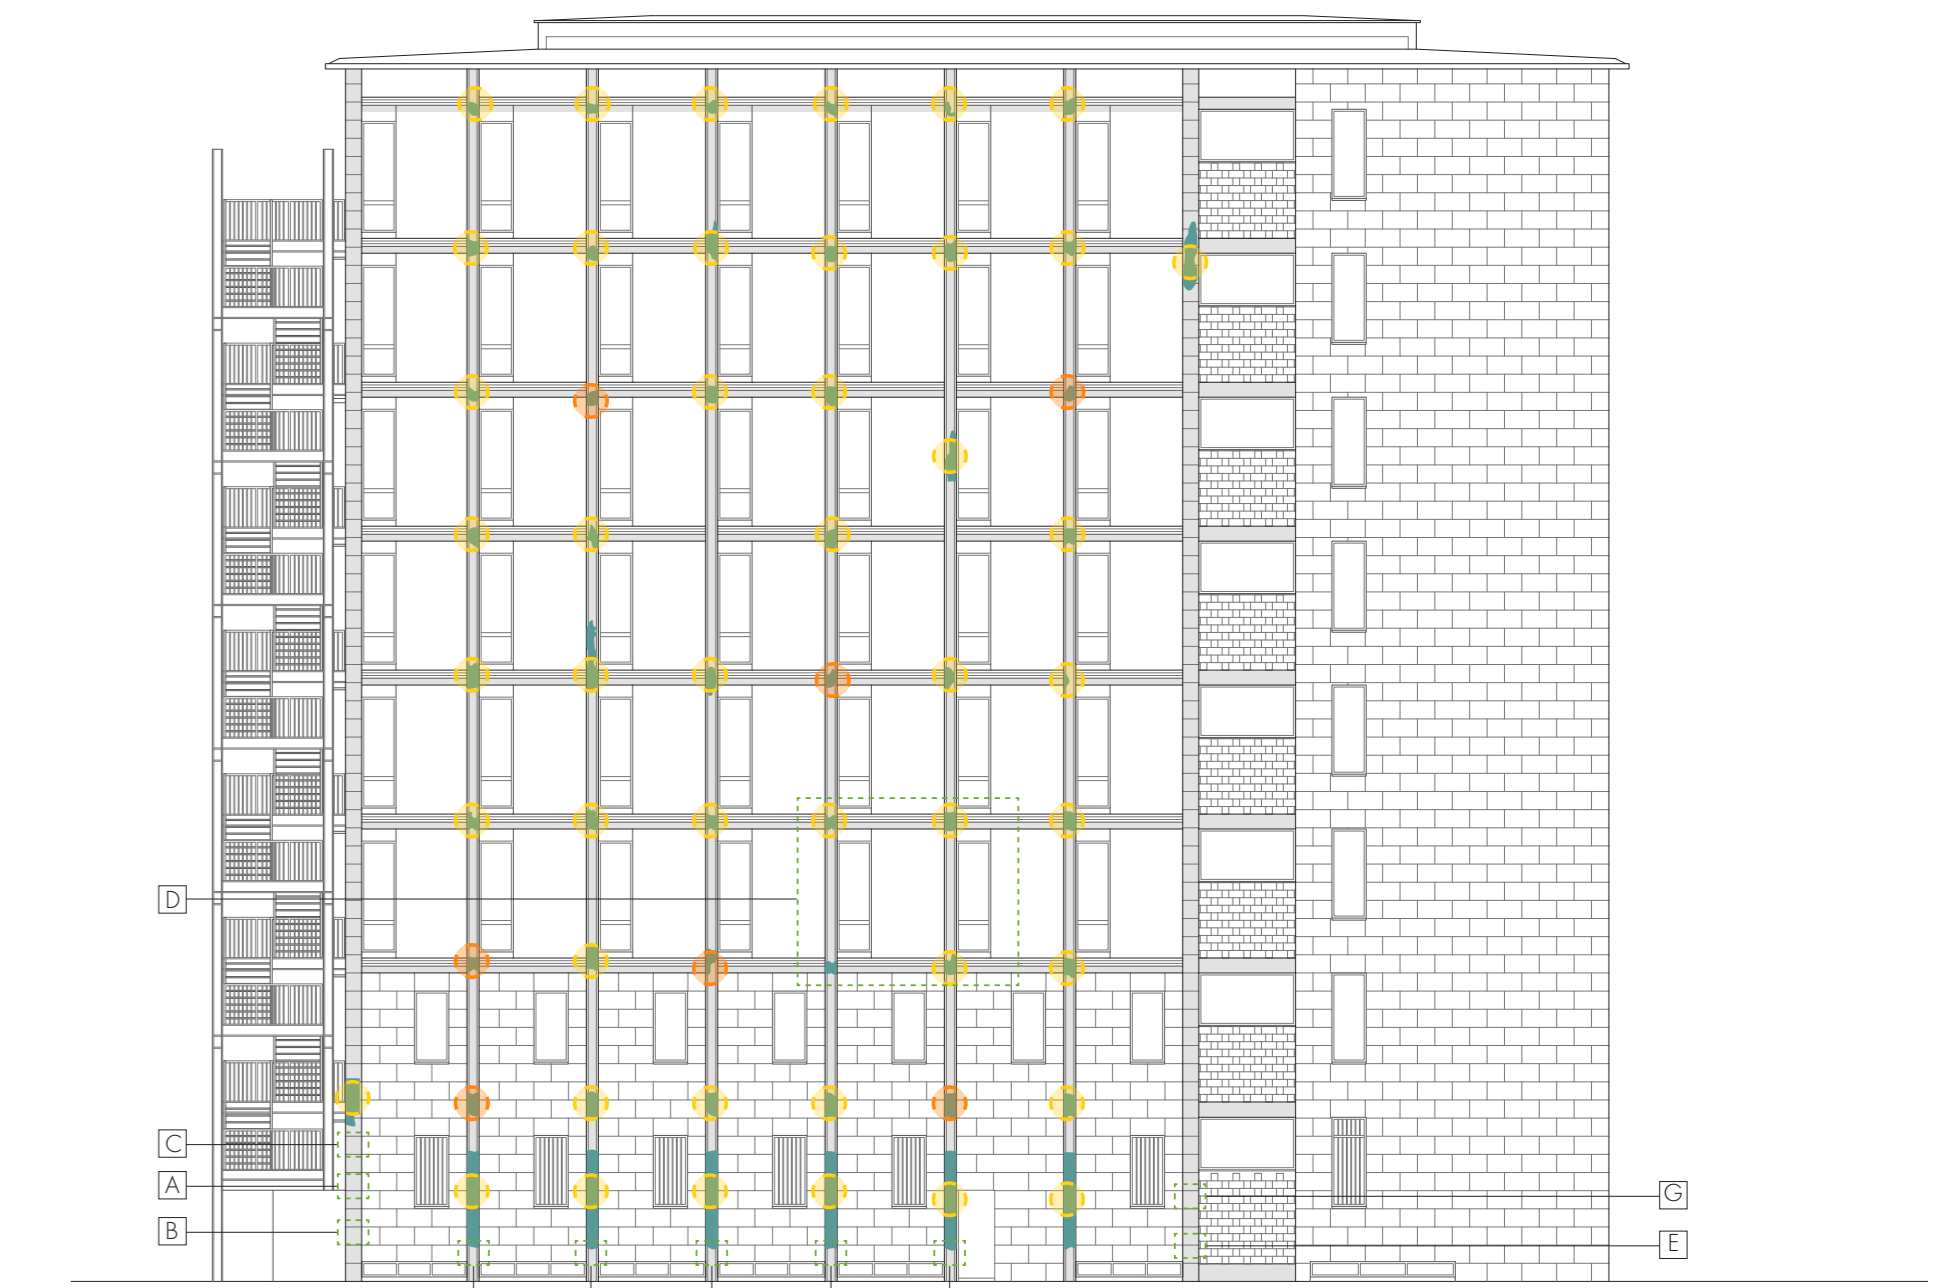
Mapping of the diagnostics works

Level of decay

- Level 1: detachment of plaster
- Level 2: presence of cracks
- Level 3: presence of exposed rebars

- Exposed reinforced concrete structure
- Damaged parts

Necessary investigations

- A. Sclerometry
- B. Magnetometry
- C. Ultrasonds
- D. Infrared thermography
- E. Electrochemistry
- F. Map cracking (on the whole structure)
- G. Core drilling
- H. Compression tests
- I. Colorimetric analysis
- L. Physical and microstructural tests

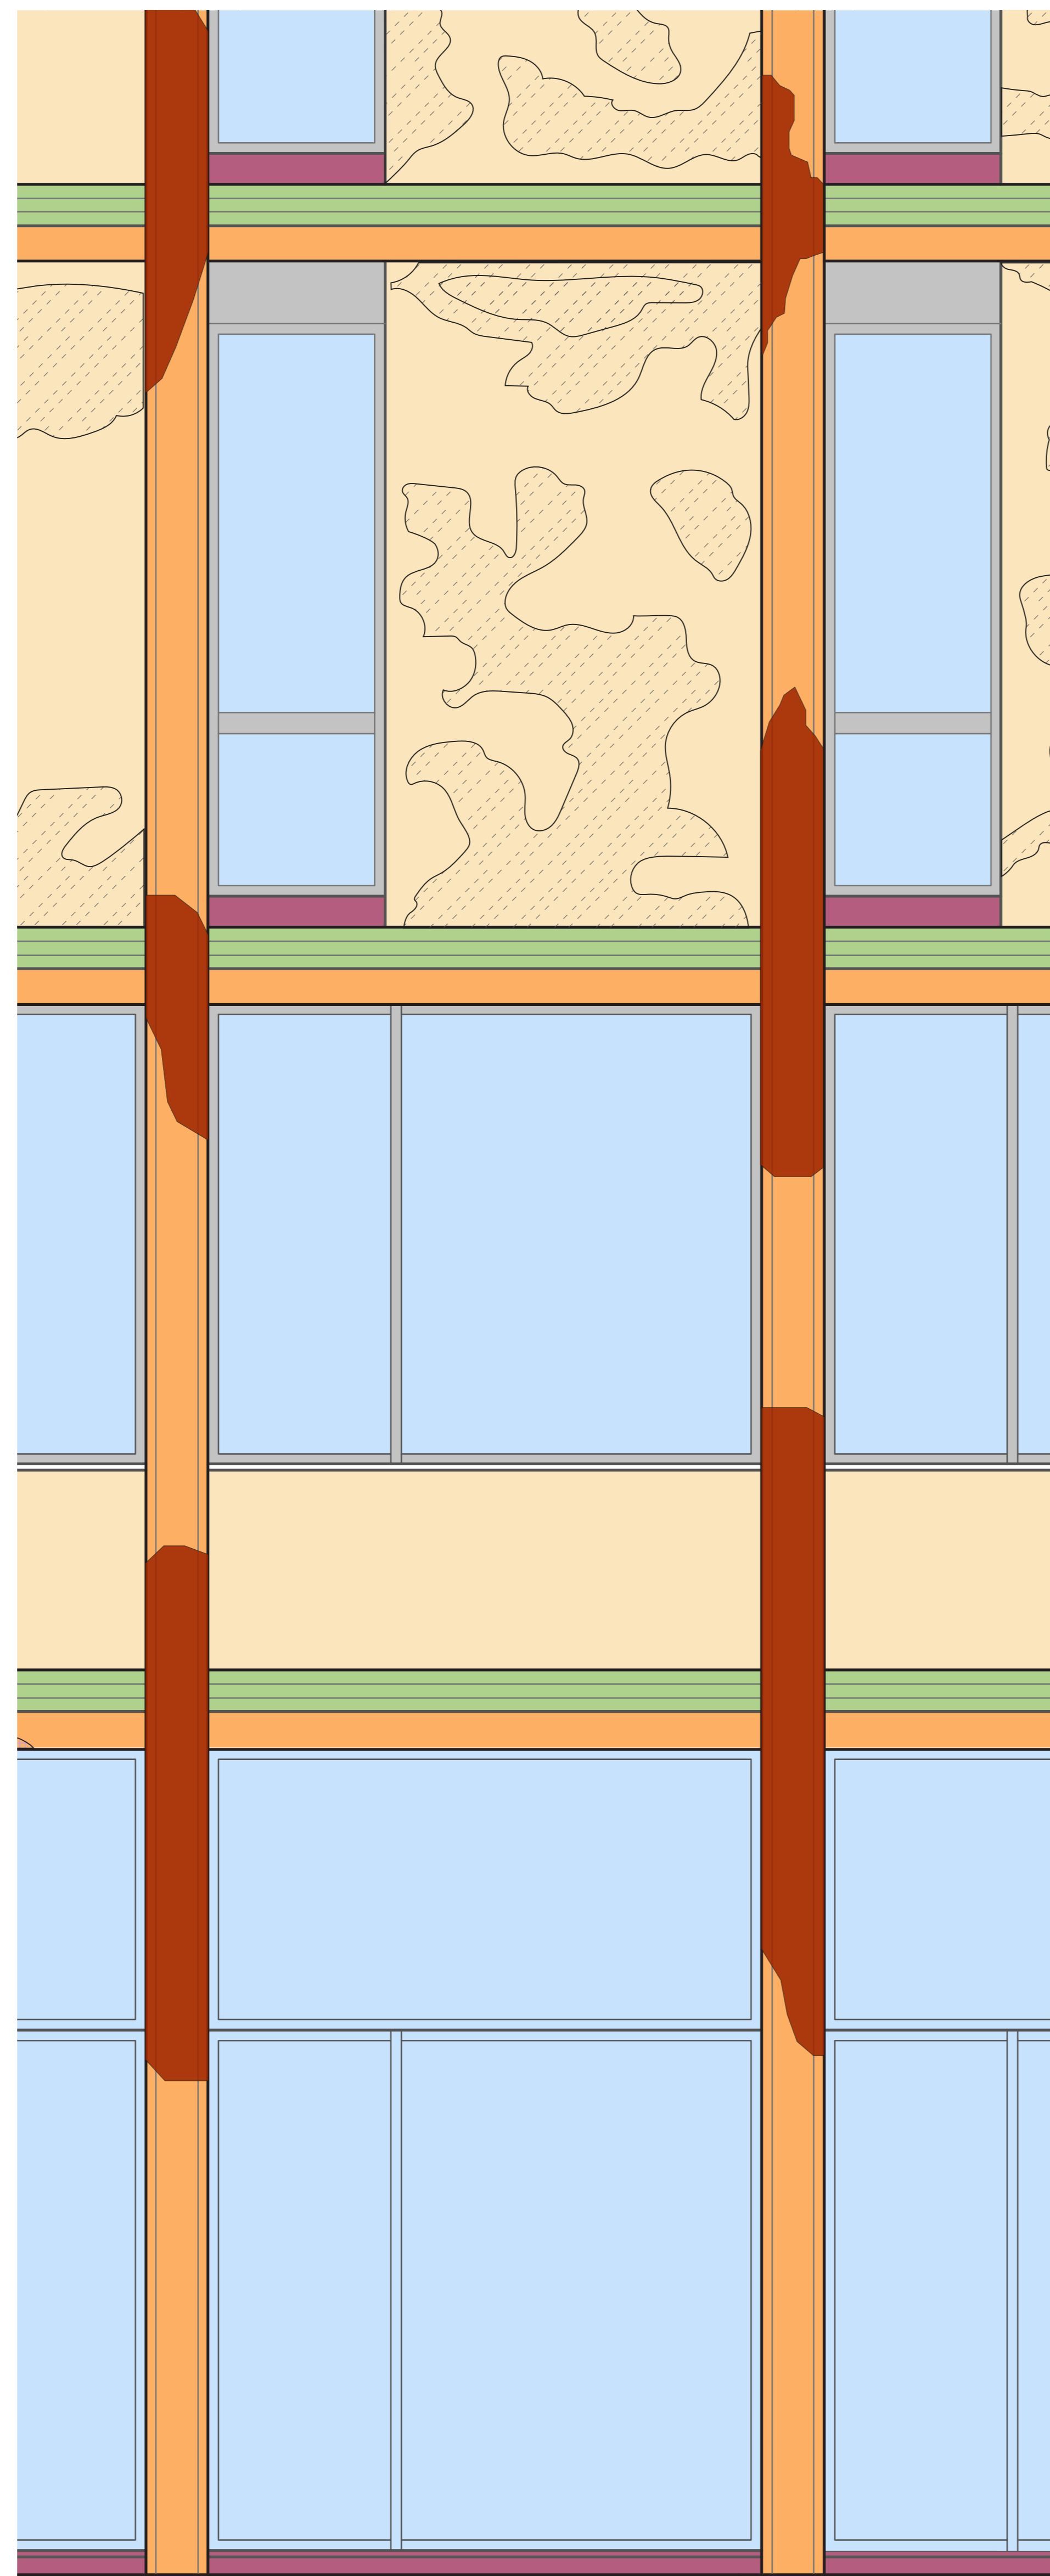
Materials and decays mapping
SCALE 1:20

_C1 Reinforced concrete	_M2 Galvanized steel	_P2 Vetro-cemento	_De1 Blistering	_De5 Moist area
_C2 Vibrated RC curb	_M3 Cemented metal sheets	_P3 Graniglia martellinata	_De2 Flaking	_De6 Missing part
_G1 Glass panels	_M4 Aluminum	_P4 Mortar integrations	_De3 Encrustation	_De7 Deposit
_M1 Copper	_P1 Rustic plaster	_PL1 Plastic elements	_De4 Oxidation process	_De8 Hair cracking
