POLITECNICO
MILANO 1863

Master of science in Geoinformatics Engineering

Assessment of a tunnel safety

"Guidelines for the assessment of the degree of safety of tunnels", following the examination of the massive investigations, the detailed inspection, the elaboration of the selective investigation plan and the conduct of the same, the results of the investigations carried out in the field and in the laboratory were collected and analyzed. The results of this activity are the subject of this Final Report on the Ratella tunnel, Via Francia.

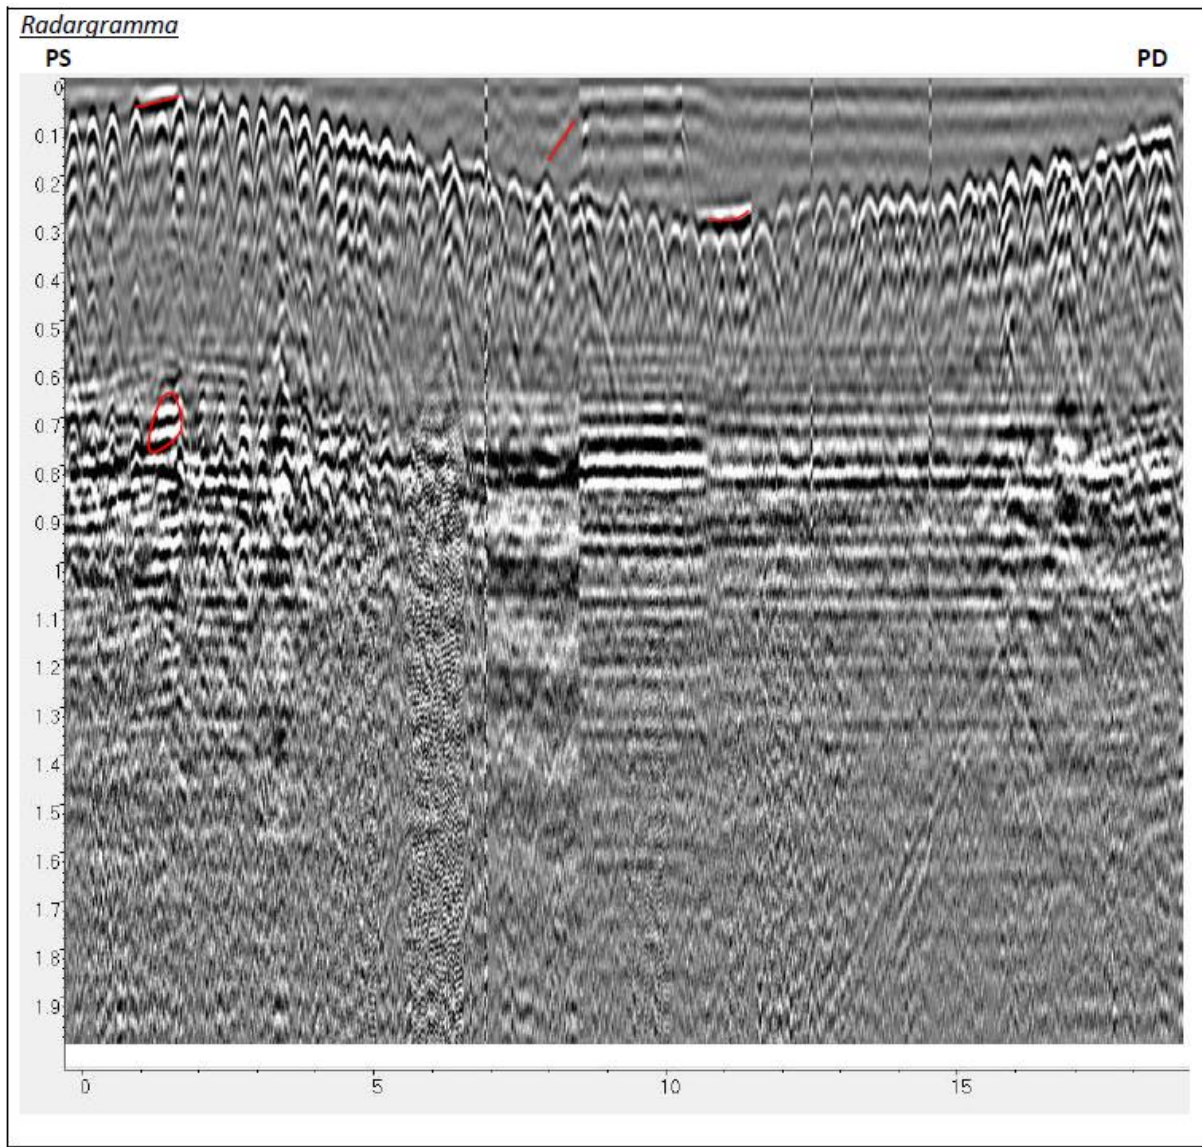
FG720-Galleria Ratella	NOTA INTERPRETATIVA	14/09/2021
Sistema di acquisizione	Georadar K2 FastWave - Antenna monostatica 900MHz	
Progressiva (m)	181.5

Figure 4: Transverse detail georadar at pm 181.5. Variability of the iron cover (construction defect).

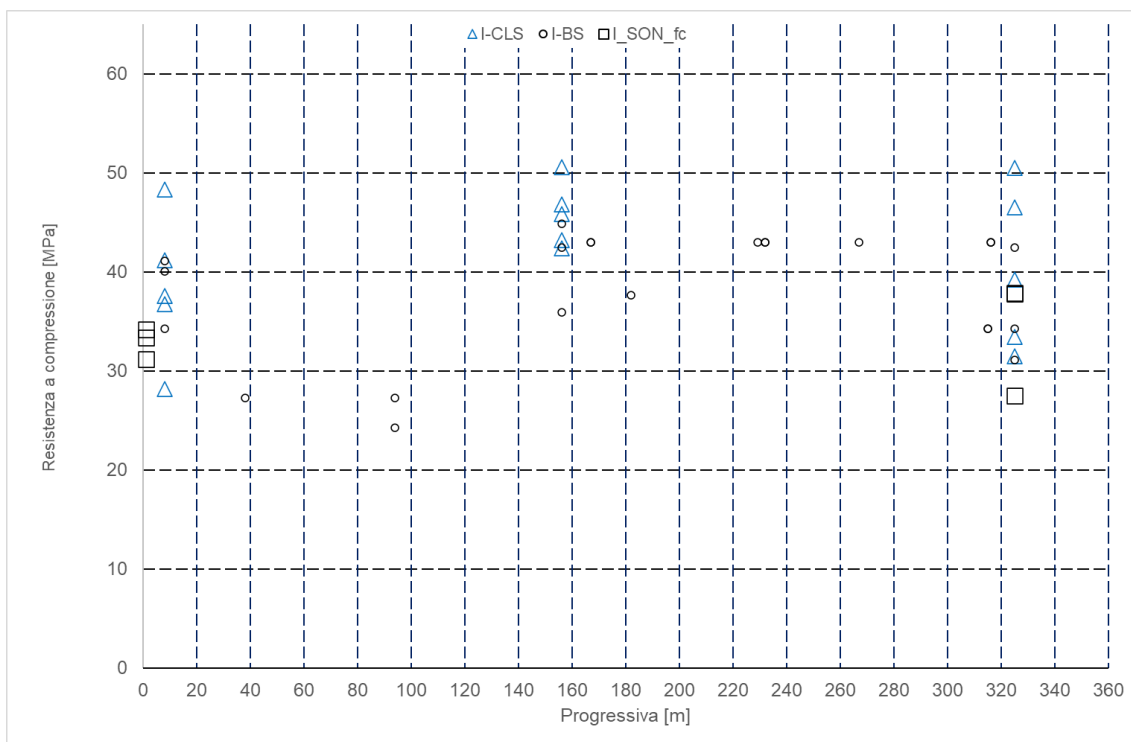
- The sclerometric measurements lead to values estimated by correlation curve of compressive strength similar to those derived from compression strength tests. The estimated maximum value is 44. 82 MPa, minimum 24. 28 MPa and the middle 38. 05 MPa;
- The average value (38. 05 MPa) is higher than the results of the Sonreb tests (3 3.6 MPa) and lower than the average of the compression tests (41. 46 MPa);
- Also in this case the deviations recorded with respect to the compressive strength tests may have been determined by degradation (carbonation) and cortical surface construction defects;

Figure 5: Comparison of compressive strength values estimated with destructive and non-destructive tests
