I N T E G R I T Y

in the center of Veterinaria Campus

Decays

Photo Documentations

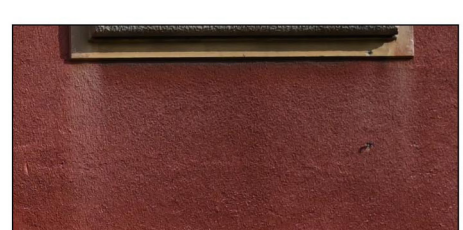
Material: plaster with red pigment
Decay type: discoloration
Decay reason: It is mainly caused by high humidity in atmosphere, especially in rainy days water would bring tiny dirt and color painting on the surface of plaster.

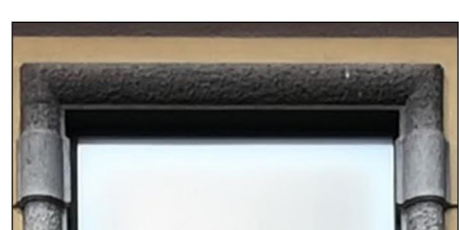
Material: decorative cement
Decay type: deposit
Decay reason: This decay could be caused by a series of complex mixtures, such as rainfall and dirt from air, tiny material losses from very surface of the cement.

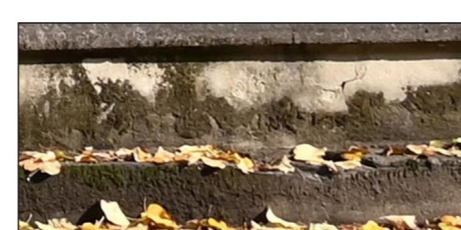
Material: concrete
Decay type: biological colonization
Decay reason: This deterioration mainly caused by high humidity of environment and floating seeds in the air, lichen and mould are possible grow at same time and position.

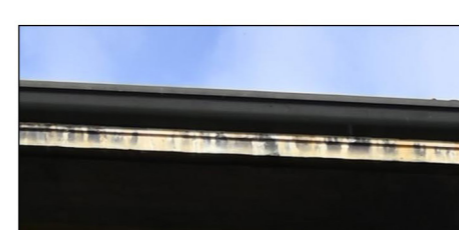
Material: copper
Decay type: corrosion and oxidation
Decay reason: Metal corrodes when it reacts with another substance such as oxygen, hydrogen, an electrical current or even dirt and bacteria.

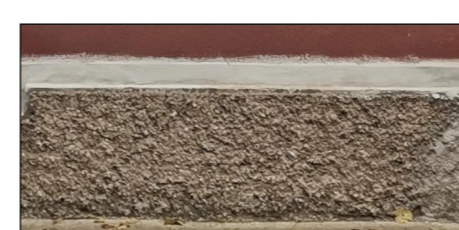
Material: artificial stone
Decay type: disintegration of artificial stone
Decay reason: Alternate wetting by rain and drying by sun causes internal stresses in the stones and consequent disintegration.

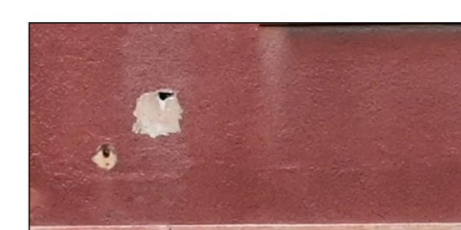
Material: mortar and plaster
Decay type: mechanical damage
Decay reason: This deterioration caused by renovation of ventilation or other equipment installment.

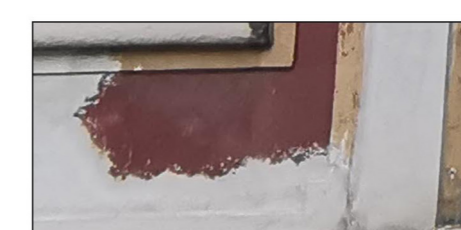
Material: mortar
Decay type: incompatible intervention (white painting)
Decay reason: This is human activities on the existing surface and the reason could be difficult to analysis, we can just assumed it ever experienced some dirty on the surface.

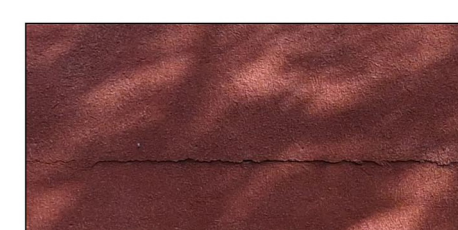
Material: mortar
Decay type: crack
Decay reason: Crack can caused by sudden temperature change and high humidity in air, gap between different materials during long periods after construction.
