# METAMORPHOSIS

## HISTORICAL STUDY

# MATERIAL AND DETERIORATION SURVEY

# CONSERVATION SURVEY

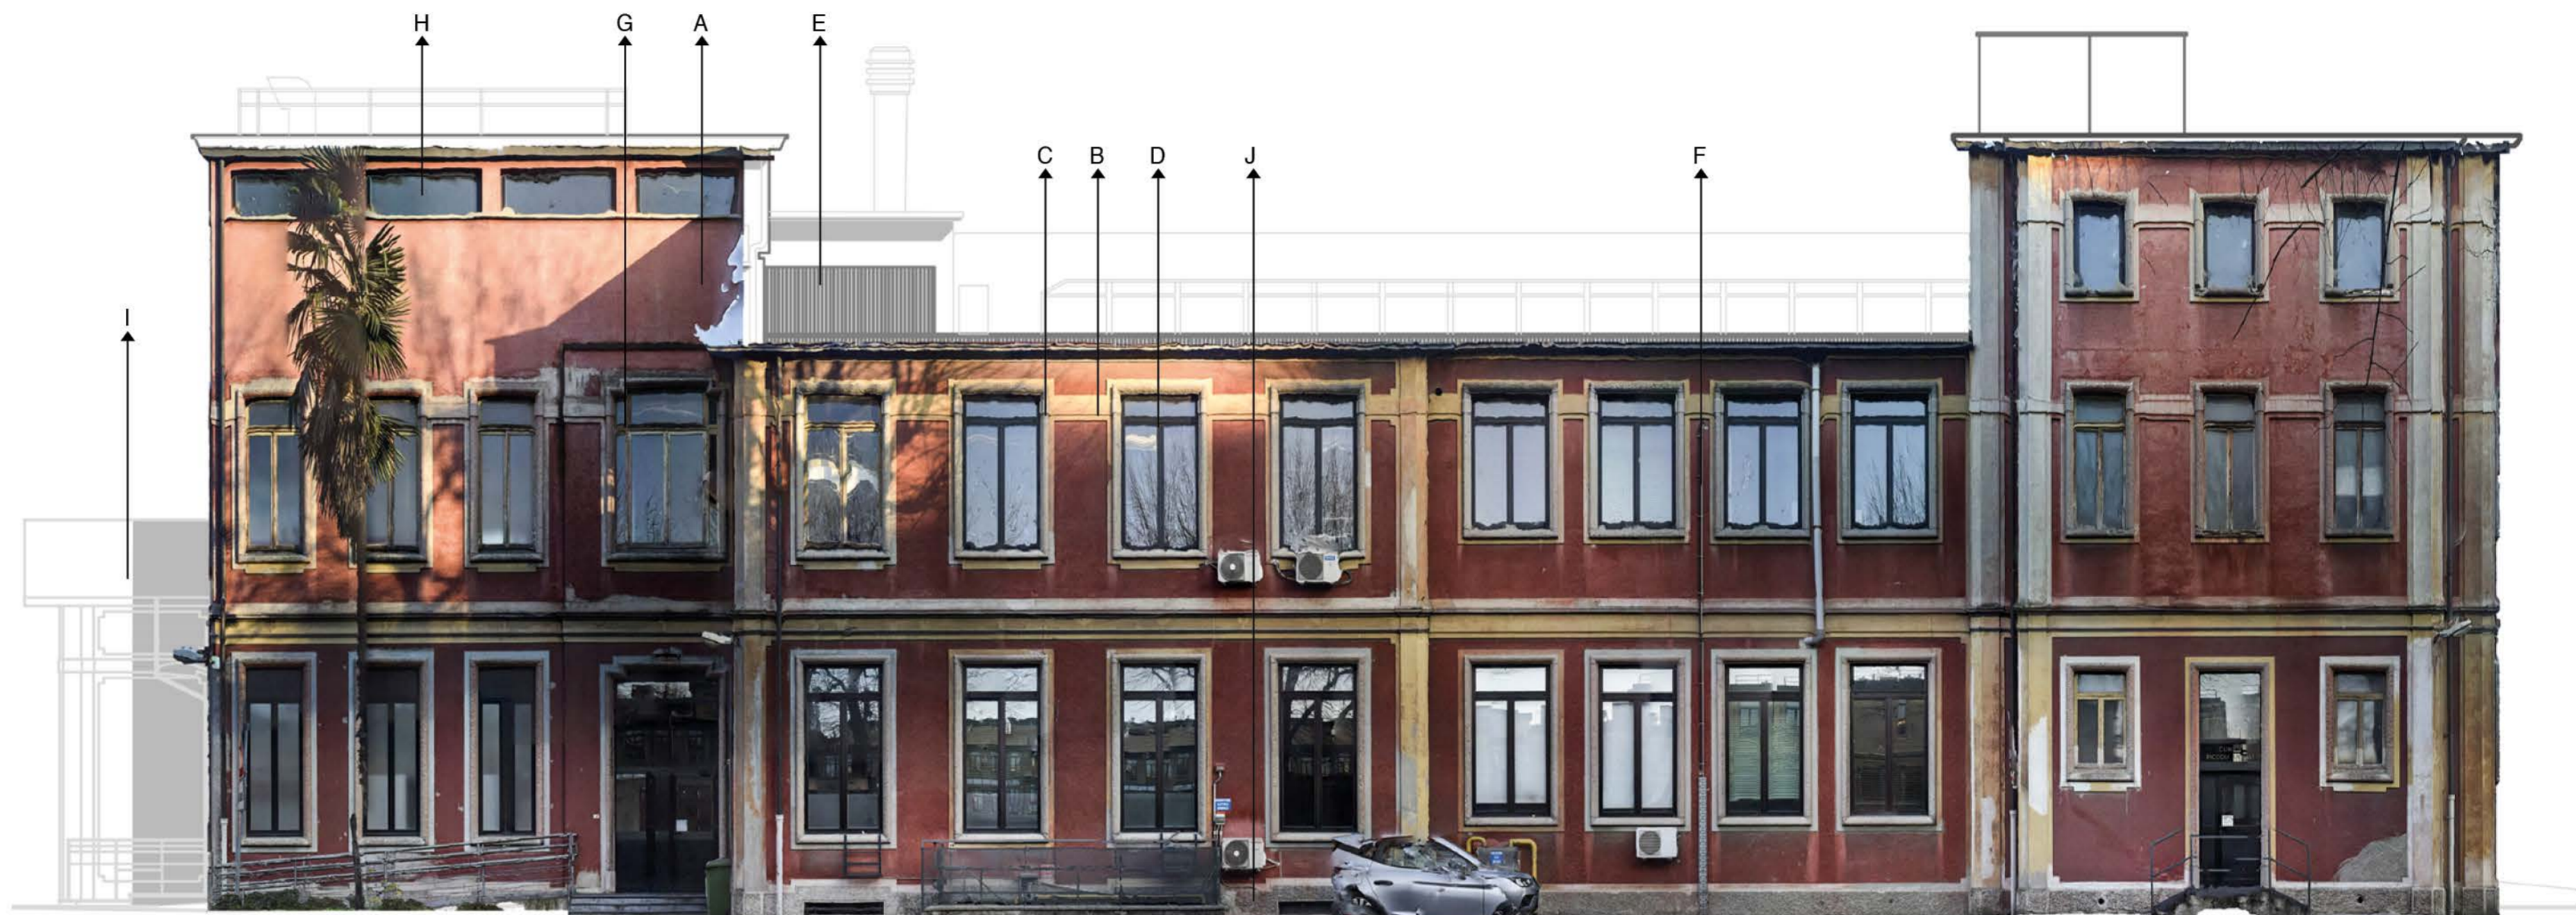
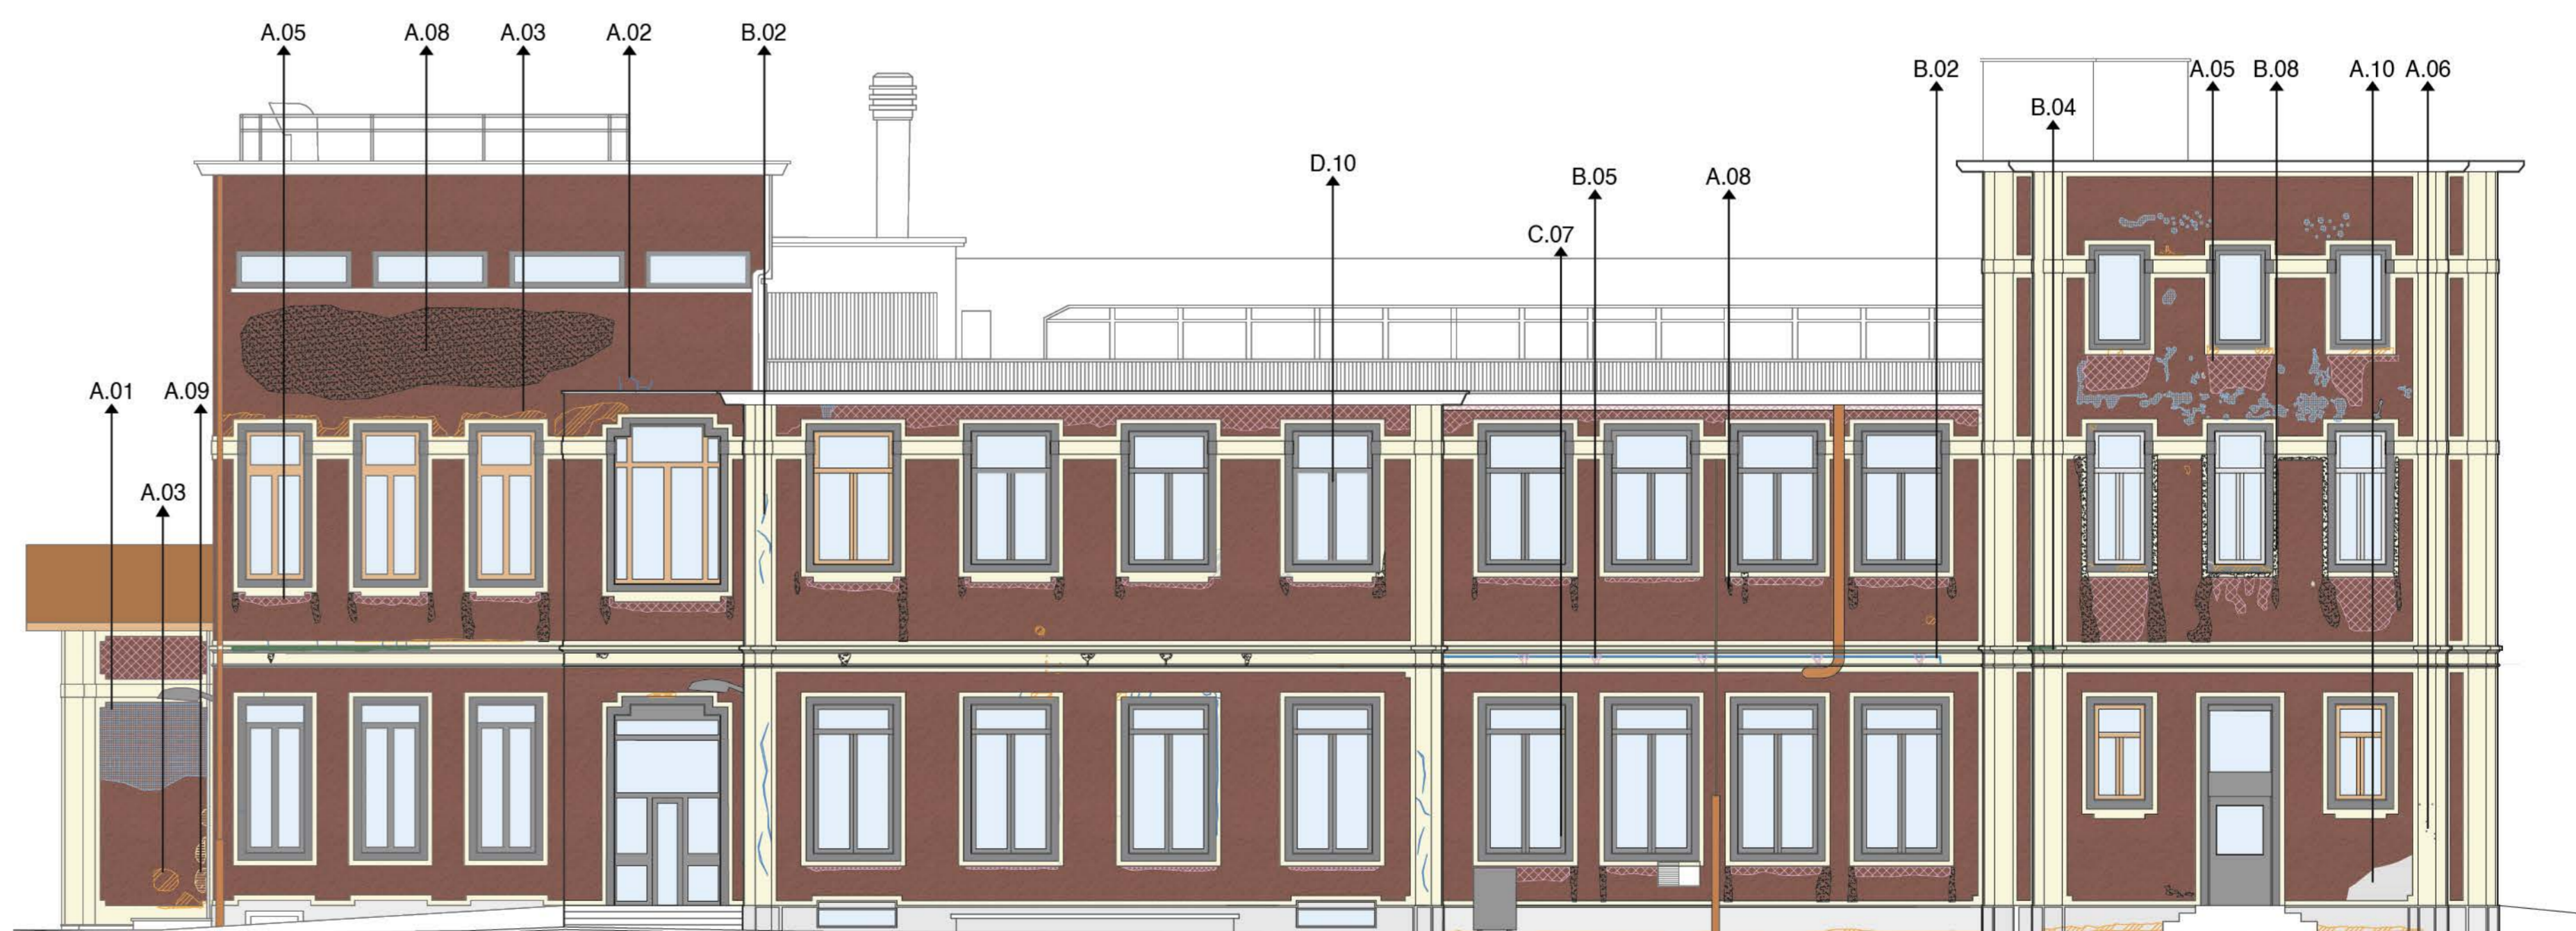
- 01. FLAKING**  
Peeling of the facade. It is caused by movement of moisture through the wall section and the presence of incompatible top layer added on the existing.

- 02. CRACKS**  
Superficial crevices on the surface of the facade developed due to varying thermal response of the interacting materials and further expanded from a freeze-thaw mechanism.

- 03. DETACHMENT**  
Caused by the existence of salt and water, the layers lose their adhesive strength. Due to the salt crystallization, the layers tend to detached from the wall substrate.

- 04. BIO COLONIZATION**  
This form of deterioration showed up because of lack of sun, presence of humidity and water. Particularly on the northern facade. Mostly harmless in nature.

- 05. MATERIAL LOSS**  
Largely located on the skirting of the facade due to physical damages and movement of water.
- 06. DEPOSIT**  
Depositing of black soot on the surface of the facade largely composed of carbon and dirt. The presence of this is in areas that are protected from the rain.

- 07. MECHANICAL DAMAGE**  
This sort of damages are present at the place of addition of signage which were added later on the original structure.
- 08. CORROSION**  
Staining of the mouldings as well the corrosion of the internal bars of the window moulds due to the carbonation which occurs largely due to the weather conditions.

- 09. DISCOLORATION**  
Caused by the movement of water on the facade. Discoloration effect varies with the varying volumes of water movement influenced both by the architectural elements and lack of maintenance.

- 10. EFFLORESCENCE**  
This decay is largely oriented with the presence of salts in the new interventions as well as the presence of salts in the water.
