WHY

SEQUENCES:

-CURRENT SITUATION -DECAY PATTERN IDENTIFICATION - CONSERVATION INTERVENTIONS - DEMOLITIONS & ADDITIONS - RESULT

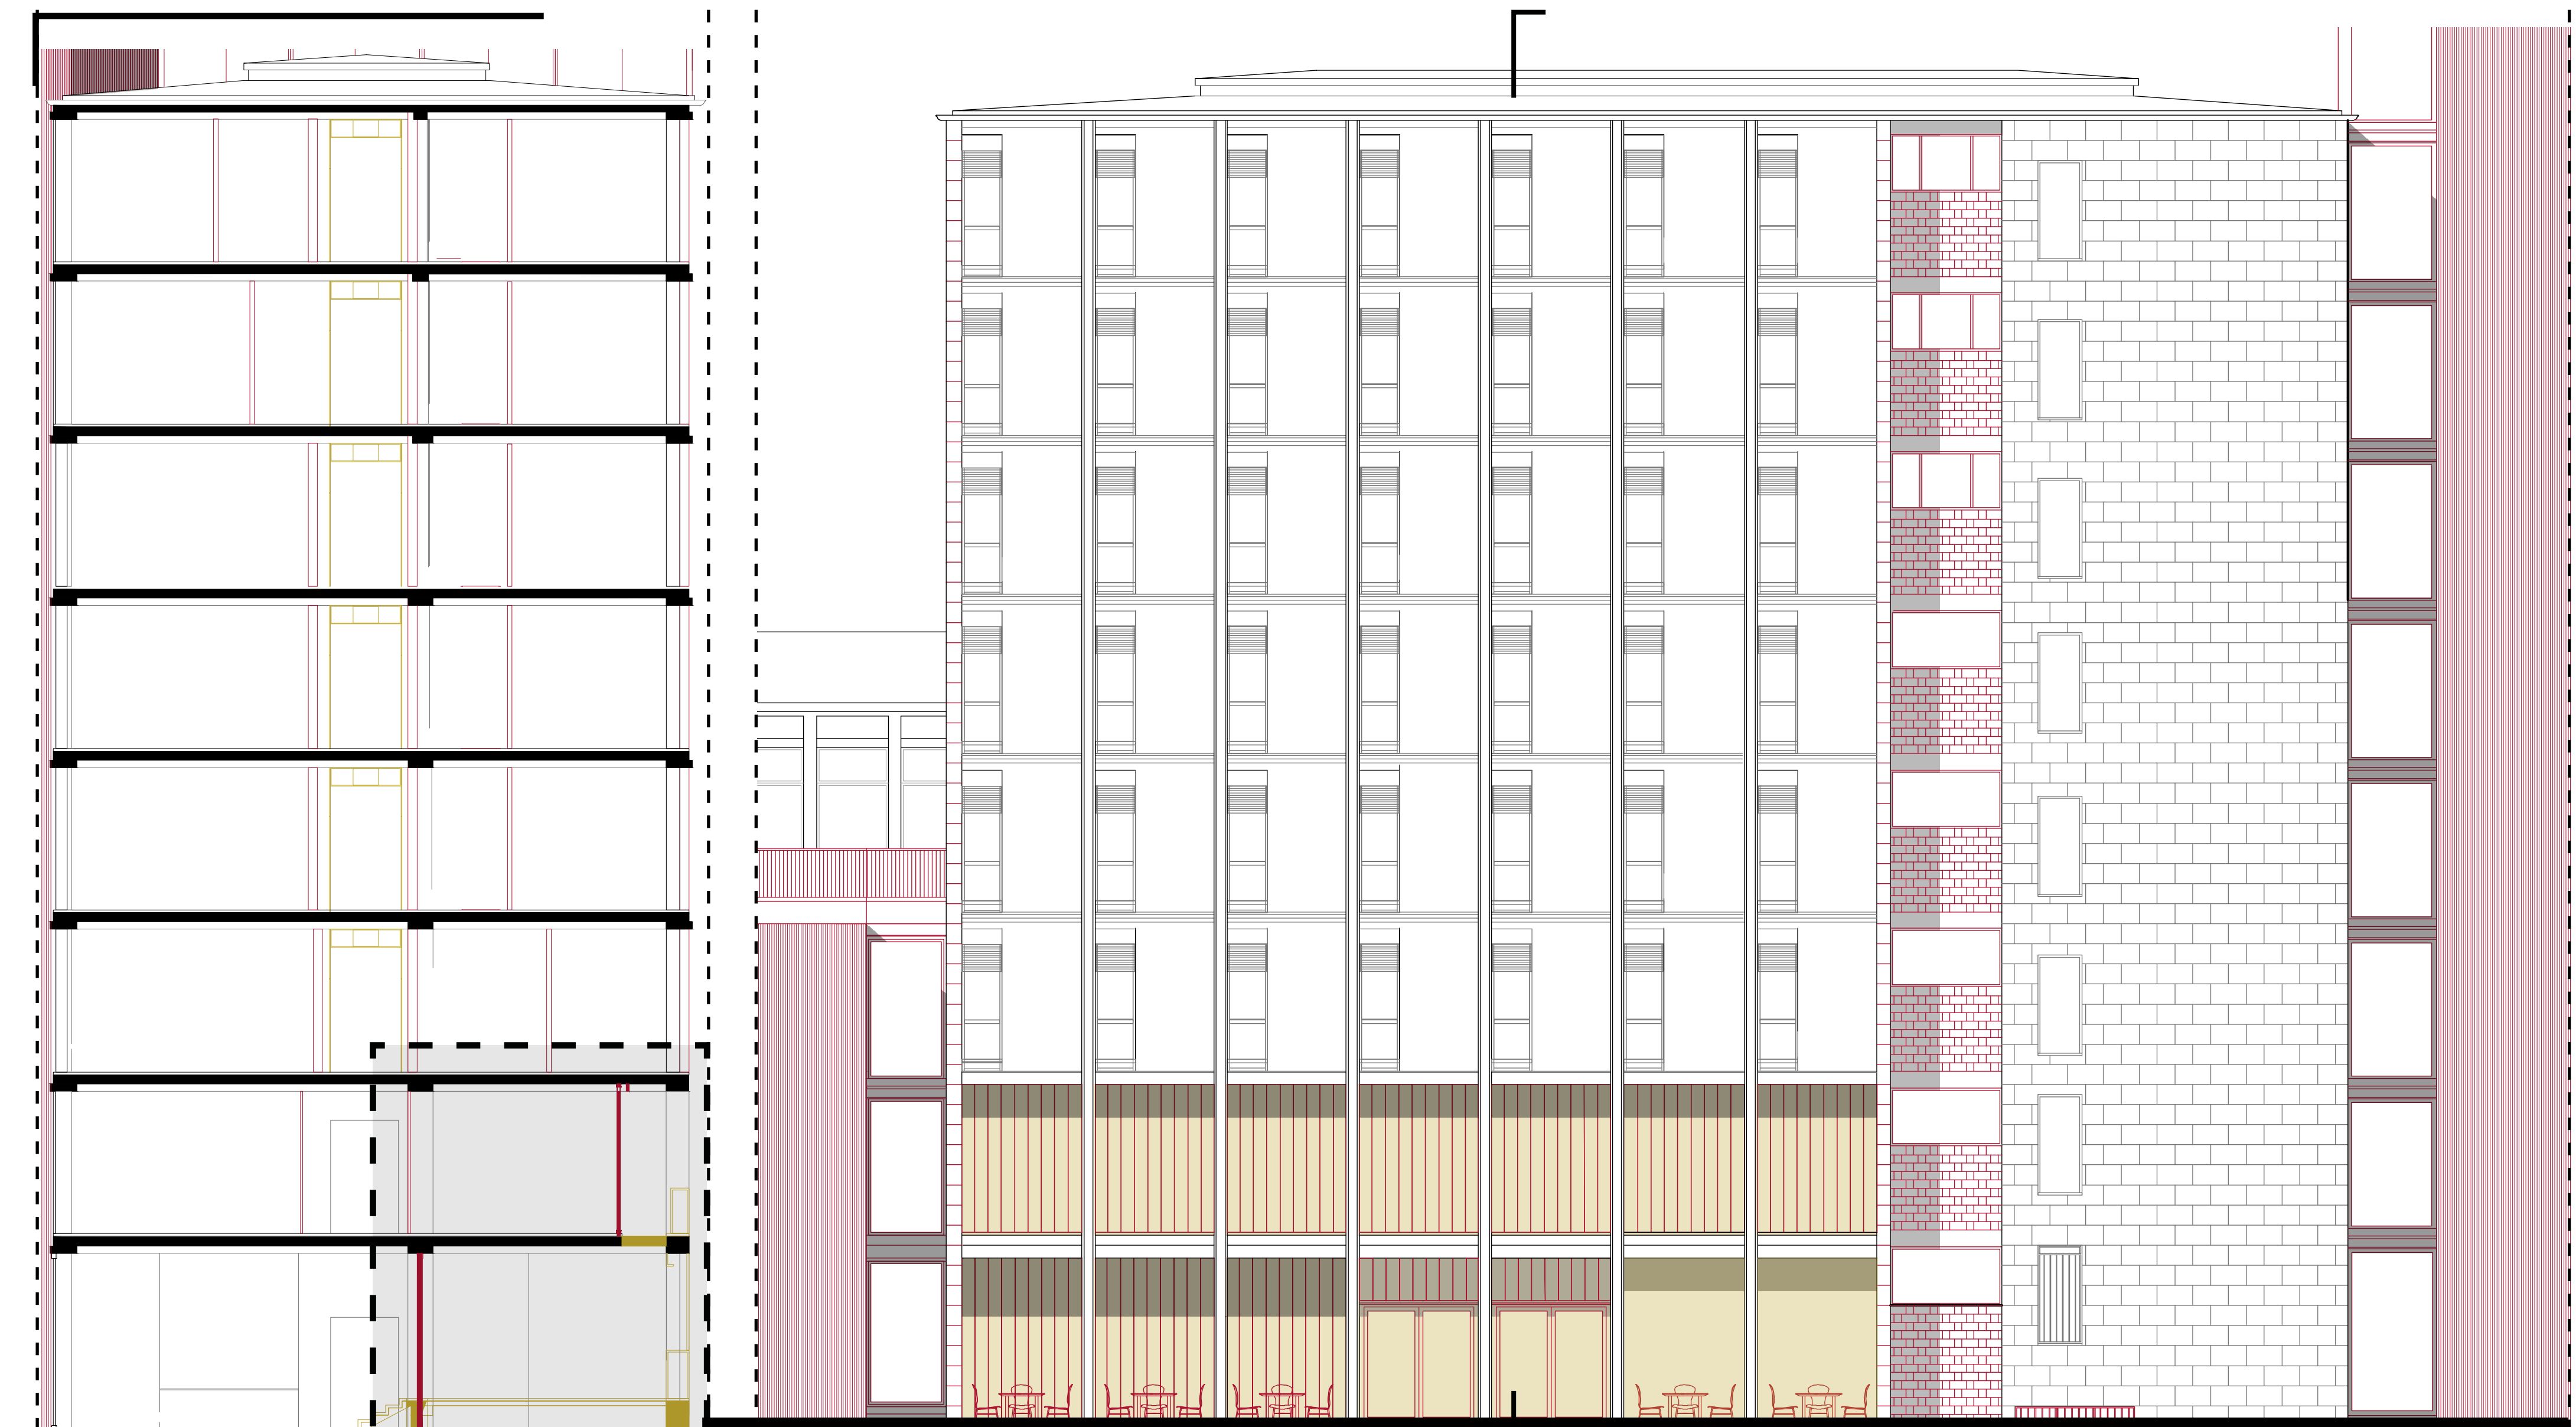
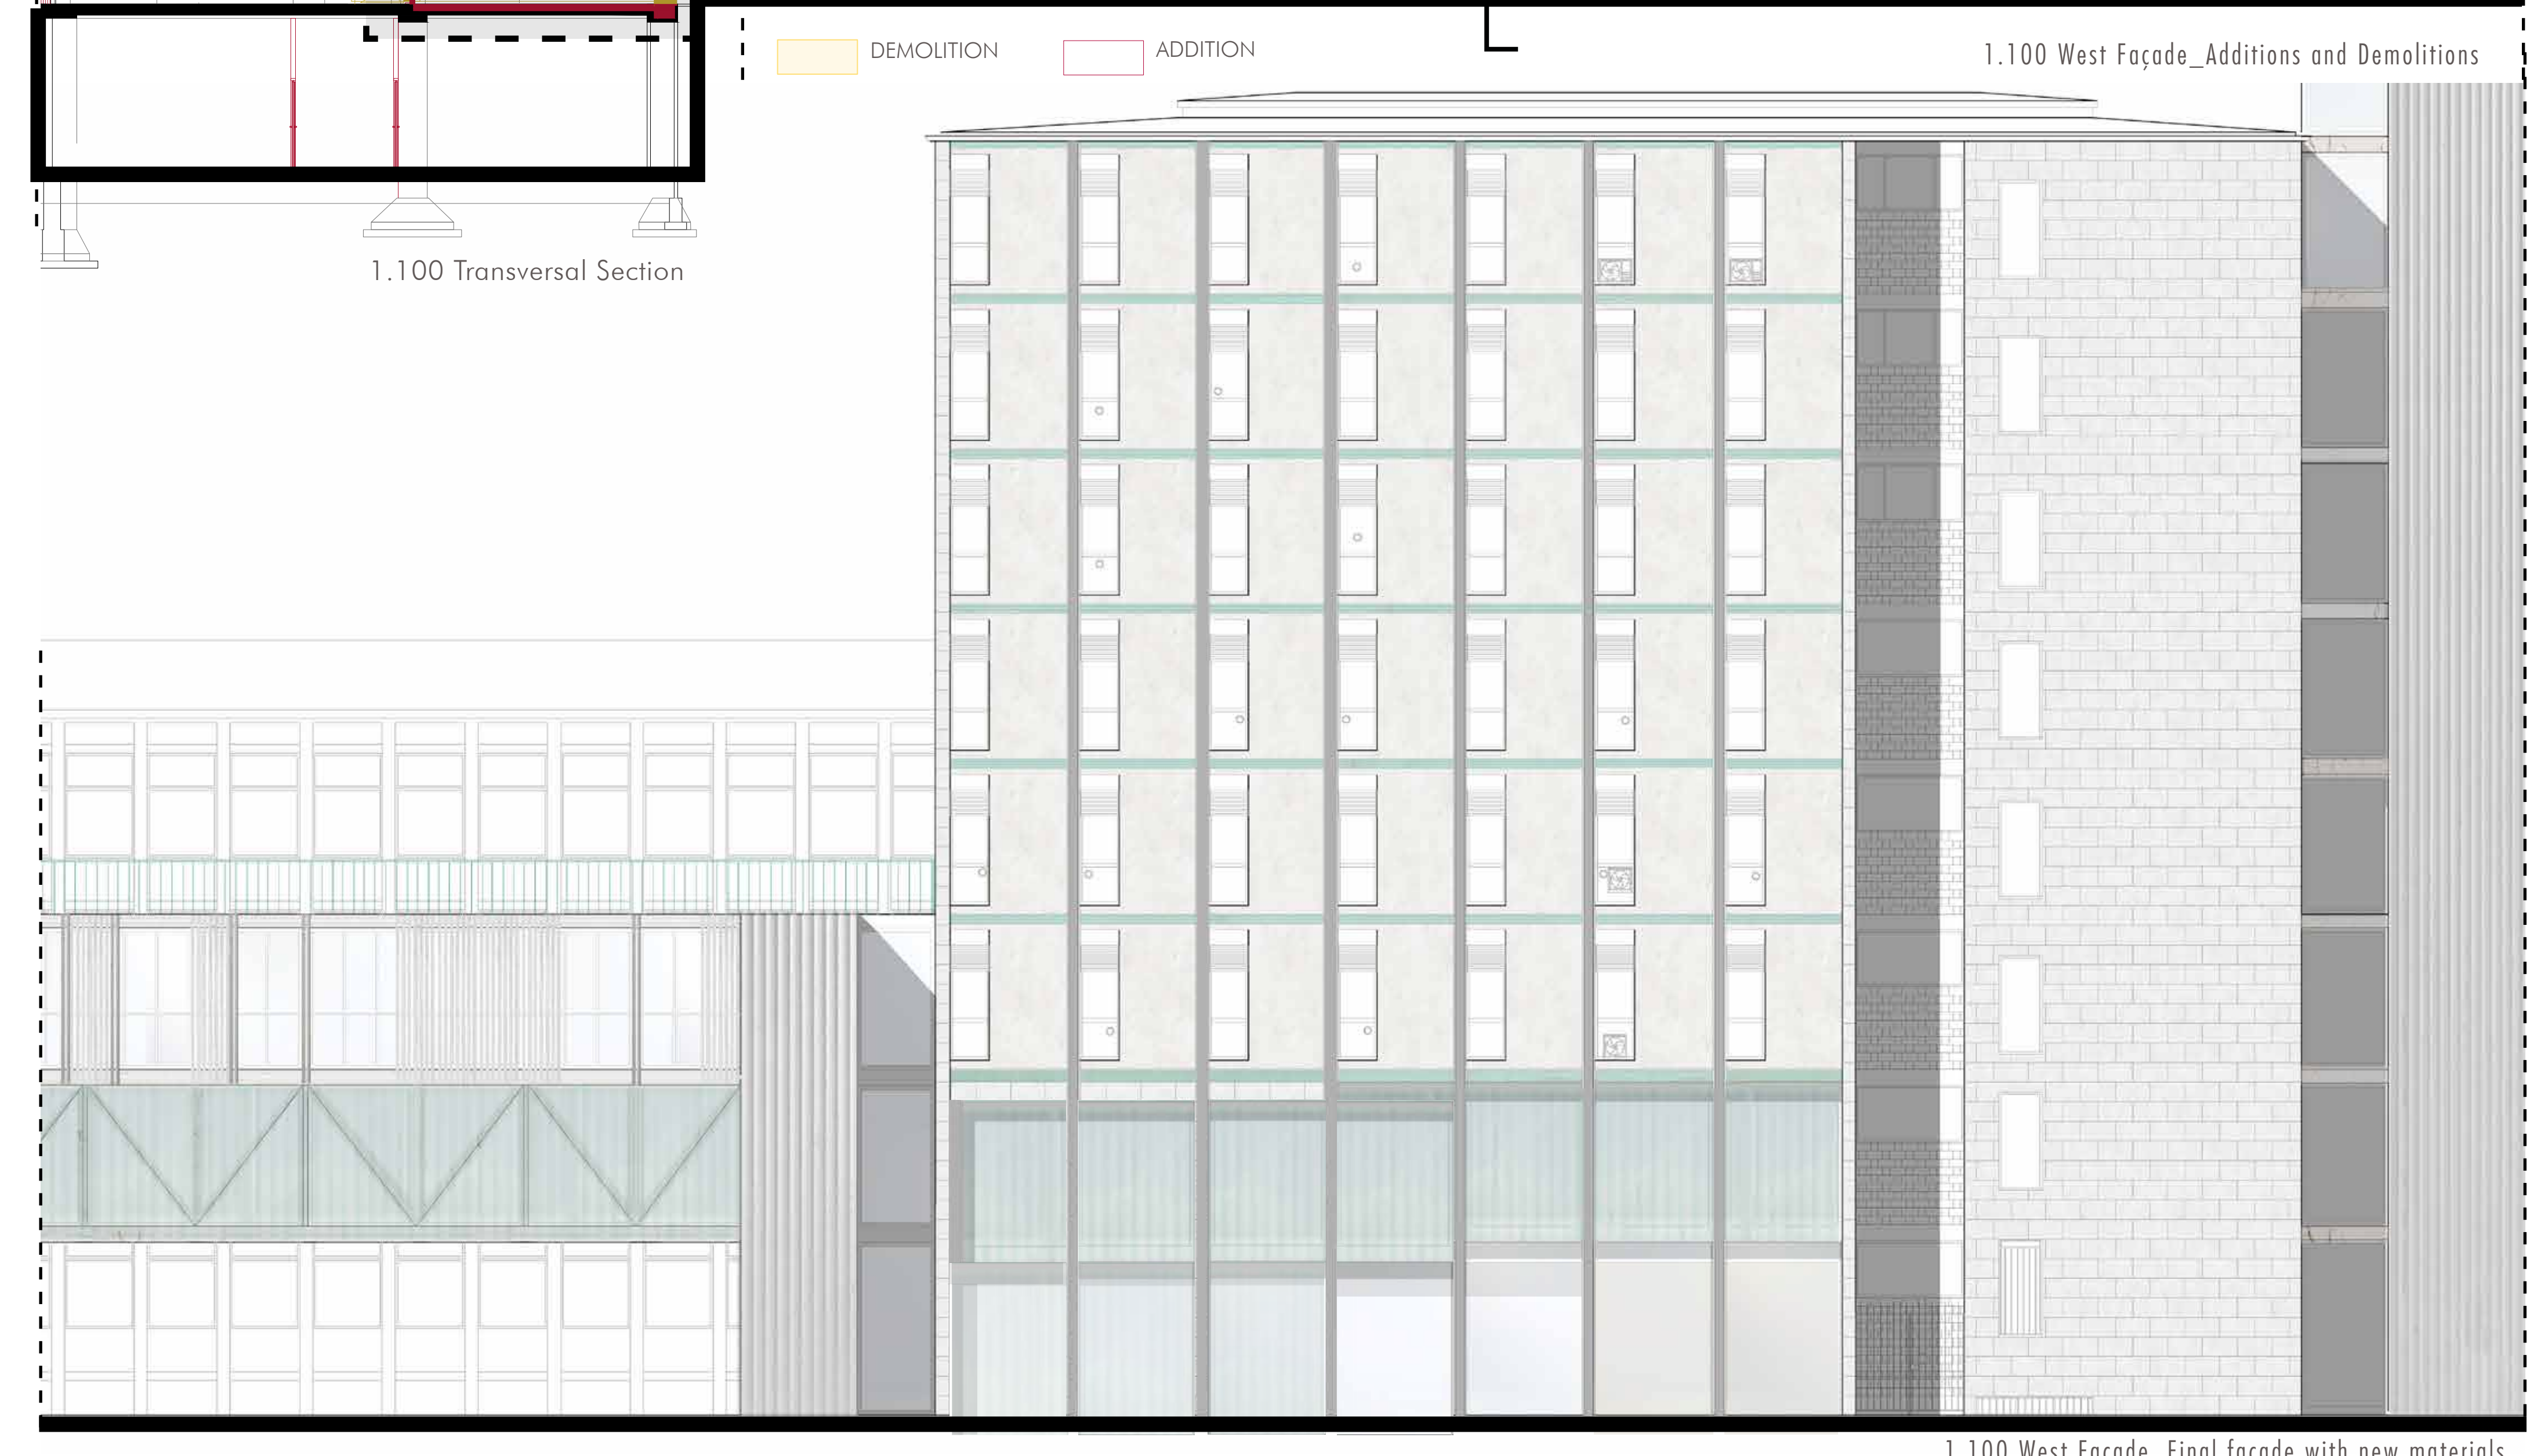
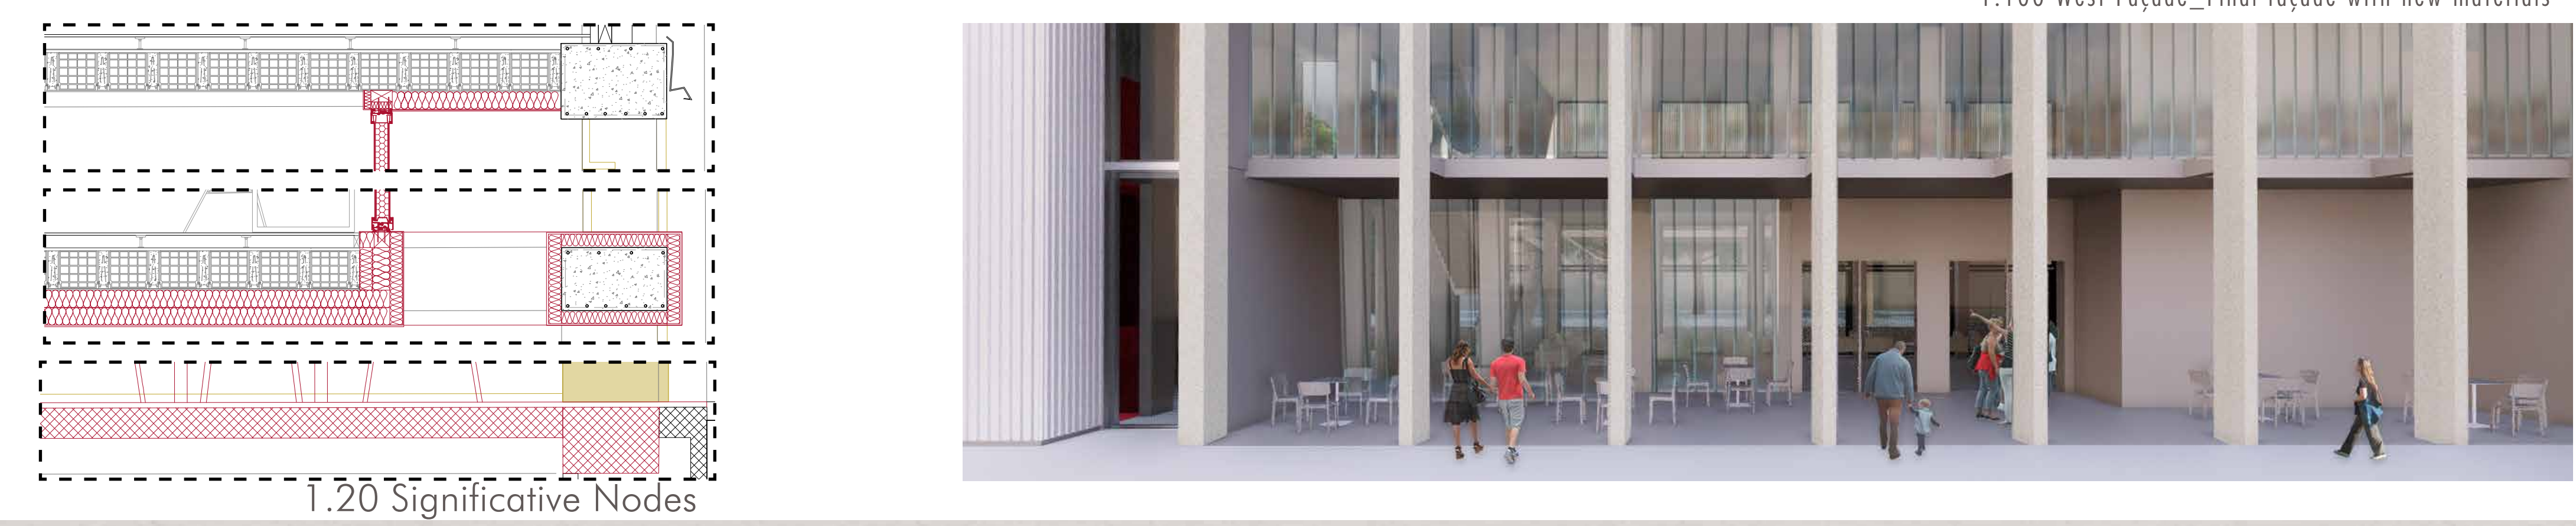
ENCrustation - SOILING		CONSolidation AND CLEANING OF PLASTER		DEMOLITION
	DISCOLOURATION - BLEACH		CONSolidation OF ROOF EAVES		ADDITION
	CRACKS		WASHING AND GENTLE WET-SAND BLASTING		
			CLEANING OF SOILING AND APPLICATION OF PROTECTIVE COATING		
			CLEANING OF YELLOW-ISH PAINT AND CONSOLIDATION		
			SUBSTITUTION OF WINDOW FRAMES		
			REMOVAL OF OLD SERVICES FROM THE FAÇADE

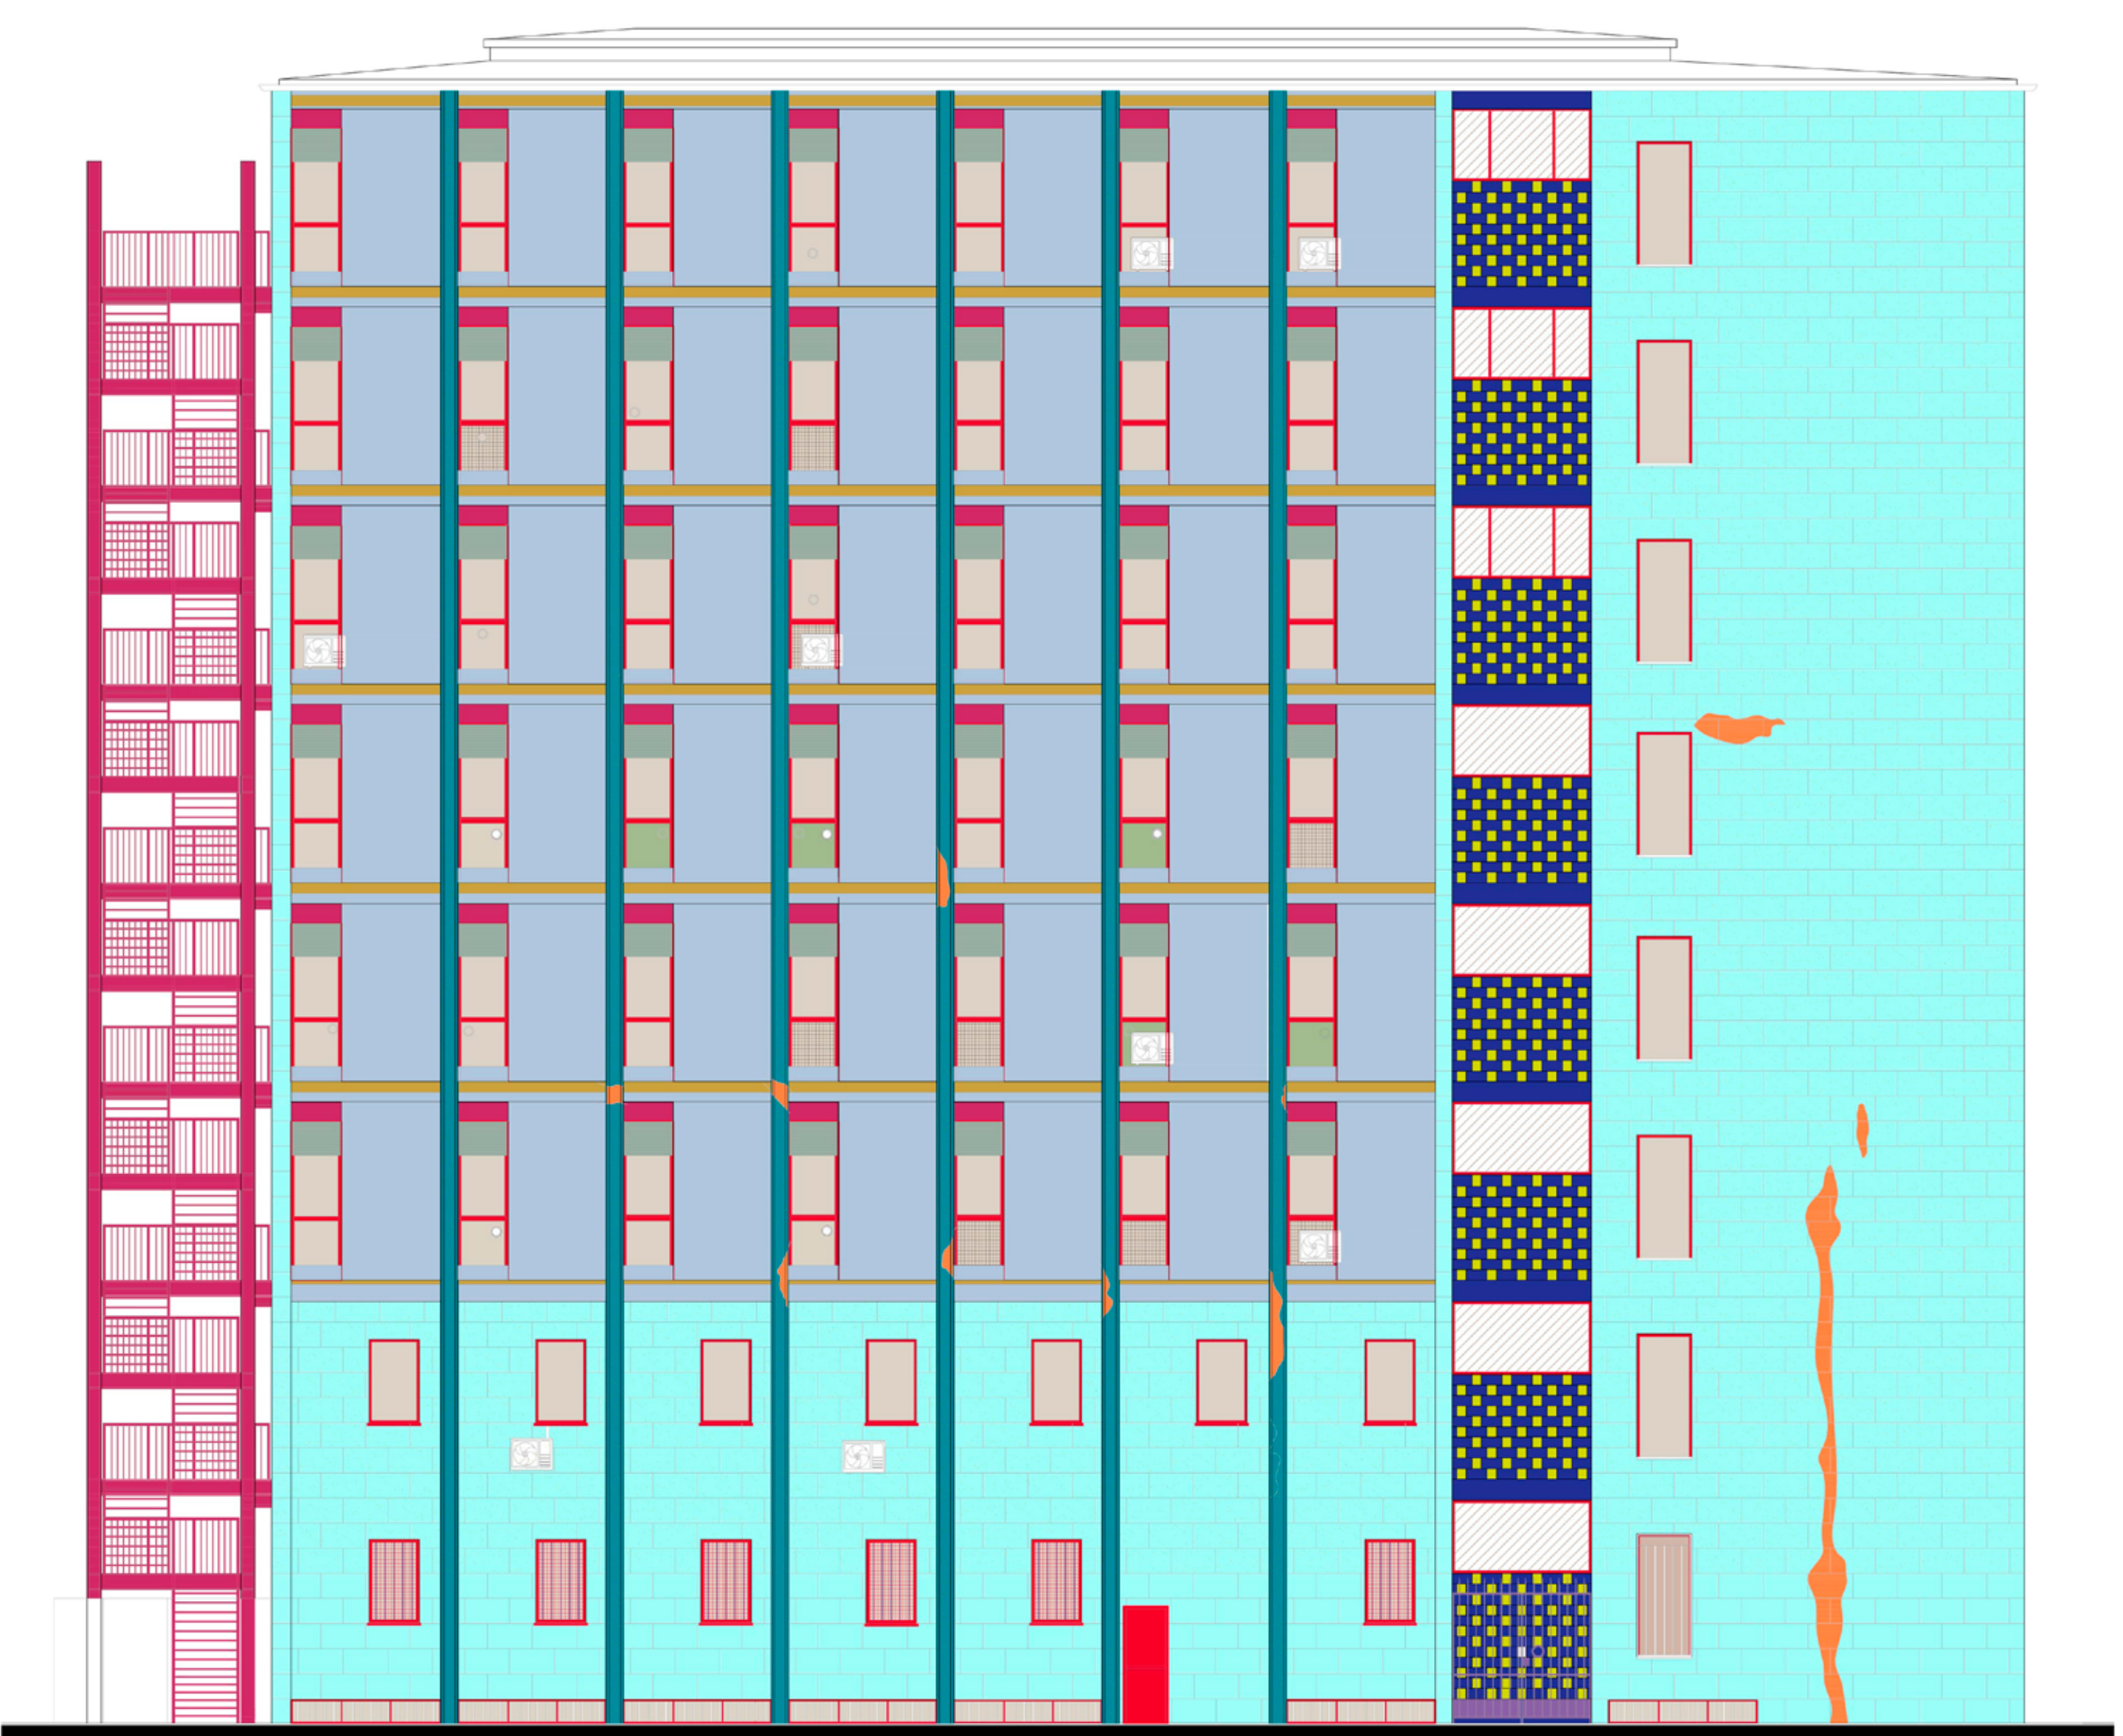
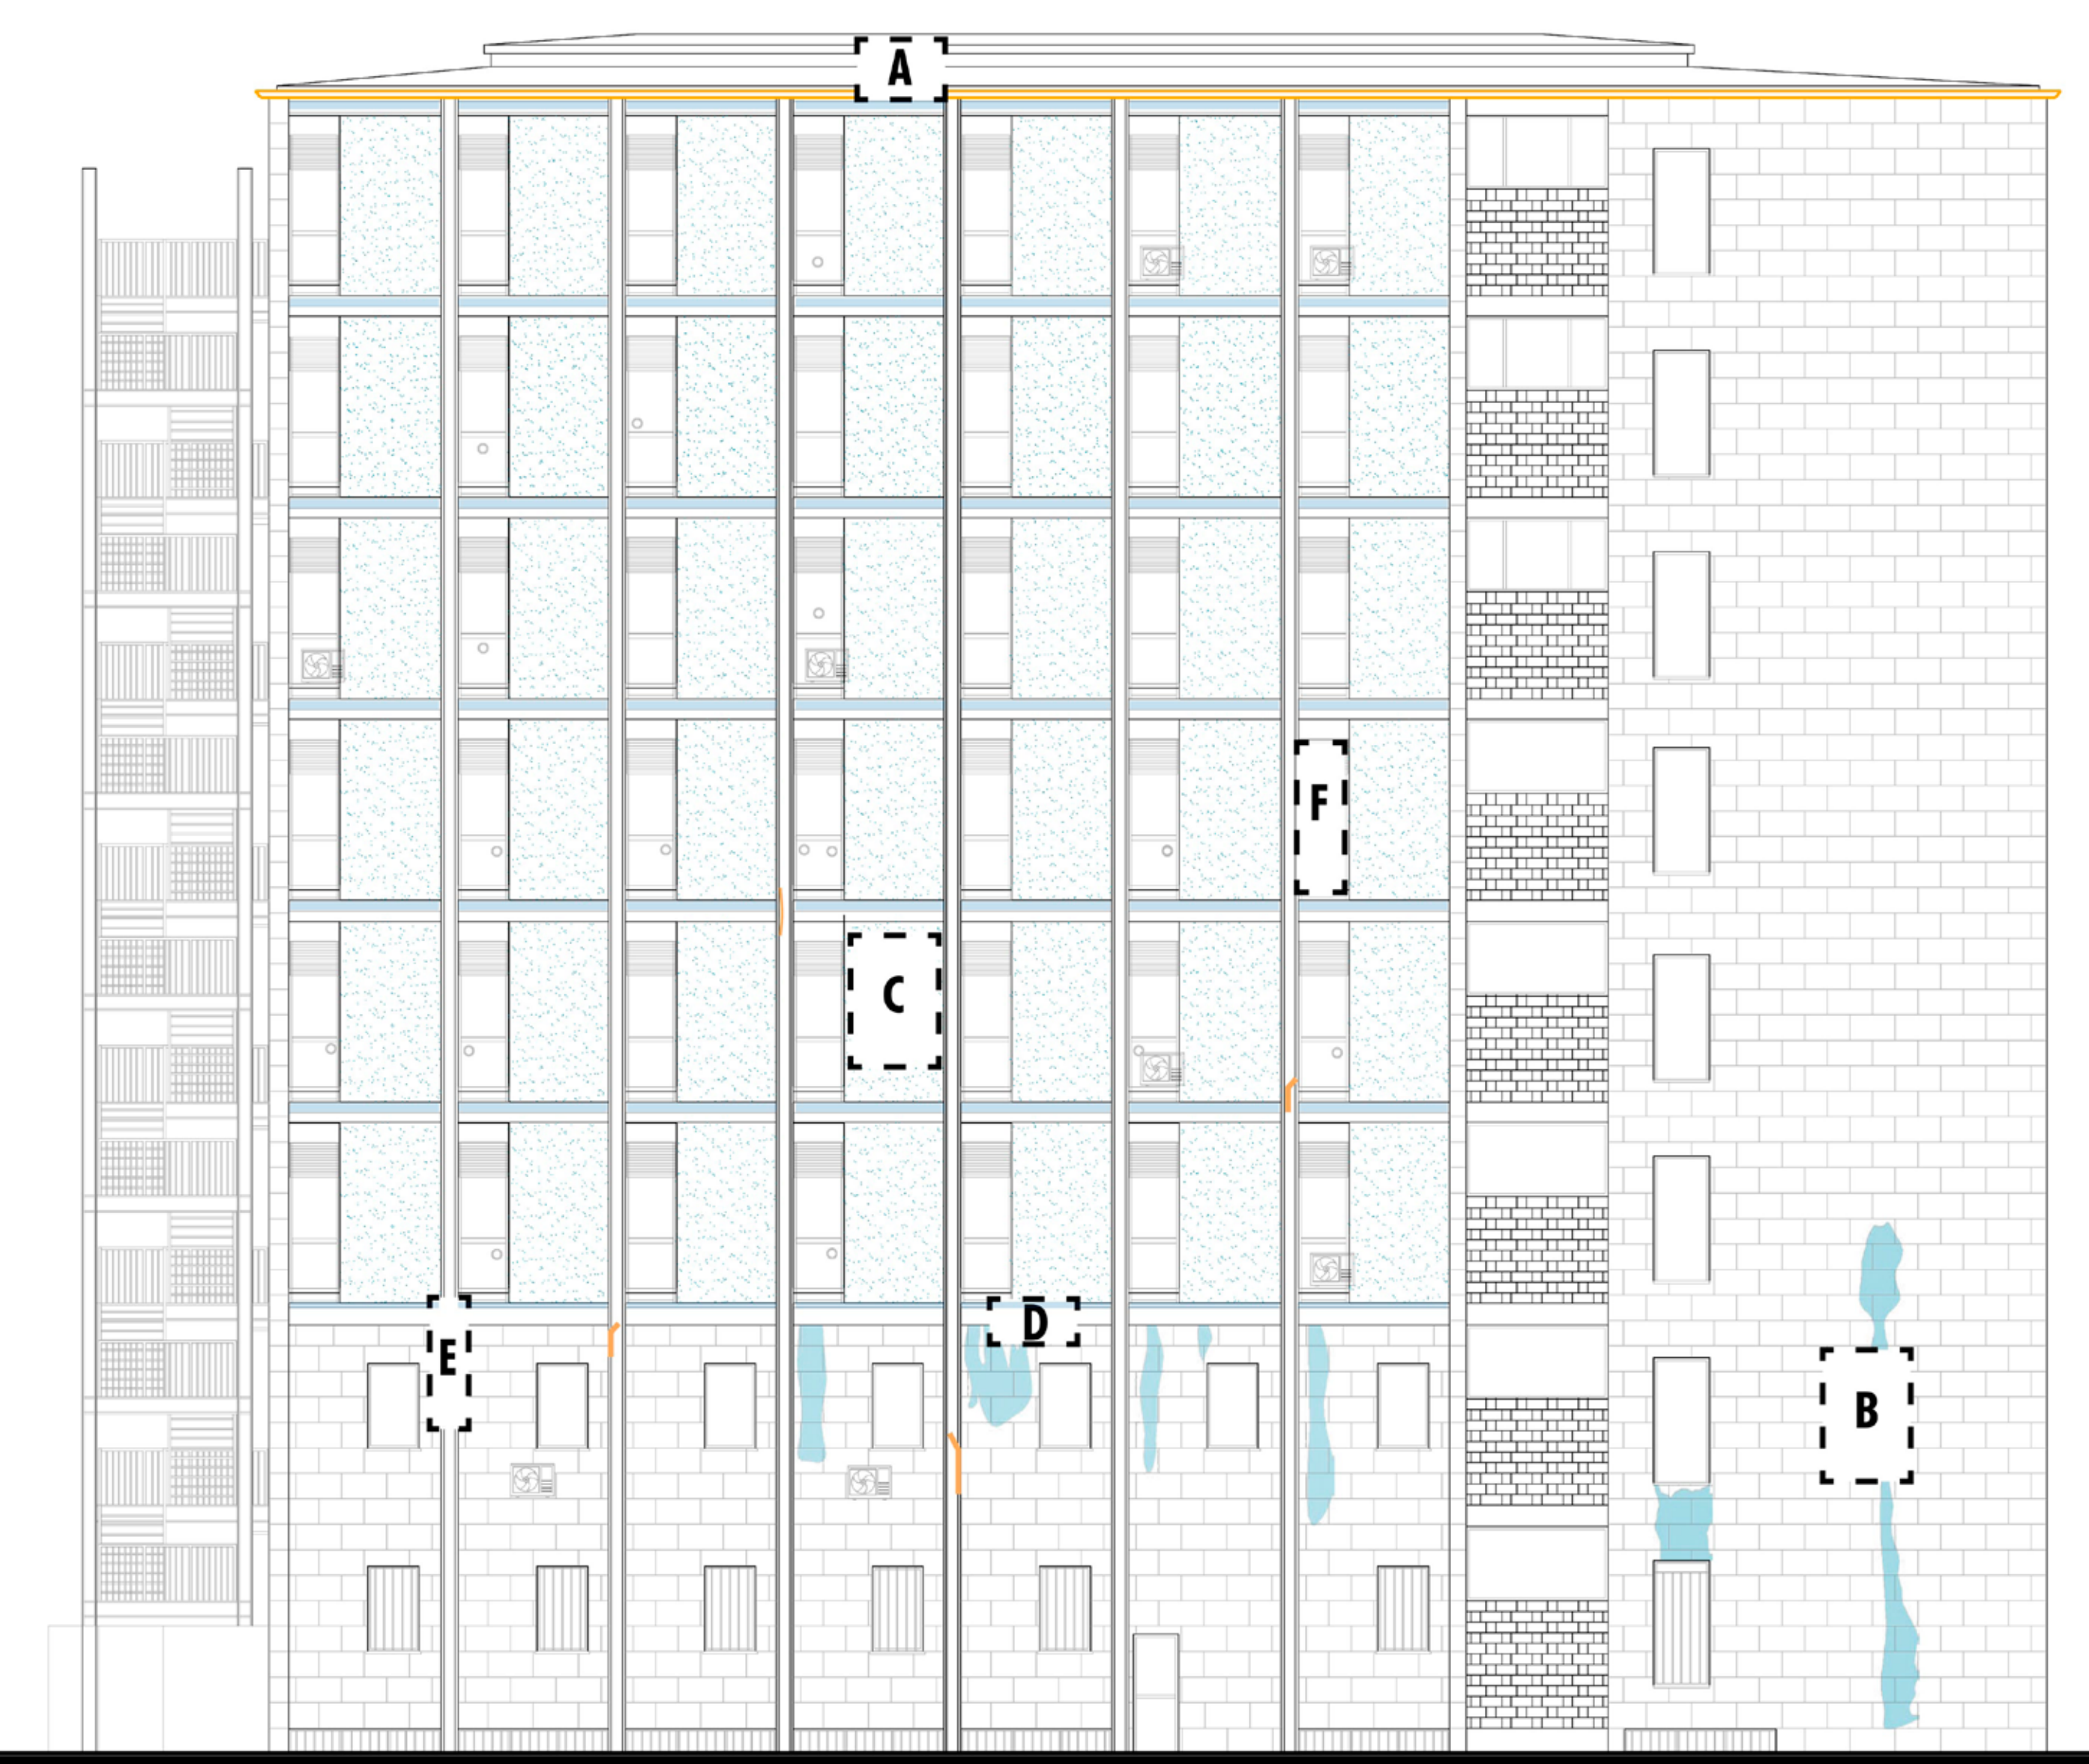
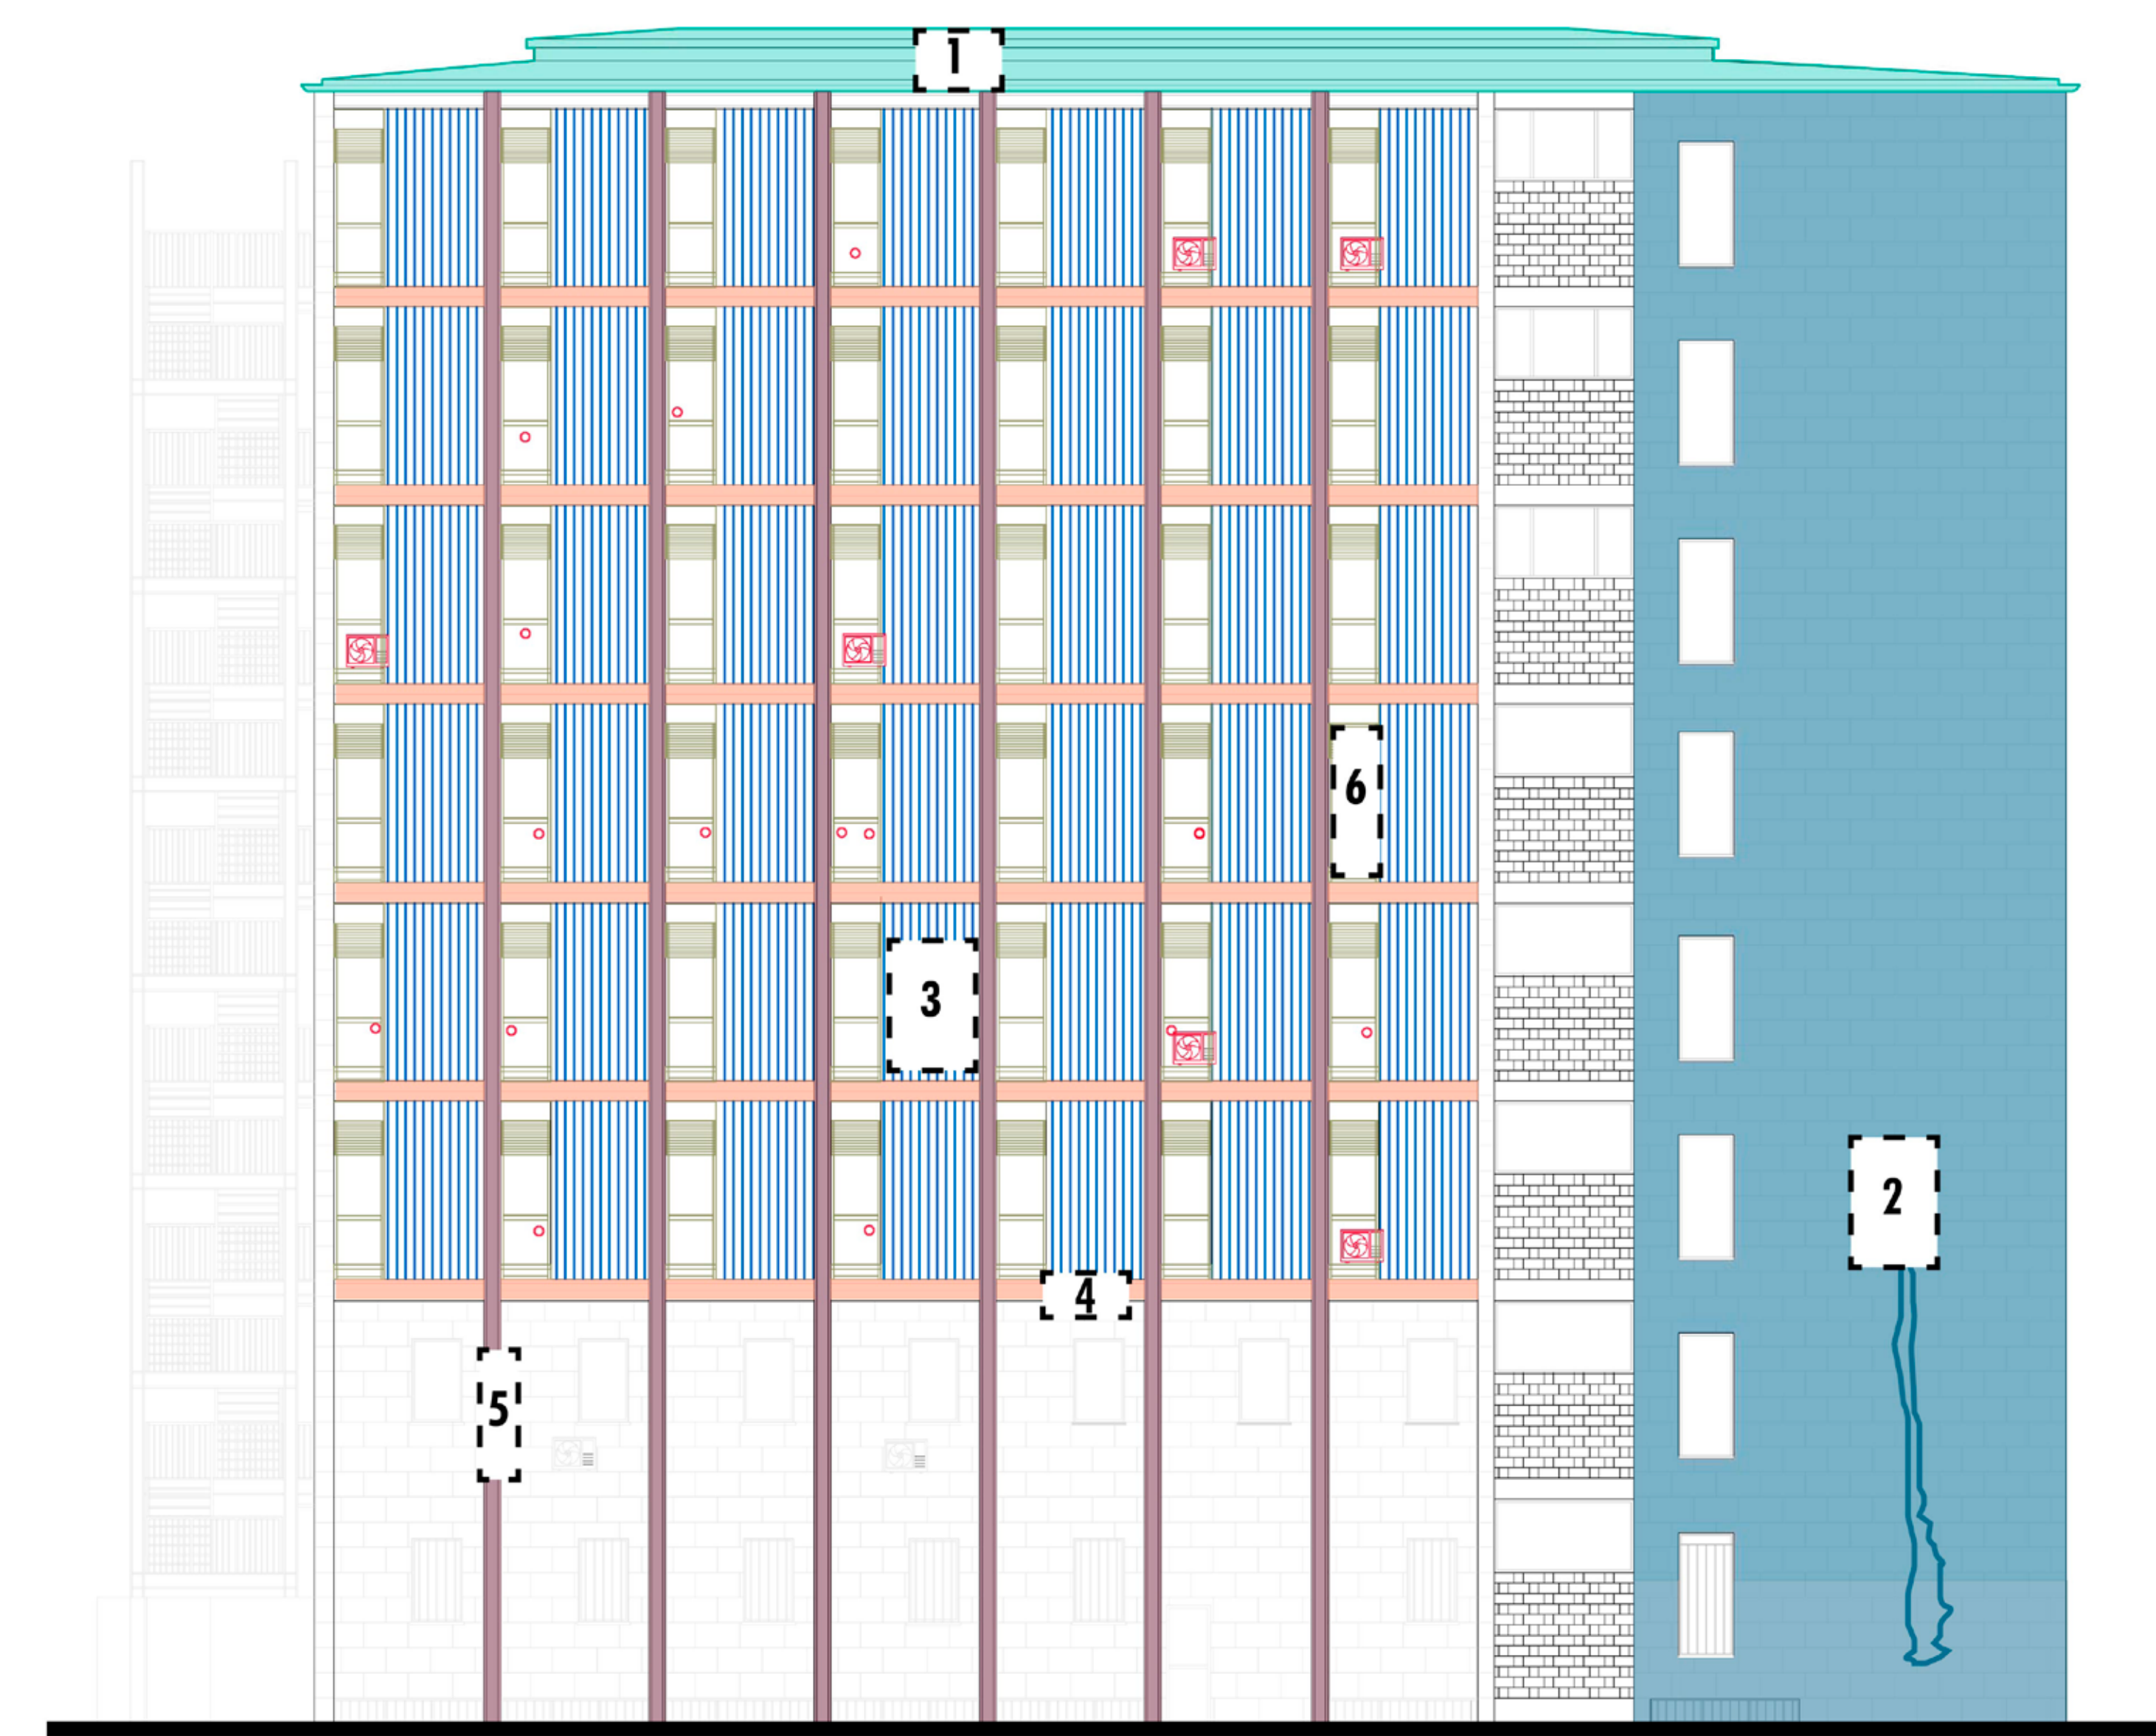
DECAY MAPPING

MISSING PART - CHIPPING/LACUNA
 CRACKS
 ENCRUSTATION - SOILING
 DISCOLORATION - BLEACH
 DISCOLORATION - MOIST AREA
 ALGA
 PLANT

A WATER LEAKAGE CRACKS

B DEPOSIT

C DISCOLORATION & PEELING

D SOILING & CORROSION

E LOCAL CRACKS & CARBONATON RISK

F THERMAL EFFICIENCY

1 Consolidation of Roof Eaves
 • Re-design of the rain-water drainage system, so as to fit also the old system with the one of the newly added volumes;
 • Consolidation on roof eaves via crack filling with cement mortar injection;
 • Coating of roof eaves with a new homogeneous layer of render as well as a protective coating.

2 Cleaning
 • Intense washing of the facade with a concentrated alkaline cleaner for quick removal of oily substances, greasy deposits from air pollution (Applied with a paint brush over the entire facade, and rinsed with plenty of water after being left to act);
 • Gentle Wet Sand Blasting of the façade.

3 Consolidation and Cleaning
 • Washing off the facade;
 • Gentle Wet Sand Blasting of the façade;
 • Cement mortar injections to the spider-webbing cracks on mortar;
 • Application of a silicate system protective product
 • Silicification on the coating material with the substrate

4 Gentle cleaning
 • low-pressure wet abrasive cleaning;
 • Protective coating for the patina to prevent tarnish and fading.

5 Consolidation and Cleaning
 • Gentle Wet Sand Blasting of the partial
 • yellowish painting layer on the pillars
 • cement mortar filling of the superficial cracks

6 Substitution of window frames

7 Contact with New Buildings
 • Demolition of localized portions;
 • Addition of a new internal finishing.

8 Removal of Old Services from the Facade
