POLITECNICO DI MILANO

Facoltà di Ingegneria Edile - Architettura
Corso di laurea magistrale in Ingegneria dei Sistemi Edilizi

Seismic performance of bridges during Canterbury earthquakes

Maria BRANDO Matr. 751083

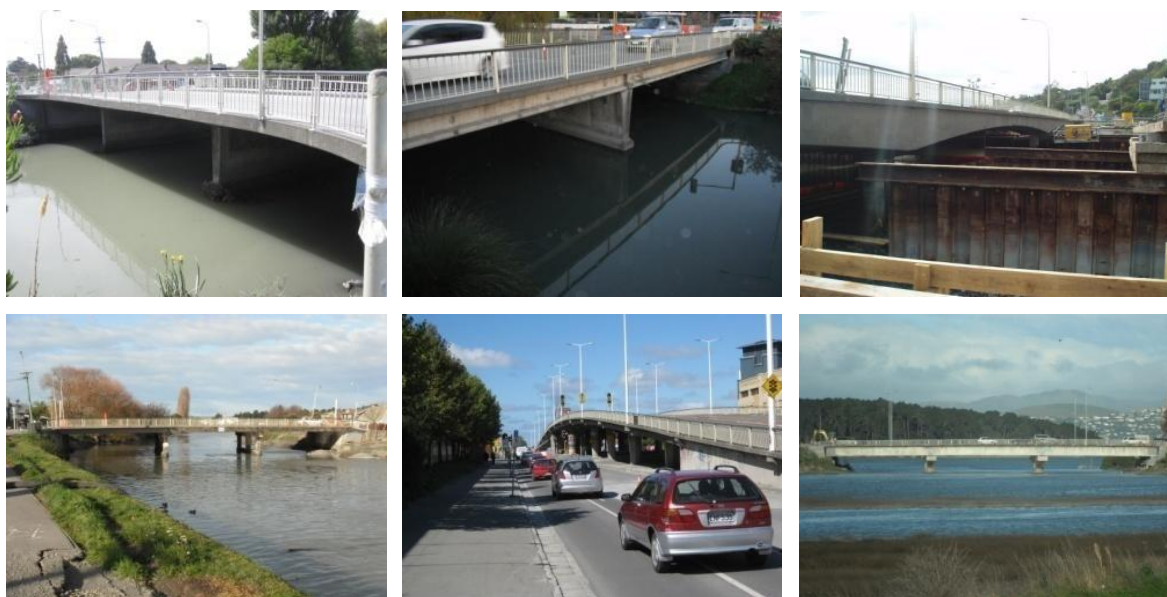
Figure 2.6. Overall views of some of the damaged bridges after February 22, 2011. Clockwise from top left: Gayhurst Rd. Bridge; Fitzgerald Ave. Bridge; Ferrymead Bridge; Avondale Bridge; Moorhouse Ave Bridge; Bridge Street Bridge

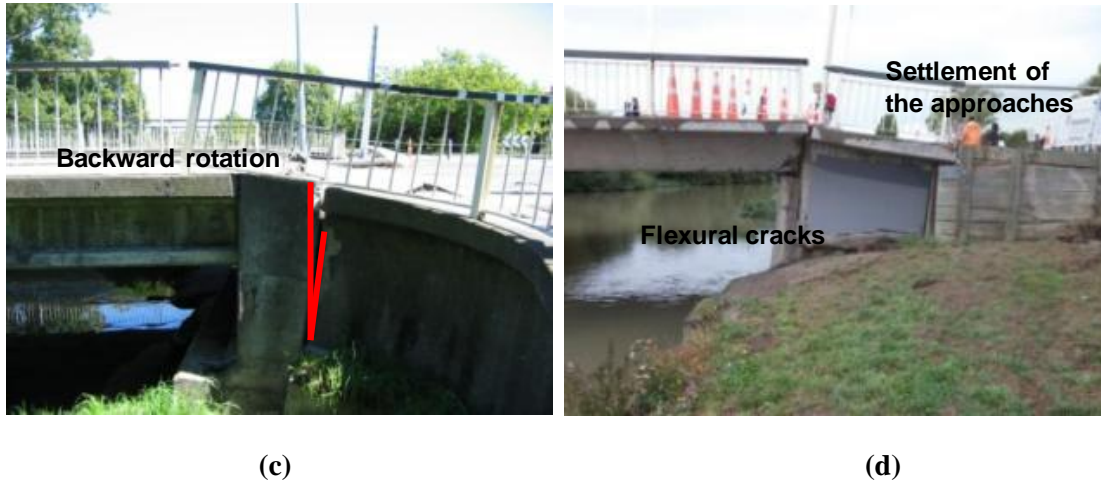
Figure 2.7. Damage at the abutments: a) Sketch of the forces acting on abutments and foundations in undeformed condition; b) Back rotated abutments of Fitzgerald Bridge [Courtesy of OPUS]; c) Back rotated abutments of Bridge Street Bridge [Photo by M. Bruneau]; d) Damaged abutments of Avondale Road Bridge [Courtesy of OPUS]

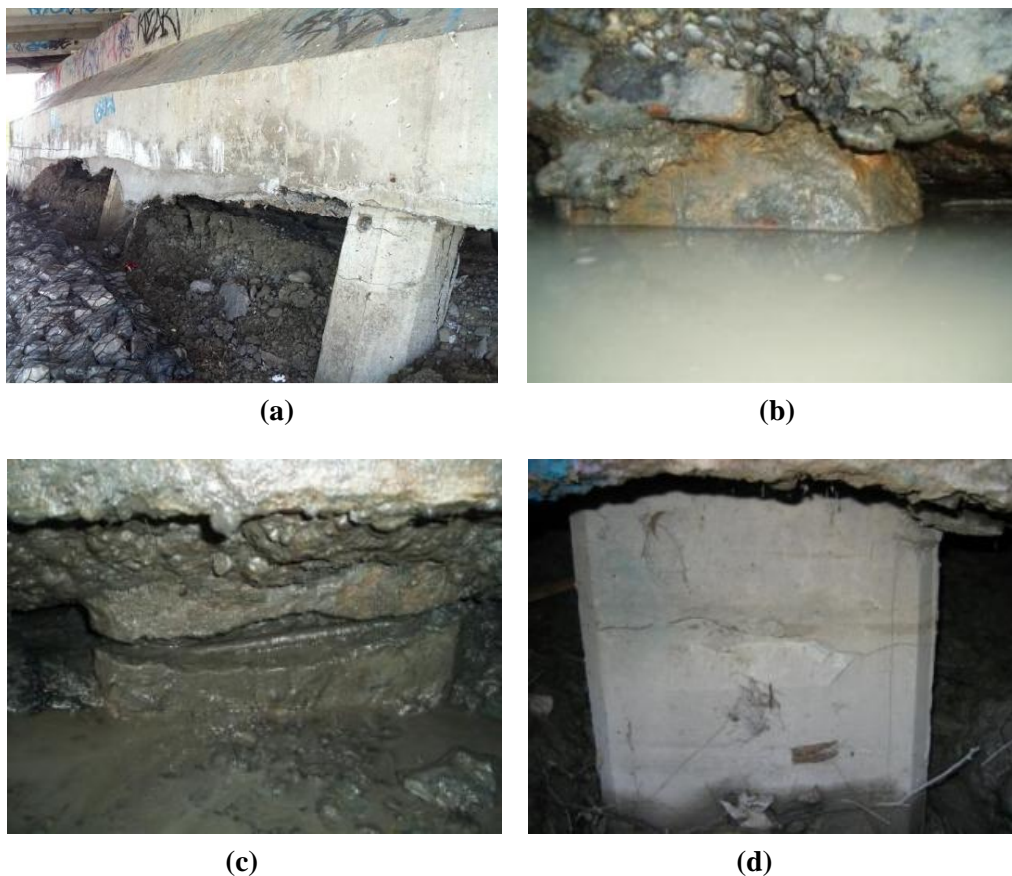
Figure 2.8. Damage to pile foundations: a) Plastic hinging in abutment piles of Bridge Street Bridge [Photo by L. Wotherspoon]; b) Exposed piles during the securing works on Avondale Road Bridge [Courtesy of OPUS]; c) Exposed piles during the securing works on Gayhurst Road Bridge [Courtesy of OPUS]; d) Flexural cracks on Fitzgerald Ave Bridge piles [Courtesy of OPUS]

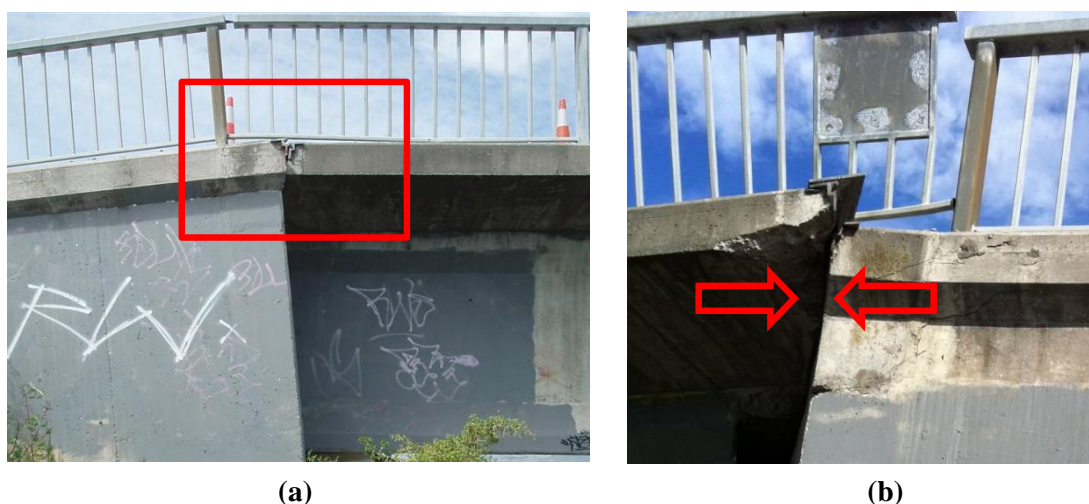
Figure 2.9. Damage to Bridge St. Bridge deck: (a) abutment gap closure [Courtesy of OPUS] and (b) pounding of the deck on the abutment after Christchurch event [Photo by A. Kivell]

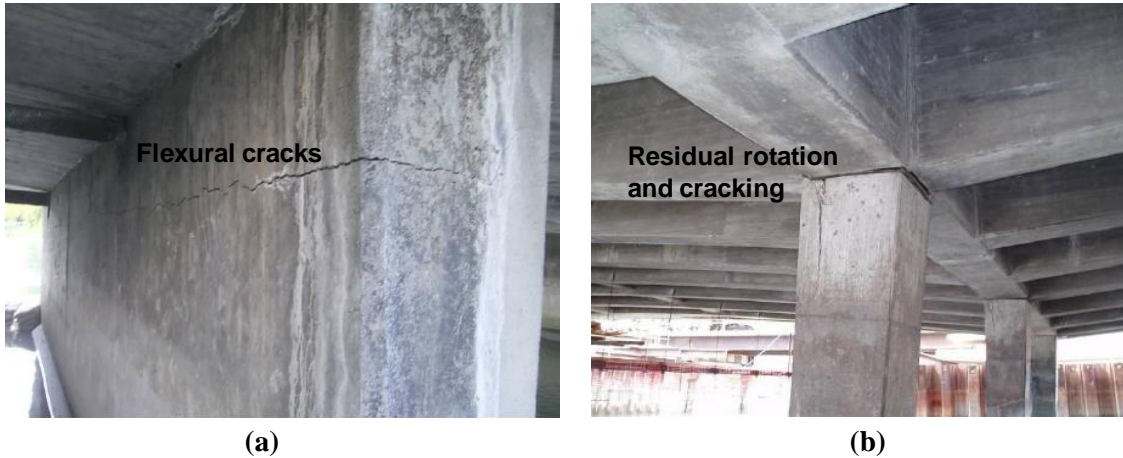
Figure 2.10. *a) Damaged pier in Gayhurst Road Bridge [Photo by L. Hogan]; b) Cracked and rotated piers of Ferrymead Rd. Bridge [Photo from CCC]*

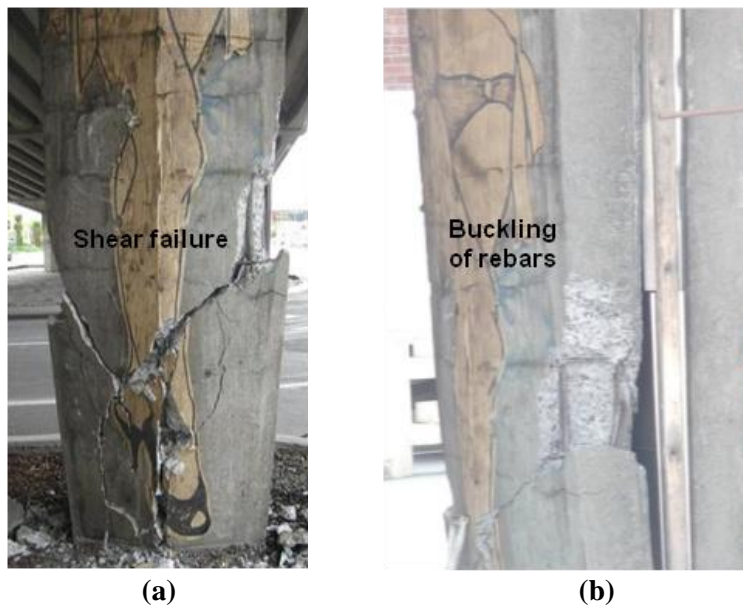
Figure 2.11. *Damage to Moorhouse Ave Bridge: a) Expansion joint at one of the piers [Courtesy of OPUS]; b) Shear failure mechanism of the pier [Photo by A. Palermo]*

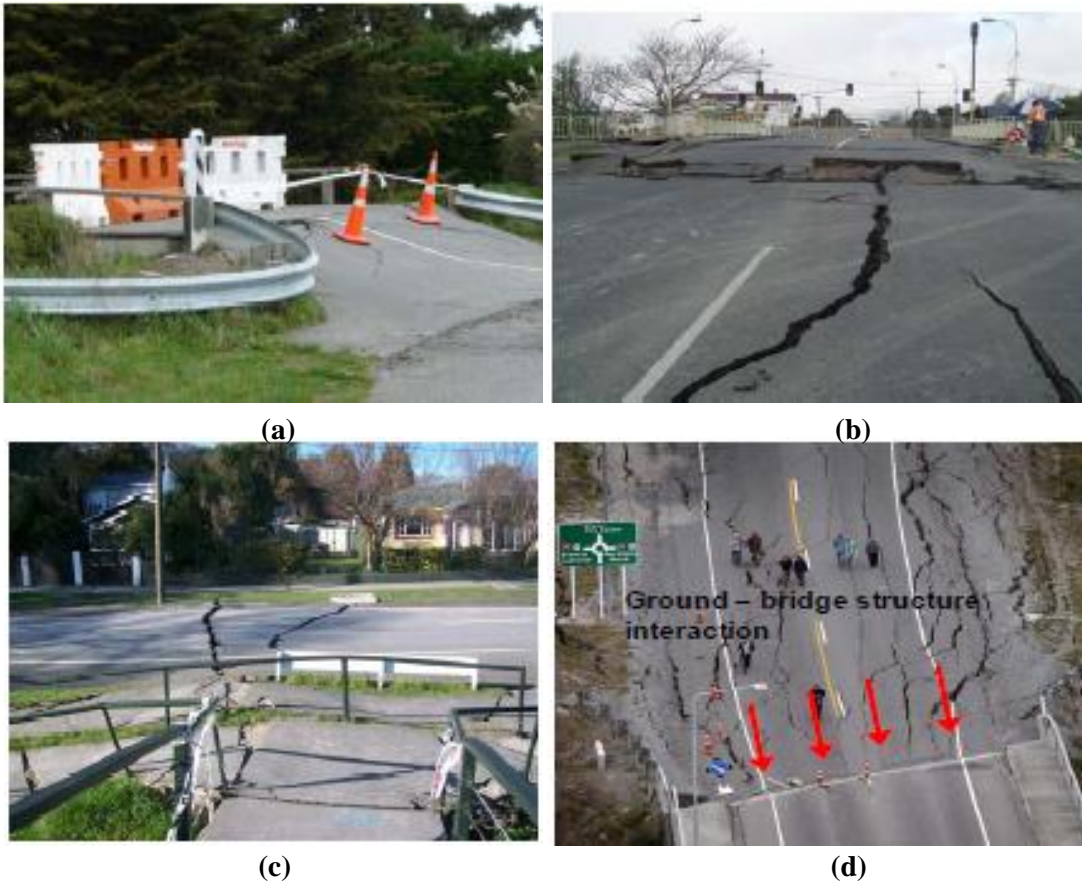
Figure 2.12. Relative vertical movement between approach and deck at: a) Davis Road Bridge, Lincoln [Photo by L. Wotherspoon]; b) Gayhurst Road Bridge [Photo by L. Hogan]; c) Bridge Street Bridge [Photo by L. Wotherspoon] d) Snell Bridge [Photo by M. Le Heux]

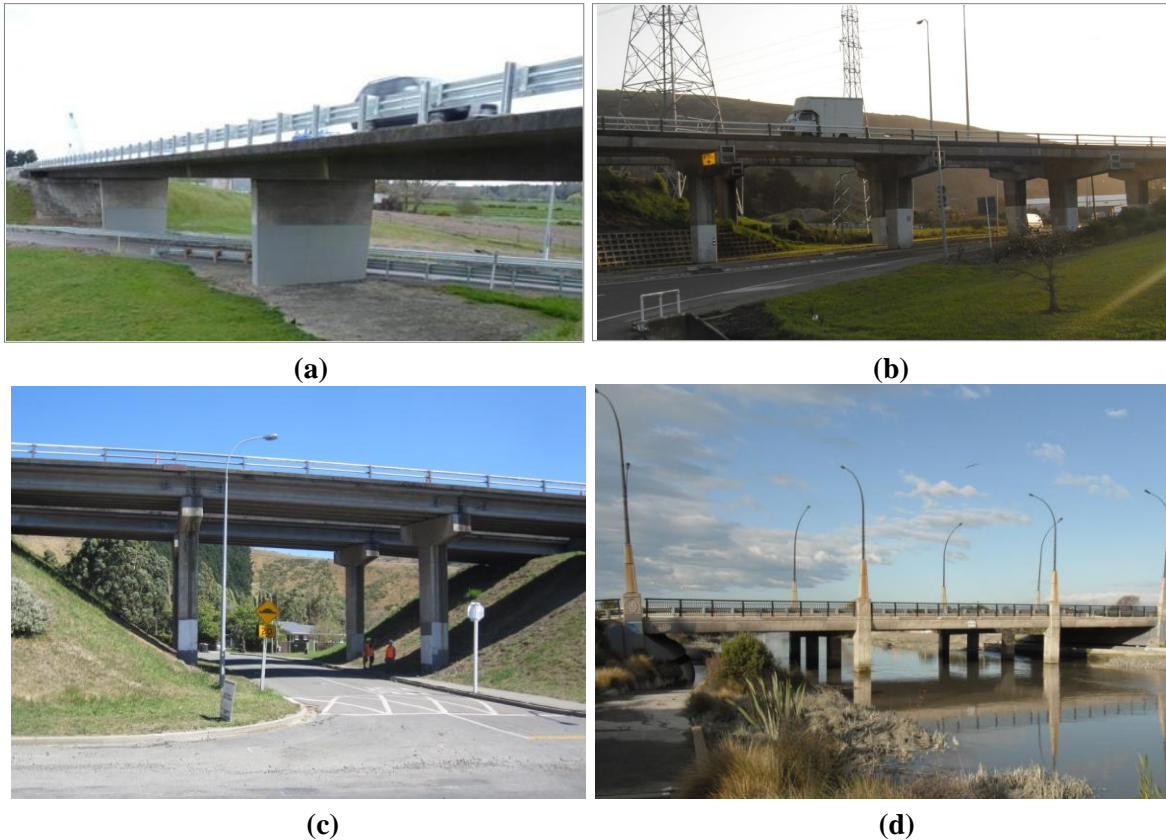
Figure 2.13. Overall view of some damaged highway bridges after February 22, 2011. a) Channeys Pass Road Bridge [Photo by M. Anagnostopoulou]; b) Port Hills Overbridge [Courtesy of OPUS]; c) Horotane Overbridge [Courtesy of OPUS]; d) Anzac Drive Bridge [Photo by E. Camnasio]

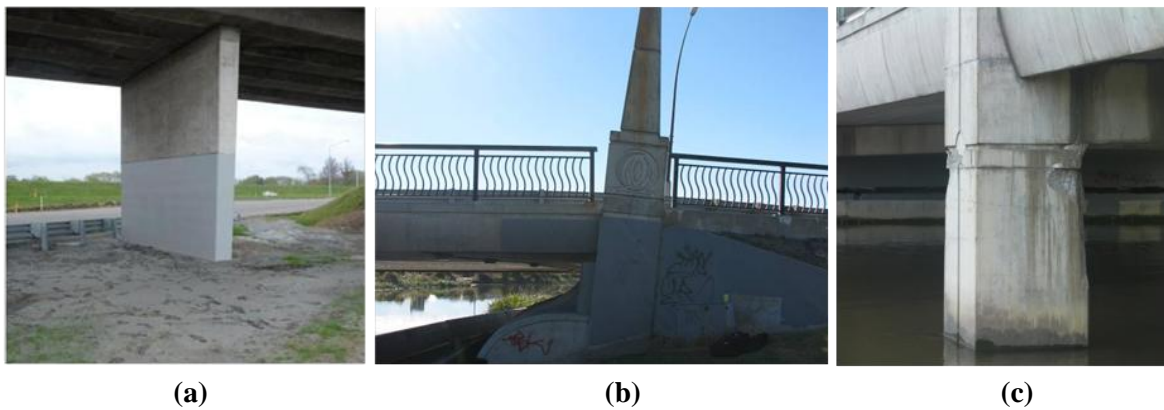
Figure 2.14. a) Liquefaction around the piers of Channeys Pass Road Bridge [Photo by M. Anagnostopoulou]; b) Backwards rotation of the abutments of Anzac Drive Bridge [Photo by A. Palermo]; c) Plastic hinging at the pier caps of Anzac Drive Bridge [Photo by E. Camnasio].

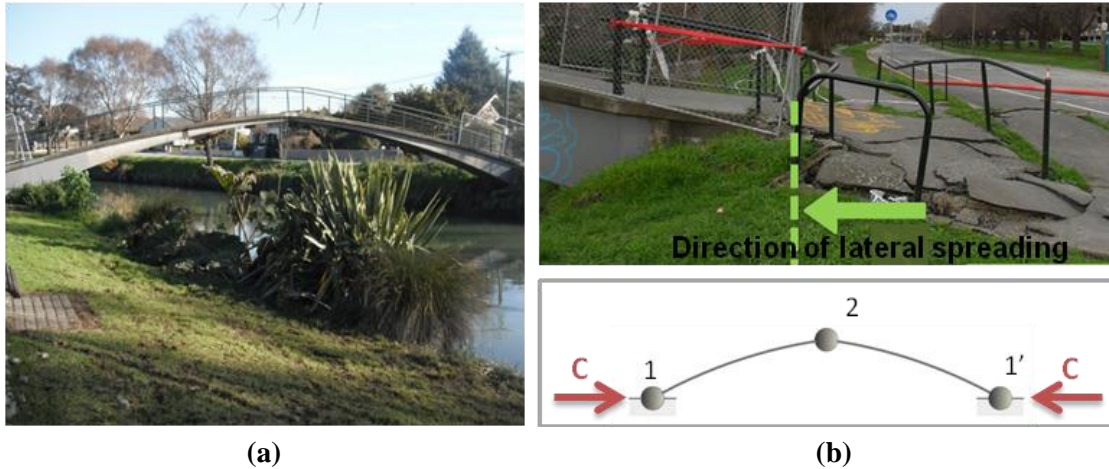
Figure 2.15. a) Overall view of the Snell Place Footbridge with indication of the three-hinge arch mechanism [Photo by A. Palermo]; b) Plastic hinge formation at the mid span [Photo by M. Le Heux]; c) Close up view of the plastic hinge at mid span from the side [Photo by A. Kivell] and from the bottom [Photo by M. Le Heux]; b) Damage to abutment: close up of the crack [Photo by M. Le Heux]

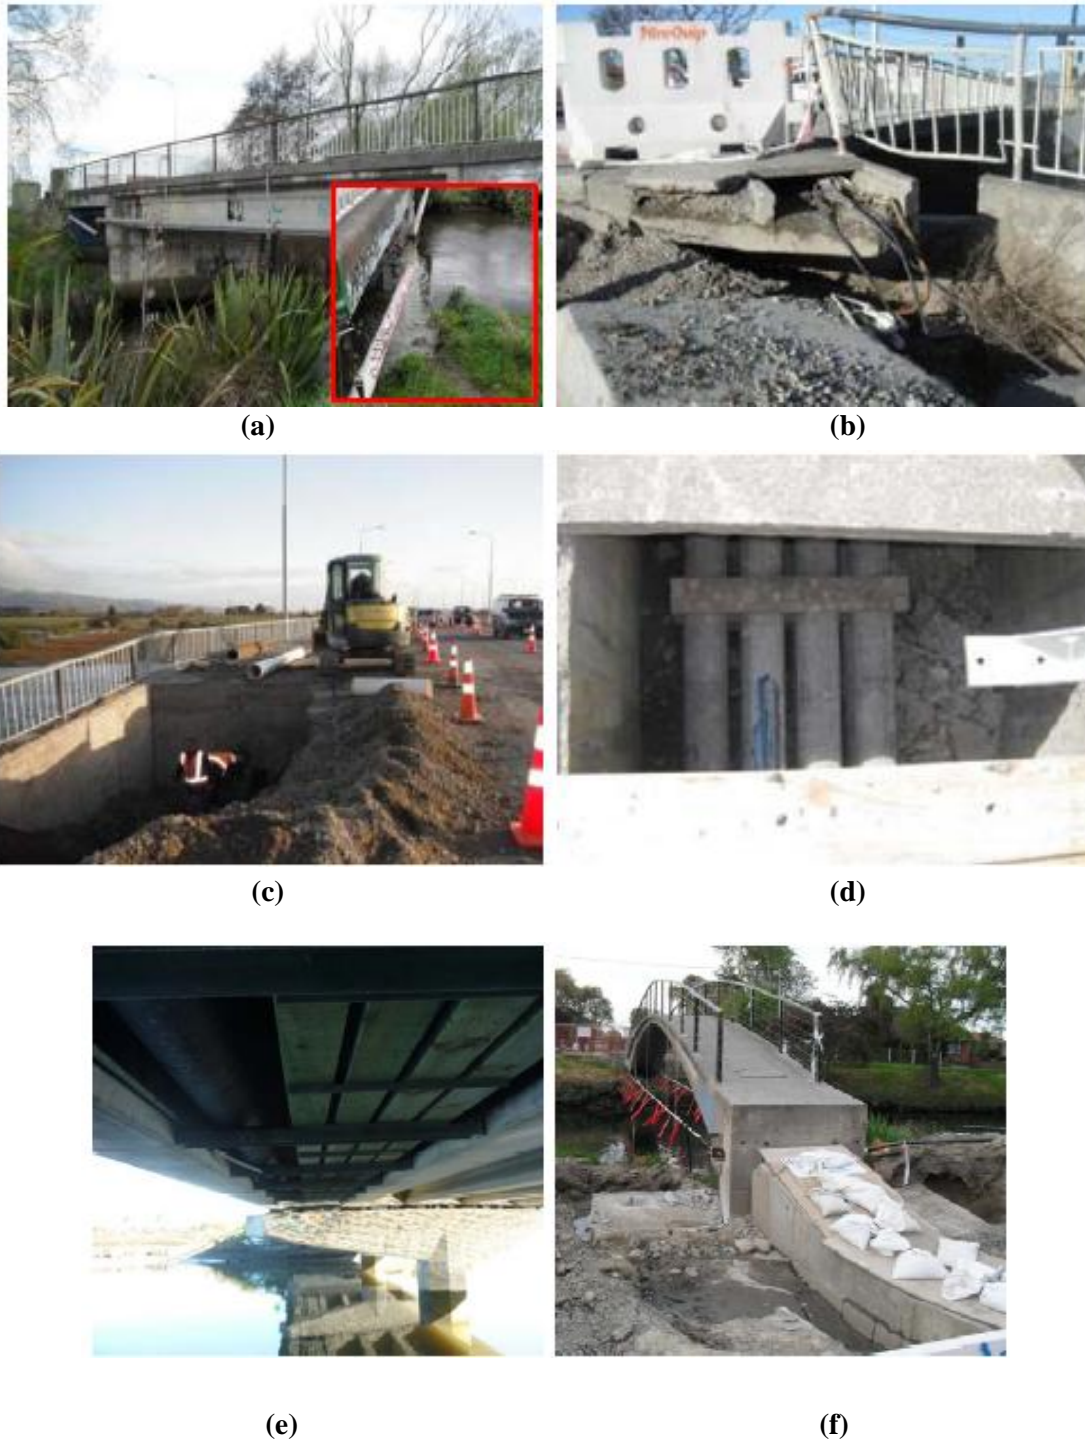
Figure 2.18. a) *Damage to pipelines at Kainga Road Bridge after September 4, 2010 [Photo by A. Palermo]; b) Gayhurst Road Bridge: damage to lifelines [Photo by A. Palermo]; c) Repairing works at at Bridge Street Bridge [Photo by A. Palermo]; d) Close-up view of damaged pipes along the deck of Ferrymead Bridge [Courtesy of OPUS] e) Damaged pipelines at Bridge Street Bridge after June 13, 2011 [Photo by E. Camnasio]; f) Dallington Pedestrian Footbridge: damage to electrical services to the Dallington area [Photo by M. Le Heux]*

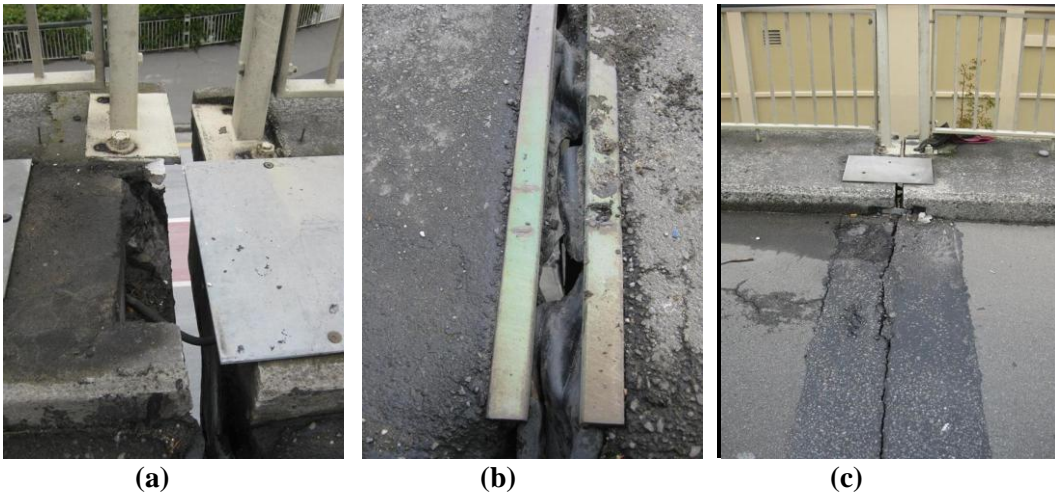
Figure 6.5. (a) 10 mm drop in deck height of centre section of bridge at east expansion joint due to failure of pier beneath. (b) Opening of the expansion joint of the deck (c) Crack of the deck in correspondence to the expansion joint

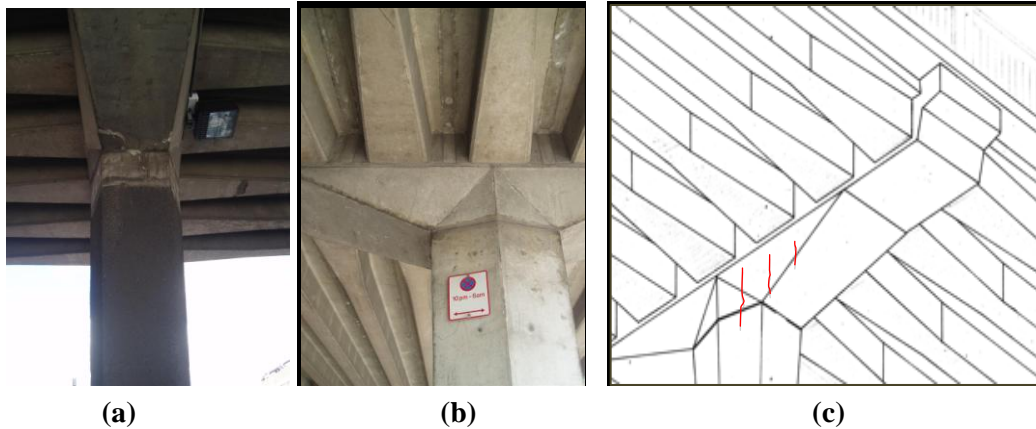
Figure 6.6. (a) Spalling on the northern face on the capping beam above south column of pier 6. (b) Vertical cracking in pier cap due to transverse movement. (c) Sketch of location of fine vertical cracking

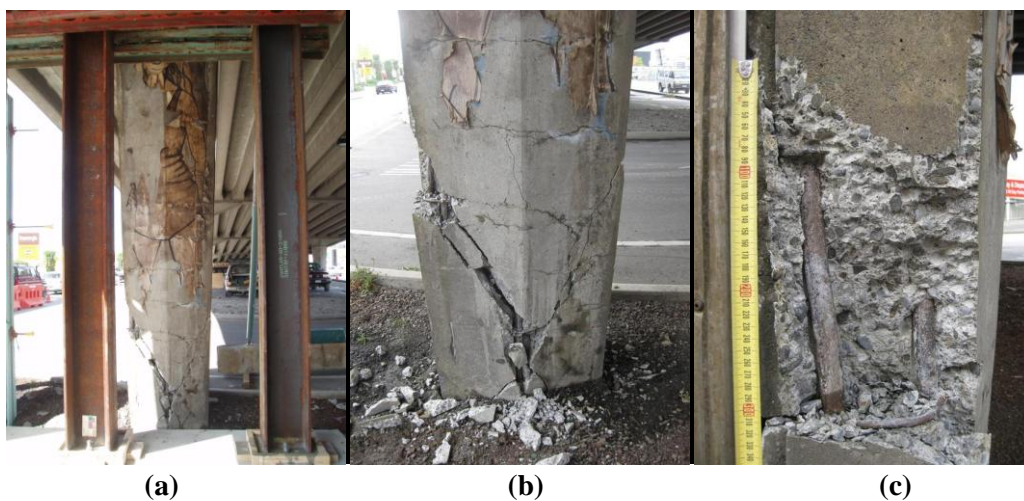
Figure 6.9. North column (a) West face (b) Detail of shear fail at the base of the west face (c) Exposure of the steel bars at the North face

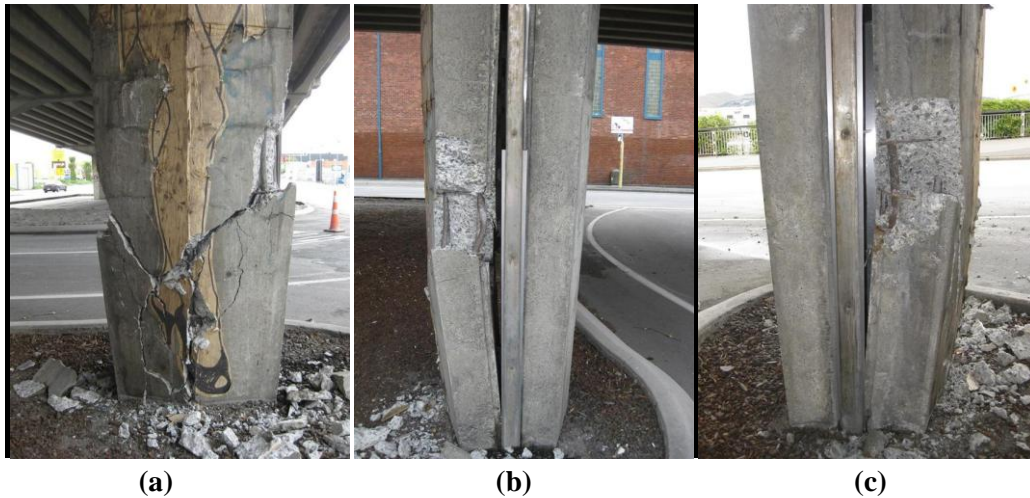
Figure 6.10. South column (a) West face (b) South face (c) North face

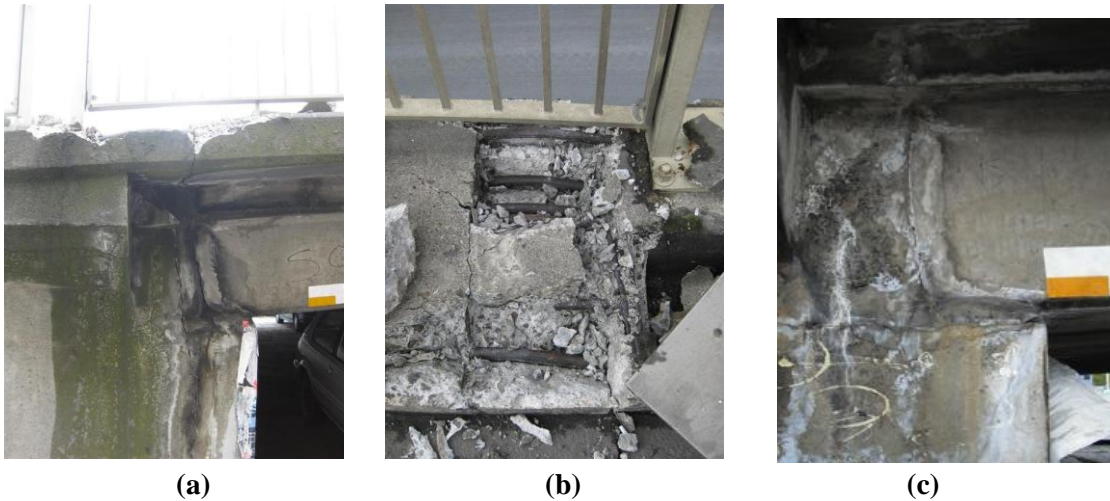
Figure 6.11. *Damage at southwest deck/abutment connection a) Tension cracks due to separation of deck/abutment during ground shaking (b) Buckling of reinforcement in reinforced concrete kerb (c) Minor cracking in northeast beam/abutment connection*
