POLITECNICO DI MILANO

The Role of Structural Homogeneity
in Seismically Active Historical Centers of Abruzzo

Castel del Monte, Castelvechio di Calvisio, Santo Stefano di Sessanio, Villa Santa Lucia degli Abruzzi

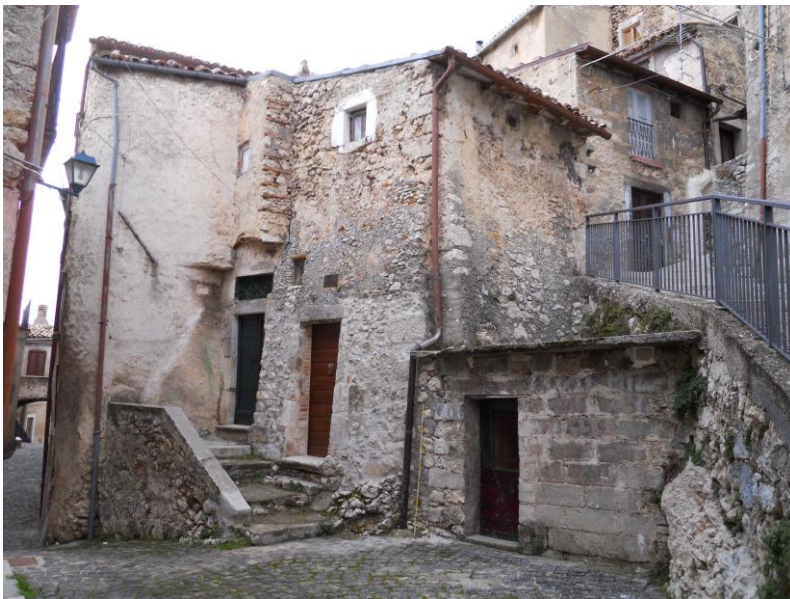
2.93 Photo of aggregate CdM 036

The sixth example is adjacent to the previously discussed aggregate. This particular example of negative structural homogeneity is found in aggregate CdM 036. As seen in the following photos,

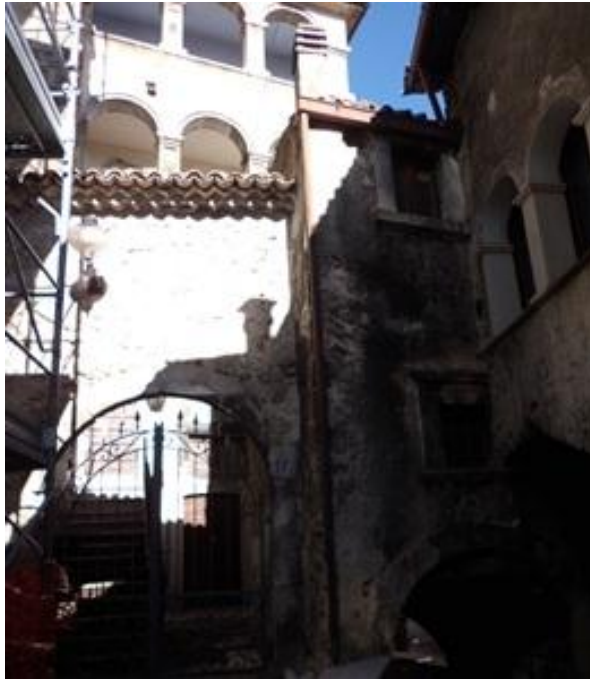
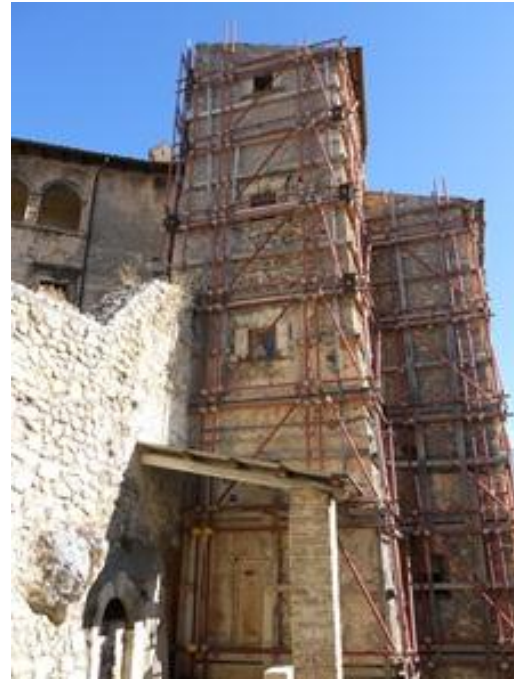
The third and final church within Santo Stefano di Sessanio, located in aggregate SSS 068, is well known due to the substantial damage its façade sustained during the 2009 seismic event.

Figure 3.18 SSS 068 Front East

Figure 3.19 SSS 068 Front North

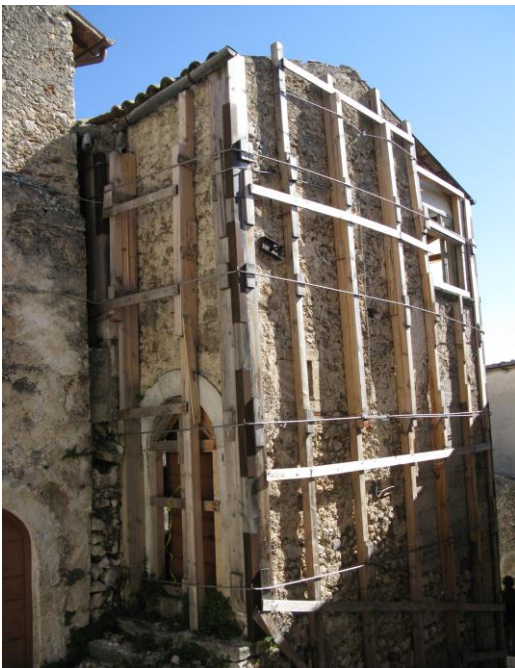
The second typology of temporary structural intervention to be discussed in Santo Stefano di Sessanio is that of wooden grid and tie interventions. An example of this typology of temporary

Figure 3.125 Wooden Grid

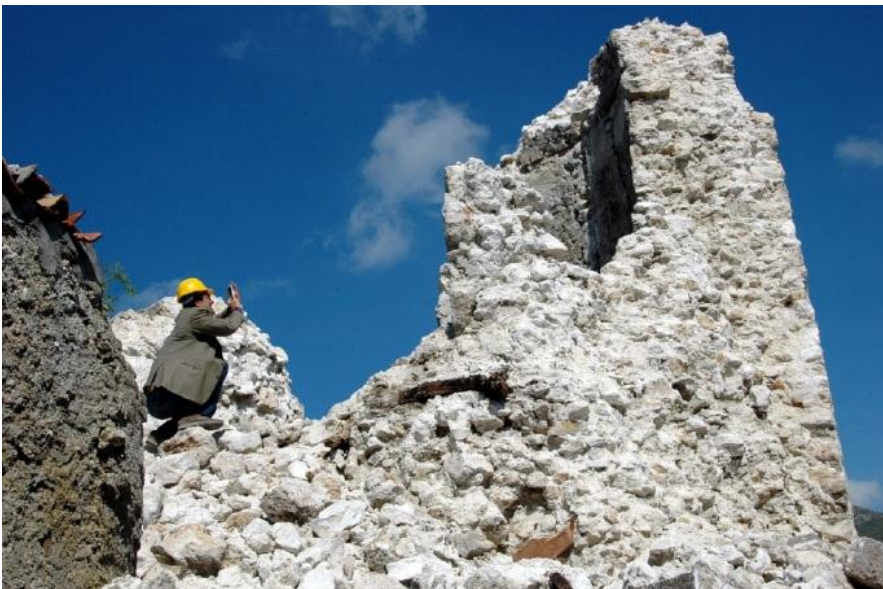
Figure 3.133 Post-Seismic Medicea Tower

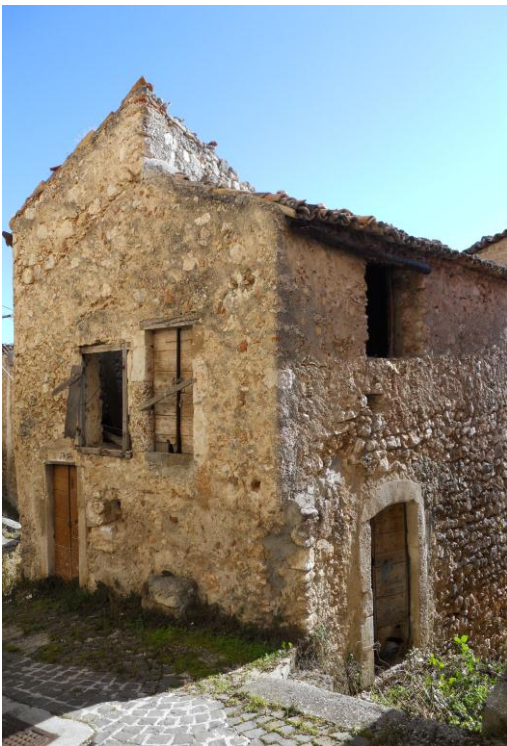
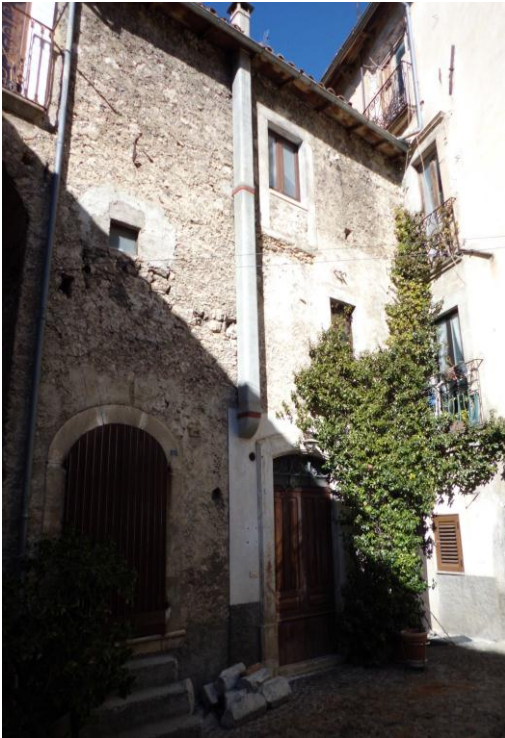
Figure 4.100 Negative Openings

The negative example of an opening placement within Castelvechio di Calvisio is found

Figure 4.101 Negative Openings

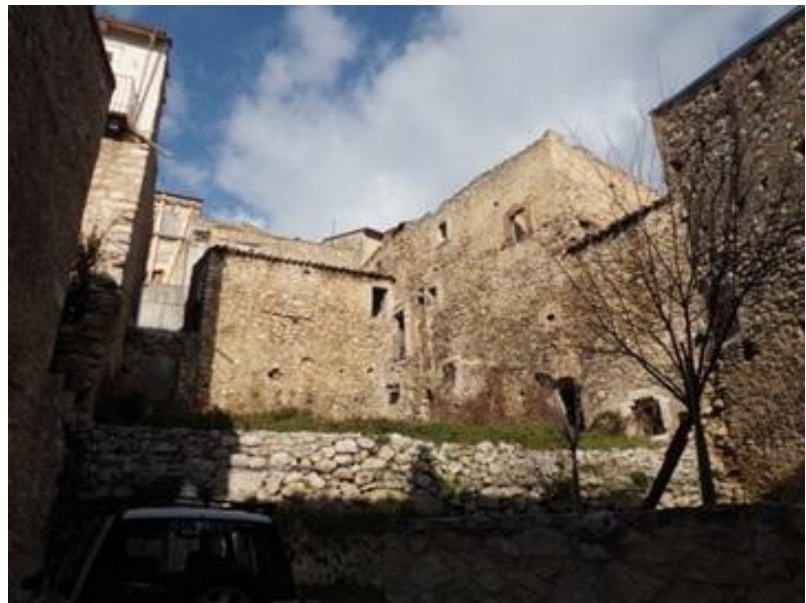
Figure 5.21 VSL 006 Ruins

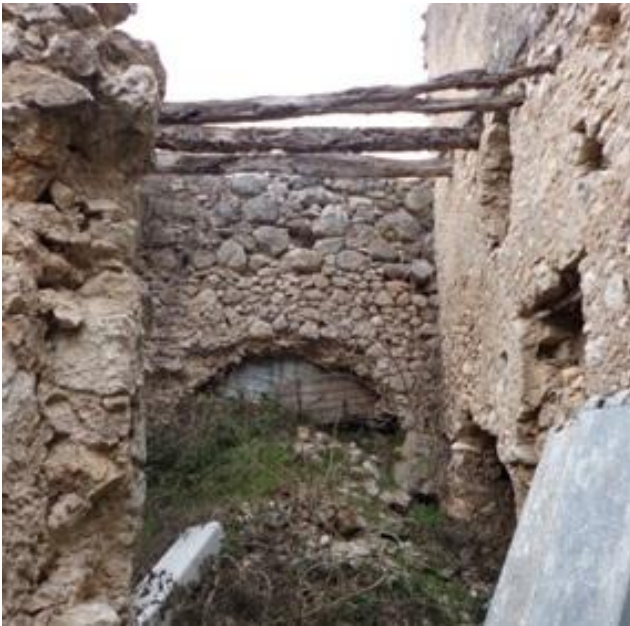
Figure 5.22 Aggregate VSL 011-A Ruins

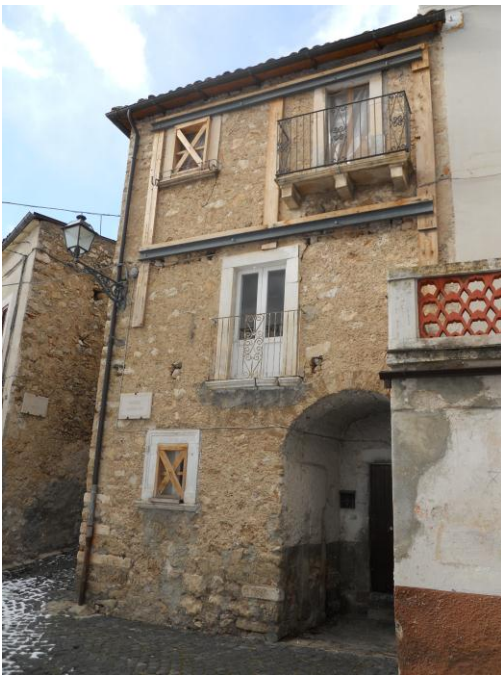
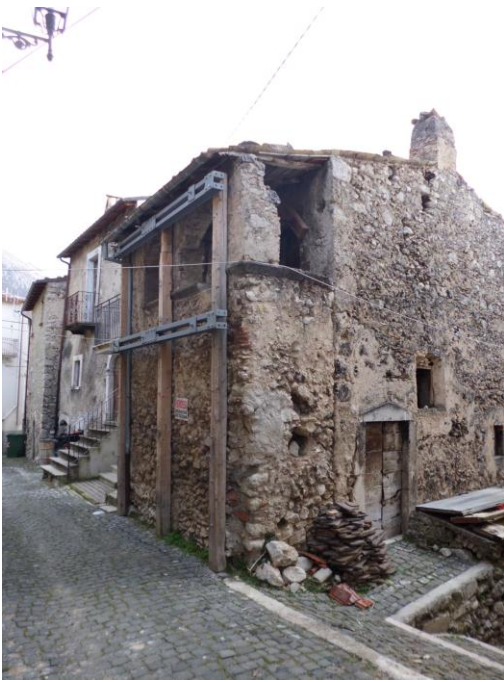
Figure 5.94 Negative Openings

Figure 5.95 Negative Openings
