**A PROPOSAL FOR THE RESTORATION AND THE
REUSE OF THE DISMISSED POWER PLANT OF EDİRNE,
TURKEY**

ÖZGE NOYAN matt. 764300

(M.Sc. Thesis)

July 2013

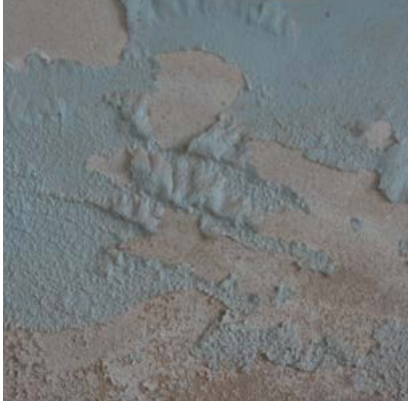
NAME OF DECAYS	DESCRIPTIONS	PICTURES
BLISTERING	Separated, air-filled, raised hemispherical elevations on the face of brick resulting from the detachment of an outer brick layer. This detachment is not related to the brick structure. Blistering of brick masonry can be caused by expansion of the weathered surface layer leading to loss of the plaster.

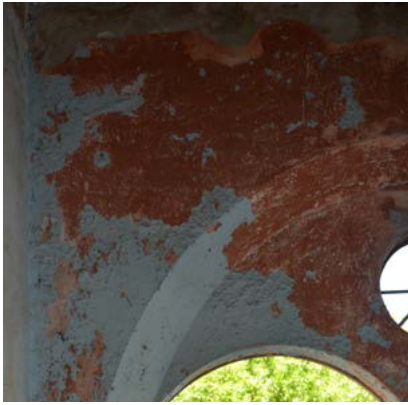
PEELING	Shedding, coming off or partial detachment of a superficial layer (thickness : submillimetric to millimetric) having the aspect of a film or coating which has been applied on the brick surface.

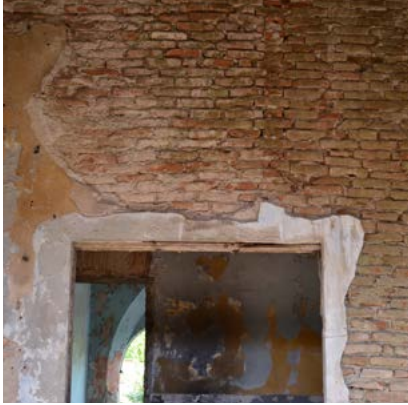
LIGHT EROSION	Missing of plaster on the brick surface. The brick structure can be observed. (thickness : centimetre)

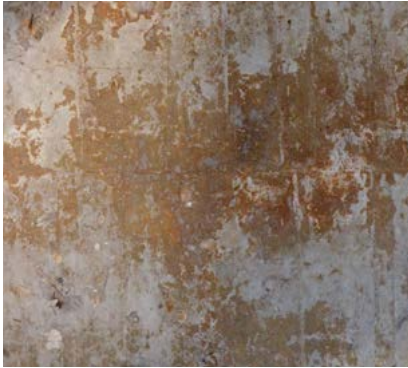
EROSION	Loss of original surface, leading to smoothed shapes. Loss of original surface, which can be due to a variety of reasons such as granular disintegration, scaling etc..

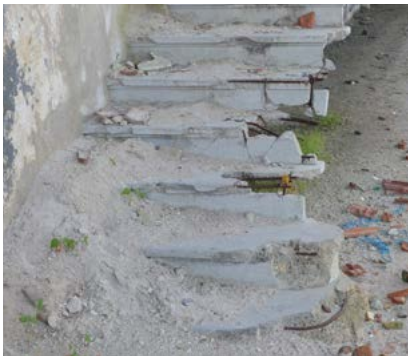
<p>MISSING PART</p>	<p>Empty space, obviously located in the place of some formerly existing part. Protruding and particularly exposed parts of materials are typical locations for material loss resulting in missing parts.</p>

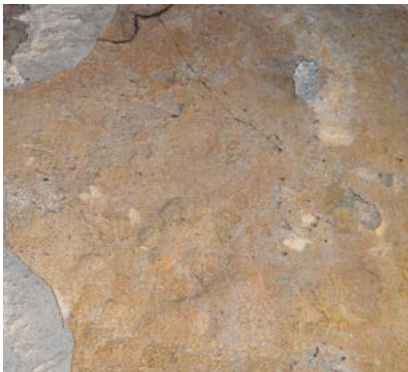
<p>DEPOSIT</p>	<p>Chromatic modification of the material, generally resulting from natural or artificial ageing and not involving in most cases visible surface deterioration.</p>

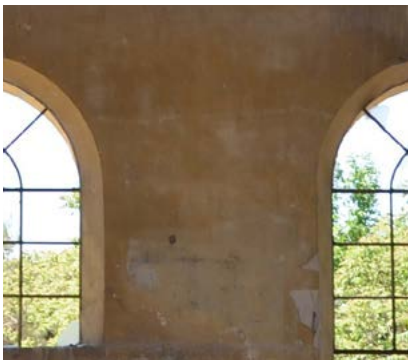
<p>SPOT</p>	<p>A kind of discolouration of limited extent and generally of unattractive appearance.</p>

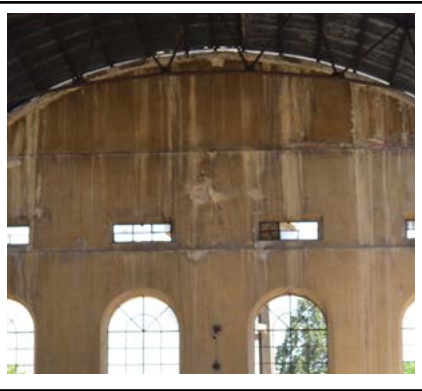
<p style="text-align: center;">LEACHING</p>	<p>A kind of discolouration, water leaks can alter surface of colour.</p>

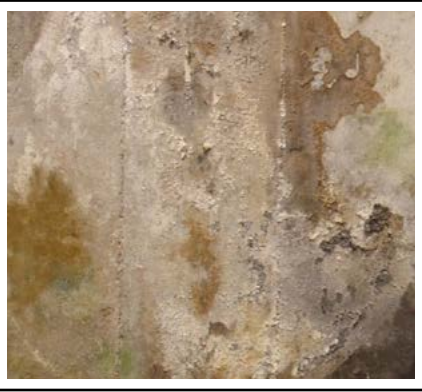
<p style="text-align: center;">EFFLORESCENCE</p>	<p>Generally whitish, powdery or whisker-like crystals on the surface. Efflorescences are generally poorly cohesive and commonly made of soluble salt crystals.</p>

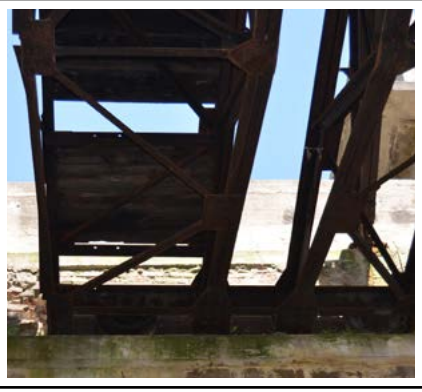
<p style="text-align: center;">RUST</p>	<p>Rust is composed of iron oxides. In colloquial usage, the term is applied to red oxides, formed by the reaction of iron and oxygen in the presence of water or air moisture.</p>

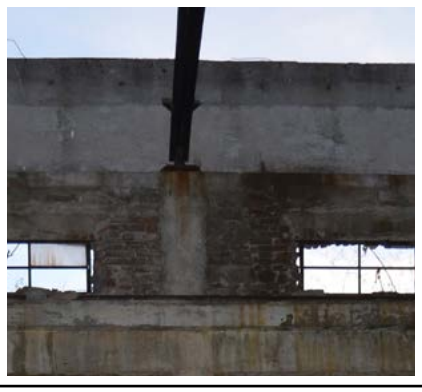
<p style="text-align: center;">STAIN</p>	<p>A kind of discolouration of limited extent and generally of unattractive appearance.</p>

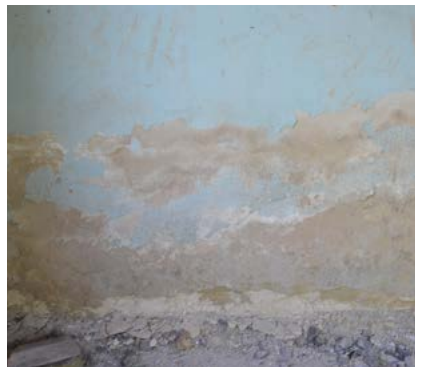
<p style="text-align: center;">HUMIDITY</p>	<p>Corresponds to the darkening (lower hue) of a surface due to dampness. The denomination moist area is preferred to moist spot, moist zone or visible damp area.</p>

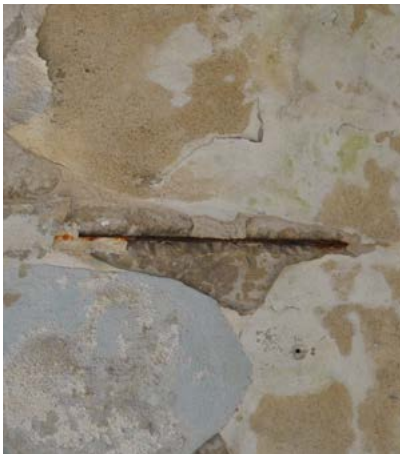
<p style="text-align: center;">CORROSION</p>	<p>Corrosion can be defined as the degradation of a material due to a reaction with its environment. Degradation implies deterioration of physical properties of the material. This can be a weakening of the material due to a loss of cross-sectional area, it can be the shattering of a metal due to hydrogen embrittlement, or it can be the cracking of a polymer due to sunlight exposure.</p>

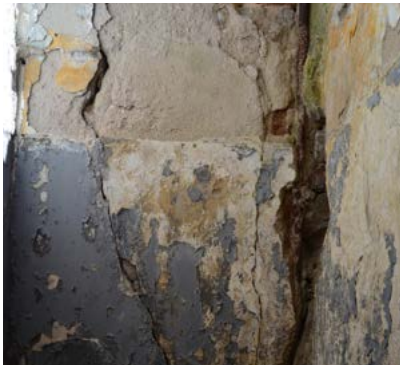
<p style="text-align: center;">CRACKING</p>	<p>Individual fissure, clearly visible by the naked eye, resulting from separation of one part from another.</p>

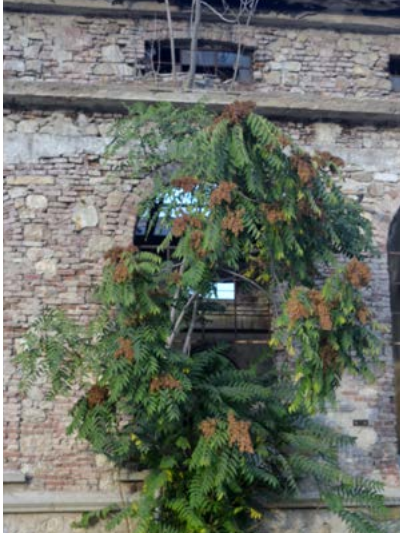
<p style="text-align: center;">PRESENCE OF VEGETATION</p>	<p>Vegetation (e.g. Tree, fern, herb) grow close to building. If buildings are not maintained, plants will eventually colonise places where water is accessible, extending roots into joints and fractures. As the roots grow they can widen these joints and cracks and break the stone. They may also contribute to keep areas damp. This in turn, exacerbates other processes such as salt deterioration.</p>

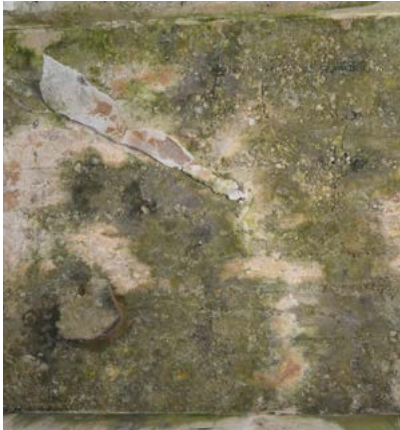
<p style="text-align: center;">ALGA</p>	<p>Alga are microscopic vegetal organisms without stem nor leaves which can be seen outdoors and indoors, as powdery or viscous deposits (thickness : tenth of mm to several mm). Algae form green brown, or black veil like zones and can be found mainly in situations where the substrate remains moistened for long periods of time.</p>

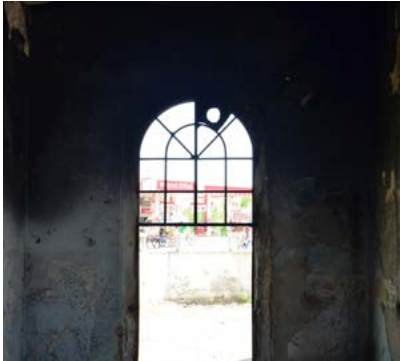
<p style="text-align: center;">ASHES DEPOSIT</p>	<p>Burning of materials stain. Ashes deposits are generally the result of an act of vandalism.</p>

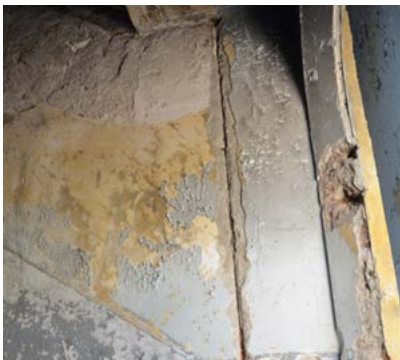
<p style="text-align: center;">MECHANICAL DAMAGE</p>	<p>Mechanical damage due to the impact of a projectile (bullet, shrapnel) or of a hard tool. Mechanical damages are made by human.</p>

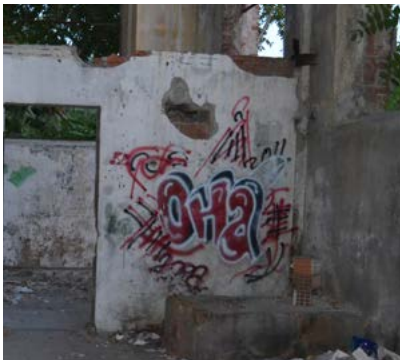
<p style="text-align: center;">PAINTING SPRAY, GRAFFITI</p>	<p>Engraving, scratching, cutting or application of paint, ink or similar matter on the stone surface.</p> <p>Graffitis are generally the result of an act of vandalism.</p>

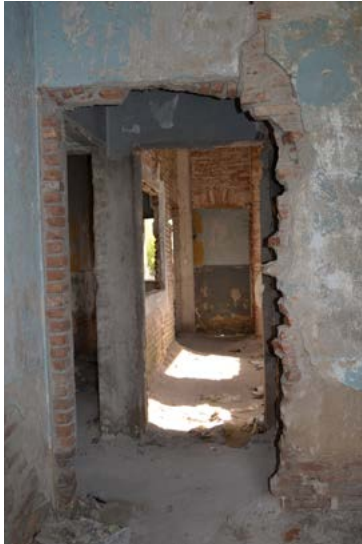
Picture 4.7

While the doors' frame, windows' frame and balusters of staircases had been removed, some doors and windows border and staircases were damaged. (*see Picture 4.7, 4.8, 4.9, 4.10*)

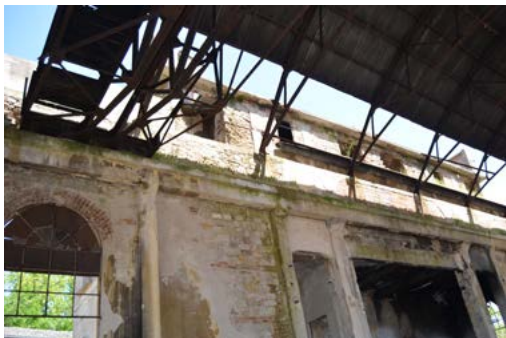
Picture 4.10

Two sides of the roofs were removed by vandals. Thus, the building was exposed to rainwater, sun, wind and snow. The roof appears rust because of the water. (see picture 4.10)

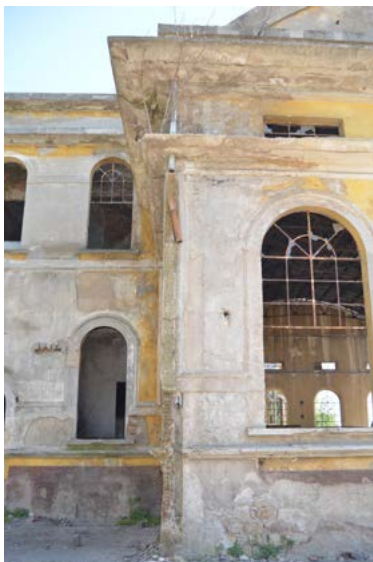
Picture 4.13

The galvanized iron rainwater pipes were broken. Thus, the gutters, eaves and saggings were deteriorated. Defective rainwater goods cause overflow of water, particularly in heavy rain; and an improper disposal of water at ground level. There are a few possible causes to the defective of rainwater goods of Power Plant. Due to defective rainwater goods,

some galvanized iron rainwater goods became rusted, biological grow and corrosion appered. (see Picture 4.13)
