RESTORATION OF ARISTIDES DE SOUSA MENDES HOUSE CABANAS DE VIRIATO, PORTUGAL

Master of Science Thesis from:
Carolina Luísa de Sá e Brito matt. 767291

(MASTER OF SCIENCE THESIS)

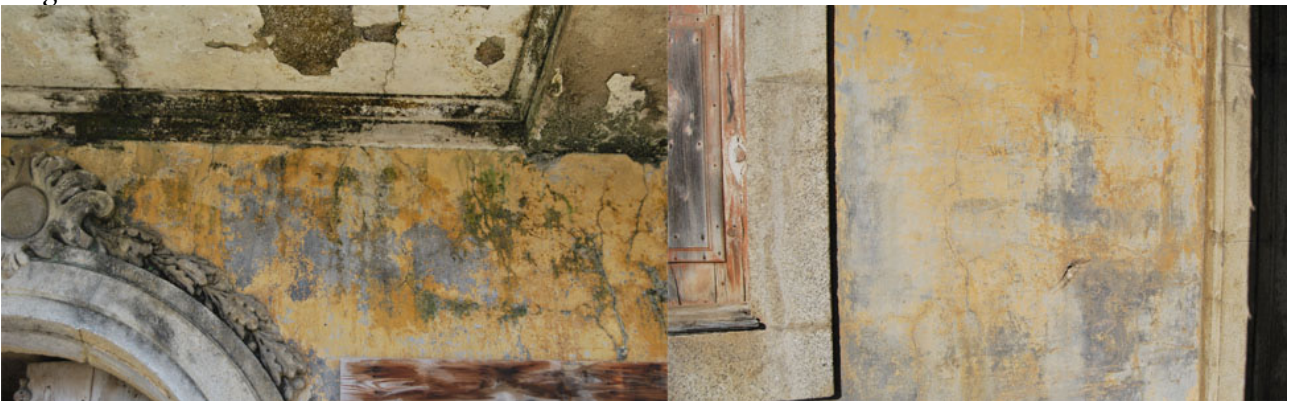
On the exterior walls the last layer of the wall composition is the ocre paint, a colour very typical of this period. Nowadays, it is possible to find some remains on the main façade, specially under the balcony where it was protected from decay. Regarding the rest of the building, this paint is no longer visible.

Figure 27: Detailed views from the remains of the ocre paint under the main façade's balcony.

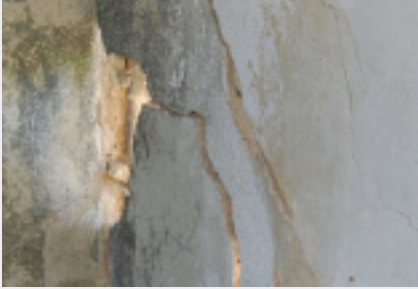
Present on the annexed building, which was built shortly after the main one, specially on the joint between the two buildings. These cracks are characterized by vertical and diagonal alignments, sometimes causing the break of the wall.

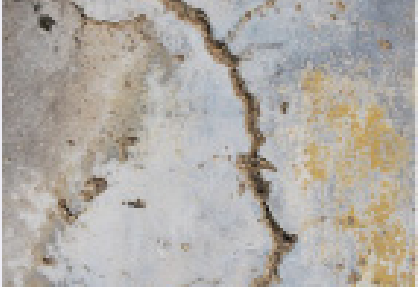
MAP CRACKING

It consists on the appearance of several vertical and diagonal fissures or cracks without being related with any structural problems. Given the “age” of the plaster and the lack of maintenance, the plaster started to create cracks along with intersections such as the window frames and lath lines.
BLISTERING

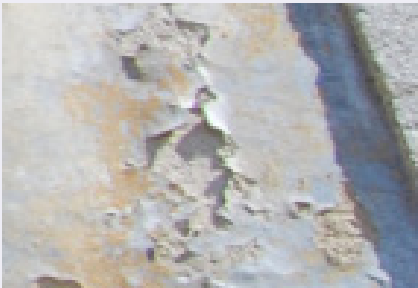
Loss of adhesion between the paint and the underlying surface. It is characterized by the appearance of blisters and bubbles of the paint. It is caused by the exposure from the atmospheric conditions and lack of maintenance.
DISINTEGRATION

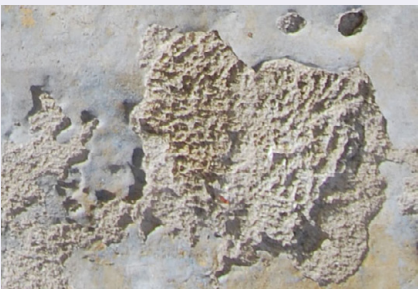
Loss of cohesion, in which the composition of the material, the single grains or aggregates start to disintegrate . It is caused by the exposure of extreme atmospheric conditions.
MATERIAL DETACHMENT

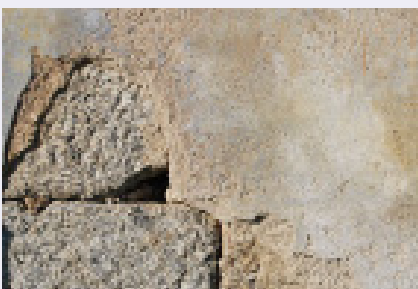
Caused by the constant exposure to the atmospheric conditions and lack of maintenance, it consists on the detachment, partially or totally, of the material from its underlying surface.

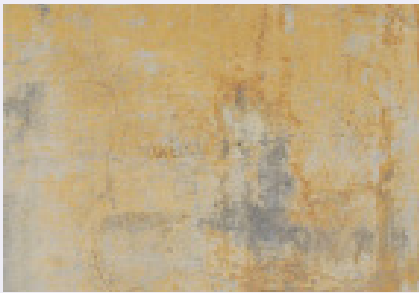
Loss of the original appearance and integrity of the paint given to its exposure to the atmospheric conditions. Some parts of the original paint can still be found in some protected areas such as under the balconies, but apart from there, the colour is fading or completely lost, showing the underlying plaster.
EFFLORESCENCE	 	The appearance of a superficial layer of a fine, white, efflorescent salt deposits on the granite elements. It is characterized by several circular white spots on the stone, sometimes with a yellow colour as well.

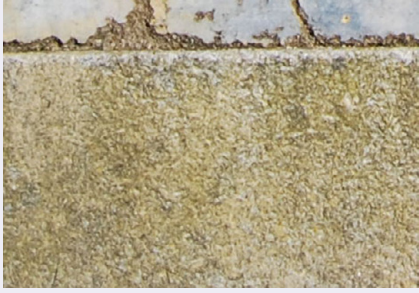
<p>Chromatic modification of the material, generally resulting from natural ageing for and not involving, the deterioration of the material surface.</p>
<p>BLACK CRUST</p>

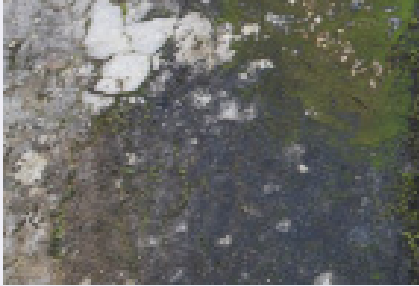
<p>A form of soiling caused by the exposure to atmospheric conditions and constant humidity this case it can be found around the broken gutters. Its black colour comes from the dust and pollutants present in the air.</p>
<p>LEACHING</p>

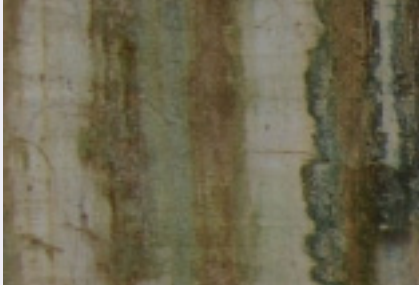
<p>Leaching stains are caused by the constant presence of water leaks upon a surface. It changes the colour the the integrity of the materials, potentializing their degradation. It can be recognized as vertical continuos stains regularly in green colour.</p>
<p>CORROSION</p>

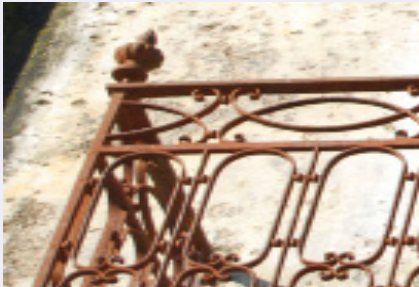
<p>Gradual chemical alteration of the metal subject to its environment, specially when exposed constantly to water. It can be found special on the handrails of the house. This phenomenon can cause the permanent loss of the material.</p>

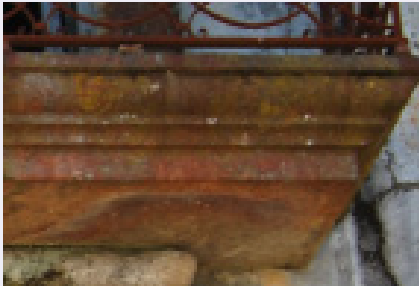
<p>Given the corrosion of the metal and its frequent contact with water, the leaks coming from it, creates these rust stains that change the colour of the base materials.</p>
<p>SOILING</p>

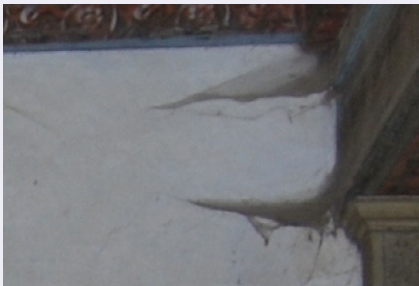
<p>Superficial layer composed by mainly dust, not particularly harmful except on the appearance.</p>

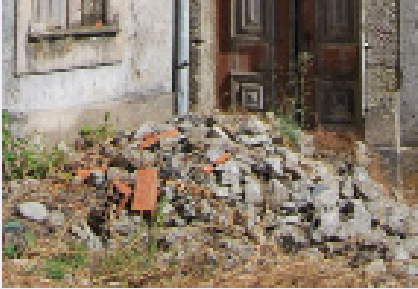
<p>Materials left piled up outside the house, mainly composed by broken pieces of the house materials, specially in the interior of the house.</p>
<p>BIOLOGICAL COLONIZATION</p>		
<p style="text-align: center;">ALGA</p>

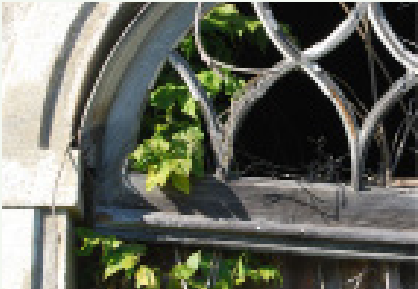
<p>Growing mainly because of lack of maintenance and the constant presence of water. These wild plants start growing and their roots can cause permanent damages in the structure such as on the masonry wall.</p>

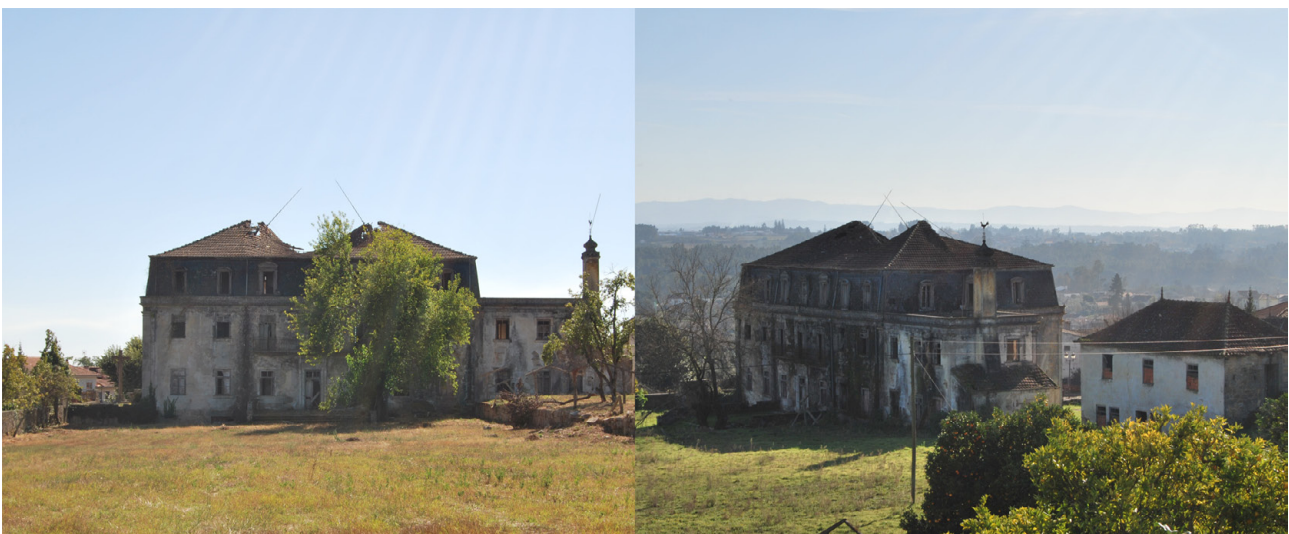
Figure 63: Views from the whole in the centre of the roof.

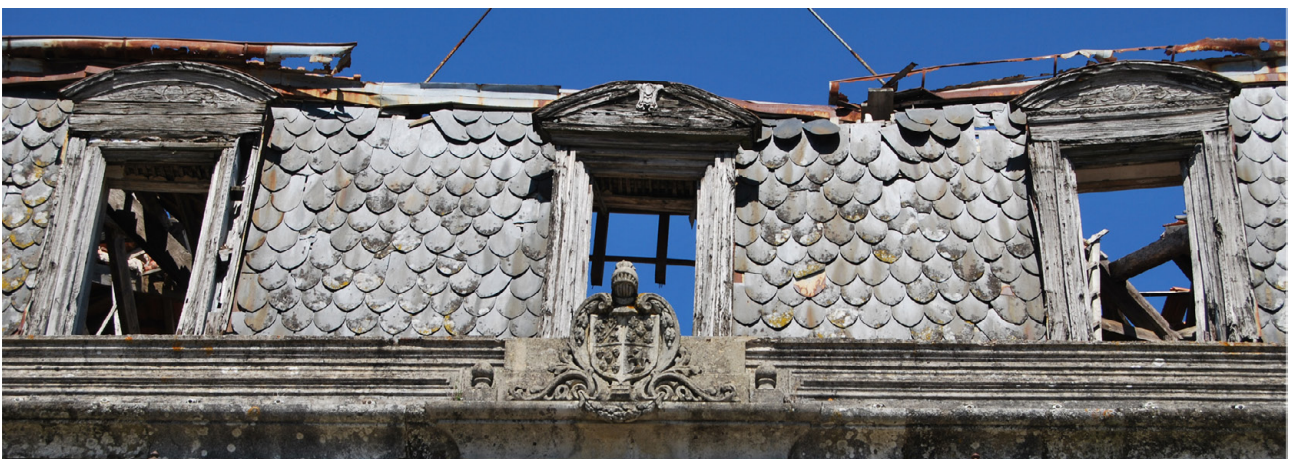
Figure 64: Closer View from the state of the Mansard Floor.
