Damage analysis of “Süleymanpa a” case study bath structure:

Table 7.7: Damage analysis of “Süleymanpa a” case study bath structure, “Cell A”

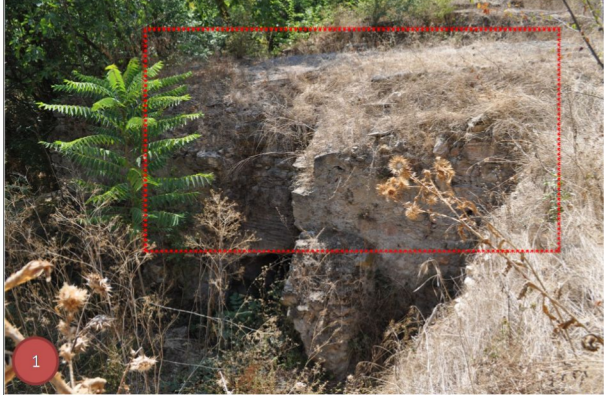
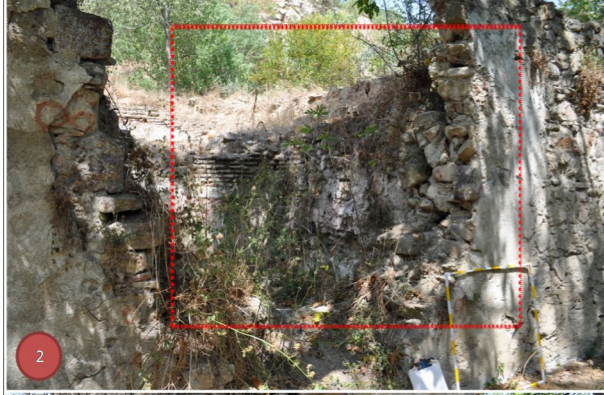
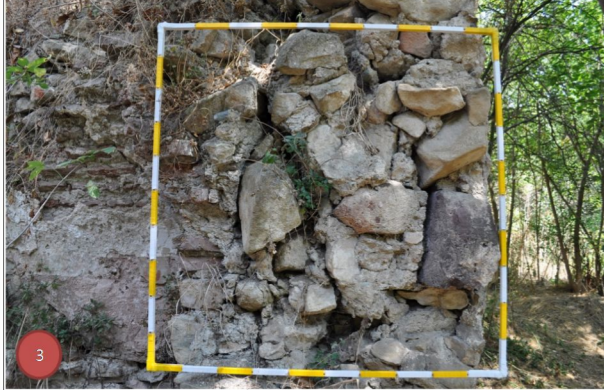
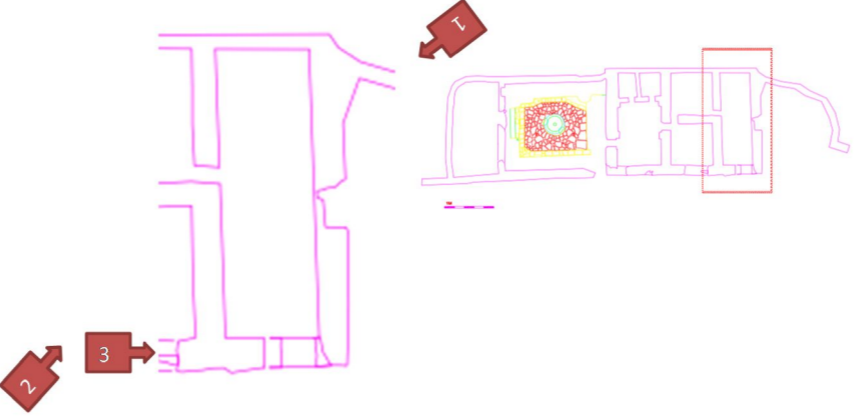
Between the masonry walls there is a consistency of the structure. The masonry structure is three leafed.	Fig: 2,3

Geometrical Modifications	Loss of verticality	In figure 1,2,3: The most of the structure is collapsed. However some parts of the structure is still standing. Cell "A" is part of this structures. The masonry walls were deteriorated highly.		
	Out of Plane A B C	Fig: 2,3

In the Plane A B C	In detail cell "A"; masonry structure is composed with various sizes and irregular shapes of stones. On the sections of the masonry wall, small pebbles and stones could be seen. The fabric is chotic. It was not respected to the horizontal rows or offset the vertical joints. Diatone stones are not used inside of the masonry stone wall.

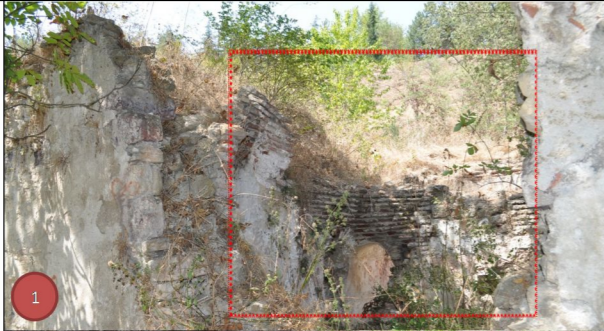
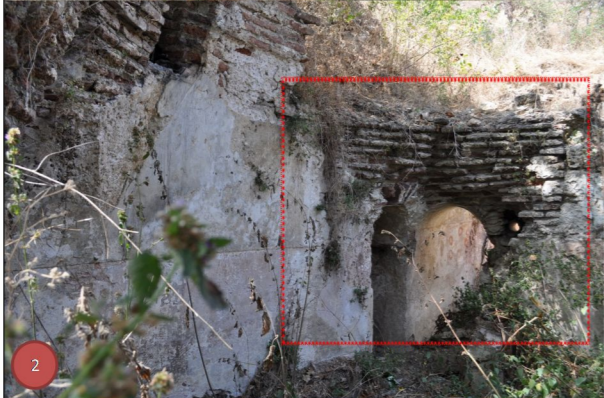
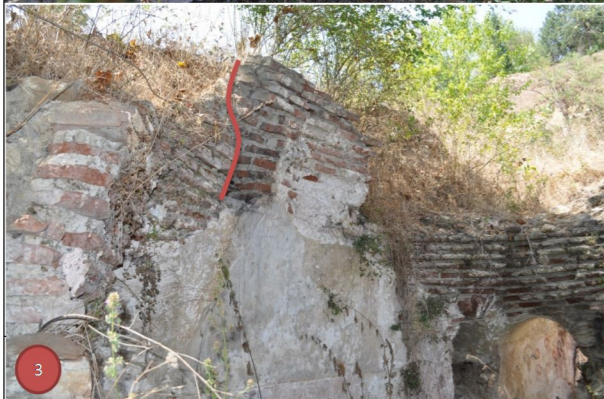
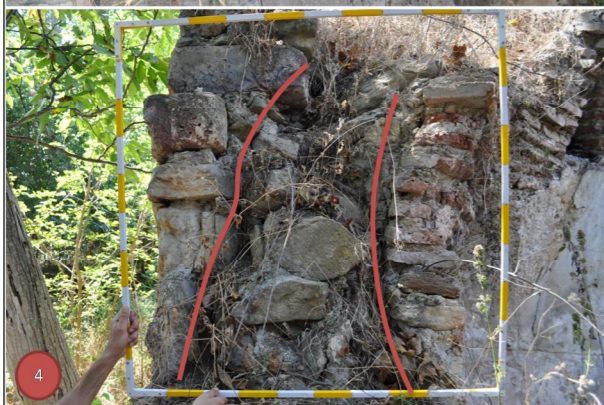
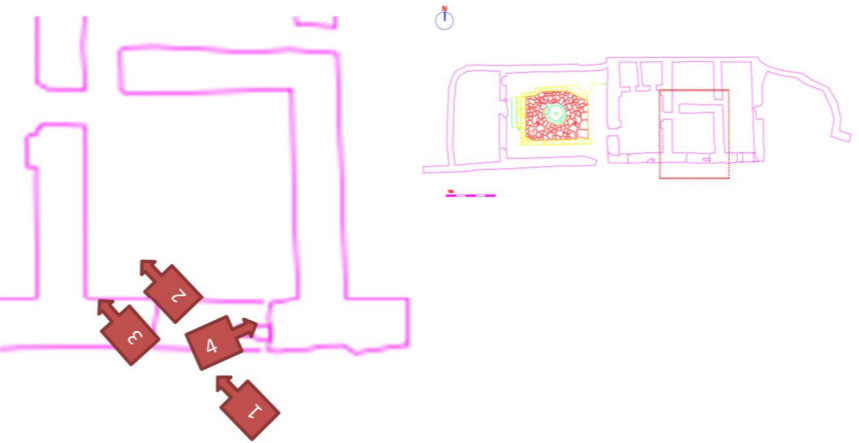
Table 7.8: Damage analysis of "Süleymanpa a" case study bath structure, "Cell B"

Vertical A B C	Qualitative methods of for evaluation is rated, "C" in vertical, out of plane and in plane actions.  In detail cell "B"; masonry structure is composed with various sizes and irregular shapes of stones. On the sections of the masonry wall, small pebbles and stones could be seen. The fabric is chotic. It was not respected to the horizontal rows or offset the vertical joints. Diatone stones are not used inside of the masonry stone wall.	Fig: All

Between the masonry walls there is a consistency of the structure. The masonry walls of the cell"B" is constructed by stones. The masonry structure is three leafed. Transitional elements of the structure is made up of brick material.	Fig: 3,4

In figure 1,2,3: The closure of the cell"B" is broken down. Top of the masonry walls is deteriorated and partly collapsed. The top of the wall structures is not on the plumb. There are some cracks on the top of these walls. In figure 4: The section of the masonry wallis seen. The adhesion of the stones and the mortar is very weak. The seperation of the leaves of the masonry wall is started.

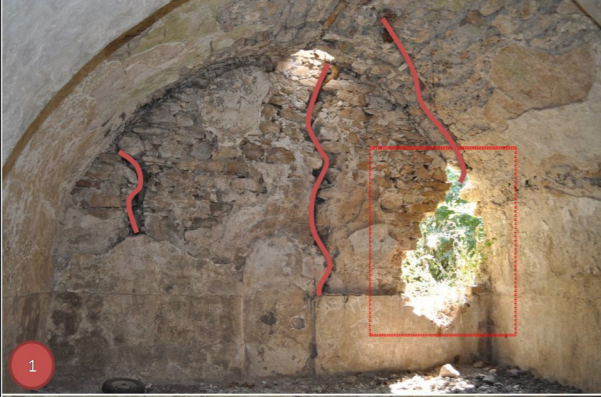
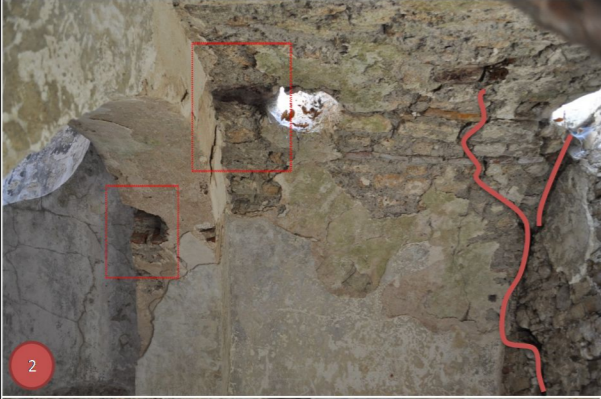
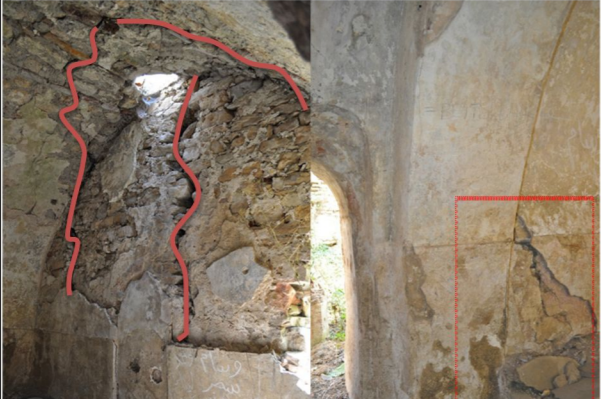
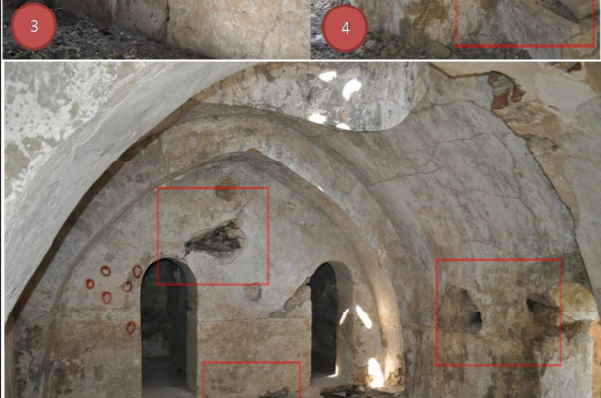
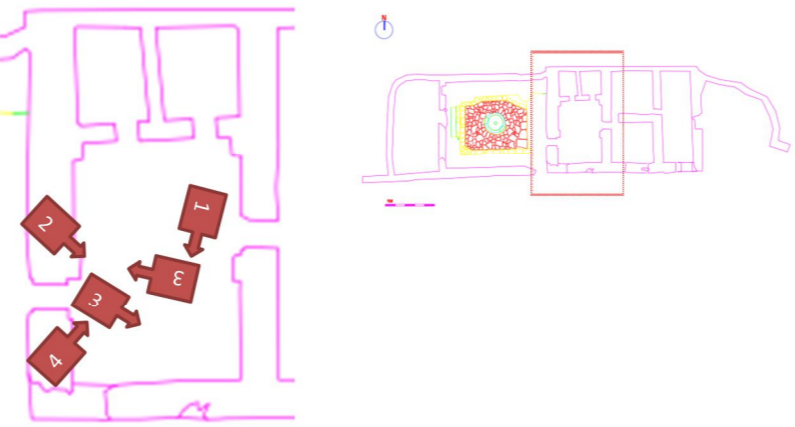
Table 7.9: Damage analysis of "Süleymanpa a" case study bath structure, "Cell C"

Between the masonry walls there is a consistency of the structure. The masonry walls of the is constructed by stones. The masonry structure is three leafed. Transitional elements of the structure is made up of brick material. The dome rested on the vault structure and the vault structure is supported by masonry walls and the brick arches.	Fig: All

In figure 1,2,3: There are big cracks on the structure cell "C". Side wall of the structure is damaged highly. The cracks is started from the wall and continue to the vault. Part of the wall was collapsed. The brick arches which were supporting the vault is also damaged. In figure 4,5: There are some localized damages on the cell. The walls partly damaged, the slab structure is partly collapsed.

In the Plane A B C  In detail cell "C"; masonry structure is composed with various sizes and irregular shapes of stones. On the sections of the masonry wall, small pebbles and stones could be seen. The fabric is chotic. It was not respected to the horizontal rows or offset the vertical joints. Diatone stones are not used inside of the masonry stone wall.									Fig: 1

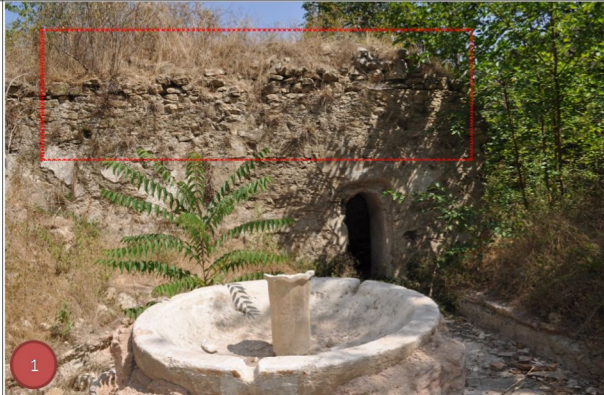
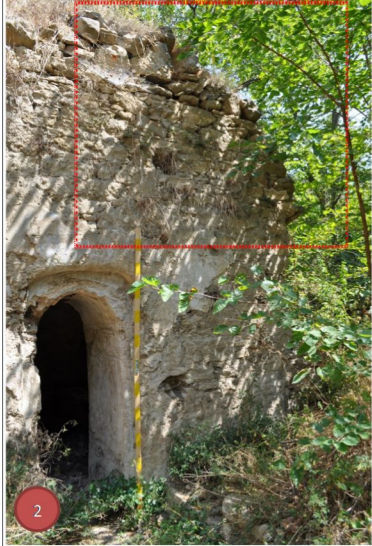
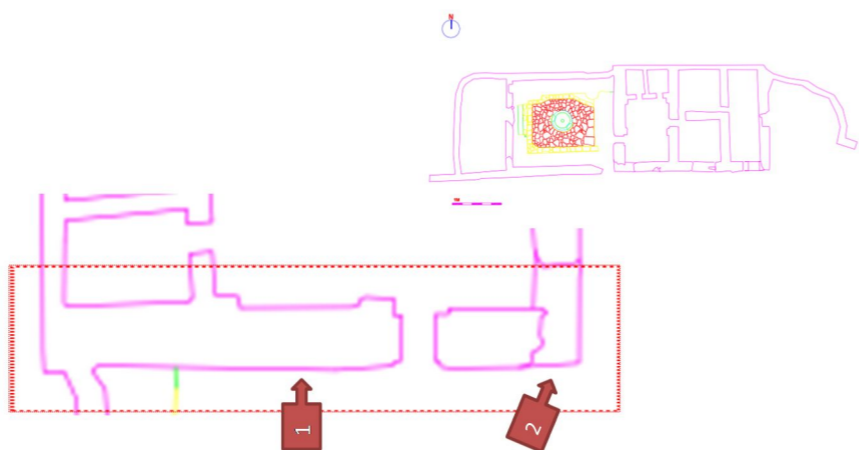
Table 7.10: Damage analysis of “Süleymanpa a” case study bath structure, “Cell D, C” elevation

<p>In figure 1: On the elevation of "D,C" the joints of the stone masonry is deteriorated. The top of the masonry structure was damaged highly. There is no adhesion between the stone and mortar. In figure 2: The corner of the masonry wall is partly collapsed.</p>

<p>Out of Plane</p> <p>A</p> <p>B</p> <p>(C)</p>								
	<p>In the Plane</p> <p>A</p> <p>B</p> <p>(C)</p>	<p>In detail cell elevation "D,C"; masonry structure is composed with various sizes and irregular shapes of stones. On the sections of the masonry wall, small pebbles and stones could be seen. The fabric is chotic. It was not respected to the horizontal rows or offset the vertical joints. Diatone stones are not used inside of the masonry stone wall.</p>

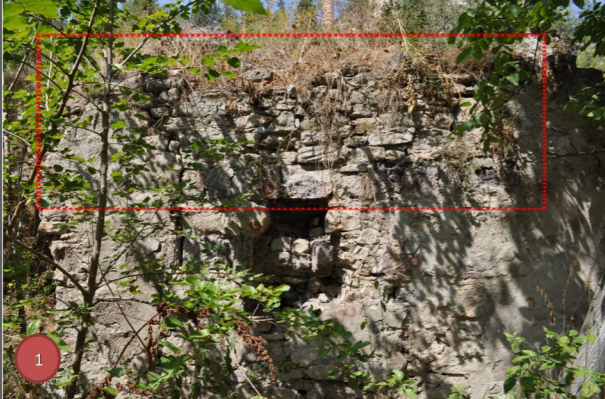
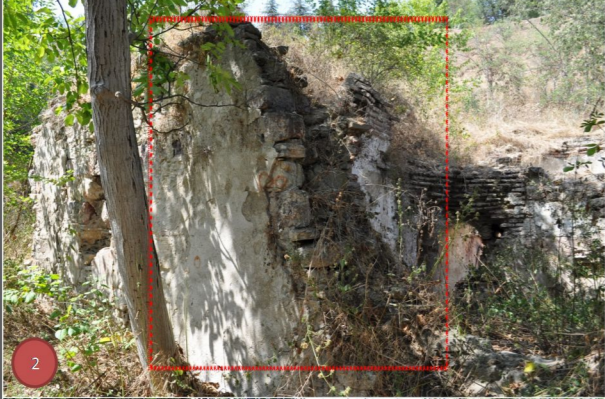
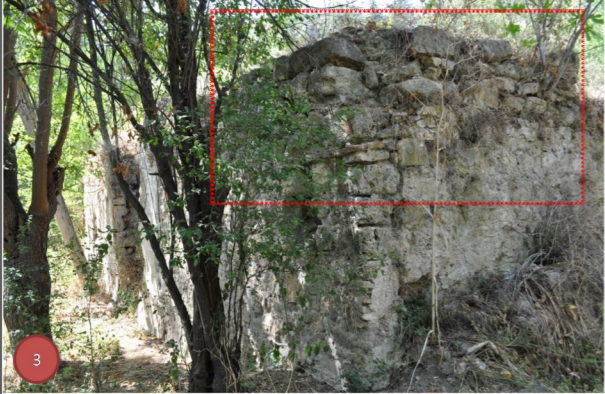
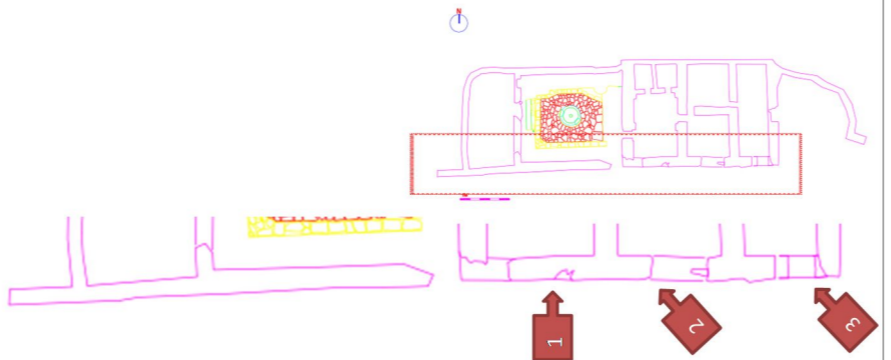
Table 7.11: Damage analysis of “Süleymanpa a” case study bath structure, “Cell C, B, A” elevation

Vertical A B C	Qualitative methods of for evaluation is rated, "C" in vertical, out of plane and in plane actions.  In detail cell elevation "C,B,A"; masonry structure is composed with various sizes and irregular shapes of stones. On the sections of the masonry wall, small pebbles and stones could be seen. The fabric is chotic. It was not respected to the horizontal rows or offset the vertical joints. Diatone stones are not used inside of the masonry stone wall.	Fig: All

Between the masonry walls there is a consistency of the structure. The masonry walls of the is constructed by stones. The masonry structure is three leafed. Transitional elements of the structure is made up of brick material.	Fig: 2

In figure 1: On the elevation of "C,B,A" the joints of the stone masonry is deteriorated. The top of the masonry structure was damaged highly. There is no adhesion between the stone and mortar. In figure 2:The part of the wall is collapsed. The wall is out of plumb. In figure 3: Deteriorated stones and joints were seen on the figure.

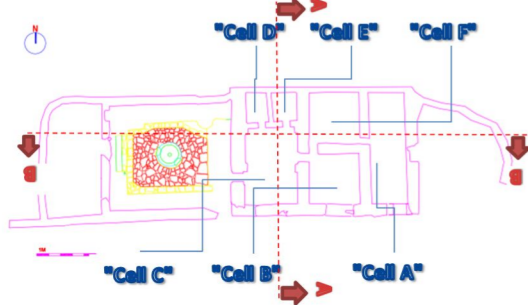
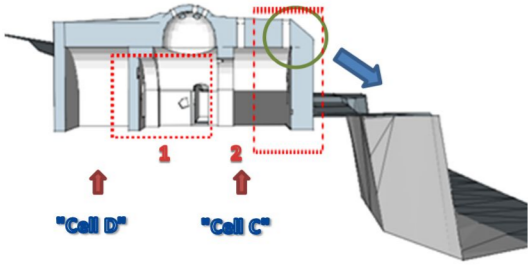
<p>Details</p>				
<p>Section A-A</p>

<p>Detail 1</p>		<p>Detail 2</p>		
<p>Symbolic Description of Action Analysis</p>		<p>Symbolic Collapse Mechanism</p>	<p>Description of Collapse Analysis</p>	<p>Symbolic Description of Action Analysis</p>	<p>Symbolic Collapse Mechanism</p>	<p>Description of Collapse Analysis</p>
<p>Middle risk of collapse if this element is under vertical actions.</p>

<p>Detail 1; Inside of the cell, on the side masonry walls damaged by users. Especially the damage happen near the door entrance could be starting mechanism for the collapse of the door entrance and also the stability of the structure. The crack on the door entrance is big. However it is on the jamb of the door opening. The possible collapse mechanism shown in symbolic description.</p>	<p>Very high risk of collapse if this element is under vertical and out of plane actions.</p>

<p>Detail 2; The outside corner of the masonry wall, stones and mortar adhesion is very weak. Some pieces are broken down. On the other hand big cracks are divided inside of the wall surface. On base corner of the masonry wall, partial part is collapsed. The cracks which are started inside of the wall surface are continued to the vault structure. The possible symbolic collapse mechanism is shown.</p>

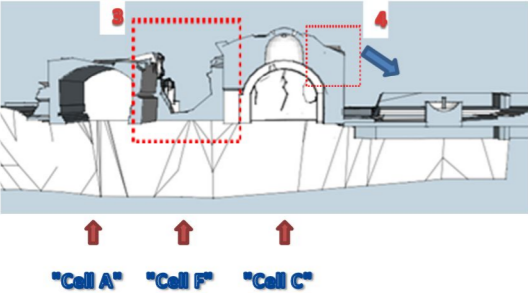
<p>Section B-B</p>

<p>Detail 3</p>		<p>Detail 4</p>		
<p>Symbolic Description of Action Analysis</p>		<p>Symbolic Collapse Mechanism</p>	<p>Description of Collapse Analysis</p>	<p>Symbolic Description of Action Analysis</p>	<p>Symbolic Collapse Mechanism</p>	<p>Description of Collapse Analysis</p>
<p>No risk of collapse.</p>

<p>Detail 3; The closure and the part of the surrounding walls of the structure are collapsed. Is assumed that the front wall of the structure is collapsed according to the collapsed mechanism of the dome. The emptiness of the structure will affected the stability of "Cell A" and "Cell C".</p>	<p>Very high risk of collapse if this element is under out of plane actions.</p>

<p>Detail 6; The corraption out side of the masonry wall, lose of adhesion of the stone and the mortar and the high thickness plantation or soil on the upper dome made the structure unstable for the out of plane actions.</p>
