Damage analysis of “ smail Bey” case study bath structure:

Table 7.16: Damage analysis of “ smail Bey” case study bath structure, “Cell A”

Collapsed analysis of “ smail Bey” case study bath structure:

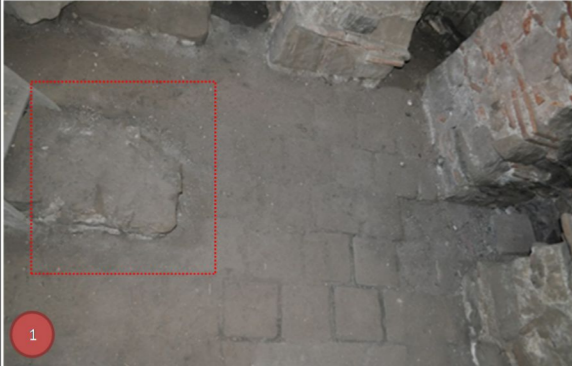
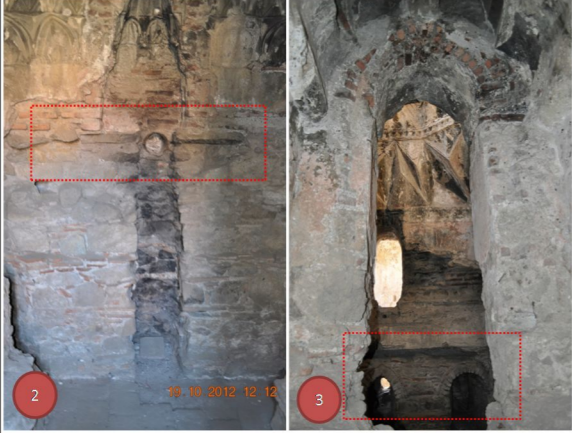
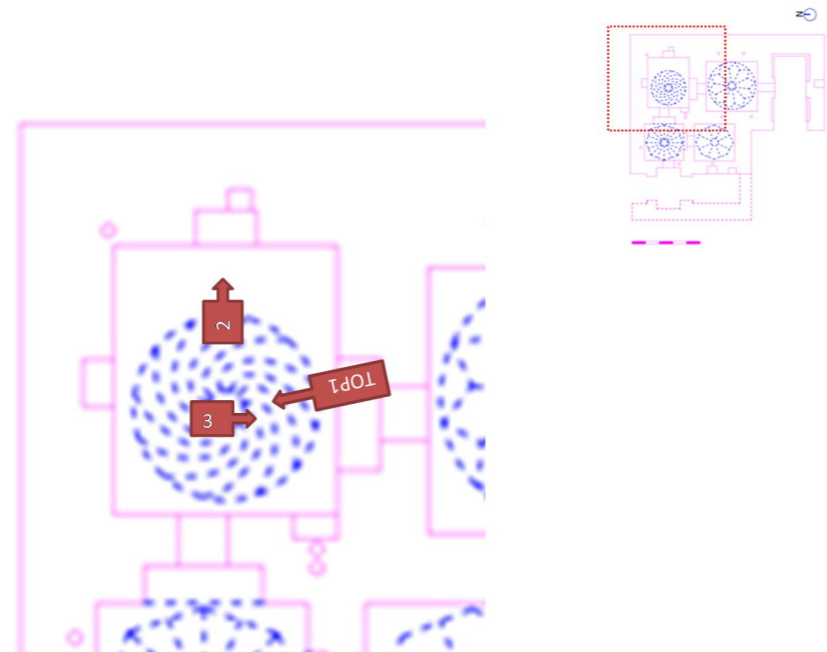
| Damage Analysis of "Ismail Bey Bath" | | | | | | | | | | |
|---|--|---|---|---|---|--|---|---|---|---|
| Cell "B" | | <p>A</p> <p>B</p> <p>C</p> <p>Qualitative methods of for evaluation is rated, "C" in vertical, out of plane and in plane actions.</p> <p>In detail cell "B"; not squared stones with bricks were used. Leaves of the masonry were not good bonded and rows between them were constructed irregularly. However there is an enforcement for linearity of bricks between the stones.</p> | <p>Fig: 2,3</p> | <p>Fig: All</p> | | <p>The slab of the bath was built with stone material on the top of the brick archs. Short coloums were used for supporting brick arches also the stone slab structure. In figure 1, remnant of the short coloum is seen. In figure 2, the possible connection part of the stone slab is seen.</p> | <p>Fig: All</p> | <p>Fig: 2</p> | | <p>Outer leaves of the masonry structures was built recently in maintenance works. Therefore there is not any clue for the cracks and collapses of the masonry walls. Trace of the short coloums were seen. In figure 3, bottom of the arch was damaged. However there is not any instability problems like cracks on this arch and its around.</p> |

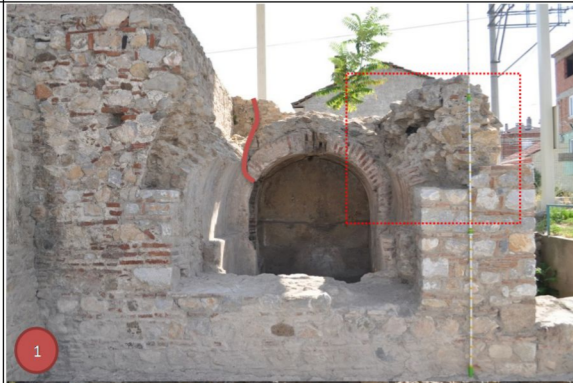
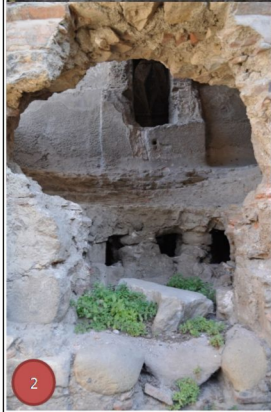
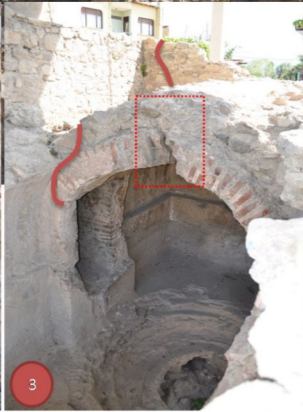
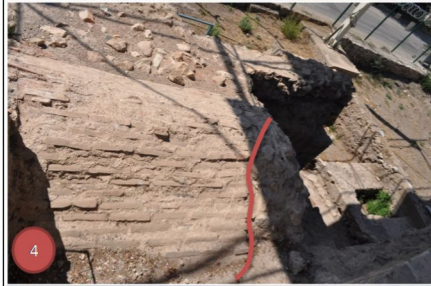
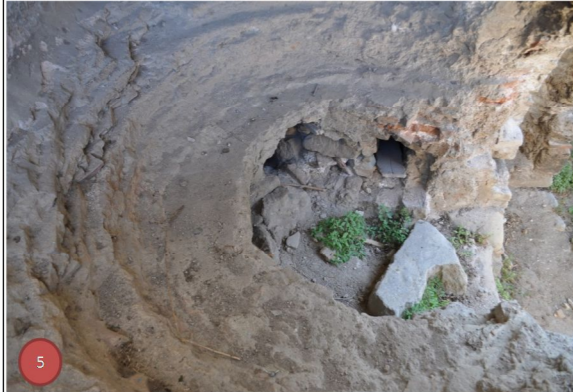
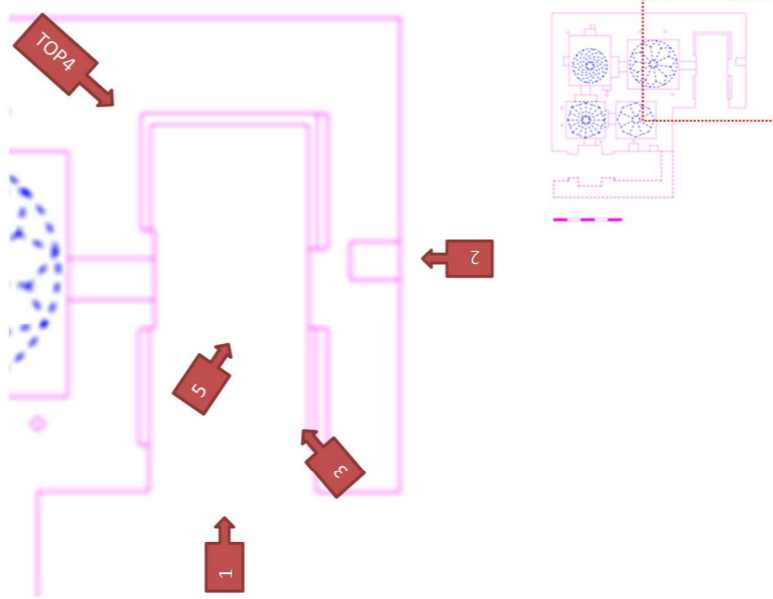
| Damage Analysis of "Ismail Bey Bath" | | | | | | | | | | | |
|---|---|---|---|--|---|--|---|--|--|---|--|
| Cell "D" | | <p>A</p> <p>B</p> <p>C</p> <p>Qualitative methods of for evaluation is rated, "C" in vertical, out of plane and in plane actions.</p> <p>In detail cell "D"; not squared stones with bricks were used. Leaves of the masonry were not good bonded and rows between them were constructed irregularly.</p> | Fig: 1 | Fig: All | | Between the masonry walls there is a consistency of the structure. Also there are sockets for timber tie rods however timber material was deteriorated in a time manner. The vault structure is built up on brick material. On the top of this structure stone and mortar is used to fill the vault structure. There is recently built outer leaf for the masonry wall in the previous maintenance operations. | Fig:1,3,4 | Fig: 1,3,4 | | Probably there were many cracks on this cell. However they were compensated in previous maintenance works. However half of the masonry is seen without any maintenance. In figure 1: The outer leaves of the masonry wall is collapsed. Inner leaf is seen with timber sockets. This part of the building is unstable for any type of action. In figure 2,5: Between this cell and the outer furnace area there is a passage which is partly collapsed. Also the half of the stone slab is collapsed. In figure 3,4: On the top of the vault structure there are big cracks which will cause an instability problems of the vault and attached walls. | |
| | | | | | Fig:1 | Fig:1 | | | Fig: 1 | Fig: 2,3,5 | |

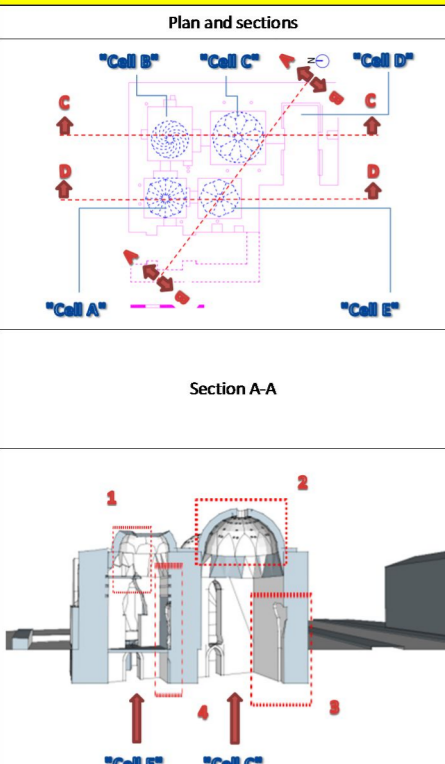
| Collapse Analysis of Critical Damaged Parts of "Ismail Bey" bath | | | | | | | |
|--|---|---|---|--|---|--|--|
| | | <p>Detail 1; has a big damage on integrity of its arch structure. Also there is a crack on the top of its arch. The masonry wall which constitute the arch is very thin. This detail is high risk of vertical actions because of its loss of structural integrity and collapsed of its top. In addition on its top the dome is collapsed. And there is a critical long crack is continues through the dome to other dome. If this arch unit is collapsed there is possibility for it to join of kinematic chain with the big crack between the domes.</p> | | <p>Detail 2; dome has a damage on its top and critical line between tension and compression. The perimeter walls of the dome are thick. However the perimeter walls have big damages on their outer layer. Some parts of the outer layers are collapsed. And also there is a big crack on the dome and continue through the masonry walls and the next cell. Folding mechanism of dome is formed by bending the outer walls through the out of plane action and in plane action.</p> | | | |
| | | <p>Detail 3; In "cell C" inside leaf of the masonry wall was collapsed. The shape of the collapsed part was irregular because of irregular pattern of stone masonry. Therefore thinner part of the masonry wall makes the wall structure weaker. The collapsed of the inside cell leaf has two reasons. First one is; outer vertical deflection. Outside leaf of the masonry wall under pressure. Therefore inside of the leaf pushed away from the wall. Second one is; weak conection between the masonry leaves and the reversal of the external leaves.</p> | | <p>Detail 4; In "cell E" the corruption inside leaf of the masonry was better condition rather than "cell C". However the void timber tie beams socket weaken the masonry structure. Therefore inner leaf of the wall structure or the total wall will be started to collapse in three different type.</p> | | | |
| | | | <p>Very high risk of collapse if this element under the seismic forces.</p> | | | | |
