Damage analysis of “Gazi Mihal Bey” case study bath structure:

Collapsed analysis of “Gazi Mihal Bey” case study bath structure:

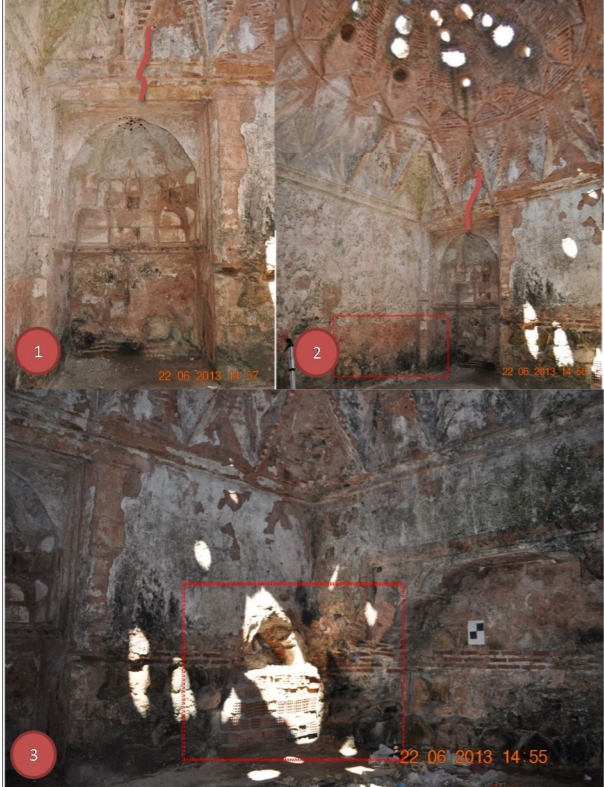
Table 7.29: Damage analysis of “Gazi Mihal Bey” case study bath structure, “Cell A”

There is a consistency of masonry structure. The masonry stone pattern inside of the masonry cell is well constructed. Brick material is used for constructing the transition elements and the dome.	Fig: 1,2

Inside of "cell A" there are few cracks in front of the masonry wall surface. However the crack is shown in figure 1,2; is started from wall surface and continued to the dome structure.

In the Plane A B C		In detail cell "A"; squared stones with bricks were used. Leaves of the masonry were good bonded. Rows between stones were constructed regularly.	Fig: All

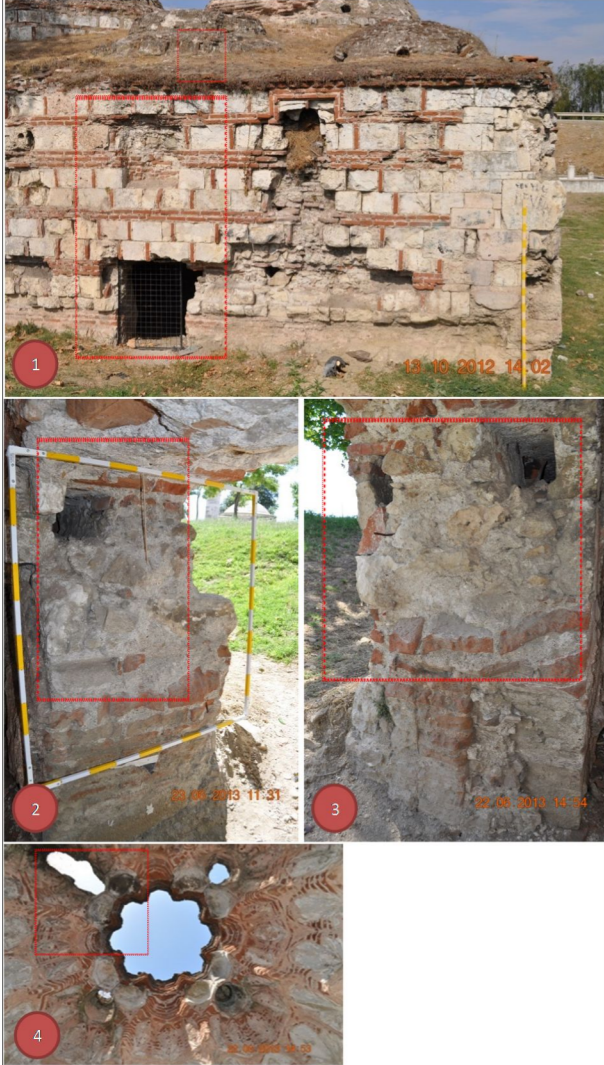
Table 7.31: Damage analysis of “Gazi Mihal Bey” case study bath structure, “Cell C”

There is a consistency of the wall structure. Brick constructed as tie beams were used on the surface of the walls. Timber tie beams sockets are present inside of the wall construction. The domes and transitional elements were built with brick tiles. There is lighting holes on the top of the domes.	Fig: 1

In figure 1: The outside masonry of the "cell C" is deteriorated. Parts of the outer layer of the masonry is collapsed. In figure 2,3: Part of the wall of the masonry was broken down by users. The broke passage was given an idea of the wall section. Empty timber sockets, diatone stones are seen in these sections. In figure 4: Cracks on the domes are seen. Top of the dome the opening was damaged and some parts were collapsed.

Out of Plane A B C		In detail cell "C"; squared stones with bricks were used. Leaves of the masonry were good bonded. Rows between stones and bricks were constructed regularly.	Fig: 1,2,3

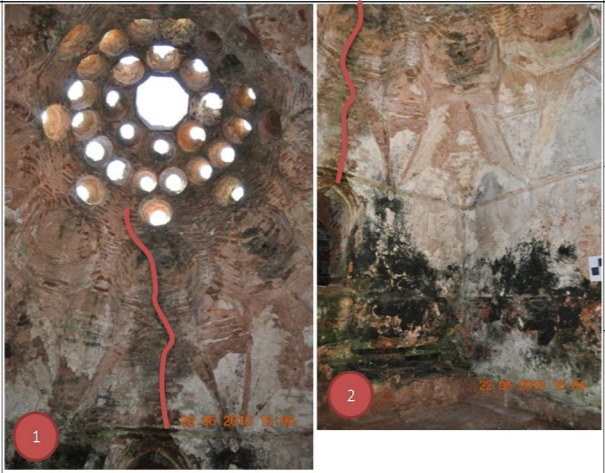
Table 7.33: Damage analysis of “Gazi Mihal Bey” case study bath structure, “Cell E”

Between the masonry walls there is a consistency of the structure. Brick constructed tie beams were used inside the walls. The domes were built up on brick tiles. There is lighting holes on the top of the domes.	Fig: All

In figure 1,2: A crack start from the opening between the water tank area and the cell and it continues to the dome.
		Out of Plane A B C		Fig: All

In the Plane A B C	In detail cell "E"; squared stones with bricks were used. Leaves of the masonry were good bonded and rows between them were constructed regularly.

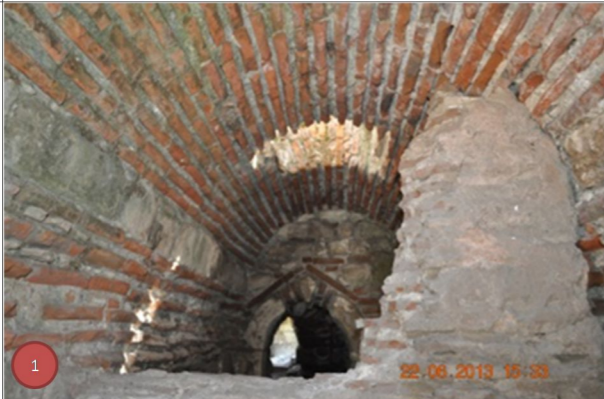
Table 7.35: Damage analysis of “Gazi Mihal Bey” case study bath structure, “Cell K”

Vault structure is built up of bricks and stones. The space of vault is divided by brick masonries mixed with stone.

In figure 1: The wall which is divided the vault space is halfly collapsed. There were opeinings on the top of the vault structure.
		Out of Plane A B C

In the Plane A B C	In detail cell "K"; bricks were used. Stones were used as beams. Leaves of the masonry were good bonded and rows between them were constructed regularly.

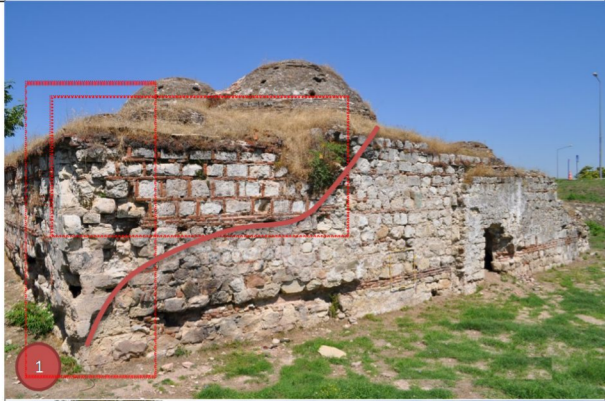
Table 7.36: Damage analysis of “Gazi Mihal Bey” case study bath structure, “Cell B, A, K” elevation

Vertical A B C	Qualitative methods of for evaluation is rated, "B" in vertical, "C" out of plane and "B" in plane actions. In detail cell "B,A,K" Elevation; squared stones with bricks were used. Leaves of the masonry were good bonded and rows between them were constructed regularly. However there is a deterioration on the elevatoin of the bath.	Fig: All

Between the masonry walls there is a consistency of the structure. Stones and bricks were used on constructing the masonry. Brick layers used as beams on the masonry. Timber tie sockets are present inside of the masonry.	Fig: All

In figure 1: The structure was affected from the vertical actors. Corner of the wall is collapsed and after the previous consolidation works is repairs. It is easily seen on the picture form the different use of material. In figure 2,3: The other corner of the bath is collapsed in the same angle with the opposite corner. however it is not repaired.

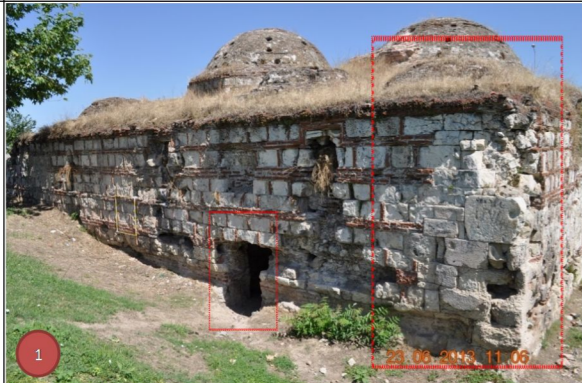
Table 7.37: Damage analysis of “Gazi Mihal Bey” case study bath structure, “Cell E, D, C, B” elevation

Vertical A B C	Qualitative methods of for evaluation is rated, "B" in vertical, "C" out of plane and "B" in plane actions. In detail cell "E, D, C, B" elevation; squared stones with bricks were used. Leaves of the masonry were good bonded and rows between them were constructed regularly. However there is a deterioration on the elevatoin of the bath.	Fig: All

Between the masonry walls there is a consistency of the structure. Stones and bricks were used on constructing the masonry. Brick layers used as beams on the masonry. Timber tie sockets are present inside of the masonry.	Fig: All

In figure 1, 2, 3: On the elevaton of the structre, there is a deterioraton of the out layer of the masonry wall. Some parts of the wall were collapsed. The consistency of the brick layer is broken down. In figure 3: The collapsed corner of the masonry is seen. It was probably repaired in the previous consolidation works.

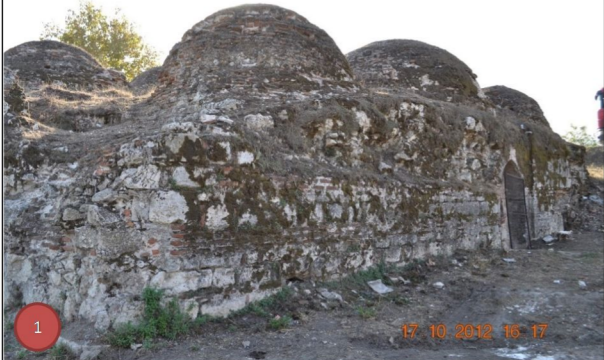
Table 7.38: Damage analysis of “Gazi Mihal Bey” case study bath structure, “Cell K, J, I, H” elevation

Vertical A B C	Qualitative methods of for evaluation is rated, "B" in vertical, "C" out of plane and "B" in plane actions. In detail cell "K, J, I, H" elevation; squared stones with bricks were used. Leaves of the masonry were good bonded and rows between them were constructed regularly. However there is a deterioration and vegetation on the elevatoin of the bath.	Fig: All

Between the masonry walls there is a consistency of the structure. Stones and bricks were used on constructing the masonry. Brick layers used as beams on the masonry. Timber tie sockets are present inside of the masonry.	Fig: All

In figure 1, 2: There is a deterioration of the elevation. Vegetation is covered whole elevation. The corner of the structure was collapsed.

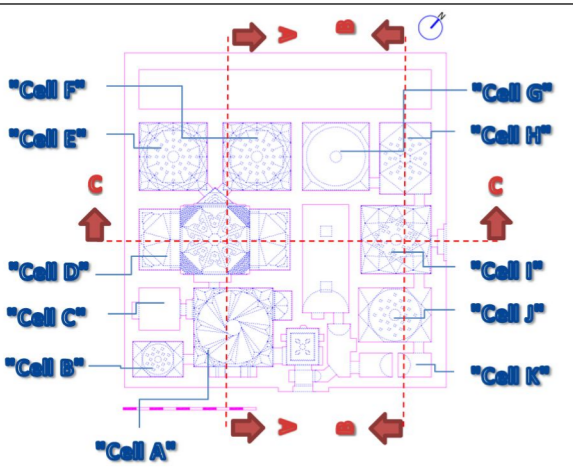
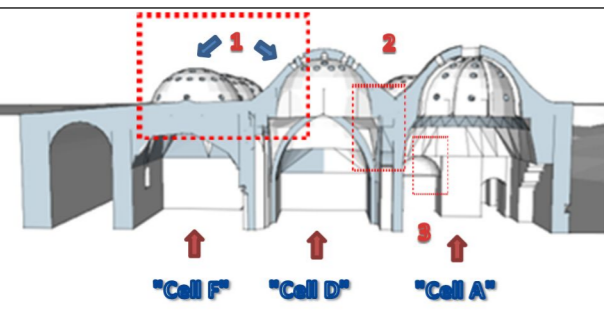
Table 7.39: Collapsed analysis of “Gazi Mihal Bey” case study bath structure, Section A-A

<p>Detail 1</p>		<p>Detail 2</p>		
<p>Symbolic Description of Action Analysis</p>		<p>Symbolic Collapse Mechanism</p>	<p>Description of Collapse Analysis</p>	<p>Symbolic Description of Action Analysis</p>	<p>Symbolic Collapse Mechanism</p>	<p>Description of Collapse Analysis</p>
<p>Very high risk of collapse if this element is under vertical and in plane actions.</p>

<p>Detail 1; In this detail, damage is big crack which is started form the door opening arch and continue to two domes. This crack is sperated two masses each other. The collapse mechanism of this arch is similar with the symbolic collapse mechanism. The part of the cracks on the domes are tended to open the perimeter of the base of the dome. However the neighbour of the domes masses are keep the structures stable. Nevertheless in seismic actions these masses are seperated to each other. In this detail vertical and in plane actions are considered for collapse.</p>

<p>Detail 2; On the top of the door opening there is a tiny crack starts from here and continues to the supporting big arch. In that point there is no out of plumb of the structure and the crack is not wide. The possible collapse of the arch is shown in symbolic collapse mechanism.</p>

<p>Detail 3</p>				
<p>Symbolic Description of Action Analysis</p>		<p>Symbolic Collapse Mechanism</p>	<p>Description of Collapse Analysis</p>			
<p>Low risk of collapse if this element under vertical actions.</p>

<p>Detail 3; tiny crack is started from the niche of the cell and it continues to the dome. The length of the crack and thickness is not long and wide.</p>

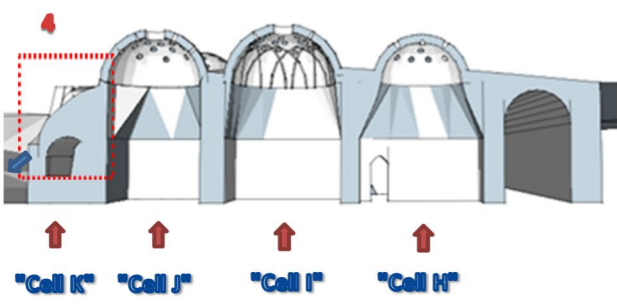
Table 7.40: Collapsed analysis of "Gazi Mihal Bey" case study bath structure, Section B-B / C-C

<p>Very high risk of collapse if this element is under out of plane actions.</p>

<p>Detail 4; Part of the partition masonry wall was collapsed inside of the fireroom. This collapse was not affected the structure stability under the seismic actions. However outside masonry structure which was adjacent to the vault was highly damaged and part of this masonry wall structure was collapsed. This damage could affect the stability of the vault structure under the out of plane actions. Because there was no side supporter structure of the vault. The possible collapse of the vault is shown on the symbolic figure.</p>			
Section C-C		Detail 6					
		Symbolic Description of Action Analysis	Symbolic Collapse Mechanism	Description of Collapse Analysis

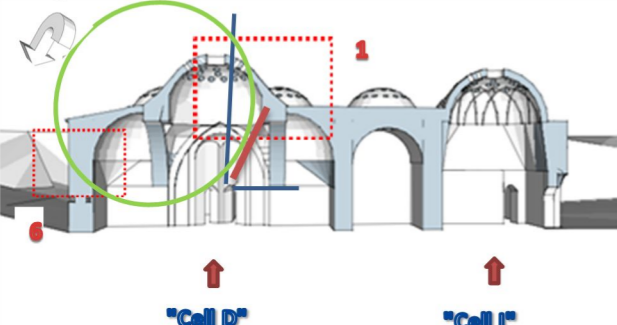
<p>Very high risk of collapse if this element is under out of plane actions. And for detail 1, in plane actions.</p>

<p>Detail 6; The critical big crack "detail 1" is affected the "detail 6" under the out of plane actions. Detail 6, was became weak because of the deterioration of the masonry, adhesion between the mortar and the stones and the empty timber tie beam sockets. This wall important for supporting the half dome and the dome masses. As seen on the section C-C, the wall became weak and narrow because of the voids and deteriorations. The assumption of the possible collapse could be activated by collapsing the masonry wall and kinematic chain of collapse continues with the dome masses.</p>
