Damage analysis of “Ke an” case study bath structure:  
 Table 7.47: Damage analysis of “Ke an” case study bath structure, “Cell A”

Table 7.48: Damage analysis of “Ke an” case study bath structure, “Cell B”

Table 7.49: Damage analysis of “Ke an” case study bath structure, “Cell C”

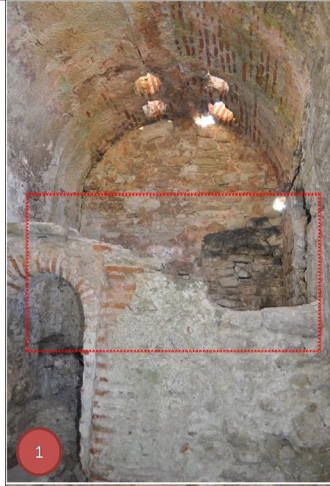
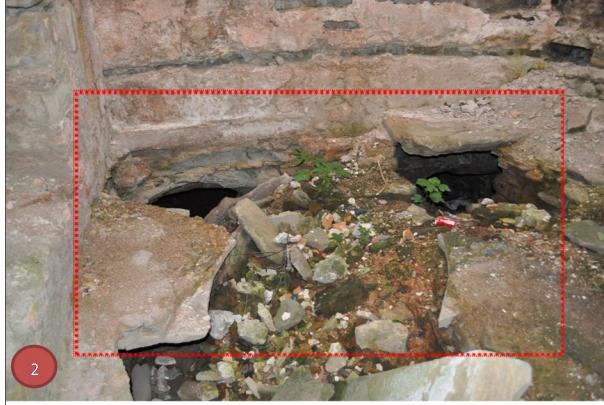
Vertical A B C	Qualitative methods of for evaluation is rated, "B" in vertical, "C" out of plane and "C" in plane actions.	Fig: 1	Fig: All		Between the masonry walls there is a consistency of the structure. However the partition wall and the structure do not any connecton. There is a deterioration of stone wall construction. The masonry walls of the structure is too wide. The dome and the transitional elements made up of brick material.	Fig: 1	Fig: 2	In figure 1: The masonry wall structure was partly collapsed. However it is not a load bearing wall of the structure. It is a partition wall. The arch and jamb of the walls are made up of brick material. In figure 2: The stone slab structure is partly collapsed. And it will affect the stability of the masonry walls.

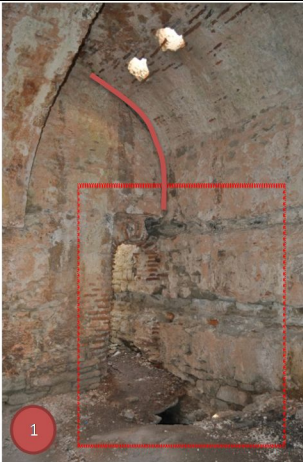
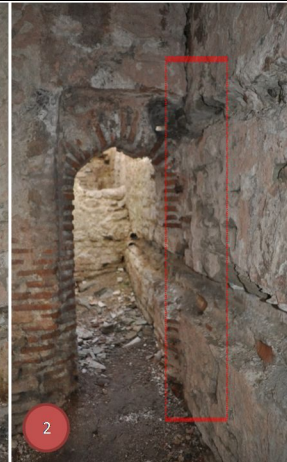
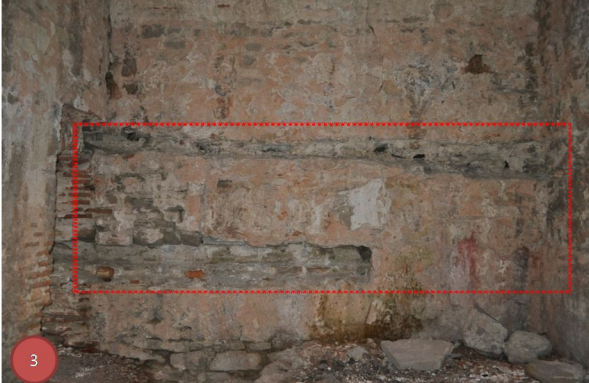
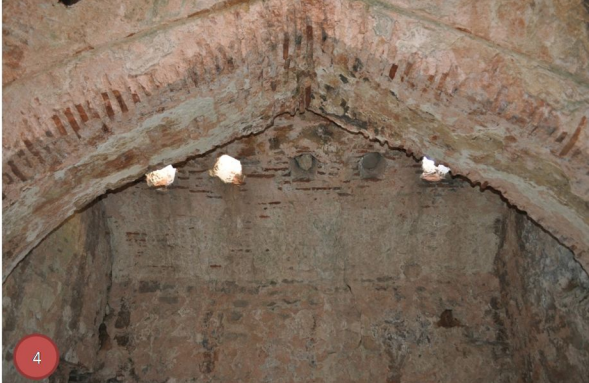
<p>Between the masonry walls there is a consistency of the structure. However the partition wall and the structure do not any connecton. There is a deterioration of stone wall construction. The masonry walls of the structure is too wide. The dome and the transitional elements made up of brick material.</p>	<p>Fig: 1</p>

<p>In figure 1: There is a crack between the wall and the vault. Interior walls of the masonry wall there are empty sockets for the piping system. In front of the wall the stone slab was broken down. The empty sockets and the broken slab affects the stability of the wall.</p>

<p>Out of Plane</p> <p>A</p> <p>B</p> <p>(C)</p>					<p>Qualitative methods of for evaluation is rated, "B" in vertical, "C" out of plane and "C" in plane actions.</p>	<p>Fig: 2,3</p>

<p>In the Plane</p> <p>A</p> <p>B</p> <p>(C)</p>									<p>In detail cell "B"; irregular shape and longitudinal stones were used. Leaves of the masonry were bonded with diatones. Rows between stones were constructed irregularly. But there is an intension to horizontal linearity.</p>

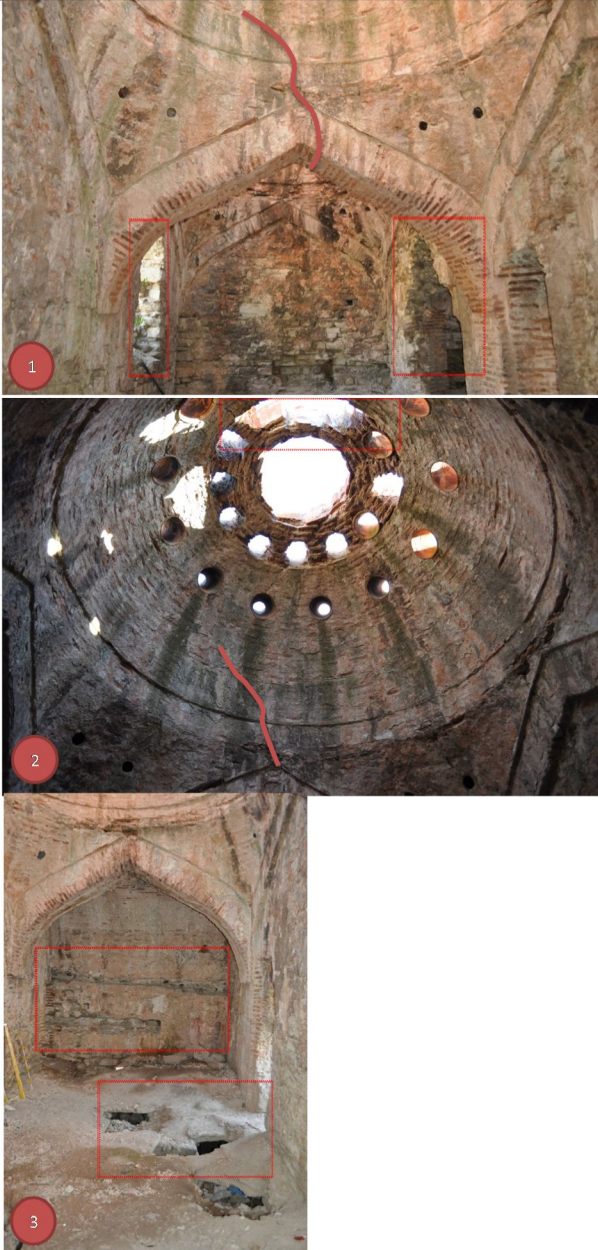
<p>Vertical</p> <p>A</p> <p>(B)</p> <p>C</p> <p>Out of Plane</p> <p>A</p> <p>B</p> <p>(C)</p> <p>In the Plane</p> <p>A</p> <p>B</p> <p>(C)</p> <p>Qualitative methods of for evaluation is rated, "B" in vertical, "C" out of plane and "C" in plane actions.</p> <p>In detail cell "C"; irregular shape and longitudinal stones were used. Leaves of the masonry were bonded with diatones. Rows between stones were constructed irregularly. But there is an intension to horizontal linearity.</p>	<p>Fig: 1,3</p>

<p>Between the masonry walls there is a consistency of the structure. There is a deterioration of stone wall construction. The masonry walls of the structure is too wide. The dome and the transitional elements made up of brick material. Pointed arches are used in this structure.</p>	<p>Fig: 1,3</p>

<p>In figure 1: There is a crack on the top of arch element. This crack is started from the point arch to the perimeter of the dome. This crack is very tiny. On the masonry walls there are two big cracks which are probaby made by users. In figure 2: The crack is same in figure 1. On the top of the dome there is damages on the middle lantern part. In figure 3: On the elevaton of the wall there are cracks and empty sockets for the piping system. On the stone floor there are some parts is broken down.</p>

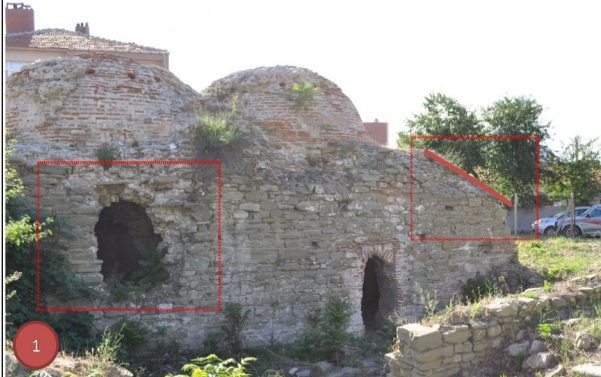
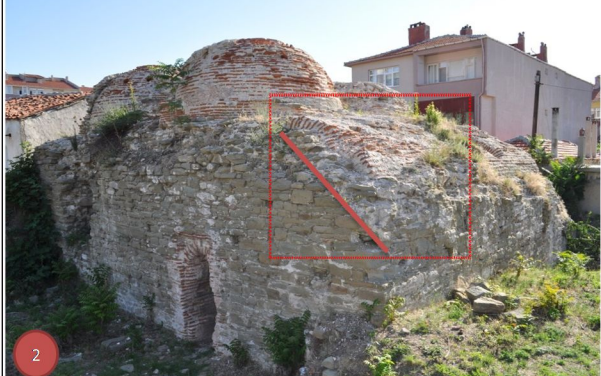
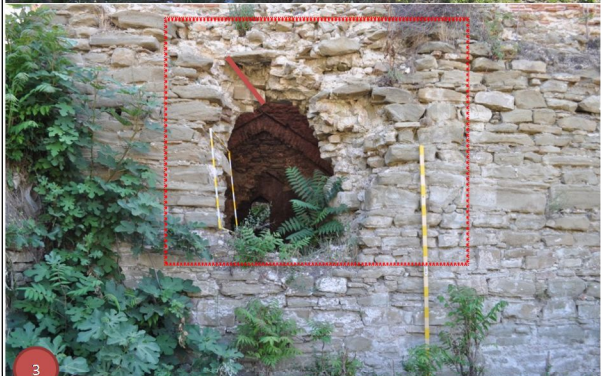
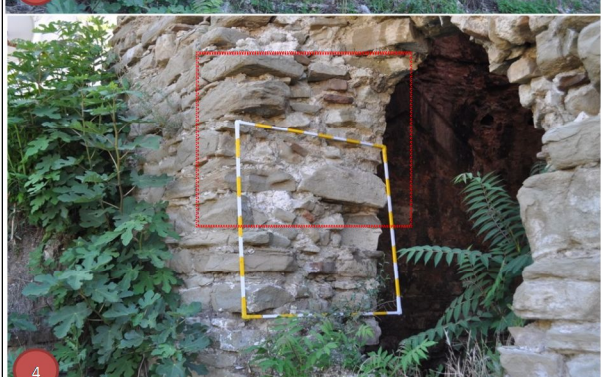
Vertical A B C	Qualitative methods of for evaluation is rated, "B" in vertical, "C" out of plane and "C" in plane actions.	Fig: All

Between the masonry walls there is a consistency of the structure. There is a deterioration of stone wall construction. The masonry walls of the structure is too wide. The dome and the transitional elements made up of brick material. Pointed arches are used in this structure.	Fig: 3

In figure 1,2,3: Around the door openings of the structure is deteriorated and collapsed. On the corner of the structure was deteriorated and collapsed. In figure 4: The section of the masonry structure is seen. The diatone stones are used for connecting the two leaves of the masonry.

Out of Plane A B C						In detail cell "C,D,E" elevation; irregular shape and longitudinal stones were used. Leaves of the masonry were bonded with diatones. Rows between stones were constructed irregularly. But there is an intension to horizontal linearity.

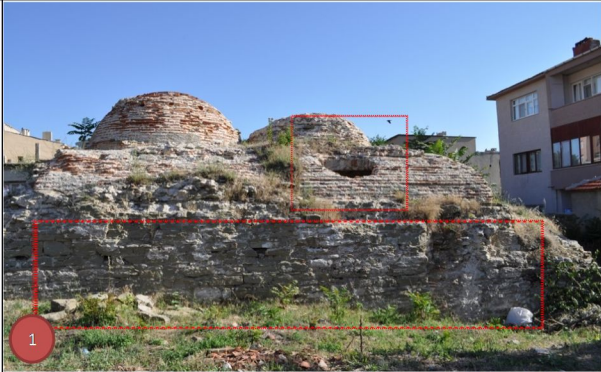
Vertical A B C	Qualitative methods of for evaluation is rated, "B" in vertical, "C" out of plane and "C" in plane actions.

Between the masonry walls there is a consistency of the structure. There is a deterioration of stone wall construction. The masonry walls of the structure is too wide. The dome and the transitional elements made up of brick material. Pointed arches are used in this structure.

In figure 1: There is a deterioration on the structure. Part of the vault structure was collapsed. The "C, B, A" elevation of the structure was deteriorated and the joints of the stones were delaminated.

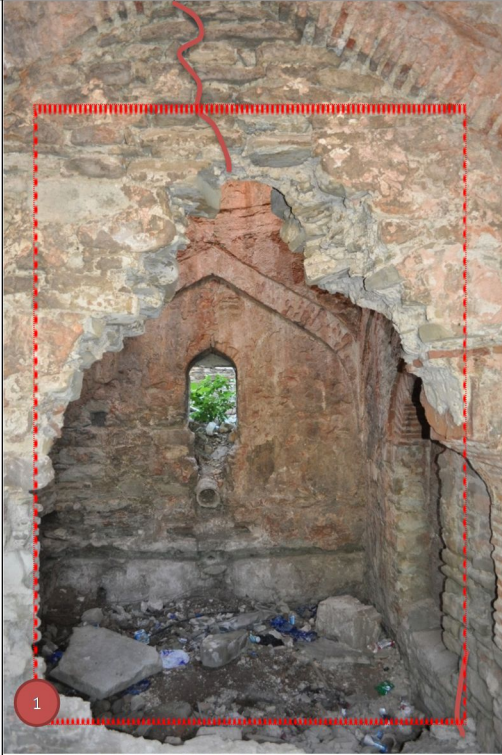
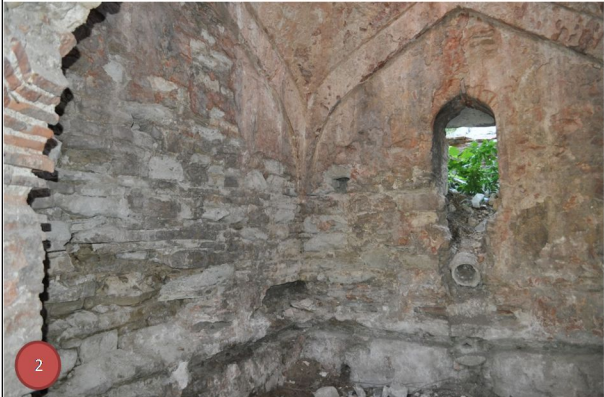
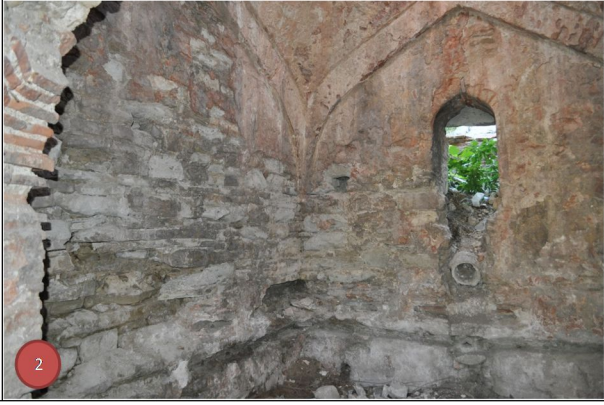
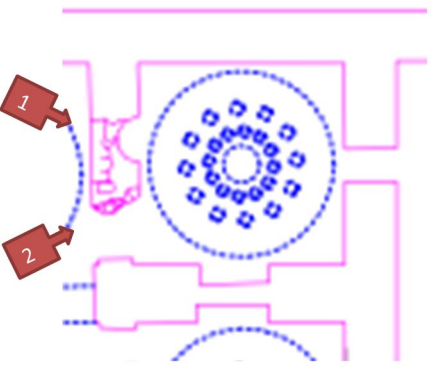
<p>Vertical</p> <p>A</p> <p>(B)</p> <p>C</p>	<p>Qualitative methods of for evaluation is rated, "B" in vertical, "C" out of plane and "C" in plane actions.</p>	<p>Fig: All</p>

<p>Between the masonry walls there is a consistency of the structure. There is a deterioration of stone wall construction. The masonry walls of the structure is too wide. The dome and the transitional elements made up of brick material. Pointed arches are used in this structure.</p>	<p>Fig: 1</p>

<p>In figure 1,2: There was a tiny cracks on the arches. In the first picture the crack was ended under the arch. However the second crack was started top of the window arch and it will continue to the transitional elements.</p>

<p>Out of Plane</p> <p>A</p> <p>B</p> <p>(C)</p>						<p>In the Plane</p> <p>A</p> <p>B</p> <p>(C)</p> <p>In detail cell "F"; irregular shape and longitudinal stones were used. Leaves of the masonry were bonded with diatones. Rows between stones were constructed irregularly. But there is an intension to horizontal linearity.</p>

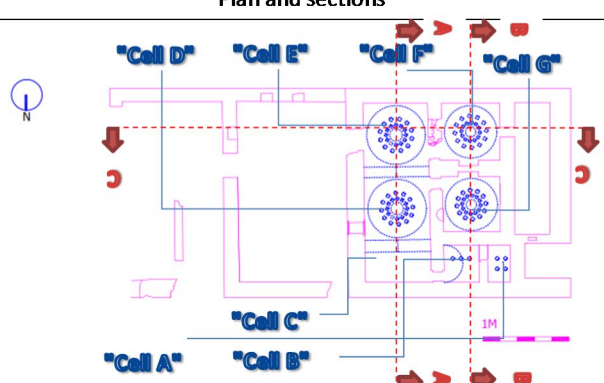
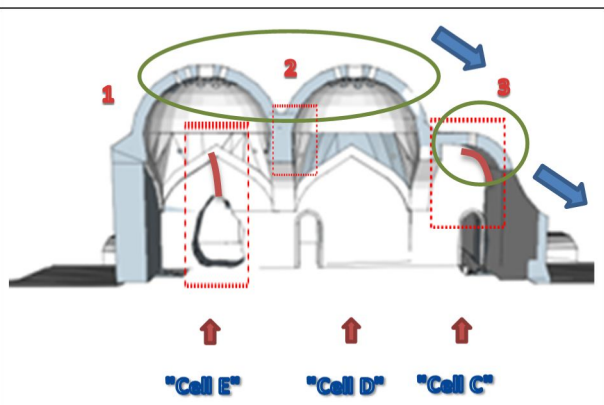
<p>Details</p>				
<p>Section A-A</p>

<p>Detail 1</p>		<p>Detail 2</p>		
<p>Symbolic Description of Action Analysis</p>		<p>Symbolic Collapse Mechanism</p>	<p>Description of Collapse Analysis</p>	<p>Symbolic Description of Action Analysis</p>	<p>Symbolic Collapse Mechanism</p>	<p>Description of Collapse Analysis</p>
<p>Low risk of collapse if this element is under vertical actions.</p>

<p>Detail 1; There is tiny crack starting from the collapsed part of the wall to the end of the supporter arch of the dome. The collapsed part of the wall did not cause any collapse kinematic chain in the structure. The possible collapse mechanism is shown in the symbolic part.</p>	<p>Low risk of collapse if this element is under vertical actions.</p>

<p>Detail 2; There is tiny crack starting from support arch of the masonry cell and it continue to dome. The possible collapse mechanism is shown in the symbolic part.</p>

<p>Detail 3</p>				
<p>Symbolic Description of Action Analysis</p>		<p>Symbolic Collapse Mechanism</p>	<p>Description of Collapse Analysis</p>			
<p>Low risk of collapse if this element is under out of plane and in plane actions.</p>

<p>Detail 3; The crack is between the vault and the partition masonry wall. The upper part of the masonry wall is free for out of plane actions. Therefore collapse mechanism is occurred according to this mechanism. In second scenario; two domes are tend to move to the direction of vault. And the crack was occurred. This action occurred in plane that cause a slipping affect of domes and vault of the structure to the right direction according to the section A-A.</p>

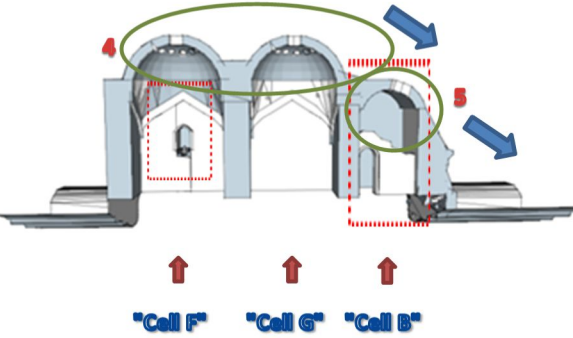
Section B-B	Detail 4			Detail 5		
	Symbolic Description of Action Analysis	Symbolic Collapse Mechanism	Description of Collapse Analysis	Symbolic Description of Action Analysis	Symbolic Collapse Mechanism	Description of Collapse Analysis

<p>Low risk of collapse if this element is under vertical actions.</p>

<p>Detail 4; There is tiny crack starting from the window opening part of the wall to the end of the supporter arch of the dome. The possible collapse mechanism is shown in the symbolic part.</p>	<p>High risk of collapse if this element is under out of plane and low risk of collapse if this element is under in plane actions.</p>

<p>Detail 5; The upper part of the masonry wall is collapsed under out of plane action. Second scenario is the same with detail 2; two domes are tend to move to the direction of vault. And the crack and collapsed was occurred. This action occurred in plane that cause a slipping affect of domes and vault of the structure to the right direction according to the section B-B.</p>

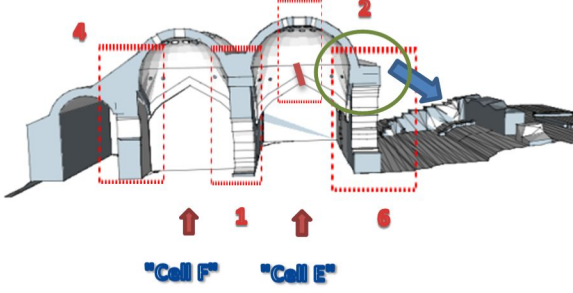
Section C-C	Detail 6					
	Symbolic Description of Action Analysis	Symbolic Collapse Mechanism	Description of Collapse Analysis

<p>Low risk of collapse if this element is under out of plane actions.</p>

<p>Detail 6; The "C,D,E" elevation of the structure is partially collapsed. The damage of the front wall separated to the tension ring of the dome. Therefore possible damage mechanism could be under out of plane action shown in symbolic collapse mechanism.</p>
