**POLITECNICO DI MILANO**

ABC **PhD** DOCTORAL PROGRAMME  
in ARCHITECTURE, BUILT ENVIRONMENT  
and CONSTRUCTION ENGINEERING

# SEISMIC VULNERABILITY OF CHURCHES: A TERRITORIAL KNOWLEDGE APPROACH

**Gessica  
Sferrazza Papa**

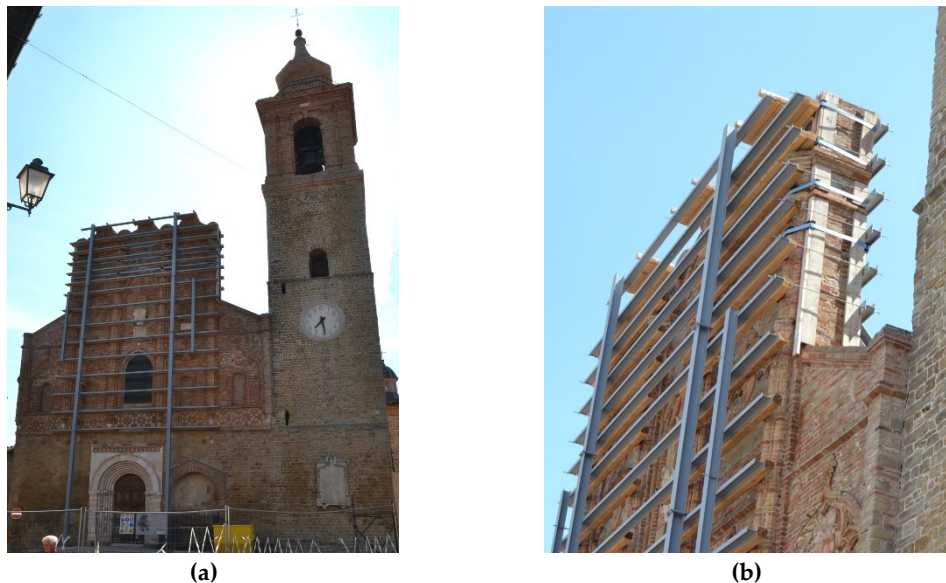
- The *façade* suffered both in-plane and out-of-plane mechanisms. The former is mainly due to the presence of openings, still existing or closed in the past by infilling; the latter was observed only in few cases in the visited churches, 4 out of 10;
- The *gable* suffered damage level 3 for 6 out of 10 churches. In the specific case of the *Collegiata di Sant'Andrea* (Figure 3- 6a), a rotation of 8 cm of the upper rectangular portion of the gable occurred, due to the overhanging characteristic of this element (Figure 3- 6b).

**Figure 3- 6** gable of Collegiata di Sant'Andrea in San Ginesio: **a.** the church; **b.** the detail of the gable (Parisi et al. 2018)

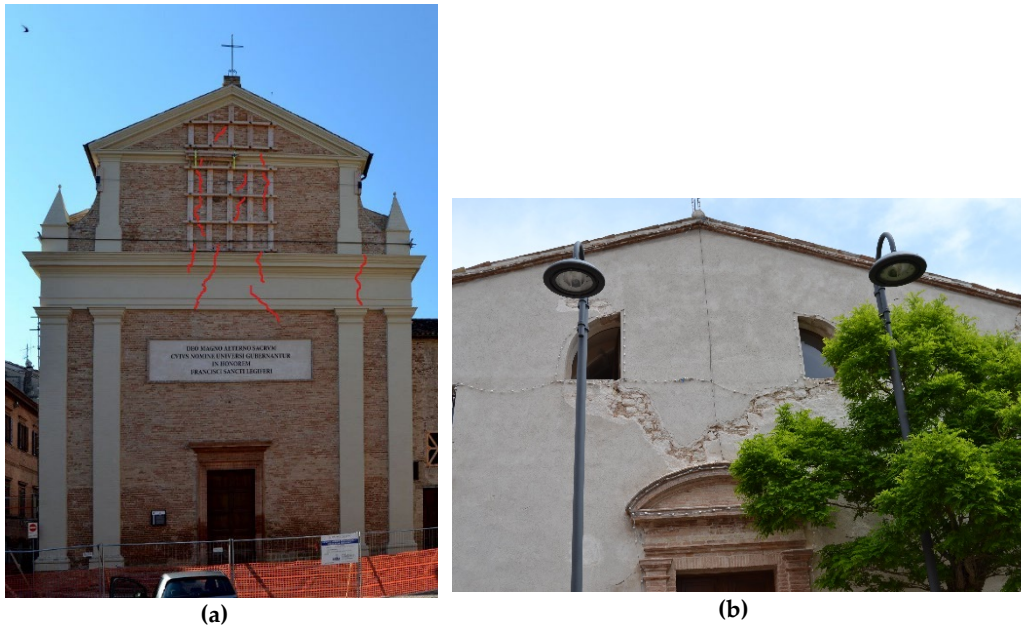
**Figure 3- 7** Example of cracks in the masonry walls: **a.** brick wall; **b.** stone wall.

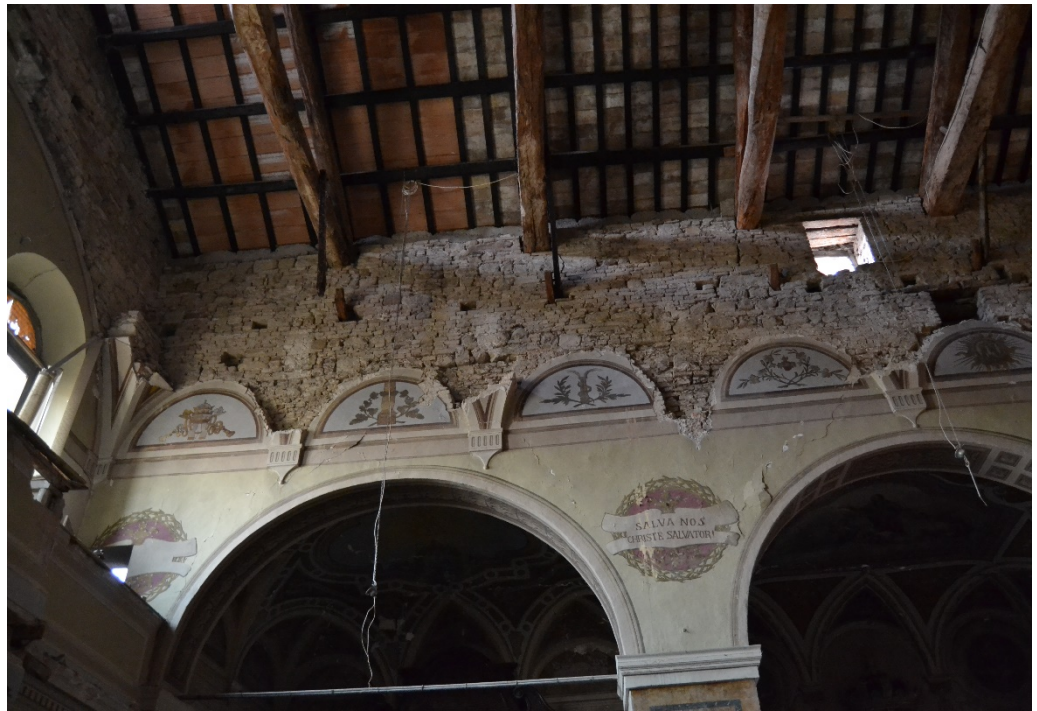
**Figure 3- 9** Trusses of the roof entering the longitudinal wall of the nave. Cracks that start from the portion of the wall where the roof beams are supported.

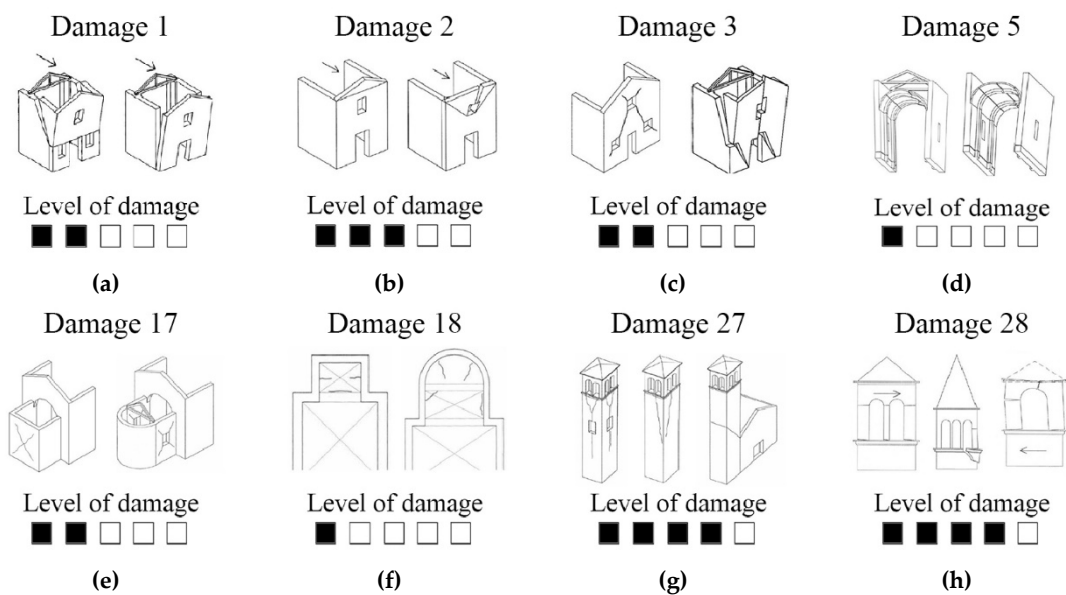
**Figure 3- 23** Activated mechanisms and level of damage: **a.** Overturning of the façade; **b.** mechanisms of the upper part of the façade; **c.** in-plane mechanisms of the façade; **d.** longitudinal response of the

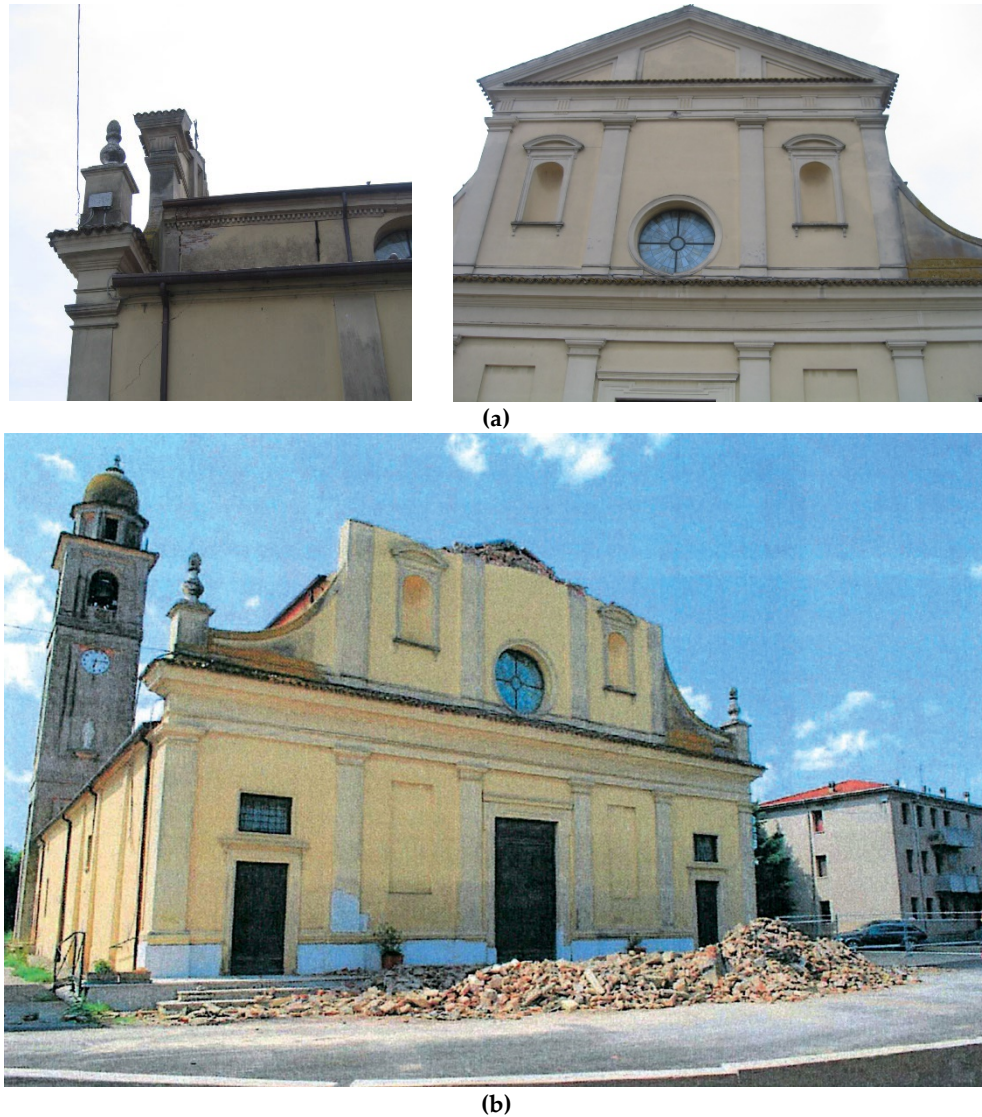
**Figure 4- 5** Damage to the gable of San Giovanni Battista (Superintendence of Brescia 2018): **a.** Damage of the gable after the first shock (May 20), with a level of damage equal to 3 according to EMS-98 scale for Mechanism 2 (Mechanism of the gable) in the abacus of mechanisms; **b.** Collapse of the gable after the second shock (May 29), damage level 5.

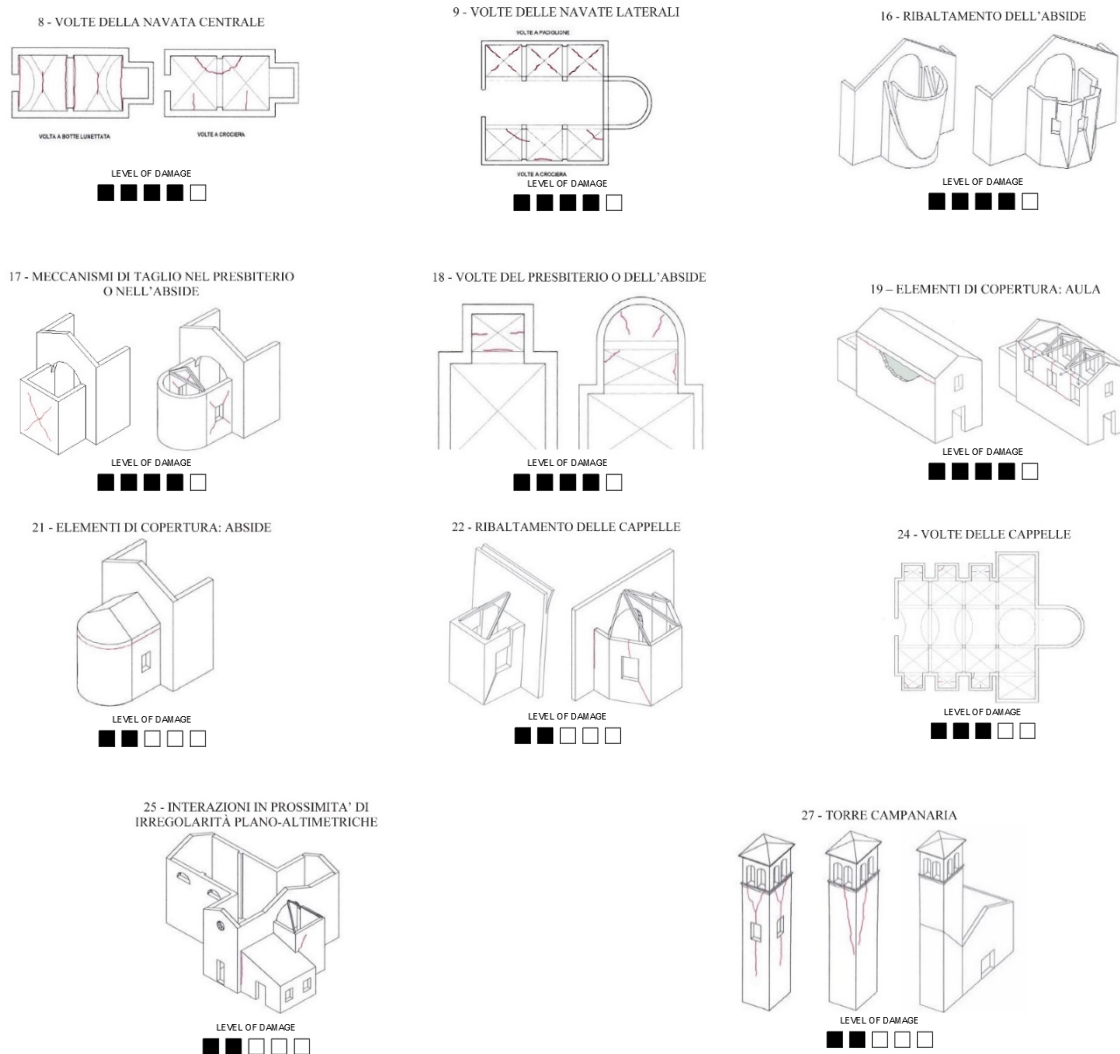
**Figure 4- 17** The occurred damage, distinguished per mechanism, after the two major shocks on May 2012. Mechanism 1: overturning of the façade; Mechanism 2: mechanisms of the upper part of the façade; Mechanism 3: in-plane mechanisms of the façade; Mechanism 5: longitudinal response of the lateral wall, in plane; Mechanism 6: Shear cracks in the walls; Mechanism 7: longitudinal response of the colonnade; Mechanism 8: crack in the vaults of the principal nave; Mechanism 9: cracks in the vaults of the lateral naves; Mechanism 16: Overturning of the apse; Mechanism 17: shear cracks in the presbytery or apse; Mechanism 18: cracks in the vaults of the apse; Mechanism 19: roof elements in the principal nave; Mechanism 21: roof element in the apse; Mechanism 22: overturning of the chapels; Mechanism 24: crack in the chapels; Mechanism 25: Crack in the part of interaction with irregularities; Mechanism 27: Cracks in the bell tower.

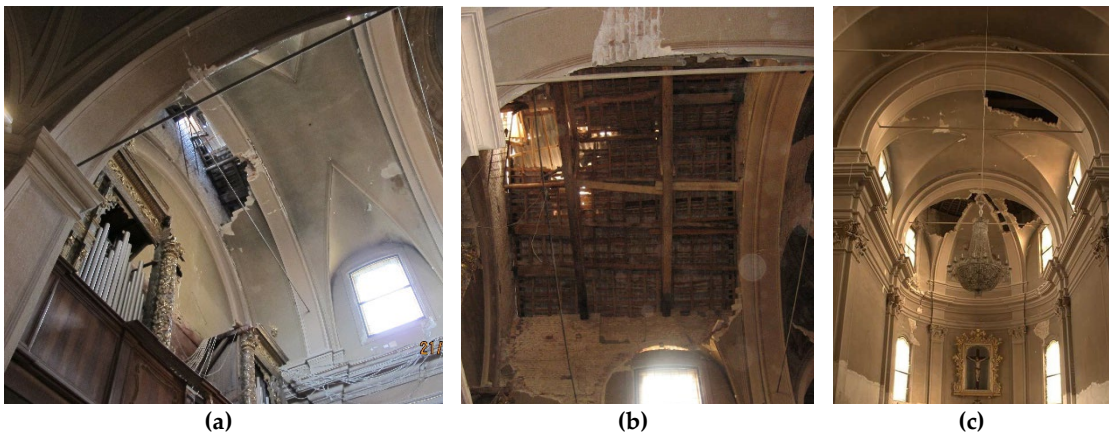
**Figure 4- 19** Collapse of the vault of the church (Superintendence of Brescia 2018): a. the vault adjacent to the façade after the shock occurred on May 20; b. the same vault after the shock on May 29; c. collapse and damage of other vaults of the church.

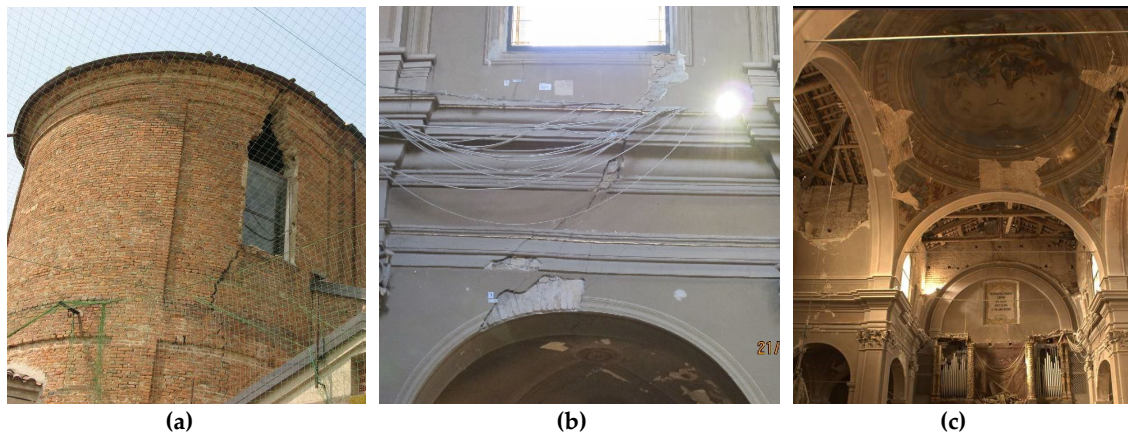
**Figure 4- 21** Other damage on the church (Superintendence of Brescia 2018): **a.** shear cracks in the apse; **b.** shear cracks in the arches of the colonnade; **c.** collapse of other vaults of the church and damage of the central dome.

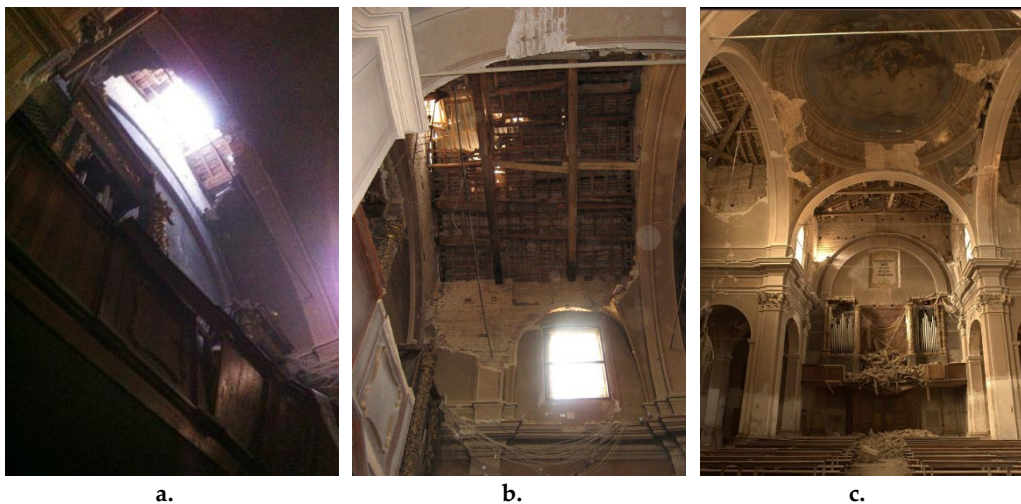
**Figure 6- 5** Damage on the thin brick vaults of San Bartolomeo church in consequence of the 2012 Pianura Padana Emiliana earthquake: a. partial collapse of the vault adjacent to the façade and part of the arch after the 1st strong shock. b. total collapse of the vault adjacent to the façade, the arch, and the second vault. c. delimitation of the damage to the vaults due to the presence of the arch. Some shear damage is present in the dome.

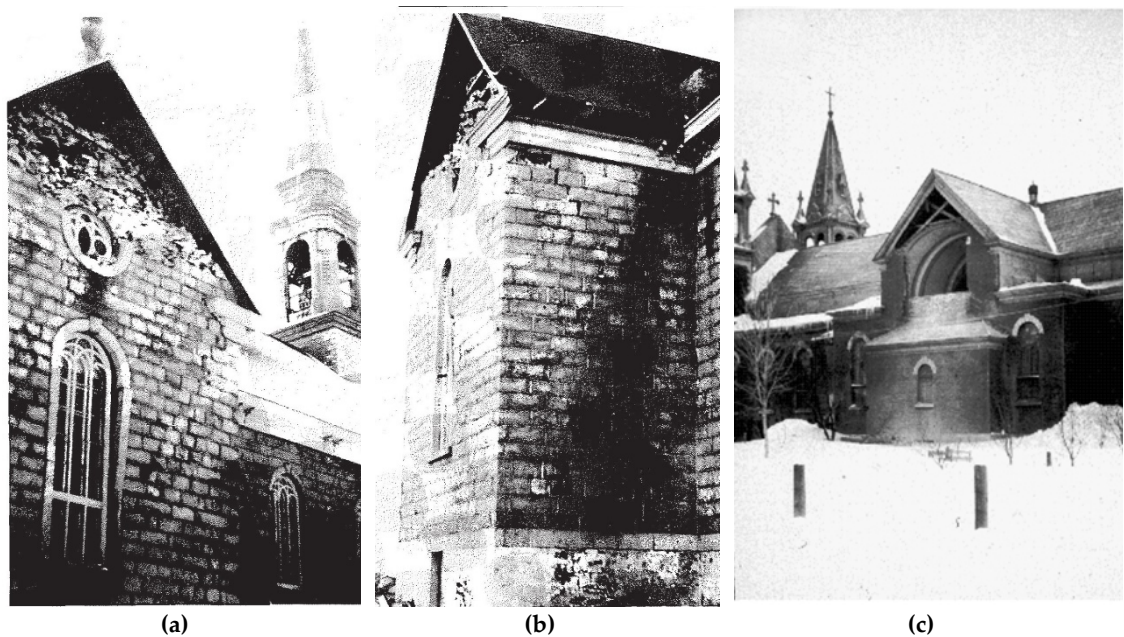
**Figure 7- 6** The images show out-of-plane modes in consequence of the 1925 Charlevoix earthquake: **a.** The overturning of the gable and shear damage of the Rivière-Ouelle church; **b.** cracks highlighting an overturning mode of the same part of the church, lateral view (Bruneau and Lamontagne 1994 p.645); **c.** overturning of the gable of a church in Shawinigan (Bruneau and Lamontagne 1994 p.649).

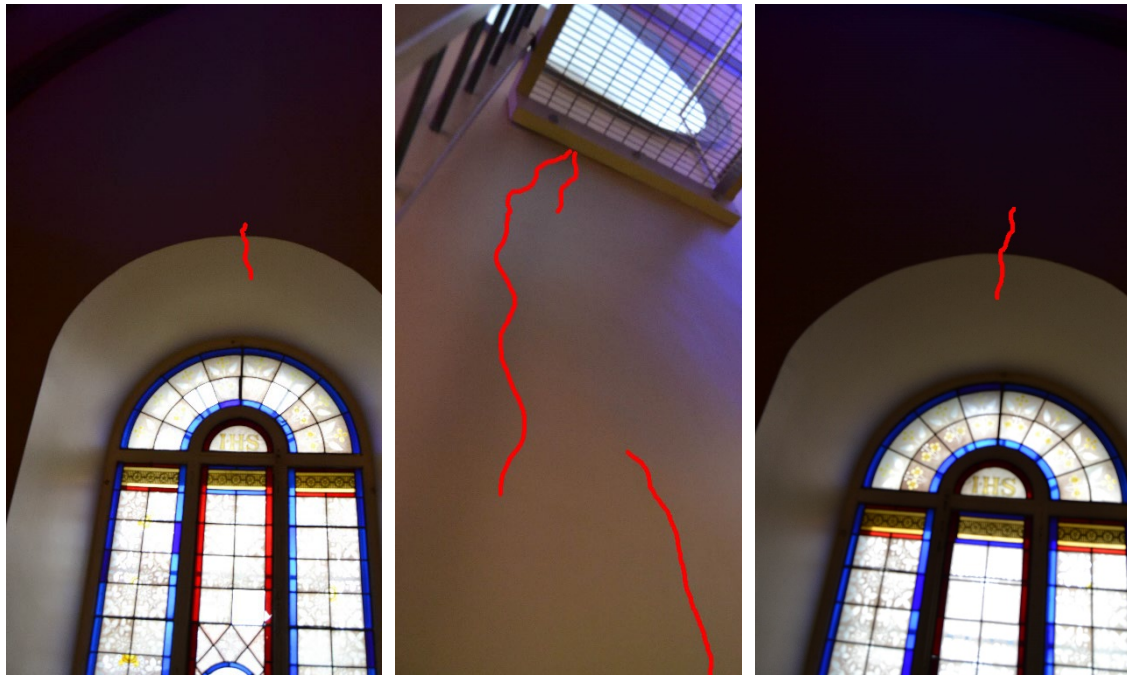
**Figure 7- 21** Cracks in Sainte Famille in Boucherville: **a.** Rose window; **b.** Left opening in the façade wall at the second order; **c.** Below the rose window; **d.** Right opening in the façade wall at the second level.

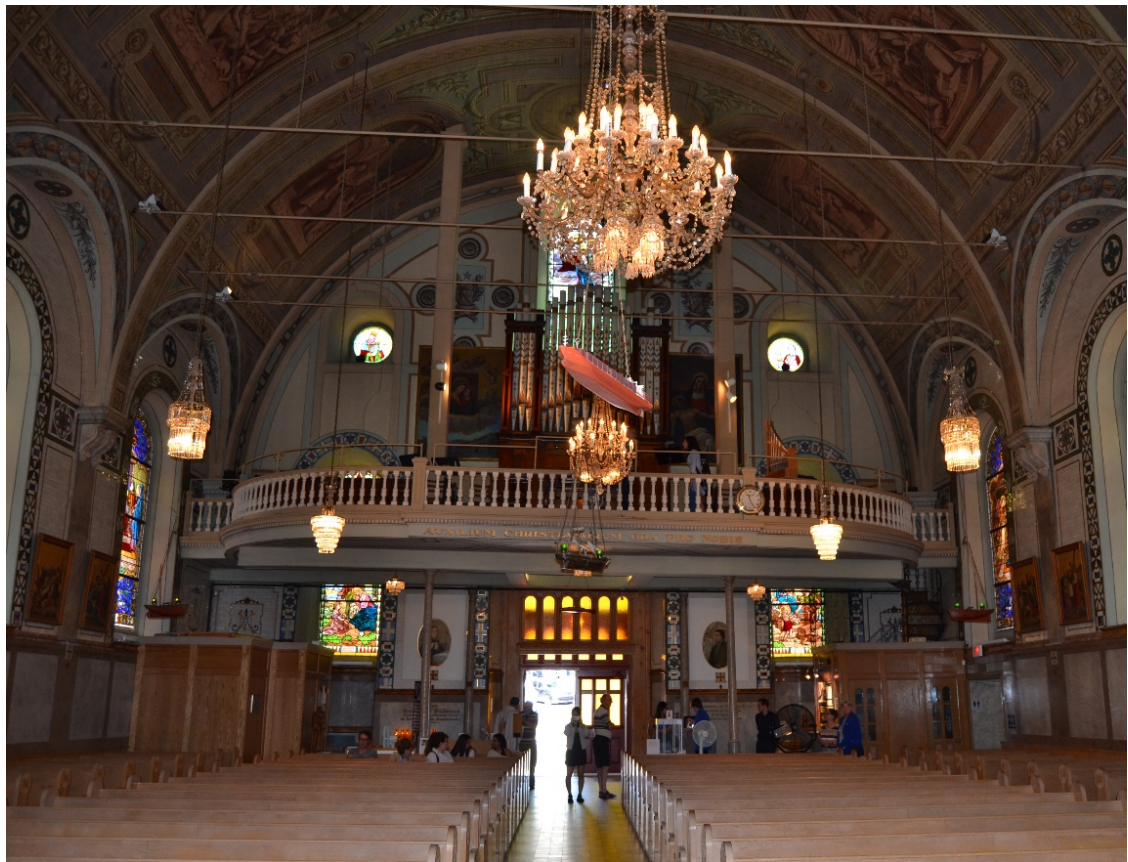
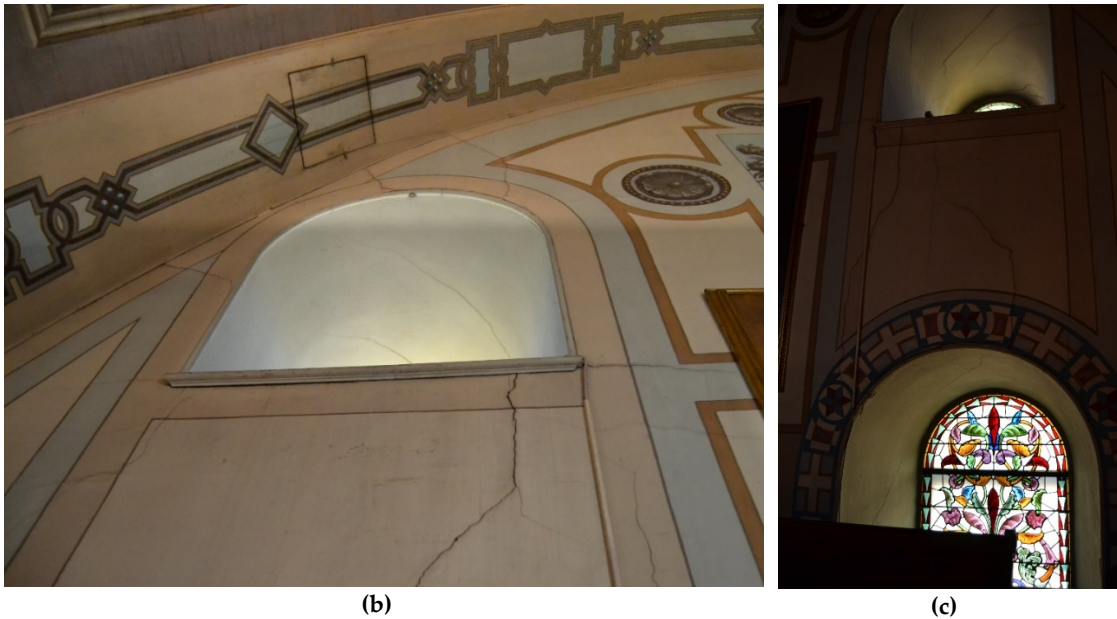
**Figure 7- 22** Cracks in the façade wall of Notre Dame de Bon Secours: **a.** complete view towards the façade wall; **b.** zoom on the crack below the left opening; **c.** zoom on the crack above the left opening.

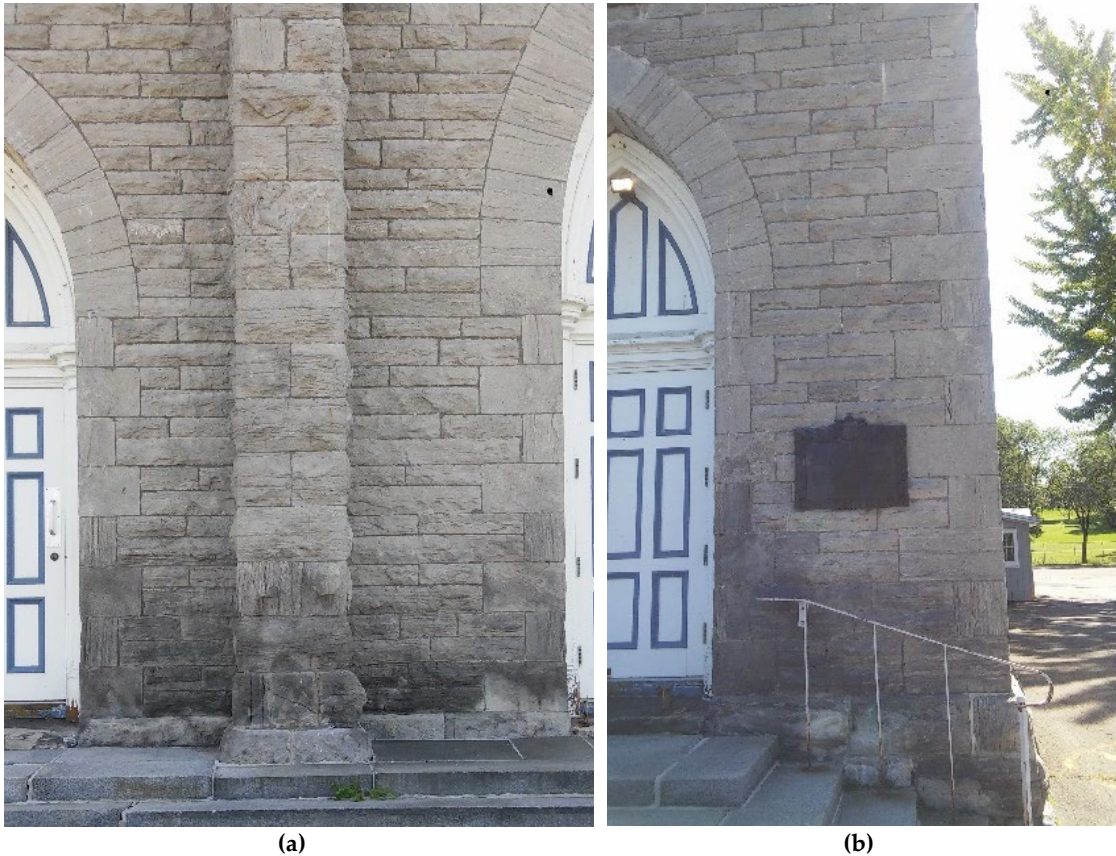
**Figure 7- 48** Rising damp visible at the base of the façade: **a.** on the center of the façade; **b.** on the right corner. The photo was taken on dry season (beginning of September).

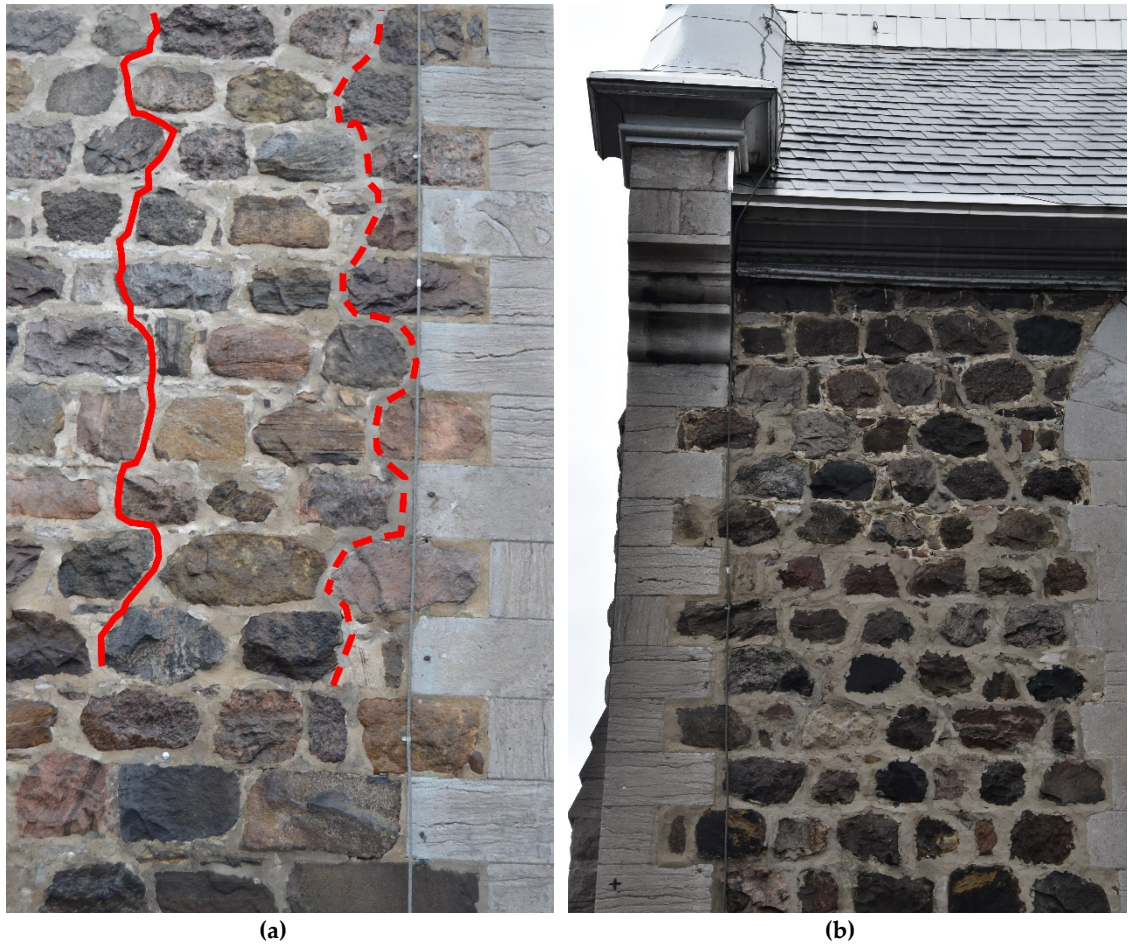
**Figure 7- 50** Crack on the lateral walls of the nave: **a.** A vertical crack close to the corner was repaired and a new similar one appeared almost parallel to the previous one; **b.** A modification of the stone fabric is visible in the area close to the corner in the opposite lateral wall of the nave. A symmetrical structural problem can be assumed.

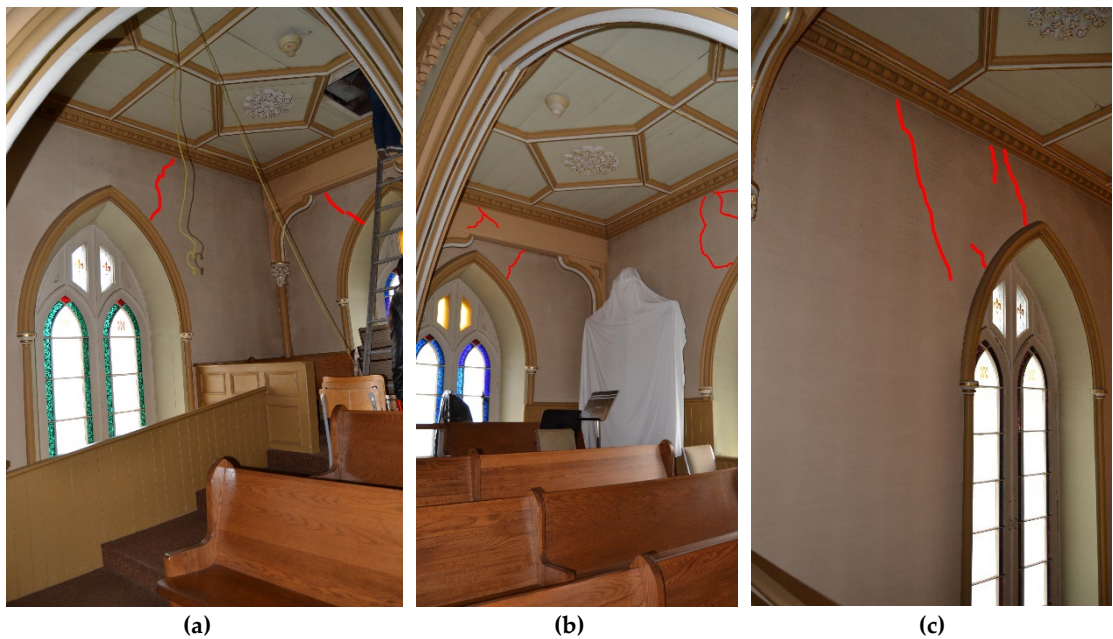
**Figure 7- 51** Cracks near the openings in the lateral walls close to the façade: **a.** first window in the north lateral wall; **b.** first window in the south wall; **c.** second window in the south wall.

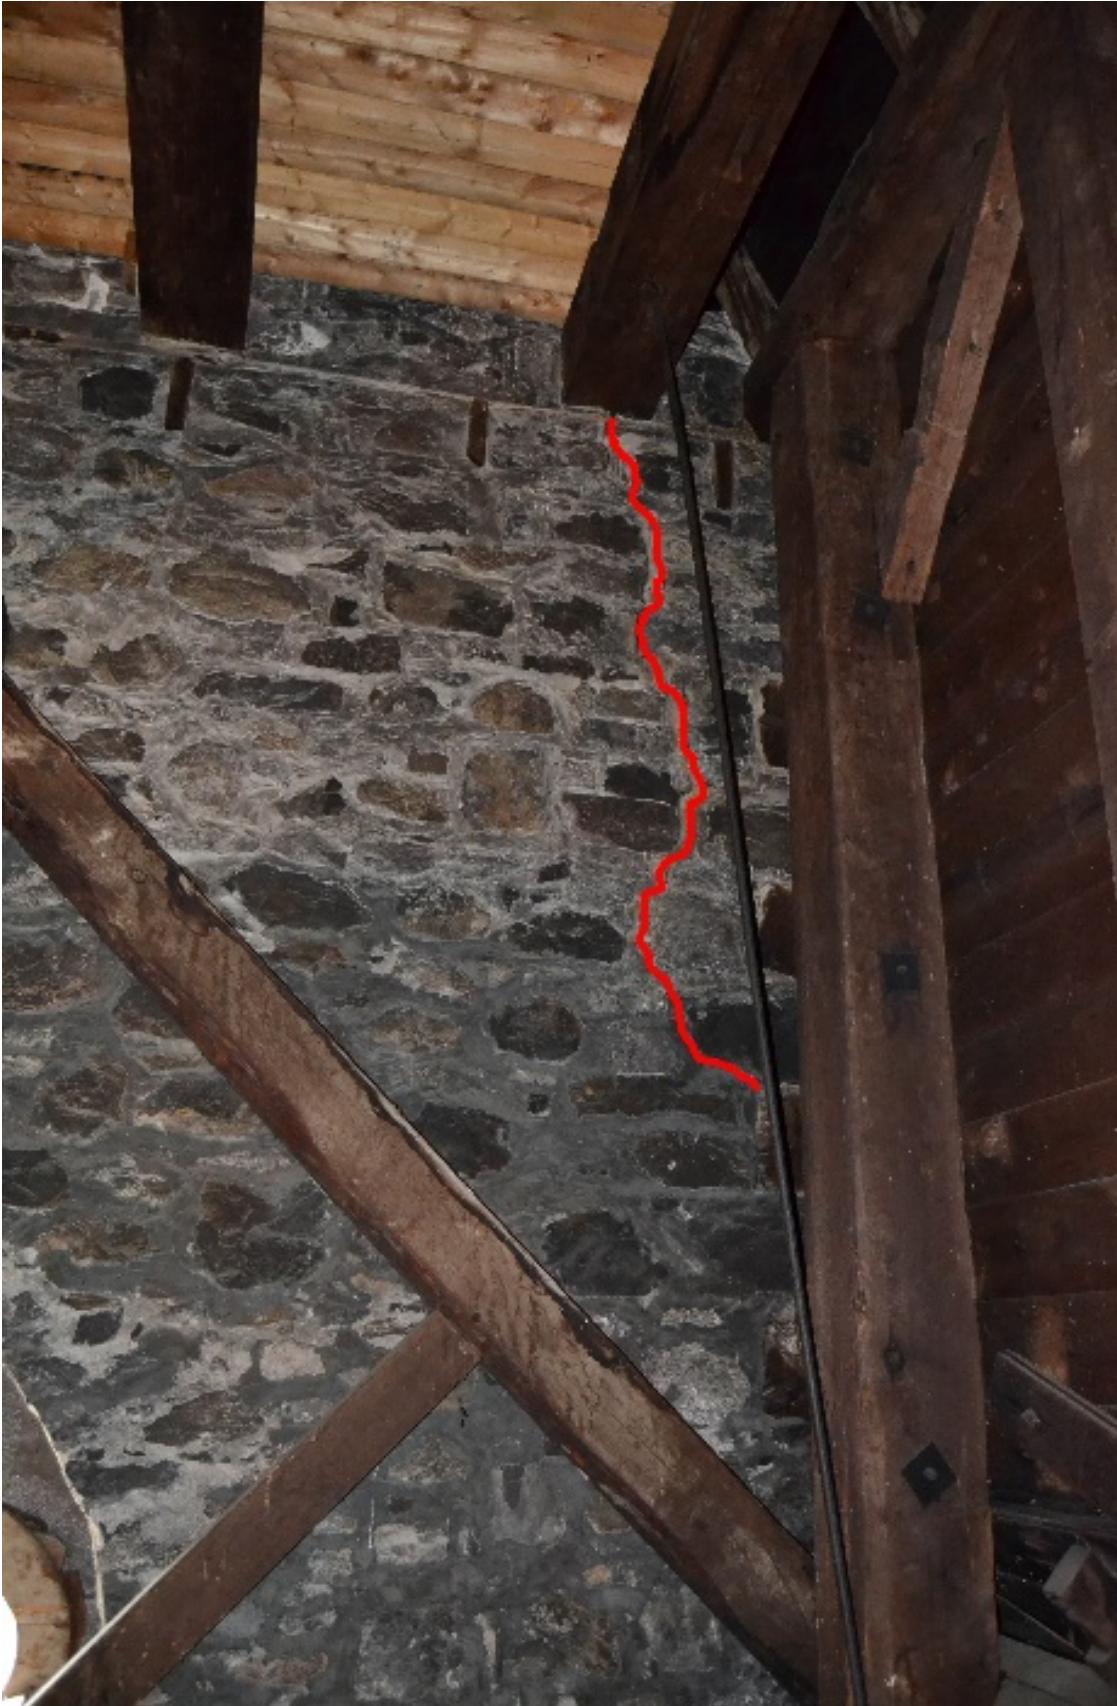
**Figure 7- 52** Crack in the interior side of the façade. It has a vertical path starting at the base of one beam of the second deck of the bell tower.
