OPEN SPACE

Architectural Design Studio For Restoration of Complex Construction

Master Thesis in Building Architecture

Politecnico di Milano
School of Architecture Urban Planning Construction Engineering
AY 2019/2020

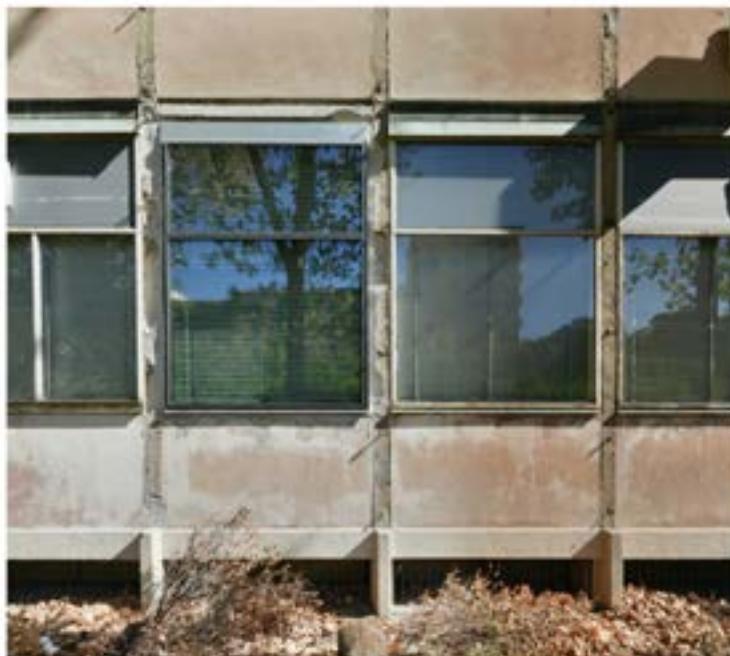
view of west facade

It is evident that west elevation of the building has not been renovated recently except the first two spans at the north side. The wall, in reinforced concrete, has a decadent painting orange layer with patially detached/cracked cement plaster layers.

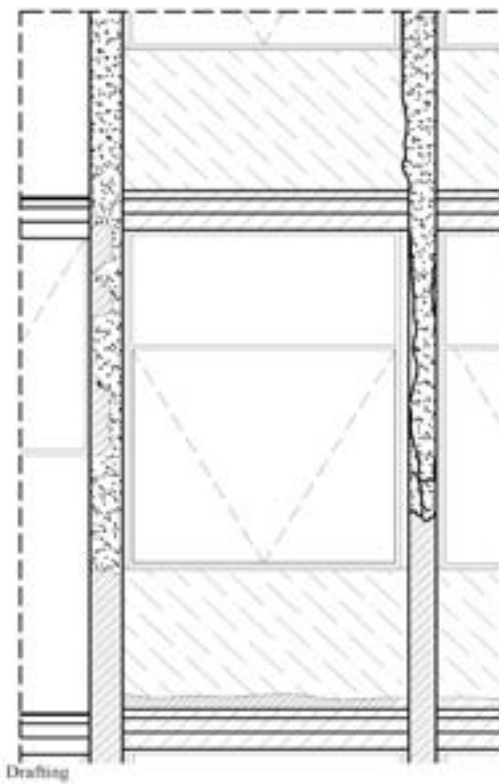
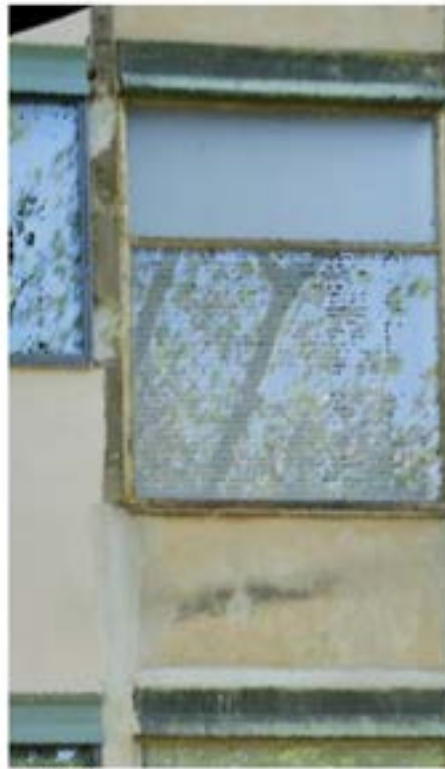
As the historical photo shows, there were vertical elements and almost all of them have been demolished. As a statistic, there were 49 vertical elements in total:

3 of them were the three edges of the facade. 1 of them were covered with alloy metal. 2 of them a large part were remained. 37 of them only a bottom were remained, the upper part were removed. 6 of them were completely removed and additional drainage pipes were embedded in it.

Among these vertical elements between 16th and 17th, 39th and 31st there are two expansion joints.

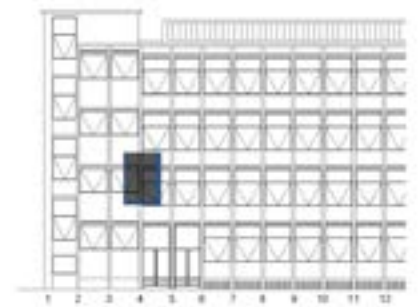
The decay of integration only happened where there is a replacement of the windows or other elements. The cement mortar was filled to cover the gap.

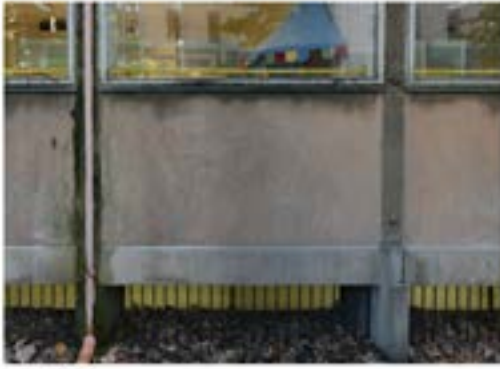
Status photo

Location of the decay: it's localized in number(33) and number (34)

About the biological colonization: it happened along drainage pipe(33). As counted, there are only one drainage pipe of sum (6) pipes to which these kind of phenomenon happened.

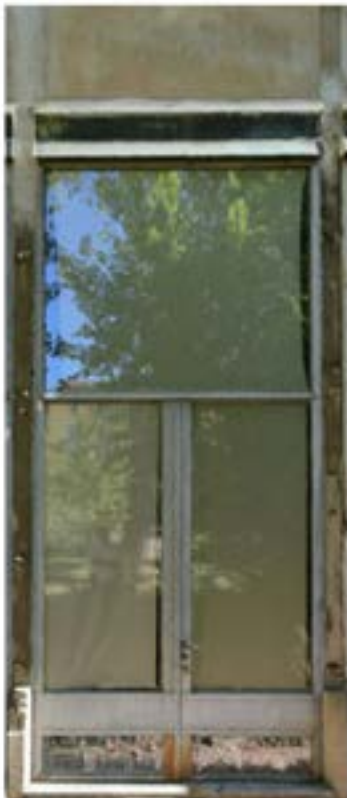
status photo

Location of the decay: it's localized in number(5)and number(6)

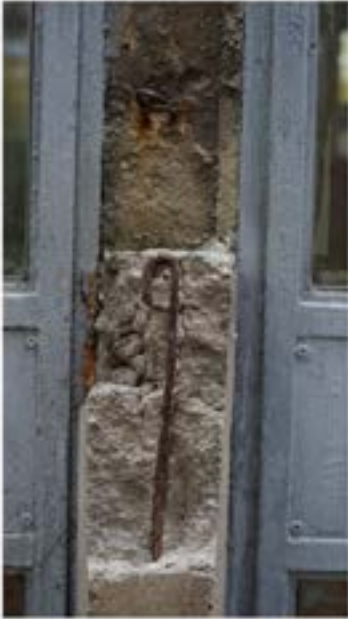
Detachment of concrete of the base(photo from the front)

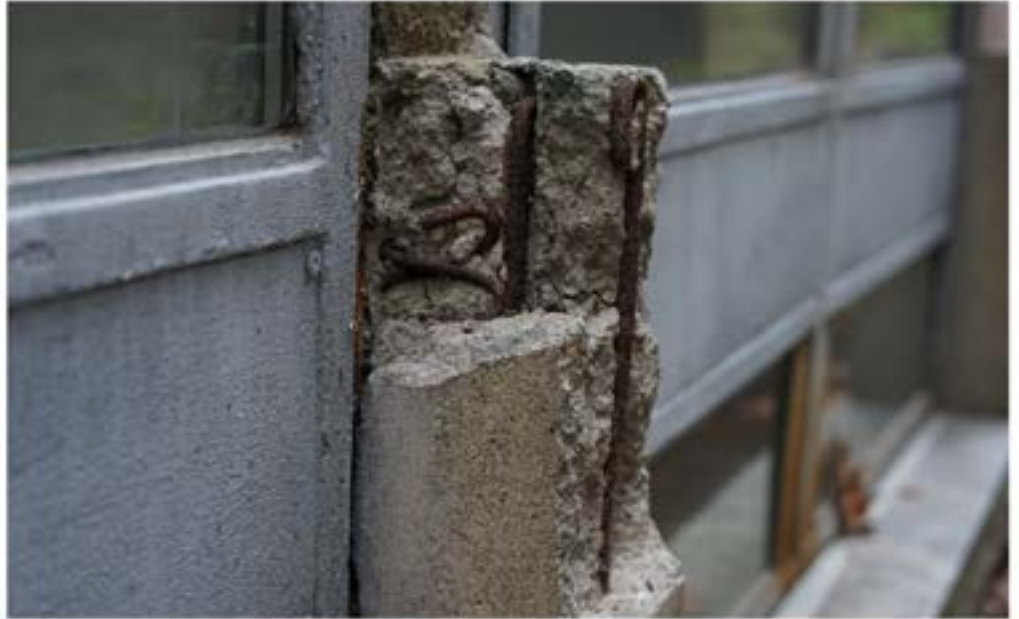
Detachment of concrete of the base(photo from the side)

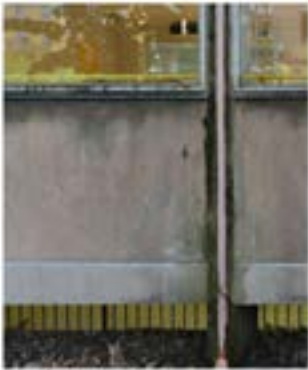
status photo

Location of the closure wall: there're localized in span(29) (6) and (10)

A general state of the plaster of the closure walls: most of the faded in color, minor parts of them peeled off , meanwhile ,minor part of them there is a hair cracks happened.

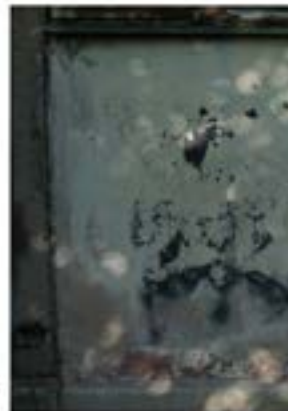
Discoloration(position 2)

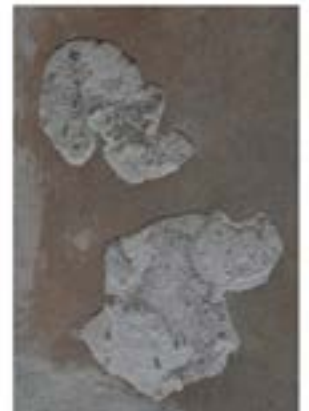
Peeling off (Position 3)

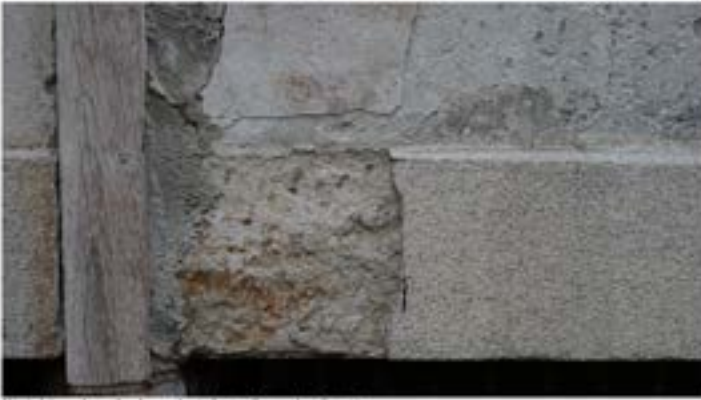
Finishing detached partly (photo from the front)

Location of the lintel: it's localized between vertical elements of number(28) and number(29)

Totally, there are 44 lintels. Most of them all covered in good condition. One of them on which detachments happened and another one of them the finishing completely detached.

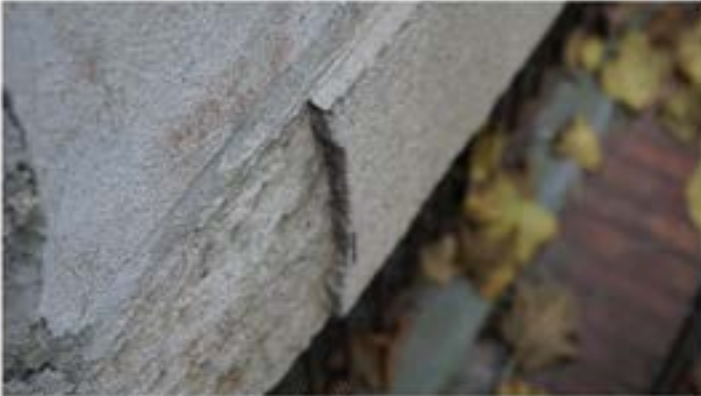
Finishing detached partly (photo from the side)

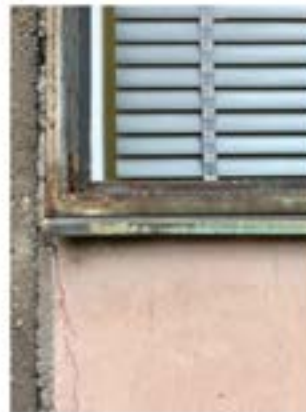
decay from the front

In west facade, there is only two doors in span(4) and (5): they are closed normally. From the frame inside stays well. Only a part of the bottom there is a corrosion. There are 225 windows in west facade:(14) are refurbished windows on the north part, the rest(211) windows are corroded with deposit on the flashing, discoloration on the copper profile and corrosion on the windows frame.

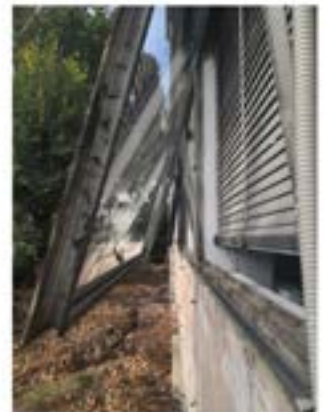
decay from the side

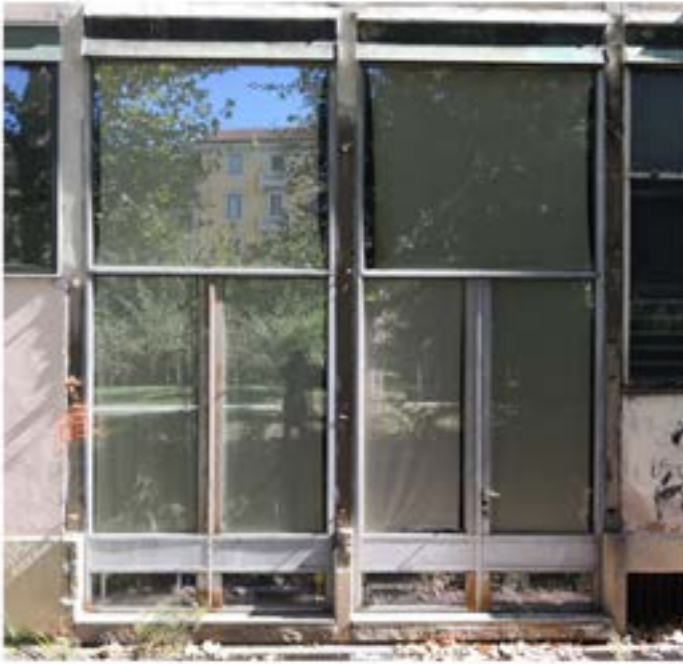
status photo

In west facade, there is only two doors in span(4)and(5): they are closed normally. From the virtual observation, they are preserved well: on peeling happened to the door frame. So the frame inside stays well. Only a part of the bottom have a problem of corrosion which can be presumed by the color.

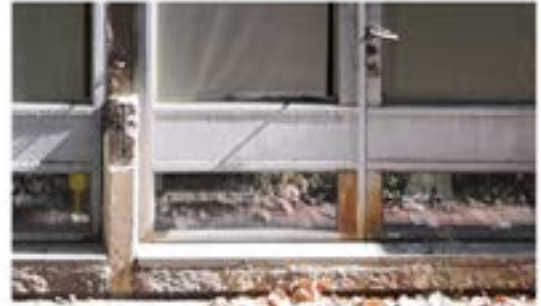
amplification of the decay

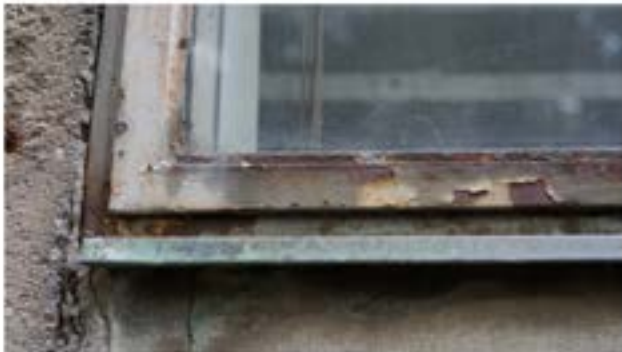
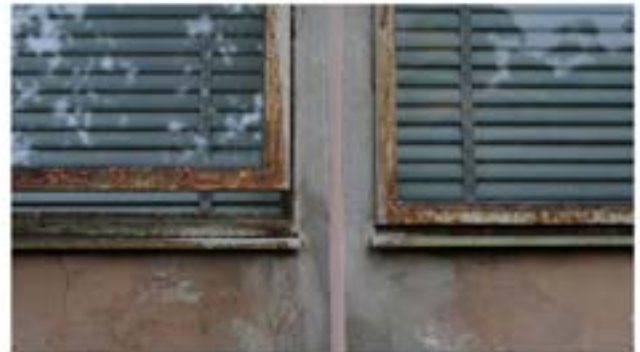
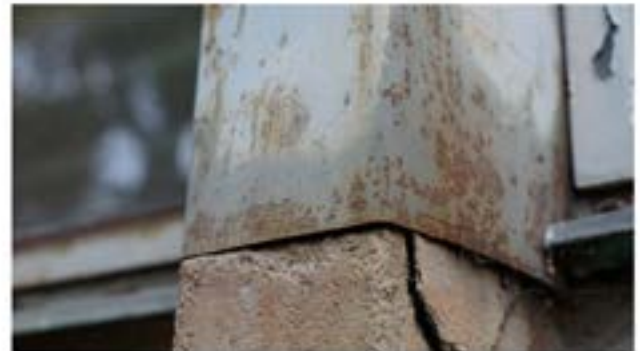
As we can see on the west elevation, the window frames, which are made of steel, are corroded because of direct contact with rainwater and oxygen due to the lack of a protective coating. We assume that the reason is due to the lack of maintenance, the painting on the framings are detached then the steel frames were in direct contact with water and air that has resulted in corrosion.

Cleaning by hand is the best way to remove thick corrosion layers, working with fine hand-tools and with the aid of a low power microscope. Chemical cleaning maybe is not the best way because it cannot easily be controlled and some chemicals may remain on the object.

We have to remove the rust from the steel framings.

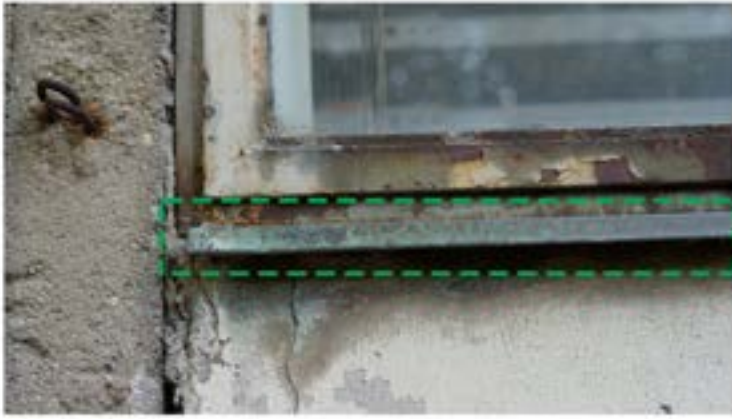
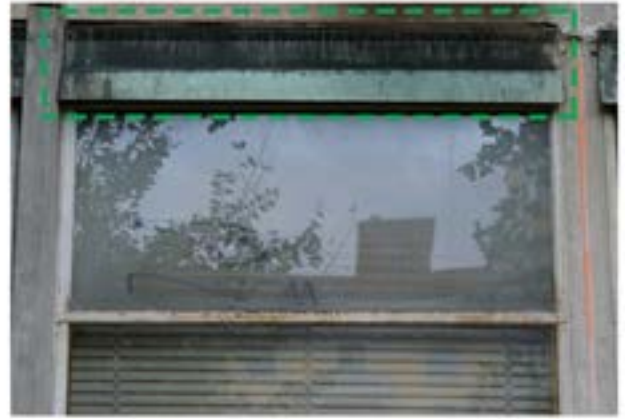
On the west elevation the flashings and awnings are made of copper that allow rainwater to fall down without contacting the facade in order to prevent damaging. Over time copper will naturally change colors-transformation from a shiny brown color to darker browns. Then blues and finally greens after a number of years. When exposed to the natural elements such as wind and rain, copper develops this "painting" which actually protects and preserves the metal underneath.
