The study area: Mendelssohn Street

Current situation

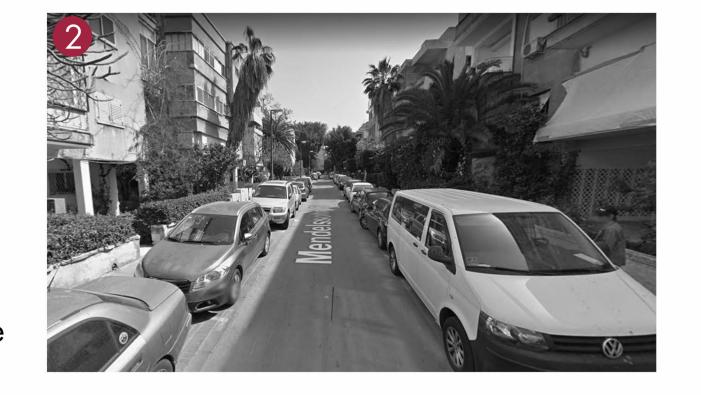
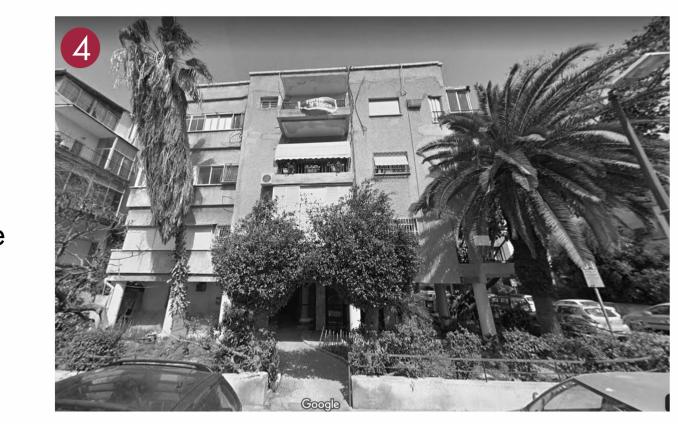
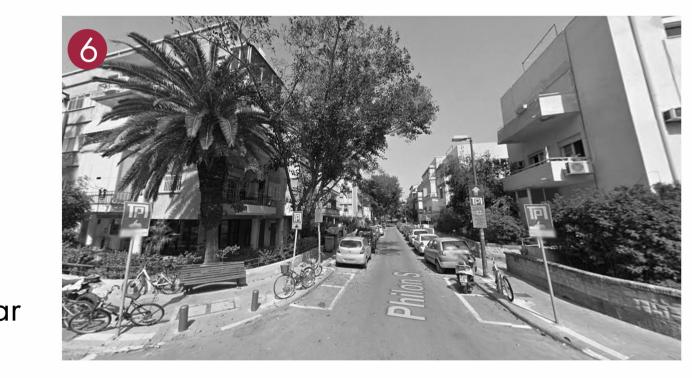
- a) Shaded resting areas are needed, we can observe in the corner spot that an attempt was made by installing a bench, but due to the hot weather it is probably not used
- **b)** There is a lack of bicycle racks, they are currently parked along the street and blocking the circulation of pedestrians
- c) A very big percentage of the street section is used for cars, with one circulation lane and two parking lanes. For this reason, the sidewalks are very narrow and the space for the pedestrians is extremely limited **d)**The majority of the houses
- present neglected greenery and fences. The decay is visible, many fences are totally or partially destroyed, while the poorly kept frontal gardens strongly affect the urban image of the street e) The street sections (both in Mendelssohn and Philon Street) are perceived as dominated by car

traffic, messy and neglected
