# RESTORATION

In the history of Società Umanitaria building, a restoration work occurred in the 90's. The work has been mainly made on the plasters, which have been cleaned, repaired and, for some of them, painted.

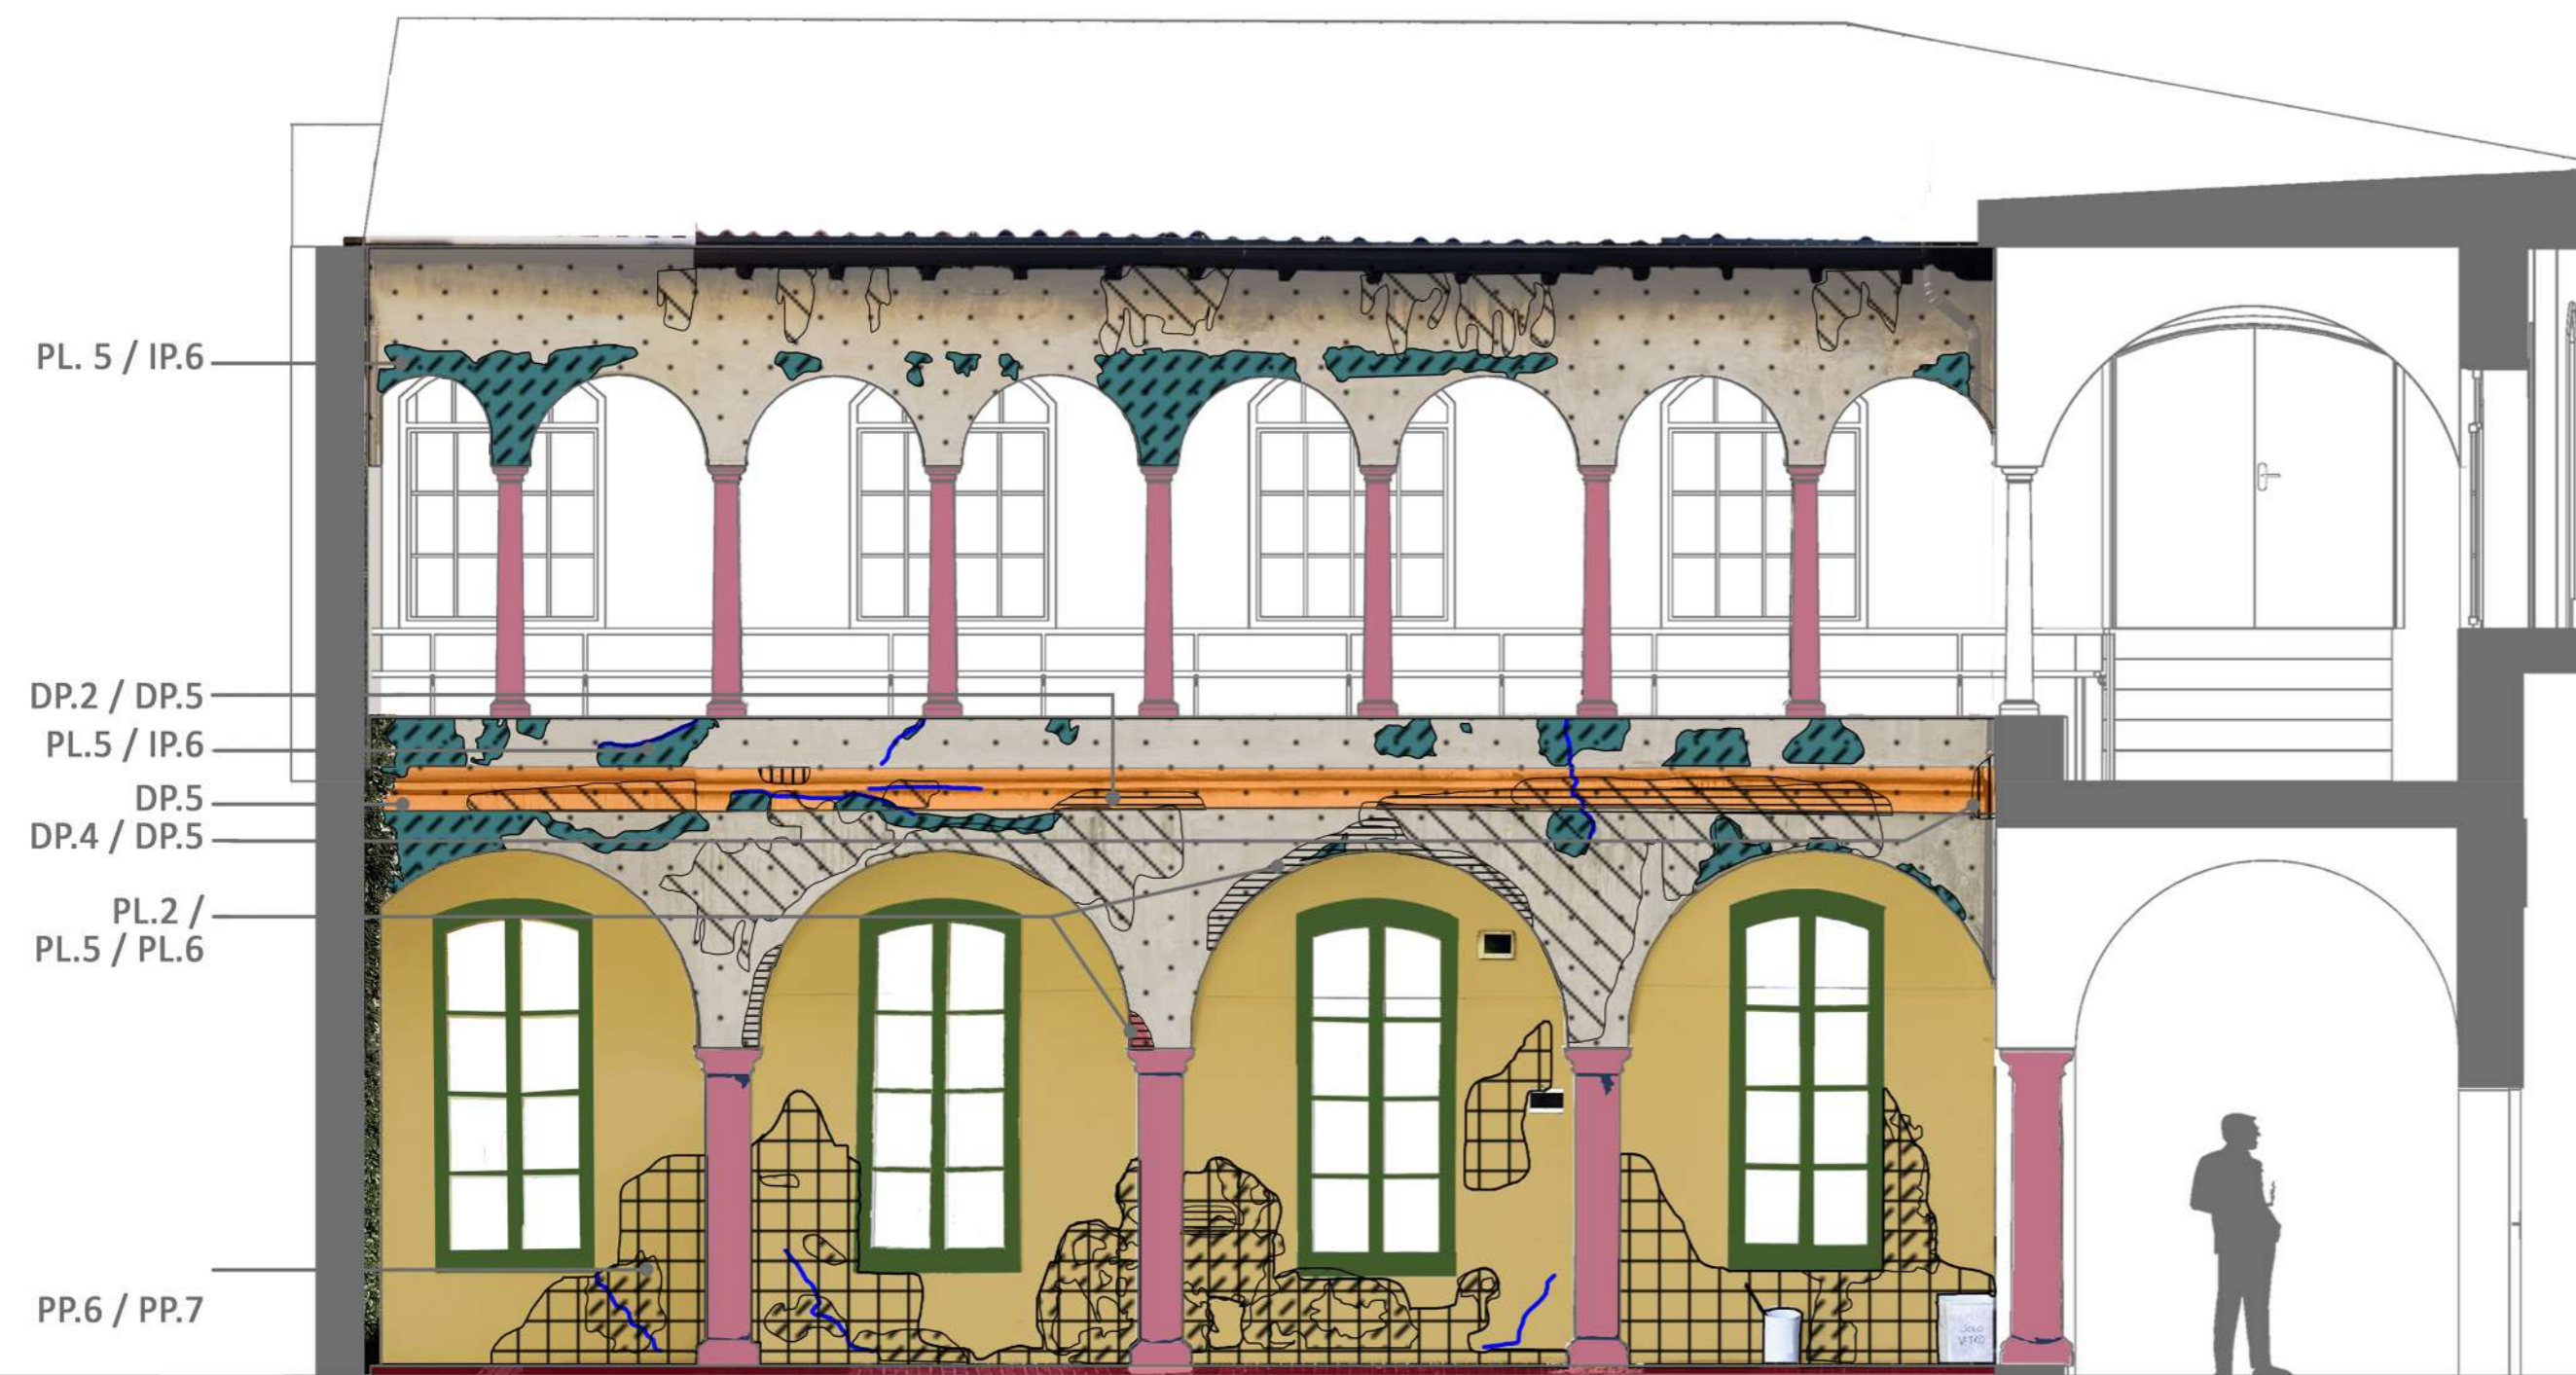
MATERIAL AND DECAY MAPPING  
1/50

Unfortunately, the work marked the architecture in time. The technics left some clear decays on the work itself but also on the original materials. The products used were not fitting the cloister's components and it created deterioration. After a deep analysis of the cloister's structure and the existent materials, a different method of intervention has been chosen to repair and restore Società Umanitaria. The intervention is presented on Chiostro della Memoria.

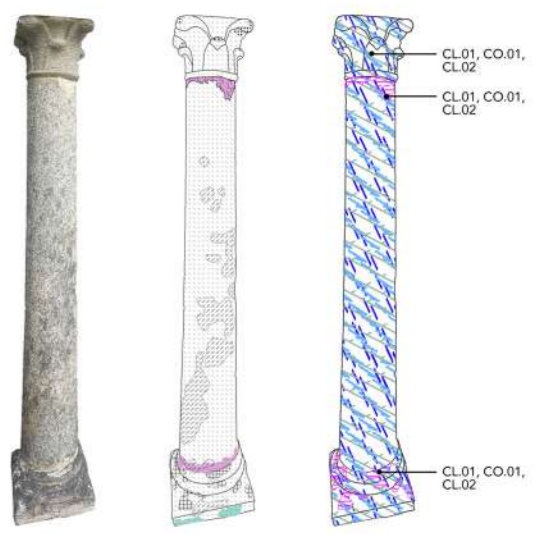
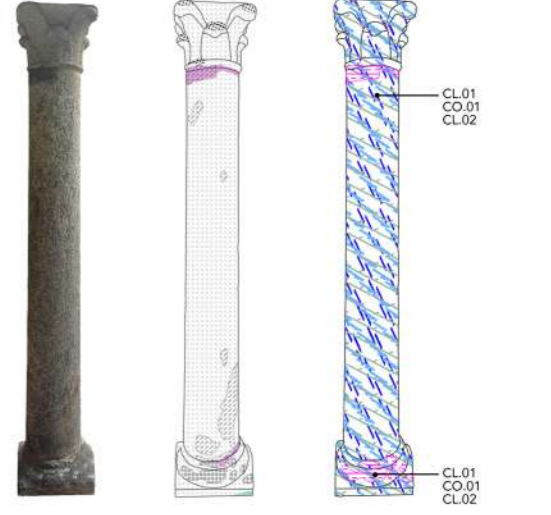
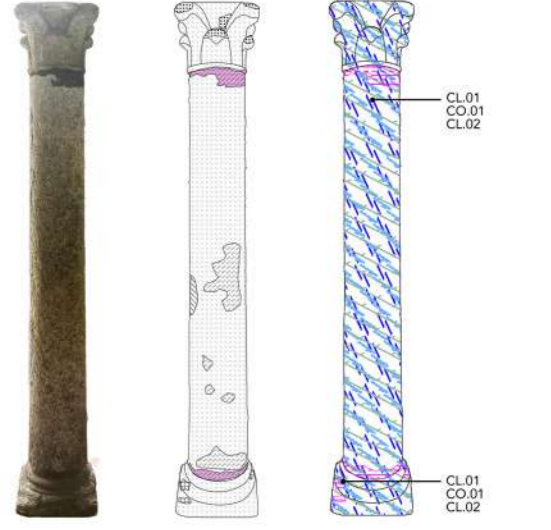
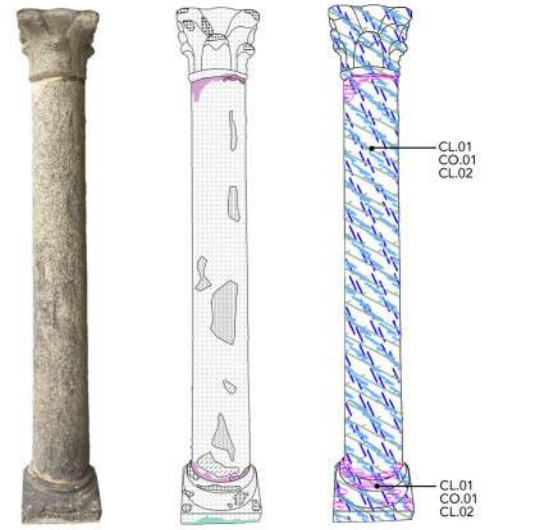
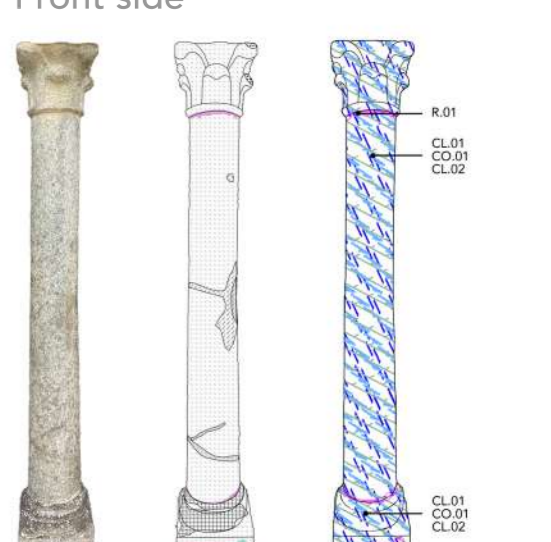
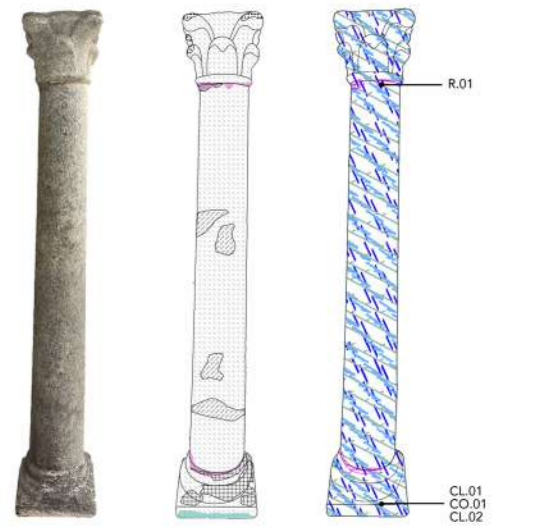
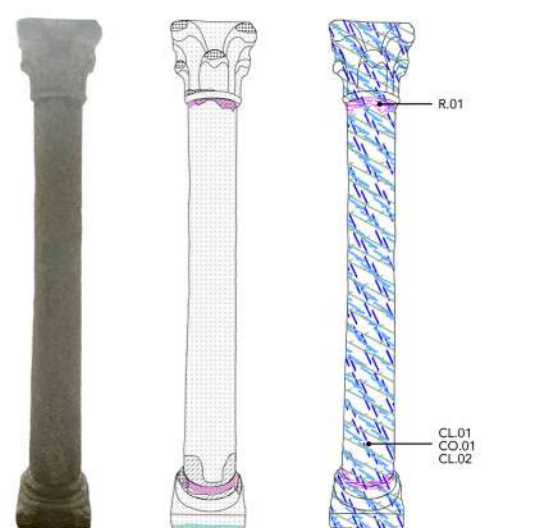
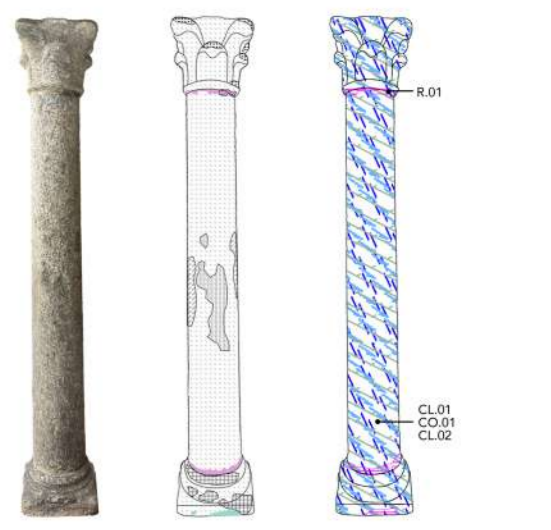
## COLUMN ANALYSIS 1/30

- MATERIAL:
- Mastic
  - Mortar
- DECAY:
- Erosion
  - Mechanical damage
  - Deposit
  - Craquelé
  - Discoloration
  - Stains
  - Efflorescence
  - Cracks
- PHASE 1:
- CL.01: Cleaning of the surface
  - R.01: Replace the mastic with a more stone fitting mortar
- PHASE 2:
- CO.01: Apply a patching material or consolidation product
  - CL.02: Finish with a final cleaning
