2003
Methodology: The intervention, with special emphasis on facades, follows the phases of:
- Historical and stylistic research.
- Decay analysis.
- Remedial intervention
- Design of a rooftop addition for each of the buildings.

Aharonovitch street is located in the core of the Central White City, in the Zone A and right under UNESCO protection.

Area of Intervention

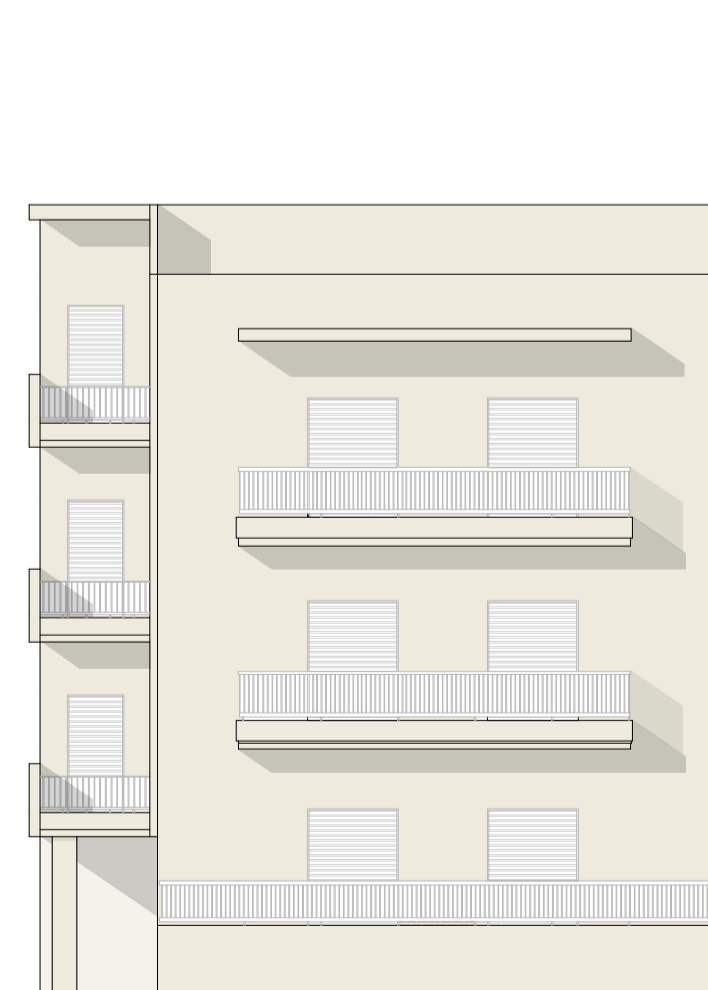
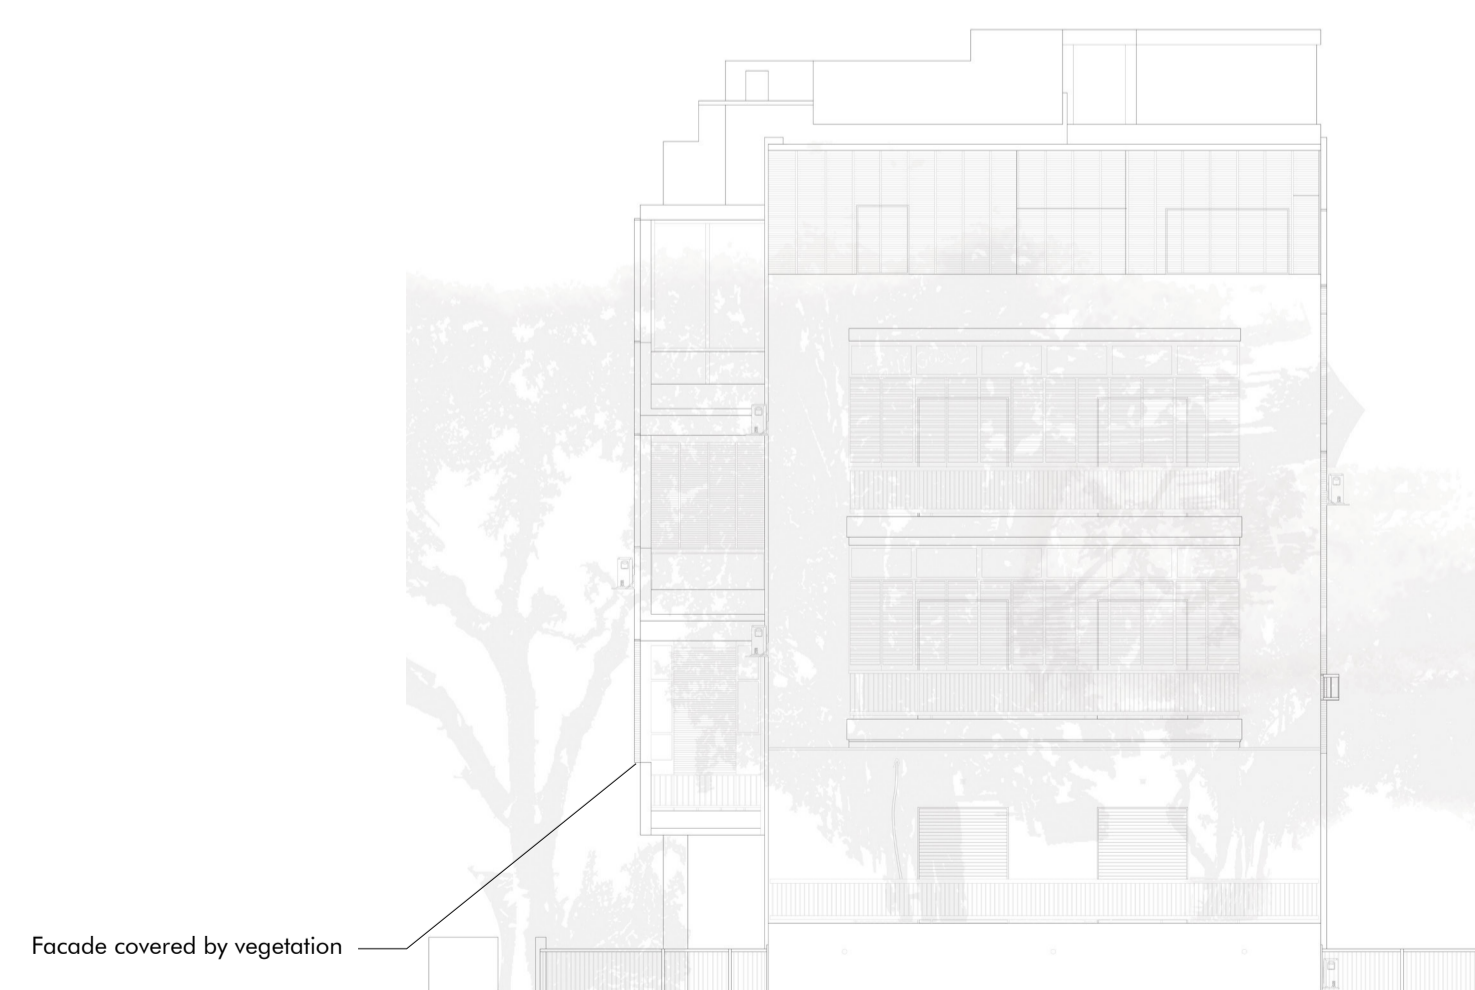
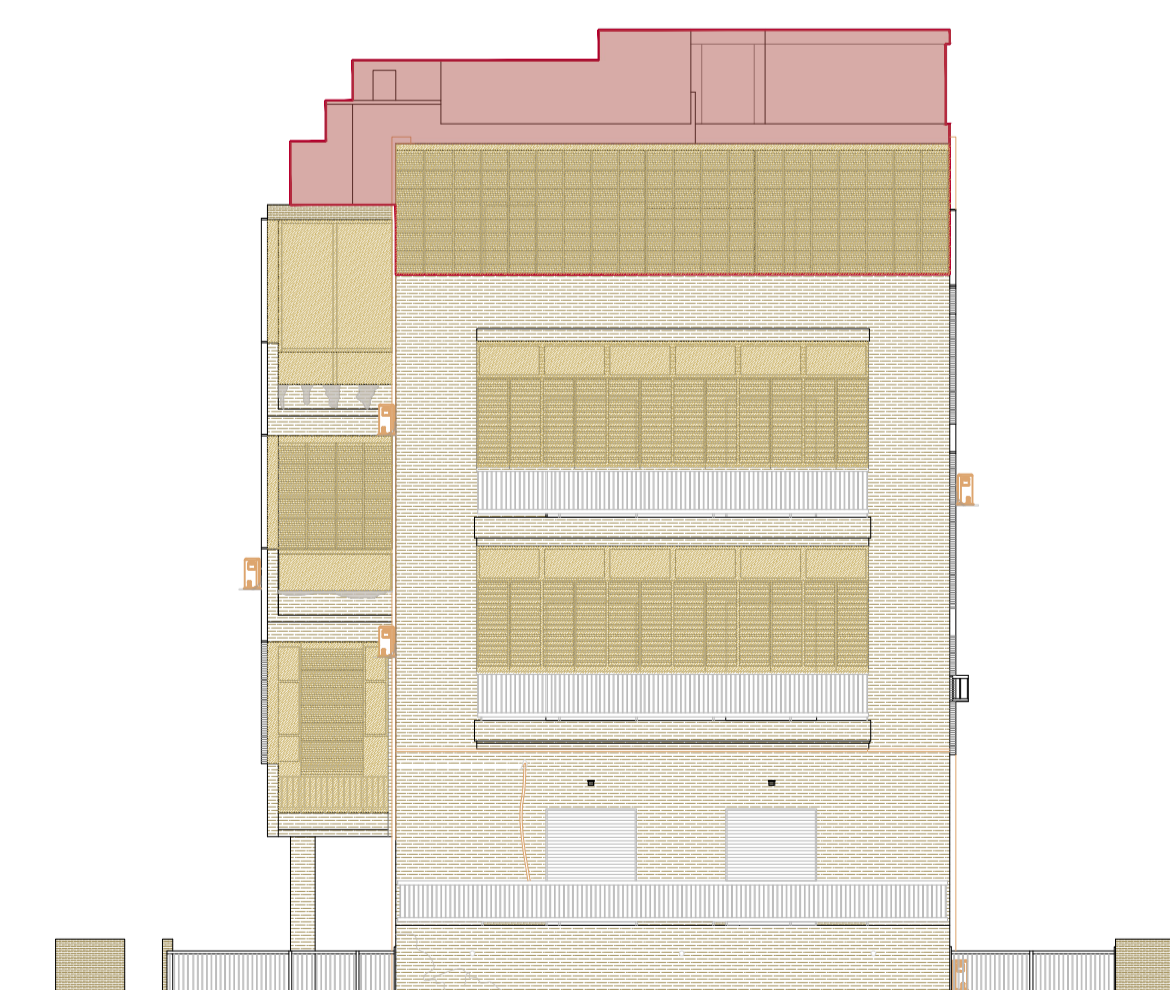
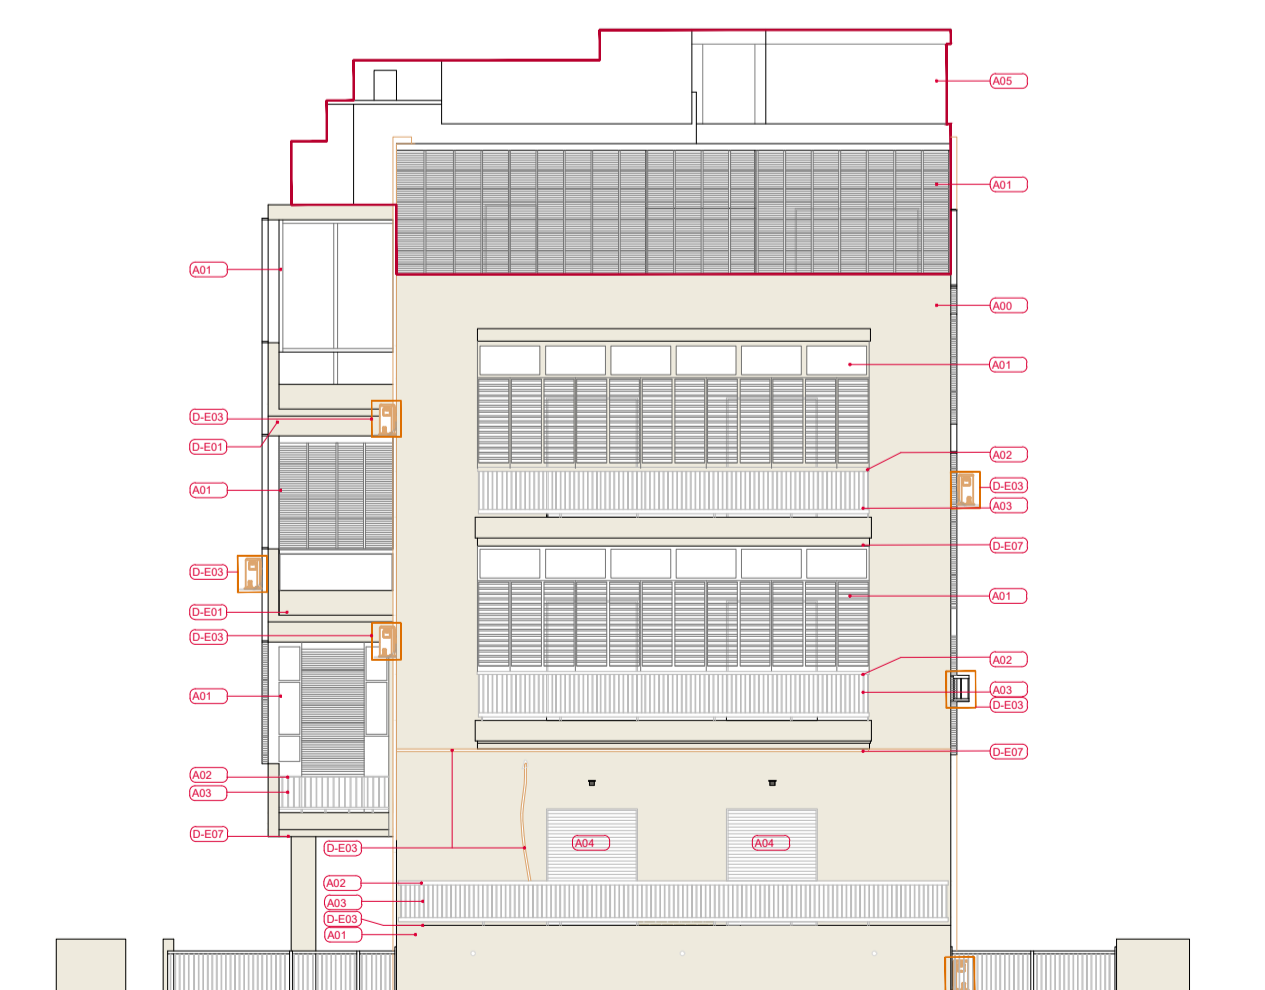
B. 7

- Approved coherent addition - civil construction over the existing structure approved by the authoritative body - inclusive of Walls, parapets and openings that are added
- Incoherent surface treatments - plastering & painting done as upkeep/repair works causing variation by color/texture/aesthetic congruency
- Incoherent additions - windows, doors & blinds - that have been modified/added/removed diverging from the original design

- Decay - weathering of plastering & painting due to lack of maintenance
- Decay - weathering of plastering & painting due to occupant activities - water seepage/faulty constructions/damages from interventions
- Decay - weathering of plastering & painting due to natural causes of water seepage/exposure to sun/heat

- Decay - metal - railings rusted/damaged due to external conditions
- Decay - windows - glass stained and metal rusted due to exposure to external conditions
- Decay - structural - damaged structural members - column/slab/beam due to exposure to outdoor conditions/aging/human interventions

- Improper installation of different shading and windows in openings
- Incoherent additions - exposed elements for plumbing/electrical/HVAC services
- Decay - wood - handrails rotten/disintegrated due to outdoor conditions

- A00 Wall surface - sanded and repainted to original color by design.
- A01 Aluminum enclosure to be removed
- A02 Handrail to be inserted with improvisation to withstand current weathering conditions
- A03 Railing to be refurbished as per original design and painted with protective coat
- A04 Door to be replaced to original detail by frame & shutter
- A05 Additional structures for awning/pergolas/shading devices to be removed

- D-E06 Wall and door built into the opening to be demolished and finished as per original elevation
- D-E07 Window to be refurbished with new glazing and improvised frames
- D-E01 Slab surface decay due to staining by water and metal elements to be cleaned and repaired
- D-E02 Wall surface decay due to staining by water - add coping on top surface with drip-mould detail
- D-E03 Service equipment to be removed
- D-E04 Wall mounted conduits to be concealed
- Mismatch in plastering during intervention - to be sanded, textured, painted to original finish

- D-E05 Railing deterioration - natural causes - to be replaced & painted to original finish
- D-E06 Window sill - marble & railing detail to be redone and rectified to original state
- D-E07 Ceiling surface - paint delamination due to natural decay and structural issues - to be investigated-plastered-painted
- D-S00 Structural beam crack to be inspected and remedied through additional reinforcement
- D-S01 Structural column - external disintegration to be recast with structural concrete
- D-S02 Structural slab to be chipped, reinforcement to be inspected and recast

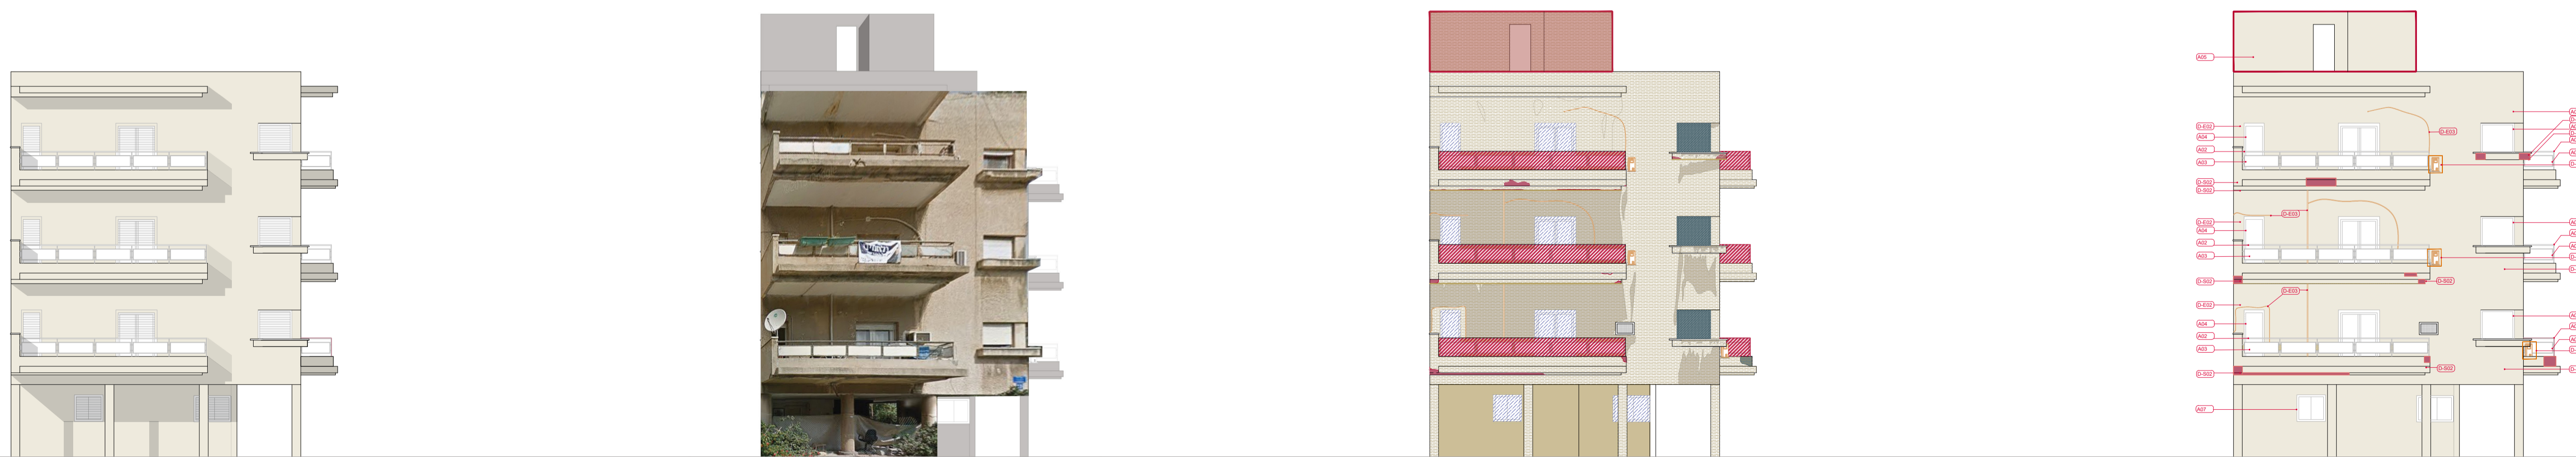
B. 13

- Approved coherent addition - civil construction over the existing structure approved by the authoritative body - inclusive of Walls, parapets and openings that are added
- Incoherent surface treatments - plastering & painting done as upkeep/repairation works causing variation by color/texture/aesthetic congruency
- Incoherent additions - windows, doors & blinds - that have been modified/added/removed diverging from the original design

- Decay - weathering of plastering & painting due to lack of maintenance
- Decay - weathering of plastering & painting due to occupant activities - water seepage/faulty constructions/damages from interventions
- Decay - weathering of plastering & painting due to natural causes of water seepage/exposure to sun/heat

- Decay - metal - railings rusted/damaged due to external conditions
- Decay - windows - glass stained and metal rusted due to exposure to external conditions
- Decay - structural - damaged structural members - column/slab/beam due to exposure to outdoor conditions/aging/human interventions

- Improper installation of different shading and windows in openings
- Incoherent additions - exposed elements for plumbing/electrical/HVAC services
- Decay - wood - handrails rotten/disintegrated due to outdoor conditions

- A00 Wall surface - sanded and repainted to original color by design.
- A01 Aluminum enclosure to be removed
- A02 Handrail to be inserted with improvisation to withstand current weathering conditions
- A03 Railing to be refurbished as per original design and painted with protective coat
- A04 Door to be replaced to original detail by frame & shutter
- A05 Additional structures for awning/pergolas/shading devices to be removed

- D-E01 Slab surface decay due to staining by water and metal elements to be cleaned and repainted
- D-E02 Wall surface decay due to staining by water - add coping on top surface with drip-mould detail

- D-S00 Railing deterioration - natural causes - to be replaced & painted to original finish
- D-S01 Window sill - marble & railing detail to be redone and rectified to original state

- D-S02 Ceiling surface - paint exfoliation due to natural decay and structural issues - to be investigated-plastered-painted
- D-S00 Structural beam crack to be inspected and remedied through additional reinforcement

- D-S01 Structural column - external disintegration to be recast with structural concrete
- D-S02 Structural slab to be chipped, reinforcement to be inspected and recast

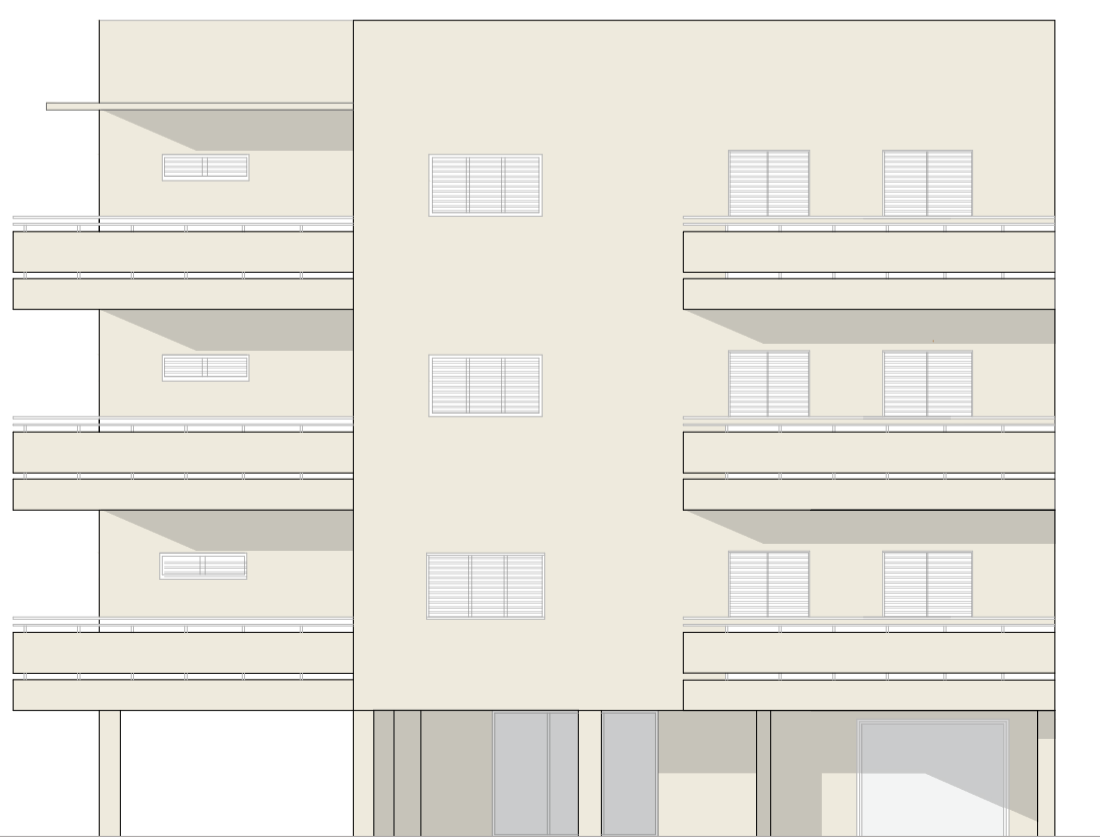
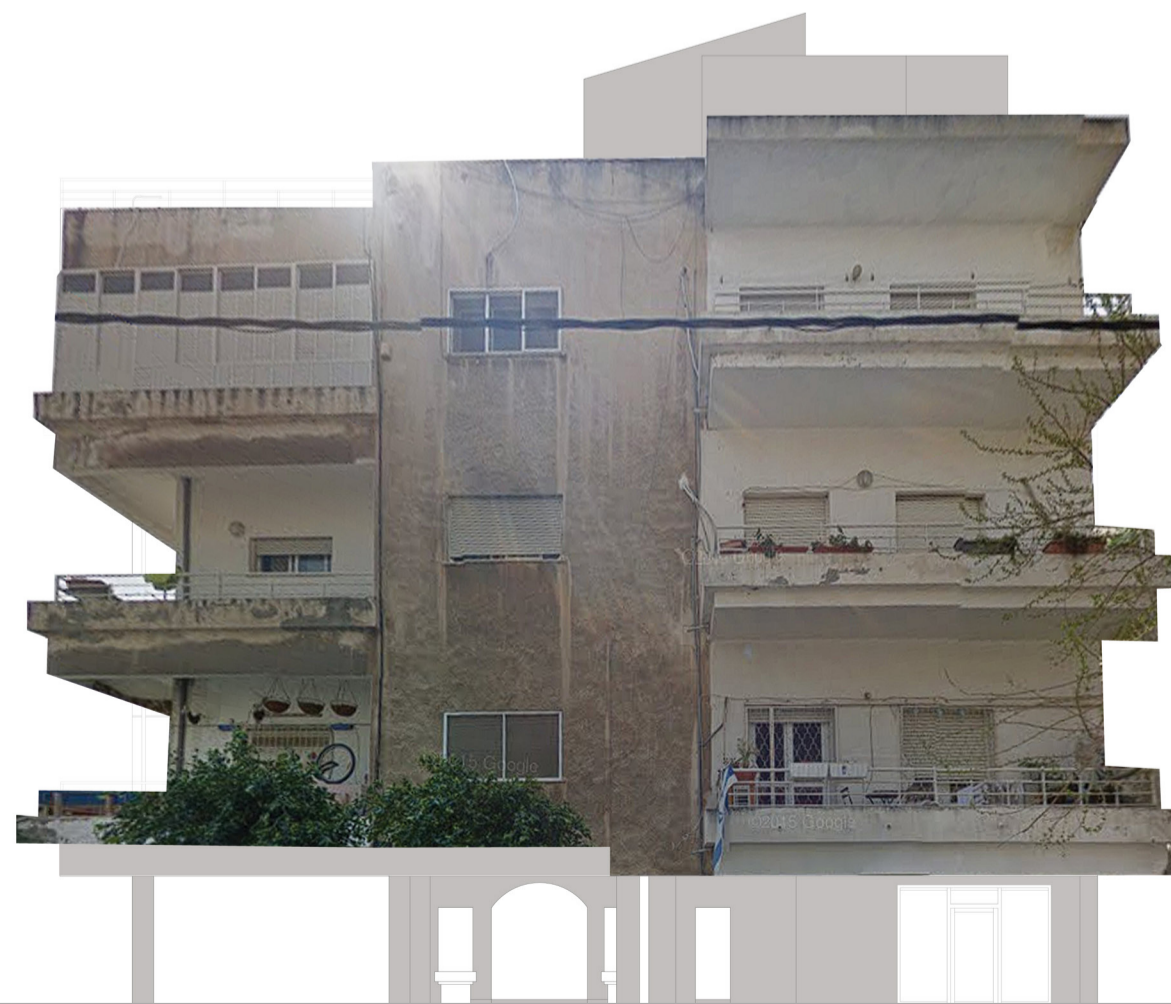
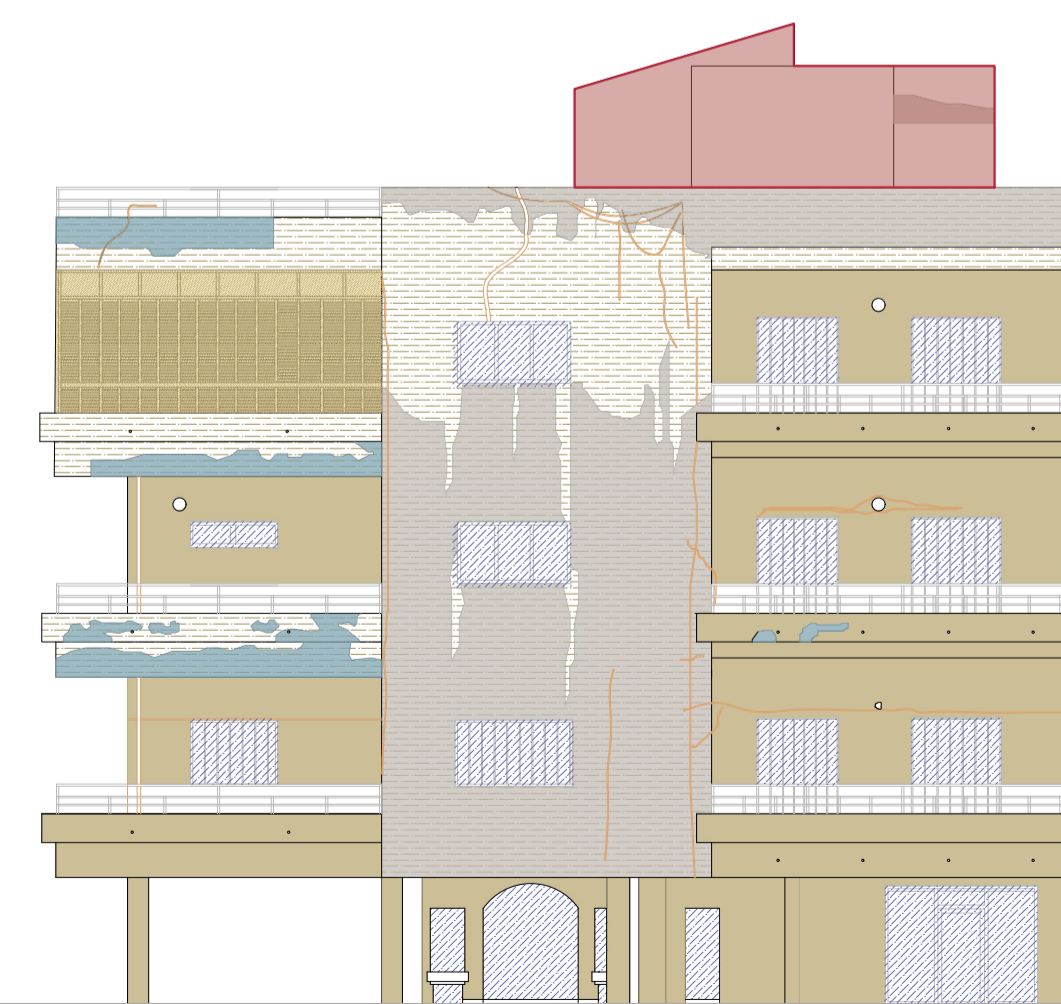
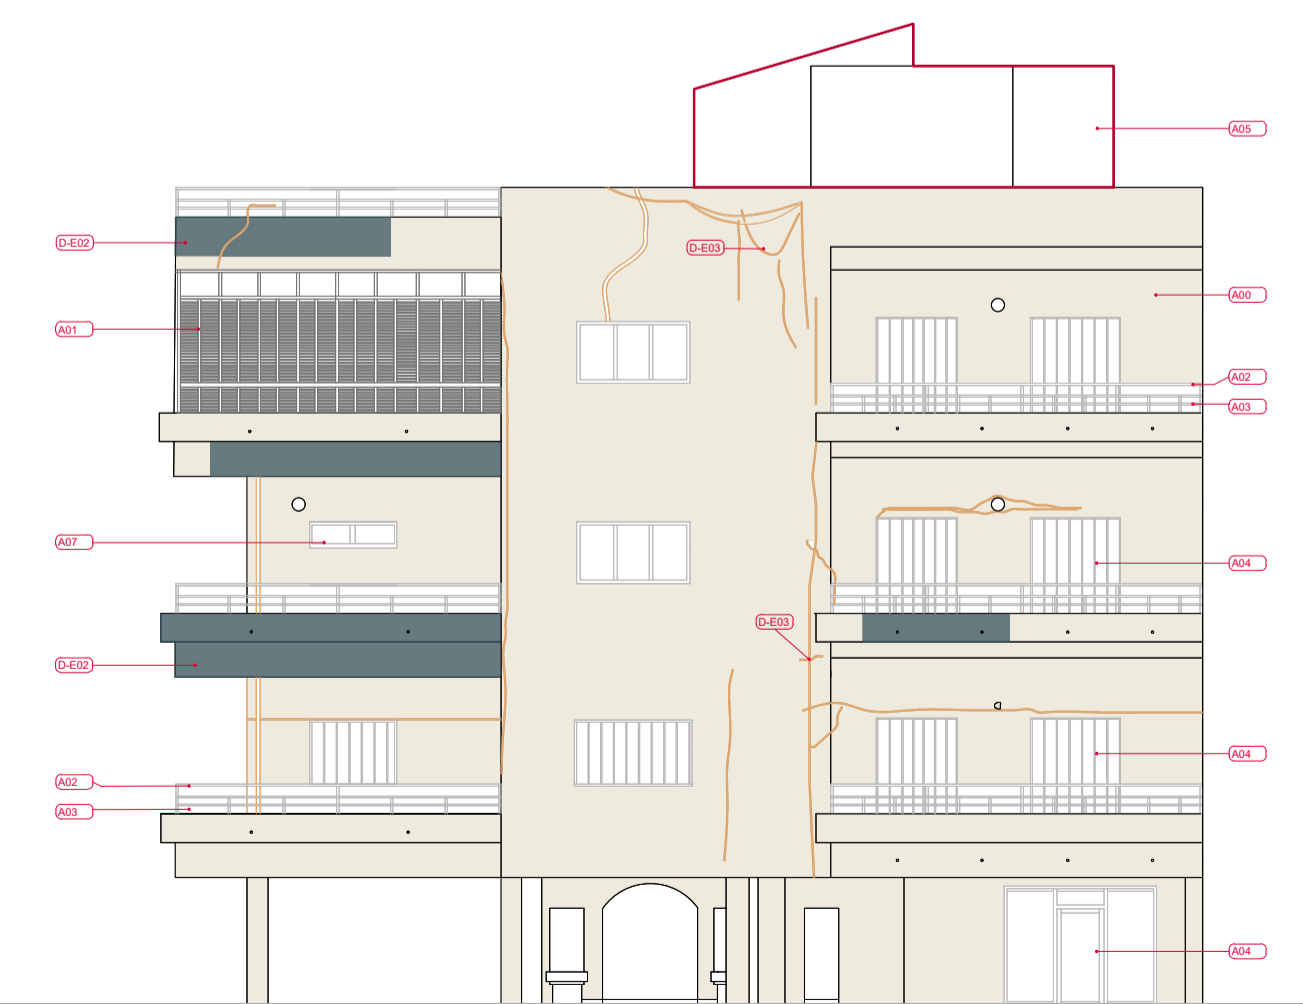
B. 10
South facade

Incoherent surface treatments - plastering & painting done as upkeep/repairation works causing variation by color/texture/aesthetic congruency

Decay - weathering of plastering & painting due to lack of maintenance

Decay - weathering of plastering & painting due to occupant activities - water seepage/faulty constructions/damages from interventions

Decay - weathering of plastering & painting due to natural causes of water seepage/exposure to sun/heat

Decay - metal - railings rusted/damaged due to external conditions

Decay - windows - glass stained and metal rusted due to exposure to external conditions

Decay - structural - damaged structural members - column/slab/beam due to exposure to outdoor conditions/aging/human interventions

Improper installation of different shading and windows in openings

Decay - wood - handrails rotten/disintegrated due to outdoor conditions

A00 Wall surface - sanded and repainted to original color by design.
A01 Aluminum enclosure to be removed
A02 Handrail to be inserted with improvisation to withstand current weathering conditions
A03 Railing to be refurbished as per original design and painted with protective coat
A04 Door to be replaced to original detail by frame & shutter
A05 Additional structures for awning/pergolas/shading devices to be removed

D-E06 Wall and door built into the opening to be demolished and finished as per original elevation
D-E07 Window to be refurbished with new glazing and improvised frames
D-E01 Slab surface decay due to staining by water and metal elements to be cleaned and repainted
D-E02 Wall surface decay due to staining by water - add coping on top surface with drip-mould detail
D-E03 Service equipment to be removed
D-E04 Wall mounted conduits to be concealed
Mismatch in plastering during intervention - to be sanded, textured, painted to original finish

D-E05 Railing deterioration - natural causes - to be replaced & painted to original finish
D-E06 Window sill - marble & railing detail to be redone and rectified to original state
D-E07 Ceiling surface - paint exfoliation due to natural decay and structural issues - to be investigated-plastered-painted
D-S00 Structural beam crack to be inspected and remedied through additional reinforcement
D-S01 Structural column - external disintegration to be recast with structural concrete
D-S02 Structural slab to be chipped, reinforcement to be inspected and recast

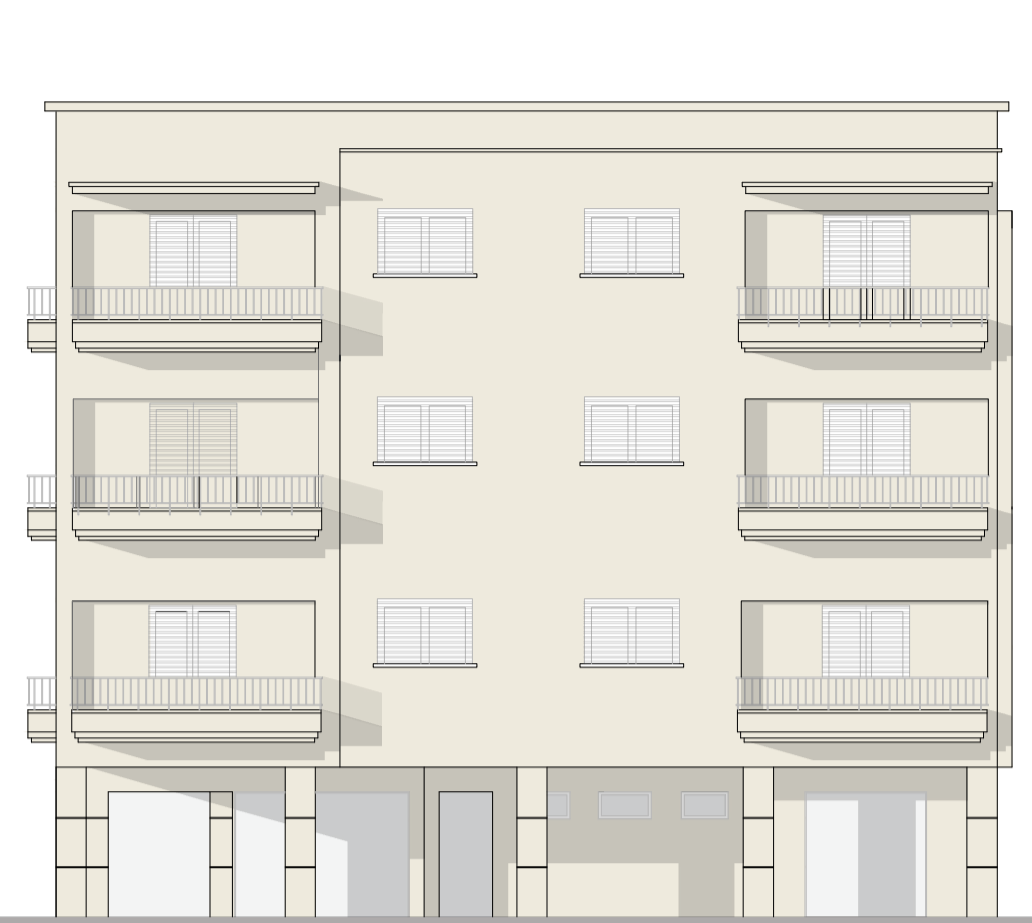
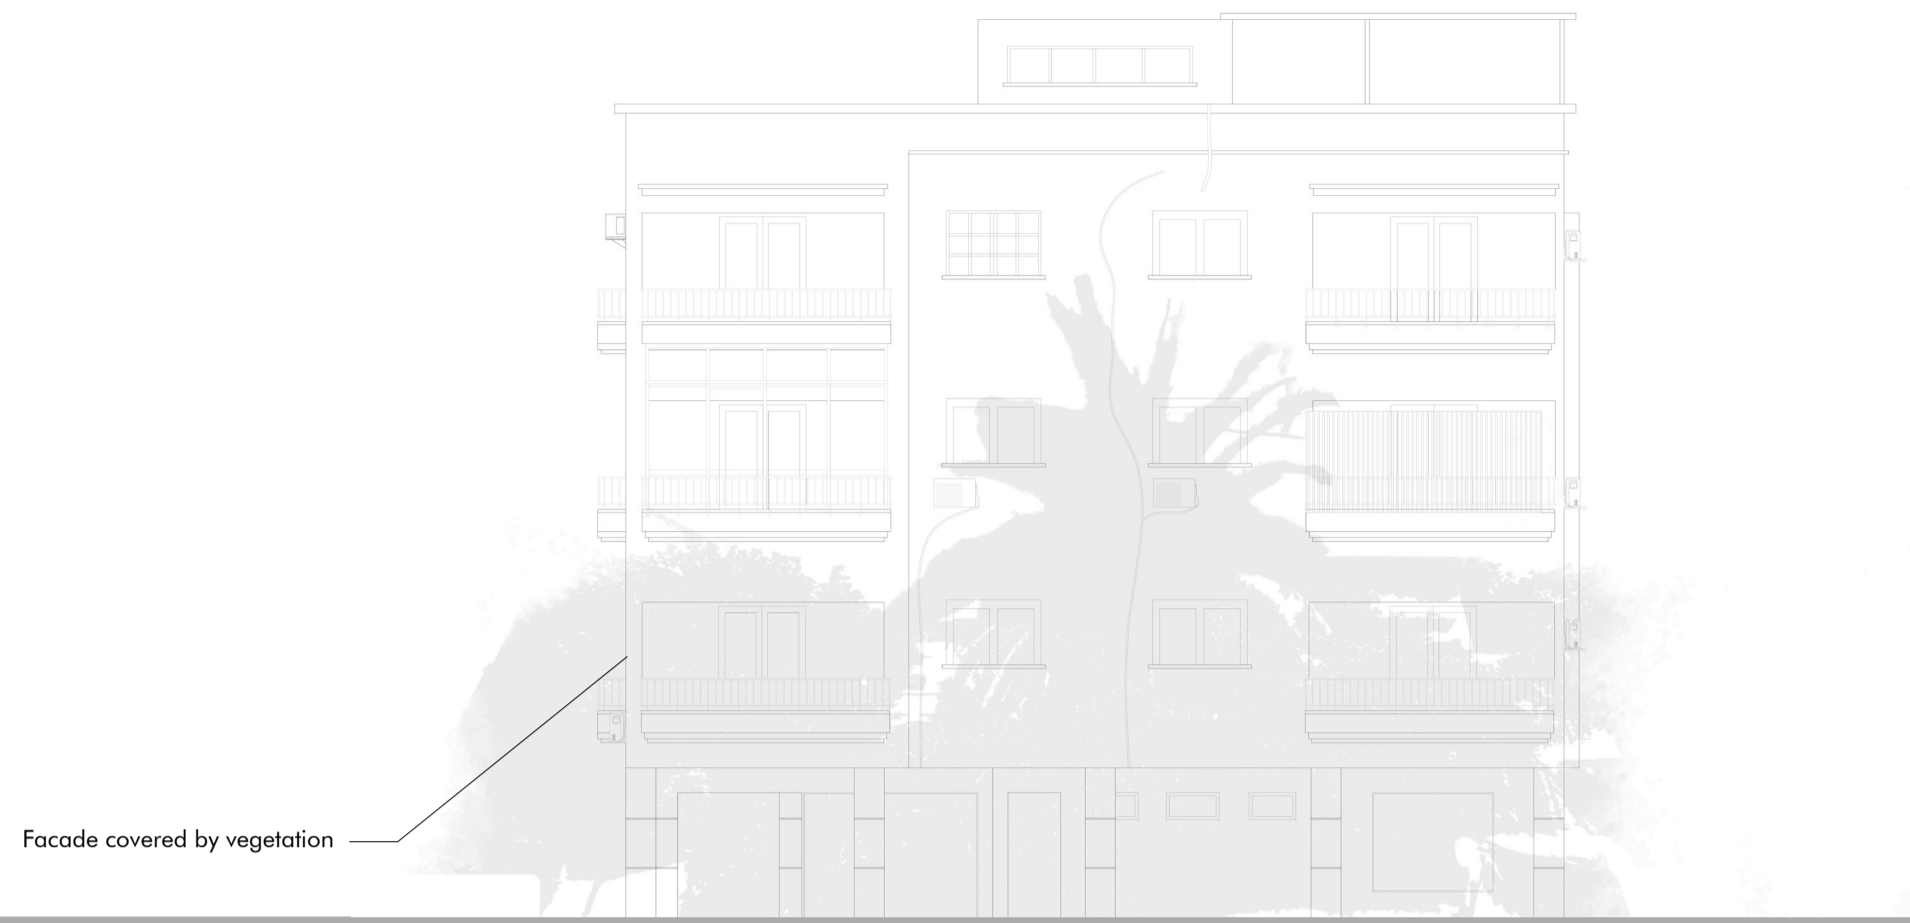
B. 8

Facade covered by vegetation

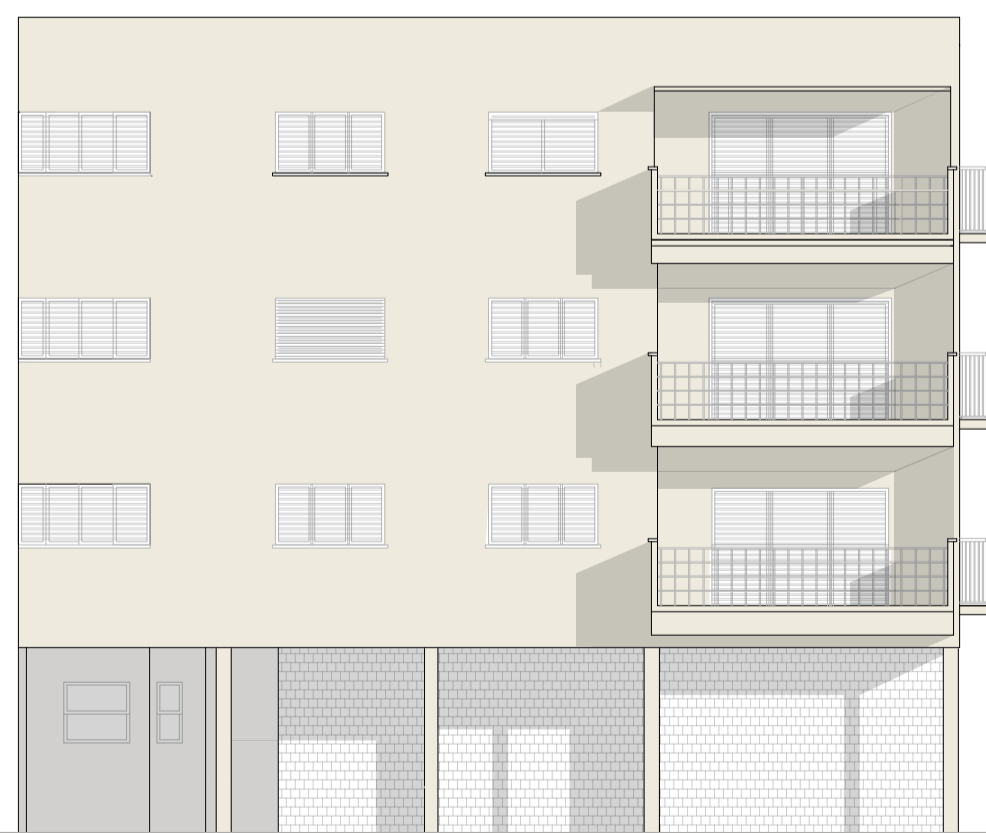
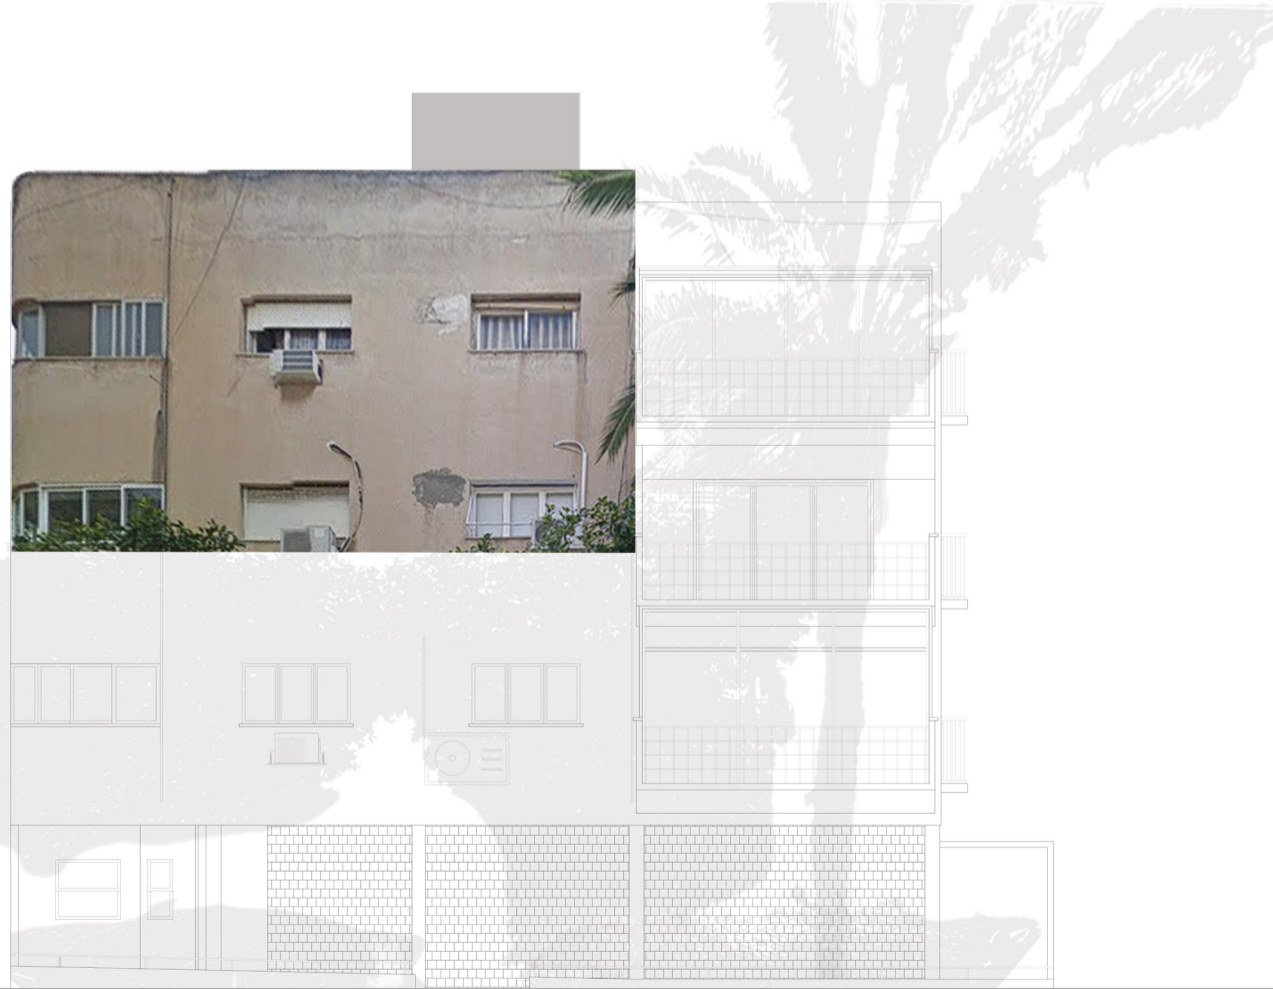
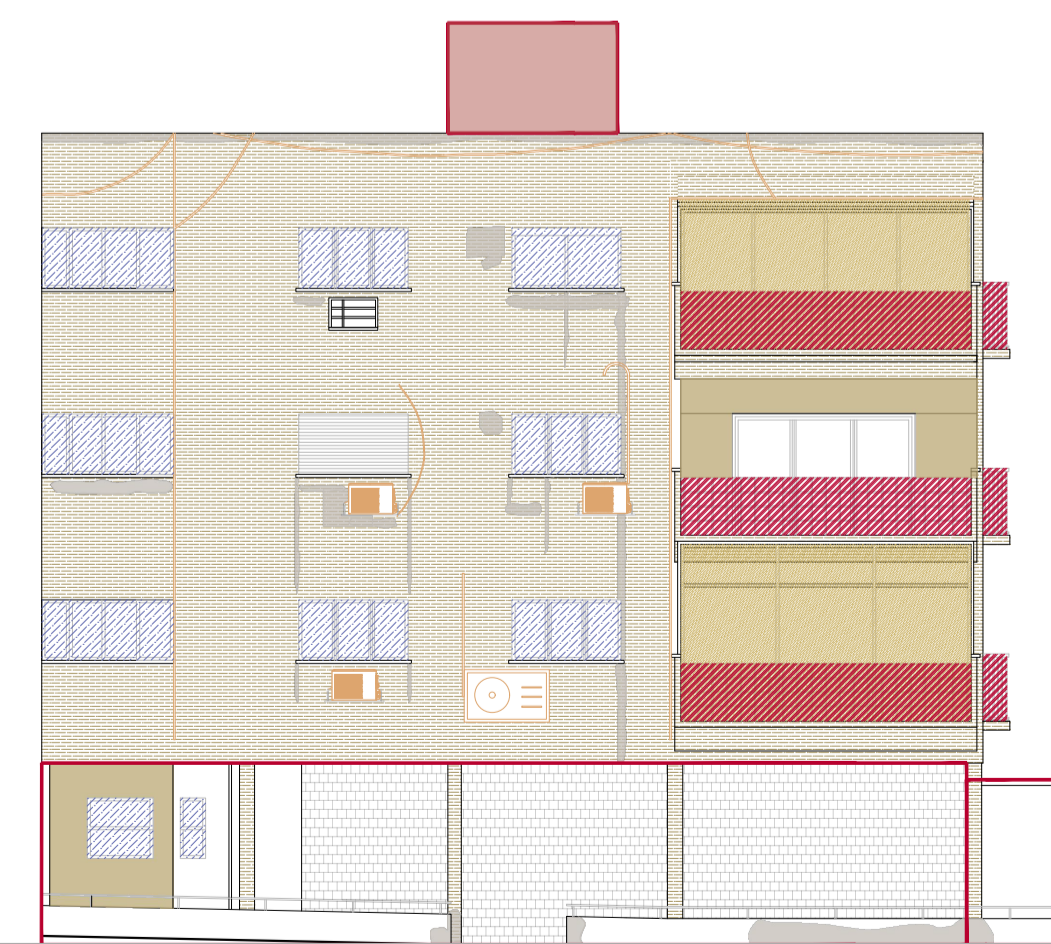
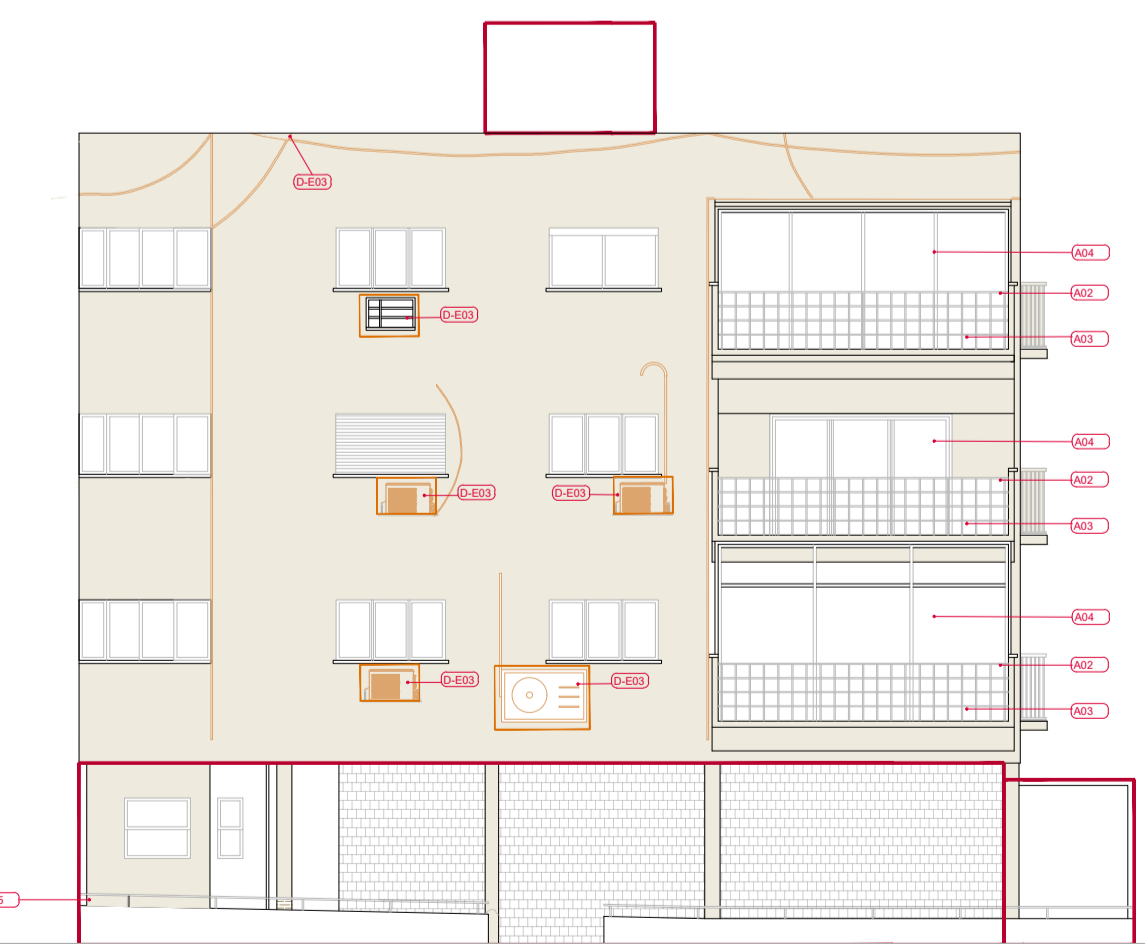
B. 6

- Approved coherent addition - civil construction over the existing structure approved by the authoritative body - inclusive of Walls, parapets and openings that are added

- Incoherent surface treatments - plastering & painting done as upkeep/repair works causing variation by color/texture/aesthetic congruency
- Incoherent additions - windows, doors & blinds - that have been modified/added/removed diverging from the original design

- Decay - weathering of plastering & painting due to lack of maintenance
- Decay - weathering of plastering & painting due to occupant activities - water seepage/faulty constructions/damages from interventions

- Decay - weathering of plastering & painting due to natural causes of water seepage/exposure to sun/heat
- Decay - metal - railings rusted/damaged due to external conditions

- Decay - windows - glass stained and metal rusted due to exposure to external conditions
- Decay - structural - damaged structural members - column/slab/beam due to exposure to outdoor conditions/aging/human interventions

- Improper installation of different shading and windows in openings
- Incoherent additions - exposed elements for plumbing/electrical/HVAC services
- Decay - wood - handrails rotten/disintegrated due to outdoor conditions

- A00 Wall surface - sanded and repainted to original color by design.
- A01 Aluminum enclosure to be removed
- A02 Handrail to be inserted with improvisation to withstand current weathering conditions
- A03 Railing to be refurbished as per original design and painted with protective coat
- A04 Door to be replaced to original detail by frame & shutter
- A05 Additional structures for awning/pergolas/shading devices to be removed

- D-E01 Slab surface decay due to staining by water and metal elements to be cleaned and repainted
- D-E02 Wall surface decay due to staining by water - add coping on top surface with drip-mould detail

- D-S00 Railing deterioration - natural causes - to be replaced & painted to original finish
- D-S01 Window sill - marble & railing detail to be redone and rectified to original state

- D-S02 Ceiling surface - paint delamination due to natural decay and structural issues - to be investigated-plastered-painted
- D-S00 Wall surface decay due to staining by water - to be investigated-plastered-painted

- D-S01 Structural beam crack to be inspected and remedied through additional reinforcement
- D-S02 Structural column - external disintegration to be recast with structural concrete

- D-S02 Structural slab to be chipped, reinforcement to be inspected and recast
