2003
Methodology: The intervention, with special emphasis on facades, follows the phases of:
- Historical and stylistic research.
- Decay analysis.
- Remedial intervention
- Design of a rooftop addition for each of the buildings.

Aharonovitch street is located in the core of the Central White City, in the Zone A and right under UNESCO protection.

Area of Intervention

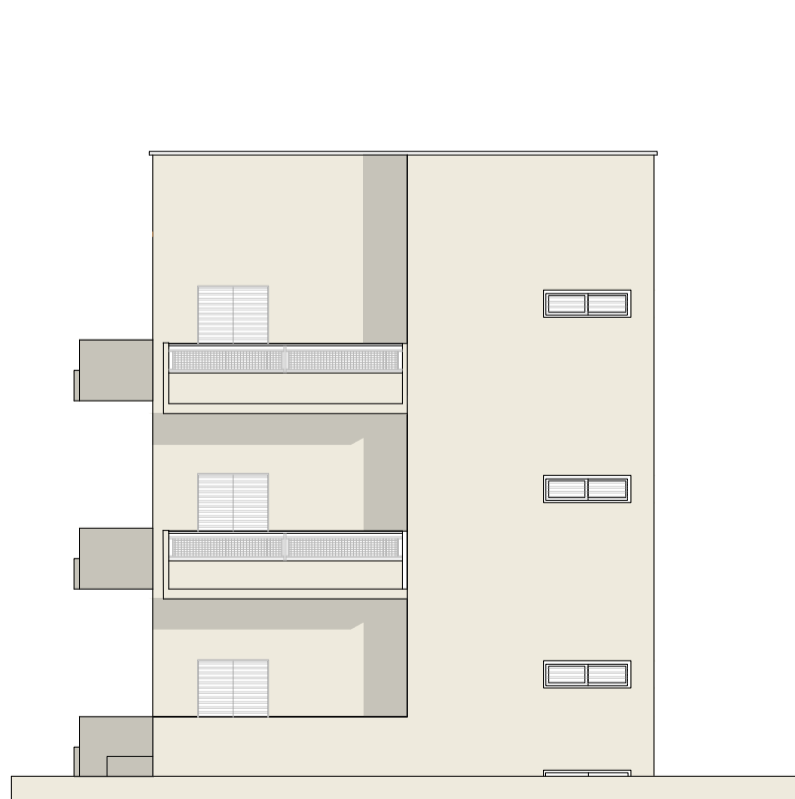
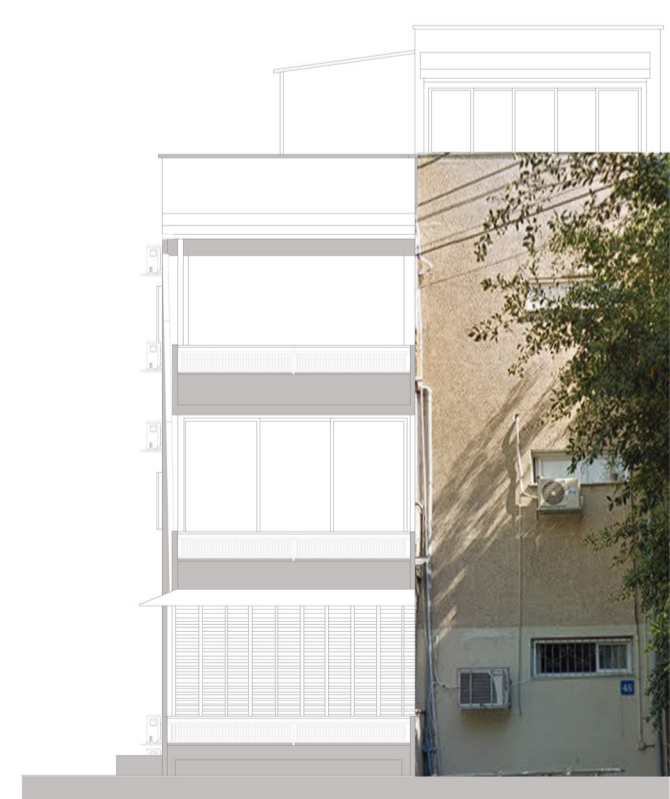
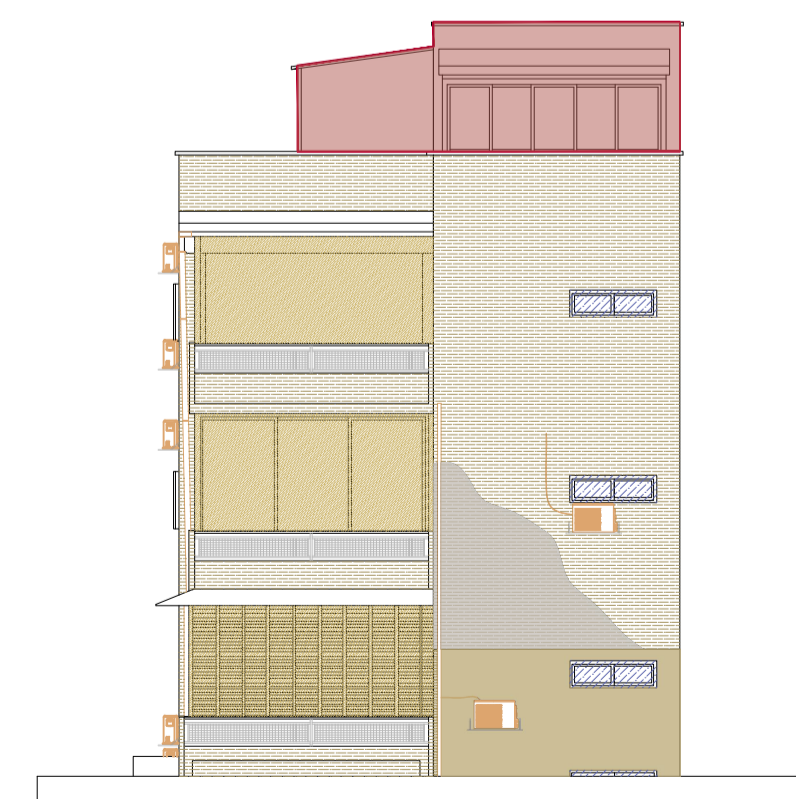
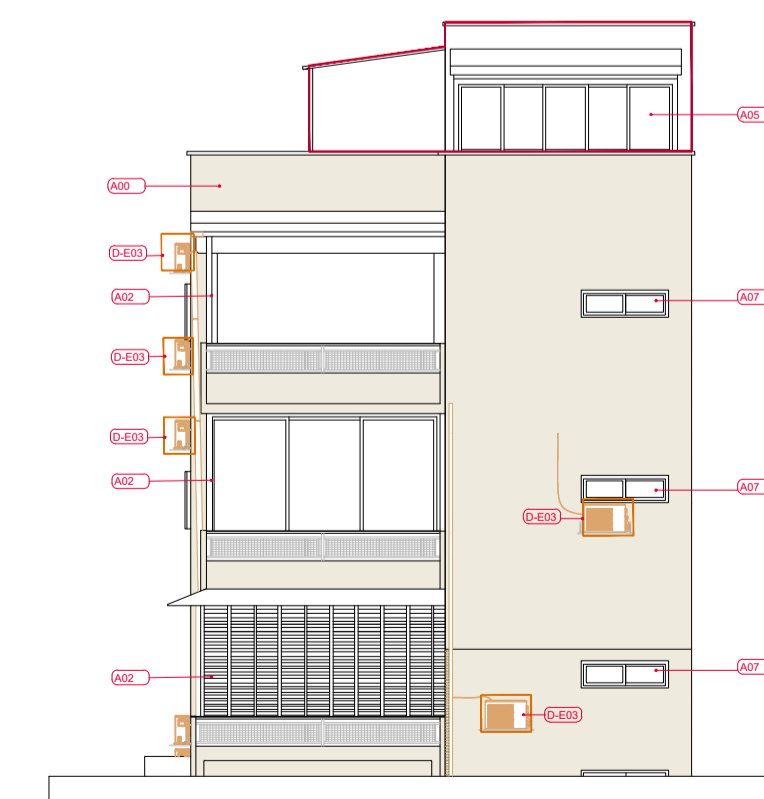
B. 2
West facade

- Approved coherent addition - civil construction over the existing structure approved by the authoritative body - inclusive of Walls, parapets and openings that are added

- Incoherent surface treatments - plastering & painting done as upkeep/repairation works causing variation by color/texture/aesthetic congruency
- Incoherent additions - windows, doors & blinds - that have been modified/added/removed diverging from the original design

- Decay - weathering of plastering & painting due to lack of maintenance
- Decay - weathering of plastering & painting due to occupant activities - water seepage/faulty constructions/damages from interventions

- Decay - weathering of plastering & painting due to natural causes of water seepage/exposure to sun/heat
- Decay - metal - railings rusted/damaged due to external conditions

- Decay - windows - glass stained and metal rusted due to exposure to external conditions
- Decay - structural - damaged structural members - column/slab/beam due to exposure to outdoor conditions/aging/human interventions

- Improper installation of different shading and windows in openings
- Incoherent additions - exposed elements for plumbing/electrical/HVAC services
- Decay - wood - handrails rotten/disintegrated due to outdoor conditions

- A00 Wall surface - sanded and repainted to original color by design.
- A01 Aluminum enclosure to be removed
- A02 Handrail to be inserted with improvisation to withstand current weathering conditions
- A03 Railing to be refurbished as per original design and painted with protective coat
- A04 Door to be replaced to original detail by frame & shutter
- A05 Additional structures for awning/pergolas/shading devices to be removed

- D-E01 Slab surface decay due to staining by water and metal elements to be cleaned and repainted
- D-E02 Wall surface decay due to staining by water - add coping on top surface with drip-mould detail

- D-E05 Railing deterioration - natural causes - to be replaced & painted to original finish
- D-E06 Window sill - marble & railing detail to be redone and rectified to original state

- D-E07 Ceiling surface - paint exfoliation due to natural decay and structural issues - to be investigated-plastered-painted
- D-S00 Structural beam crack to be inspected and remedied through additional reinforcement
