FIBER OPTIC ACOUSTIC EMISSIONS MONITORING SYSTEM

***An experimental investigation in a laboratory application for
rainfall-induced landslides in different soil materials slope models***

Master degree thesis by:

Cerri Giulia

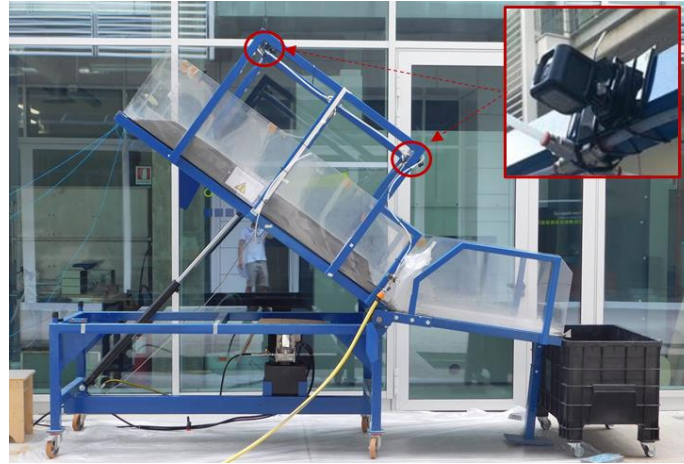
The sequential images were further used in a digital image correlation (DIC) software (GOM Correlate, <https://www.gom.com/index.html>) in order to estimate surface displacements during the experiments.

Figure 49: Action cameras position and prototype

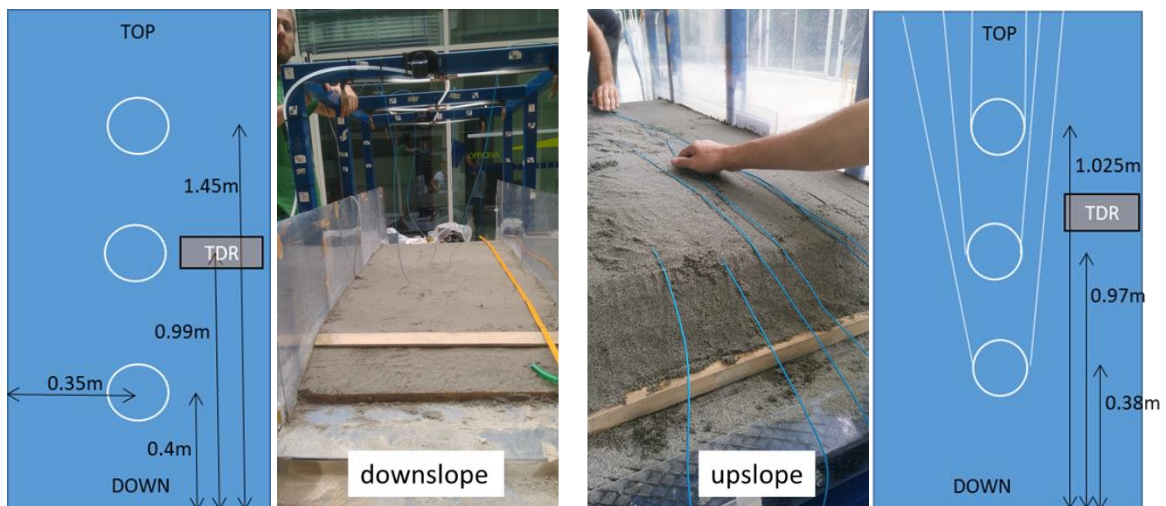
Furthermore, as illustrated in *Figure [53]*, two different ways of installation on the slope model have been assessed for the rests of the fiber optic cables: in experiments 1 and 3 sensing is limited to the coil, while the rest of the cable leading to the interrogating device protrudes out of the soil body surface, while in experiments 2 and 4 the cable leading out runs within the soil and protrudes from the upstream end of the soil body.

Figure 53: Types of FO cable installed configurations
