A BOX IN THE BOX

Putting a new space in Milan post-war modernist architecture

ARCHITECTURAL DESIGN STUDIO FOR RESTORATION OF COMPLEX CONSTRUCTION

LIGHT MACHINERY LABORATORY

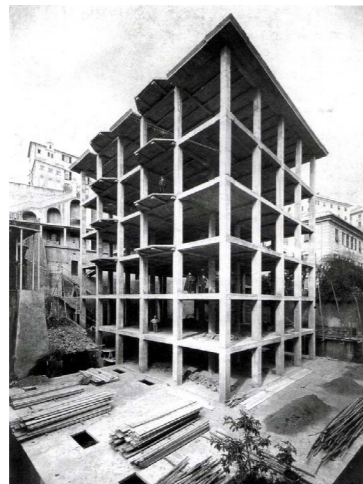
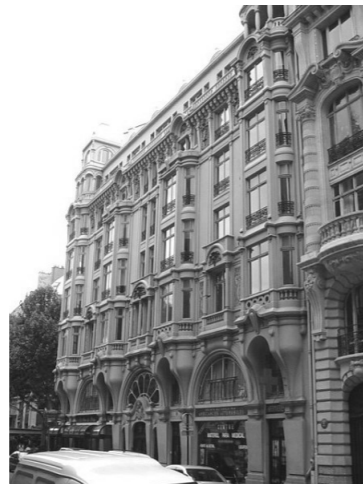
1, rue Danton, Paris

Rue Danton is between 1889 and 1892 that a turning point emerged, it is especially the patent filed in 1892 by engineer Francois Hennebique that will revolutionize the use of this material, and will make him one of the inventors of reinforced concrete construction.

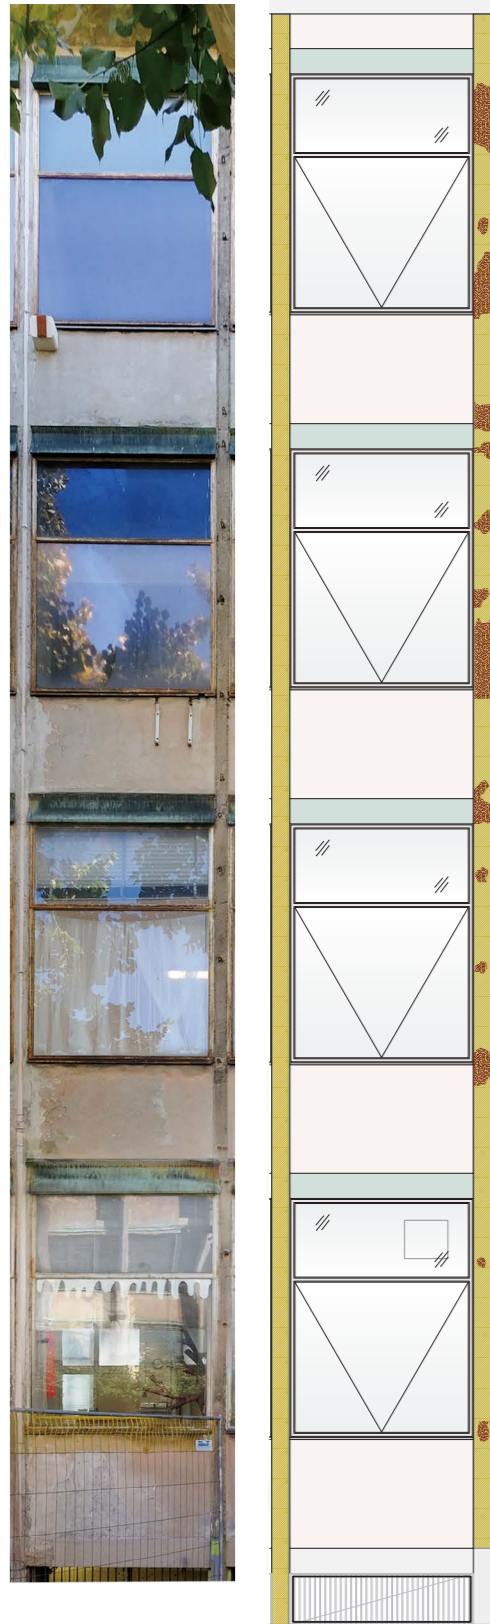
PILLAR

Most of the decorative and protective pillar components on the facade have been lost, leaving exposed iron metal hooks. These metal components are directly exposed to the outdoors and directly react with rain and air, resulting in a lot of rust and chemical reactions. The internal force generated also caused the concrete around the component to begin to fall off

The decorative columns on the exterior of the building's façade columns are missing, leaving only the bottom part, where can see the exposed iron hooks

Due to the loss of external decoration materials, the iron hooks in the concrete pillars are exposed to the air, and the rust spreads, cracking the concrete and losing the bonding force between the steel bar and the concrete.

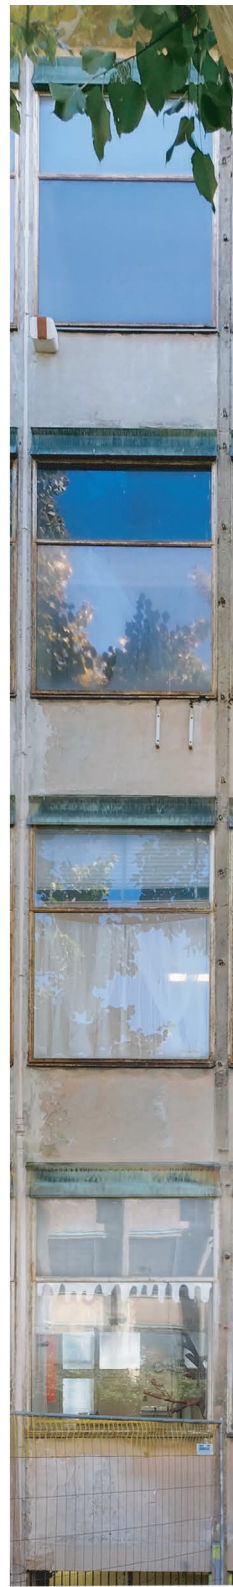
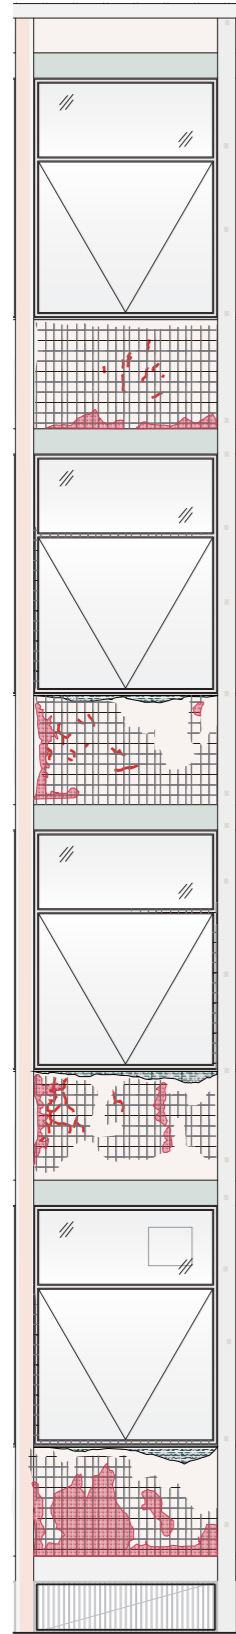
WALL - PLASTER

Because the wall has been washed by rain for a long time, high temperature in summer and severe cold in winter, the surface coating structure is destroyed, first cracks occur, and then the paint part begins to peel off. At the place where water vapor accumulates seriously, the entire paint layer begins to bulge and peel off in a large area.

The surface of the coated wall has cracks visible to the naked eye

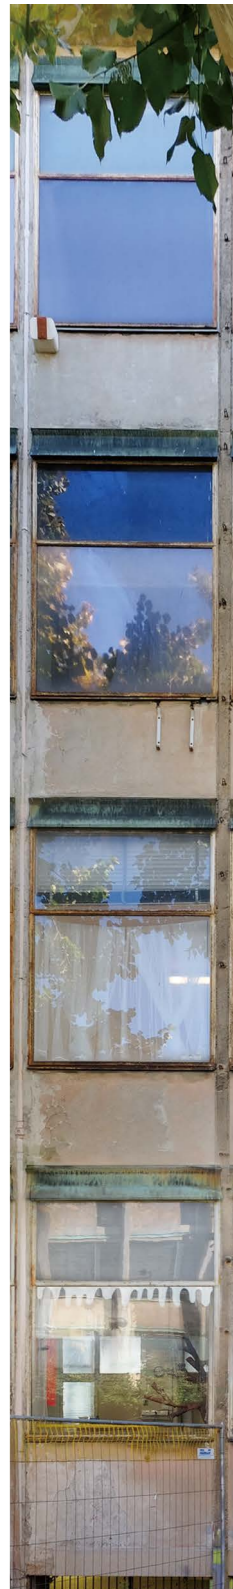
BEAM

Fragmentation of side beams at the bottom of the building

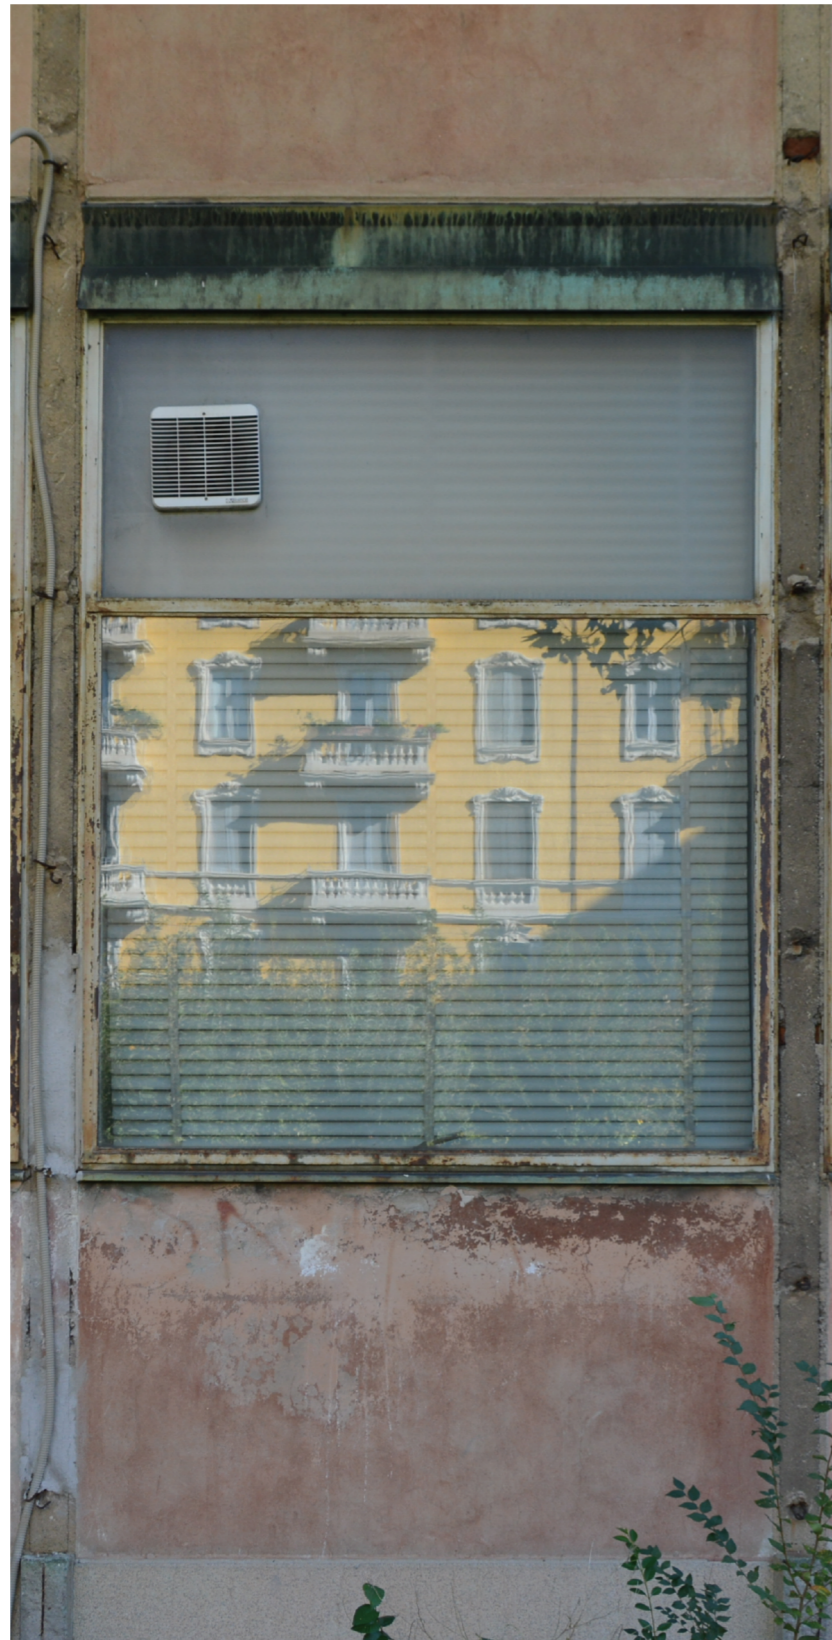
Walls

WHAT IS THE PROBLEM?	WHAT CAN WE DO?	STEP BY STEP
<p>GRAFFITI: There is graffiti on the coating surface of the wall, but it does not damage the coating, it just adheres to the surface.</p>	<p>First of all, we need to clean up the wall, where there are color changes or graffiti, and keep a clean exterior wall.</p>	<p>R.01 REMOVAL OF PLASTER STRONGLY DETACHED</p> <ul style="list-style-type: none"> • Beating of the plaster to verify any area of detachment in addition to those indicated on the graphic layouts. • Removal of plaster detached by manual instruments (chisels), making a light pressure and taking care not to damage the brick wall. • Removal of the dust and of the incoherent residuals by cleaning clothes and brushes. • Afterwards, the surface should be prepared to apply the new plaster or the whitewashes.
<p>STAINING: Affected by the water, the metal rain shields and metal window frames rusted, and the rust flowed down to the wall.</p>	<p>Secondly, due to the serious peeling off of the outer coating, we need to clean it and apply a new coating again to protect the internal brick wall.</p> <p>Because only the outer layer of is damaged by cracks, we only need to clean it and add a new protective layer.</p>	<p>R.02 REMOVING OF FILLING WITH CEMENT MORTAR</p> <ul style="list-style-type: none"> • Protection of the areas near to the element to be removed with masking tape. • Removal of the filling with cement mortar by manual instruments (chisels, hammers and so on), taking care not to damage the plaster in the area and the underlying brick wall. The execution must be done on small areas, from top to bottom. • Cleaning of the surface with brushes and compressed air.

<p>MOIST AREA: Darkened areas in different shapes, according to pipe leakage, rising damp, hygroscopic behaviour due to the presence of salts, condensation.</p>	<p>Also the infill cement should be removed, after remove them, we could consolidation them again.</p>	<ul style="list-style-type: none"> • Execution of the new sealing of the crack or refilling of laying of lime plaster and surface finishing by adding surkhi or blue pigments in relation to the area to be treated according to the indication of the Work Director.
<p>CRAQUELE: The surface of the coating showed network cracks and did not damage the internal brick wall.</p>		<p>PL.01 DRY CLEANING</p> <p>PL.02 HYDRO CLEANING WITH DEIONIZED WATER (by spray)</p> <ul style="list-style-type: none"> • Removal of consistent deposits and dry cleaning by manual instruments (such as scrapers, brushes) and with the help of extractor fan, to obtain a surface completely free of dust and rubble. • Repeated washes until the complete extraction of salts by deionized water by spray with brushing. • Final drying and removal of the salts crystallized on the surface by soft brushes. • Controlling of the intervention by conductivity measurements of the washing water.

<p>BLISTERING: The coating is affected by the internal air, forming a bubble-like surface, and in some places the surface layer falls off due to pressure.</p>		<p>Co.01 GROUTING OF JOINTS WITH INJECTIONS OF LIME MORTAR</p> <p>Pr.01 LAYING OF LIME PLASTER</p> <ul style="list-style-type: none"> • After cleaning the surfaces as sheet PL.02; • Wetting surfaces; • To lay a plaster made by aerial lime mortar. The final thickness would be the same as existing plaster, but we have to see the edge profile of the integration without any cracks, irregularities in alignment and also in the corners or other defects
<p>PEELING: In some places, the outer painted plaster was peeled off, and some parts the inside cement was also peeled off.</p>		<p>Pr.02 LAYING OF LIGHT PLASTER WITH PIGMENTS</p> <ul style="list-style-type: none"> • Protection of the lower parts to avoid the fall of mortar, water and so on the underlying painting. • After cleaning the surfaces as sheet PL.01 or PL.02

<p>FILLING WITH CEMENT MORTAR: There is a large area of new cement coating under the windows, which may because of the old damaged wall that eroded by water and rust.</p>

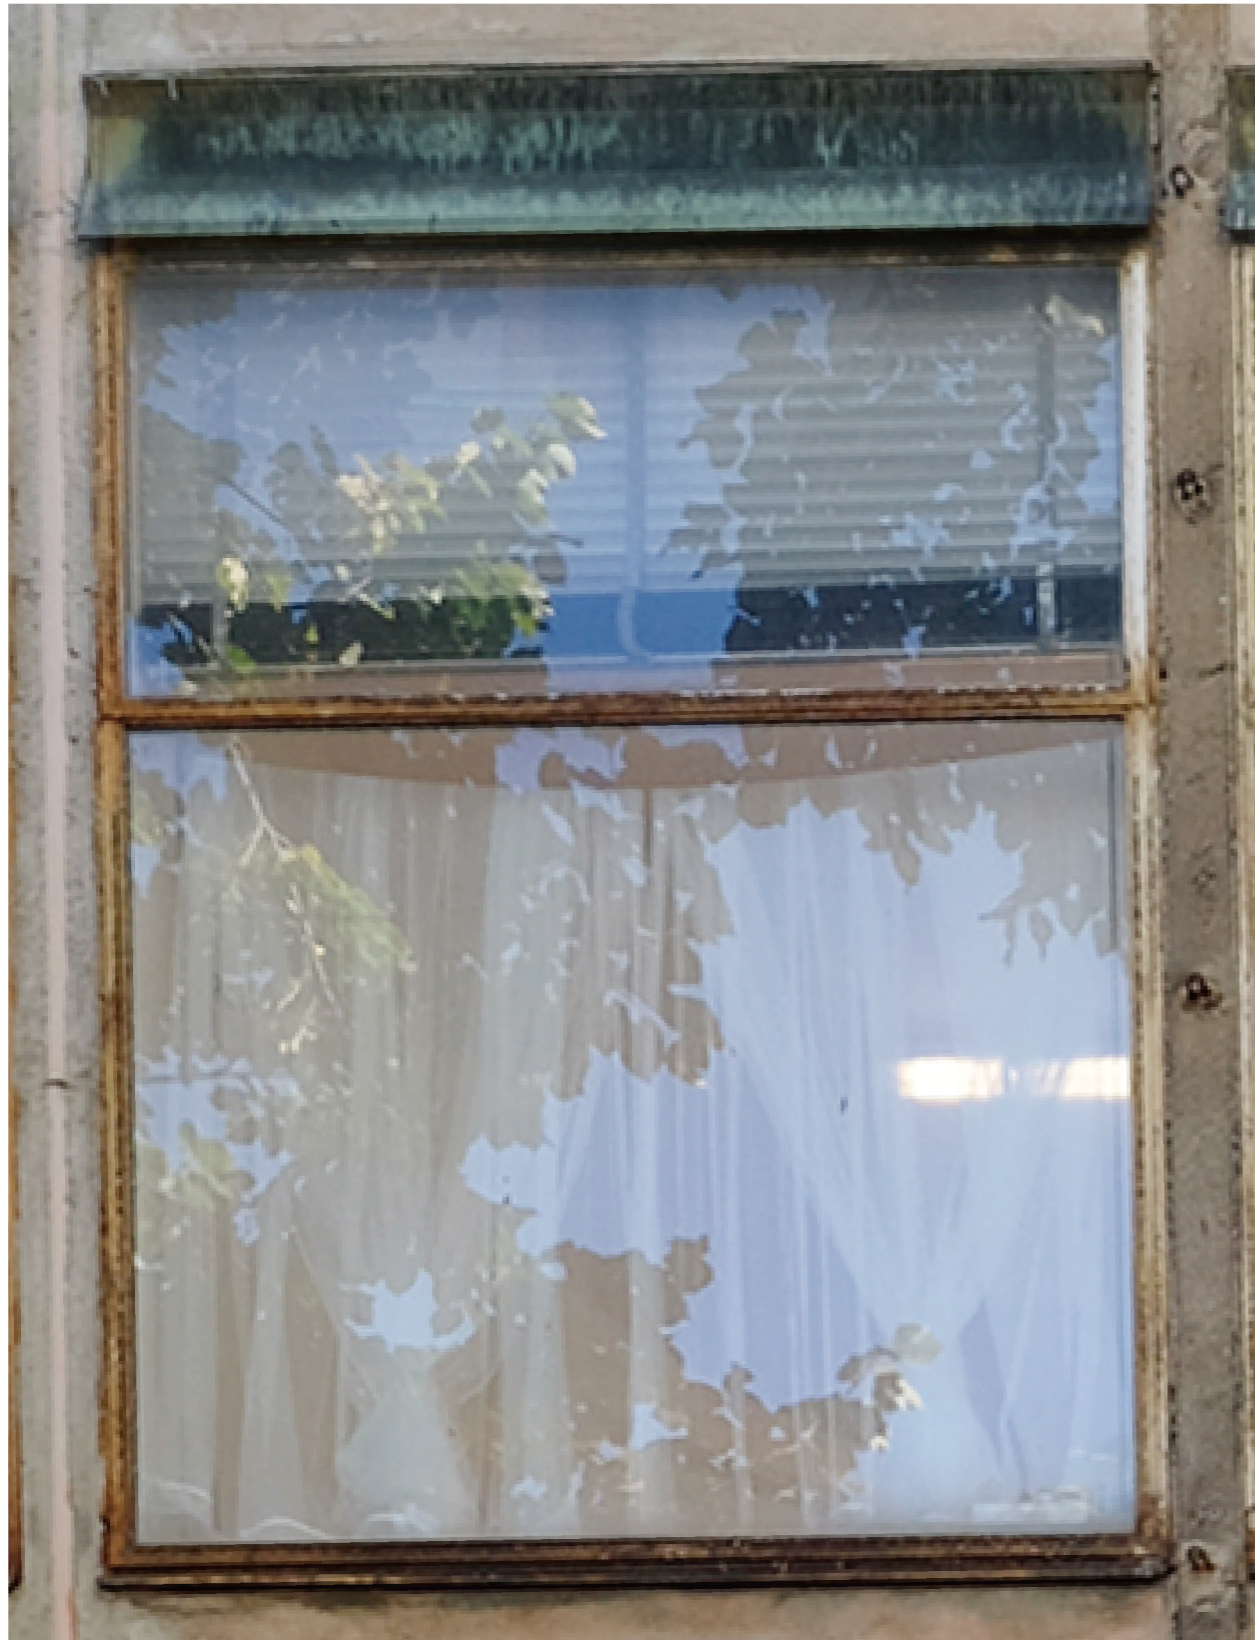
Windows

WHAT IS THE PROBLEM?	WHAT CAN WE DO?	STEP BY STEP
<p>STAINING: The metal rain shield is affected by water, causes stains on the glass.</p>	<p>First of all, we need to clean the glass. Second, we need to clean up the rust on the rain shield. If it is seriously damaged, it needs to be replaced. The window frame needs to be cleaned of the peeling paint coating, and then powdered new paint which will protect the metal window frame after cleaning.</p>	<p>PL01 DRY CLEANING</p> <ul style="list-style-type: none"> • Dry cleaning by dusting with brushes, cleaning clothes and brooms. The cleaning must remove the deposit of atmospheric particles, soluble salts and incoherent residues of plasters. • The execution will take place from top to bottom for horizontal fields.
<p>PATINA: Iron rich patina</p>		<p>PL02 HYDRO CLEANING WITH DEIONIZED WATER (by spray)</p> <ul style="list-style-type: none"> • Removal of consistent deposits and dry cleaning by manual instruments (such as scrapers, brushes) and with the help of extractor fan, to obtain a surface completely free of dust and rubble. • Repeated washes until the complete extraction of salts by deionized water by spray with brushing. • Final drying and removal of the salts crystallized on the surface by soft brushes. • Controlling of the intervention by conductivity measurements of the washing water.

<p>PEELING: In some places, the outer painted plaster of window frames was peeled off.</p>		<p>Pr.01 LAYING OF PAINTING PLASTER</p> <ul style="list-style-type: none"> • Protect metal window frame

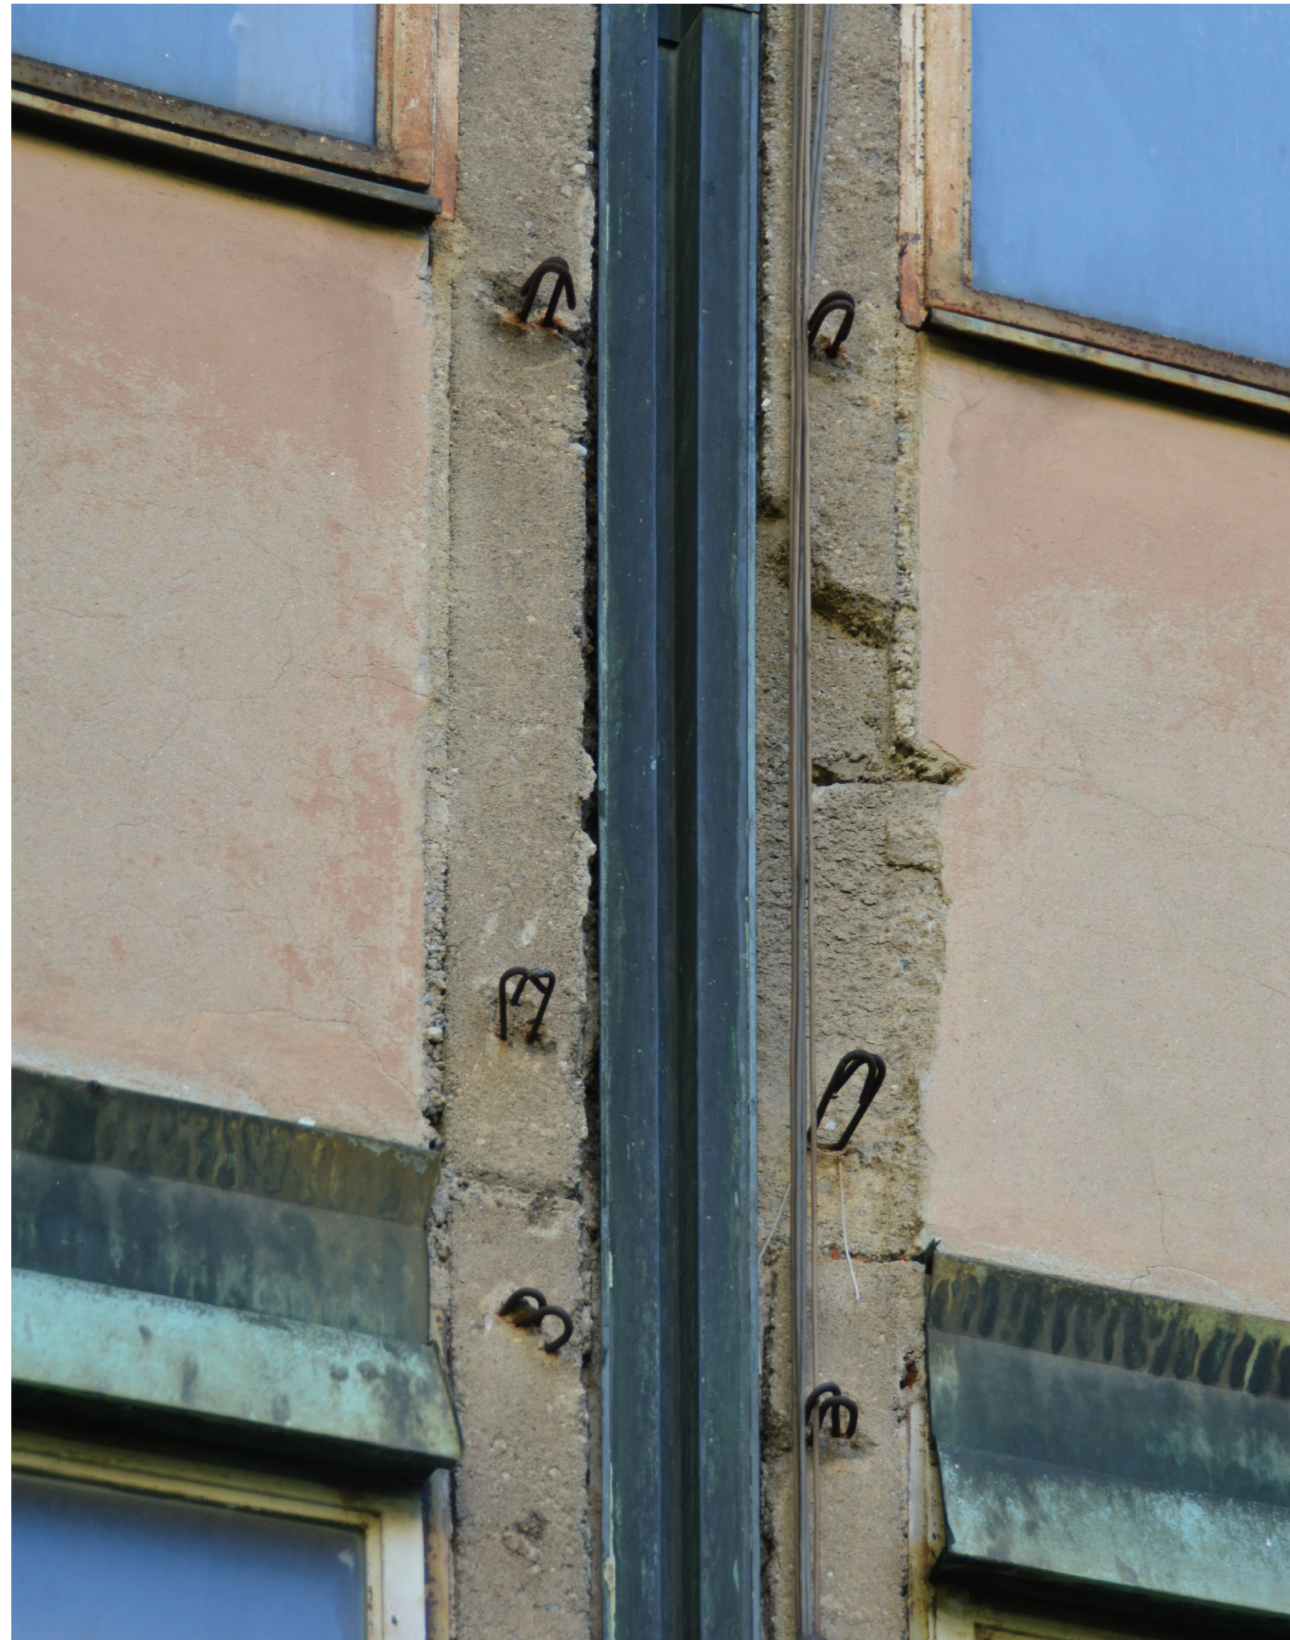
Pillars

WHAT IS THE PROBLEM?	WHAT CAN WE DO?	STEP BY STEP
<p>CRACK: There are some cracks between the structural pillars and the decorative pillars, and the cracks on the decorative pillars are more serious.</p>	<p>First, we need to clean the surface, fill in the missing places, and replace some of the old cement with new ones.</p> <p>At the same time, the metal bolts also need to be cleaned and reinforced.</p>	<p>R.01 REMOVING OF FILLING WITH CEMENT MORTAR</p> <ul style="list-style-type: none"> • Protection of the areas near to the element to be removed with masking tape. • Removal of the filling with cement mortar by manual instruments (chisels, hammers and so on), taking care not to damage the plaster in the area and the underlying brick wall. The execution must be done on small areas, from top to bottom. • Cleaning of the surface with brushes and compressed air. • Execution of the new sealing of the crack or refilling of laying of lime plaster and surface finishing by adding surkhi or blue pigments in relation to the area to be treated according to the indication of the Work Director.

<p>PEELING: Many of the metal -protecting paints have peeled off on the metal skin that was originally used to protect the decorative pillars.</p>	<p>Then we need to refill the missing decorative pillars. Finally, a metal shell needs to be added to protect the decorative pillars outside.</p> <p>For the parts that are not lost, we need to clean the metal and apply a new paint coating to prevent the metal from being corroded by water again.</p>	<p>PL.01 DRY CLEANING</p> <ul style="list-style-type: none"> • Dry cleaning by dusting with brushes, cleaning clothes and brooms. The cleaning must remove the deposit of atmospheric particles, soluble salts and incoherent residues of plasters. • The execution will take place from top to bottom for horizontal fields.
<p>SCALING: Detached contour scaling on beams.</p>		<p>PL.02 HYDRO CLEANING WITH DEIONIZED WATER (by spray)</p> <ul style="list-style-type: none"> • Removal of consistent deposits and dry cleaning by manual instruments (such as scrapers, brushes) and with the help of extractor fan, to obtain a surface completely free of dust and rubble. • Repeated washes until the complete extraction of salts by deionized water by spray with brushing. • Final drying and removal of the salts crystallized on the surface by soft brushes. • Controlling of the intervention by conductivity measurements of the washing water.

<p>FILLING WITH CEMENT MORTAR: In order to protect the structural pillars from further damage, the surface of the missing decorative pillars was smoothed with cement.</p>		<p>Co.01 SEALING OF CRACKS WITH INJECTIONS OF HYDRAULIC LIME MORTAR</p> <ul style="list-style-type: none"> • Protection of surfaces with masking tape; • Cleaning the cracks with compressed air; • Deep injection of hydraulic lime mortar; the Works Director should verify the necessity of insertion of brick fragments, according to the size of crack. • Finish with lime mortar and sieved sand (inert-binder ratio 1:1) with burnt bricks powder; the Works Director should choose the color according to the surrounding surface. • The finish should be realized 5 mm undercut for the exterior front (layout CO4, side G) .
<p>MACHENICAL DAMAGE: The metal used to fix the decorative pillar is now exposed, and the pillar is damaged by the metal bolt. There was a missing part around the metal bolt.</p>		<p>Co.02 FILLING OF MISSING PARTS</p> <ul style="list-style-type: none"> • Cleaning of the cavity by compressed air; • After wetting the surface, filling of missing parts with natural hydraulic lime mortar, taking care to seal any interruption; • Finishing with lime mortar and natural riddled sand with the addition of powder burnt bricks.

<p>MISSING PART: Very few parts of the pillars are missing, leaving the materials inside exposed to the outside.</p>		<p>Pr.01 ADDING STEEL TO PROTECT DECORATED PILLARS</p>

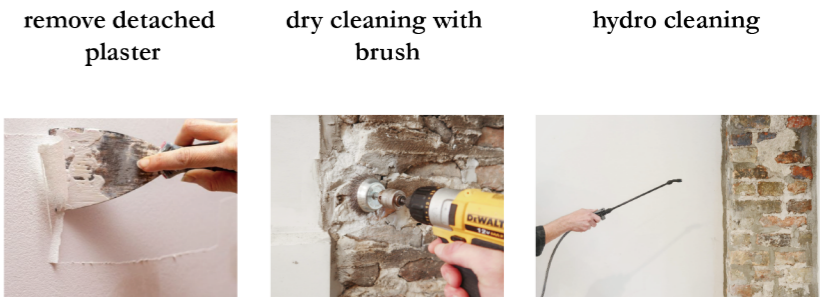
Brick walls
Infilled walls need to be protect and consolidation

The brick walls are a part of the facade, it's protected by the outer cement layer and painting layer.

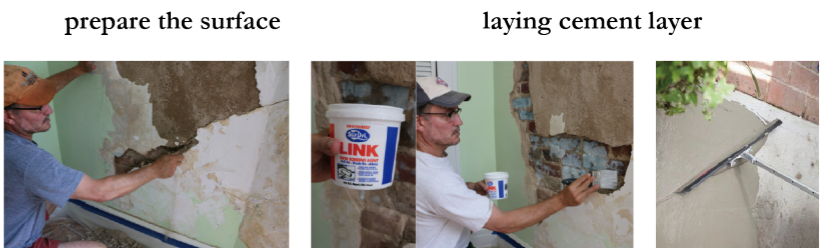
Cement layer
Give a new cement layer to the brick wall

After consolidation the brick wall, we need to prepare the surface for next step laying the cement layer.

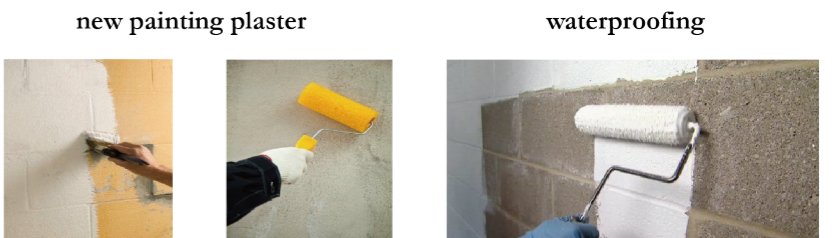
Painted layer
Laying a new waterproof painting layer

After laying the cement layer we give a new waterproof layer.
