Tobacco Routes and  
Historical Expansion

## Existing Conditions on Site

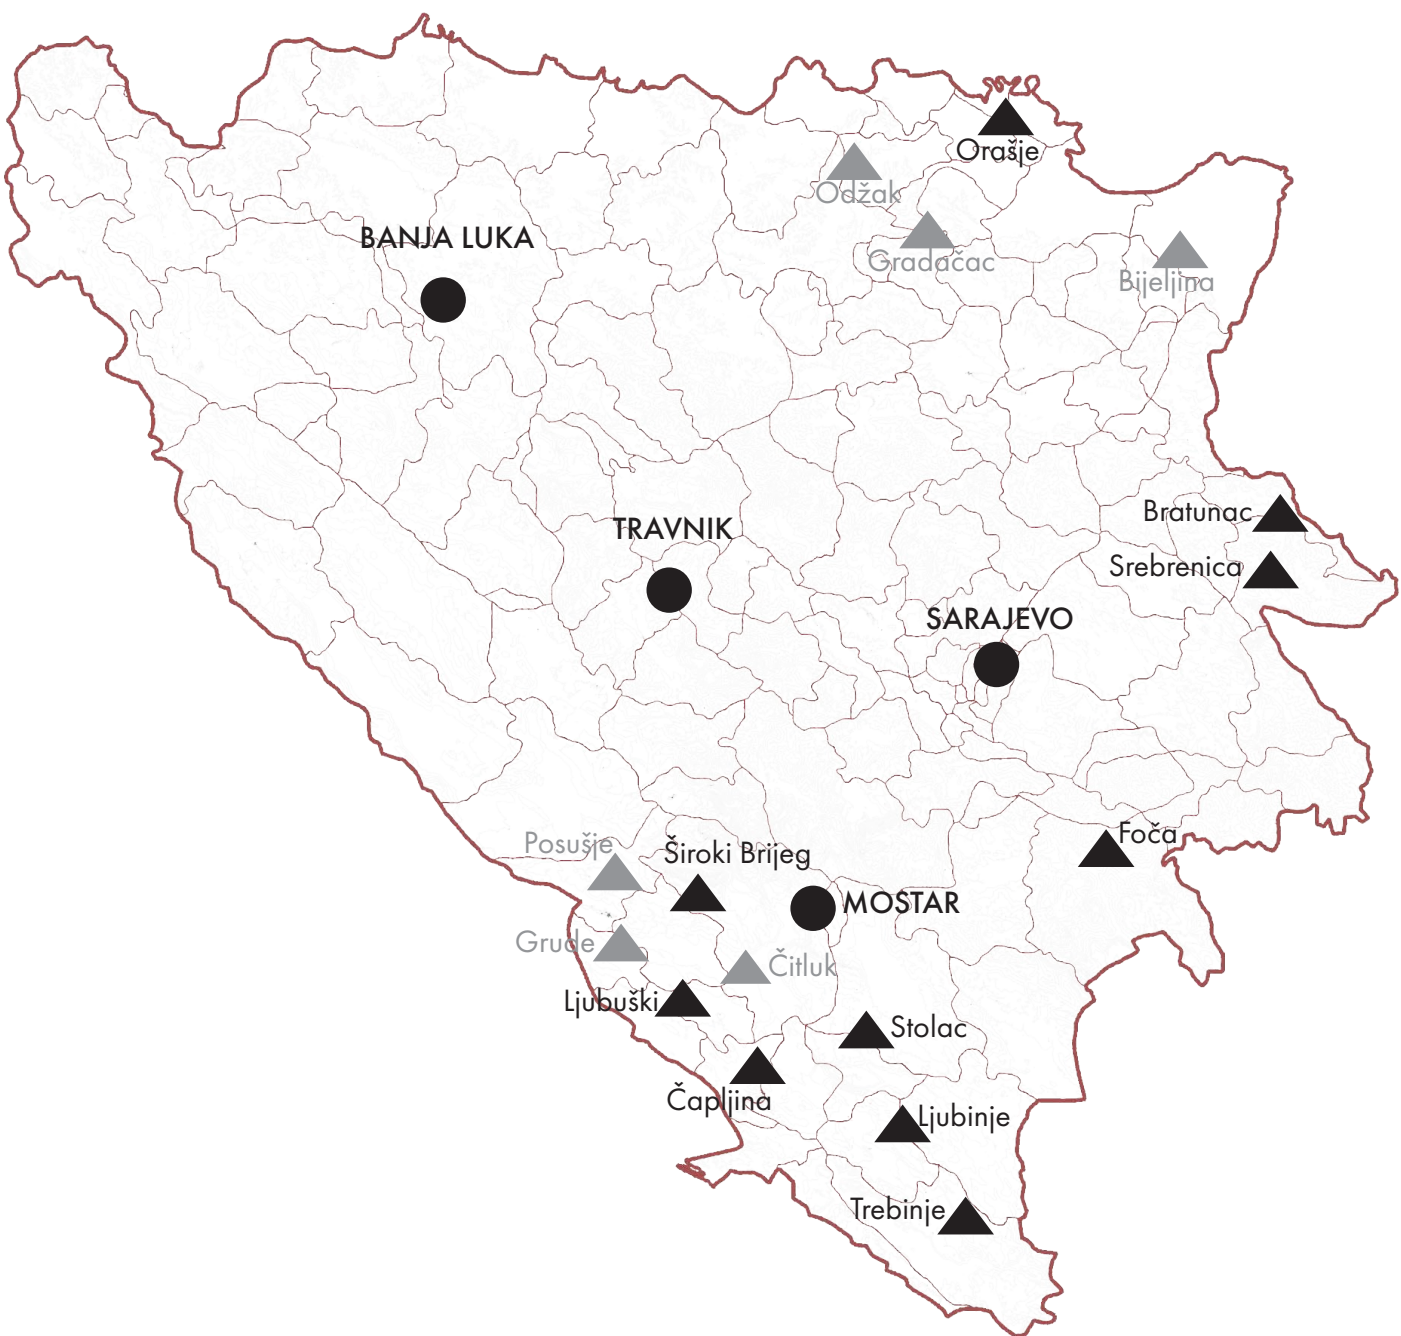
Network of Tobacco Stations in Bosnia and Herzegovina

- Tobacco factory
- ▲ Tobacco stations 1880 - 1914
- ▲ Tobacco stations after 1945

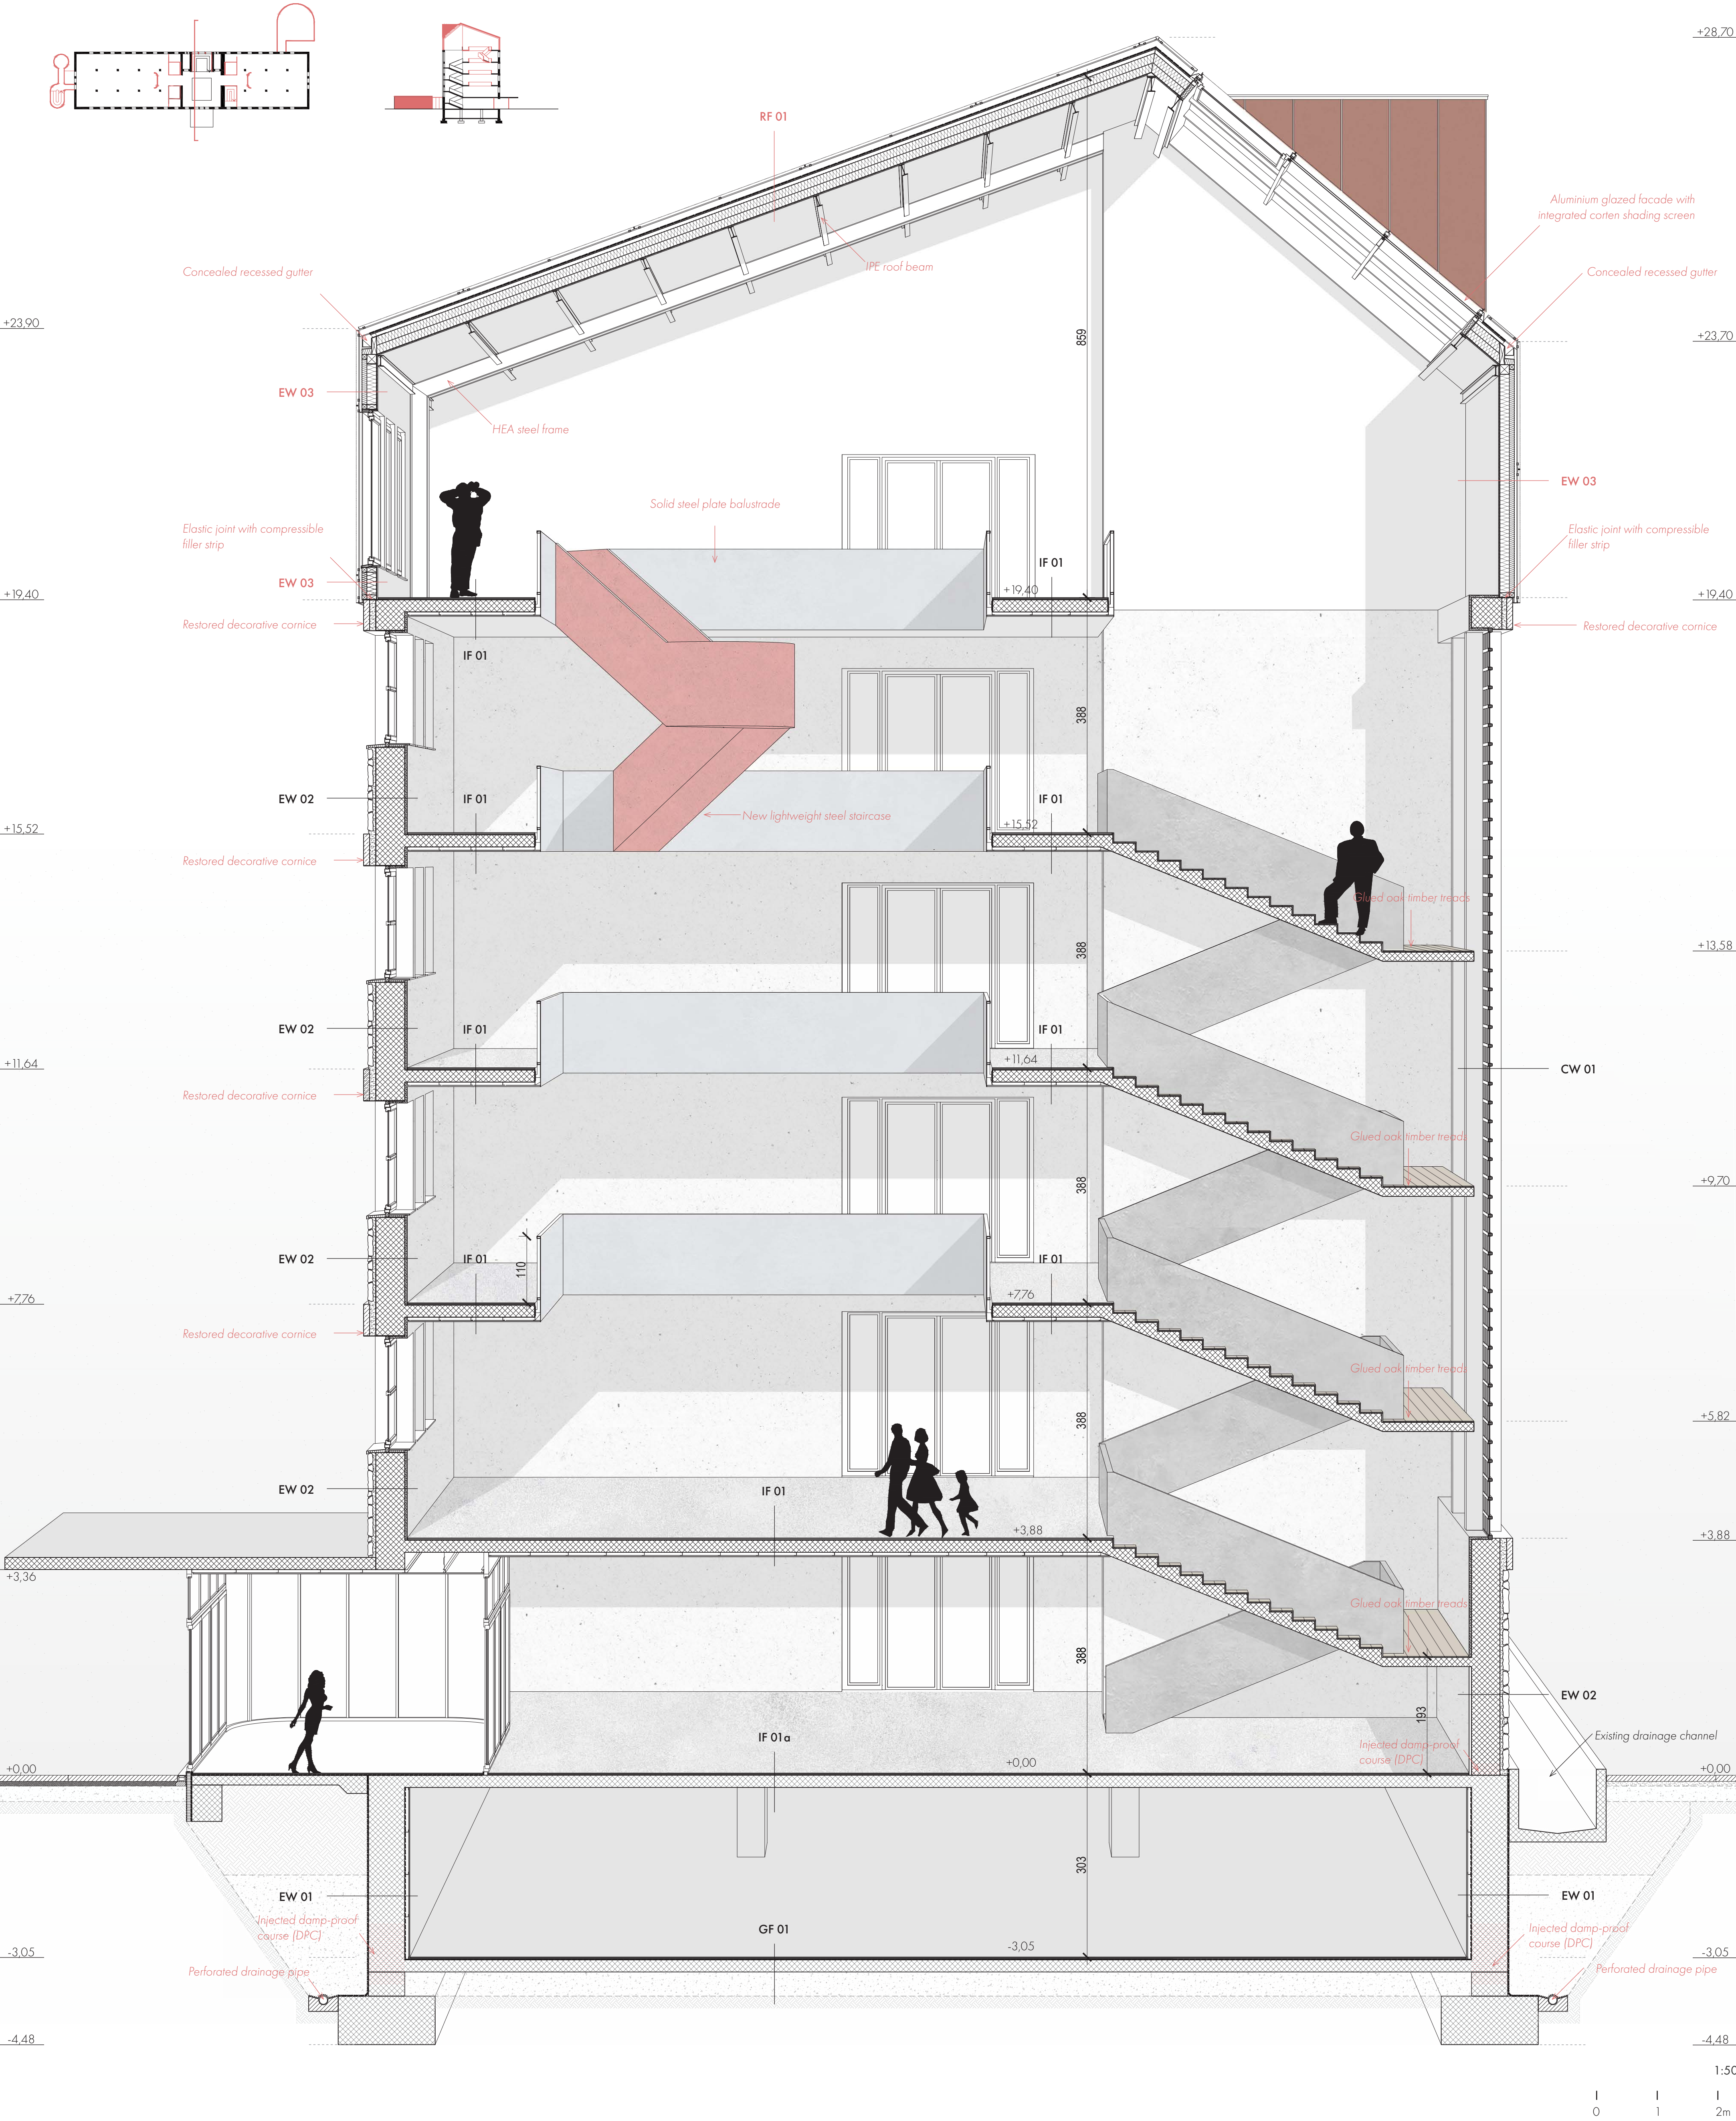
Detail Section

| GF 01 - Ground Floor | IF 01 - Intermediate Floor | RF01 - Pitched Roof | EW 01 Basement Wall | EW02 Existing External Wall | EW 03 Lightweight External Wall |
| <ul style="list-style-type: none"><li>Microcement finish</li><li>Gypsum fibre board, 12.5 mm x 2</li><li>Acoustic insulation layer</li><li>Self-adhesive bituminous waterproofing membrane</li><li>Existing reinforced concrete floor slab</li><li>Crushed gravel subbase</li><li>Compacted soil</li></ul> | <ul style="list-style-type: none"><li>Microcement finish</li><li>Gypsum fibre board, 12.5 mm x 2</li><li>Acoustic insulation layer</li><li>Existing reinforced concrete slab</li><li>Suspended ceiling cavity with CD metal substructure</li><li>Gypsum fibre board ceiling, 12.5 mm x 2</li></ul> | <ul style="list-style-type: none"><li>Perforated corten steel on subconstruction, screen with variable perforation density</li><li>Air cavity with timber substructure</li><li>UV-resistant synthetic roofing membrane</li><li>OSB roof sheathing</li><li>Ventilated cavity</li><li>Diffusion-open membrane</li><li>Thermal insulation between timber battens, 140 mm x 2</li><li>PEHD vapour barrier membrane</li><li>Visible OSB roof deck</li></ul> | <ul style="list-style-type: none"><li>Renovation lime plaster</li><li>Polymer-cement waterproofing coating</li><li>Existing reinforced concrete wall</li><li>Dimpled drainage membrane</li><li>Geotextile filter layer</li><li>Backfilled soil</li></ul> | <ul style="list-style-type: none"><li>Thermal insulating lime plaster</li><li>Existing reinforced concrete structural wall</li><li>Cement mortar bedding</li><li>Existing limestone cladding</li></ul> | <ul style="list-style-type: none"><li>OSB sheathing</li><li>PEHD vapour barrier membrane</li><li>Thermal insulation between vertical timber battens</li><li>Thermal insulation between horizontal timber battens</li><li>Ventilated cavity</li><li>Perforated corten steel on subconstruction, with operable panels</li></ul> |
| <ul style="list-style-type: none"><li>0,3 cm</li><li>2,5 cm</li><li>1,0 cm</li><li>0,4 cm</li><li>18,0 cm</li><li>25,0 cm</li><li>-</li></ul> | <ul style="list-style-type: none"><li>0,3 cm</li><li>2,5 cm</li><li>1,0 cm</li><li>18,0 cm</li><li>5,0 cm</li><li>12,5 mm x 2</li><li>2,5 cm</li></ul> | <ul style="list-style-type: none"><li>0,3 cm</li><li>2,5 cm</li><li>1,0 cm</li><li>18,0 cm</li><li>5,0 cm</li><li>2,2 cm</li><li>6,0 cm</li><li>-</li><li>28,0 cm</li><li>-</li><li>1,8 cm</li></ul> | <ul style="list-style-type: none"><li>4,0 cm</li><li>0,3 cm</li><li>60,0 cm</li><li>1,0 cm</li><li>0,3 cm</li><li>-</li></ul> | <ul style="list-style-type: none"><li>4,0 cm</li><li>40,0 cm</li><li>4,0 cm</li><li>12,0 cm</li></ul> | <ul style="list-style-type: none"><li>1,8 cm</li><li>-</li><li>16,0 cm</li><li>8,0 cm</li><li>4,0 cm</li><li>4,0 cm</li></ul> |
| | | | | <ul style="list-style-type: none"><li>CW 01 Restored Curtain Wall</li></ul> | |
| | | | | <ul style="list-style-type: none"><li>Restored reinforced concrete frame</li><li>Thermally broken aluminium profile</li><li>Double insulating glazing unit</li></ul> | |
