**SEISMIC ANALYSIS
OF HISTORICAL MASONRY BUILDINGS**

**"The Church of Assunzione della Beata Vergine Maria in
Villavesco, Tavazzano"**

Master Thesis

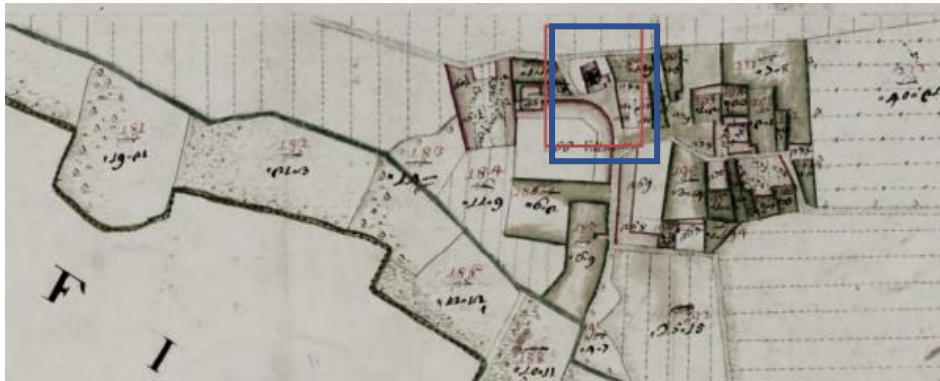
Figure 2 - Teresian Cadaster, 1722, Villavesco

Over time some transformations of the volumes of the church have taken place, and the historical land registers contain the main information. Below are some of the fundamental extracts taken from the most relevant land registers, which mark the evolution of our case study. The following image shows an extract from the Teresian Cadaster, made around 1722; at that time the parish was already present, except for the semicircular apse.

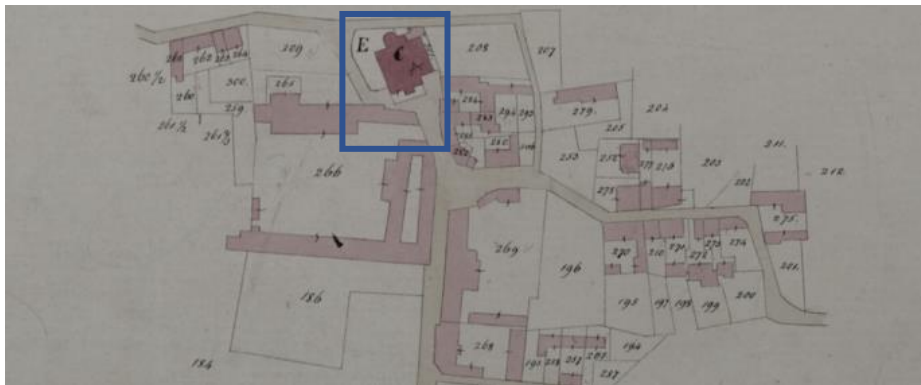
Figure 3 - Lombardo-Veneto Cadaster, 1860, Villavesco

With the subsequent Lombardo-Veneto Cadaster, dating back to about 1860, it can be noted that the volumes of the building considered have changed considerably; in fact, the apse and part of the new nave to the east are added.

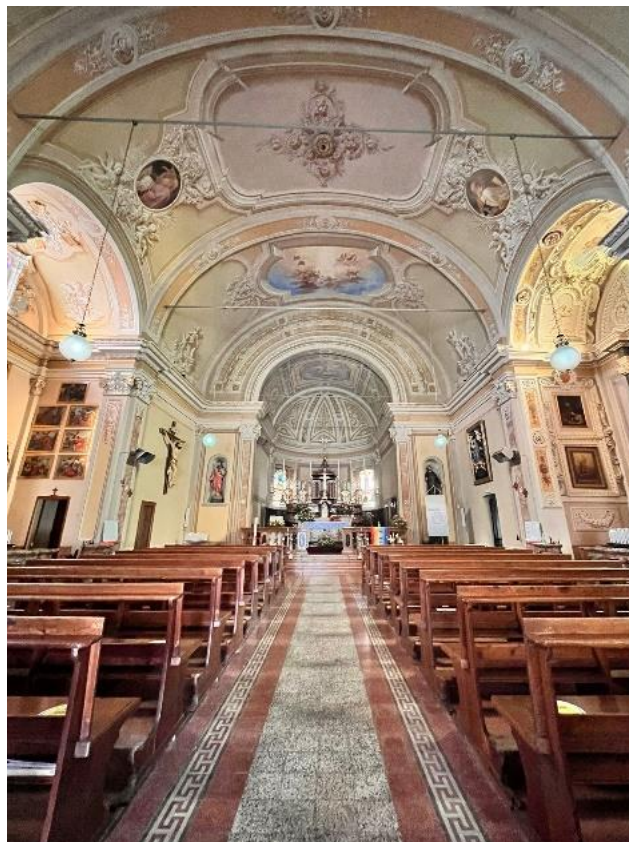
Figure 7 - Internal central nave view

At the end of the nave, as can be seen from the image, there is a rectangular apse and a semicircular choir; these are covered by a spherical cap, internally decorated with three-dimensional representations.

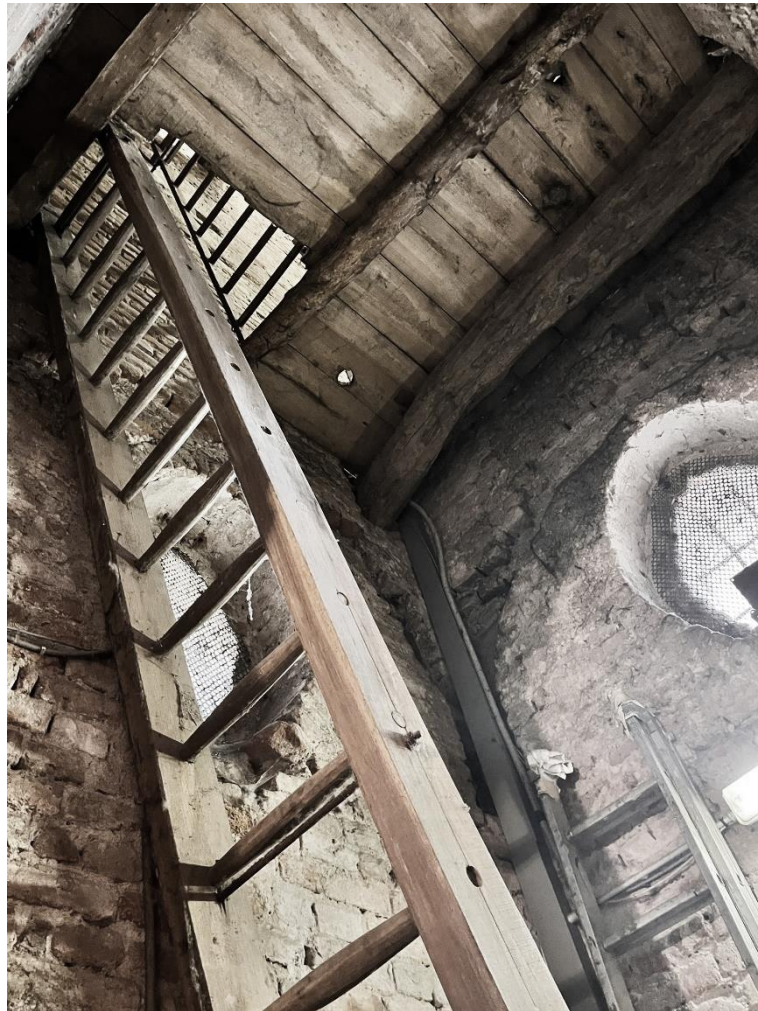
Figure 8 - Interior of the bell tower

The bell tower is composed by a continuous and visible brick masonry, with wood slabs and stairs that allow to pass from one floor to another, in case of necessity. Inside the bell tower you can also see the presence of some cross vaults, present when the bell tower was still in its original position. Internally the bell tower is plastered up to about 2cm in height, then the masonry is exposed.

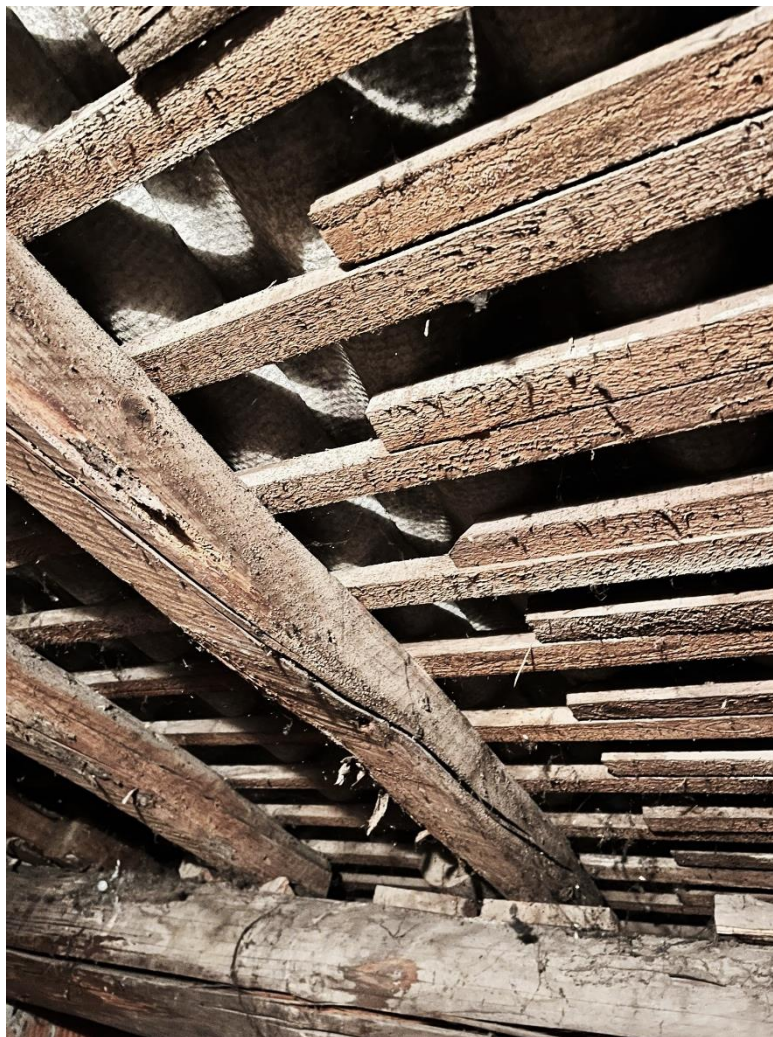
Figure 9 – Roof Structure

Recently, restoration work has been carried out on the church roof; this is visible from the attic and the openings of the bell tower. A ridge beam is supported by masonry pillars that are positioned at the end of the vaults that we find in the nave; from here, orthogonally, other joists are distributed and supported by the perimeter walls.

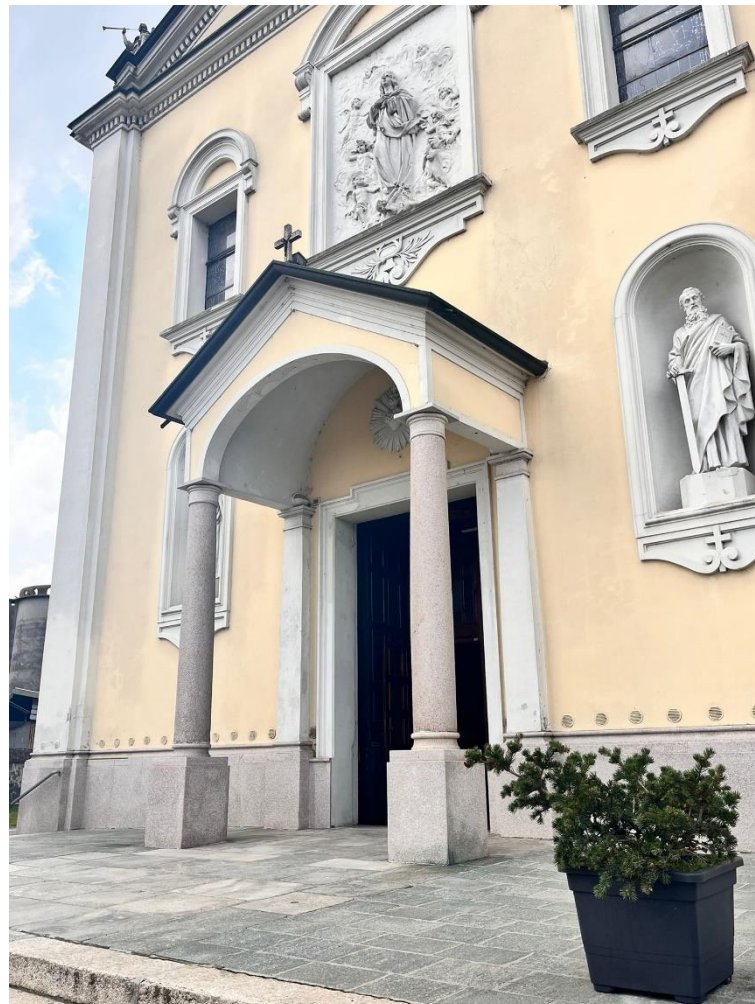
Figure 10 - View of the Church from the Frontal Façade

The church is well integrated with other buildings; the external façade is plastered unevenly and at the upper order there is a bas-relief above the terracotta porch as a Eucharistic symbol, two side windows with a decorative and illustrative panel in the center. At the lower order of the façade, we find two niches with statues of Saints, symmetrical with respect to the central door.

Even the bell tower is decorated externally even if, lately, it is subject to degradation and detachment of some parts of plaster; here we find a frame with geometric patterns.

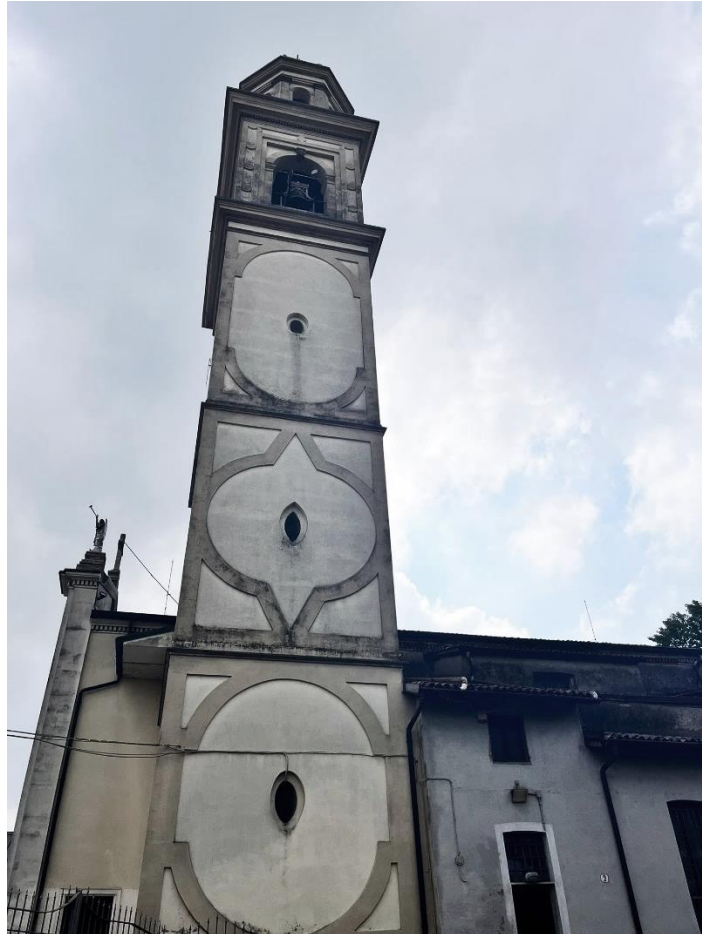
Figure 11 - The bell tower

One of the most damaged points of the exterior is the bell tower, where cracks and detachment of plaster are clearly visible. The main façade, facing South-East, is the side that presents the greatest problems, the degradation has developed points where the wall is totally exposed. The south-facing side is the one with the least damage.

The bell tower, as previously confirmed, presents decay on each side, in fact it has detachment of plaster in various points and serious cracks, in the most exposed facades there is the lack of even a few square meters of plaster; there is therefore the risk of the sudden detachment of some portions of the cover of the wall.

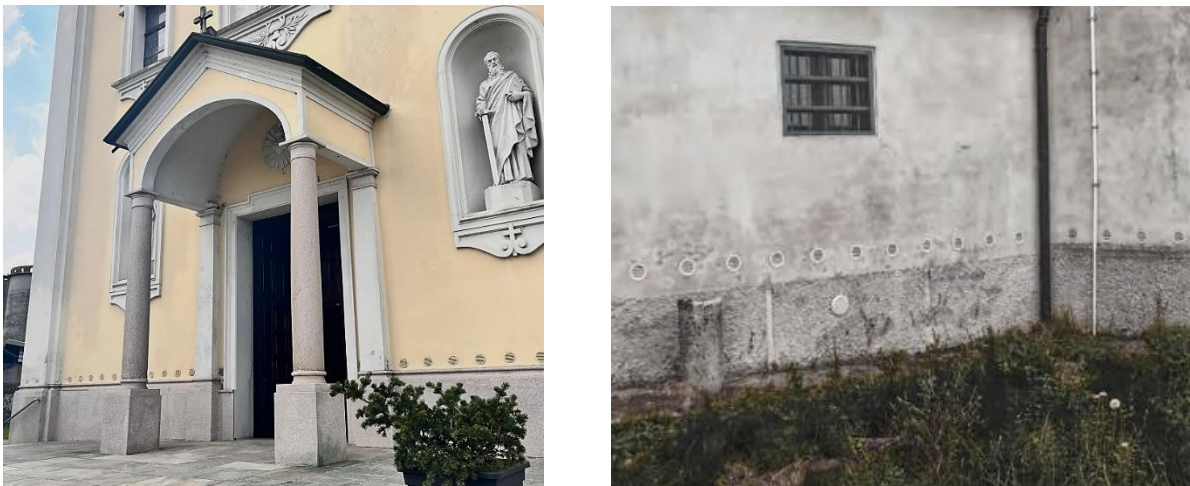
Figure 12 – Conservation through humidity reduction systems

To avoid aesthetic damage and try to reduce the danger of these damages, slabs have been placed at the foot of the building that cover up to a height of about 70cm from the ground. On the façade and on the back, however, "vents" have been placed that are clearly noticeable as they have a diameter of about 10 to 15cm. They are visible as pipes, covered externally by grids, which have the function of reducing the accumulation of moisture inside the masonry.

These interventions have been made very recently on this structure, it is thought in different processes as the pipes differ in the type of material used, plastic or aluminum with covering grids. Generally, this system is widely used in this area, since it is in the Pianura Padana Region, and so the presence of moisture is the normality.

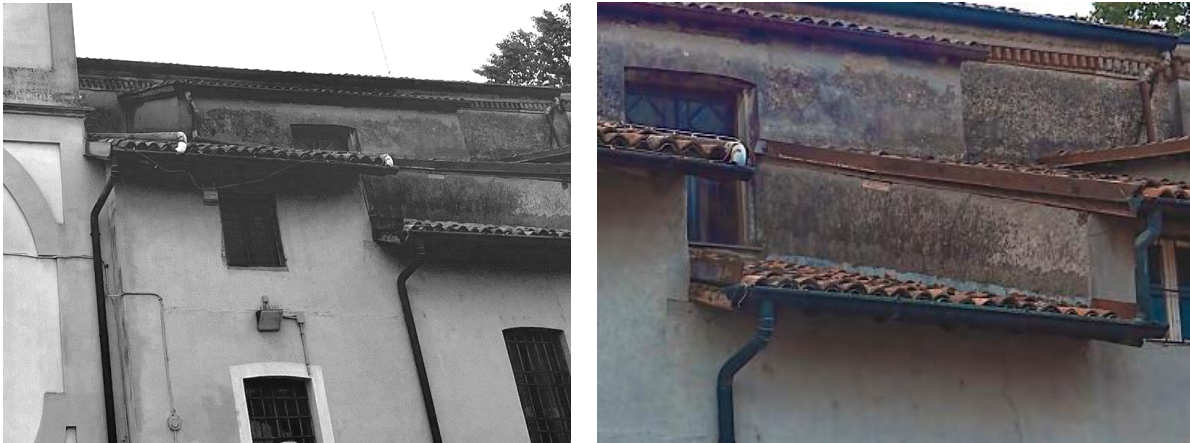
Figure 13 – External Walls Defects

On the side of the inner courtyard, however, where there is the parish priest's house, the damage is much more evident and concerns the structural part of the building.

This very evident damage is reminiscent of the presence and accumulation of pollutants on the surfaces; due to the lack of protective elements, as the walls are totally exposed to atmospheric agents and rainwater discharges.

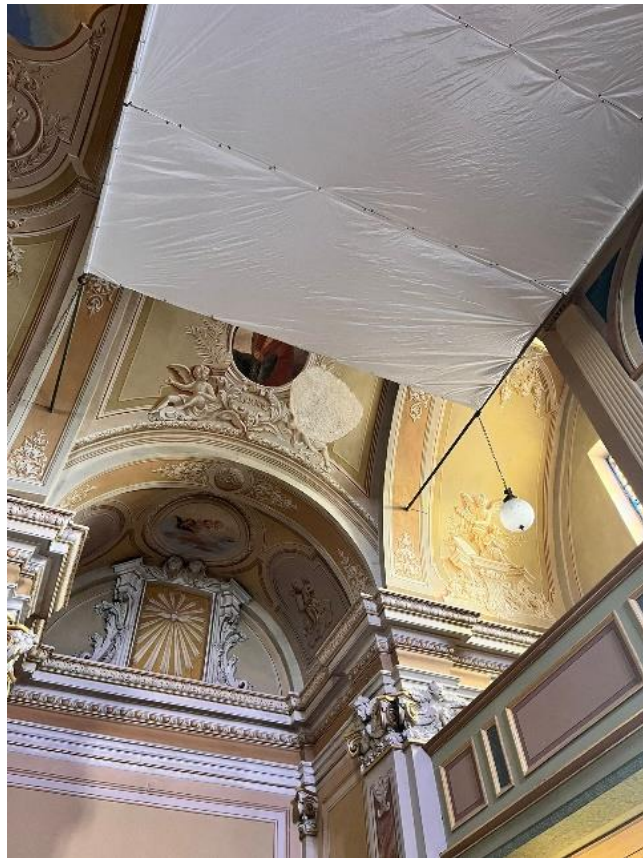
Figure 14 - Protection against plaster detachment

Compared to the outside, the internal damage is milder, although the presence of mold and small sediments of external material can be found, due to polluting external elements. Currently (as clearly visible in the figure) in the central nave protection systems have been mounted as lately there have been episodes of detachment of plaster from the ceiling. As can be seen again in the figure, there are also horizontal support elements, tie-rods, useful to join the two sides of the nave, which retain the thrust from arches but are also an important protective element in case of earthquake.

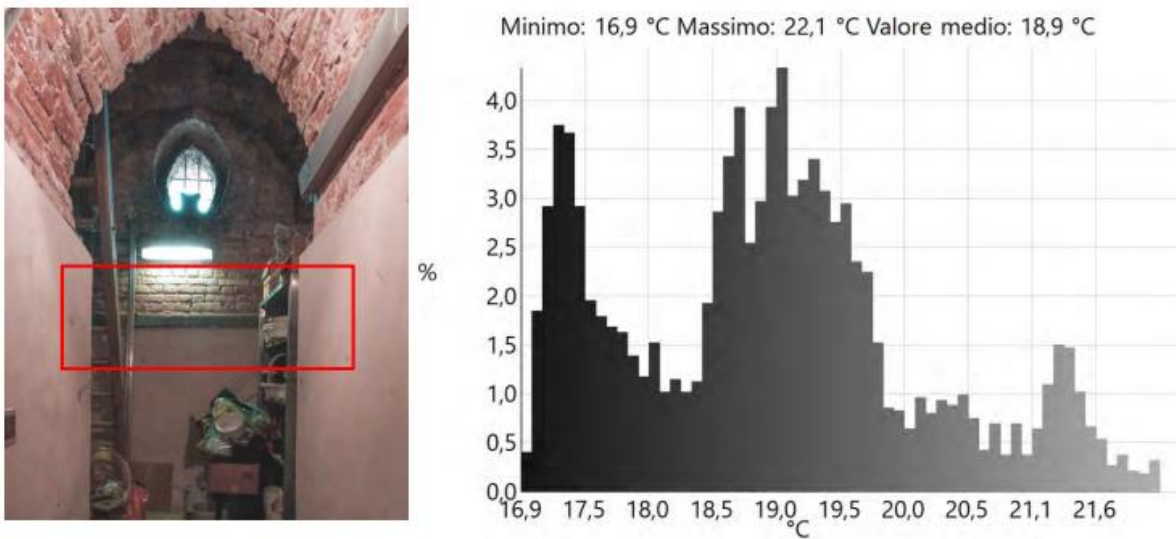
Figure 26 – Difference of materials inside the bell tower and thermography

From the image on the left above it can be seen that the base of the bell tower is composed of a different material; at this point it will then highlight a greater thickness of the masonry and of the cover, while above this point the masonry is visible. The different coloration represents two different temperatures, and they have two different thermal inertias.

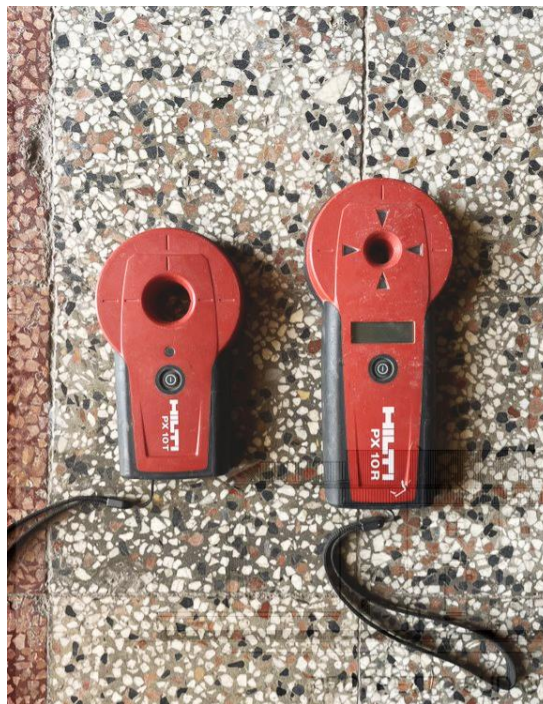
Figure 30 - Instrument for the wall thickness measurement

- It allows you to perform drilling operations quickly and efficiently.
- It allows you to freely choose the direction of drilling, for example when drilling through slabs or before complex coring applications.
- Drilling operations can also be marked in multi-level slabs or non-aligned partitions.
- It prevents damage caused by drilling through insulation or coatings ensuring that it is performed in the correct direction.

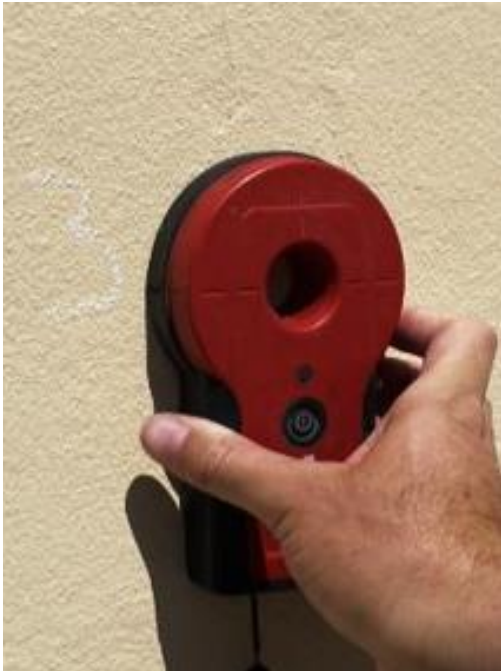
Figure 32 – Photographic representation during in situ testing

The following figure represents the measurement of the wall of the entrance door.

The measurement was evident only when the two objects were perfectly superimposed; the arrows colored green, in fact, serve to indicate the exact position and are useful to follow to find the indicated point. Once the thickness of the chosen masonry is measured, the grid is composed to carry out the next necessary tests.

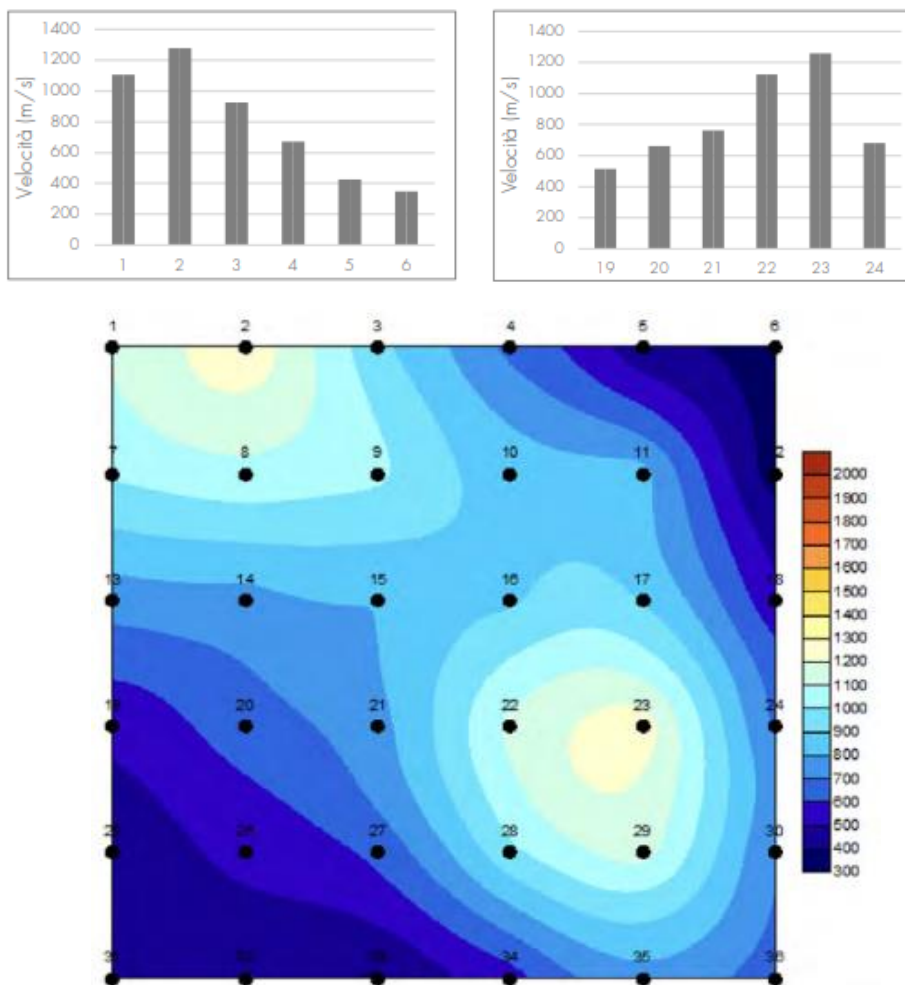
Figure 33 – Test S01, Facade

The first test is carried out on the façade; the velocity range is highly variable, between 400 and 1300 m/s, which indicated the presence of voids or materials not well connected, where velocity is higher the connection is better and so will be the material properties; viceversa, for lower velocities, materials properties are also lower.

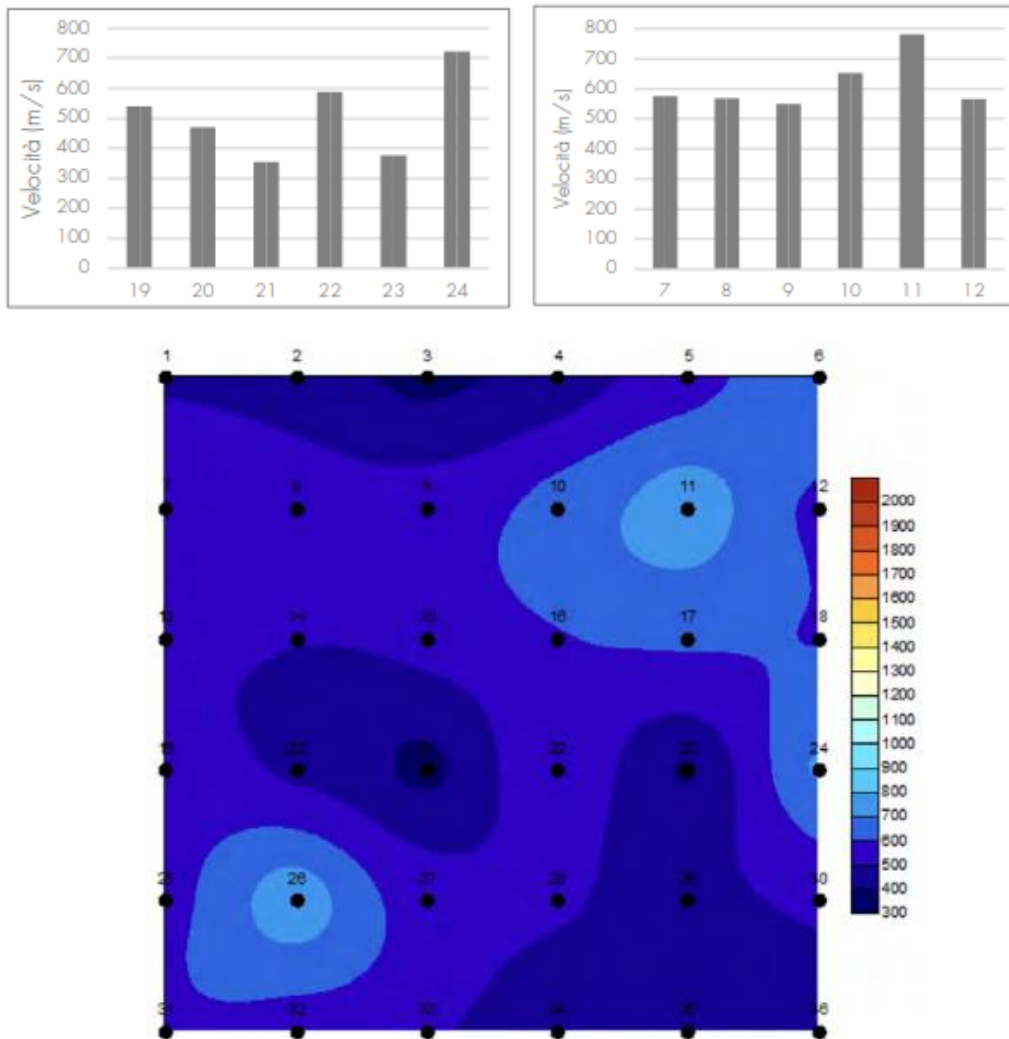
Figure 35 – S05 Test, Apse

One of the tests with worst results is from the apse, where speeds are very low, indicating high discontinuity in the materials. Despite of the presence of discontinuities and voids, speeds after all are constant in that grid, which implies that masonry was built in a regular way, even if the composition was by low quality.

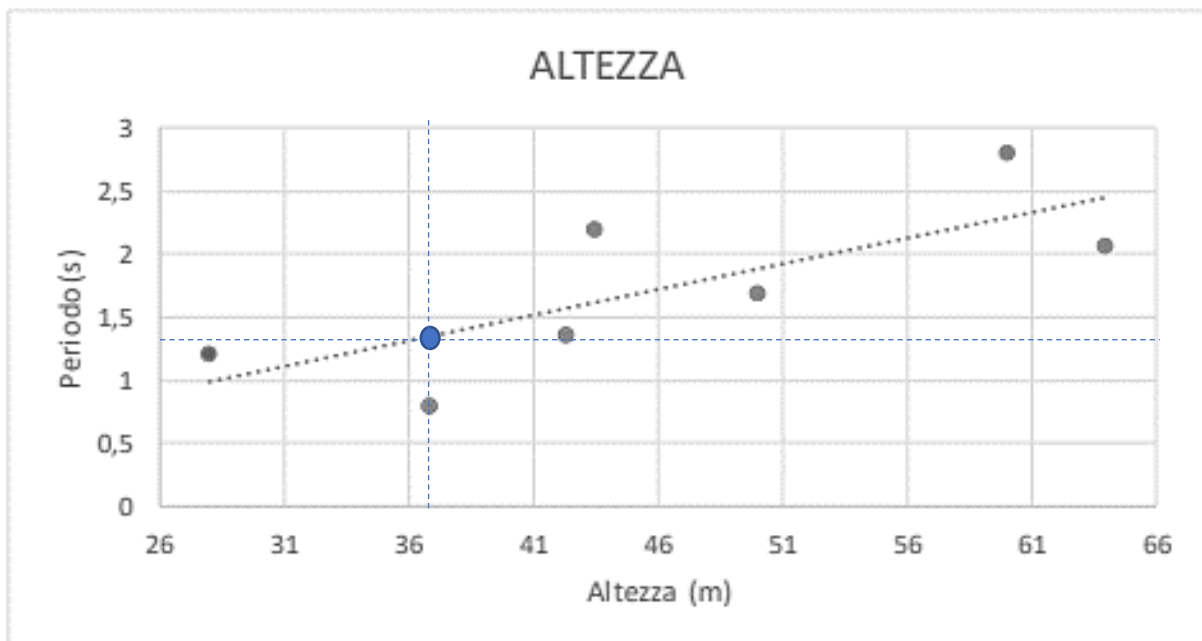
The bell tower analysed follows the linear trend shown in the table.

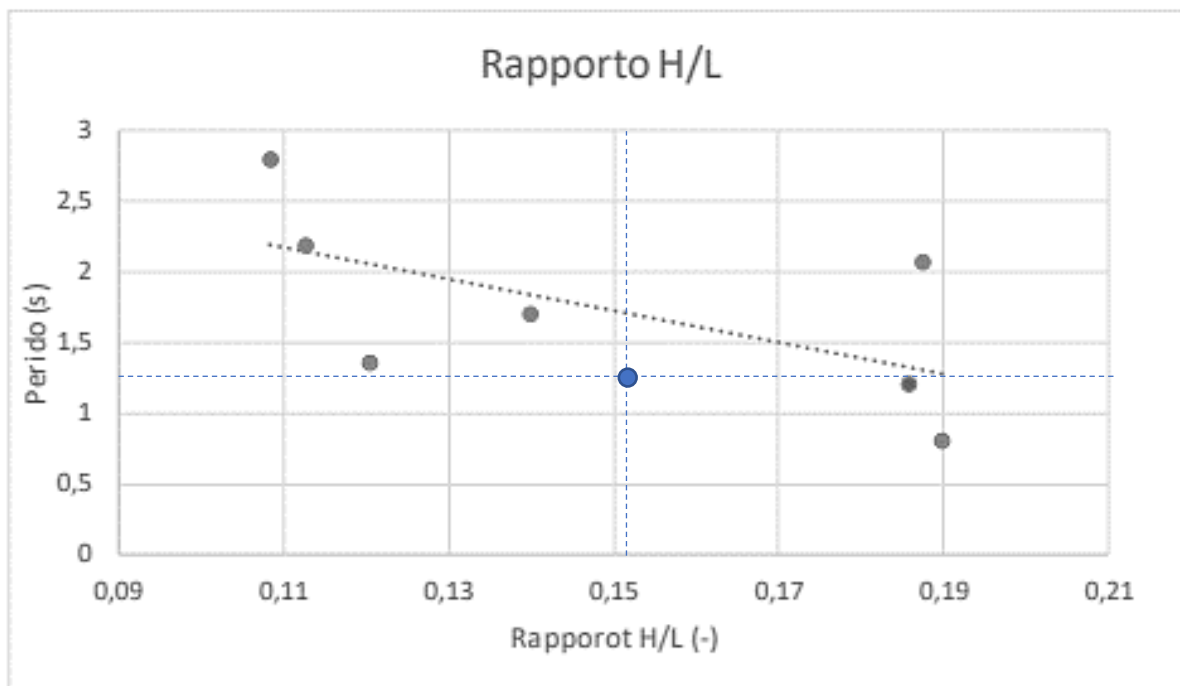
The same is done in terms of H/L ratio, the bell tower of the case study is reported in blue.

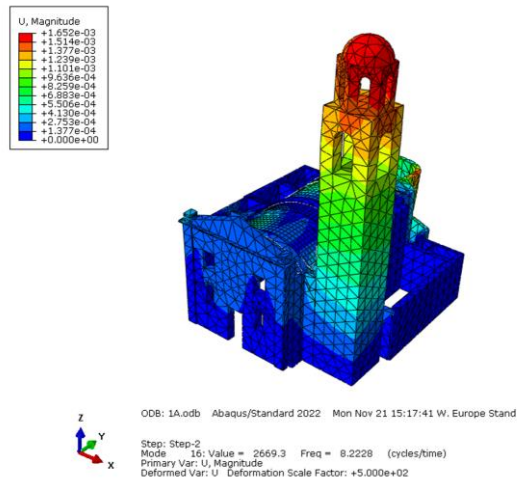
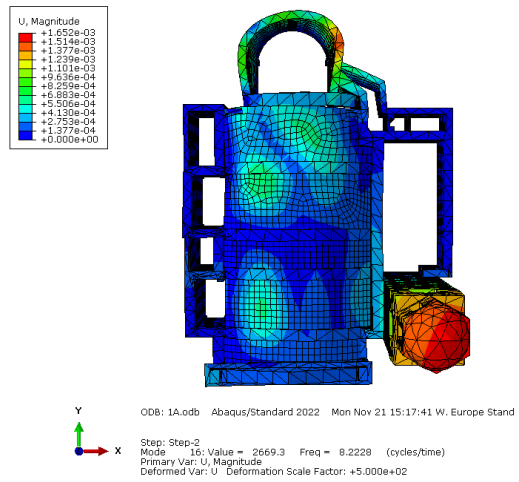
Mode 16

T [s]: 0.1216
