Politecnico di Milano

Department of Architectural Projects and Department of Structural Engineering

**ASSESSMENT OF HISTORICAL MASONRY BUILDINGS: RESEARCH ON
APPROPRIATE NON-DESTRUCTIVE DIAGNOSTIC TECHNIQUES**

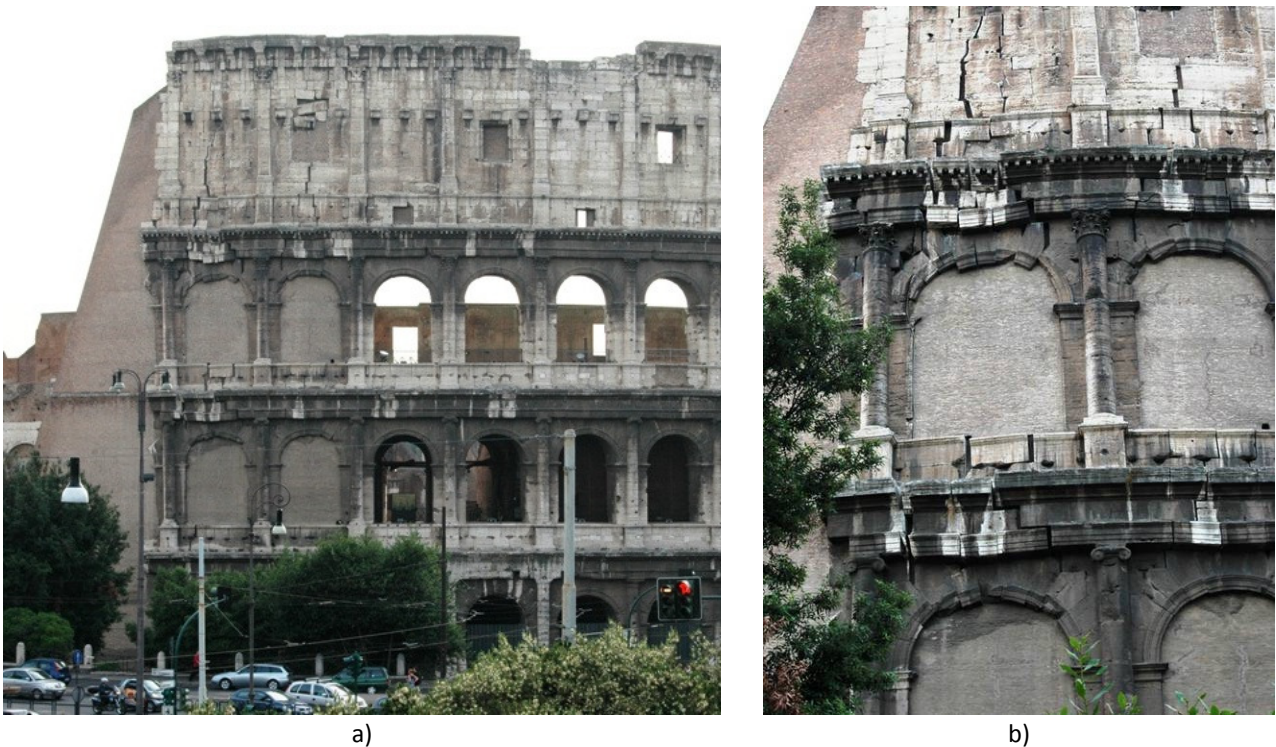
Figure 1.2: View of the Stern's buttress a) incorporating two spans of the external ring of the Coliseum and b) detailed view of the shattered arches blocked in a sort of snapshot of the history (pictures of the author).

left by Raffaele Stern and Giuseppe Valadier who, respectively, in 1086 and 1823, reinforced the Coliseum in Rome avoiding mimetic interventions. Stern's design, above all, represents a masterpiece with the solution of a travertine buttress incorporating two spans of the three orders (Figure 1.2a). The choice to leave the visible damages of the arches (Figure 1.2b), shattered by the 1823 earthquake that compromised the stability of the monument, showed a deep respect for the signs of the time on the buildings.

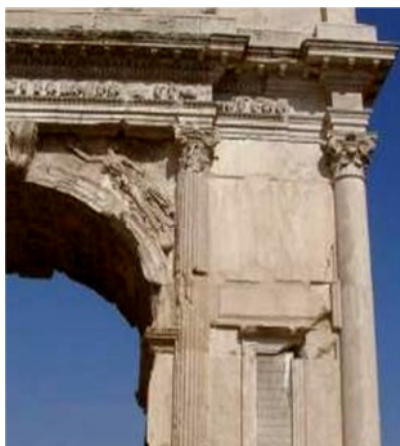
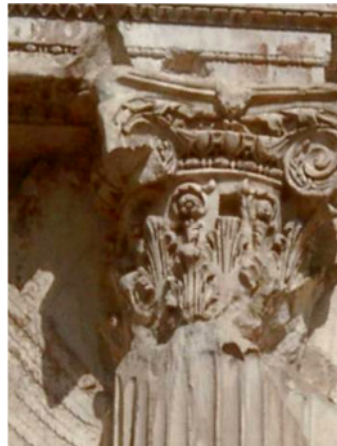
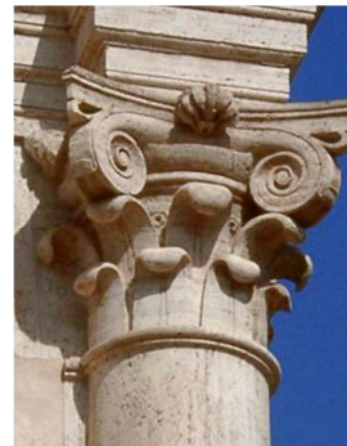
Figure 1.6: a) view of portion of Titus's arch and detailed views of a) the original capital and c) of the simplified capital (pictures of the author).

unusual for that time: he proposed to reconstitute the missing geometry of the monuments (Figure 1.5b), but using a simplified language for the new additions (like the decorations), in order to distinguish the original remains of the arch from the rebuilt parts (Figure 1.6).

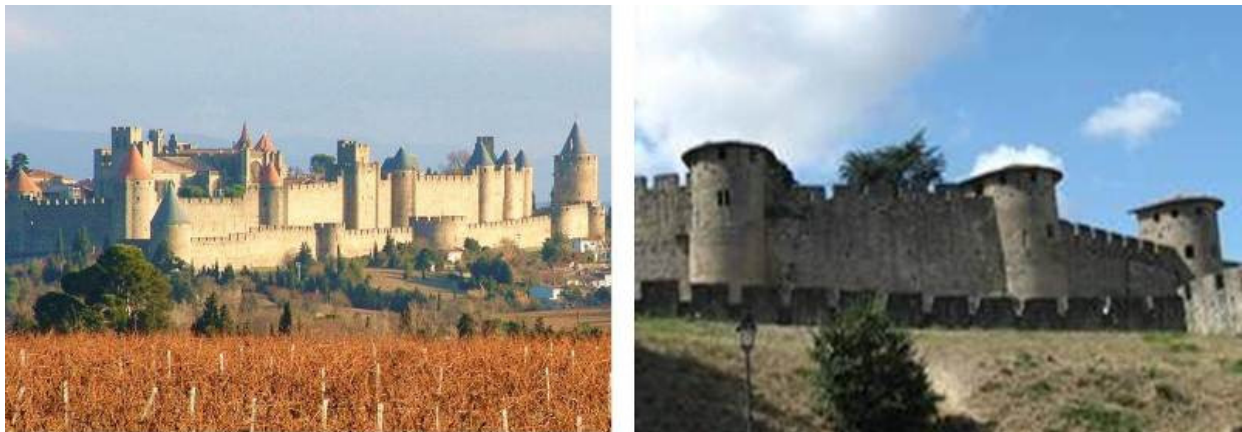
Figure 1.8: Two views of Carcassonne. On the left the defensive walls present the conic roofing design by Viollet le Duc. On the right the conic roofing has been dismantled (pictures free available from the Carcassonne City hall website).

The defensive walls of Carcassonne, a medieval town in south France (Figure 1.8), represent another example of the complexity of the problems generated by a restoration design based on wrong interpretations. Viollet le Duc realized a detailed reintegration of the lost roofs for the towers of the walls and the town acquired a new image in the XIX century. Nowadays the researchers established that the slanting roofs in south France were not characterized by marked slopes and for this reason Viollet le Duc's work is under dismantlement. Also in this case the historical truth that the monument should present was betrayed by the results of the first restoration and the monument is under work to correct its meaning.

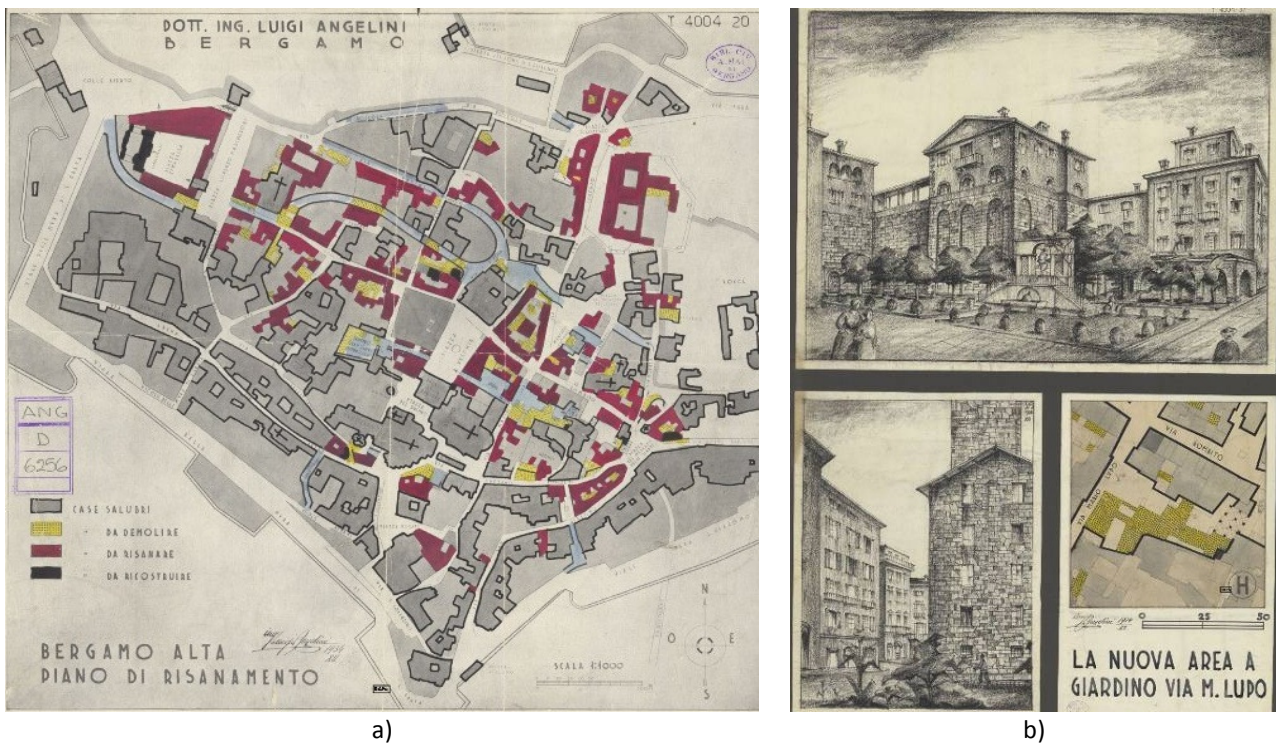
Figure 1.15: Urban renewal plan for the historical centre of Bergamo, designed by L. Angelini in 1934: a) plan with the detailed indications of prudent local regenerations and b) detailed plate of the renewal results in a central area (from Biblioteca Civica Angelo Mai, Bergamo. Archivio storico fondo '900, available on Archivio ARUP – www.arup.it).

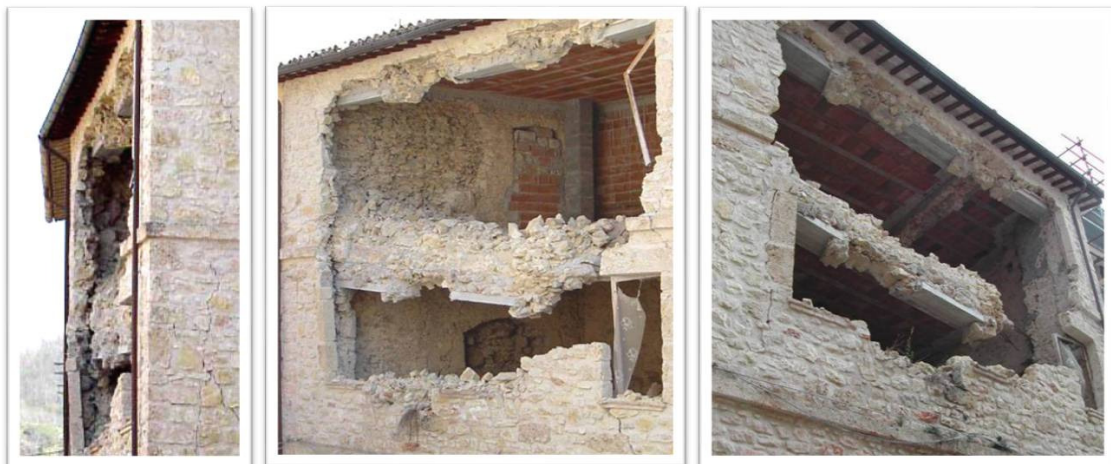
Figure 1.23: Three views of a building stroke by the 1998 Umbria earthquake. The overturning of the façade is connected to the presence of stiff floors made by hollow bricks and reinforced concrete (courtesy of Arch. Antonella Saisi).

In Italy, the worst effects, were observed after the seismic events. The mechanical response between mixed structures, containing more deformable elements (like brick-works or stone-works and timber structures) and stiff elements, was often the cause of the collapse of the building (see Figure 1.23).

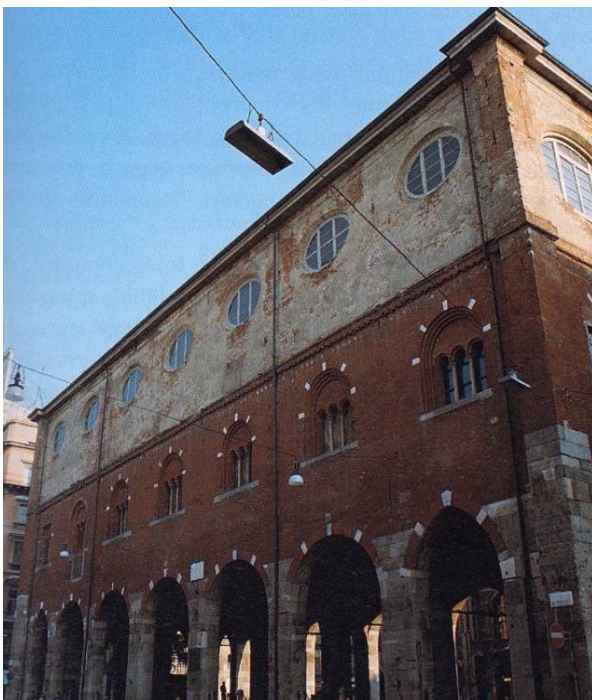
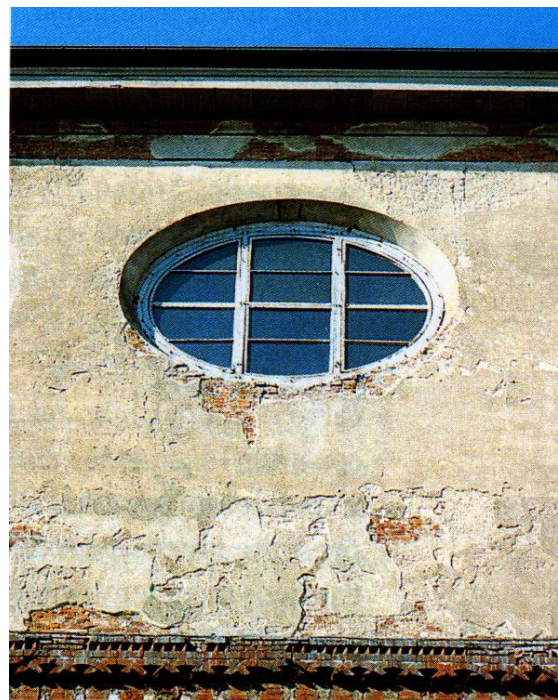
Figure 2.1: Milan, Palazzo della Ragione: a) facade on via Dante and b) detail of the preserved overlap of the surface of the facade (pictures from G. Carbonara, "Trattato di restauro architettonico", p. 609).

this reason the conservation techniques are not integrally applied to the so-called diffused historical patrimony. For instance, the conservation design adopted for the preservation of the stratigraphic overlap of the plasters in the *Palazzo della Ragione* of Milan (Figure 2.1) is the result of the procedures described in paragraph 1.3.2. This peculiar attention to the consistency of the material data and of the signs left by the time on the surfaces of the facades is not present for the typical renewal of an old building without monumental characteristics. In this cases the signs of the time on the external surfaces are totally erased and so the historical aspect of these buildings is substituted by the standardization of the surfaces (Figure 2.2). The same approach is adopted for the hidden building structures, which are more respected in the monumental buildings than in the diffused one.

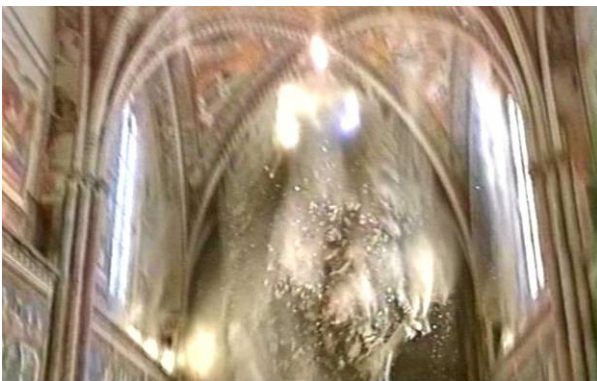
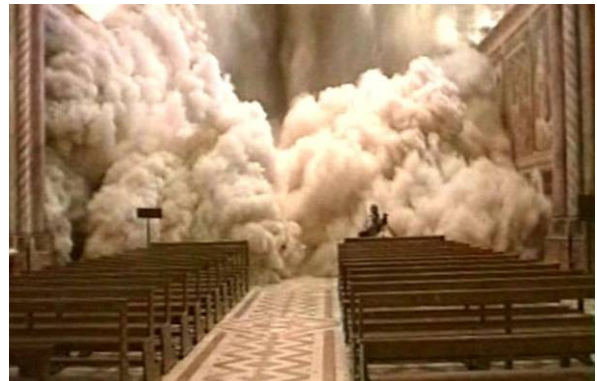
Figure 2.4: Two frames of the video recorded in the superior Basilica of Assisi during the collapse of the vaults of the first two spans of the nave (pictures available in the web at the following link:)

The main damages reported in recent seismic events take origin from an incomplete comprehension of the mechanical behaviour of ancient masonry and timber structures. Monumental buildings present complex spatial structures, such as domes and vaults, and the interaction between them and two-dimensional elements (like walls or floors) is not easy to interpret. Usually these kind of structures were realized following very high standards of efficiency, but their response under the effects of an earthquake can have unexpected results. This is the case of the collapse of the vaults of the first two spans in Assisi Cathedral (Figure 2.4).

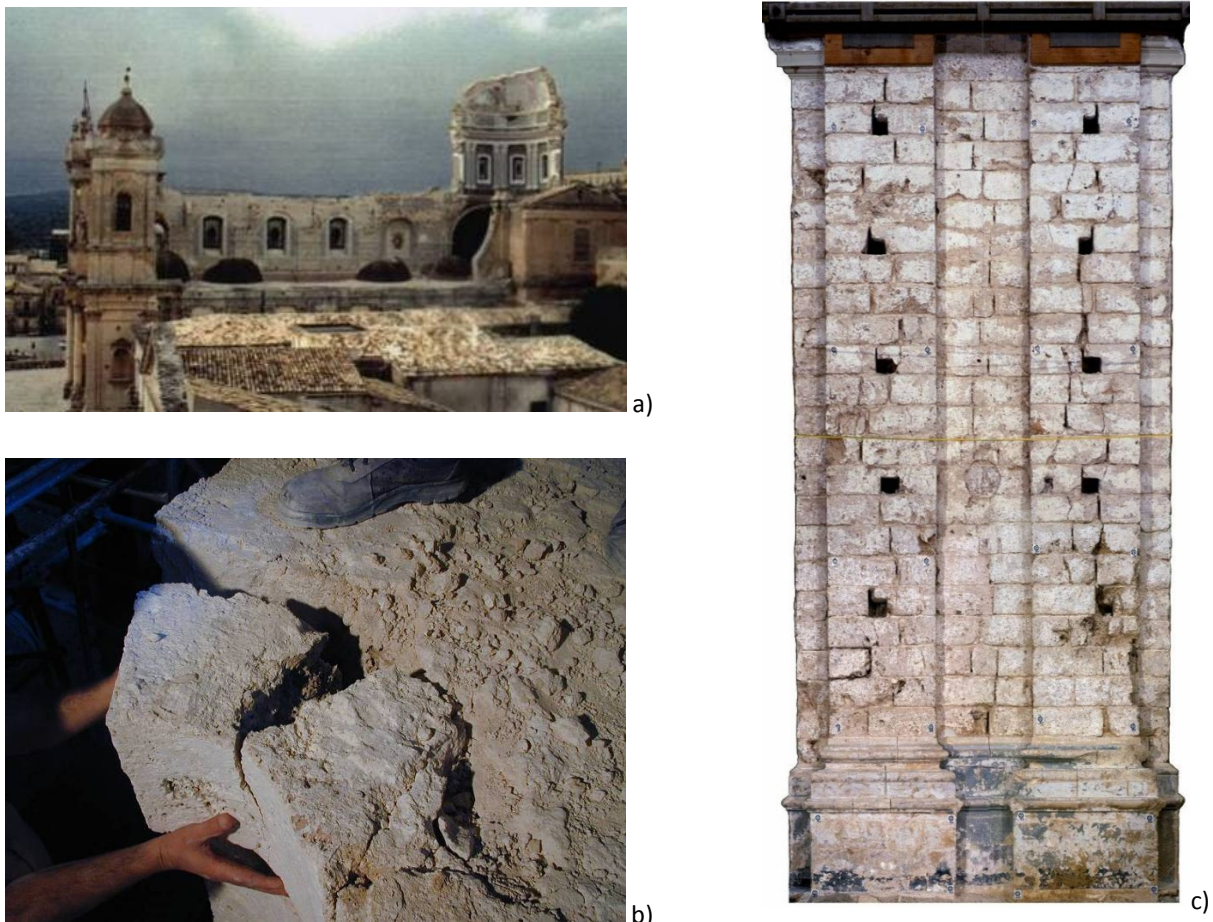
Figure 2.5: Pictures from the collapsed Noto Cathedral: a) view of the interior of the cathedral after the collapse (picture taken from R. De Benedictis e S. Tringali "La ricostruzione della Cattedrale di Noto", LCT Edizioni, 2000, p. 20 (De Benedictis, 2000)) ; b) view of a stone during the dismantling of a pilaster (courtesy of prof. L. Binda); c) digital photo-straightening of one side of a pillar of the nave after the removal of the plaster (courtesy of A. Saisi).

In other cases the buildings techniques used for large structures were not correctly designed or not properly realized, as the collapse of the Cathedral of Noto demonstrated (Figure 2.5a). Here the pilasters of the nave presented a diffused crack pattern along vertical paths, index of a progressively loss of effectiveness of the masonry structures under the compressive stresses, but this clear indication was unfortunately ignored. The missed recognition of a dangerous state of conservation of the structures drove to the failure of the pillars of the south side of the nave,

which produced the collapse of the roof of the main nave, the south aisle and the dome⁶². During the reconstruction works the survived pillars were investigated in depth: the dismantling of these pilasters could be performed (during the investigation phase) by hands, due to the bad conditions of the stones (Figure 2.5b). Moreover, after the removal of the plaster, several cracks were observed on the masonry structure (Figure 2.5c).

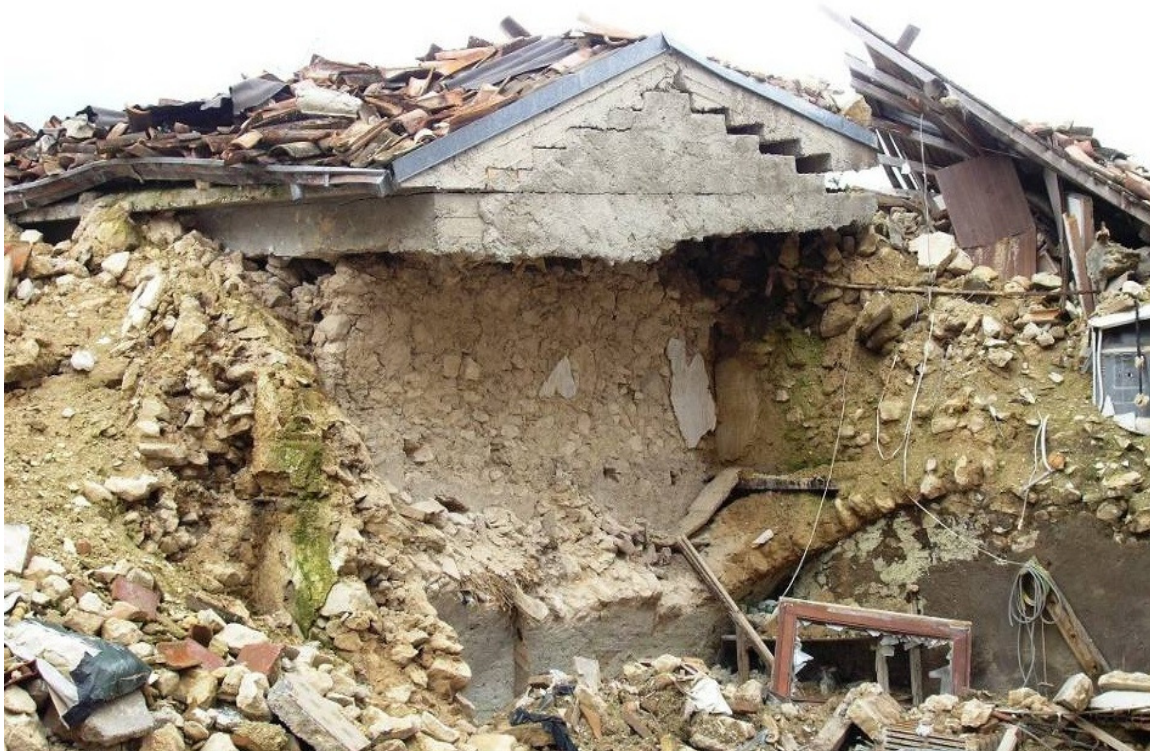
Figure 2.6: Onna (L'Aquila). View of a collapsed building, damaged by the wrong design of the new adapted r.c. roofing system, placed on the existing masonry structures (author's picture).

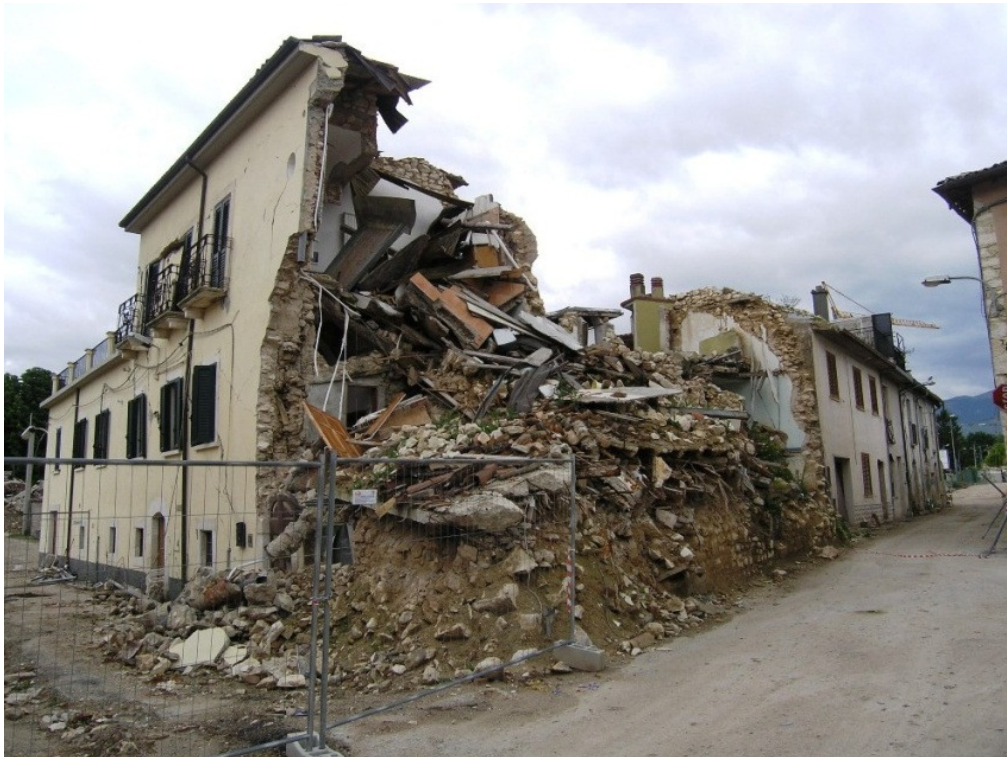
Figure 2.7: Onna (L'Aquila). View of the devastation of an urban quarter in the centre of the village. (author's picture)

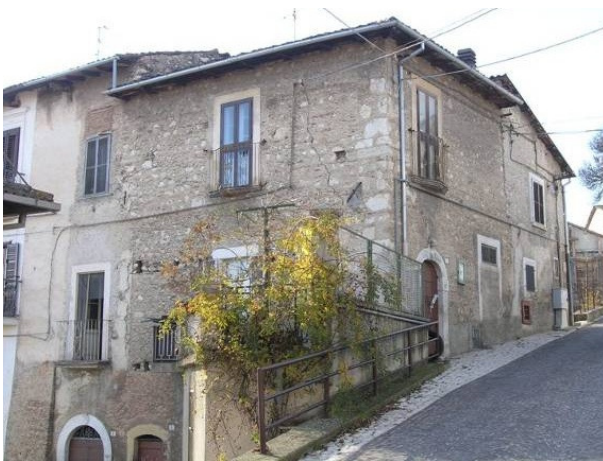
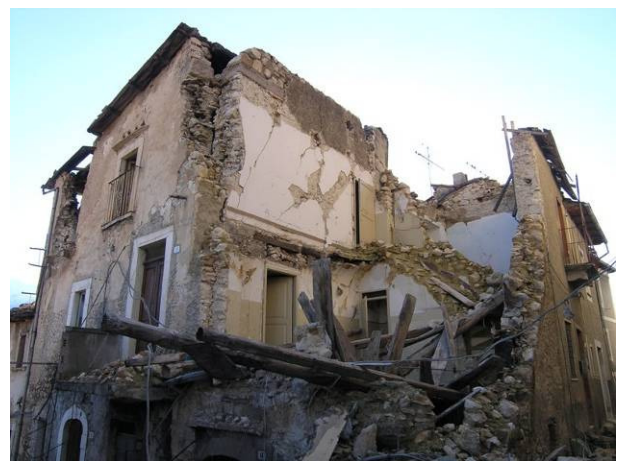
Figure 2.8: Bazzano (L'Aquila). Comparison between two historical buildings stroke by the 2009 earthquake: a) view of an existing building (an aggregate) that was able to face properly to the earthquake; b) view of a collapsed existing building, placed in the nearest of the previous one, that was not able to contrast the seismic actions (author's pictures).

Figure 2.9: Bazzano (L'Aquila). Detailed views of the buildings presented in figure 2.8: a) the texture of the walls reveals an edge built with larger shaped well connected stones and the floors are even connected to the vertical masonry walls through tie rods as shown by the head of the rod visible on the façade; b) the collapse of the building is due to an insufficient connection between the components of the building (author's pictures).

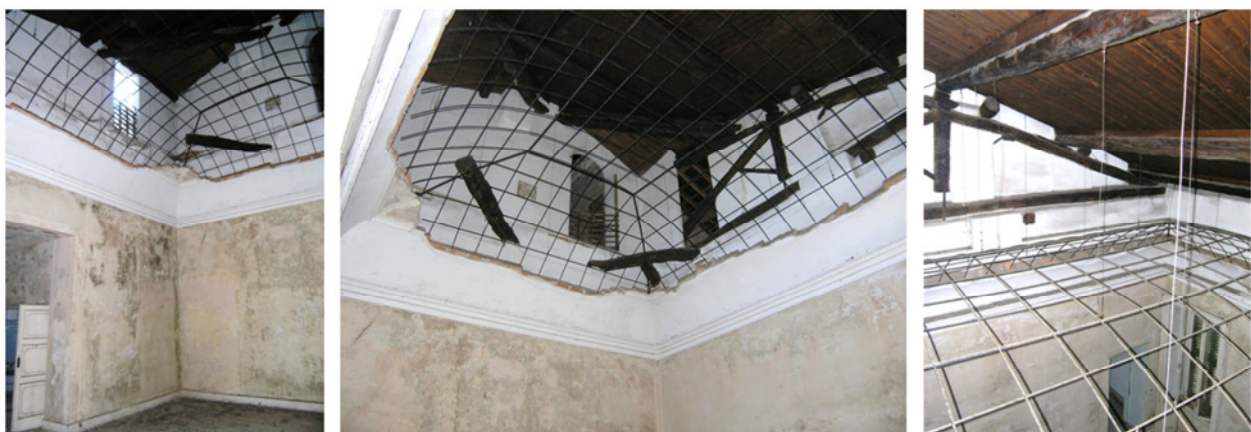
Figure 2.20: Reproduction of a collapsed vault in a room of Villa Borromeo-D'Adda in Arcore (Milan), a misused building under the protection of the FAI - Italian Fund for the Environment (pictures by the author).

instance. The intervention could consist in an integration of the image of the lost structures, by using new materials in different ways. The shape of a vault can be reproduced by a light wire-framed grid (Figure 2.20). In the same way the idea of the collapse mechanism of a timber can be represented by hanging the original damaged element to a steel beam (Figure 2.21).

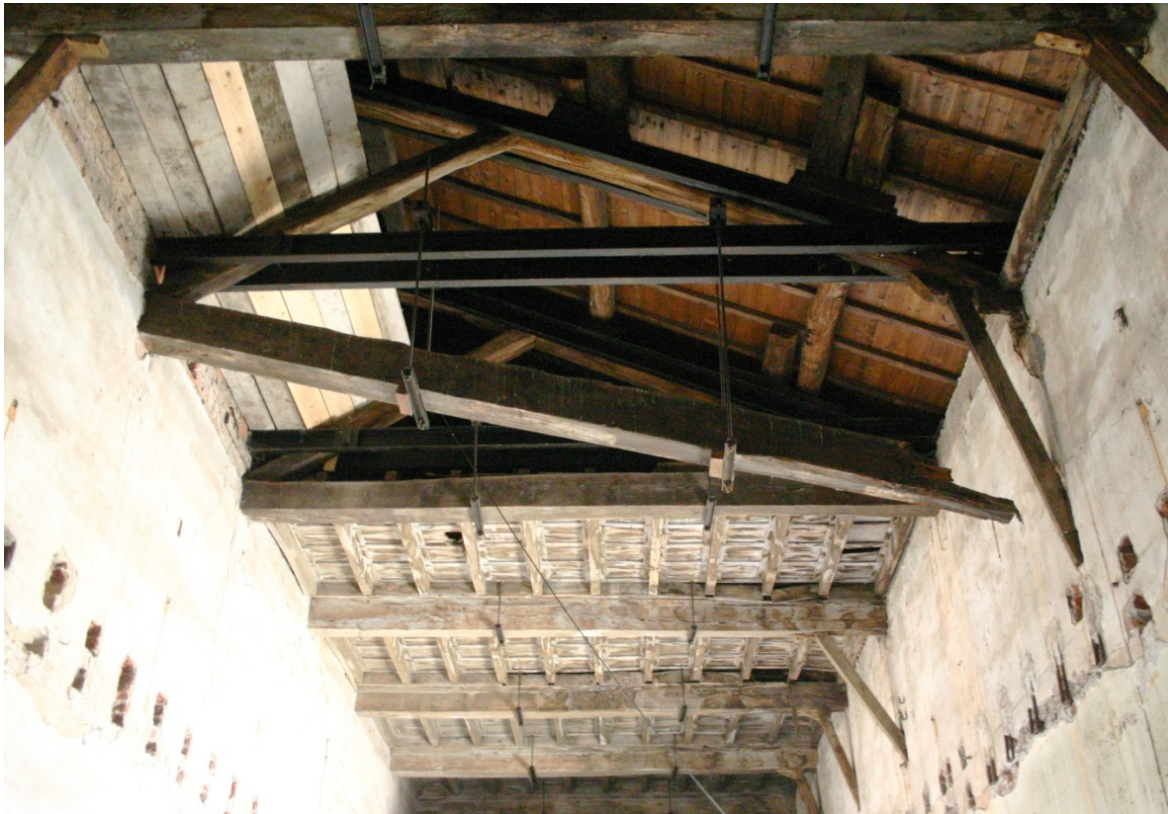
Figure 2.21: Example of a didactical arrangement of a collapsed truss in a room of the Melegnano Castle (Milan), substituted by a steel beam (picture by the author).

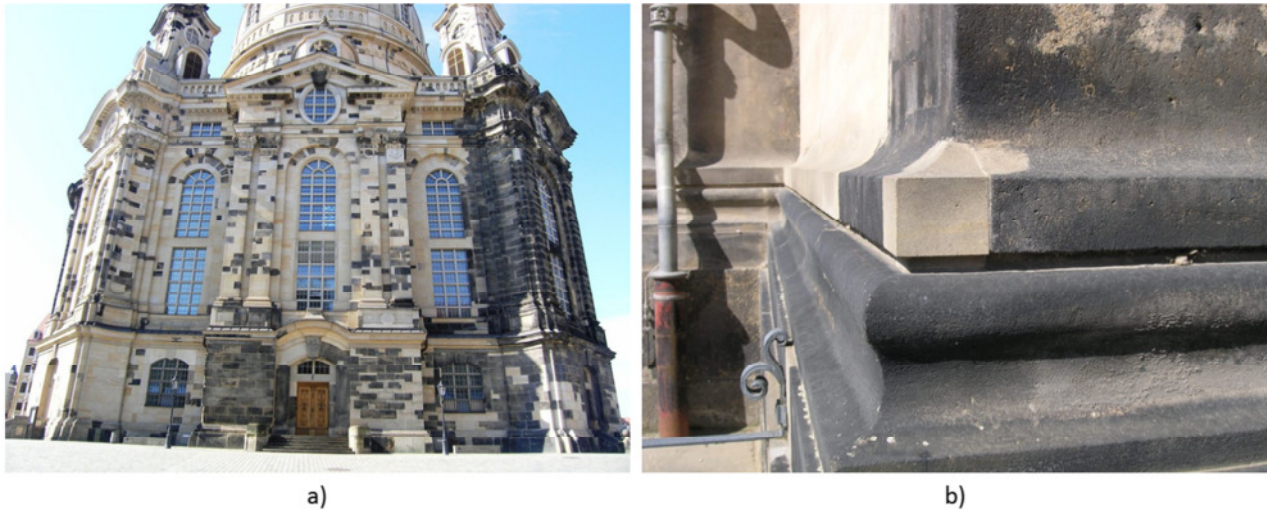
Figure 2.23: a) South front of the Fraenkirche in Dresden; b) detail of the integration of a moulding, maintaining the original material (pictures by the author).

The requirements of *compatibility* and *non-obtrusiveness* (including replacements of materials and distinguishing from the original one) seem to support the design for the reconstruction of the Frauenkirche in Dresden. Although the building was entirely destroyed by fire bombs in 1945, the new design was developed with the aim of preserving the unique apse that survived to the collapse of the dome. In addition the available original stone blocks conserving good mechanical properties were used for the new masonry structures. They maintain their typical dark colour (due to the fire) and are distinguishable from the new light stone blocks used for the reconstruction (Figure 2.23).

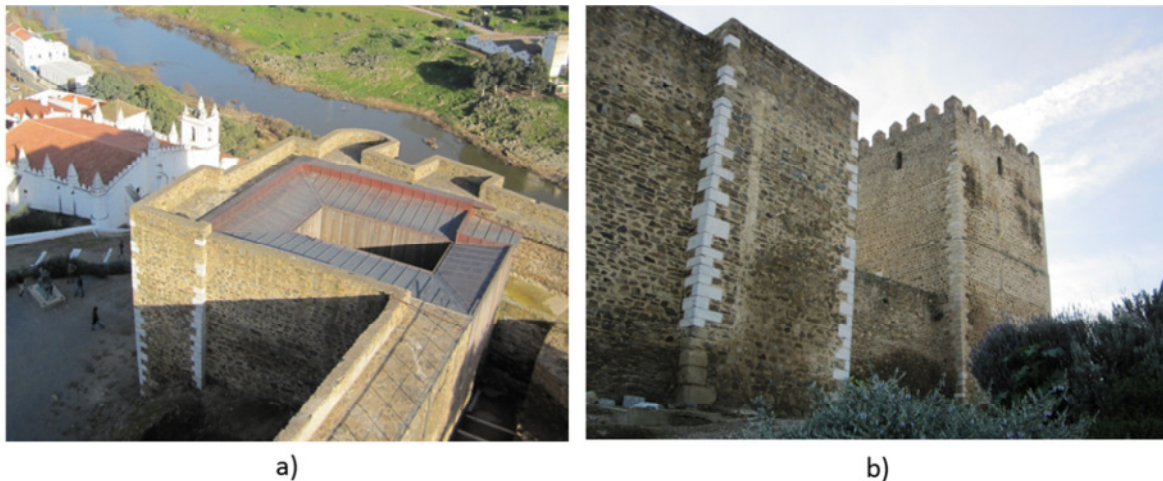
Figure 2.25: Mertula Caslte: the new volume hosting the museum was realized by wooden walls and covered with PVC panels, maintaining it under the skyline of the existing towers (pictures by the author).

These structures are the result of the technical innovations in building field. Their diffusion is strictly connected to their compatibility with the existing walls. In other cases, instead a clear exhibition of the new elements, modern structures composed by PVC or other plastic derivatives were hidden behind existing massive walls, in order to create the spaces requested by the project, avoiding any contraposition between new and old elements (Figure 2.25).

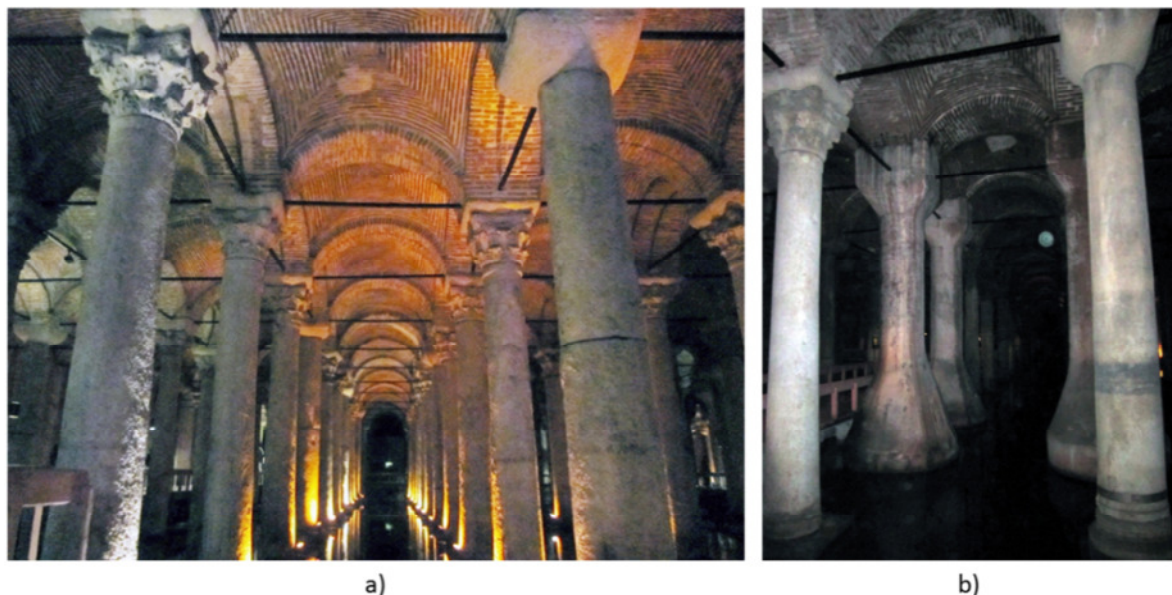
Figure 2.26: a) view of the Roman cistern in Istanbul; b) view of some rebuilt columns and pulvino realized by reinforced concrete (pictures of the author).

The use of different materials is one of the most effective methods for distinguishing the original remains from new additions. In this way, the use of an adaptable product like cement or the strengthening provided by reinforced concrete structures appeared as a strategic solution to repair ancient buildings, in order to respect the *structural reliability* and *non-obtrusiveness* requirements (Figure 2.26).

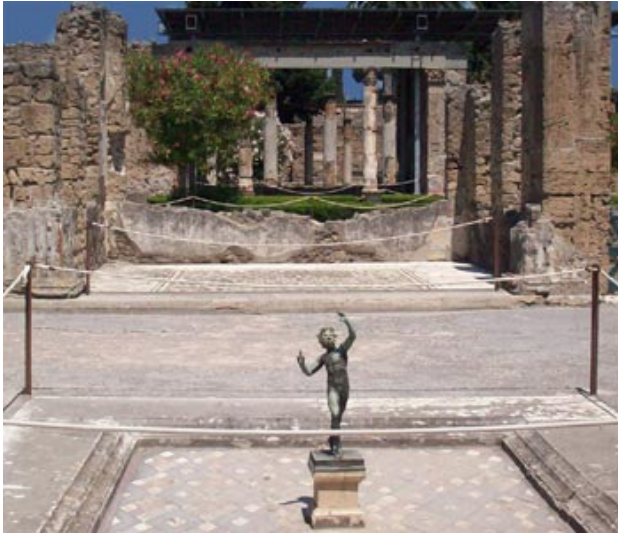
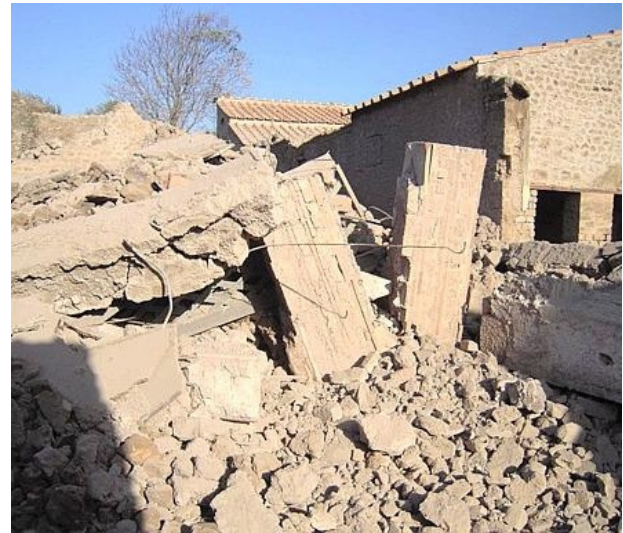
Figure 2.28: Fauno House in Pompeii: a) before the collapse; b) after November the 6th 2010 collapse (pictures from the “Sole 24 ore” website, at the following link: <http://www.ilsole24ore.com/art/cultura/2010-11-06/scavi-pompei-crolla-domus-135046.shtml>).

Moreover, the combination or conjunction of structures made with different constructive techniques such as masonry walls and modern reinforced concrete floors can be totally unsuccessful. In this sense recent episodes showed that the compatibility between massive multiple leaves masonry walls and reinforced concrete floors/coverings: this is the case of the Fauno House in Pompei (Figure 2.28), collapsed at November the 6th 2010.

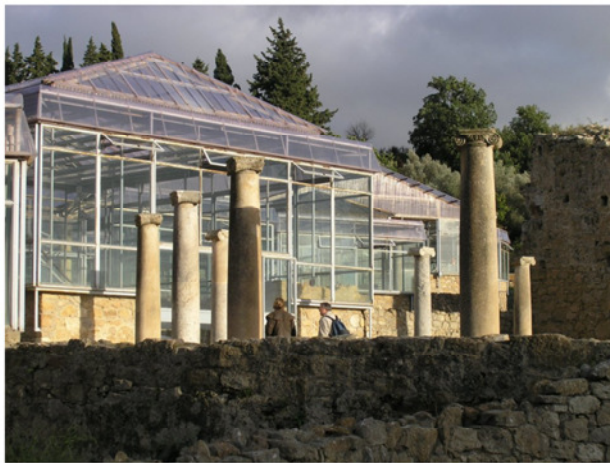
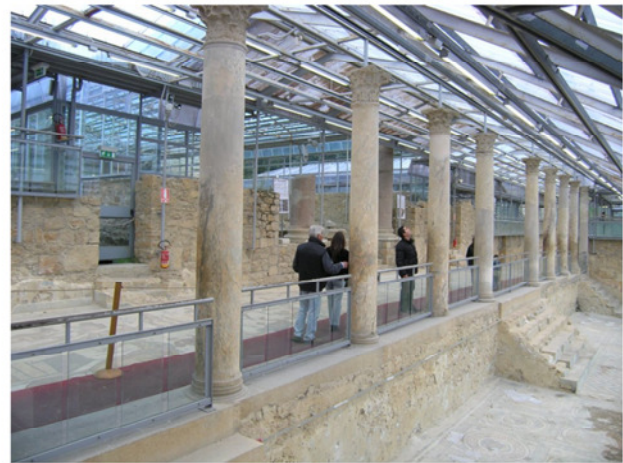
Figure 2.29: Villa del Casale in Paizza Armeria (Sicily): a) external view of the volumes of the villa reconstituted by metallic frames and plexiglass panels; b) internal view of a visitors path (pictures by the author).

Reinforced concrete is not the unique building technology presenting incompatibility for its application: negative long term effects can appear also using modern volumes made by synthetic materials, with the aim of covering and preserving archaeological ruins. The realization of the visiting paths for the Roman Villa del Casale in Piazza Armerina (Sicily) is an example of modern techniques (modern for the 70s of the last century) applied to existing remains. F. Menissi designed a re-composition of the image of the lost bodies of the villa (Figure 2.29). Through the use of scaffolding pipes and Plexiglas, he wanted to recall the monumental spatiality of the villa. This design represents the culture of that time, looking for a compromise between minimalism, new poor materials experimentation, compatibility and functionalism. Menissi's work became soon a masterpiece in architecture: his low cost solution guarantees still nowadays pedestrian paths for visitors, who can look to the roman mosaic works from an appropriate distance, and a

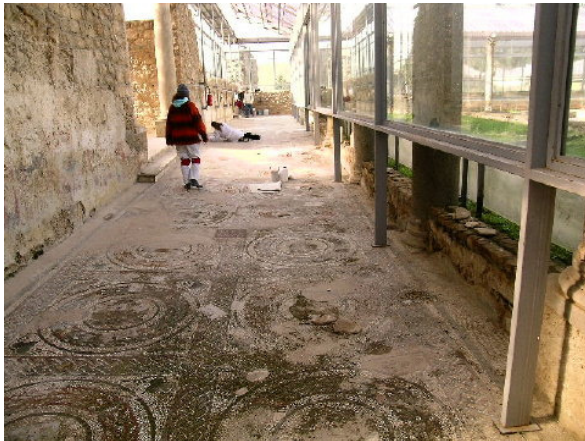
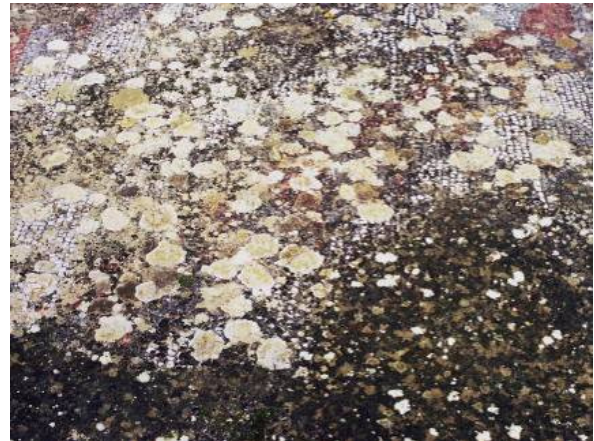
Figure 2.30: Views of the current state of conservation of the mosaics in Villa del Casale: a) general view of a corridor presenting biological growth; b) detailed view of the incrustations grew over the mosaics formed by lichens and algae (pictures downloaded from the official website of the Italian Ministry for Cultural Activities).

During the first decade of the new century, the debate around Menissi’s integrations became a current topic: the effects of the translucent bodies forming the geometry of the various parts of the villa gave rise to deep changings in the internal climate conditions and the conservation of the mosaics was compromised (Figure 2.30). Also in this case the lack of knowledge about long term

effects of a sort of “glasshouse” placed on a pre-existing structure was the basilar cause of the failure of the design strategy. The decay of the “glasshouse” itself has nowadays become a problem: oxidation of the metallic frames and deformations of the Plexiglas elements are compromising the safety of the whole complex.

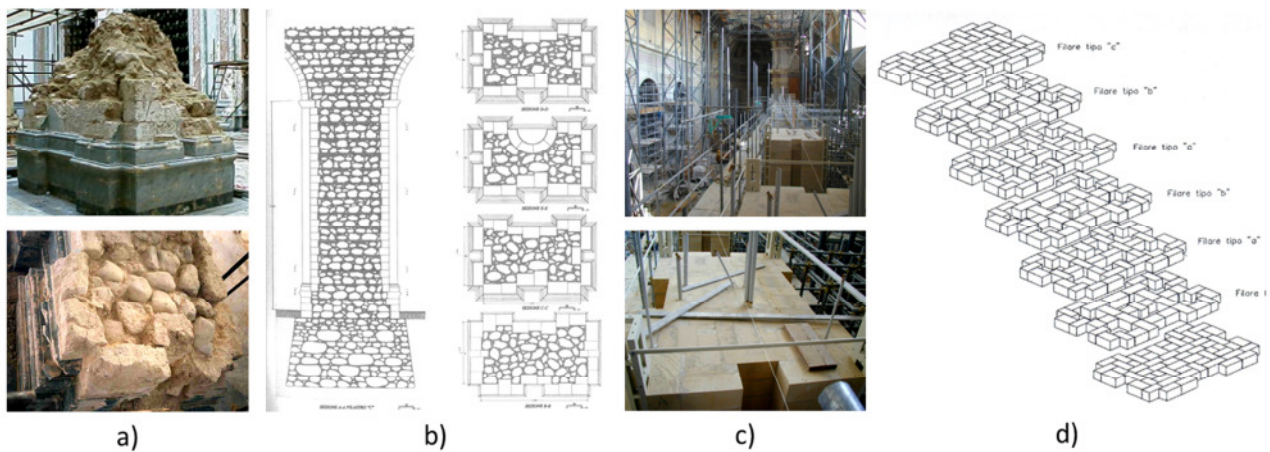
Figure 2.33: a) visual inspection of the remains of a collapsed pillar of the nave (courtesy of L. Binda); b) hypothetical reconstruction of the building technology of the pillars of the nave (from R. De Benedictis, S. Tringali, cit., 2000, p. 27); c) view of the pillars during their reconstruction (pictures by the author); d) 3D layout of the new texture used for the pillars (from R. De Benedictis, S. Tringali, cit., 2000, p. 63).

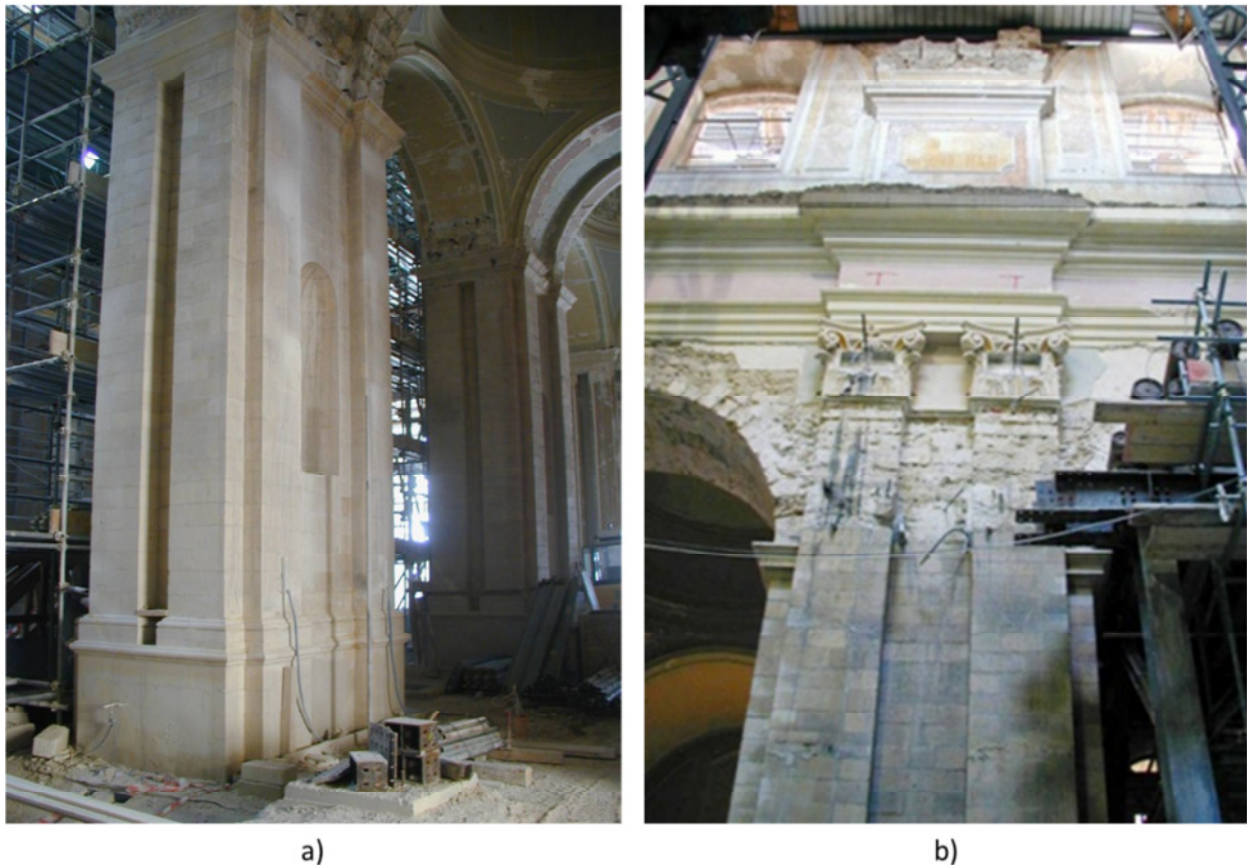
Figure 2.34: a) view of two pillars rebuilt from the basement to the springer; b) view of the connection between a rebuilt pillar and the overhanging original wall of the central nave of the cathedral (pictures by the author).

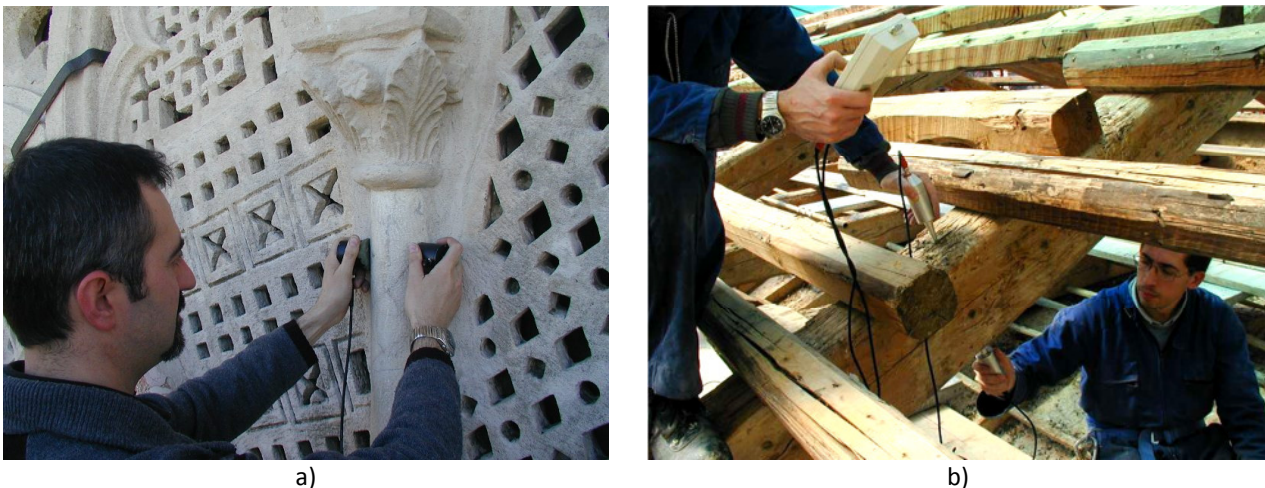
Figure 3.12: Two different transducers and receivers used for direct ultrasonic tests: a) flat devices and b) devices with wedges (pictures by the author).

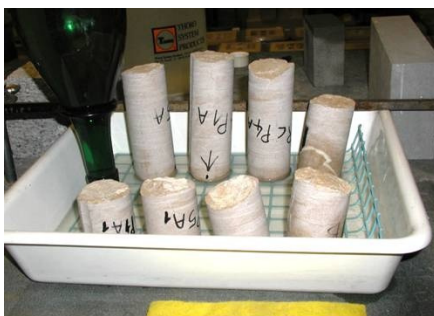
Figure 3.35: Determination of the water absorption by capillarity rise. Samples in the water and example of diagram showing the average coefficient of suction (courtesy of Arch. C. Tedeschi).

The volumetric mass¹³⁶, the water absorption by total immersion, the water absorption by capillary rise¹³⁷ (Figure 3.35) are important characteristics needed to determine the durability of the materials and the effects of surface treatments. The initial rate of suction of bricks and stones and the water retentivity of mortars can be useful when choosing mortars and grouts for repairs.

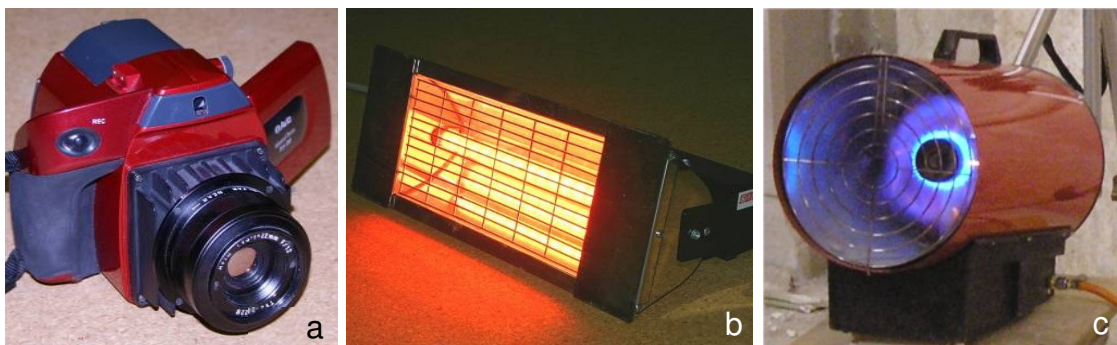
Figure 4.1: Devices used for the thermographic test: a) IR camera; b) IR lamp; c) warm air generator

In order to ensure the correct heating of the surfaces, the acquisition performed by an infrared thermo-camera should be supported by additional devices like warm air generator or infrared lamps (Figure 4.1), required in the interiors of the buildings.

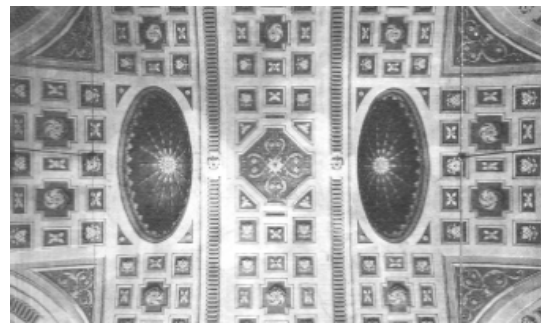
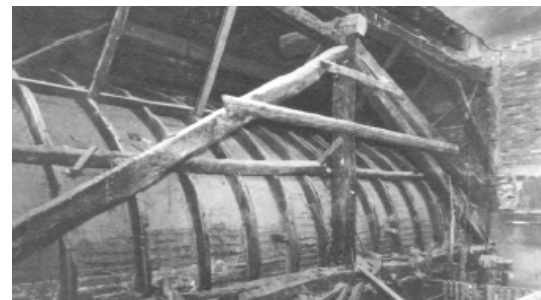
Figure 4.23: View of the Assembly Room (a); digital straightening image of the intrados of the vault (b) (courtesy of professor M. Chiorino from Politecnico di Torino); view of the extrados of the vault (c).

Carrying out thermographic tests from the intrados of the vault of the Academy of Science of Turin, the wooden frame of the structure was detected (Figure 4.23). This kind of vaults are not very well known, due to the difficulties connected with access to the extrados and the presence of decorations covering the surface of the intrados. Manuals of the traditional techniques suggest an interpretation of the most common timber vaults diffused in Italy, but each single case, studied in depth, presents own peculiarities¹⁵⁶.

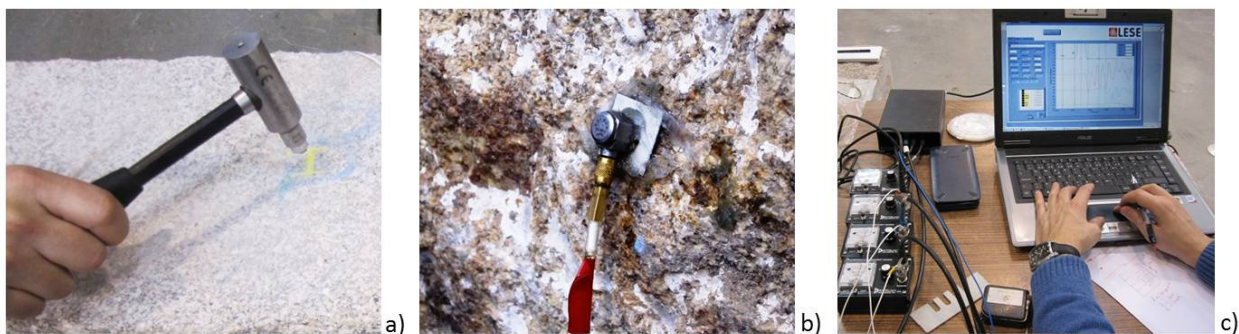
Figure 4.30: Devices used for sonic tests: a) instrumented hammer; b) accelerometer; c) computer (author's pictures).

As already mention in chapter no. 3 of the thesis, a signal is generated by percussion with an instrumented hammer or by an electrodynamics or pneumatic device (transmitter) and is received by means of an accelerometer (receiver), which can be placed in various positions. The resulting signals can be stored by a waveform analyser coupled with a computer or, thanks to the new virtual machines, stored into a personal computer connected with a digital acquisition module (Figure 4.30).

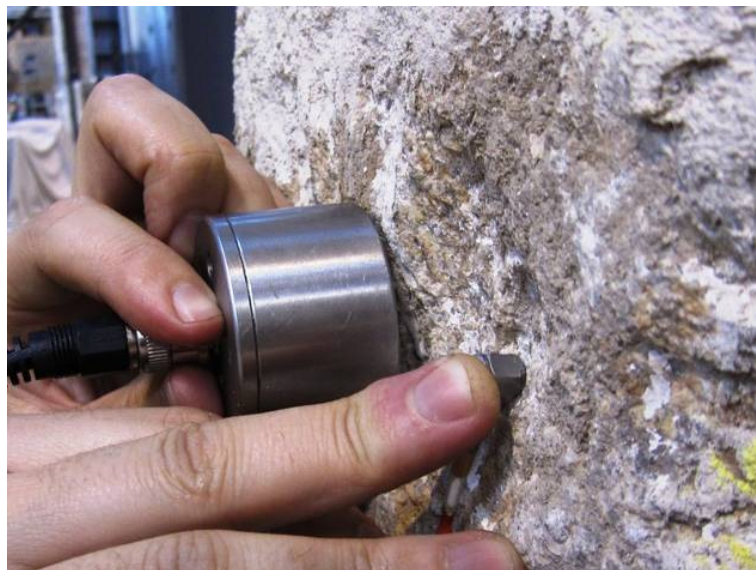
Figure 4.34: Example of bad contact between the receivers and the rough surface of a stone

- noise from partially damaged connections of cables;
- lack of adhesion between plaster (if present) and masonry;
- correct displacement of the accelerometer on rough surfaces: voids between the receiver and the external surface can contrast the correct acquisition of the waves arrival (*Figure 4.34*);
- scattering of the results (repeating the test for several times in the same position, it does not permit to obtain the same value for the sonic velocity).

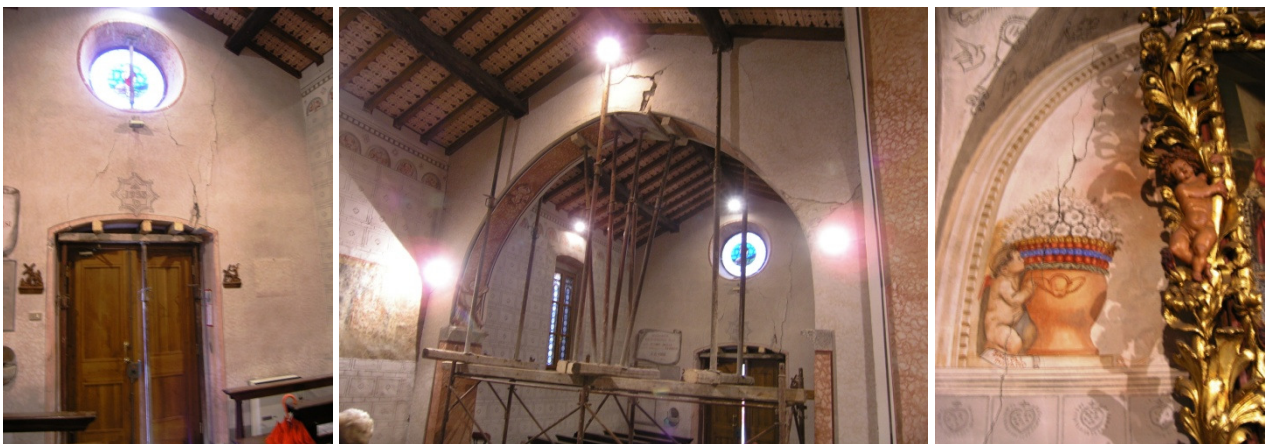
Figure 4.43: Views of the main cracks in a church damaged by the earthquake in the Garda Lake area (pictures by the author)

Irregularities of lower dimension can be recognised by the same configuration of the test presented above, as shown in Figure 4.39. That case refers to the control of the connections of the walls of an apse in a church stroke by a seismic event near Garda lake (north Italy), in 2005. The church was characterized by several cracks on the vertical walls (Figure 4.43) and different direct sonic tests were carried out in order to evaluate the masonry morphology and the extension of the damage.
