Politecnico di Milano

Department of Architectural Projects and Department of Structural Engineering

**ASSESSMENT OF HISTORICAL MASONRY BUILDINGS: RESEARCH ON
APPROPRIATE NON-DESTRUCTIVE DIAGNOSTIC TECHNIQUES**

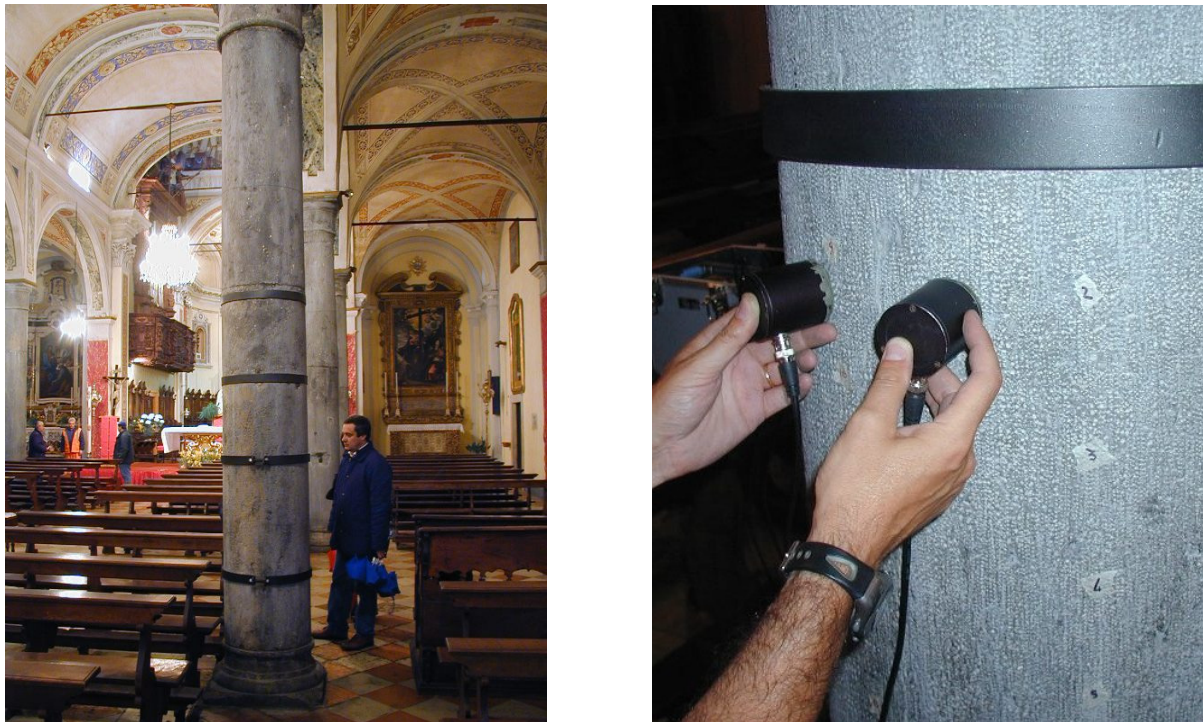
Figure 4.47: View of the damaged column, presenting a diffused crack pattern and application of the transducers for the ultrasonic test (author's pictures).

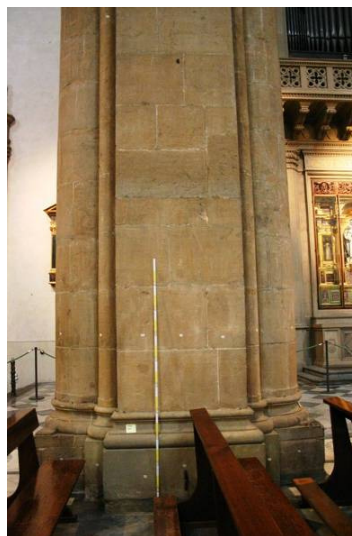
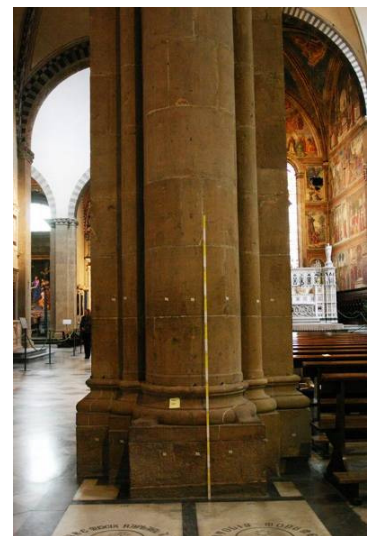
Figure 4.49: Partial views of 3 sides of the pilaster in Santa Maria Novella characterised by direct sonic tests on the basement and on the shaft (author's pictures).

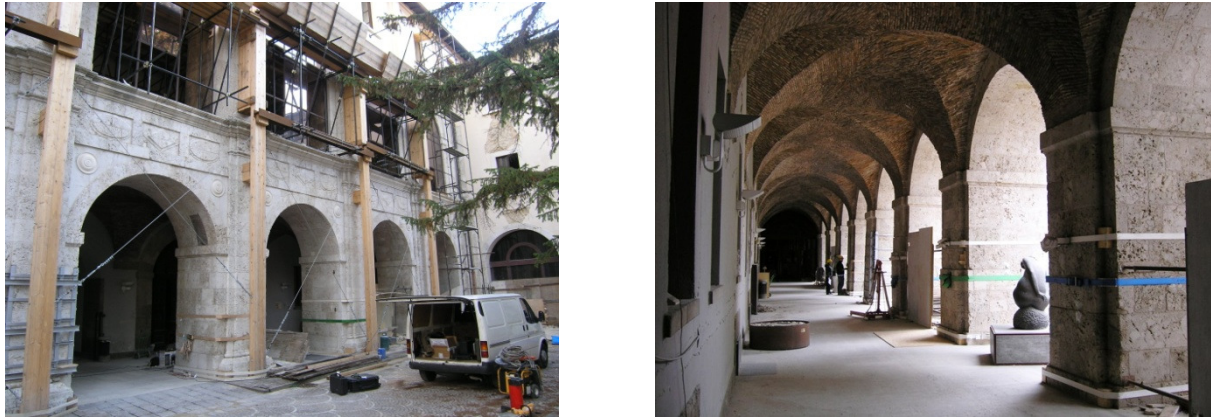
Figure 4.52: Views of the pilasters of the courtyard of the Spanish Fortress in L'Aquila (author's pictures).

In the next case, a similar configuration of the test was used on two different pillars of the courtyard of the Spanish Fortress in L'Aquila (Figure 4.52). The Building was struck by the 2009 6th April earthquake. Diagonal cracks were visible on the pilasters and sonic tests had the aim to evaluate the extension of the damage in the internal part of the structure.

The two pillars taken into account had the same geometry but one (pillar no. 4) did not present any crack pattern, whilst the other one (pillar no. 6) had important diagonal cracks (Figure 4.53a and b). On pillars no. 4 and no. 6 direct sonic tests were performed reporting 28 points around the borders (Figure 4.53c) of the structure at a height of about 126 cm from the floor. After computing the average value obtained for each intersection between the main trajectories, a plan-map of the distribution of the velocity was created (Figure 4.54). Pillar no. 4 revealed an homogeneous

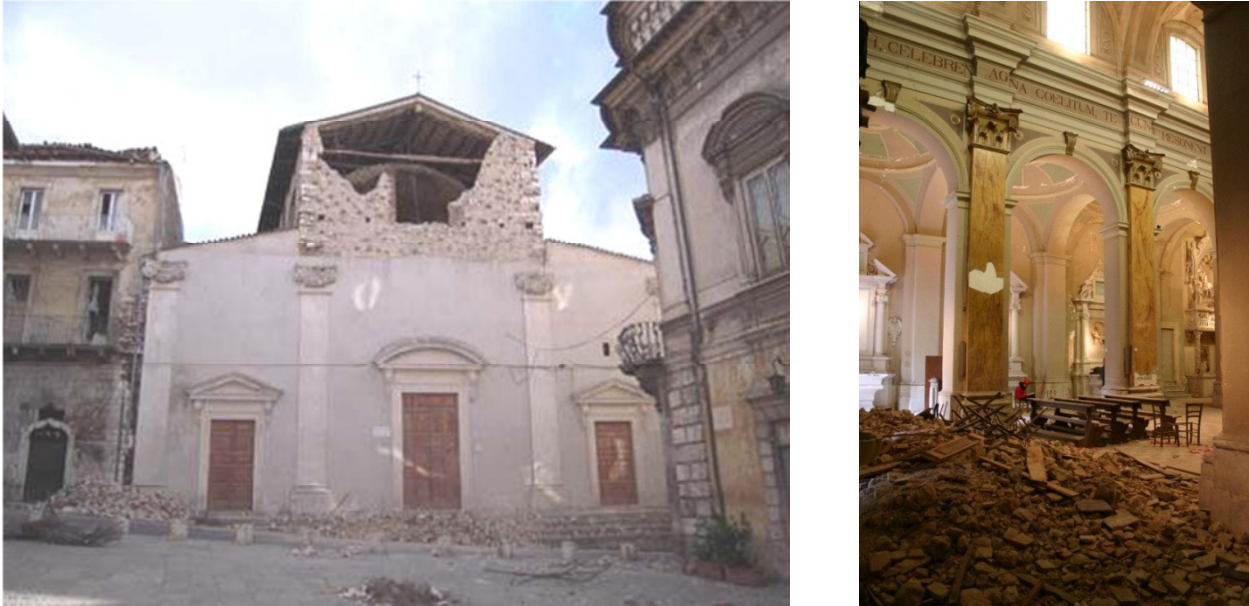
The well promising results obtained through the application of direct sonic tests along crossing trajectories was used to qualify the pillars of the St. Biagio Church in the historical centre of L'Aquila, seriously damaged during the 6th April earthquake in 2009. The church presented a diffused crack pattern and a partial collapse of the upper part of the façade (Figure 4.57). Nevertheless, the building faced the seismic event without reporting other collapses. The problem

Figure 4.57: External and internal view of the St. Biagio Church in L'Aquila

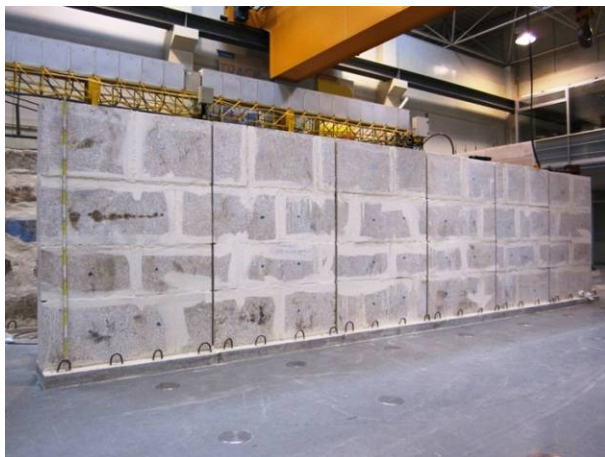
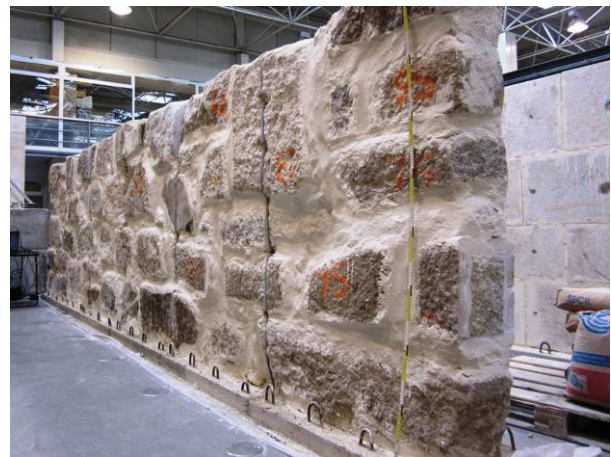
The specimens used in this study consisted in 12 one leaf stone masonry panels constructed at FEUP and presented in Figure 4.63, with a volume of $1.20 \times 1.79 \times 0.28 \text{m}^3$. The masonry panels present two different typologies:

- 6 perfectly regular wall panels, with regularly sawn stone blocks and joints made by a lime based mortar;
- 6 irregular wall panels, with irregular stone blocks and irregular joints made of small stones and lime based mortar.

Figure 4.63 – Tested walls: a) regular stones wall panels and b) irregular stones wall panels (pictures by the author).

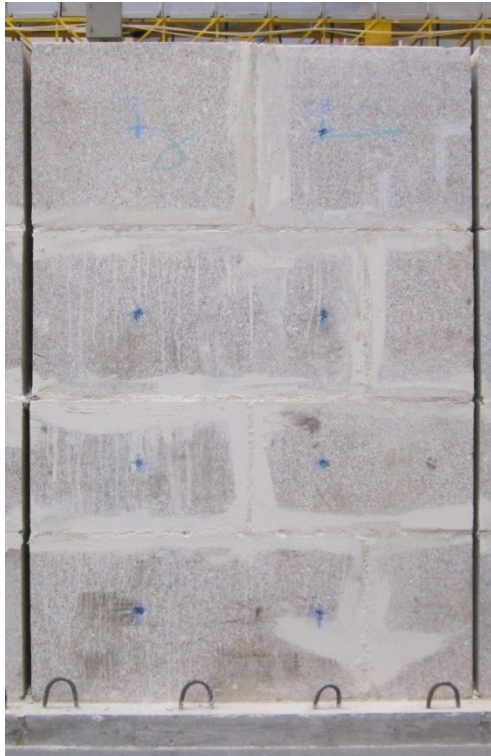
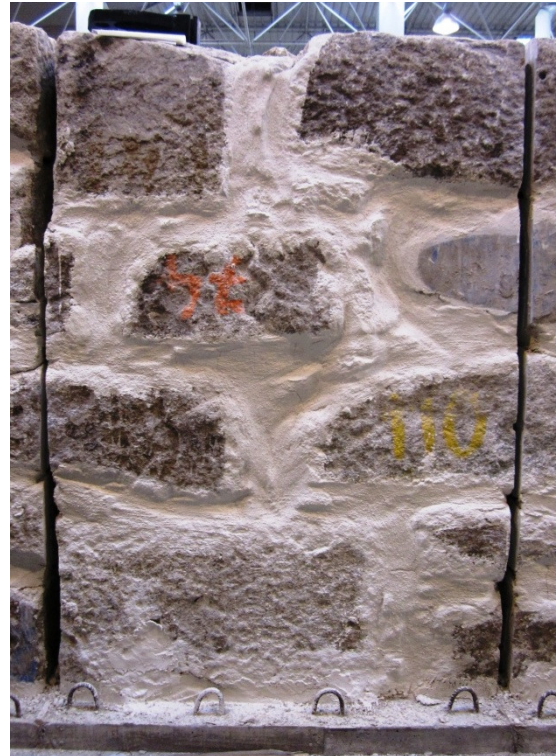
The P-wave velocity of the stones belonging to the two categories of tested wall panels was measured using a direct configuration. The following average values were obtained: 4200m/s and 3000m/s for the stones of the panels with regular and irregular texture, respectively, with correspondent standard deviations of 668m/s and 722m/s, using a total of 72 direct sonic tests per panel type. Thus the stones from the panels with irregular texture present an average propagation velocity that is 30% lower than that from the regular ones (Figure 4.69). This difference can be related to the provenience of the stones (they come from different sites): they represent two different classes or qualities.

Average sonic velocity obtained by P-waves:
4200 m/s

Average sonic velocity obtained by P-waves:
3000 m/s

Figure 4.69: Comparison between the results obtained by considering P-waves (pictures by the author).

Considering only the stones, it is interesting to notice that the velocity of P-waves on the stones of the regular wall panels was 30% higher (on average) than the velocity on the stones of the irregular panels. However, looking at the average values of the panels, the regular walls presented a P-wave velocity about 70% higher than that of the irregular walls. This means that other parameters beyond the stones quality influence the final results. The irregular shape of the stones and of the mortar joints should be among the most important causes for this reduction. The tendency revealed by these results are in agreement with Vasconcelos ones. Moreover, the results in Table 4.4 show that the final ratios between the average deformation moduli of the wall panels and the stones (E_w/E_s) are equal to those found by that author for the regular wall panels, i.e.

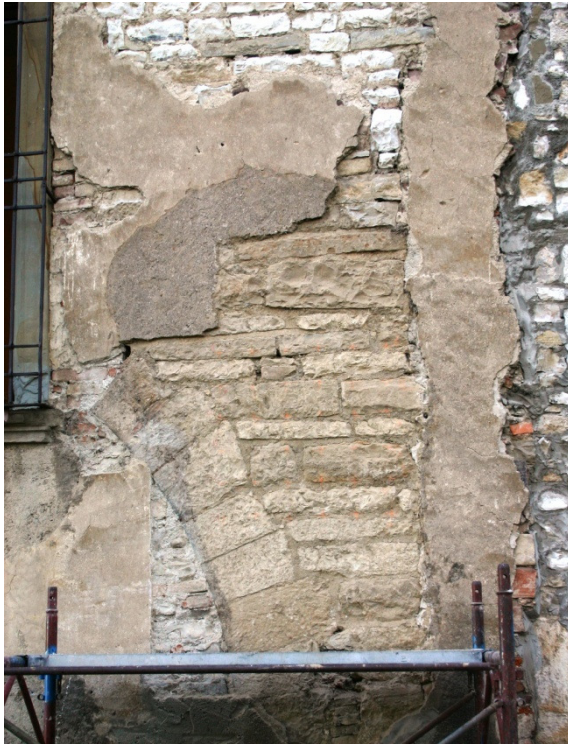
The development of the structures across different centuries is clearly recognisable observing some features of the building: stratification of layers coming from different ages are visible on the facades (Figure 5.10 and Figure 5.11), by different stylistic elements used for decorations and styles of the vaults inside the building (Figure 5.12 and Figure 5.13).

Figure 5.10: Different textures appearing from the decayed plasters on the east façade (author's picture)

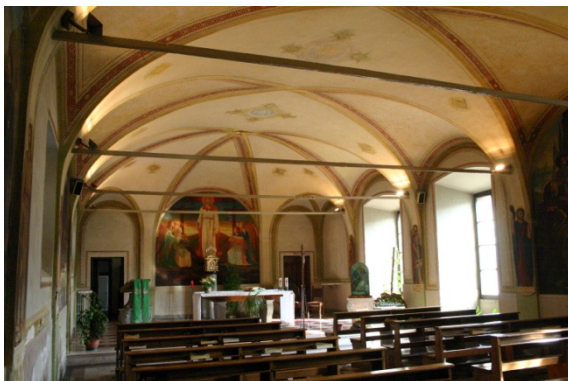
Figure 5.12: Chapel of the convent, covered by a vault built in a style diffused in XV century (author's picture).

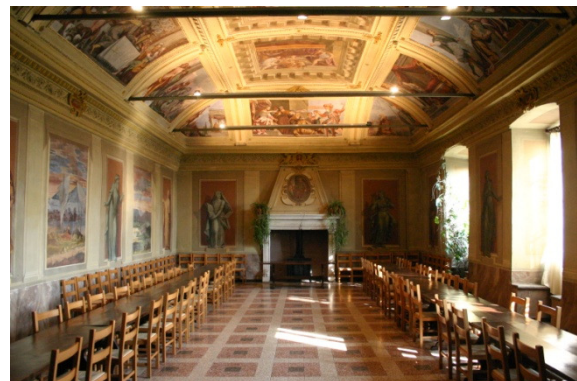
Figure 5.13: Refectory of the convent, covered by a vault built in a style diffused in XVI century (author's picture).

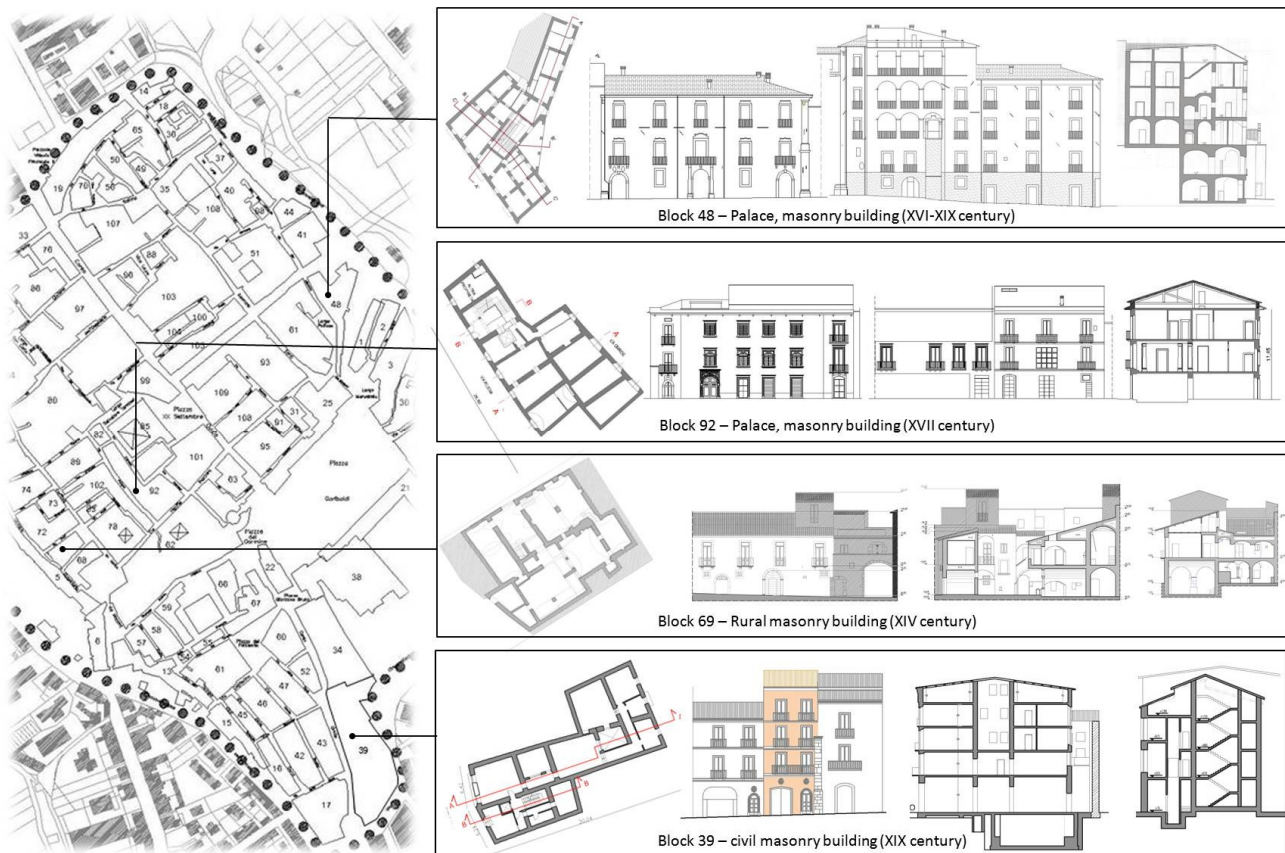
The S. U. belonging to the block no. 39 is a 3 storey house (Figure 5.33a) with a very articulated horizontal distribution in plan. According to historical sources, it was built during the expansion of the city occurred during XIX century. The S. U. belonging to the block no. 48 was the Palace of the Sardi family. It preserves a public façade towards a square (Figure 5.33b) and a very complex development on several levels following the steep descent of this part of the centre. Historical maps indicate that a part of the building was constructed on the pre-existing defensive walls of the town. The S. U.s forming the block no. 69 are located in an area along the ancient defensive walls. The building chosen for the research is a two storey house (Figure 5.33c), conserving a wine cellar and a courtyard. The S. U. used to represent the block no. 92 is a Palace organized on three levels. It was deeply changed during the time: in origin it was the palace of the Meliorati Family (Figure 5.33d) and actually is under renewal to host a bank. A comparison between the typologies of the investigated buildings is contained in Figure 5.34.

Figure 5.34: Comparison between the 4 investigated building typologies (layouts, rearranged by the author, are a courtesy of Professor A. Anzani and Arch. G. Cardani).

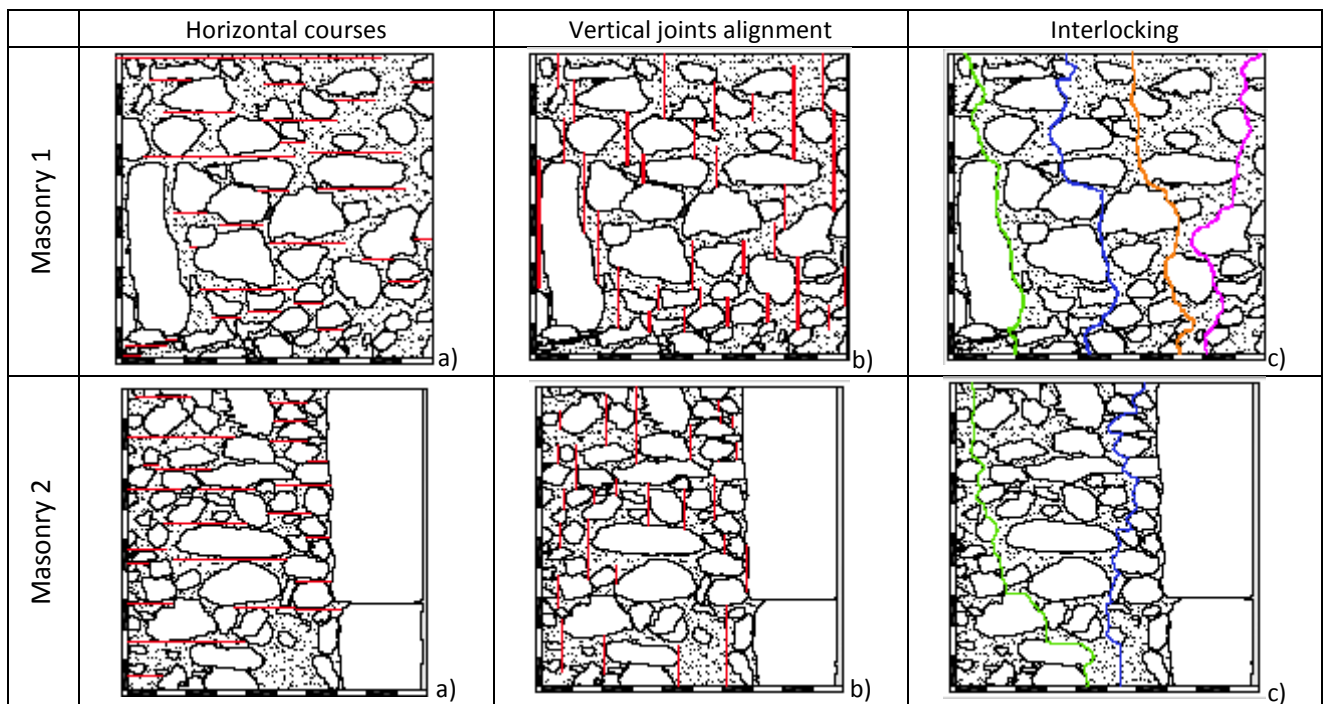
Figure 5.39: Analysis of the masonry texture for two walls belonging to the rural house in block 69. (courtesy of professor A. Anzani and Arch. G. Cardani).

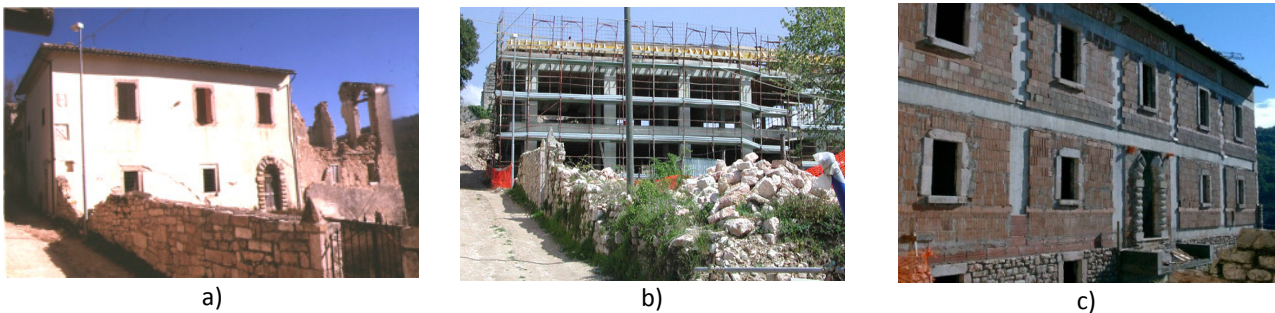
Among several documented interventions on existing buildings, organized in accordance with the present standardized constructive methodology, new attention for a more compatible design was developed in some cases. Since the appearing of the D.M.LL.PP. 16/1/1996, the idea of improving the existing structures (i. e. vertical masonry walls and traditional floors) was not adequately supported: the knowledge of the structural model of the existing building was not seen as the key point of the design process. A total renovation of these elements with the introduction of more familiar contemporary building systems was considered safer (Figure 5.56).

Figure 5.56: Sequence of the reconstruction of a palace stroke by the 1997 Umbria and Marche earthquake: a) 1998 picture showing the conditions of the palace after the earthquake; b) 2002 picture showing the building technology used for the reconstruction (courtesy of arch. A. Saisi); c) 2003 picture showing the modern hollow brick infill between the r.c. structure (picture by the author).

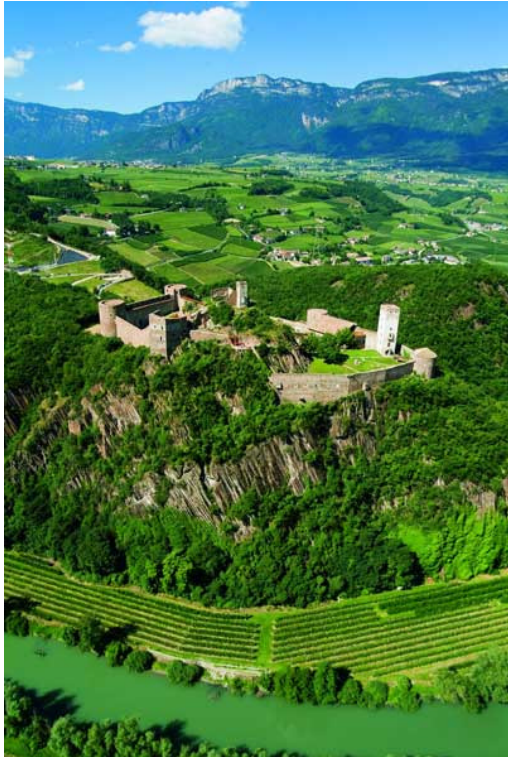
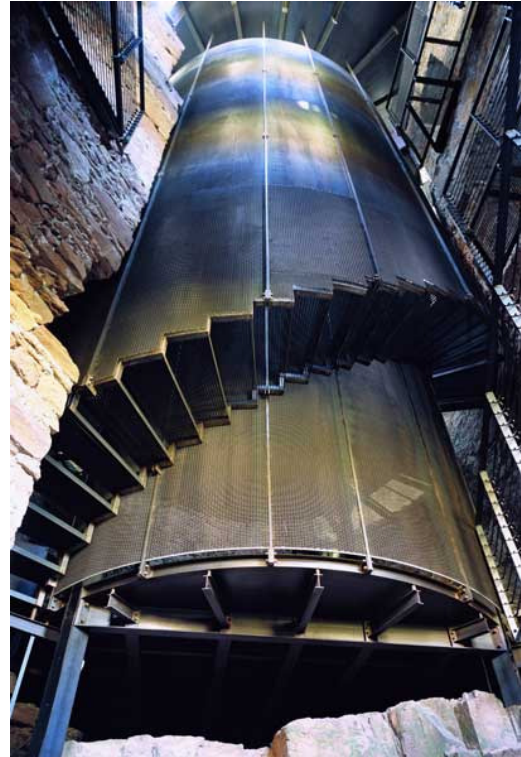
Figure 5.57: a) view of Firmiano Castle in Trentino; b) new stairs inserted in the south-east tower of the complex (pictures from W. Tscholl's official web-site: www.werner-tscholl.com).

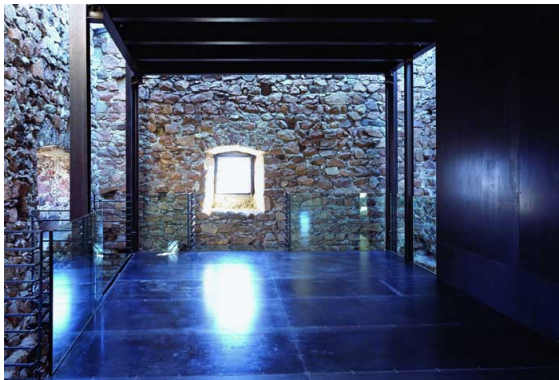
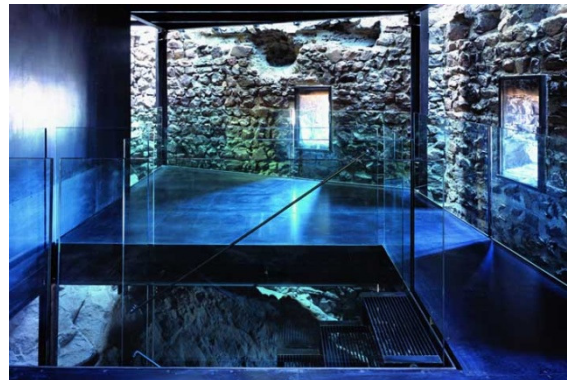
platforms in rough steel (not painted). These new structures are independent from the existing walls, in order to provide the necessary compatibility and reversibility (Figure 5.58).

Figure 5.58: Firmiano Castle: views of the new steel floors of the museum (pictures from W. Tscholl's official web-site: www.werner-tscholl.com/).

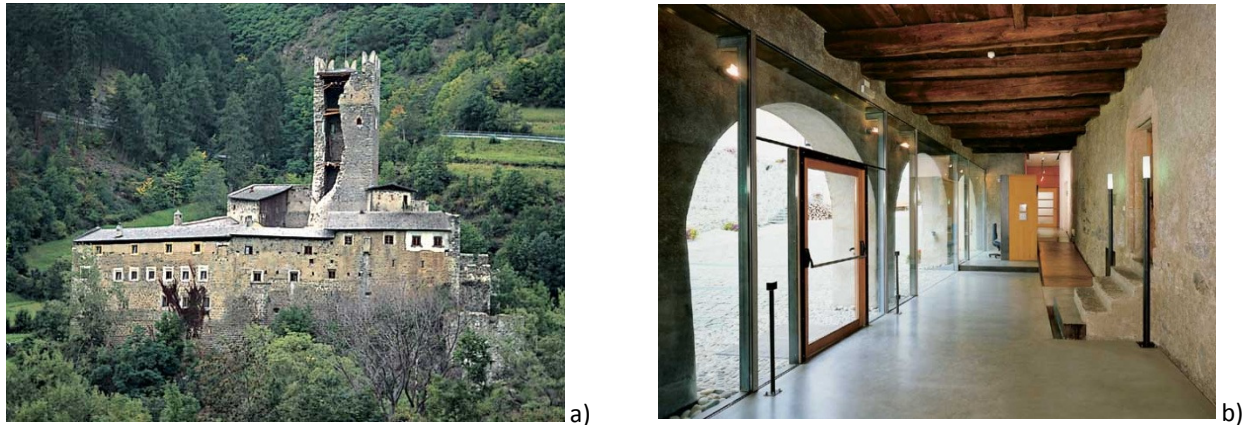
W. Tscholl faced the project of another existing building in Austria: his proposal for the restoration of the Furstenburg Castle recalls the philosophy used in Bolzano for the Firmiano Castle. In this second case, the main tower of the castle is characterized by the partial collapse of

one edge (Figure 5.59). The addition of new floors inside the tower becomes here also a strengthening design for the masonry walls of the partially collapsed tower.

Figure 5.59: Furstemburg Castle: a) view of the partially collapsed tower and b) view of a closed cloister (pictures from W. Tscholl's official web site: www.werner-tscholl.com).

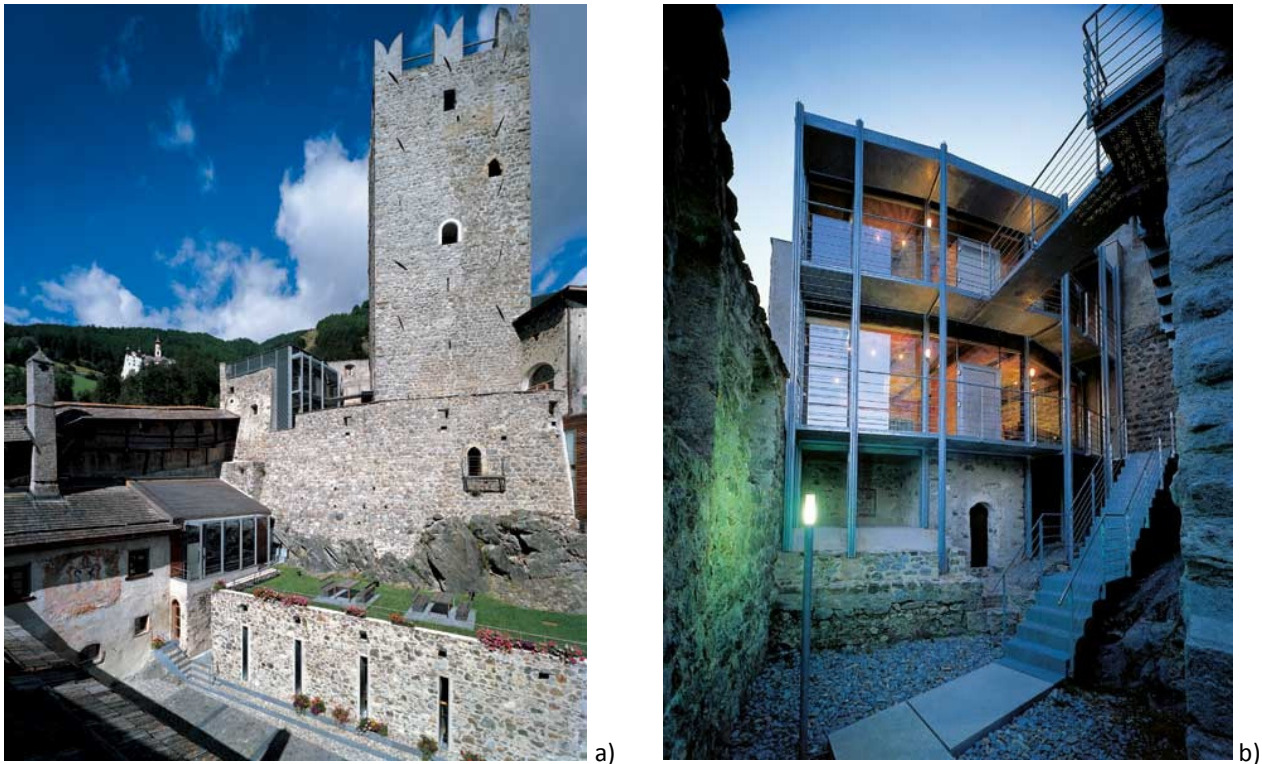
Figure 5.60: Furstemburg Castle: a) view of the partially collapsed tower with the new additions and b) view of the new horizontal and vertical connections (pictures from W. Tscholl's official web site: www.werner-tscholl.com).

The logic of the intervention, based on the addition of new functional elements (footways and stairs for the visitors), is again developed around the idea of a coexistence of the old and the new parts, without a structural interaction between them (Figure 5.60). This can be a choice of the designer but it is not a necessity: after the correct investigation of the existing structure, the information for evaluating the effects of an interaction between new and old structures can be assessed. As outlined in the second chapter, the interaction between existing structures and new additions was pursued in two complicated cases: the reconstruction of the Noto Cathedral and of the Fraenkirche in Dresden. In those cases, the intensive application of diagnostic techniques allowed a general comprehension of the mechanical behaviour of the survived structures, in order to connect old and new parts in a unique structural system. Nevertheless, as a consequence, the deep linkage between existing and added structures can compromise the reversibility of the intervention, indicated in the Venice Charter. For this reason, when making those choices as a way of no return the decision should be taken after deep investigation and many discussions when apparently there is no way to add but only reconstruction.

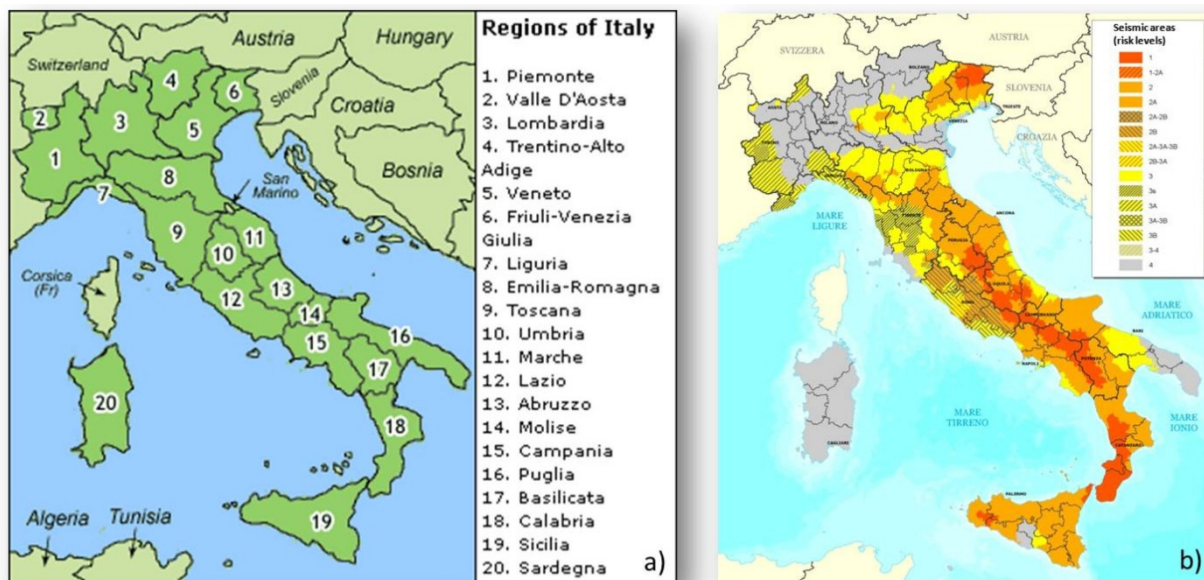
Figure 5.61: Map of Italy with the administrative regions (picture from the website www.big-italy.uk); b) map of the seismic risk of Italy (map from the website <http://zonesismiche.mi.ingv.it/>).

the new Italian map of the seismic risk indicates that the entire national territory is subjected to seismic events (Figure 5.61), even though with different levels of intensity. This thesis work supports the application of thermovision and sonic tests for investigating respectively the masonry texture (if not visible) and the masonry morphology. As shown in the last paragraph, the velocity of the elastic waves is a parameter that cannot satisfy a complete knowledge of the mechanical properties of the masonry, but a correlation with the deformability properties detected through double flat jack tests is well promising.
