POLITECNICO DI MILANO

Master of Science in
Civil Engineering for Risk Mitigation

**Dynamic monitoring and structure
assessment of “Gabbia Tower”**

This MSc Thesis deals with long-term dynamic monitoring, modal identification and damage assessment of a masonry tower. The investigated tower, about 54.0 m high and dating back to the XII century, is known as the “Gabbia” Tower and is the major historic tower in Mantua, Italy.

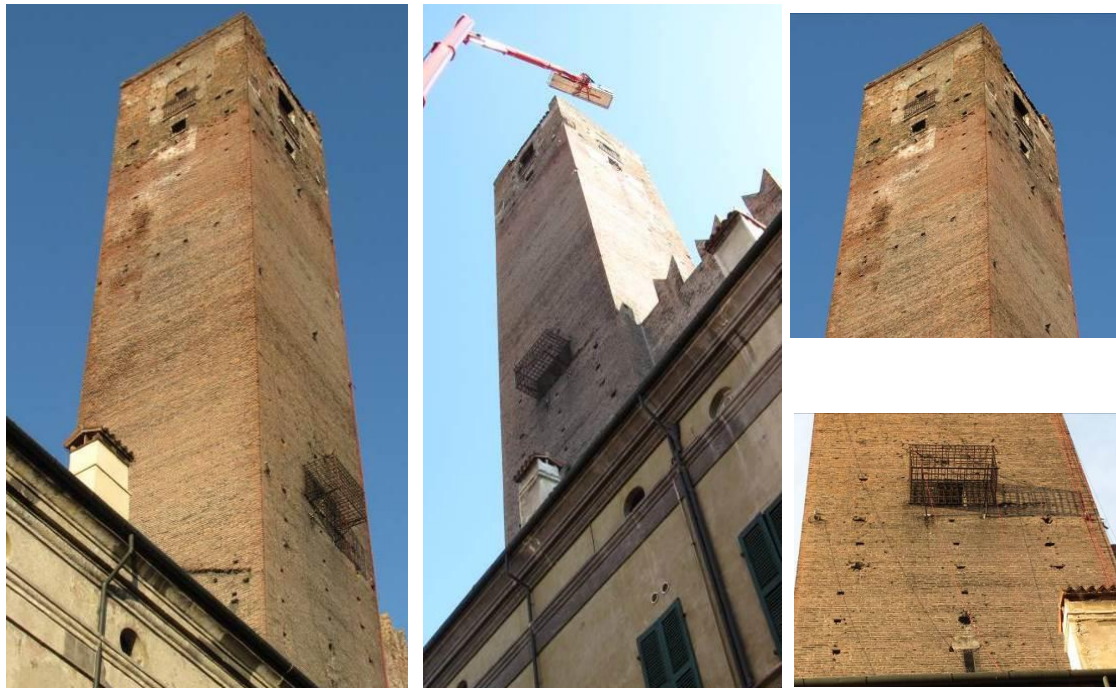
Figure 0-2 Tower of "Gabbia": overall views and details of the top and the cage

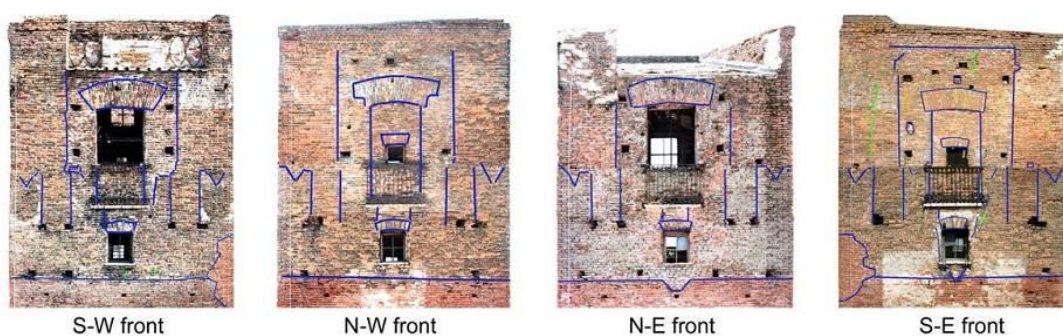
Figure 0-3 Map of the discontinuities on top of the "Gabbia" tower.

research; (b) geometric survey and visual inspection of the bearing walls; (c) on-site survey of the crack pattern and structural discontinuities; (d) non-destructive and slightly destructive tests of materials on site (i.e. sonic pulse velocity tests and flat-jack tests); (e) dynamic tests in operational conditions (Gentile et al, 2013). Visual inspection of all main bearing walls clearly indicated that the upper part of the tower is characterized by the presence of several discontinuities due to the historic evolution of the building, local lack of connection and extensive masonry decay (Figure 0-3).

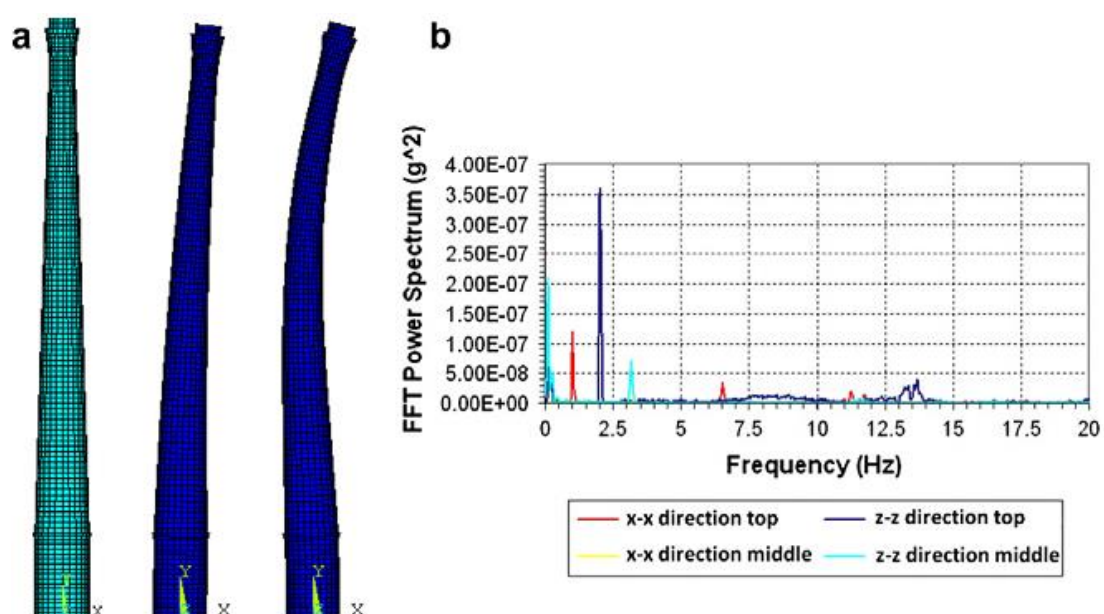
Figure 1-13 a) Numerical model and two mode shapes b) Frequency spectrum from AVT (Pallarés et al. 2011)

The frequencies identified are shown in Figure 1-13 after the application of the Fast Fourier Transform, together with two vibration modes (numerically obtained through an updated model) (Benedettini & Gentile. 2011).

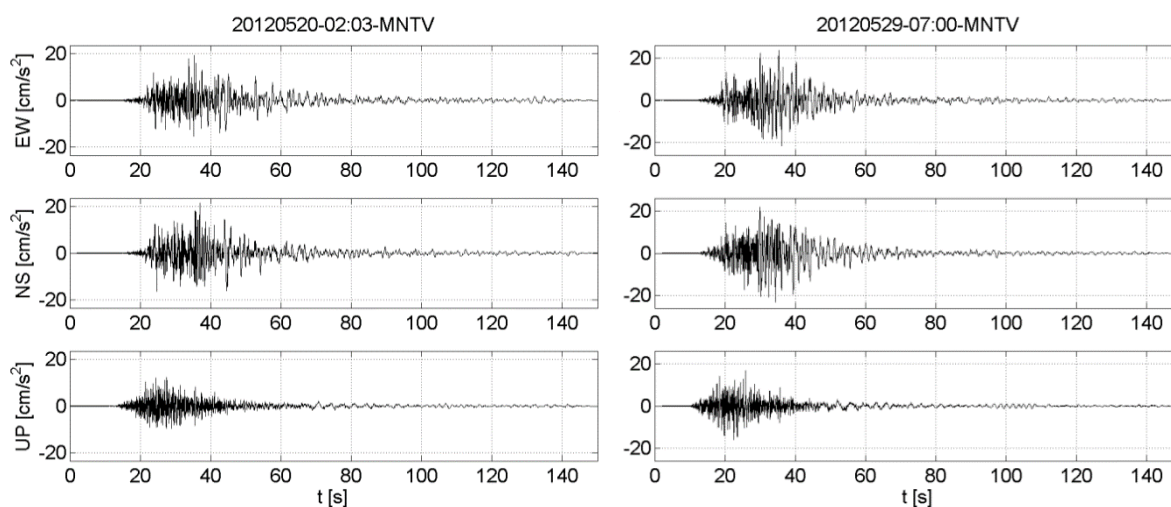
Figure 3-1 The acceleration of earthquakes recorded in Mantua

The acceleration of the two earthquakes was recorded by the sensors installed in Mantua (Figure 3-1). In Figure 3-2 examples of damaged buildings are shown.

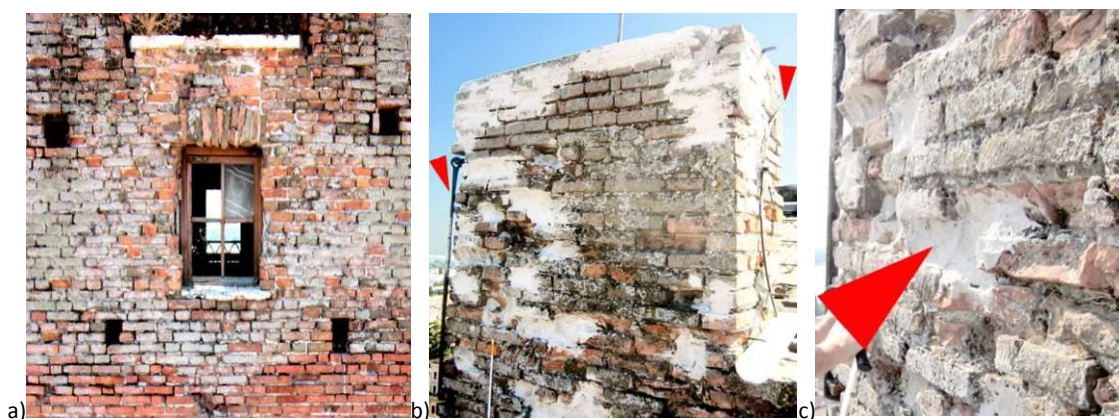
Figure 3-8 a)Walls between two openings; b),c)The degradation of bricks and repair mortar

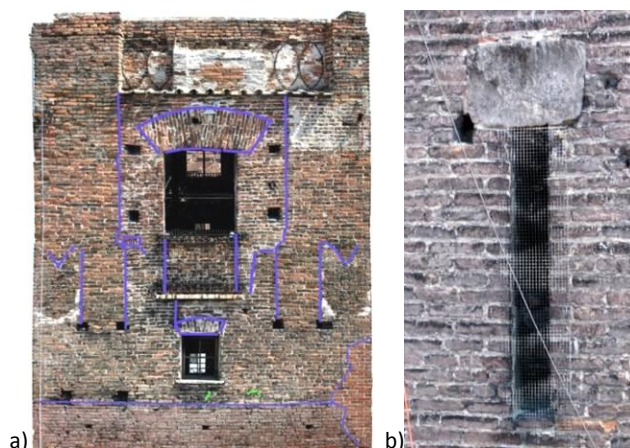
Figure 3-12 a) Top of the South-West front; b) The presence of a blocks of stone

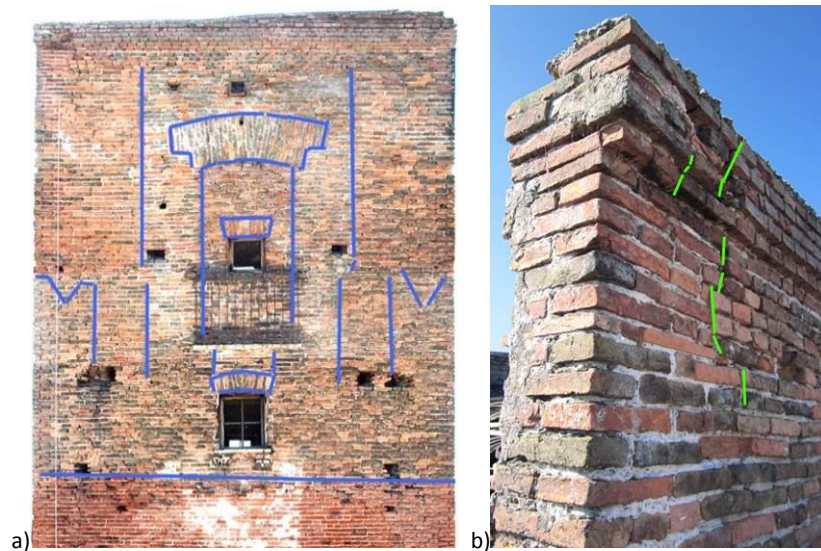
Figure 3-14 a) Top of the front North-West with highlighting structural discontinuities; b) The loss of horizontality joints and the degradation in depth of mortar joints and brick.

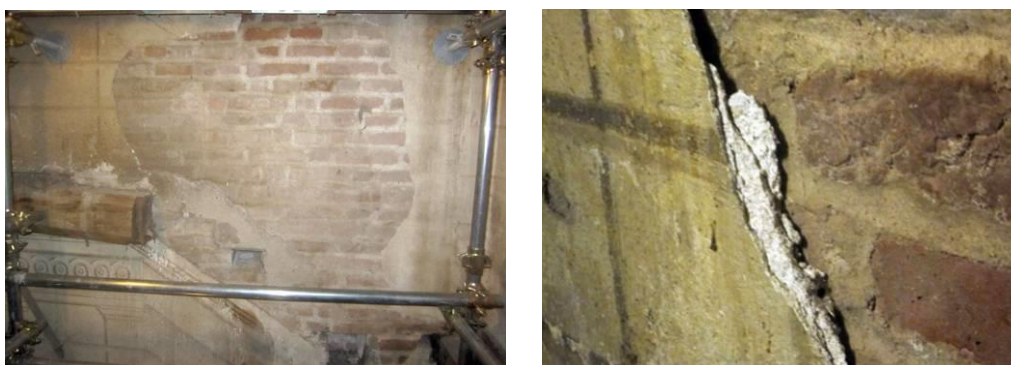
Figure 3-16 Detail of wall texture in correspondence with gaps render (about 16 m from the top). The equipment is ordered and the mortar of good consistency.

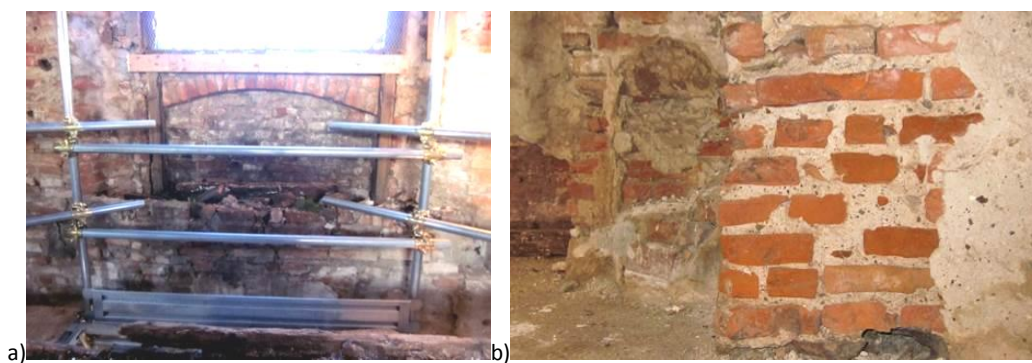
Figure 3-17 a) Detail of the opening of the interior elevation view corner Southwest and West;
b) Details of the wall texture of the corner pieces to the third level
