5.1. Case study regions in Anatolia

CHAPTER: 5 EARTHQUAKES IN ANATOLIA

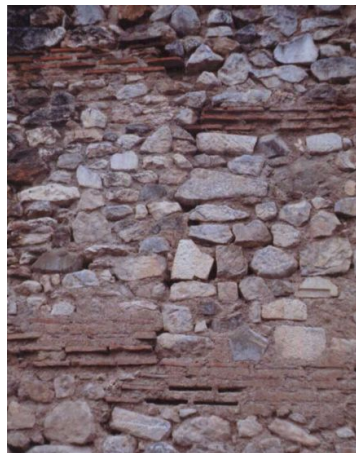
Fig 5.6: Traces of offset in historical walls surrounding znik (south wall) (Adatepe, Erel 2006)

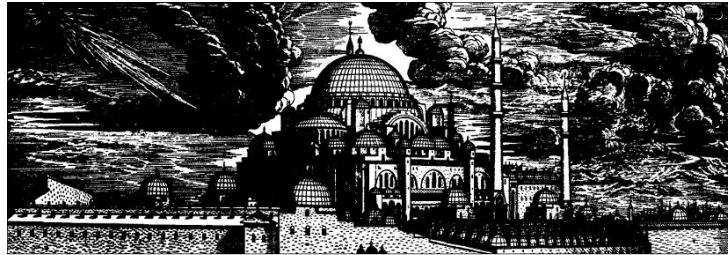
Fig 5.14: Fatih mosque complex from a mid-sixteenth century engraving by M. Lorichs (*Ambraseys, Finkel*)

In fig 5.13: woodcut by Peter Coecke in 1529, the mosque of Sultan Mehmet II were seen without minarets. They would not repaired for a long time after the earthquake. However the engraving of Fatih mosque complex in mid sixteenth century by M. Lorichs (fig 5.14); it was seen that there were tall minarets outside of the main body of the building. From those evidences it could be understand that the repairs of the minaret and the mosque done between 1530 and 1550 (*Ambraseys, Finkel*).

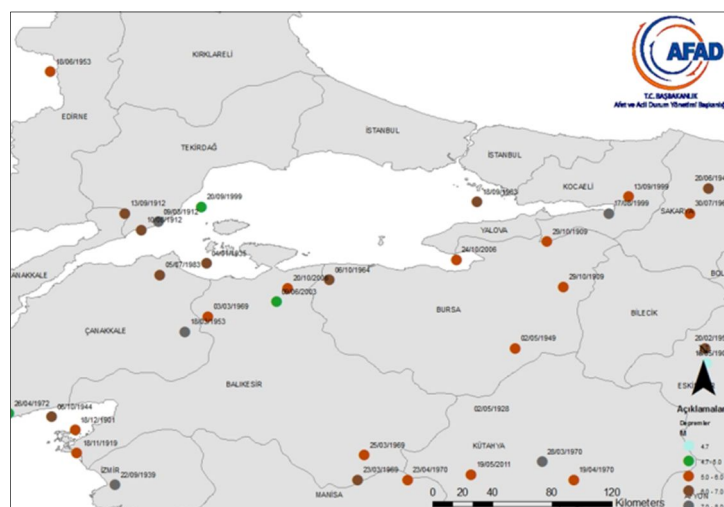
Fig 5.15: Marmara region seismic magnitudes in last century: Grey color: 7.0-8.0, Brown color: 6.0-7.0, Red: 5.0-6.0, Green: 4.7-5.0, Aqua: 4.7 (*Turkey'.T.C. Basbakanlik Afet ve Acil Durum Yönetimi Başkanlığı, Deprem Dairesi Başkanlığı*).

In Marmara region seismic magnitudes in last century was shown on Fig 5.15.

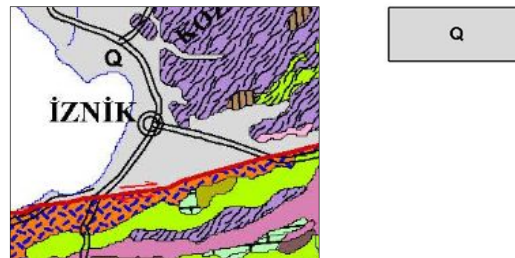
Undifferentiated quaternary rocks are the geological specification of İznik.

Fig 5.17: Geological Map of İznik settlement (*The Geological Map of Turkey, 2002*)

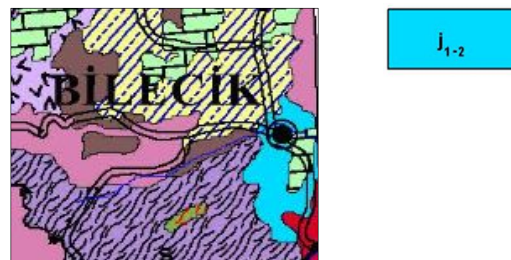
Carbonate and clastic rocks are the geological specification of Bilecik.

Fig 5.18: Geological Map of Bilecik city (*The Geological Map of Turkey, 2002*)
