7.6.Havsa Sokollu Bath (Havsa settlement - Edirne)

7.6.1. Methodological application (A)

7.7.Ke an Bath (Ke an settlement – Edirne)

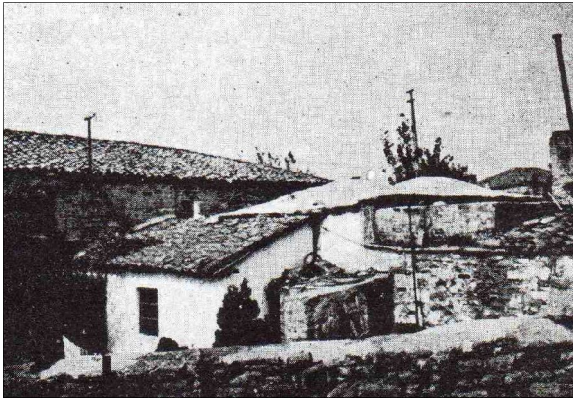
Fig 7.72: Herseko lu Ahmet Pasha Bath, (*Ayverdi IV, 1989*).

There was other bath structure in Ke an which was built in R.1135 (1722) and it was a part of Herseko lu Ahmet Pasha complex buildings. Mosque, school, fountain and bath were the buildings that composed the Herseko lu Ahmet Pasha complex. The bath structure in the complex was very small which comprised single cold area and ‘halvet’ (*Ayverdi IV, 1989*).

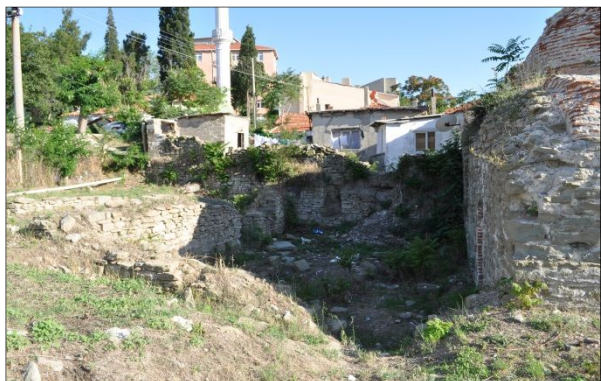
Fig 7.75: Ke an bath, undressing area

Current situation of the Ke an bath was ruin. It was composed of undressing area, hot area, ‘halvet’ cells, toilet and water tank. The closure space of the undressing area was collapsed. Hot area was composed of two domed cells combined together with arch. As well ‘halvet’ cells were closed with dome structure. There are two vault structures which were used as closure of water tank and toilet and its surround space. Pendentives were used as transitional elements. Masonry wall structure is composed with masonry blocks of hewn stone and pebbles.

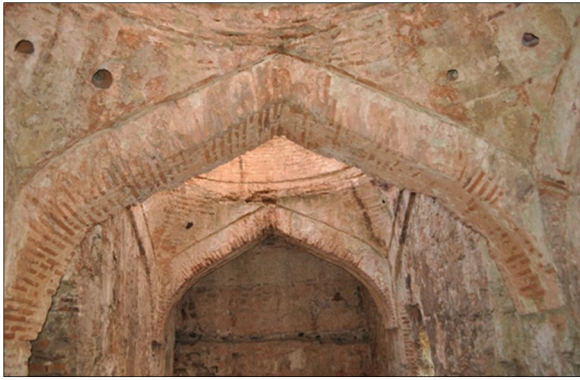
Fig 7.76: Ke an bath, hot area

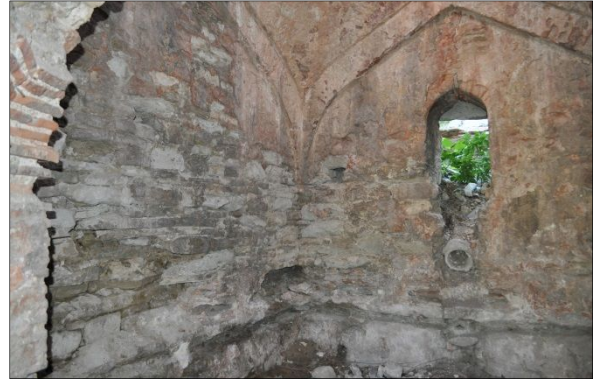
Fig 7.77: Ke an bath, 'halvet' cell

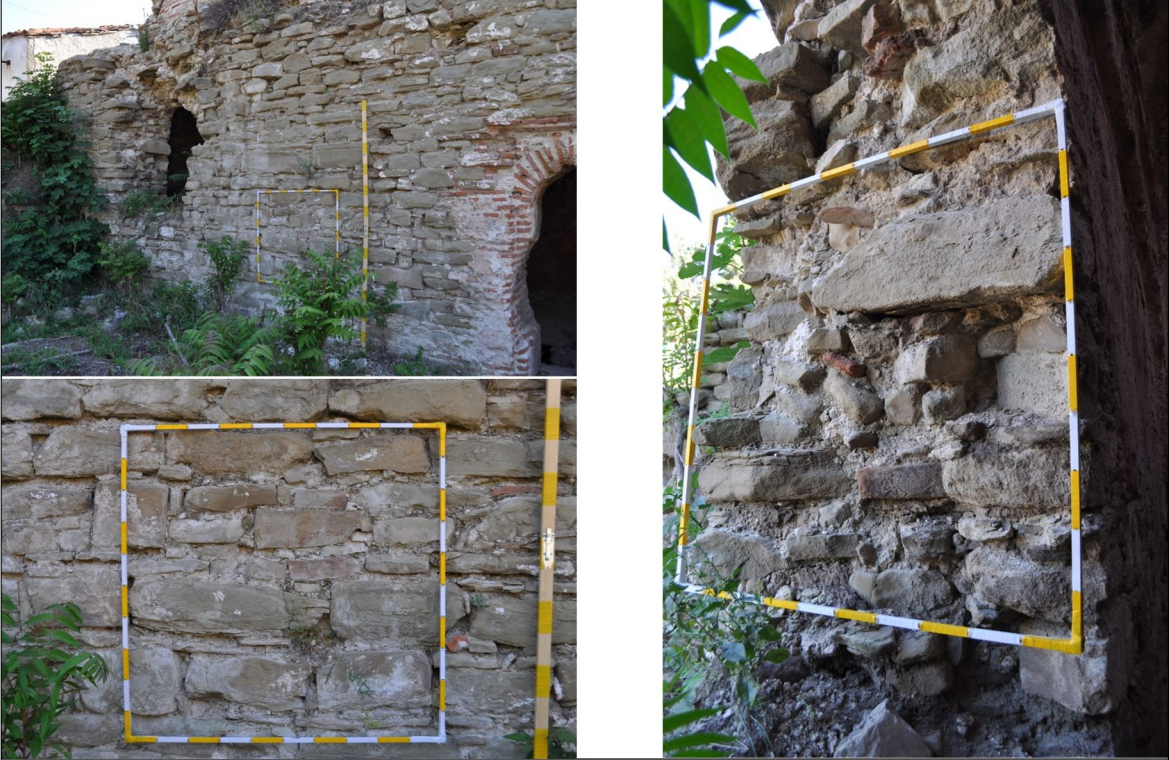
PHOTOS

Qualitative Methods for Evaluating the Quality of the Walls	
Edirne-Keşan City, Keşan Bath	
Masonry blocks of hewn stone and pebbles

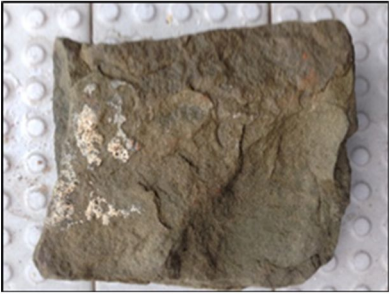
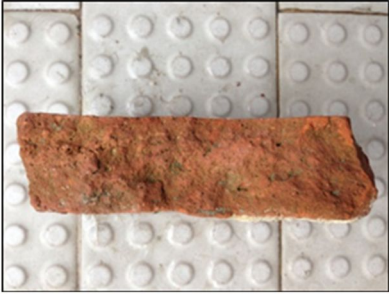
<p>Description of Keşan Bath: Masonry stone structure is composed with masonry blocks of hewn stone and pebbles. There was no clue for timber tie beam connection inside of the masonry stone walls. On the sections of the masonry wall small pebbles and stones could be seen. The wall fabric is chaotic, it was not respected to the horizontal rows or offset of the vertical joints. Diatone stones are used inside of the masonry stone wall structure. There was an effort for horizontal linearity.</p>		DESCRIPTION	
<p>Keşan bath; stone material is composed of volcanic tuff with green color which was extract from Kizilkapan village mine.</p>

MATERIAL	
Stone Sample	Brick Sample

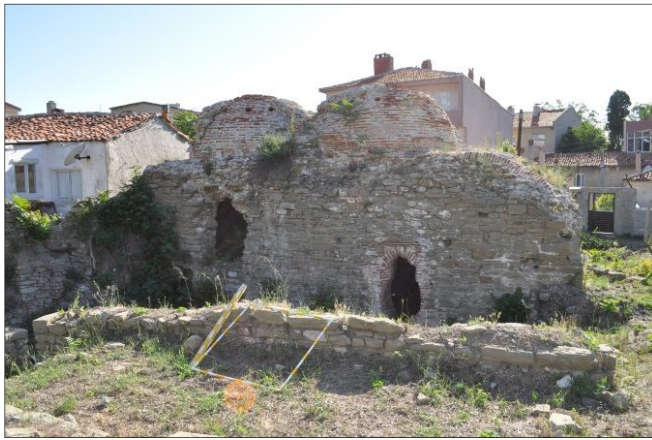
Fig 7.81: Perspective view of “Ke an” bath

Perspective views and general bird eye views of “Ke an” bath is shown on the following pictures.
