7.8.Yeniçeri Bath (Edirne city)

7.8.1. Methodological application (A)

Table 7.55: Qualitative methods for evaluating the quality of the walls in Yeniçeri bath: A

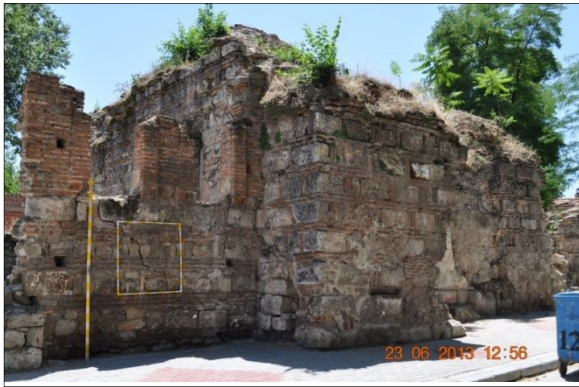
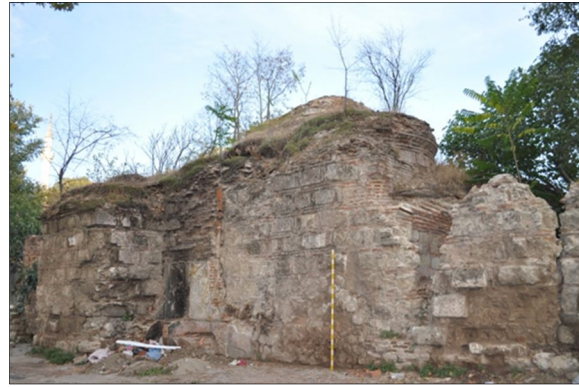
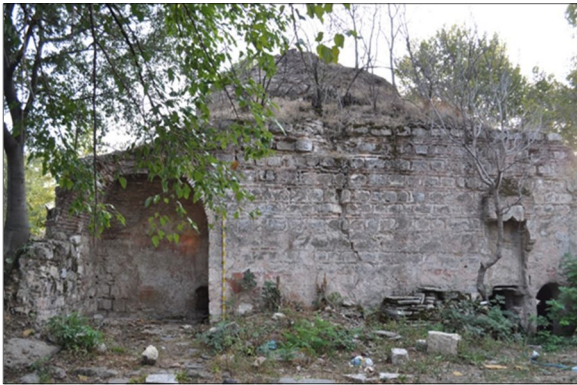
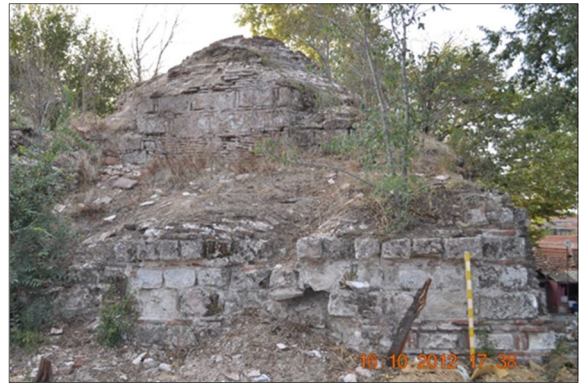
Fig 7.85: Perspective view of Yeniçeri Bath 1

Fig 7.86: Perspective view of Yeniçeri Bath 2

Fig 7.87: Perspective view of Yeniçeri Bath 3

Fig 7.88: Perspective view of Yeniçeri Bath 4

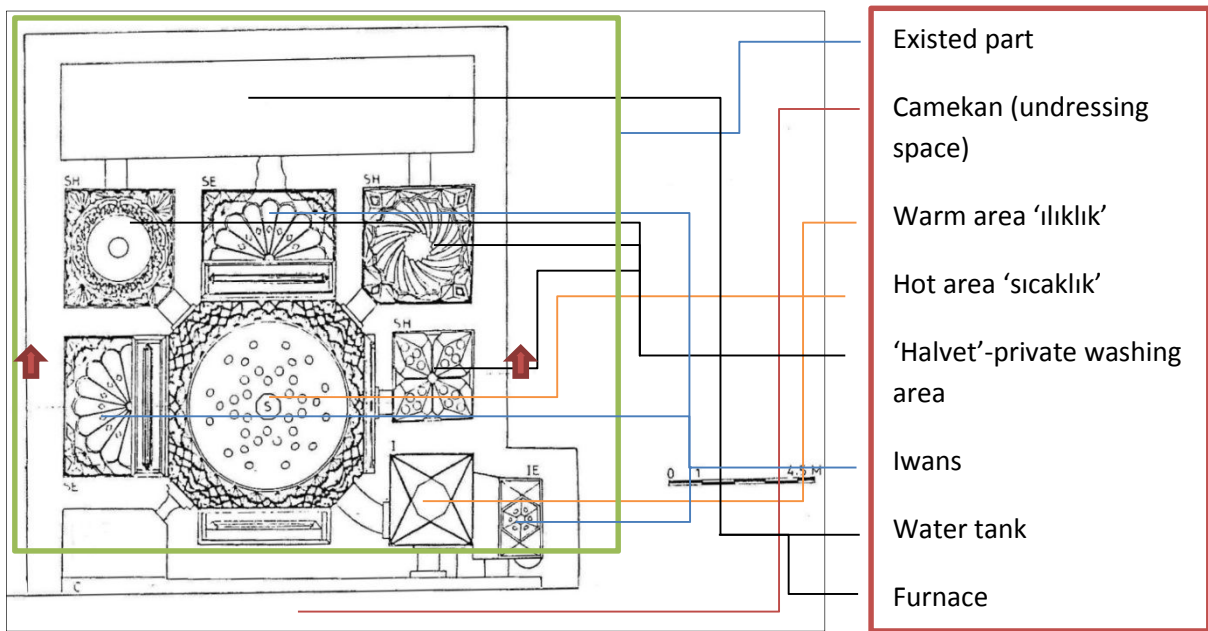
Fig 7.89: Yeniçeri Bath, functional specifications (Say, 2011).

The closure of the warm area was cross vault. On the top of the vault there was an octagonal opening. One iwan was connected to the warm area with arch. The closure of the iwan was dome form with six pieces (Say, 2011).

The hot area was composed of one central area connection with two or three iwans. The closure of the central area was simple dome. Pendentive and muqarnas structural elements were used in the central area for the connection between wall and the dome. One big iwan was composed of seven slices of dome which connected to the central area with arch. In half dome structures muqarnas structural elements were used as transitional elements. The closure elements of the ‘halvet’ were; vault, spiral dome and a simple dome structures (Say, 2011).

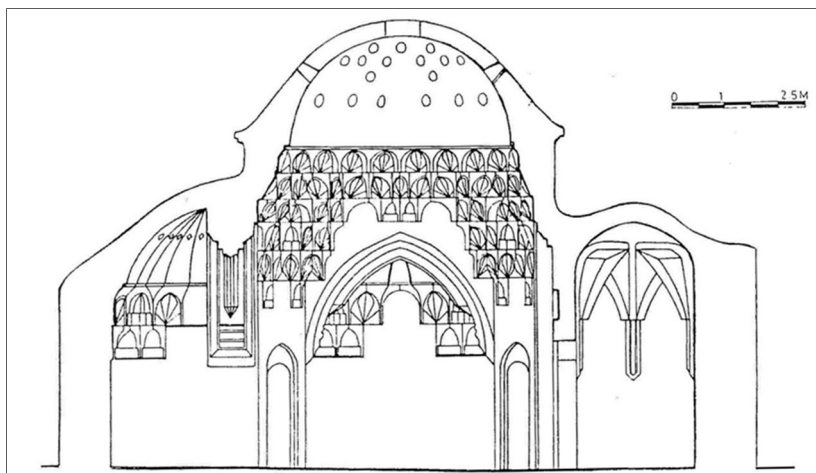
Fig 7.90: Yeniçeri Bath, section (Say, 2011).

The masonry wall structure of the building was one row of cut stone with two rows of brick layout. The closure and transitional elements were built in a high quality workmanship. Yeniçeri bath was specific in the usage of its closure and transitional structural elements. Pendentive structure was not used. And the vault structures were used very rare. Curvilinear openings with glass closures ‘filgözü’, were used in a high percentage according to other bath structures (Say, 2011).

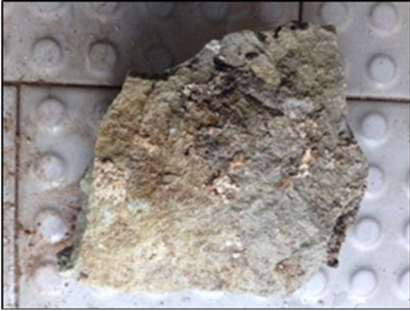
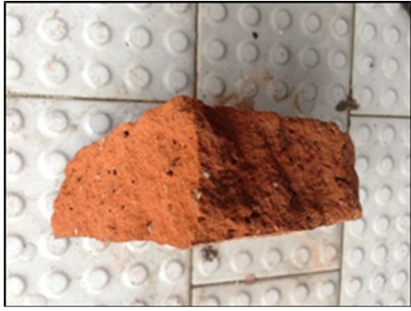
| <p>Stone Sample</p> | <p>Brick Sample</p> | | |

| <p>In Yeniçeri bath; stone material is composed of volcanic tuff with green color which extract from Keşan mines. Brick materials is refractory brick therefore it is resistant to the heat. Therefore magnesium and aluminum percentage were high in the compound of the brick.</p> | | MATERIAL | |
