# THE {POST-SANDY} NEIGHBORHOOD ASSESSMENT PROJECT

student:  
Paola Libardoni

UNIVERSITA' POLITECNICO DI MILANO  
SEDE DI MANTOVA  
FACOLTA' DI ARCHITETTURA  
LAUREA MAGISTRALE IN ARCHITETTURA  
AA. 2014-2015

**THE {POST-SANDY}  
NEIGHBORHOOD  
ASSESSMENT PROJECT**

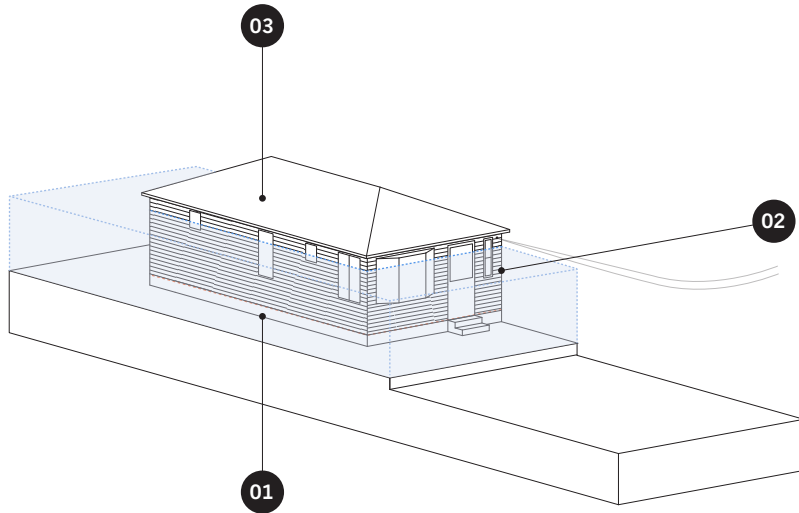
# THE BUNGALOW

### FOUNDATION 01

Most of the bungalows rest on a CMU foundation and are not strongly tied down. Many homes were either shifted off the foundation or the foundation developed cracks.

Many homes were completely flooded and need to be gutted and renovated. Electrical and mechanical systems and appliances were also damaged, and will have to be replaced. In cases where the structure shifted, cracks developed in the floor.

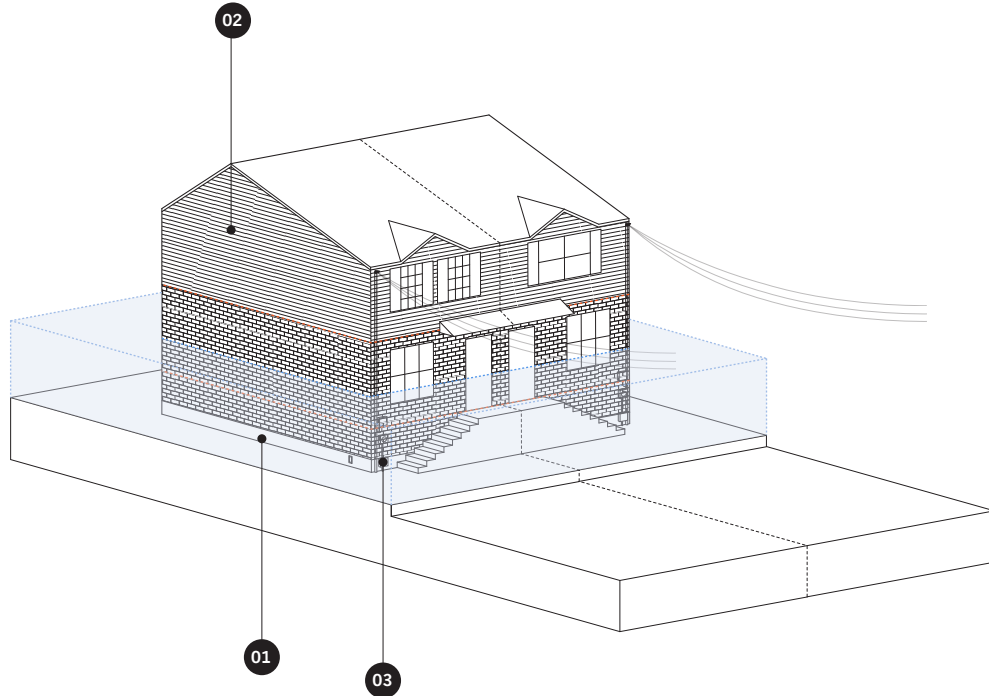
# NEW CONSTRUCTION ATTACHED SINGLE FAMILY

## FOUNDATION 01

These homes were typically built on raised concrete foundations with the first floor an estimated 4 feet above grade. In lieu of basements, there are crawl spaces below these homes, with vents to the exterior.

Most homes had 1 to 3 feet of water on the first floor. Interiors had to be gutted, appliances thrown out, and, in some cases, floors and base heaters had to be removed and replaced due to warping.

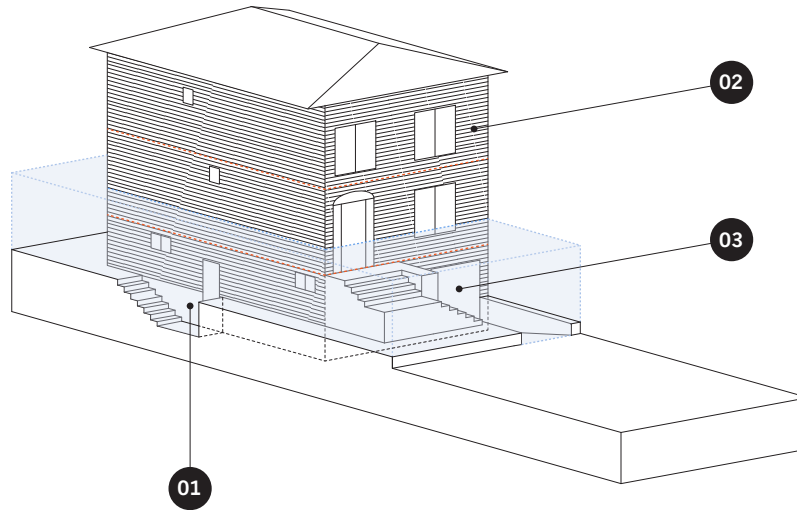
# NEW CONSTRUCTION DETACHED SINGLE FAMILY

## FOUNDATIONS + BASEMENTS

Many of these homes suffered typical flood damage from Sandy, with degree of damage depending on whether the home had been elevated or if it had below grade spaces. Interiors had to be gutted and dried out to remediate for mold.

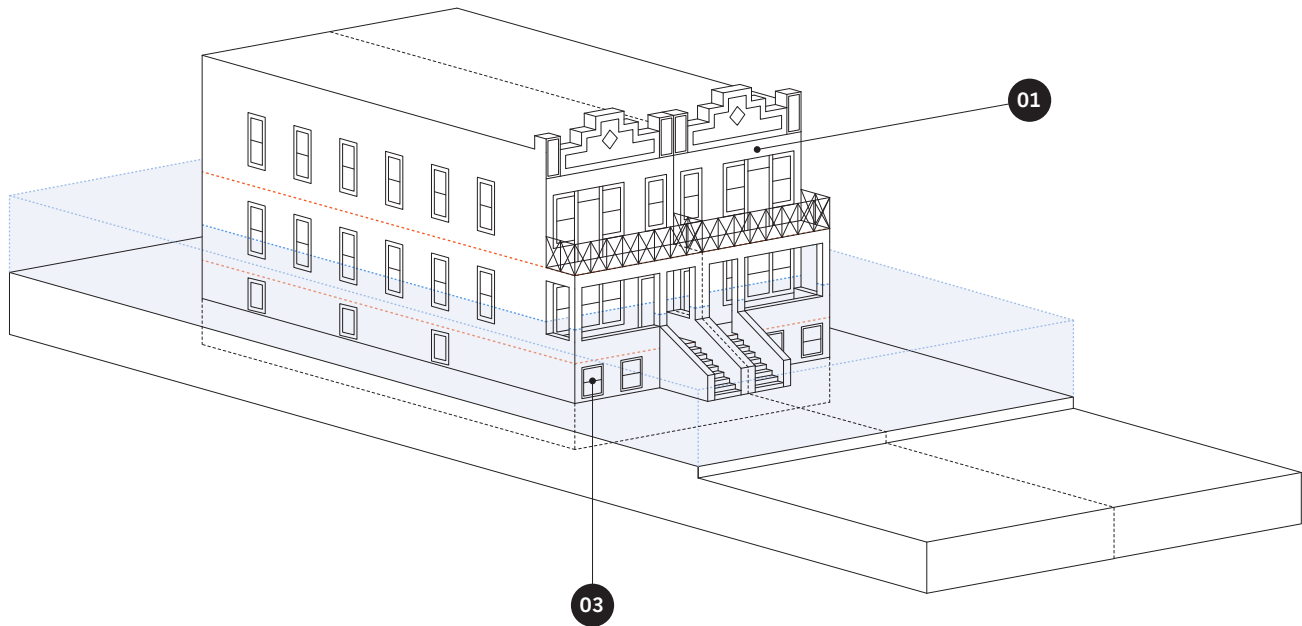
# ATTACHED PRE-WAR MULTI-FAMILY

## BUILDING ENVELOPE

Pre-war homes are typically clad in brick and were secure against wind damage. Basement windows and vents at the sidewalk level and exterior stairs to the basement allowed for the infiltration of floodwater below grade.

The majority of these homes had the mechanical and electrical systems in the basement, and these systems need to be repaired.

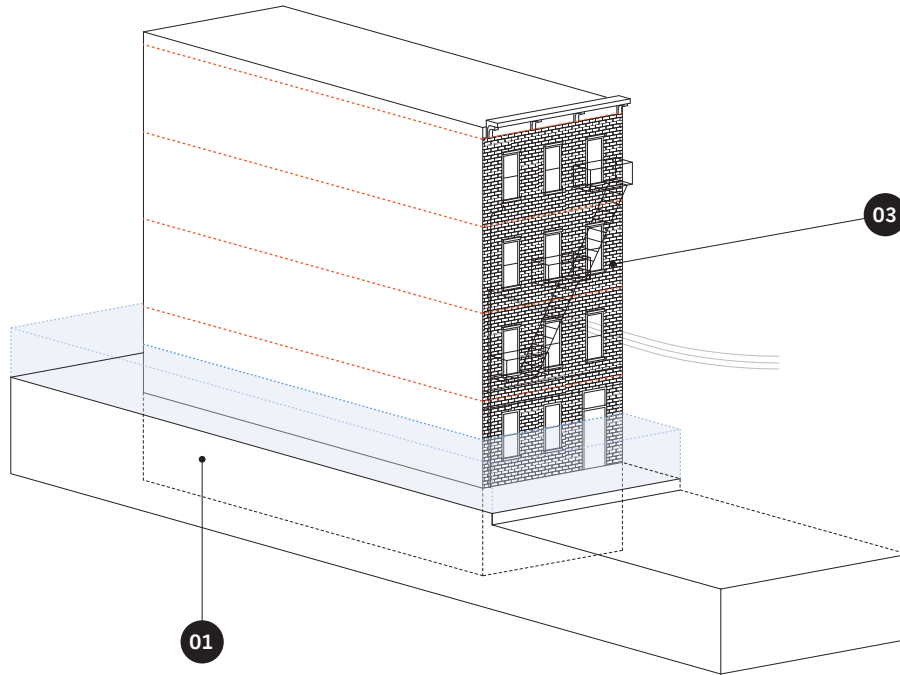
# ATTACHED MULTI-FAMILY APARTMENT BUILDING

## 01 BASEMENTS AND BUILDING SERVICES

Depending on their age, these buildings range from 2 to 4 stories in height. The majority have basements, which completely flooded during Sandy. Although there are cases where these spaces are occupied by tenants, the majority are service spaces.

These buildings either have residential or commercial storefront space on the ground floor. Flooding on the ground floor necessitated that interiors be gutted and dried out. In several cases, this was not done due to low landlord involvement or inability to fund repairs.

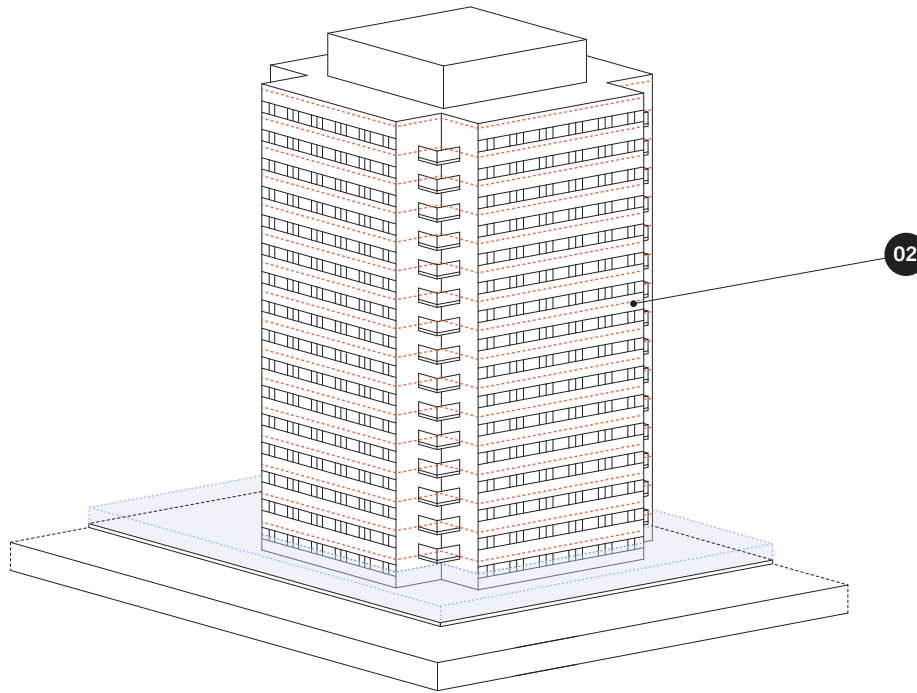
# HIGH RISE APARTMENT BUILDING

## 01 BASEMENTS AND BUILDING SERVICES

Much of a high rise's building services are located in the basement, such as boilers and fuel supply. When floodwater inundated these buildings, these systems were damaged. This included damage to electrical systems and elevators. After Sandy, many of these buildings had installed temporary systems for service.
