POLITECNICO DI MILANO

Master of Science Degree in Space Engineering

TESI DI LAUREA MAGISTRALE - AA 2014-2015

**Experimental analysis
of a self-healing ionomer in a tank
with an internal aluminium filler**

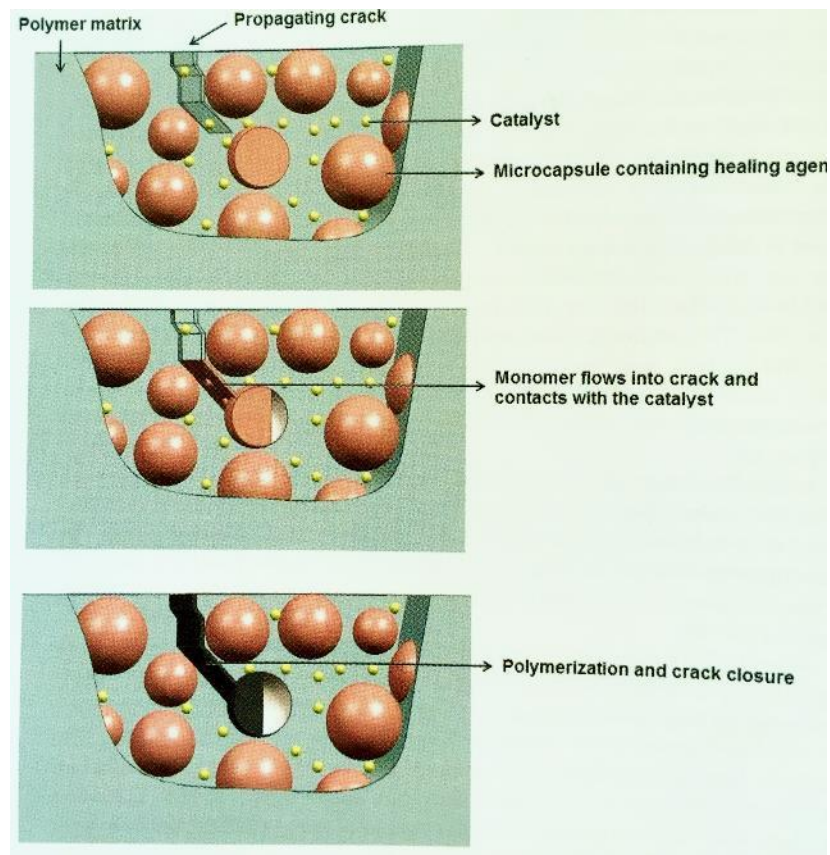
Figure 1 - Self-healing concept using embedded microcapsules [1]

Microcapsules are put inside a composite material containing a particular resin since the beginning; resin is the "repairing agent". When a fracture occurs inside the material, capsules located in that area break, thus releasing the resin. This resin flows inside the polymeric matrix, where it polymerize thanks to the presence of the catalyst. As a result, the crack is filled and the original mechanical properties of the material are restored.

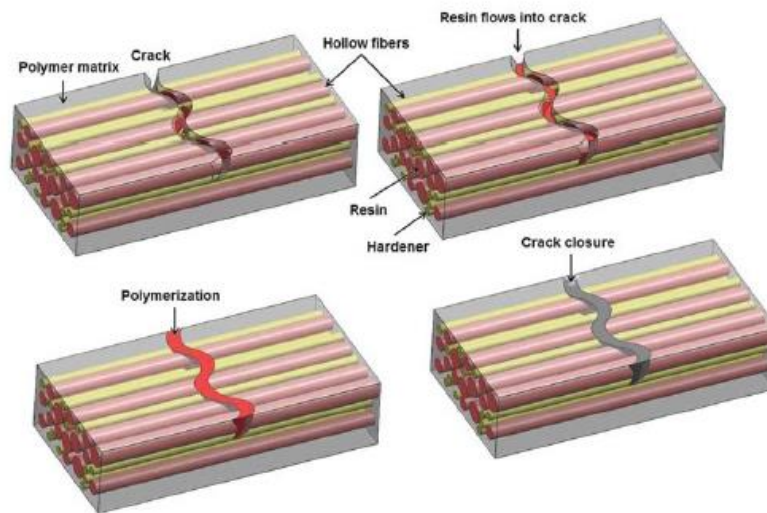
Figure 3 – Hollow fibres healing schematic concept [1]

In a similar way to what described for microcapsules, when a damage occurs (i.e. a fracture or a delamination) the broken fibres release the resin and the catalyst: they react one another and fill the crack. Also in this case the functioning is based on a chemical reaction, which is spontaneous or activated by temperature or UV radiation.

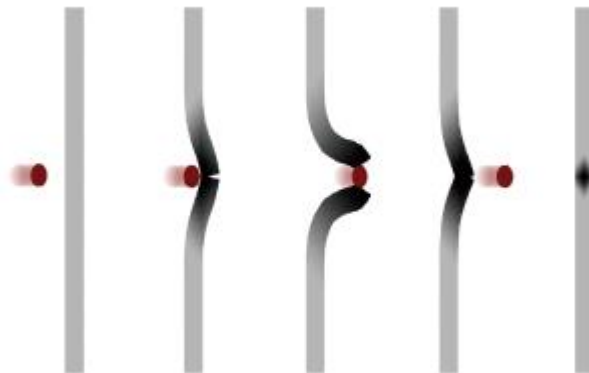
Figure 7 – Schematic sequence of healing during ballistic impact

The self-healing phenomenon for this type of ionomers shows up spontaneously with no external intervention. Reparation is caused by the energy due to impacts: a part of the kinetic energy of the projectile is transferred to the material in the form of heat and elastic energy. If the ballistic impact brings enough energy to the ionomer, the material is locally melted, and the fused part experiences an elastic return in its original position. The following solidification of the material completes the healing. All these phases take place in some centesimal of millisecond only.

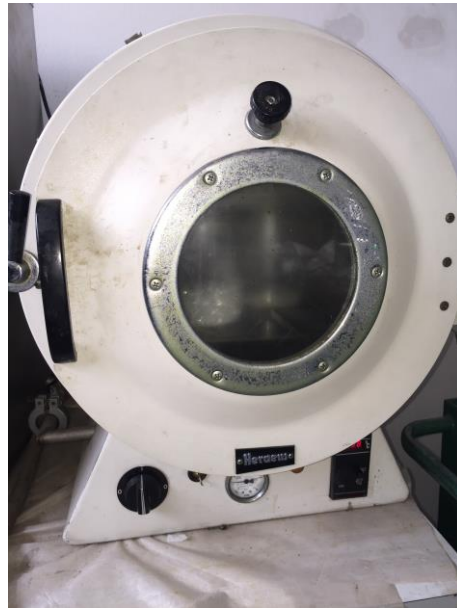
Ionomer pellets were dried in vacuum (about 0.1 bar) at 60°C for 5 hours, with the aim to extract humidity from the material.

Figure 12 – Ionomer’s vacuum drying

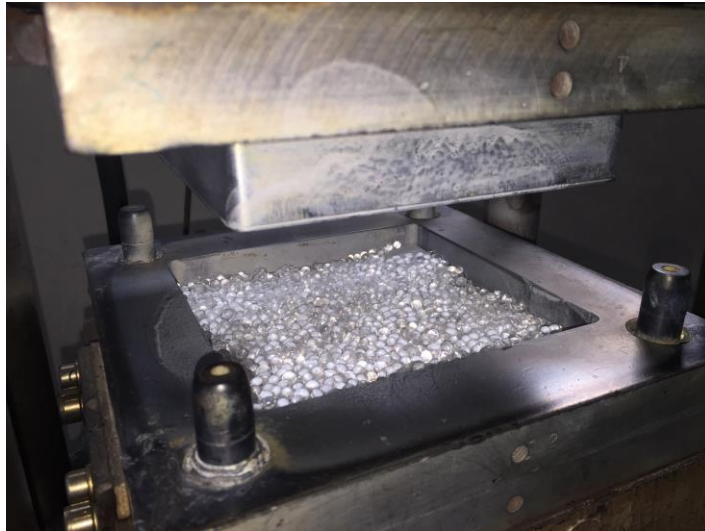
Figure 13 – Surlyn® 8940 compression moulding

Square plates (120 × 120 mm) of different thickness (ranging from 1 to 3 mm) were produced by compression moulding at 180°C. Unfortunately, no different specimen sizes were possible because of the machine limitations.

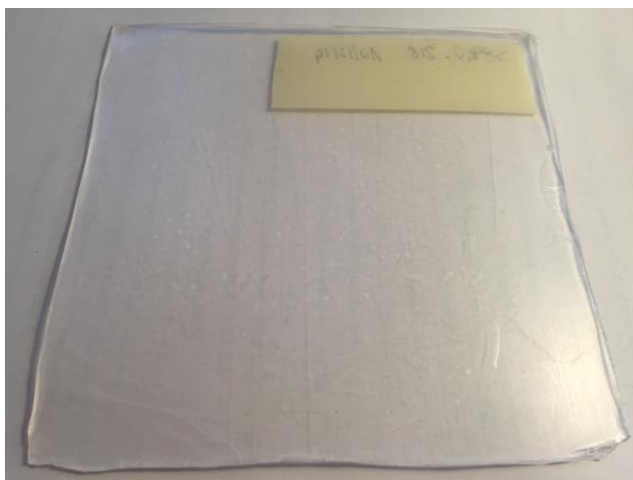
Figure 14 – final ionomer panel

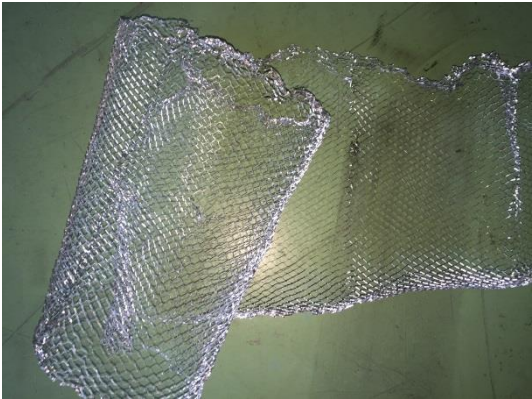
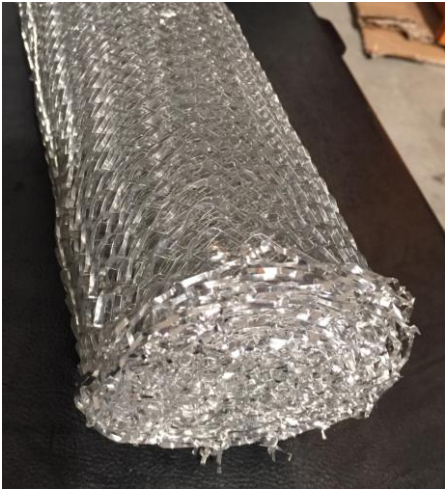
Figure 16 – Explosafe cylindrical block used in the present thesis’s tests.

Once placed inside a tank, Explosafe only takes up 1-3% of the tank volume. All the tests presented in this thesis have been performed using a cylindrical shaped block of Explosafe that perfectly fitted the experimental tank, kindly offered by Explosafe Limited of Switzerland . Single layers were rolled in order to match precisely the internal diameter of the tank, and then inserted inside the cylinder. The filler was specifically targeted to grant contact with all the tank's internal surfaces.

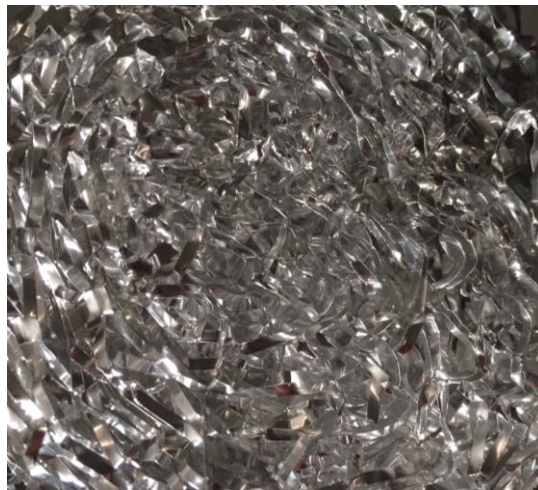
Figure 17 – Frontal view of Explosafe

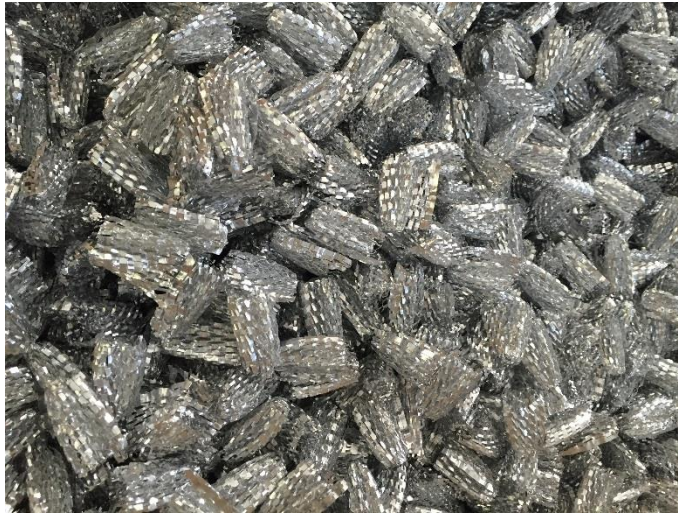
Figure 19 – Explosafe small cylindrical pellets configuration

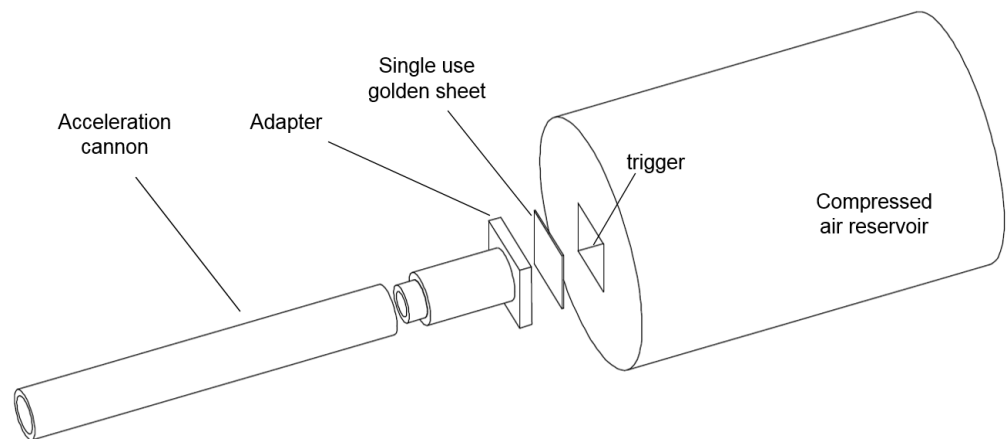
Figure 21 – Detailed view of cannon's base attachment. Sabot is inserted inside the barrel between the adapter and the acceleration cannon.

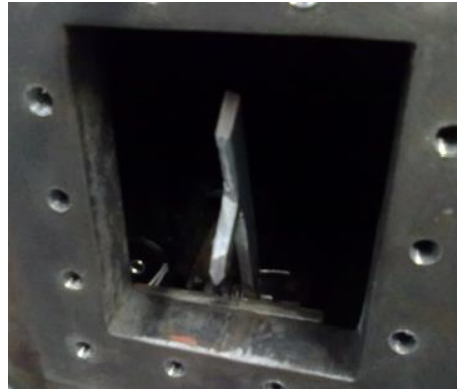
Figure 22 – trigger

After the puncture, the differential pressure causes the expansion of the compressed air in a long aluminium tube (length 7 metres, internal diameter 40 mm, external diameter 70 mm). The air expansion pushes a high density polyethylene (HDPE) sabot, which contains the selected size steel sphere inside the aluminium tube till it reaches the end of the barrel, made by a dissipative small thickness aluminium tube (absorber) and an aluminium stopper (a sort of cover cap). This terminal part was recently modified in its design in order to facilitate the recharging operation and it is more accurately described in §2.2.1 .

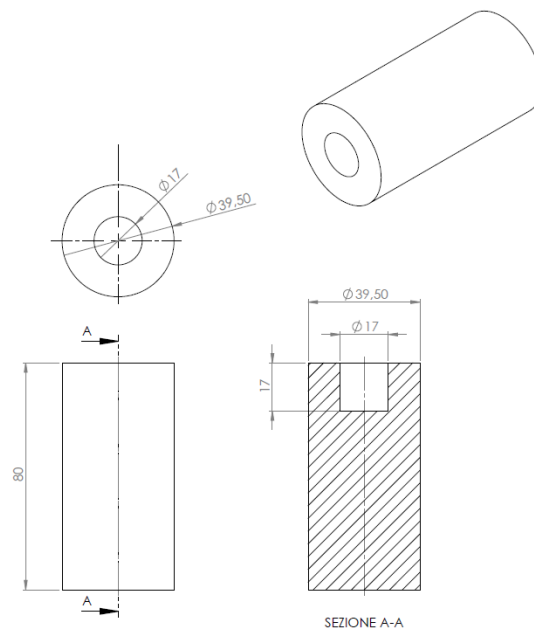
Figure 23 – Sabot technical drawing

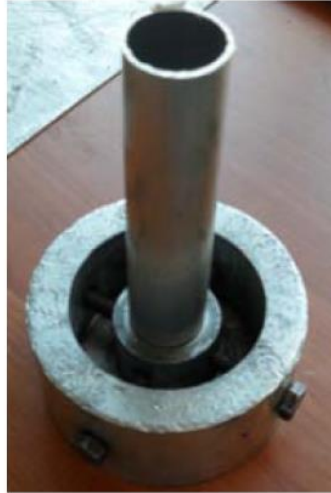
Figure 24 – sabot end-run stopper and absorber

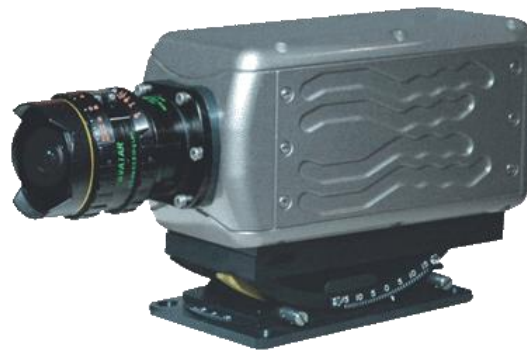
A high velocity Phantom v5.1 camera was used to measure the projectile's speed before and after the impact by computing the time elapsed by the projectile to cover a fixed distance.

Figure 25 – Phantom v.5.1 high speed camera

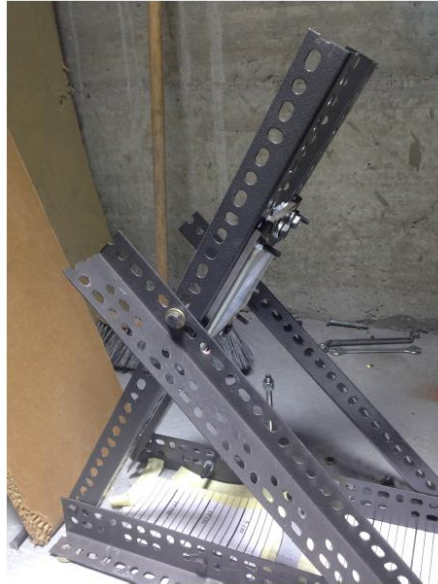
Positioning of the ionomer was dependent on the kind of tests done (i.e. in air or in the water environment). In the former case, ionomer specimens were installed on a steel rigid support. The frame was anchored to the ground by four M6 bolts and the L shape of the beam section guarantees a lower deflection of the structure during the impact. In this thesis, the support's option of varying the inclination of the specimens with respect to the panel motion was not exploited.

Figure 26 – steel support used for tests in air environment

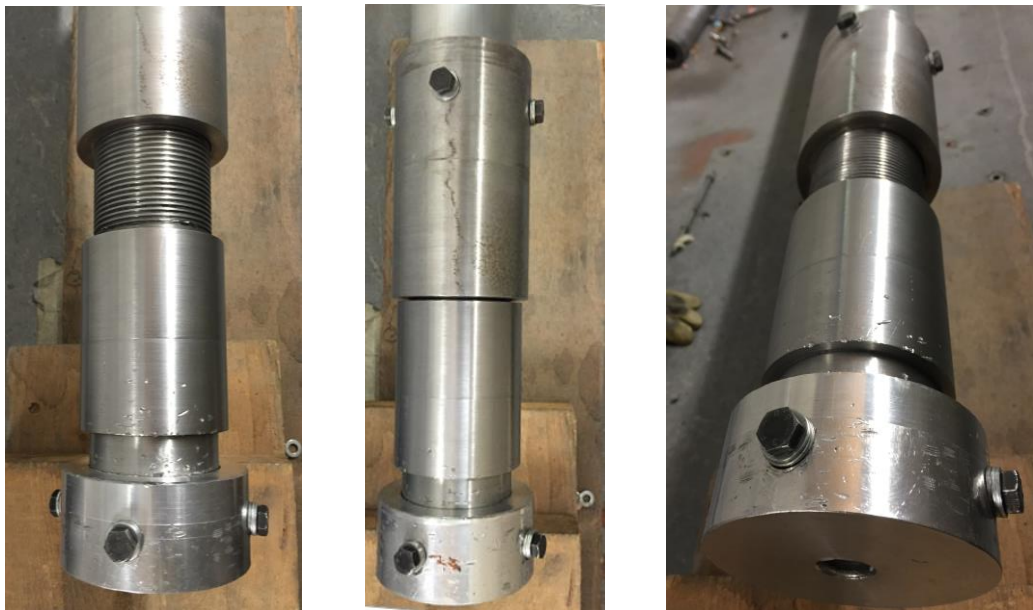
Figure 28 – Photographs of the terminal part of the acceleration cannon

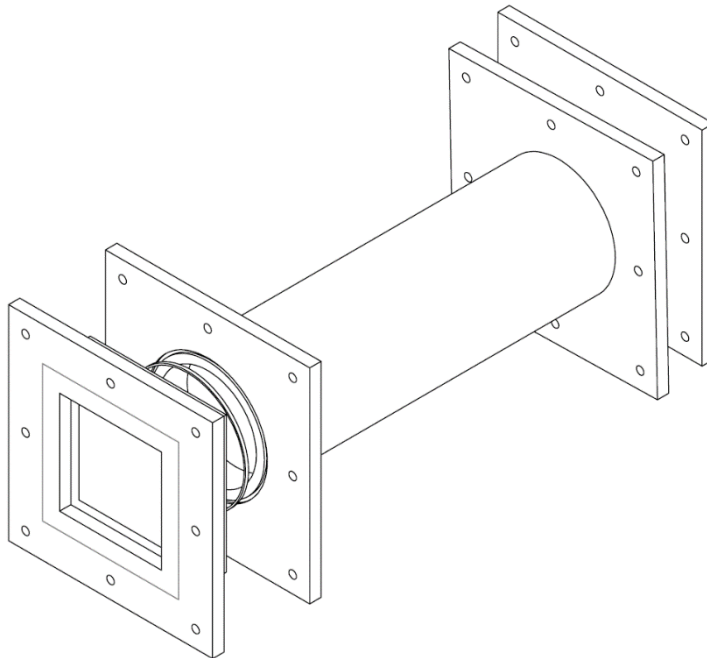
Figure 29 – Sketch exploded view of the experimental tank.

- The tank shall be compact enough to be easily moved by one person only at full capacity;
- The tank shall be able to withstand the forces arising from a maximum of 16.6 mm spherical steel bullet at 200 m/s.;
- The tank shall be predisposed to pressurization;

- The ionomer panel shall be easily changed in few minutes, without the need to remove the liquid inside the tank;
- At least for some tests, the ability to see inside the tank shall be granted;
- The tank shall be predisposed to pressure sensors installation.

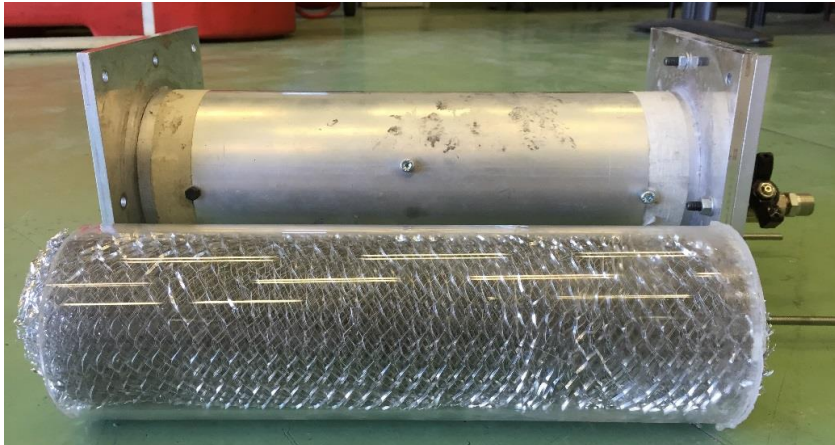
Figure 31 –Lateral view of the two different tank configurations put aside. The plexiglass cylinder in the photograph is filled with Explosafe, but tests without the filler have been performed too.

Aluminium flanges separation from the central cylinder was prevented by four long steel screws.

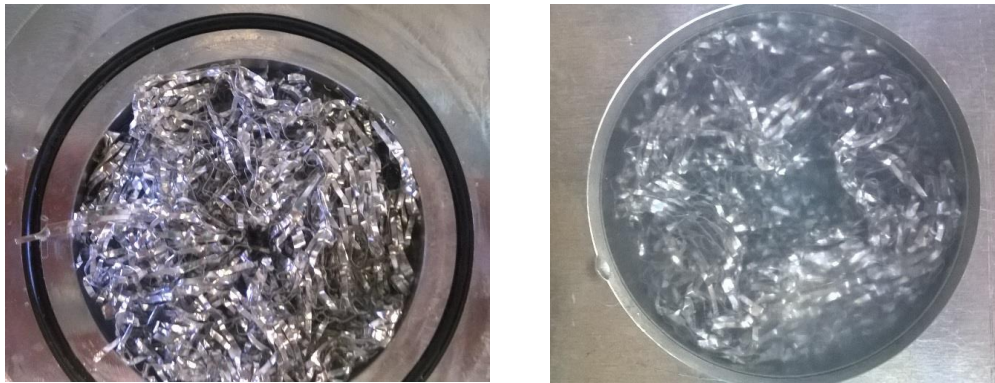
Figure 32 – Explosafe frontal view inside the tank (without and with ionomer panel respectively)

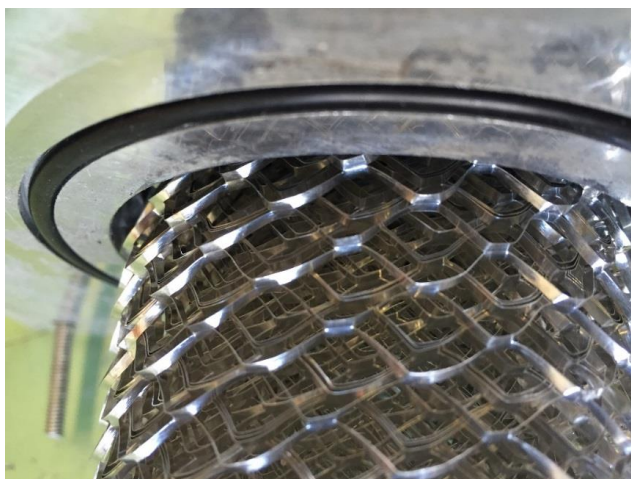
Figure 33 – Explosafe insertion phase inside the experimental tank.

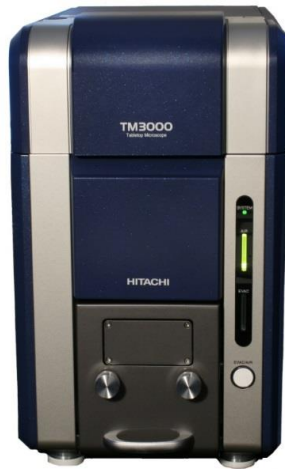
In addition, scanning electron microscope (SEM) allowed an analysis at a smaller scale both in the bullet entry and exit sides. A Hitachi TM3000 instrument was employed.

Figure 36 – Scanning Electrons Microscope in use at Politecnico di Milano laboratory.

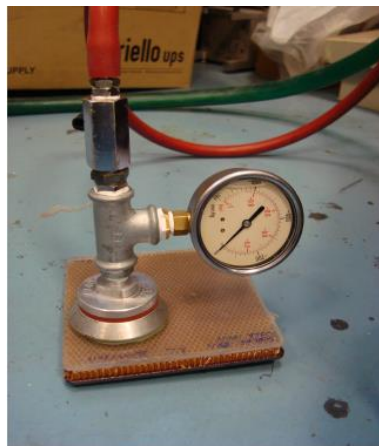
Figure 37 – Leakage test instrument.

In the case of testing in the tank configuration, water passage through impact zone was checked before operating the air leakage test just described.

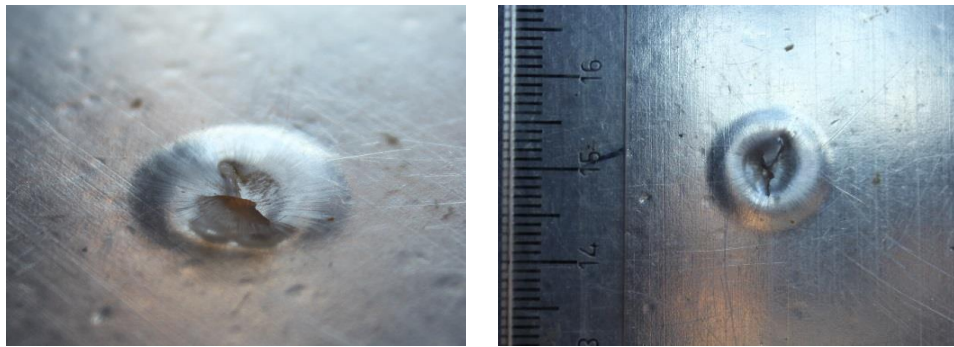
Figure 38 – Panel 306

The surrounding region presented a bulking region on the backside of the panel. In this region, visible cracks were never registered. The outer border represented the projectile's diameter approximately. Outside the range given by that diameter, in fact, no remarkable sign of modification was never found.

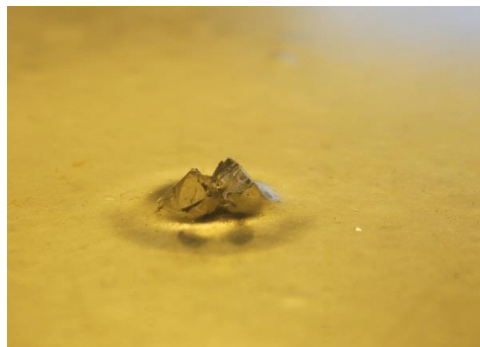
Figure 39 – Panel 210

The first evidence of healing was from a visual analysis: the spherical projectile perforated the ionomer panel but the impact region did not always present a hole. The passage area was closed, though leaving a permanent deformation and clear evidence of a damage event.

The closure pattern presented some petals, probably generated from the cracks geometry during the impact. The contemporaneity of the elastic return with the solidification of the molten ionomer granted the sealing of petals, which generally were no more than three.

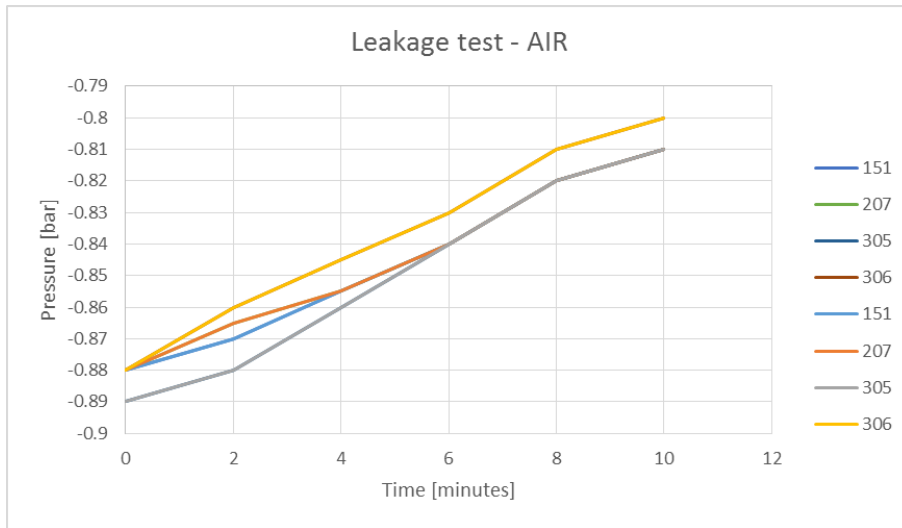
Figure 40 – Leakage tests for panels in air environment

Leakage tests' graphical results are reported in Figure 40. The behaviour of the repaired panels were similar, and sometimes they were graphically superposed. Not perfect leakage behaviour was imputed to be a cause of the experimental system used. However, results were comparable to the previous thesis, and thus in case of less than 10% pressure reduction in 10 minutes, the panel was considered to be repaired.

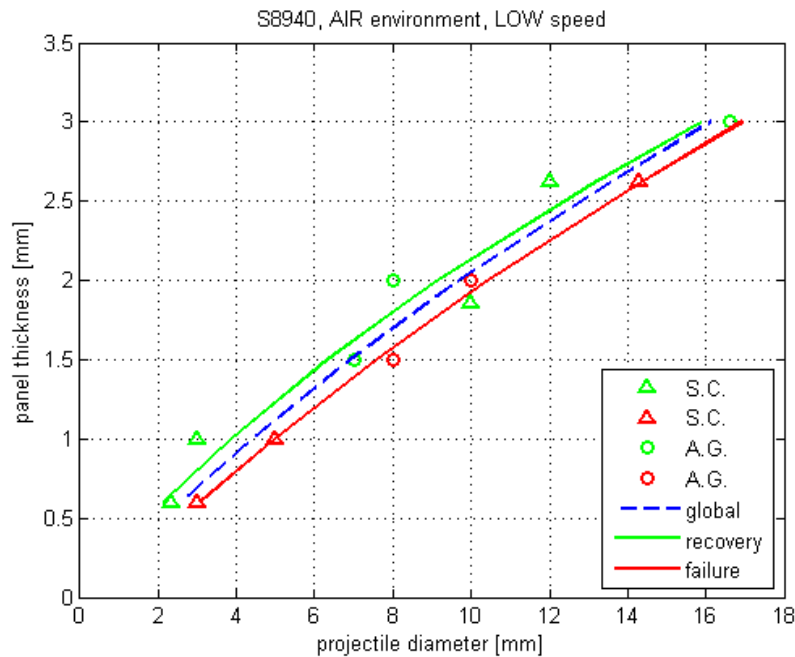
Figure 41 – s/d limit graph in air environment (2nd degree polynomial interpolation)

for higher thickness of the panel. Unfortunately, the testing facilities did not permit tests with bullet calibres higher than 16.6 mm. This means that a non-healing condition could not be found for the 3mm-thick panel.

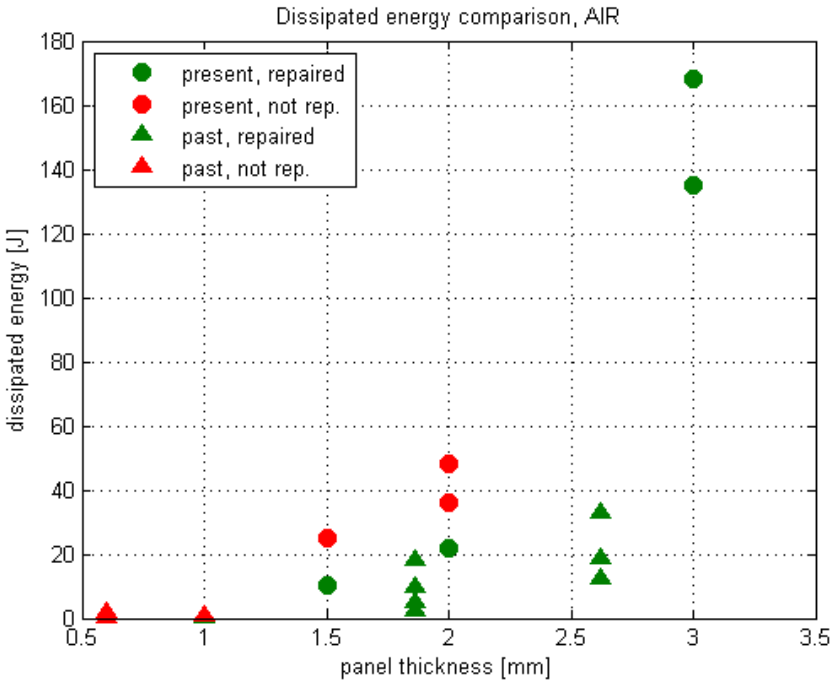
Figure 42 – dissipated energy graph for pure Surlyn8940 in air environment

Perhaps the region that experienced a high temperature was too large, and the deformation was too high to guarantee an elastic return.

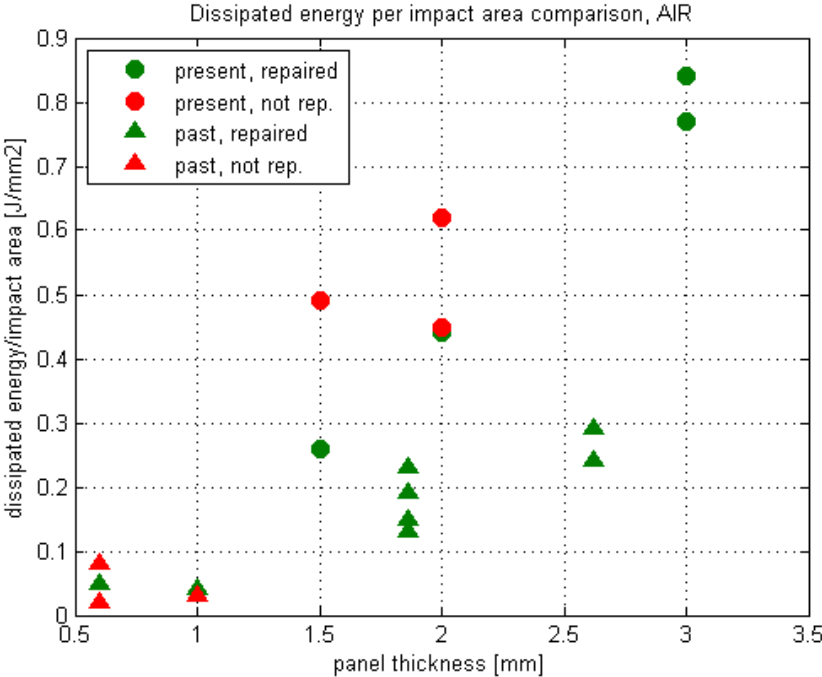
Figure 44 – Dissipated energy per impact area for S8940 in air

Tendency had now a linear trend, instead of an exponential one. Non repaired panels were still positioned in the upper part of the graph for the higher thickness panels, while for 1 and 0.6 mm panels, more ambiguity is present because of superposition of results.

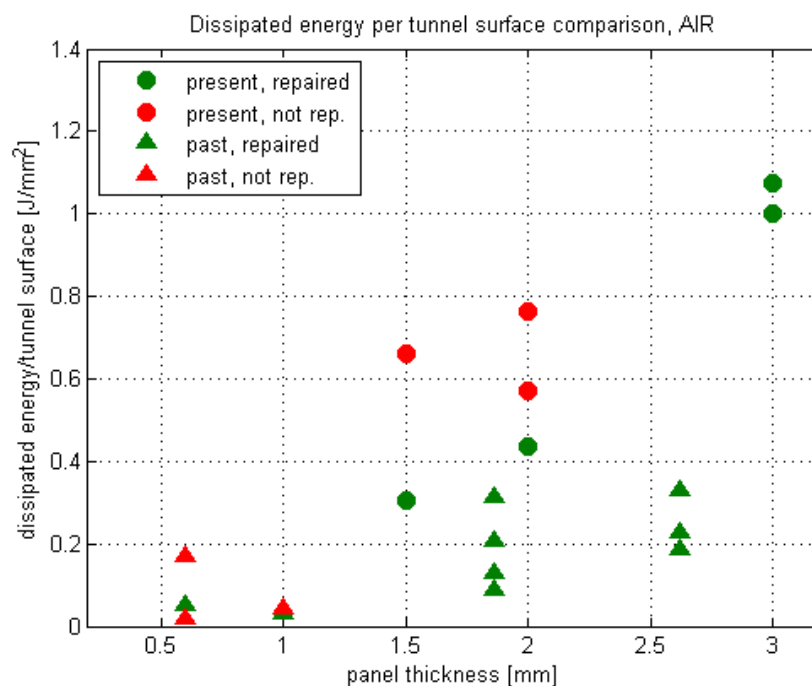
Figure 45 - dissipated energy per tunnel surface for S8940 in air

Results of these two normalizations are represented in Figure 45 and Figure 46. It is possible to observe a very similar behaviour to the ones obtained with the cross sectional area, but some additional separation between some red and green points is visible. Red and green points on 1.5 and 2 mm panel thickness continued to show a sort of critical value that can discriminate healing.

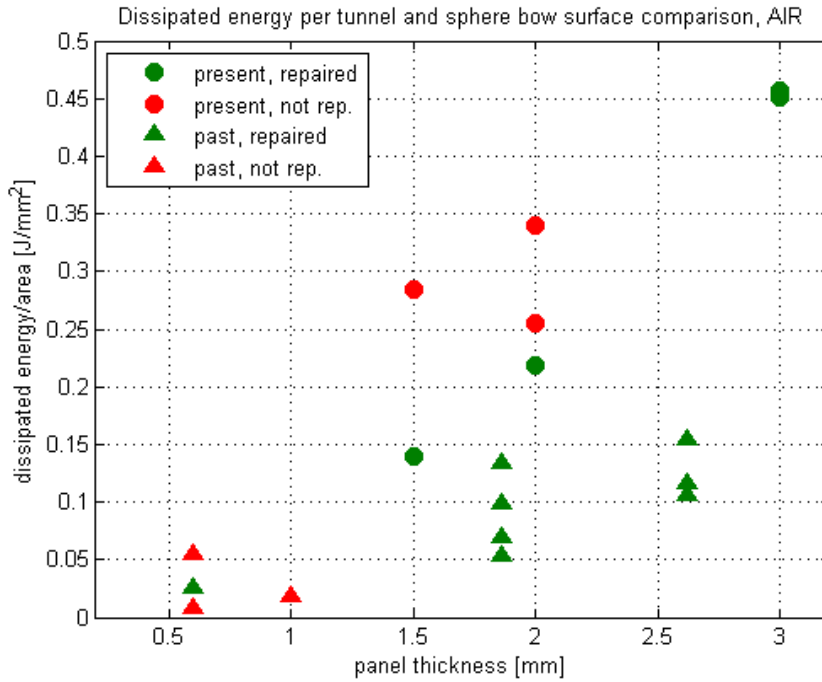
Figure 46 – Dissipated energy for tunnel and bow area.

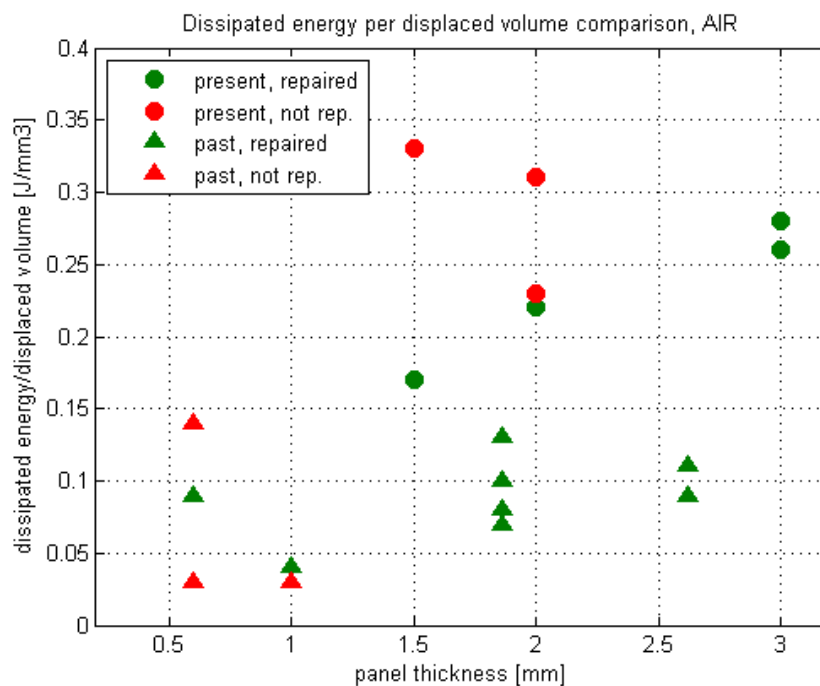
Figure 47 – Dissipated energy per impact area multiplied by panel thickness for S8940 in air

Literature is not completely in agreement with temperatures during healing, and to now data are still quite poor in number. Thermal imaging could be the definitive way in order to attempt a correlation of this theoretical computations with reality.

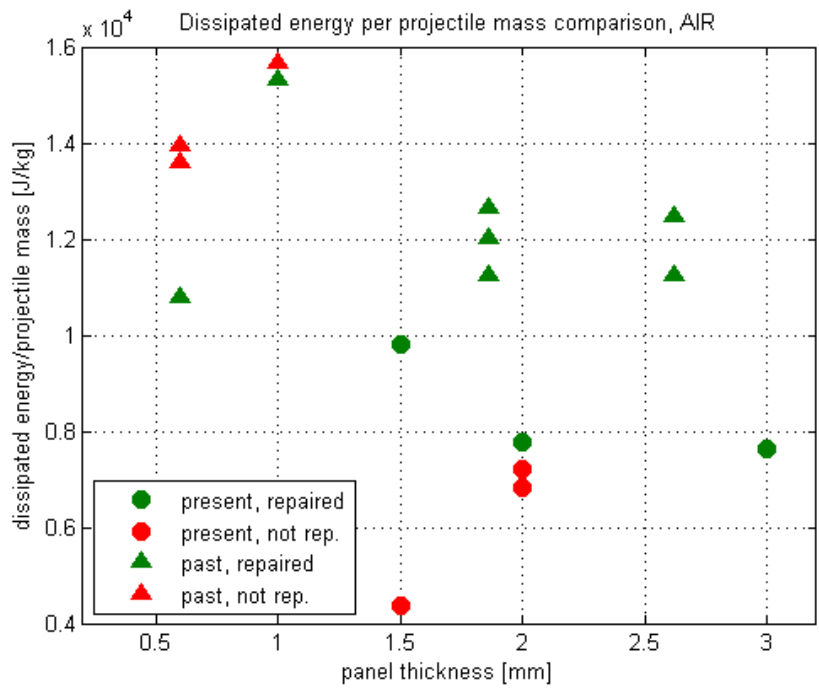
Figure 48 – dissipated energy per projectile’s mass for pure Surlyn8940 in air environment

In conclusion, a graph with normalization with respect to the mass of the projectile has been developed too. Results are quite similar to the ones described on $\Delta E/V$, even if they were subjected to a symmetrical inversion.

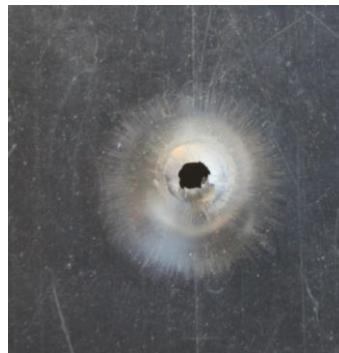
Also in the water case, even when the panel reparation was not complete, the hole reduction was substantial. Panel 204 is a paradigmatic case of regions division and small residual hole even if reparation failed.

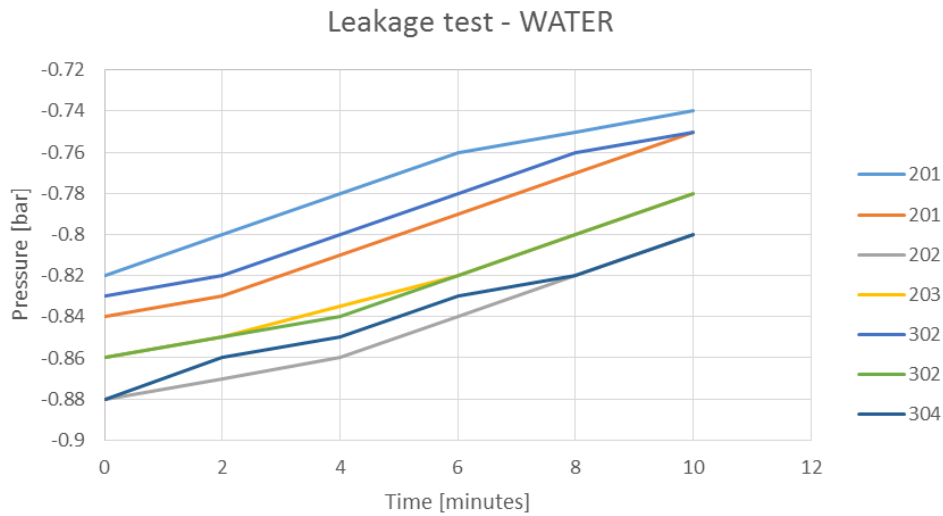
Figure 50 – Leakage tests for panels tested in water environment

Air leakage tests results were grouped in Figure 50.

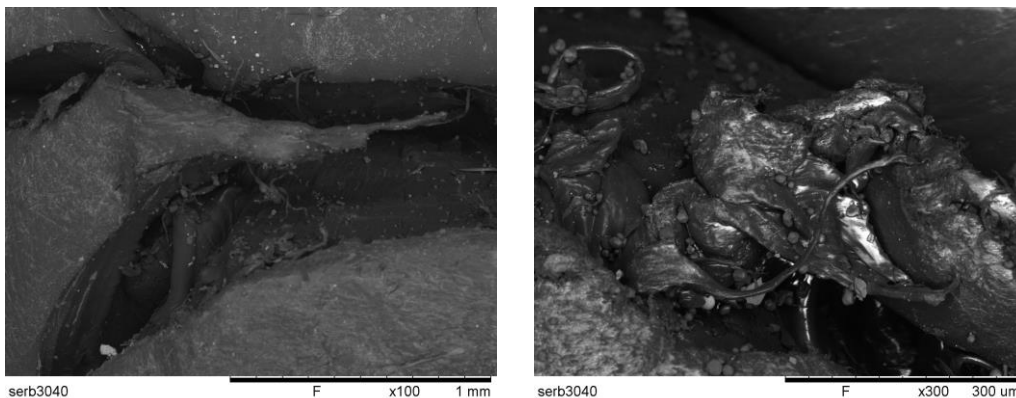
Figure 51 – SEM images for panel #302 (entry side)

These agglomerates were probably the result of the fast ionomer solidification process, which was probably speeded up by the cooling effect of water.

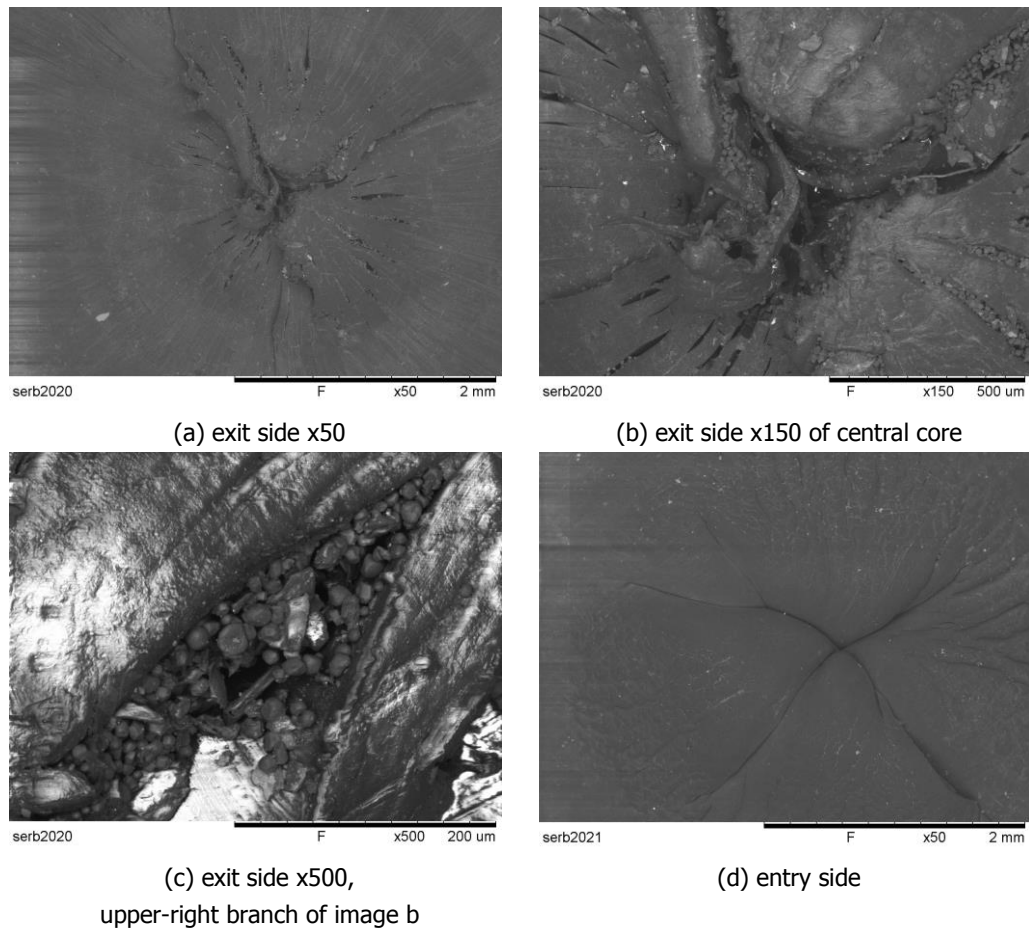
Figure 52 – SEM images for panel #202 (water, $s=2\text{mm}$, $d=12\text{mm}$, hole perfect closure)

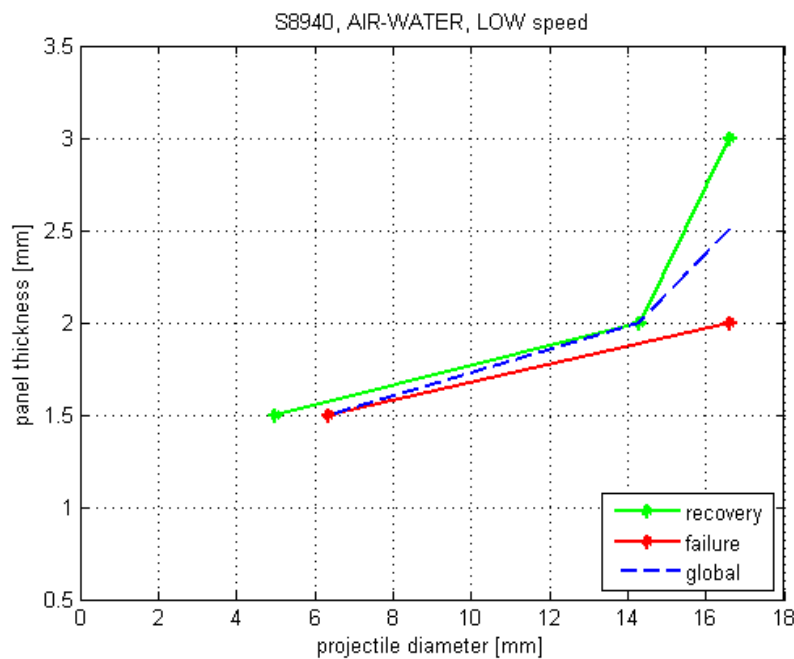
Figure 53 – s/d limit diagram in air-water environment

Unfortunately, because of the experimental facility limitations, non-reparation confirmation was not possible to be checked in the case of 3mm-thick ionomer.

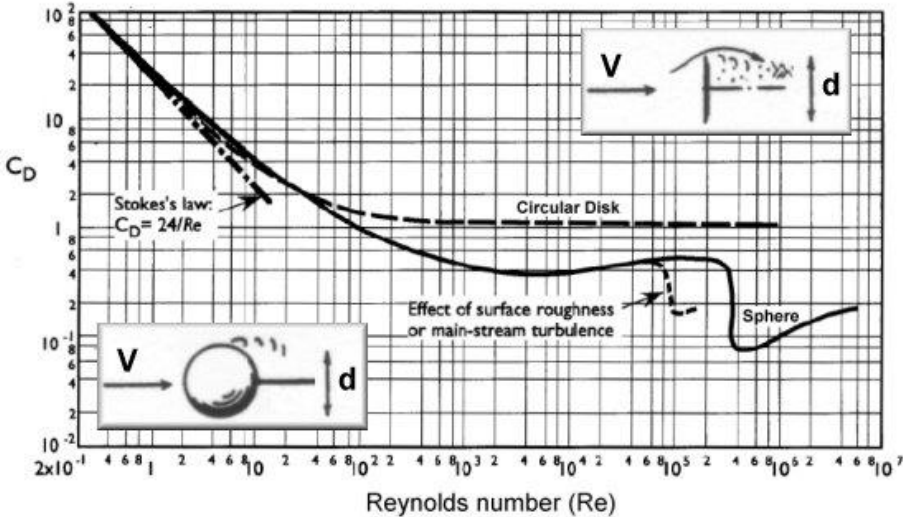
Figure 54 – Drag coefficient as a function of Reynolds number

In addition, complexity of numerical model is augmented by the fact that Reynolds number for this phenomenon (around 10e5) fell in the cavitation zone. Evaluation of drag coefficient (C_D) was thus quite complicated.

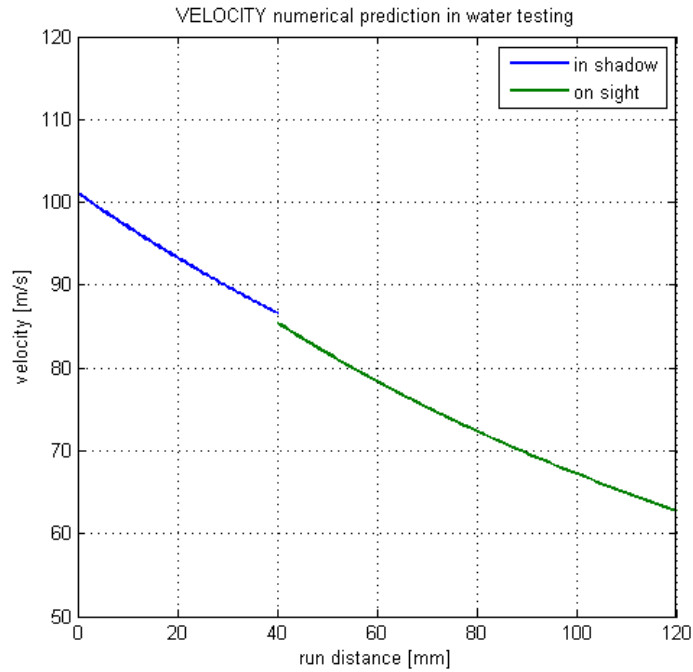
Figure 55 – Velocity prediction plot for panel 302.1

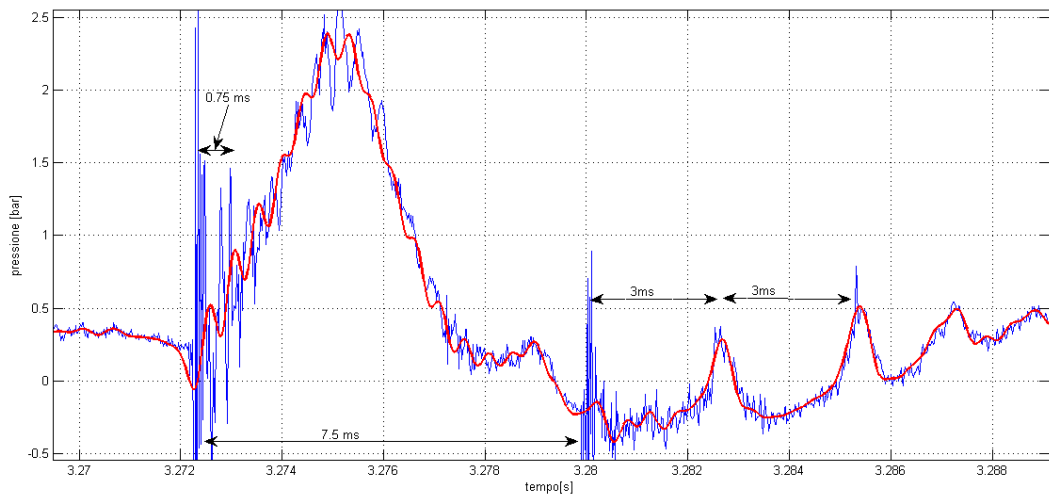
Figure 56 – Panel 154 raw pressure plot (in blue) and filtered signal (in red) at $F_c=2200$ Hz

Before proceeding to signal analysis, it is worth mentioning that in all pressure plots in the present thesis, the zero pressure value is the reference one, taken with the fluid at rest condition.

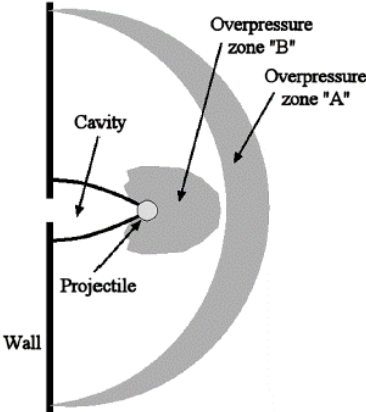
Figure 57 – Overpressure zones inside the fluid

distorted peak was observable. This was probably the footprint of the ionomer rupture event, when the projectile perforated the panel. Then, after the perforation, a compression wave was visible; in this point, the highest pressure peak is reached. After the peak region, a number of oscillations of about 100 Hz frequency were sensed by the pressure gauge. Those were probably due to the interaction of the compression and expansion waves generated by the projectile impact and the passage of the bullet cavity region inside the tank.

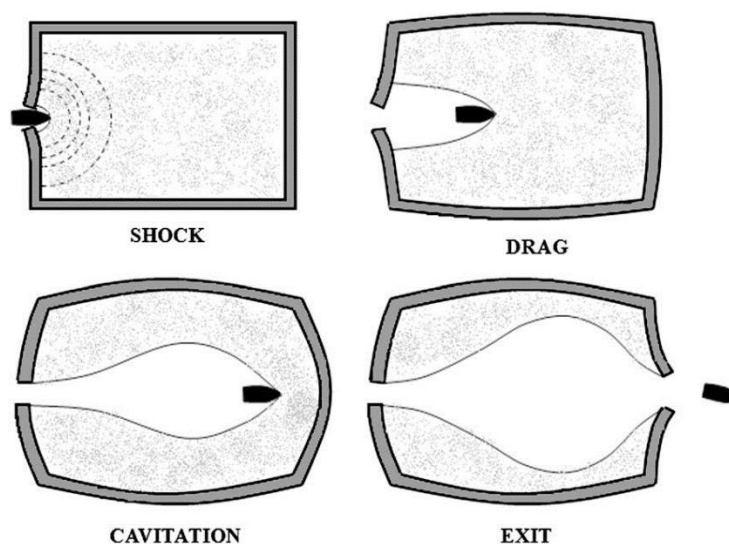
Figure 59 – Phases of hydrodynamic ram

The displacement of fluid during the drag stage forms a cavity behind the projectile. The subsequent expansion and collapse of the cavity are known as the cavitation stage. The oscillations of the cavity can cause significant pressure pulses. These pulses are less intense than the pressure generated by the shock wave, but have a longer duration in time.

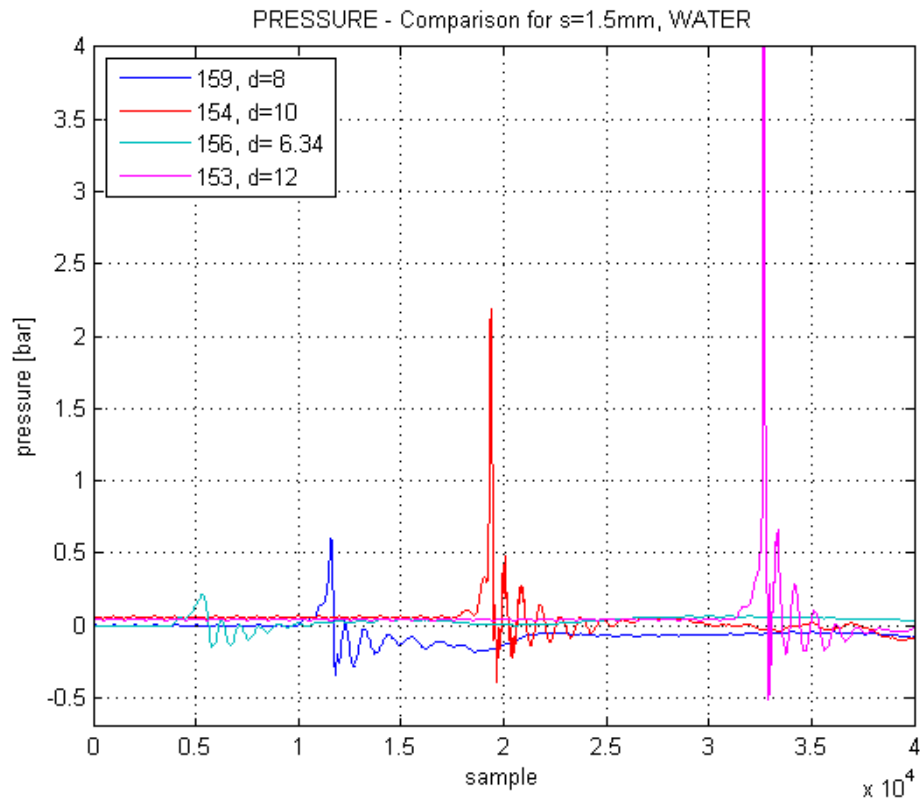
Figure 67 – Comparison graph for all tests in water with perforation of the panel
(for visualization purposes, signal 153 was cut in its maximum amplitude)

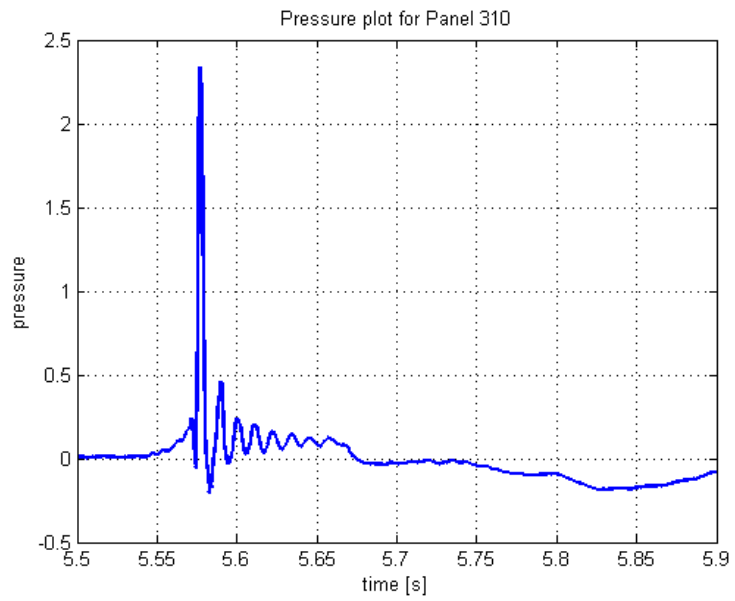
Figure 69 – Panel 310 (trapped projectile) pressure plot

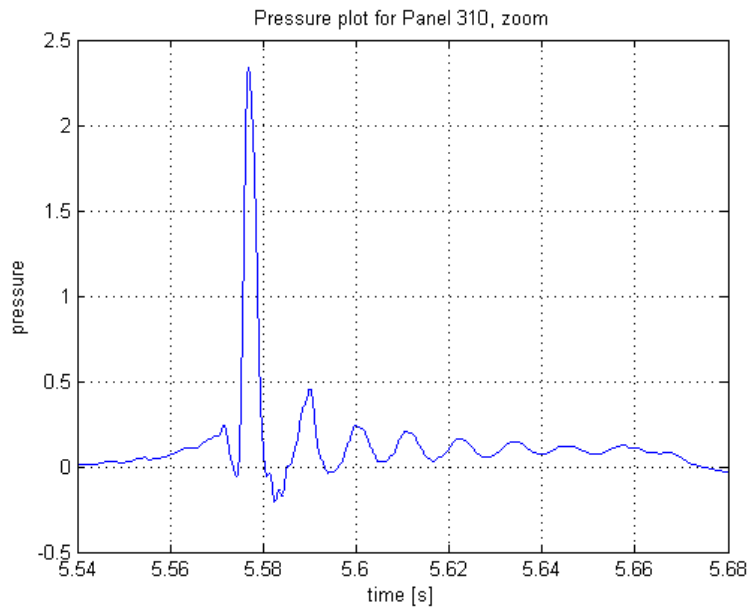
Figure 70 – Panel 310 pressure plot (zoom view)

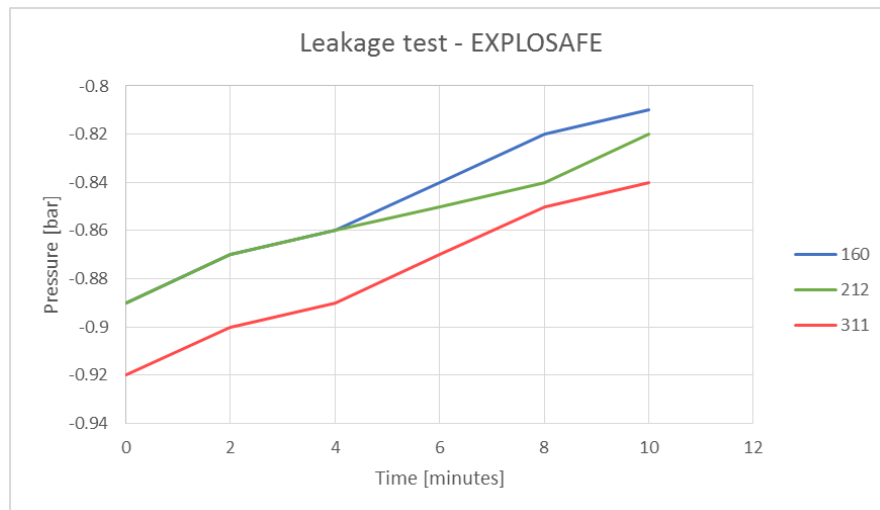
Figure 74 – Leakage tests graphs on repaired panels (water-Explosafe environment)

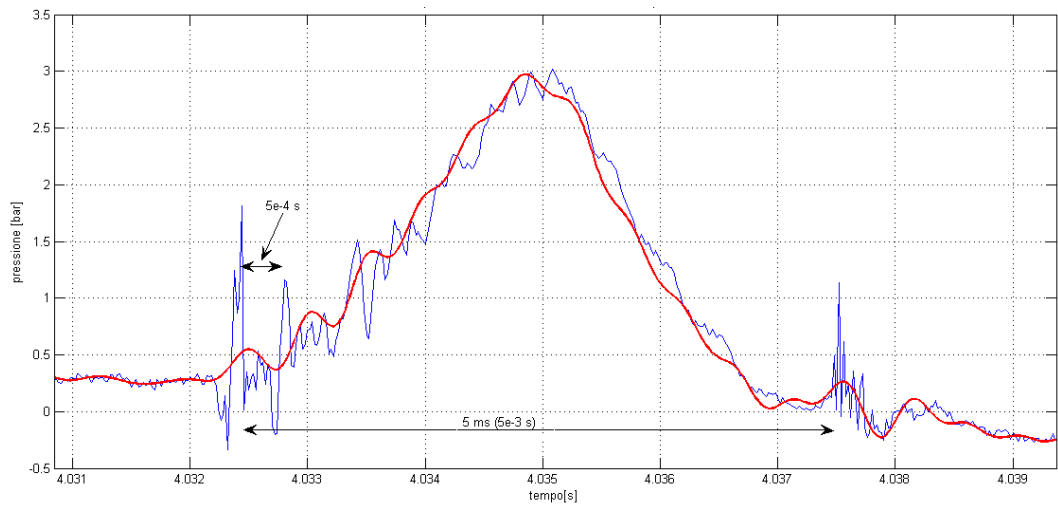
Figure 80 – Panel 211 pressure plot, with cut frequency (in red) at 2200Hz
