POLITECNICO DI MILANO

Master of Science Degree in Space Engineering

TESI DI LAUREA MAGISTRALE - AA 2014-2015

**Experimental analysis
of a self-healing ionomer in a tank
with an internal aluminium filler**

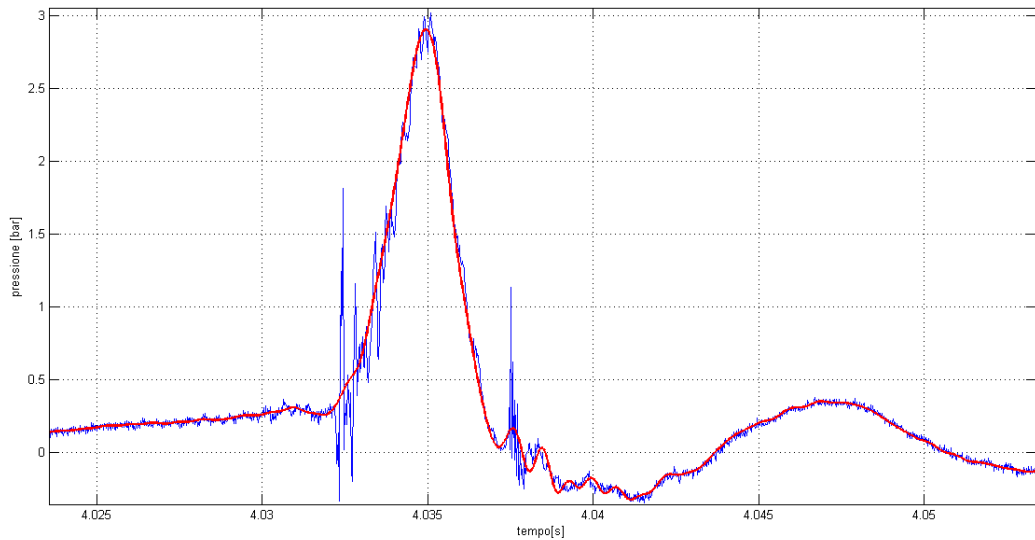
Figure 81 – Panel 211 pressure plot, with cut frequency (in red) at 600 Hz

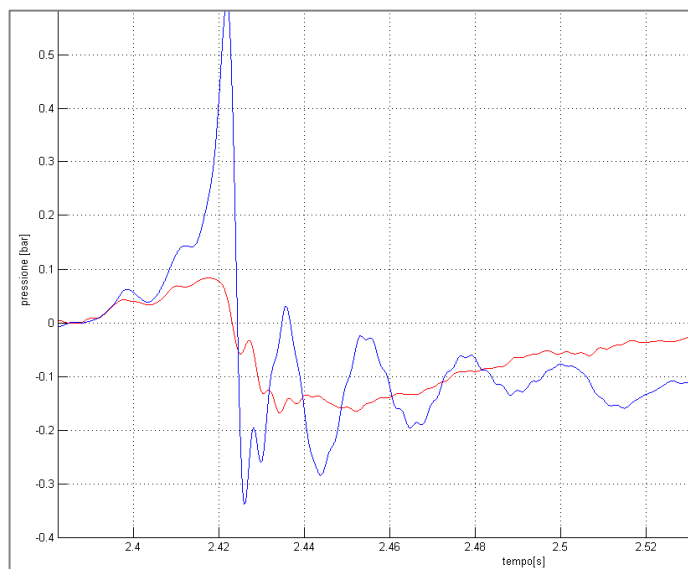
Figure 90 – Pressure variations comparison in the first instants (blue: water; red: with Explosafe)

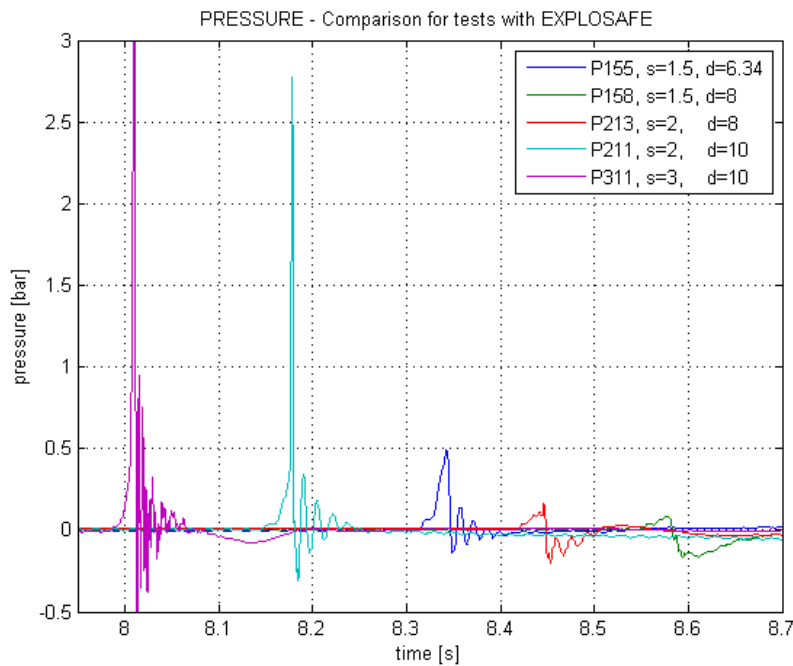
Figure 95 – Pressure wave comparison for tests with Explosafe

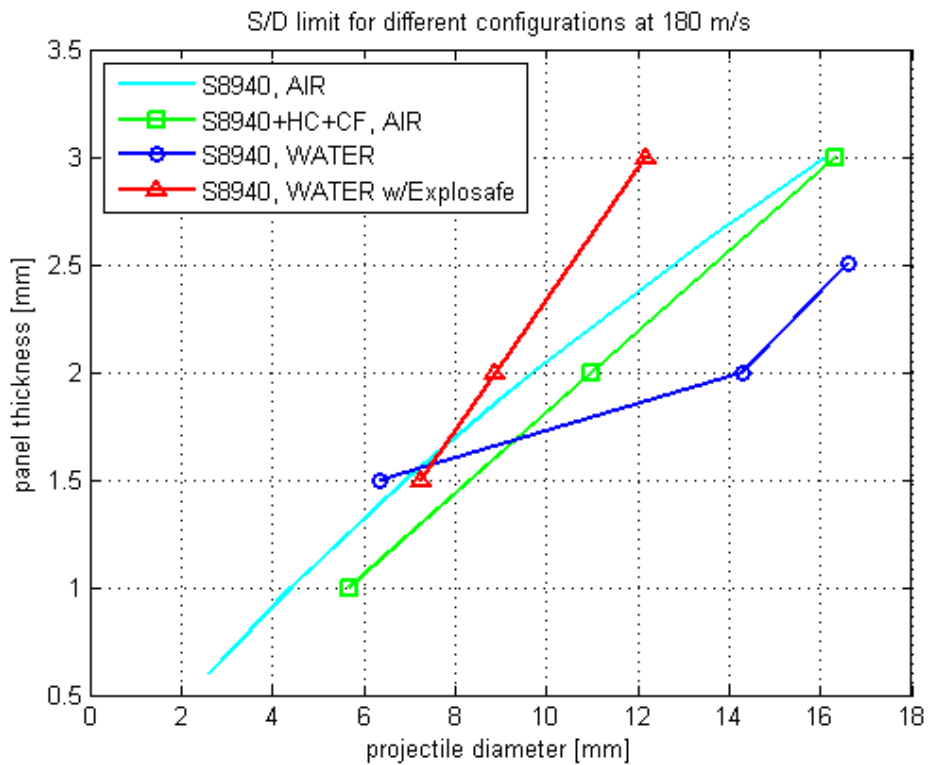
Figure 96 – S/d limit graph for different configurations
