UNIVERSITY POLITECNICO DI MILANO
SCHOOL OF ARCHITECTURE URBAN PLANNING CONSTRUCTION ENGINEERING
DEPARTMENT OF ARCHITECTURE
MASTER THESIS

CONSERVATION AND REVITALIZATION OF SAN GIOVANNI FORTRESS

4. CONSERVATION AND REVITALIZATION OF SAN GIOVANNI FORTRESS

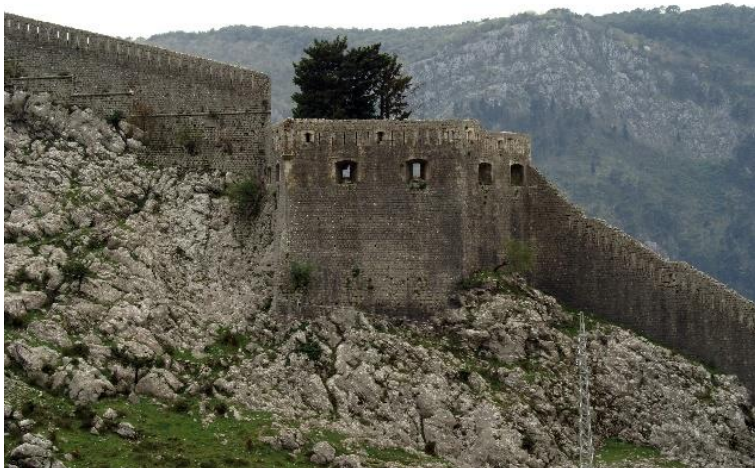
1 Bataglia platform, eastern elevation

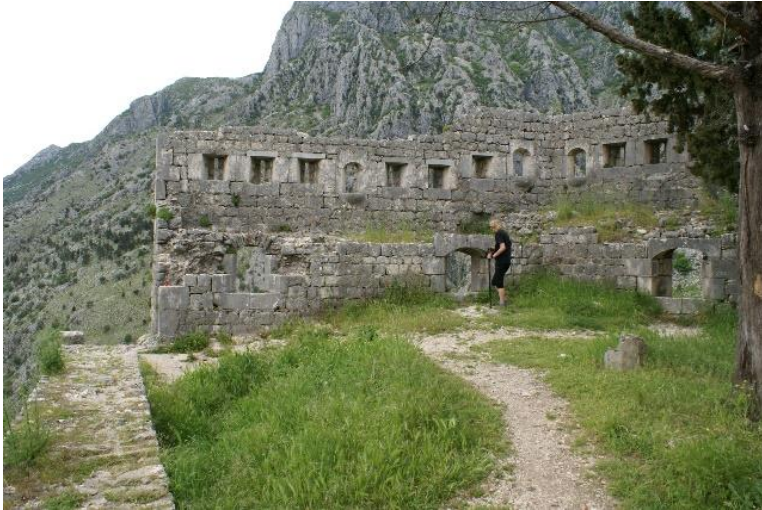
Rampart walking path that extends from the inside of the platforms, along the walls with loopholes, is in very bad state of conservation and almost impassable which presents a loss of significant, and for visitors very attractive, segment of fortification architecture. Also, in many situations, there is an increased risk visitor's safety due to missing parapet walls on the exposed positions.

2 Bataglia platform, missing parapet wall and inaccessible walking path

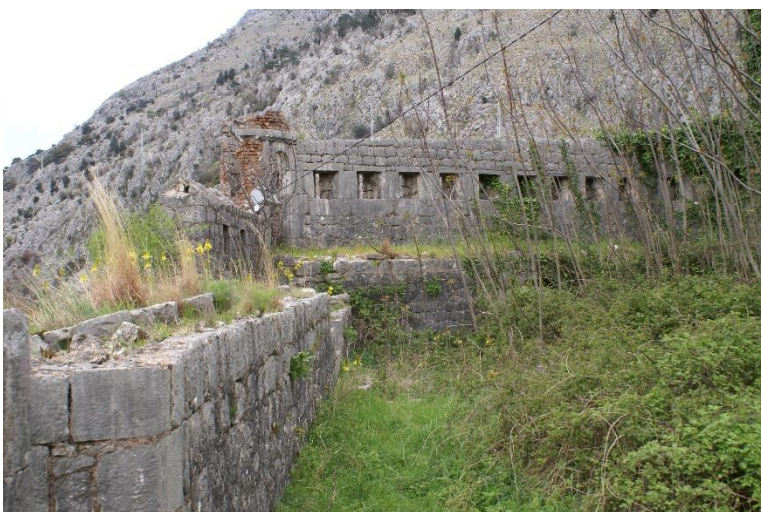
Chronologically, articulated artillery positions were built in different periods, but always solid with high quality of foundations constructed on a stable rock base. Well-built foundations are responsible for high degree of preservation of all mentioned positions which for centuries have not shown signs of structural instability. At all positions, high eastern walls intended for refusing the artillery attacks from the direction of *Njegusi*, are very well preserved with little or no traces of serious damages. The defects and signs of decay are mostly occurring in the upper zones of the walls and on the inner, western, side of the platforms where we can notice the damage caused by natural factors, human neglect and poor maintenance. The separation of stones and larger parts of masonry in these zones most often occurs as a consequence of seismic activity and vegetation pressure.

4 Priuli platform, vegetation pressure

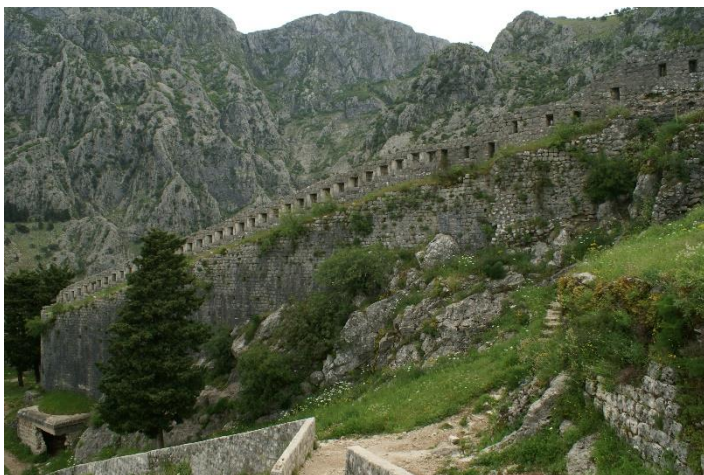
The most frequent damage occurs on the upper zones of the ramparts, more precisely on the walls with loopholes, where we can notice separated or missing parts of masonry. Rampart walking paths are in very poor state of preservation and almost inaccessible. Protection stone rail is missing in most of the cases while the stone steps are heavily damaged. Although very dangerous, the movement along these walking paths is not prohibited, so tourists often use them. In this way, their own safety, as well as the safety of other visitors who use regular paths passing under the ramparts is also jeopardized.

9. Rampart walking path

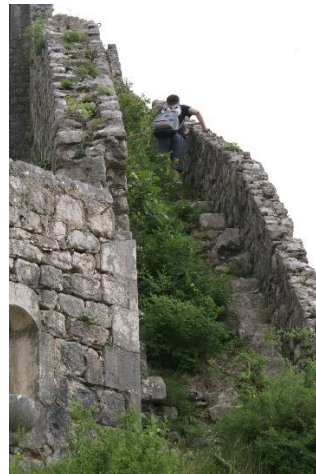
10. Compromised visitors safety

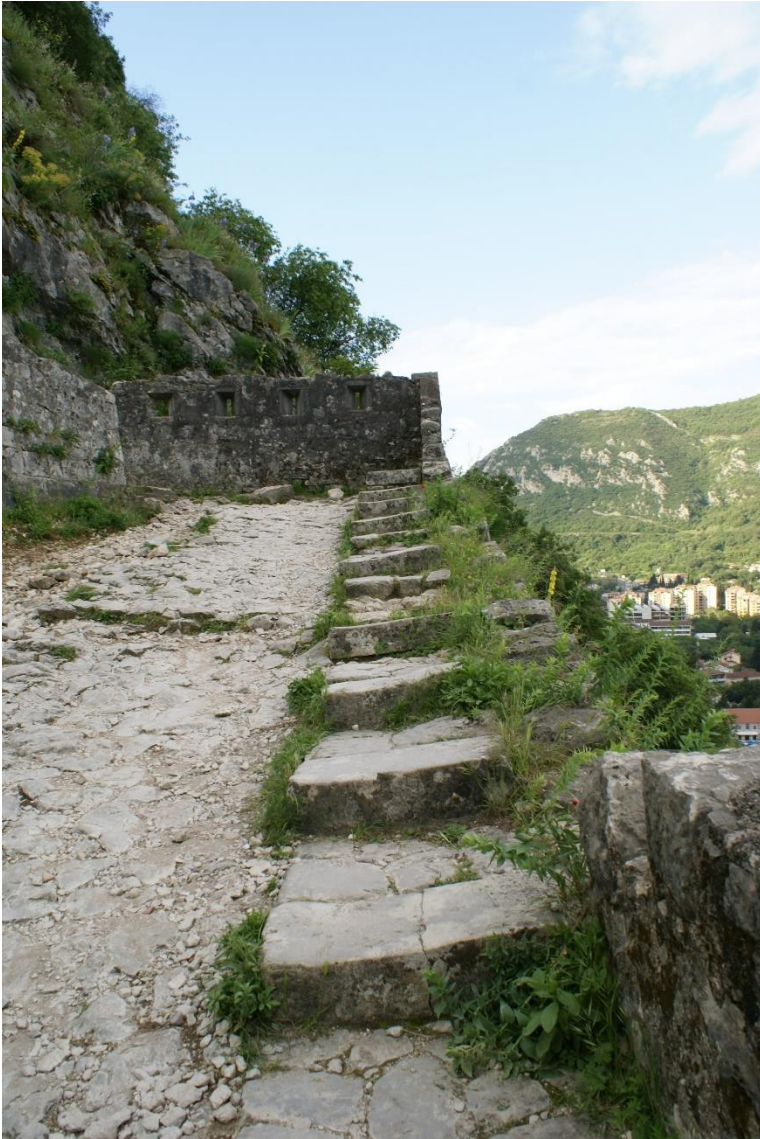
Today this road is structurally well preserved. From the bottom to the top there are some 1800 stone stairs that are in some cases damaged or completely missing. Situation is similar when it comes to the stone rails walls that are protecting exposed sides of the road from bottom to the top. Transportation ramps are in some portions well preserved and in some damaged or completely missing. It can be noticed that the most serious damages are caused by landslides occurring after heavy rains. This problem presents risk for the visitor’s safety as the landslides were already occurring when the presence of visitors on the roads was high.

22 Example of missing stone rail

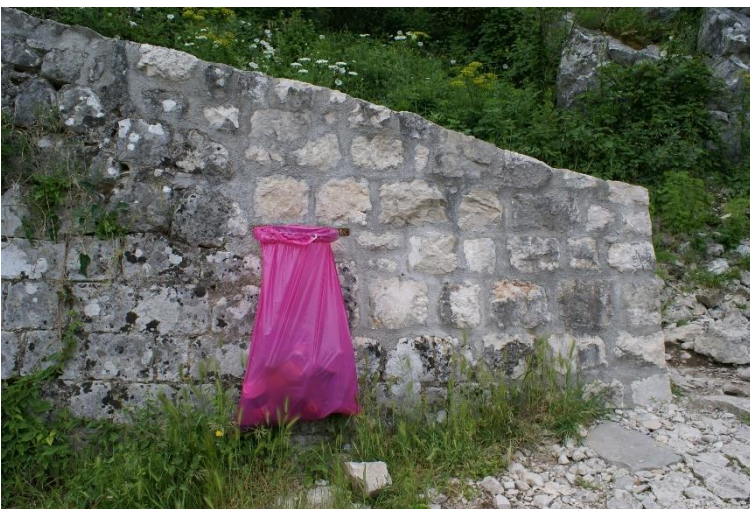
23 Example of repair intervention

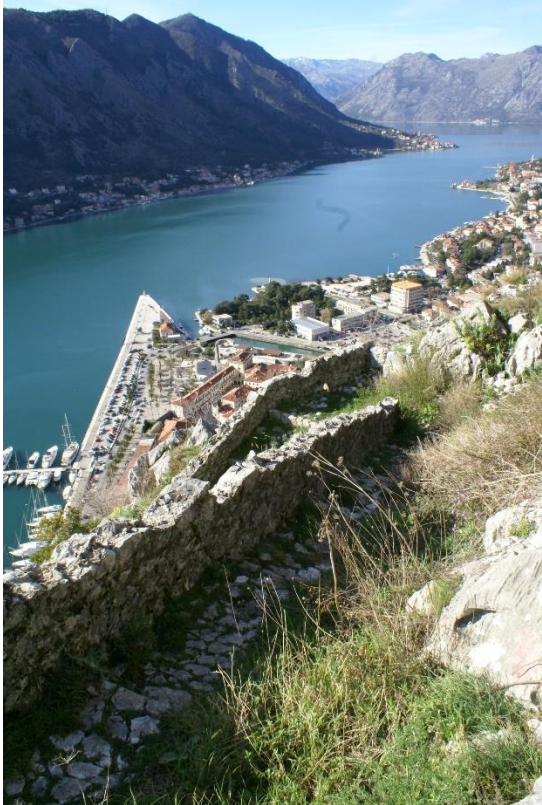
Communication path generally in poor state of conservation. Large portions of stone railing wall are missing. In some portions path was secured with iron fence which was most likely stolen by the residents. Absence of railing presents a problem considering that in some portions path is passing along very high cliffs. As already mentioned, the pressure of vegetation is very high. The problem of unstable rock mass is particularly high in this part of the ramparts. In recent years frequent landslides have significantly damaged parts of fortification structures, retaining walls, communication roads, but also jeopardized residential buildings located at the foot of the hill. It was exactly during the last case of landslide that the initial part of the path, at the position of *Gurdic bastion*, was completely destroyed and cut off, so today the path is also impassable.

26 Maintenance and deterioration issues

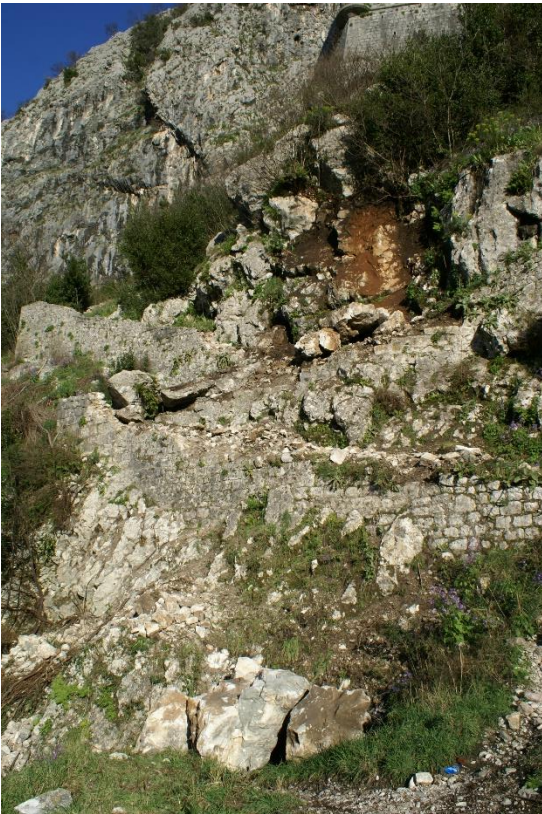
27 Damage caused by landslides

Another natural pressure caused by heavy and long rains are the frequently occurring landslides that are causing serious damages to the property components and endangering the safety of visitors.

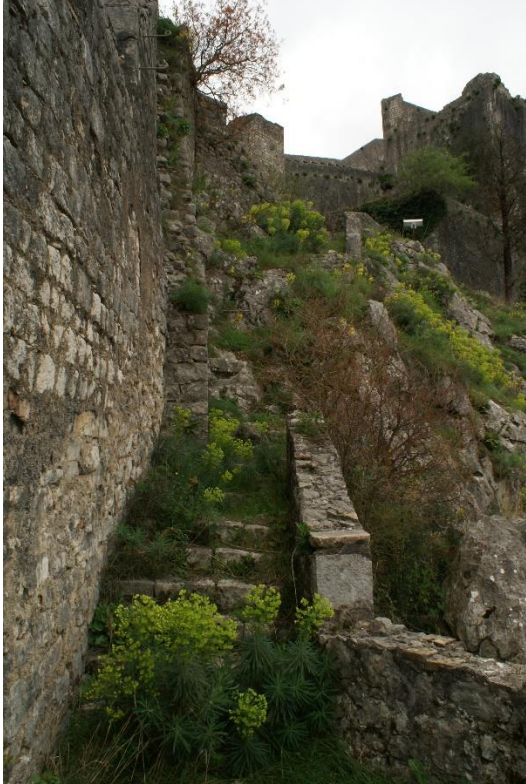
30 Neglect and bad maintenance example

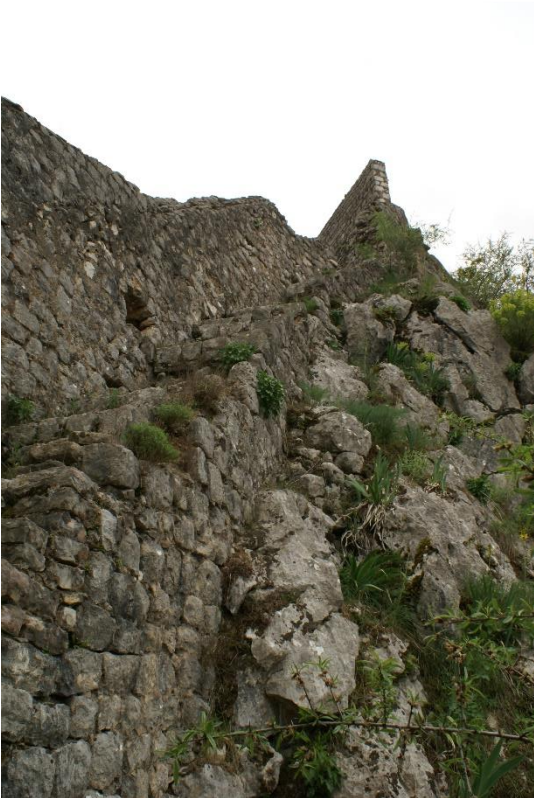
31 Example of exposed walking paths

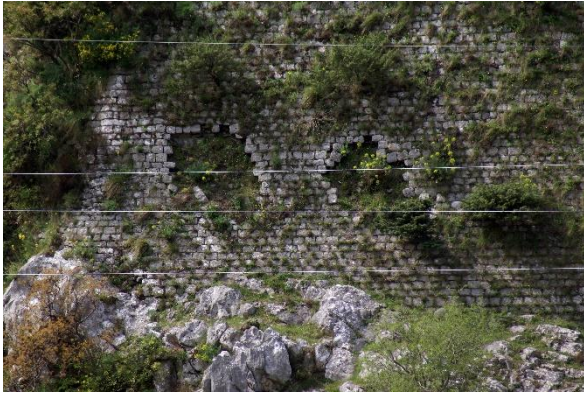
Today, curtain walls are in poor state of conservation mostly due to the seismic and atmospheric influences, combined with bad or non – existing maintenance. Zones with detached and missing stones can be noticed at several positions. In some portions such damage can lead to structural problems causing partial or complete collapse. Any kind of future interventions on this part of the fortress would present complex undertake mainly because of the terrain inaccessibility. (figure 1 - 2)

Figure 1. Venetian curtain wall; decay example

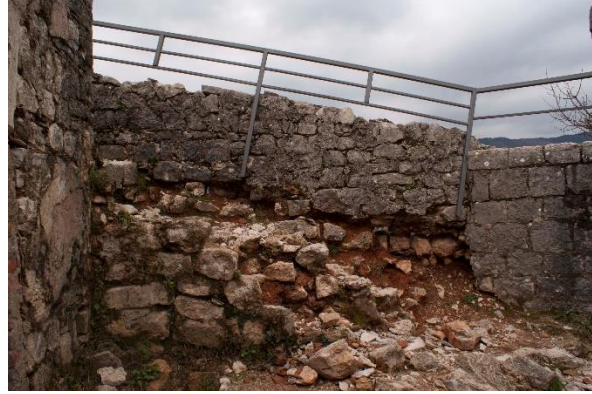
Figure 2. Courtyard wall, decay example

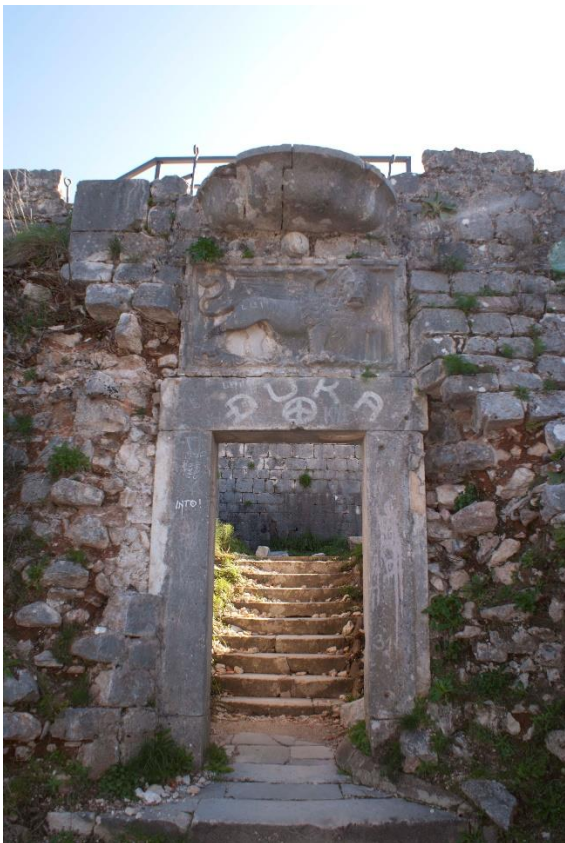
In poor state of conservation. Deterioration process is continuous and caused by seismic activity, vegetation, atmospheric and anthropogenic influence which can be evident by comparing available photos from 2006 and 2017. Non – existing maintenance problem remains, even on the positions that are relatively easy to reach.

Figure 3. Venetian gate

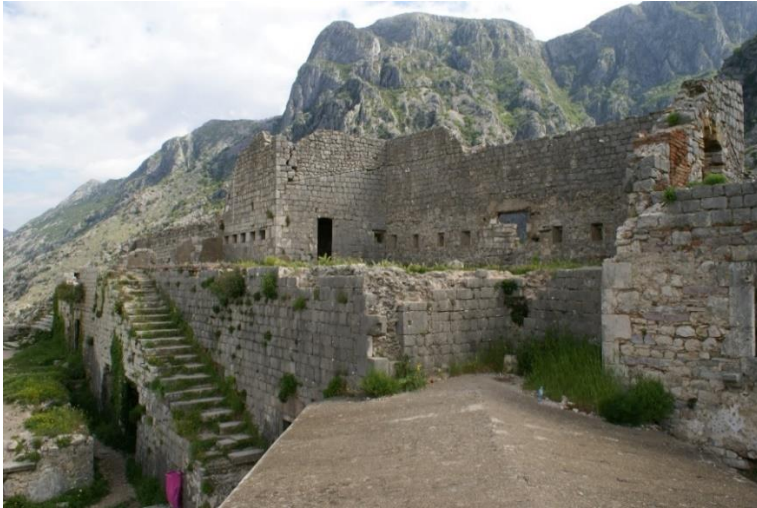
Tiles on the free ends of the platform are unstable, separated from the base and missing in several areas. Due to the human influence these tiles are often falling off from the platform causing further damages and danger for visitors.

Separation of the stones is evident on the crown of the wall, causing damage and danger for the visitors.

Staircase is in poor state of conservation with partially fractured and missing step tiles. This damage is mainly caused by the impact of the stones that falls from the upper levels.

Crown of the wall is unstable, subject to decay and separation of the stones causing further damages and danger for visitors.

Large crack, jeopardizing the structural stability, is evident on the corner of the eastern and northern wall.

Figure 4. Platform with cistern

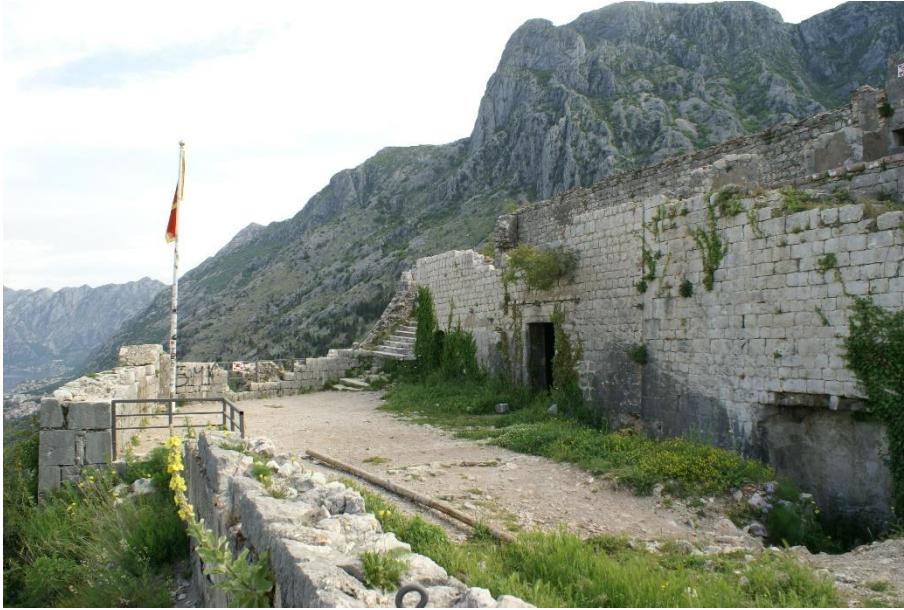
Two large structural cracks are evident, one on the corner and the other in the middle of the wall.

Crown of the wall is unstable, subject to decay and separation of the stones, causing further damages and danger for visitors.

Reinforced concrete slab appears to be in good structural condition. Steel panels and beams are decaying due to corrosion.

Figure 5. Barrack and military magazines

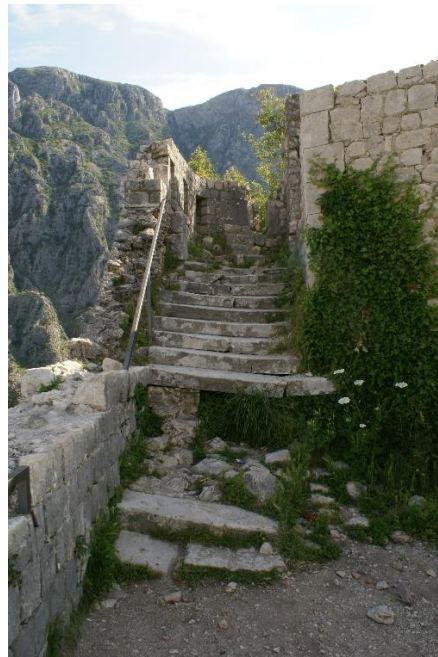
Staircase: In poor state of conservation. Large parts of the steps are missing.

Figure 7. Staircase; example of decay

Demands urgent measures.

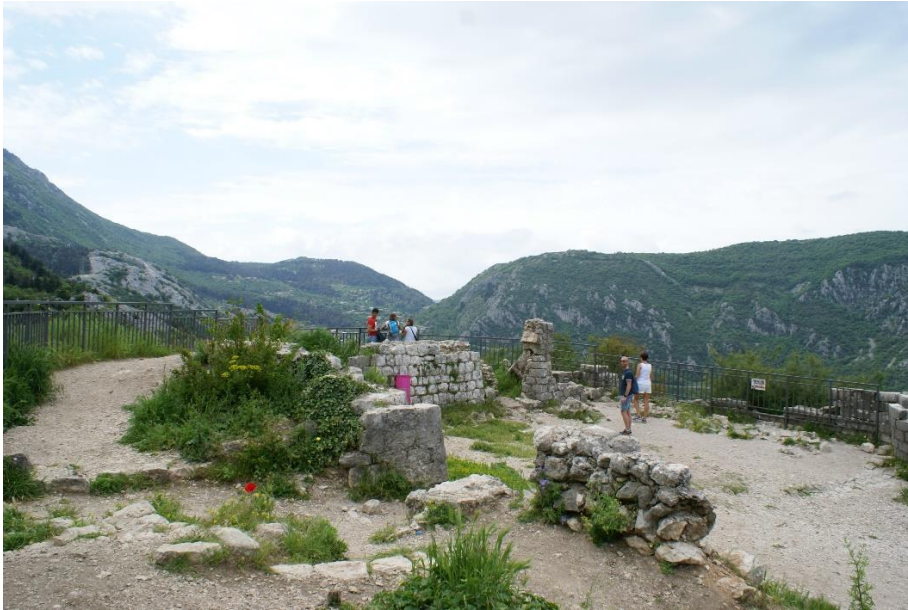
Deterioration of artillery positions and protection walls due to natural and human influence.
 Non-existing presentation of the platforms original function.
 Visually, historically and aesthetically inadequate new fence. (figure 8)

Figure 8. South artillery platform

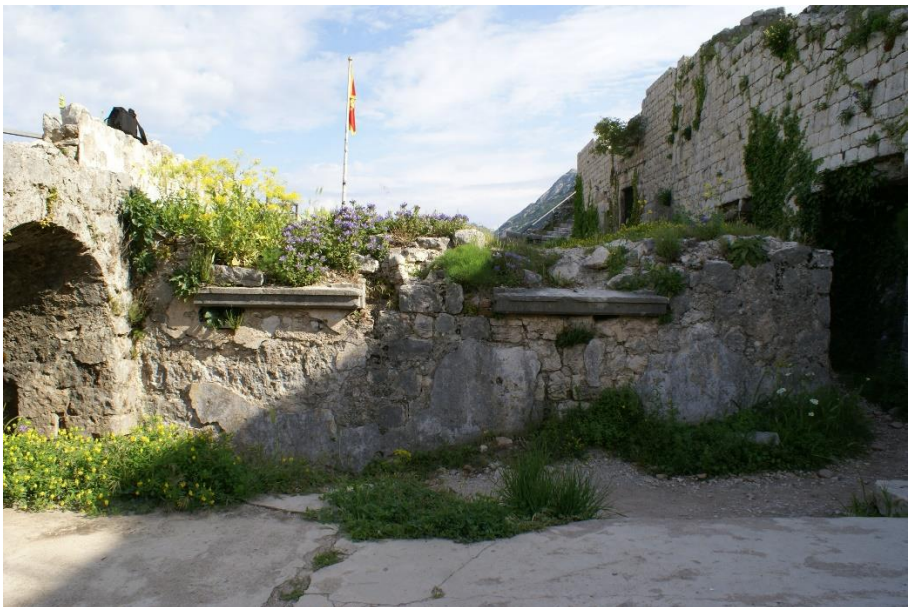
The remains of the building below the Northern artillery platform.
 Remaining walls with window openings are in the process of deterioration.
 Archaeological studies have never been carried out. (figure 9)

Figure 9. Remains of the "Correction house".

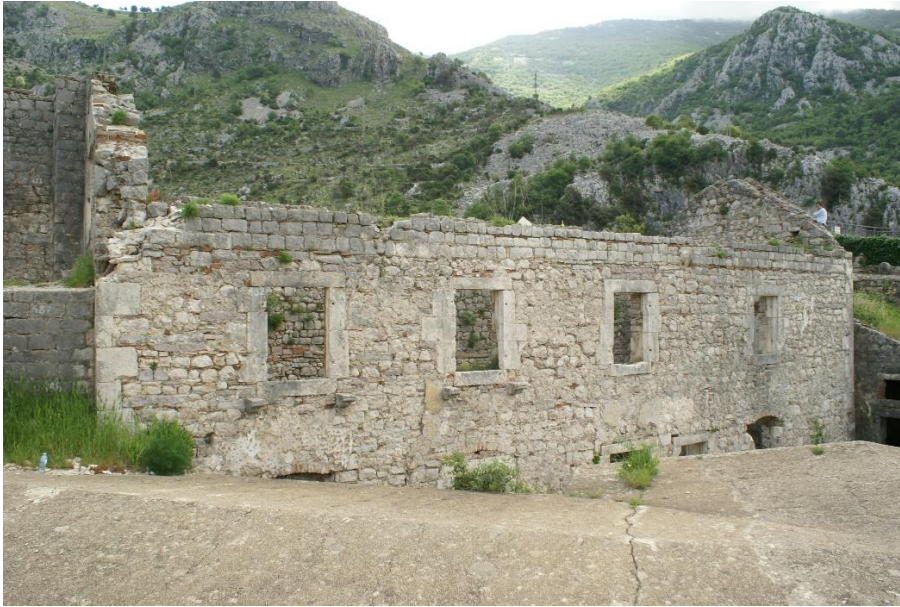
Peripheral and interior separation walls are the only preserved elements and subjected to progressive deterioration.

Layers of soil, trash and vegetation are covering the floor.

Figure 10. Main military barrack; western elevation

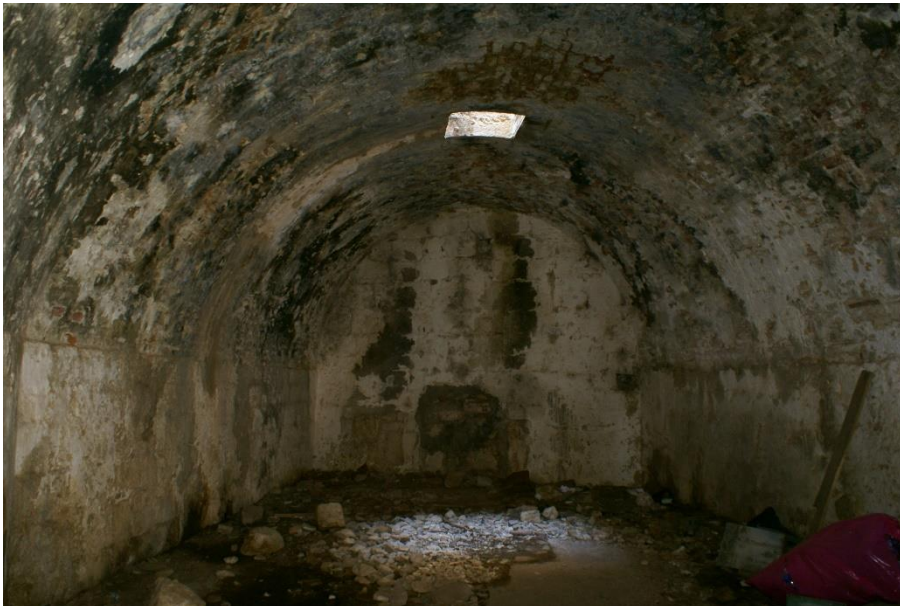
In very bad condition, neglected and without any functions.

Moisture and water penetration are the main problems causing progressive deterioration.

Figure 11. Casemate

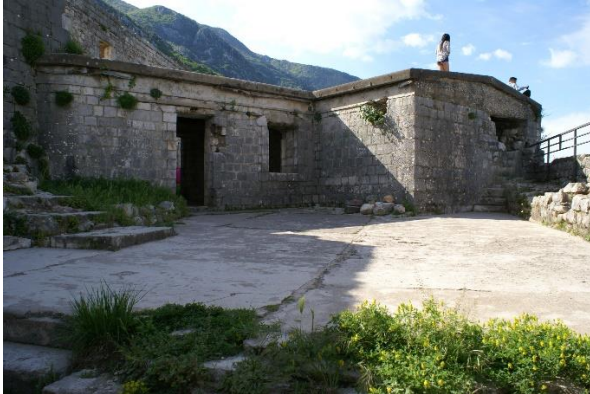
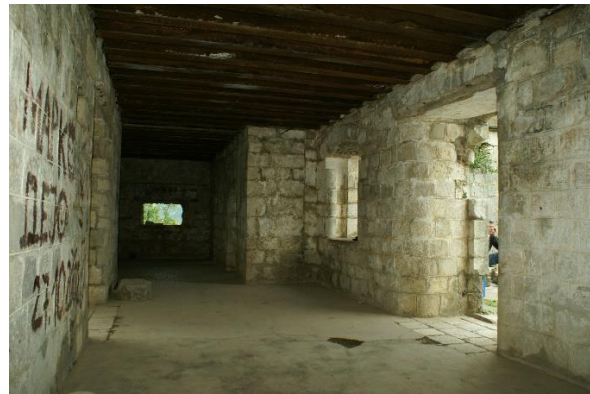
Walls are in good condition and do not show traces of decay, except partial collapse on a few positions.

Reinforced slab steel elements have corroded but do not show evidences of structural vulnerability.

Doors and windows have been removed allowing layers of soil and water to enter from outside during heavy rains.

Figure 12. Artillery building

Figure 13. Artillery building; interior

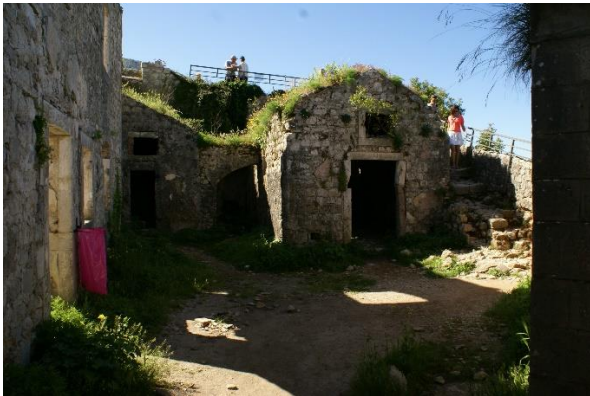
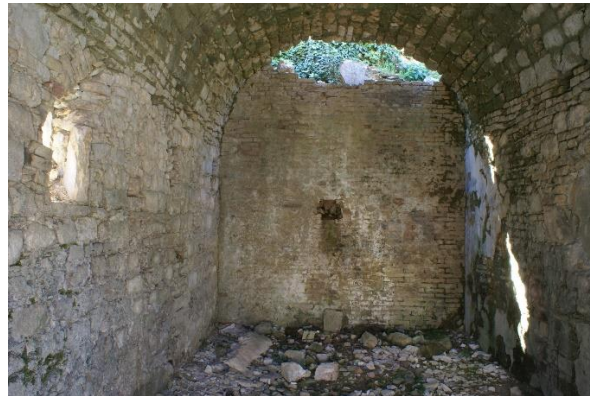
In very bad condition.

Both buildings are structurally jeopardized and in demand urgent interventions.

Problem of moisture and water penetration is evident.

Figure 14. Saint John church and powder magazine

Figure 15. Saint John church interior

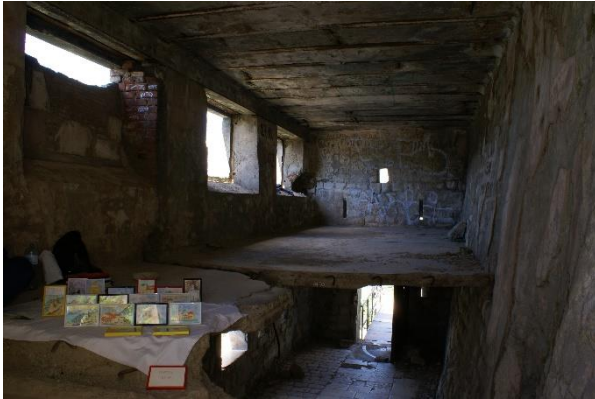
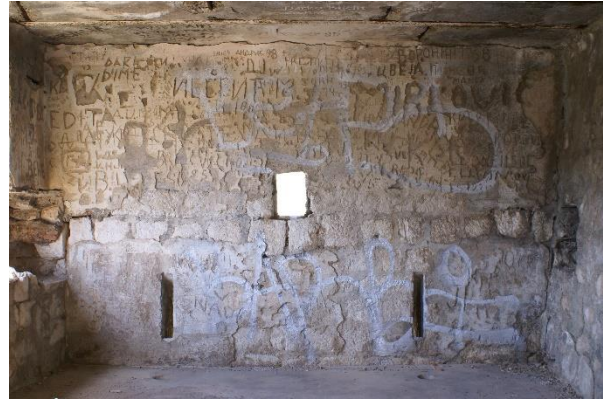
Evident large amount of decays, mainly caused by natural and human influence.

Structural damage of the walls could lead to collapse in case of seismic activity.

Former drawbridge is not functional. Present bridge is damaged and inadequate.

Figure 16. New entrance building

Figure 17. Example of decays

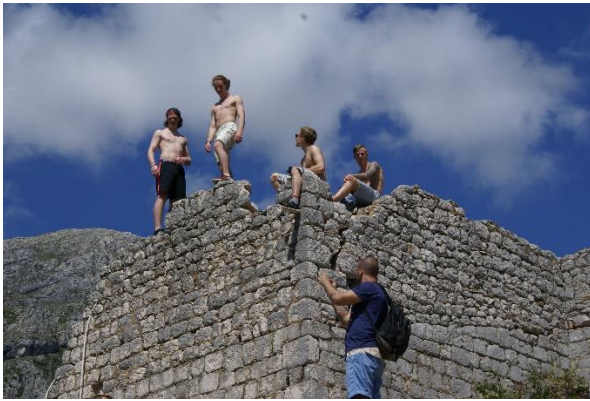
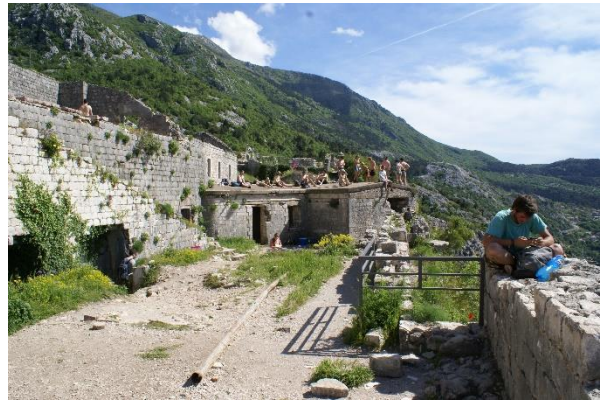
Figure 18. Uncontrolled visitors pressure, example

Figure 19. Visitors pressure, example

It is important to note that elderly people, with limited physical fitness and ability to move, present high percentage of visitors that are trying to reach the top of the hill during the summer touristic season when the temperatures are extremely high. In addition to the unsafe nature of the paths itself (detailed described in chapter 6.2.1) we can conclude that the safety of the visitors is compromised from many points of view.
