POLITECNICO DI MILANO

Corso di studi di Laurea Magistrale in Ingegneria dei  
Sistemi Edilizi

"Self-healing efficiency evaluation of UHPFRC  
enhanced with Crystalline Admixtures and  
Nanomaterials"

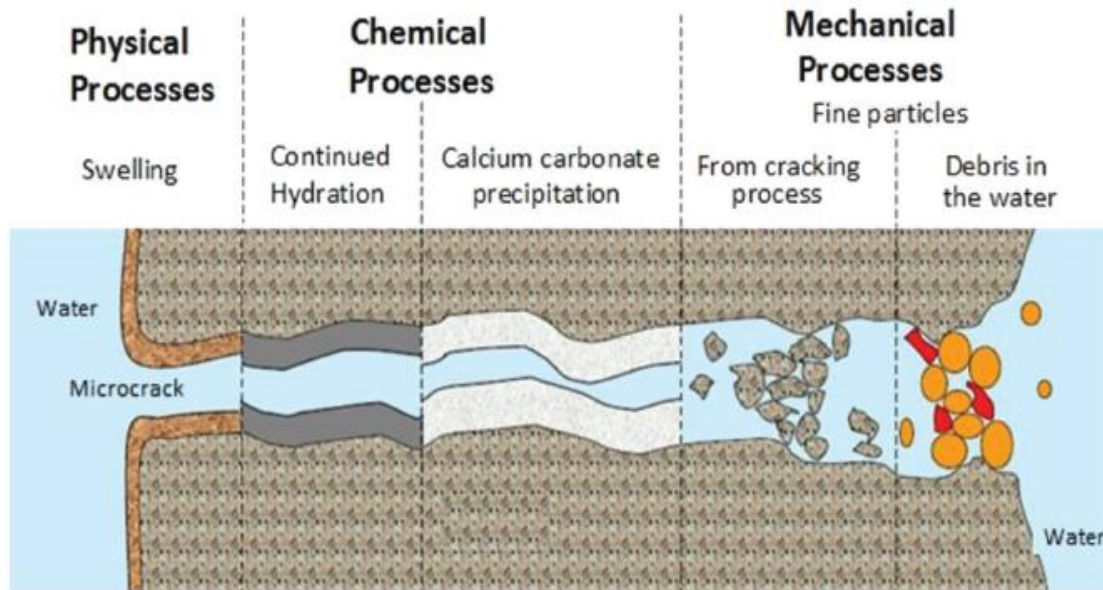
Figure 2–1. Processes causing autogenous healing (De Rooij et al., 2013)

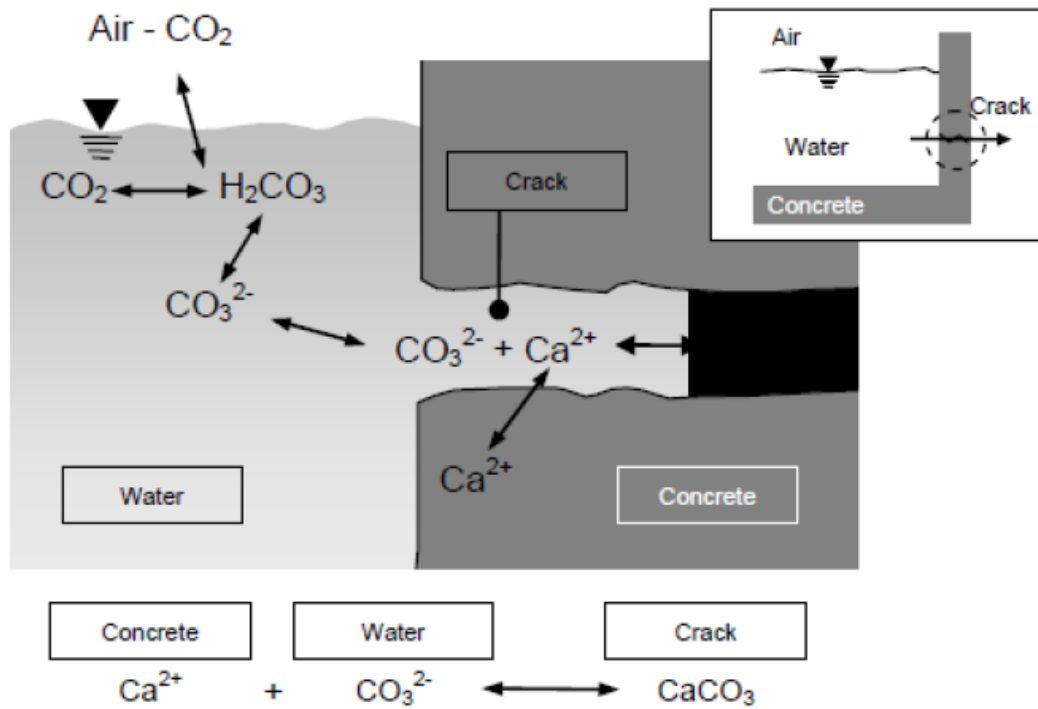
Figure 2–2 shows an example of carbonation phenomenon in a cracked concrete wall of a water tank (Edvardsen, 1996).

Figure 2–2. Carbonation process in a crack produced in a water tank (Edvardsen, 1999)

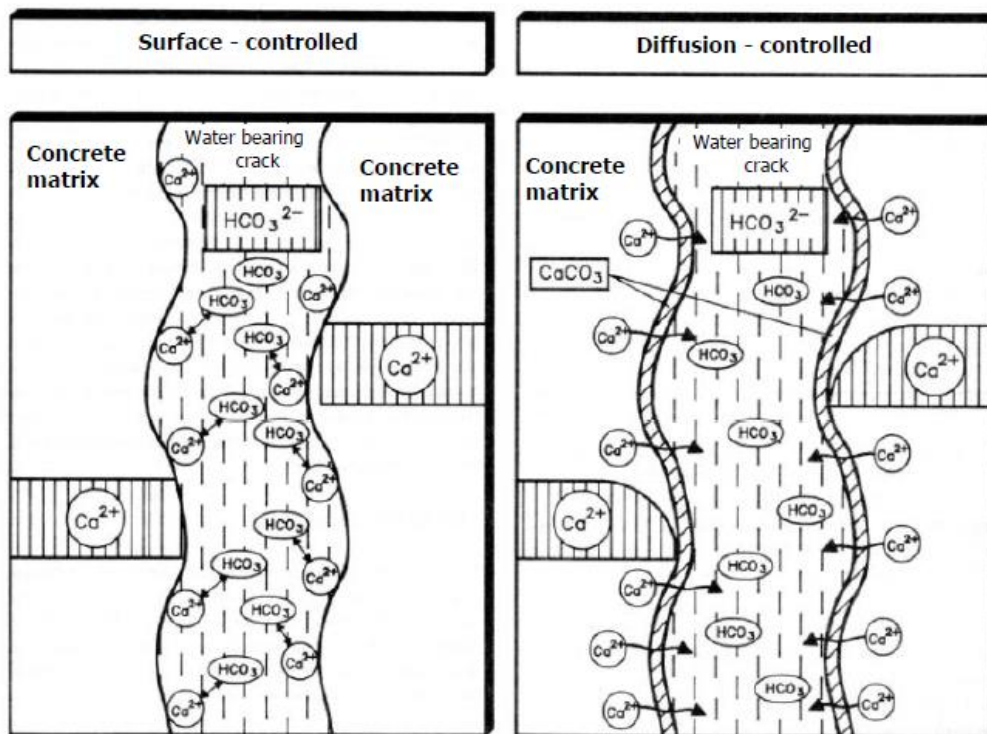
from crack walls, favouring the deposit of crystals, during the so-called phase "surface-controlled crystal growth". However, once an initial film of calcite has formed on the crack faces, the concrete matrix nearby has remained poor in calcium ions. Here the second phase called "diffusion-controlled crystal growth" takes place, which implies a slow diffusion of  $\text{Ca}^{2+}$  ions which have to cross the cement and the  $\text{CaCO}_3$  layer to ensure a crack width reduction (Figure 2–3) (De Belie et al., 2018).

Figure 2–3. Surface and diffusion healing process by carbonation (Edvardsen, 1999)

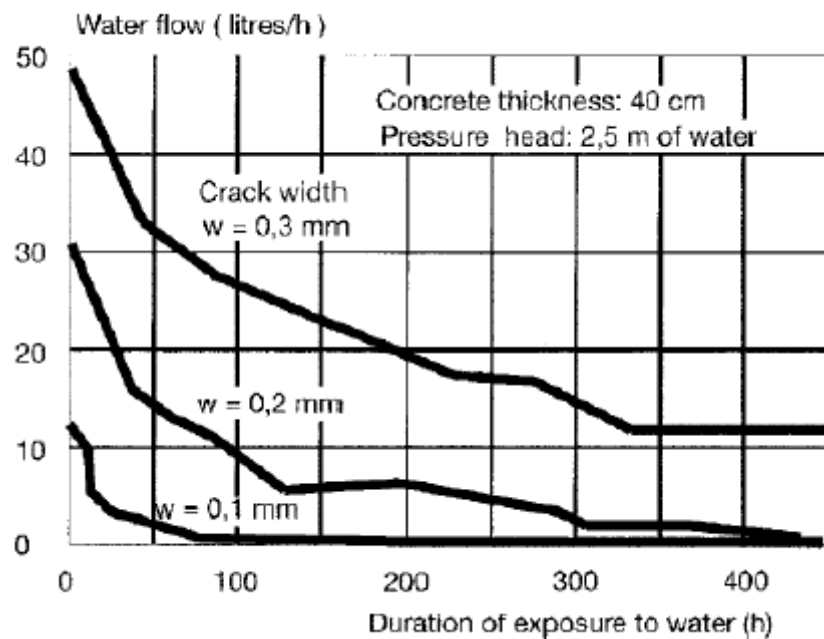
The geometry of cracks, namely, crack width, length, depth, and cracking pattern (branched crack or accumulated crack) may determine their autogenous healing degree. Edvardsen (1996, 1999) reported that crack width is the parameter that most affects the healing process, since the narrower the cracks, the more efficient the autogenous healing. Therefore, by limiting and controlling the crack width, the potential autogenous healing can be substantially improved. The addition of fibres to the cementitious matrix, which resulted into the development of fibre-reinforced concrete (FRC) and high-performance fibre reinforced cementitious composites (HPFRCCs), has been proposed for the first time by Li and co-workers in order to promote autogenous healing, due to due to fibres ability in restrict crack width (Van Tittelboom and De Belie, 2013).

Figure 2-4. Correlation between water flow and time for different crack widths (Edvardsen, 1999)

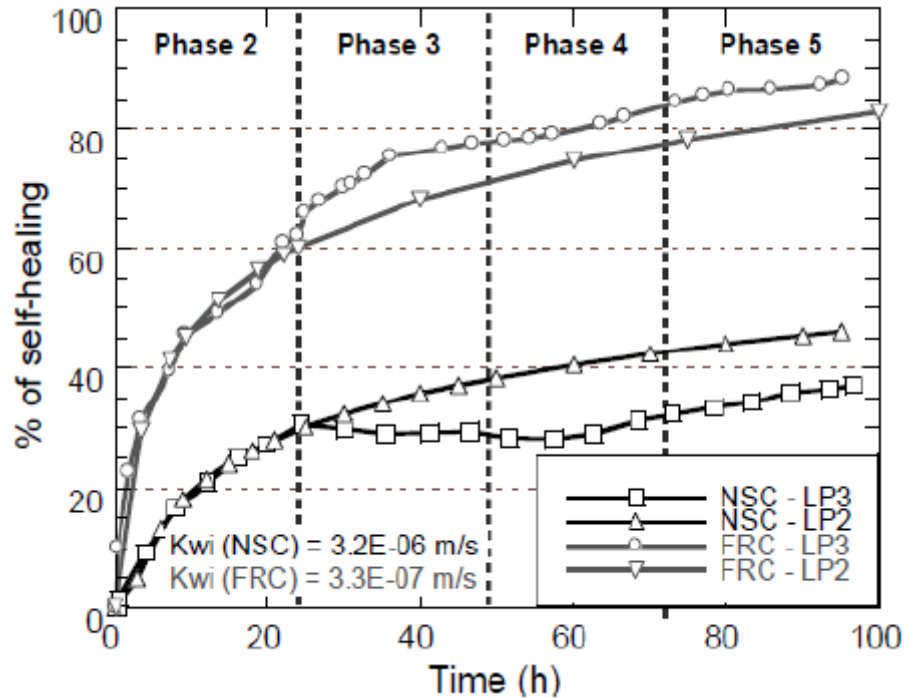
fibres and lower water/cement ratio, as it is shown in the Figure 2–5 with the different healing evolutions of the two concrete types.

Figure 2–5. Self-healing evolution for NSC and FRC samples (Desmettre & Charron, 2012)

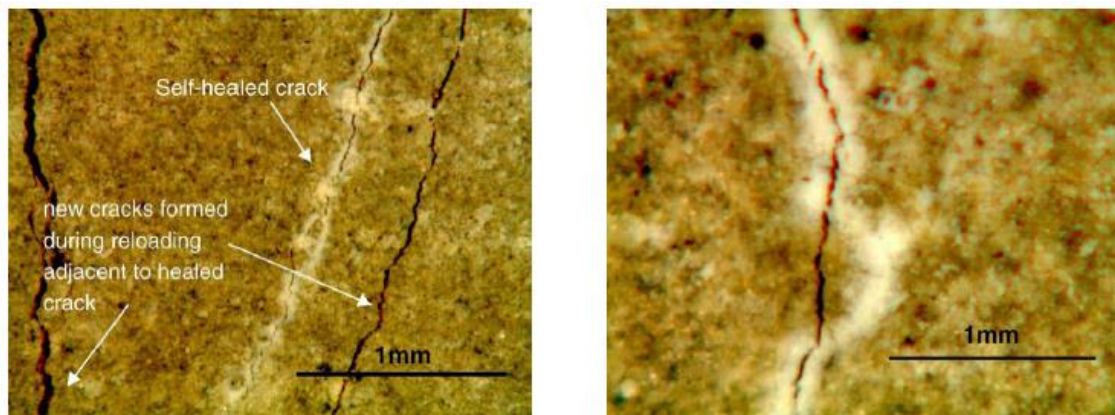
Yang et al. (2009; 2011) conducted experiments with ECC demonstrating that after the healing process, the healed material retained a ductile behaviour and the healed cracks were sufficiently resistant to produce new cracks in the adjacent areas when a reload was applied (Figure 2–6).

Figure 2–6. Old healed crack and new cracks produced (Yang et al., 2009)

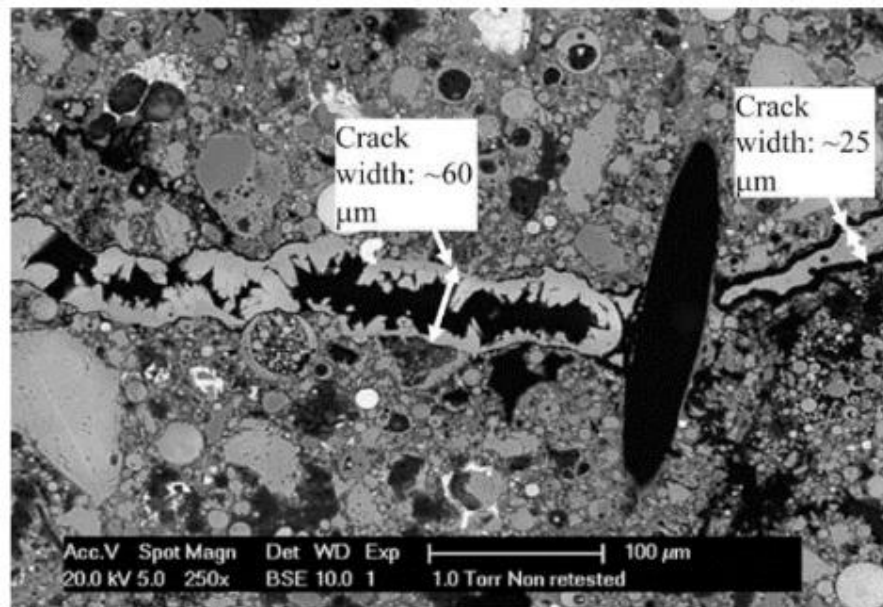
In literature, a wide range of possibilities of healable cracks can be found, ranging from a few tens  $\mu\text{m}$  (Jacobsen et al., 1995) to 100  $\mu\text{m}$  (Reinhardt and Jooss, 2003) and even 300  $\mu\text{m}$  (Edvardsen, 1999). This healing naturally depends on the duration of the healing time and its conditions as well, for this reason it is necessary to look at these data with the right degree of criticality. Generally, it is accepted that only narrower cracks are likely to be totally healed and that only partial healing is feasible in wider cracks. When using crystalline admixtures even larger cracks up to 300–500  $\mu\text{m}$  can be closed (Roig Flores et al., 2015, 2016; Ferrara et al., 2016). However, visual healing by means of microscopy or naked eye does not always mean that the specimen is completely healed. The extent of healing in the interior of the specimen has to be analysed in order to assess whether the closure only affects the surface or is also extended within the sample, where the cracks may still be not totally healed. Recent studies such as these by Nishiwaki et al. (2012) state that cracks up to 300  $\mu\text{m}$  are healable by carbonation, whereas more recent studies performed by Kim, et al. (2014) state that autogenous healing capability is limited to cracks of about 50  $\mu\text{m}$  (Figure 2–7).

*Figure 2–7. Partial crack healing after water exposure (Qian et al., 2009)*

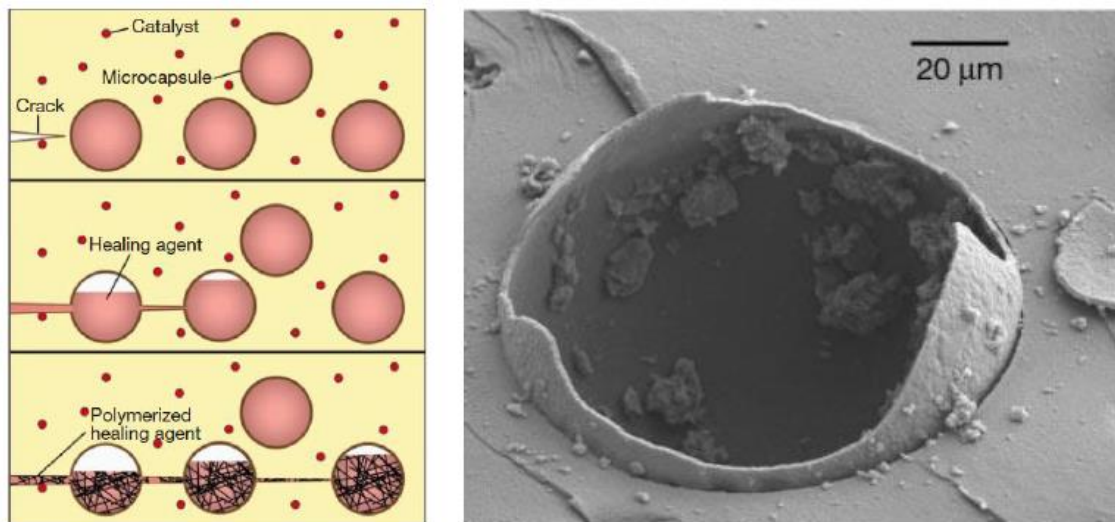
microcapsules, used as additional product in the mix for widespread and unpredictable cracks. The use of microcapsules as carriers of the self-healing agent was proposed by White, et al. (2001). According to White et al., when a crack appears and crosses a microcapsule, the latter releasing the healing agent and activating the reaction with a catalyst that will fill the crack by capillary action (Figure 2–8). The second type consists of localized capsules, mainly glass tubes, filled with healing agents and embedded in the structural element in fixed positions, where cracks are supposed to be formed (M. Roig Flores, 2018).

Figure 2–8. Process of release of the healing agent (left) and a broken microcapsule (right) (White et al., 2001)

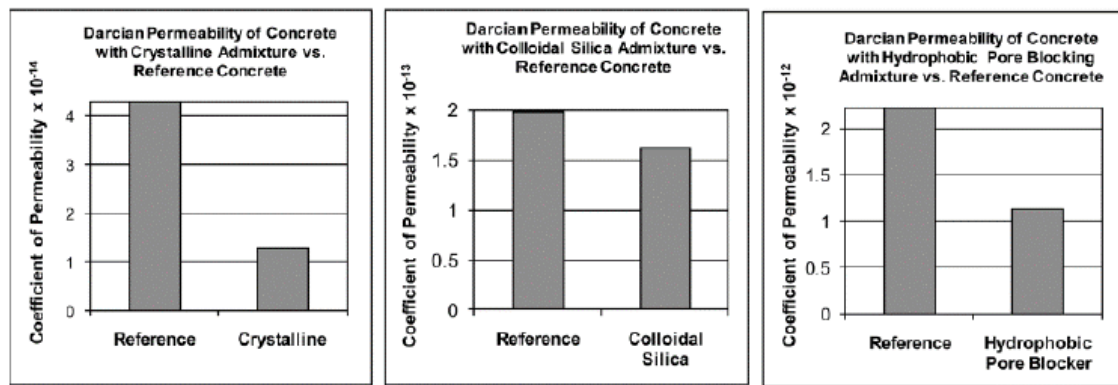
Experiments reported by the ACI Committee 212 (2010) have showed a major permeability reduction with the addition of crystalline admixtures, by comparing the results achieved with other types of PRA, as the following Figure 2–9 shows.

Figure 2–9. Comparison of permeability reduction achieved by different PRA (ACI Committee 212, 2010)

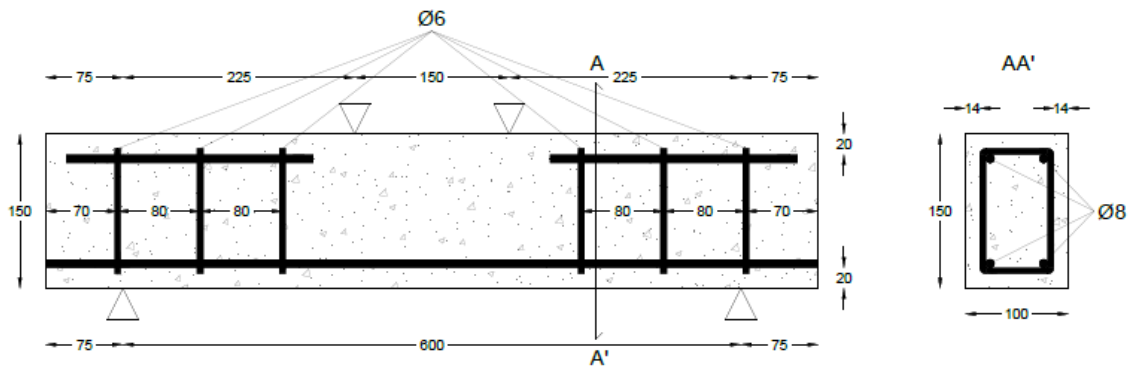
in producing functionalized UHPFRCs, based on the HB3 and HB4 mix design, with the addition of different concentrations of crystalline admixtures and nanomaterials just mentioned. Beams used for the study of durability properties were provided with 2 $\phi$ 8 lower reinforcing bars and 6 $\phi$ 6 stirrups which afterwards have been pre-cracked at different cracking levels. Subsequently, beams have been sawed to obtain smaller specimens and perform permeability tests before healing (BH) and after healing (AH). Dimension, number and layout of the reinforcing bars and stirrups with the relative distances and points of support for performing the four-point bending test are shown in Figure 3–1.

Figure 3–1. Reinforced beam model

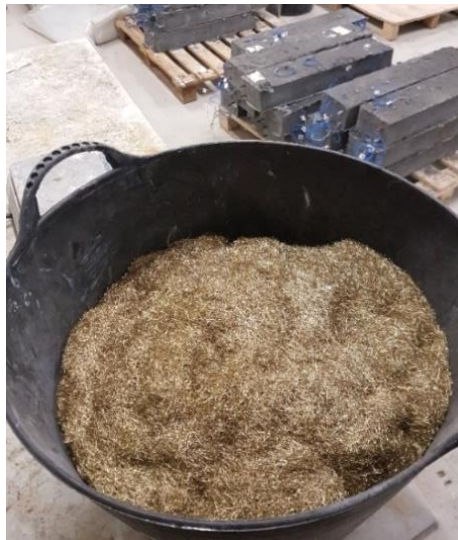
In UHPFRC mix high tensile strength micro steel fibres 0,22x13 mm were used. This type of fibres provides a better control of the first microcracks that appear in the concrete, thus increasing the pseudo-elastic phase and avoiding brittle fractures; furthermore, fibres allow to keep crack width fixed after the pre-cracking has been performed. In traditional and high-performance concrete, no fibres were added.

*Figure 3–9. Fibres used in concrete mix*

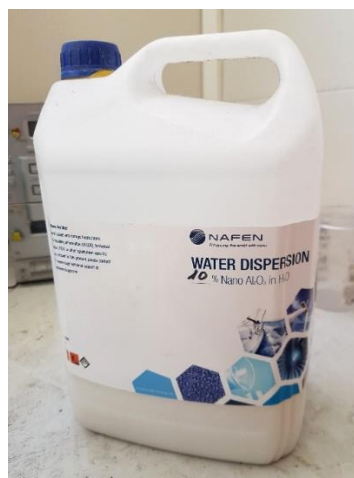
Alumina Nano-Fibres (ANF) from Nafen (Figure 3–12) are expected to improve the cracking behaviour. These nanoparticles have a diameter between 4 and 11 nm and a length between 100 and 900 nm. They are supplied in a white opaque liquid solution in which the solid content is diluted in deionized water for a 10% concentration (10% solid / 90% water). This was considered when adding the product into the concrete mix to maintain the same final amount of water. In this research experiments have done with the recommended 0.25% of the weight of the binder. Parallel investigations have confirmed that the addition of ANF for dosages up to 0.25% by the weight of cement produces reductions in compressive strength in the base mixes HB3 and HB4 and a loss of workability for the only concrete HB3, which has been compensated by adding 5 litres/m<sup>3</sup> of water without impairing significantly the final compressive strength.

*Figure 3–12. Alumina Nano-Fibres from Nafen used as addition in concrete mix*

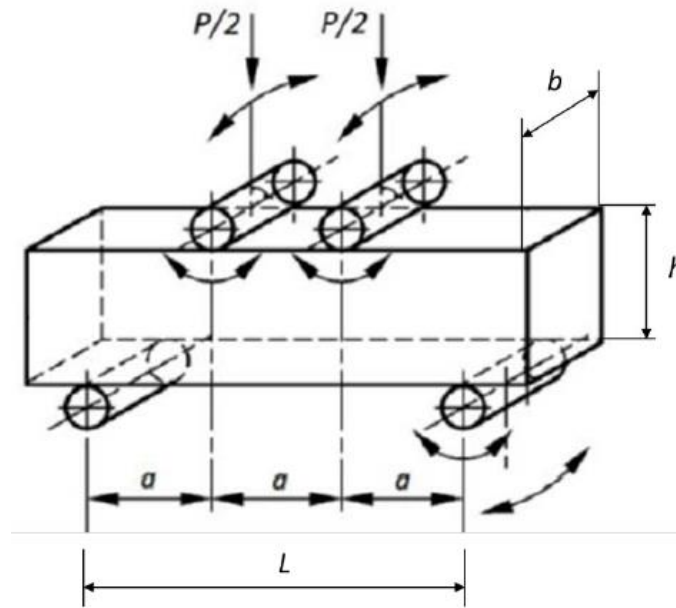
- Length of the span  $L = 450$  mm
- Distance between rollers  $a = L/3 = 150$  mm

Figure 3–19. Specimen size and degrees of freedom FPBT

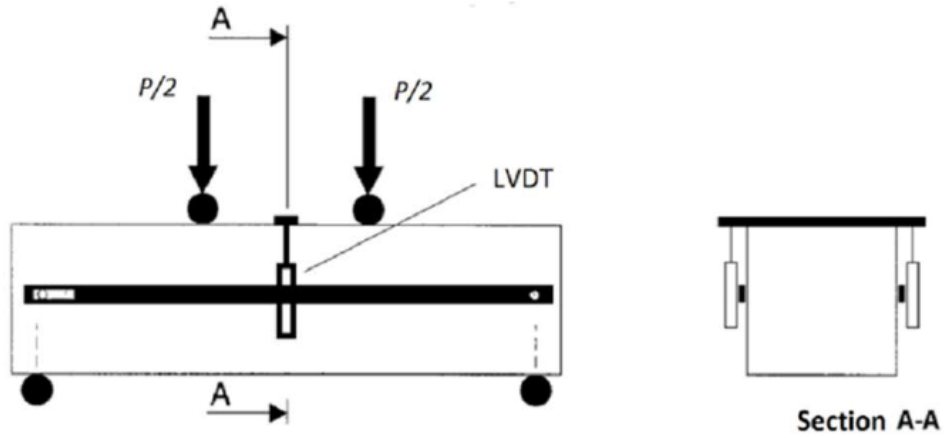
Figure 3-20. Displacement measurement at mid-span by means of two LVDTs

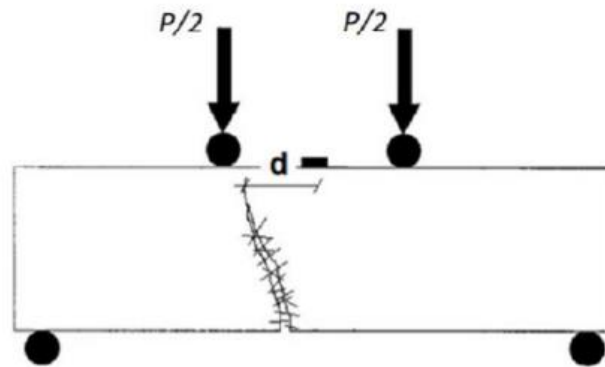
Figure 3-21. Measurement of the distance of the crack from the mid-span ( $d$ )

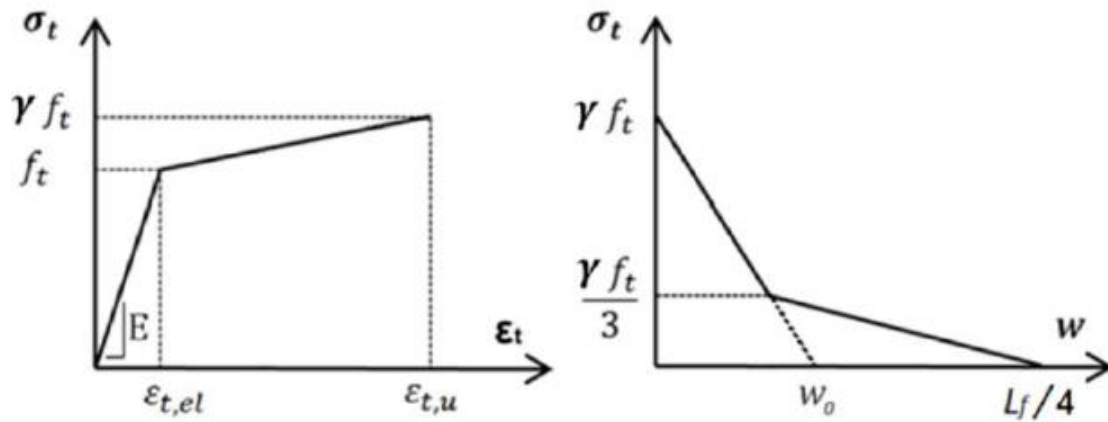
Constitutive model for UHPFRC proposed is illustrated in Figure 3–23 which is defined as a function of six parameters: elastic modulus ( $E$ ), cracking strength ( $f_t$ ), ultimate cracking strength ( $f_{tu}$ ) and its associated strain ( $\epsilon_{t,u}$ ), crack opening at the intersection of the line that defines the initial slope to the  $w$  axis ( $w_0$ ) and the characteristic crack opening ( $l_f/4$ ), being  $l_f$  the fibre length.

Figure 3–23. Constitutive model for UHPFRC proposed

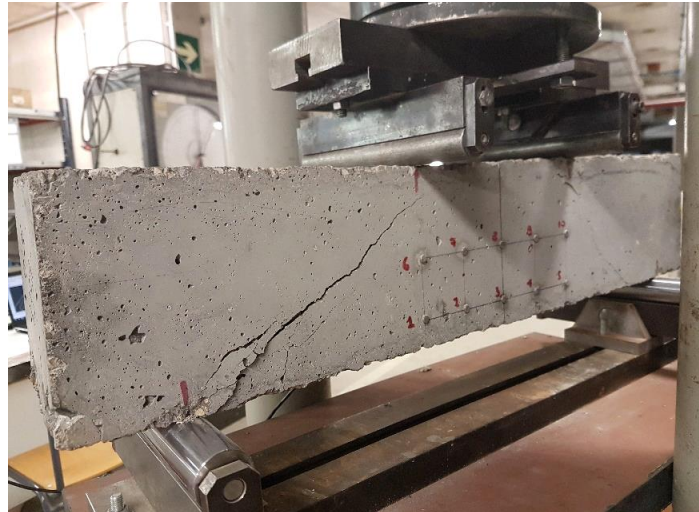
At the beginning, it was difficult to control the crack opening during the whole test; in particular, at high levels of strain, diagonal shear cracks (Figure 3–26) appeared before reaching the desired cracking level in the tension area (flexural cracks) where fibres are stretched.

*Figure 3–26. Shear crack appeared during pre-cracking*

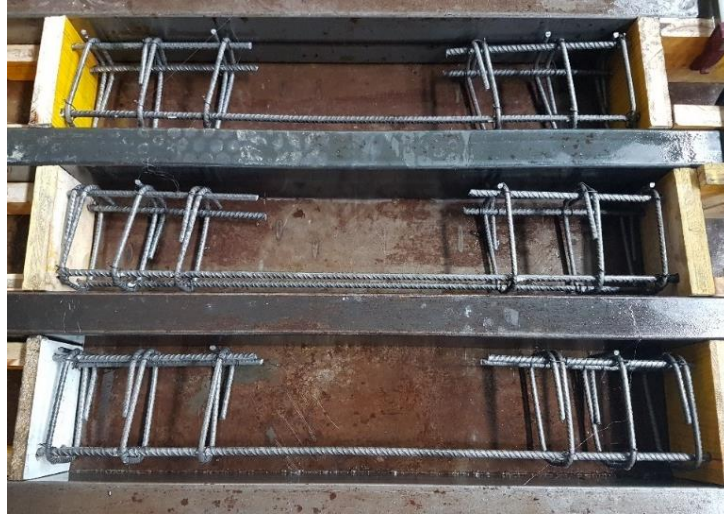
- 2 $\varnothing 8$  inferior reinforcing bars throughout the length;
- 6 $\varnothing 6$  stirrups, 3 for each side, with central section free;
- 2 $\varnothing 8$  superior bars, with central section free, with the only aim of supporting stirrups.

*Figure 3–27. Reinforced beams with rebars and stirrups*

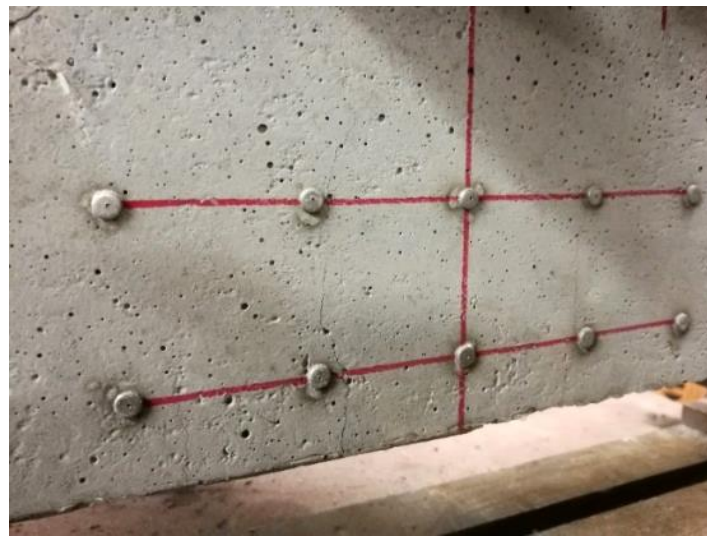
Using this reinforcement, it was possible to perform a controlled test and achieve the desired cracking level in the central area subject to bending (Figure 3–28)

*Figure 3–28. Visible crack in the bending area*

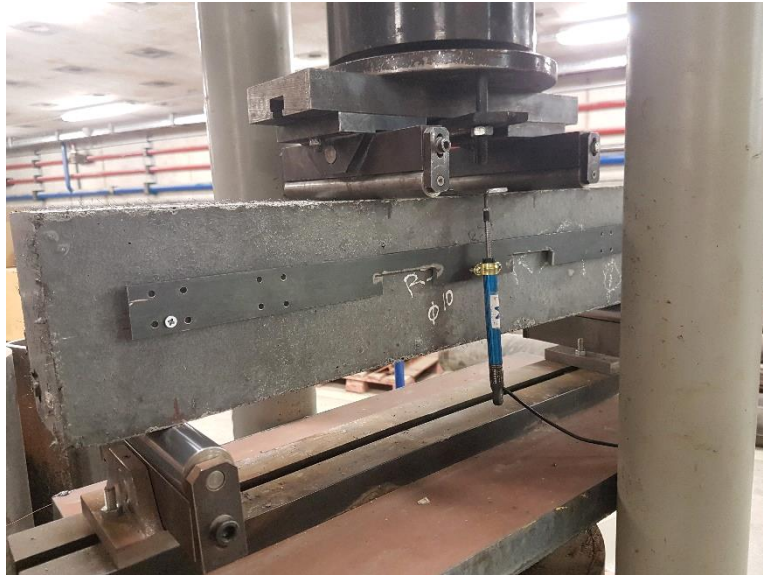
and one mobile; it allows to measure lengths with the precision of thousandth of a millimetre, being previously calibrated on the length of a reference bar. However, it is important to specify that the device is only indicative of a certain level of overall damage but is not representative of the opening of each single crack. Finally, a displacement sensor (Figure 3–29) has been installed on the other side of the sample which, connected with a personal computer, provides in real time the load-displacement graph related to the test. Once the sample is ready and placed symmetrically respect to the points of support, the test can start. Since a press with manual loading has been used, it was necessary to pay close attention in increasing and decreasing load slowly, with a rate of stress as constant as possible.

Figure 3–29. Displacement sensor used in the pre-cracking stage

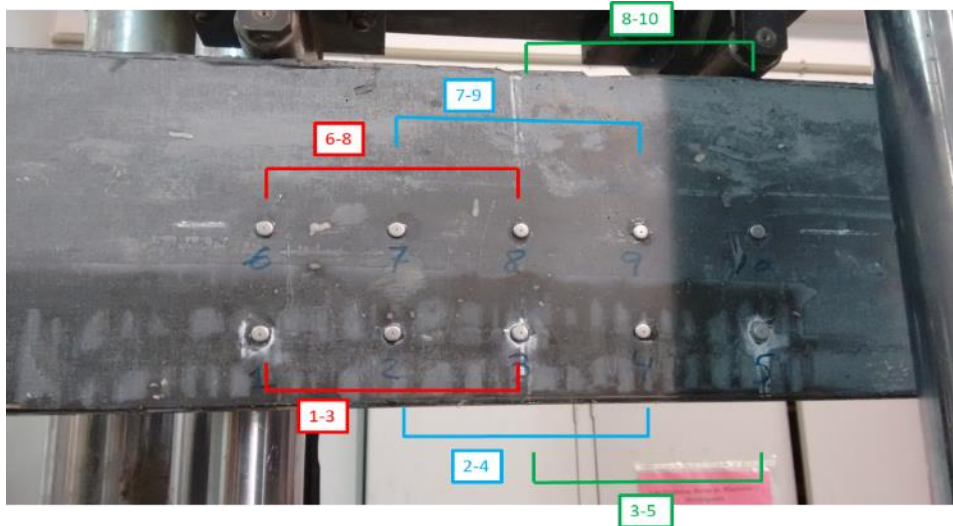
This method allows to control crack width at two different heights: at the lower row (points 1-5) and at the upper row (points 6-10). The first one is located at middle depth of the beam and the second at the reinforcement level. The latter suffers the highest deformation and has been used in this study as reference for reaching the "large cracking level".

Figure 3-30. DEMEC points glued to the beam to measure strain

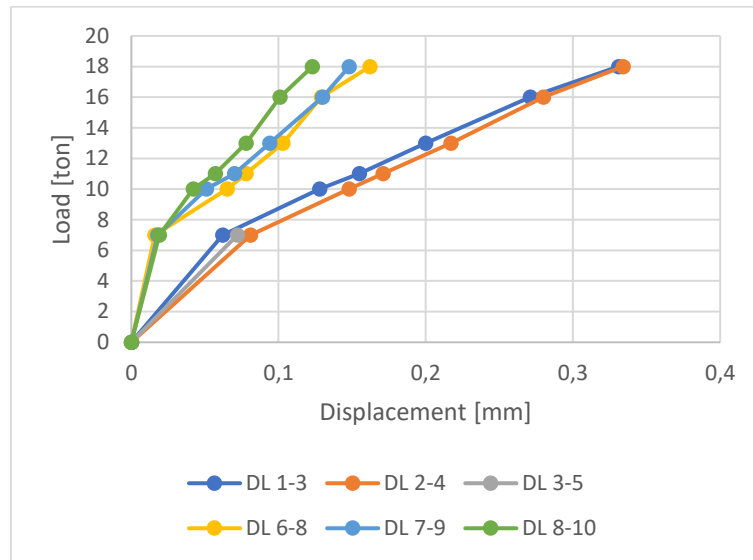
The load-displacement curves obtained with this method show the expected different trends for the two rows (Figure 3–31), demonstrating that the levels proposed are possible to be reached and measured.

Figure 3–31. DEMEC intervals displacement as a function of the load

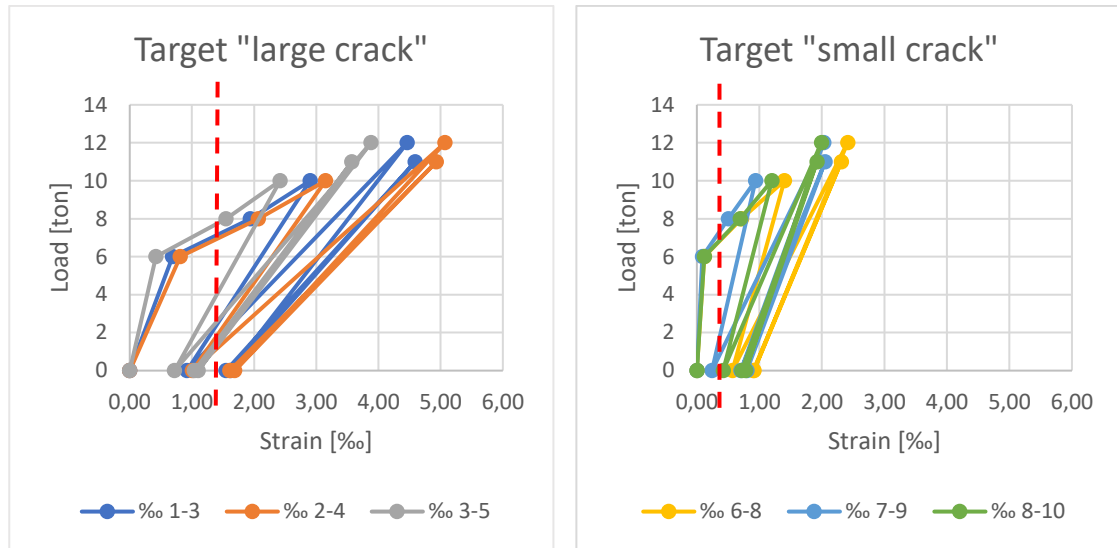
Regarding the different proposed crack levels, "small crack" or "crack closed", defined as the set of cracks obtained during loading when measuring an average strain of 0,5‰ at the upper row, is translated after unloading into strains close to 0,25‰. "Large crack", defined as the set of residual cracks obtained after loading when measuring an average strain between 1‰ and 2‰ at the lower row, is achieved after strains of 4‰ - 5‰ under load.

Figure 3-32. Strain target for "large crack" and "small crack"

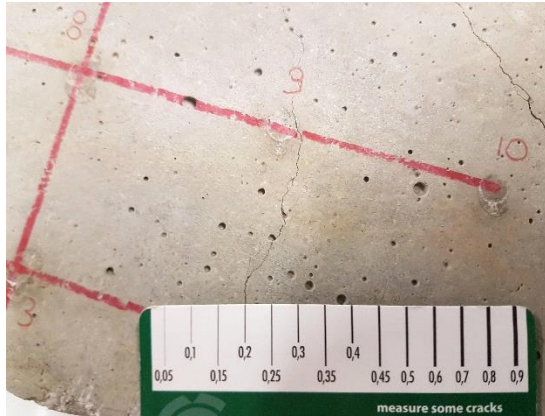
- A *Crack Width Meter*, used to easily measure visible cracks, with graduations from 0,05 mm to 0,9 mm (Figure 3-33);

*Figure 3-33. Crack Width Meter*

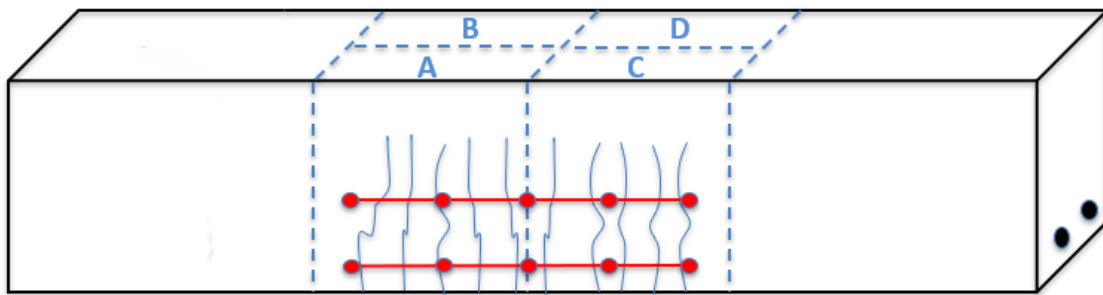
*Figure 3–35. Sawing scheme*

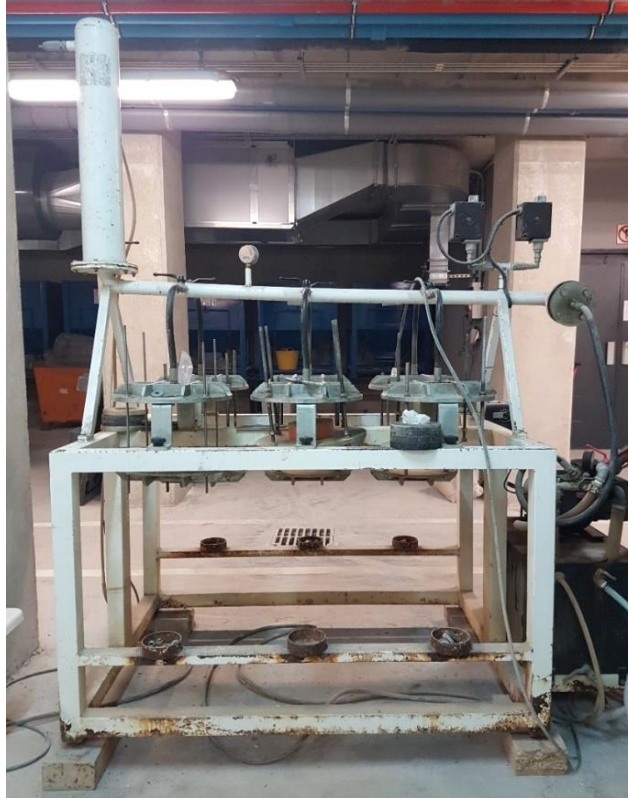
*Figure 3–37. Permeabilimeter used for performing high-pressure water permeability tests*

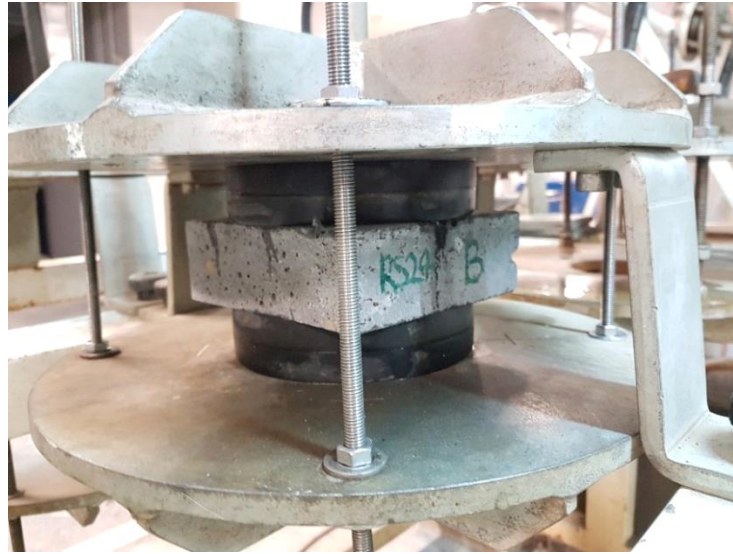
Figure 3–38. High-pressure water permeability test methodology

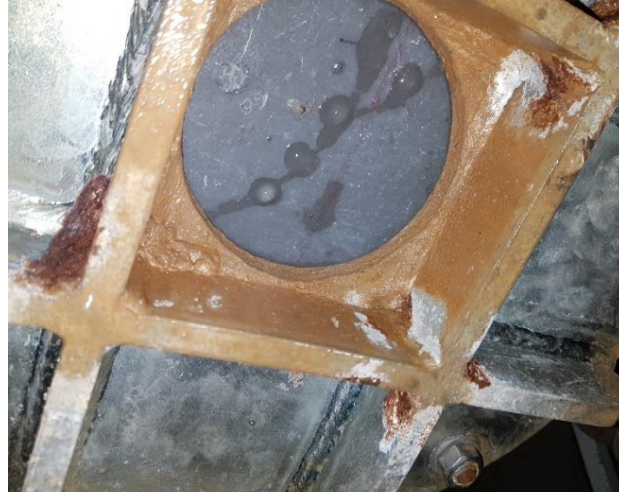
*Figure 3–39. Drops of water from a 0.05 mm crack during high-pressure water permeability test*

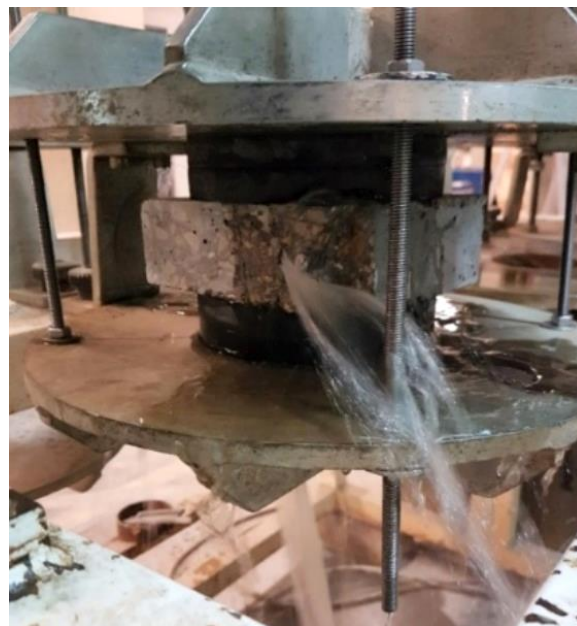
*Figure 3–40. Leakage of water from a side crack during the high-pressure water permeability test in a traditional concrete*

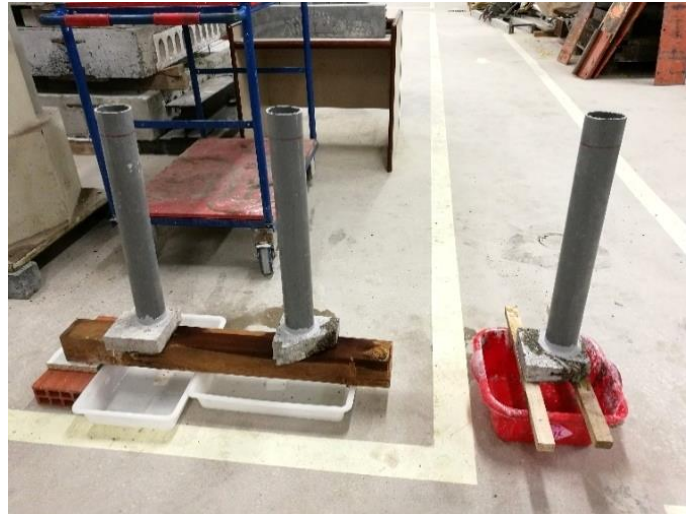
*Figure 3-41. Low-pressure water permeability test methodology*

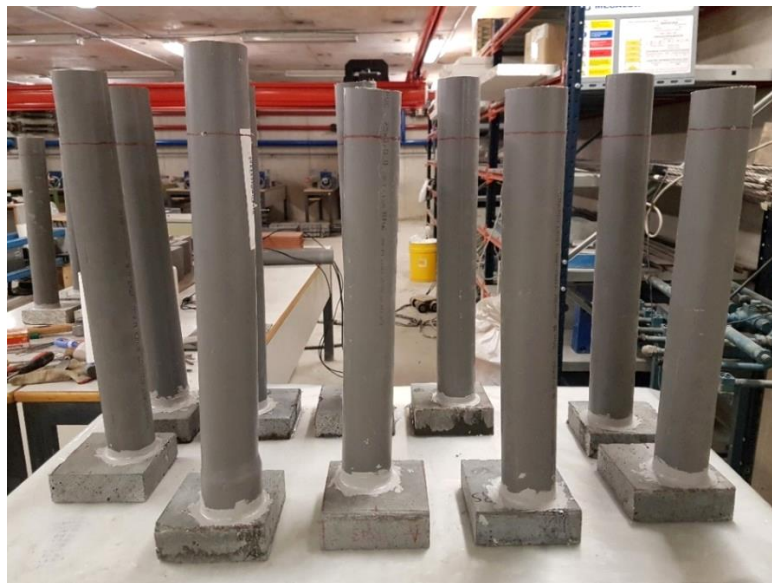
*Figure 3-42. Chloride penetration test methodology*

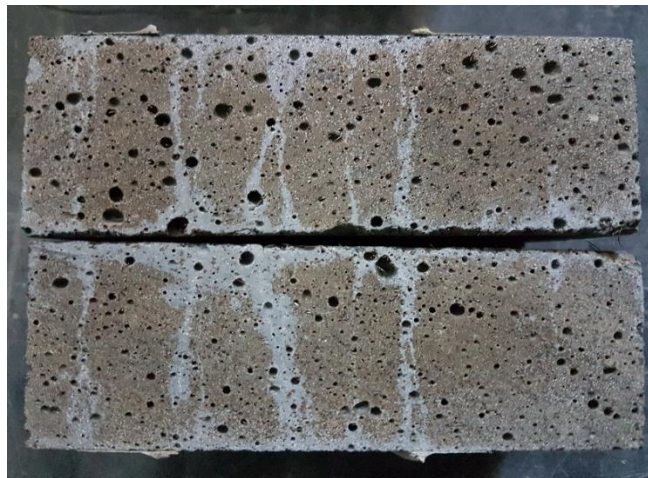
*Figure 3–45. Chloride penetration through the specimen thickness (HB4)*

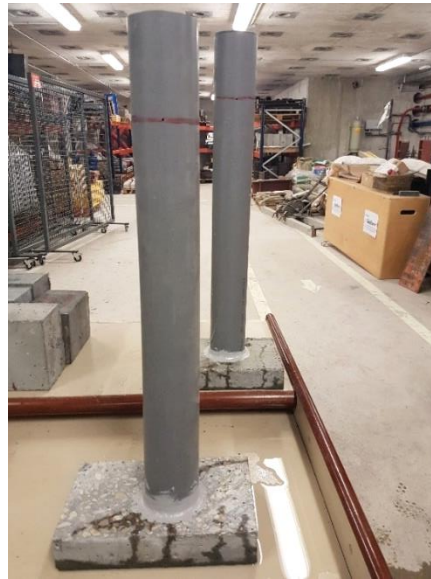
*Figure 3–46. Attempt of chloride penetration test with a HPC with 0.3 mm of crack width*

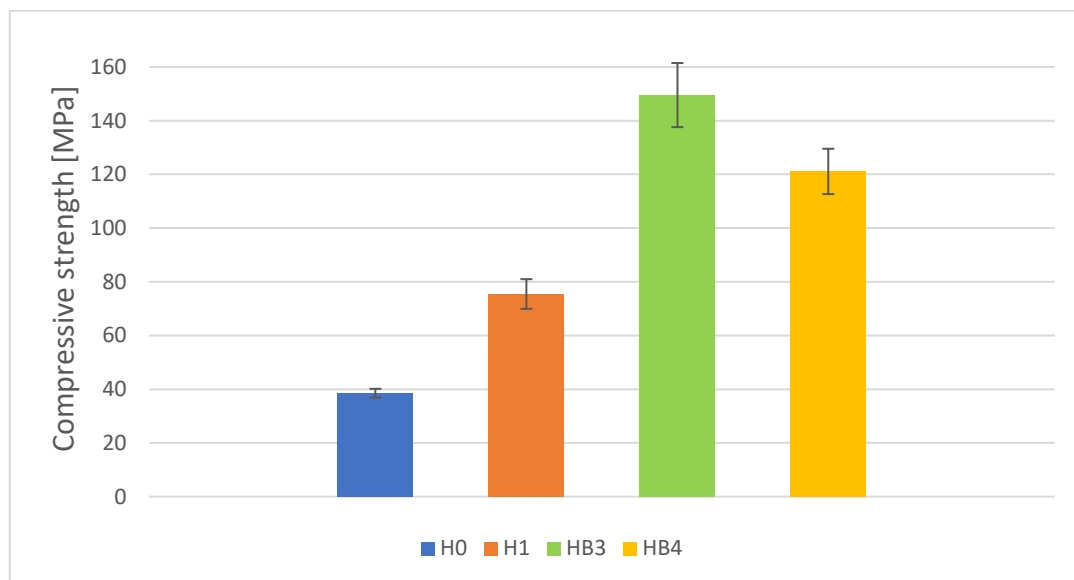
Figure 4–2. Average compressive strength H0, H1, HB3 and HB4

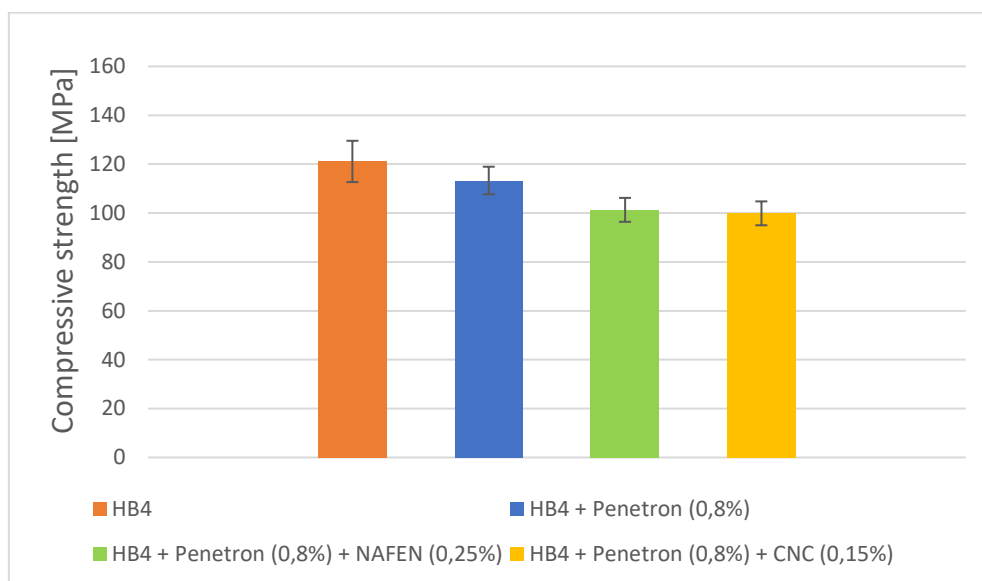
Figure 4-4. Average compressive strength HB4 functionalized batches

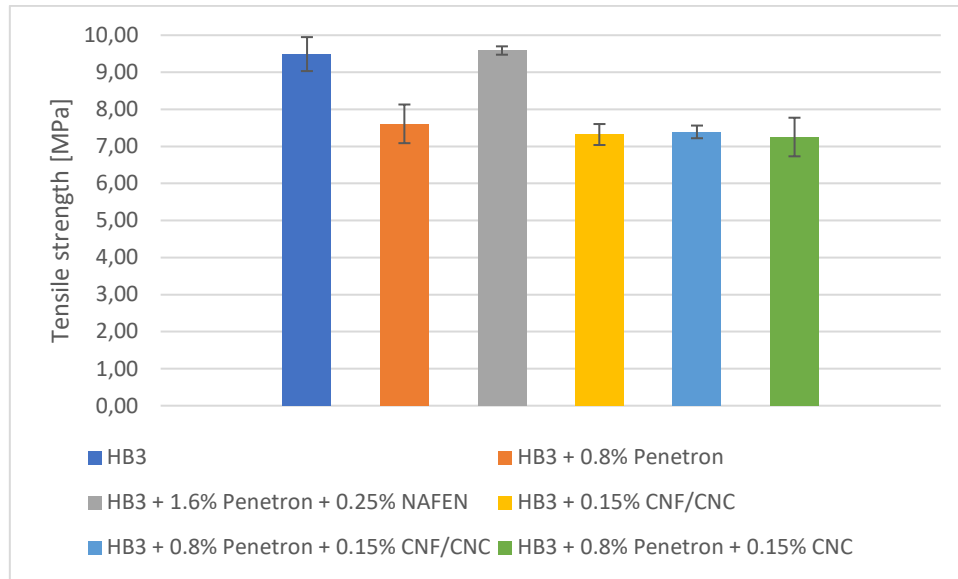
Figure 4-5. Average tensile strength HB3 functionalized batches

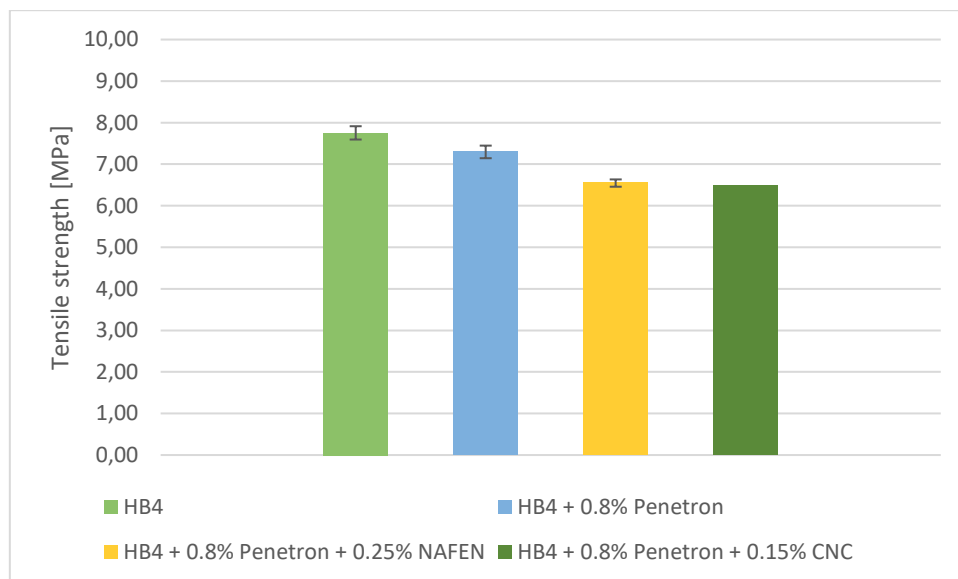
Figure 4-6. Average tensile strength HB4 functionalized batches

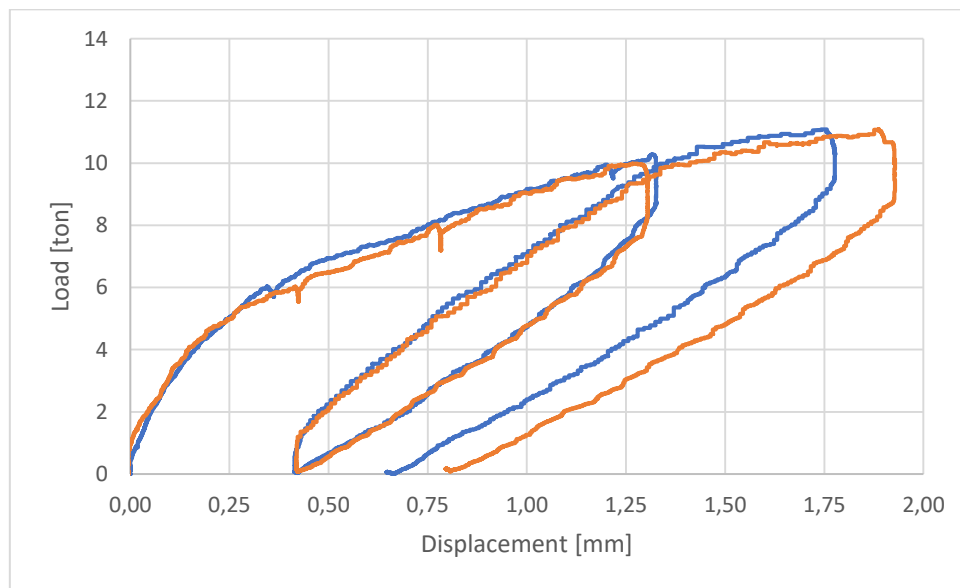
Figure 4–7. UHPFRC Load-Displacement graph

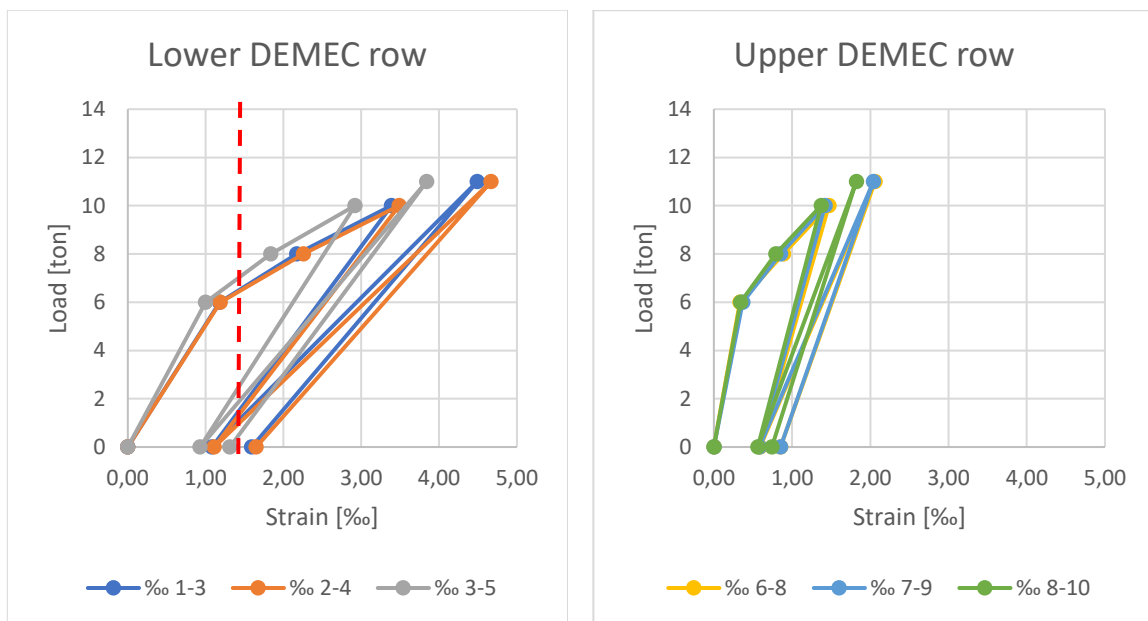
Figure 4–8. UHPFRC Load-Strain graphs

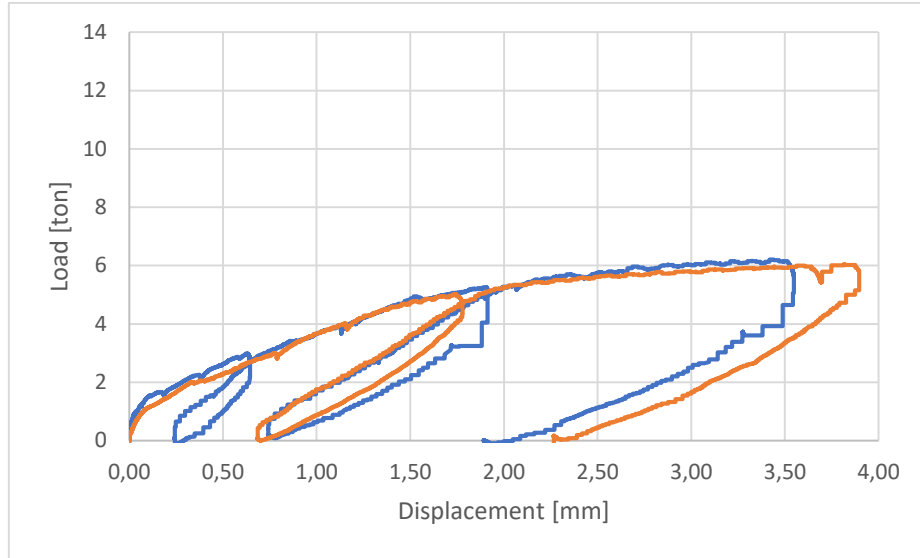
Figure 4-9. Traditional concrete Load-Displacement graph

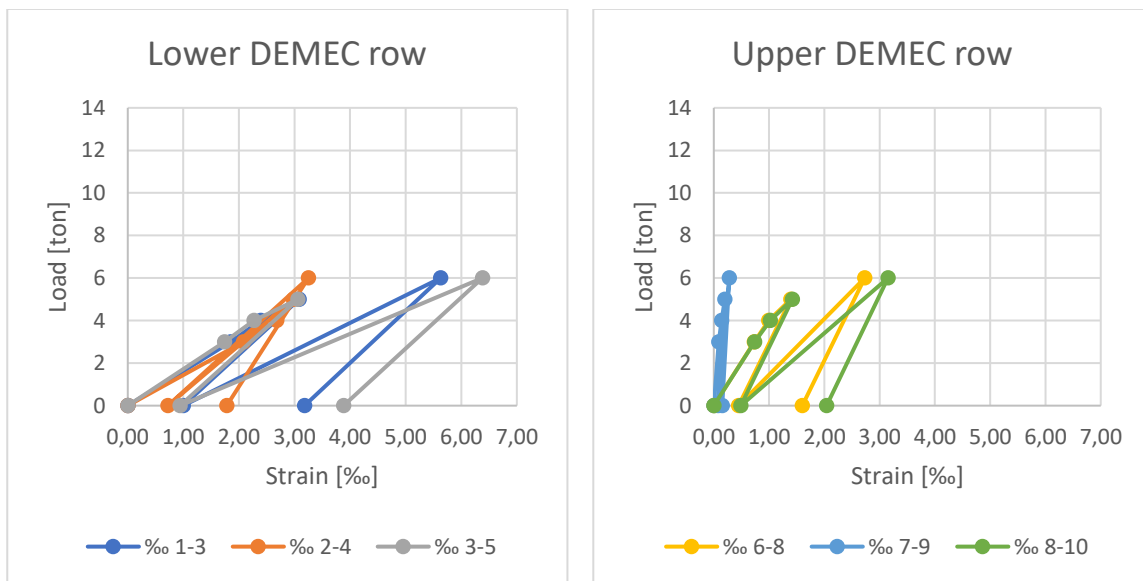
Figure 4-10. Traditional concrete Load-Strain graphs

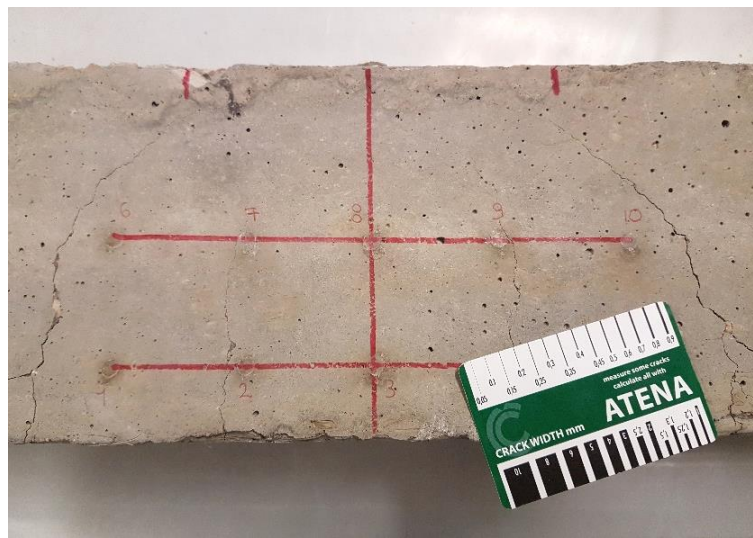
*Figure 4–11. Traditional concrete cracking pattern with few localized cracks*
