POLITECNICO DI MILANO

Corso di studi di Laurea Magistrale in Ingegneria dei  
Sistemi Edilizi

"Self-healing efficiency evaluation of UHPFRC  
enhanced with Crystalline Admixtures and  
Nanomaterials"

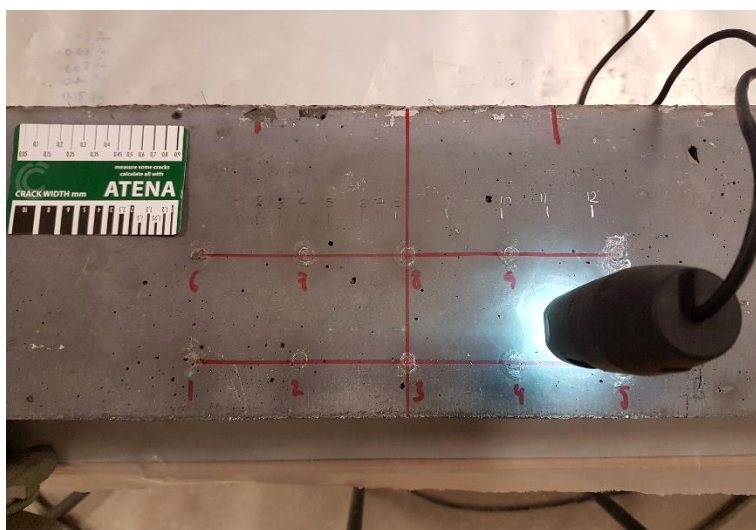
*Figure 4–12. UHPFRC cracking pattern with multiple micro-cracks*

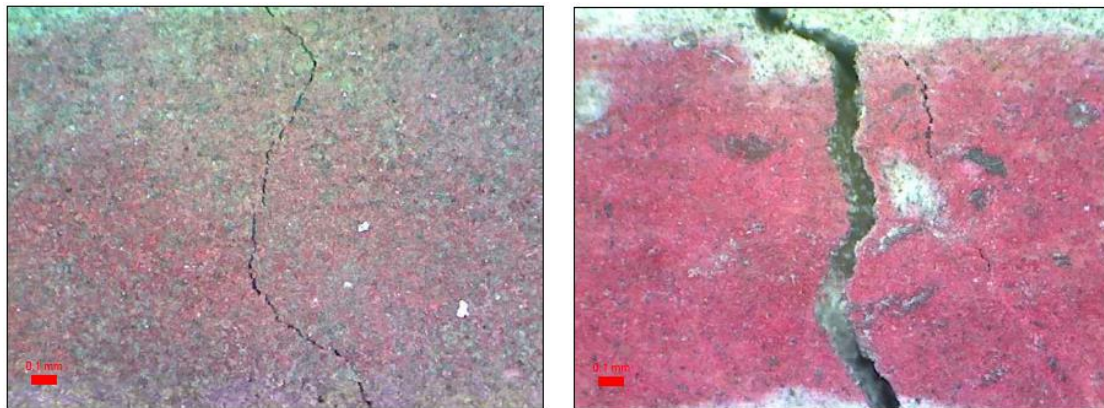
*Figure 4–13. Comparison between a crack of 0.01 mm in a UHPFRC and a crack of 0.1 mm in a traditional concrete at the same magnification (200X)*

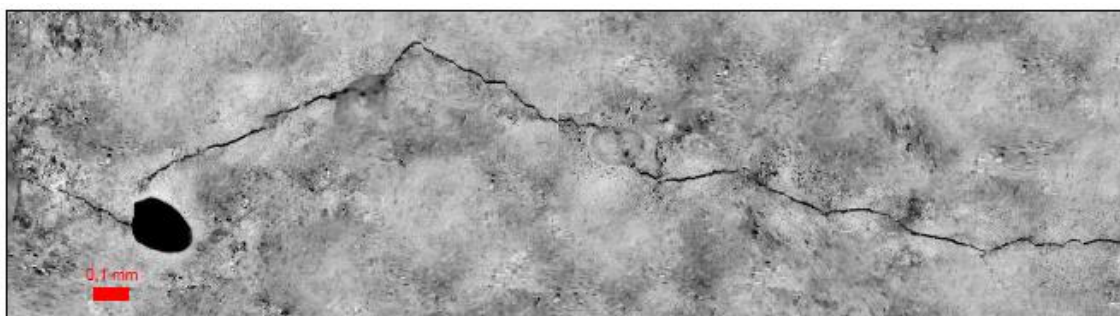
*Figure 4–14. Panorama of a 0.01 mm UHPFRC crack*

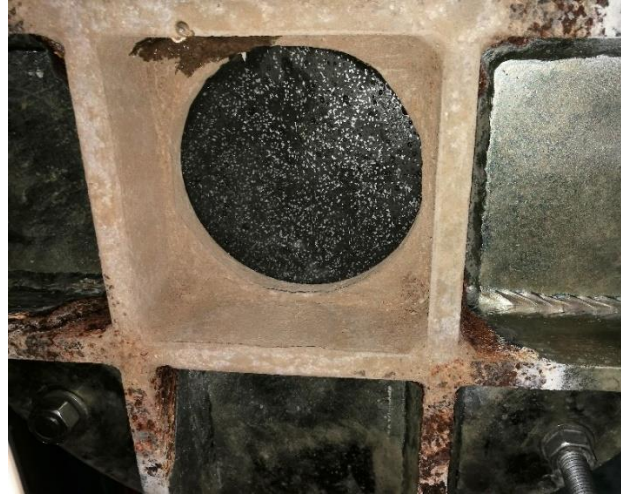
Figure 4-16. Bottom of a UHPFRC specimen during a water permeability test in 2 bar pressure

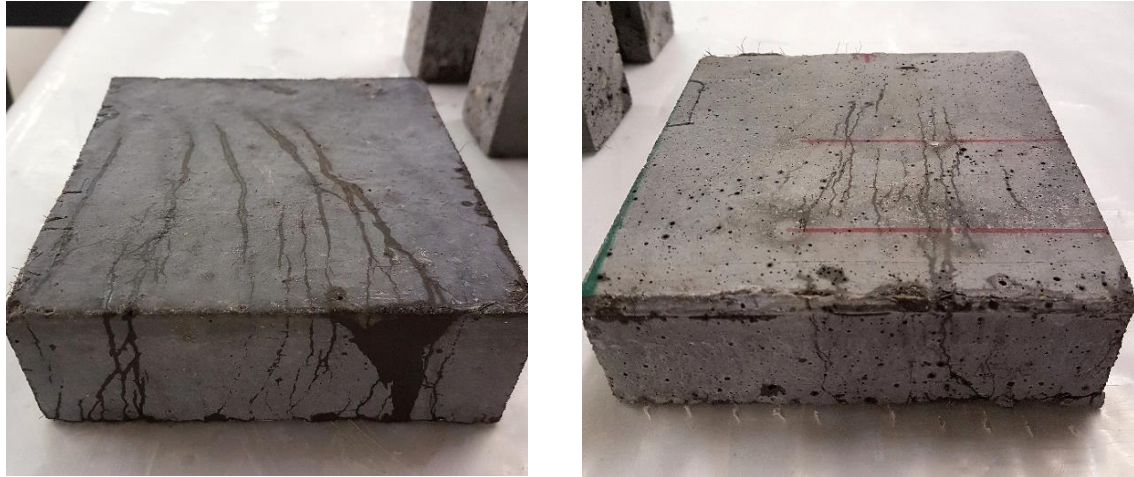
Figure 4–17. Cracks made visible by the water permeability test

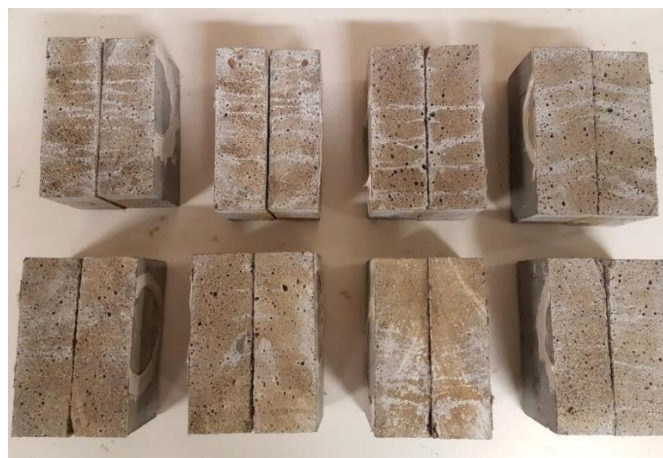
*Figure 4–19. Visible chloride penetration in UHPFRC specimens after the spray of silver nitrate*

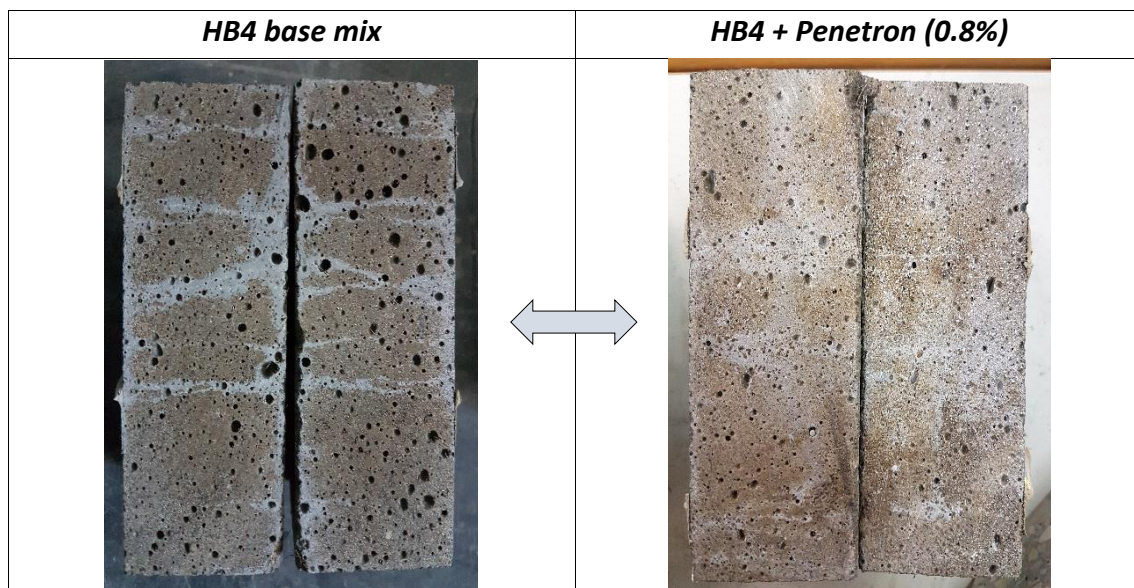
Figure 4-25. Comparison between chloride penetration in HB4 and HB4 with addition of Penetron

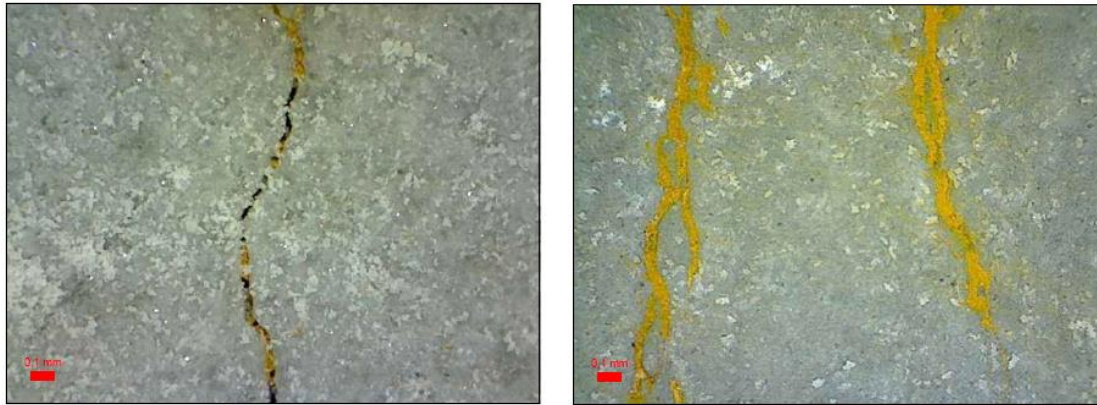
Figure 4-27. Cracks closure detected in UHPFRCs after 28 days of healing exposure

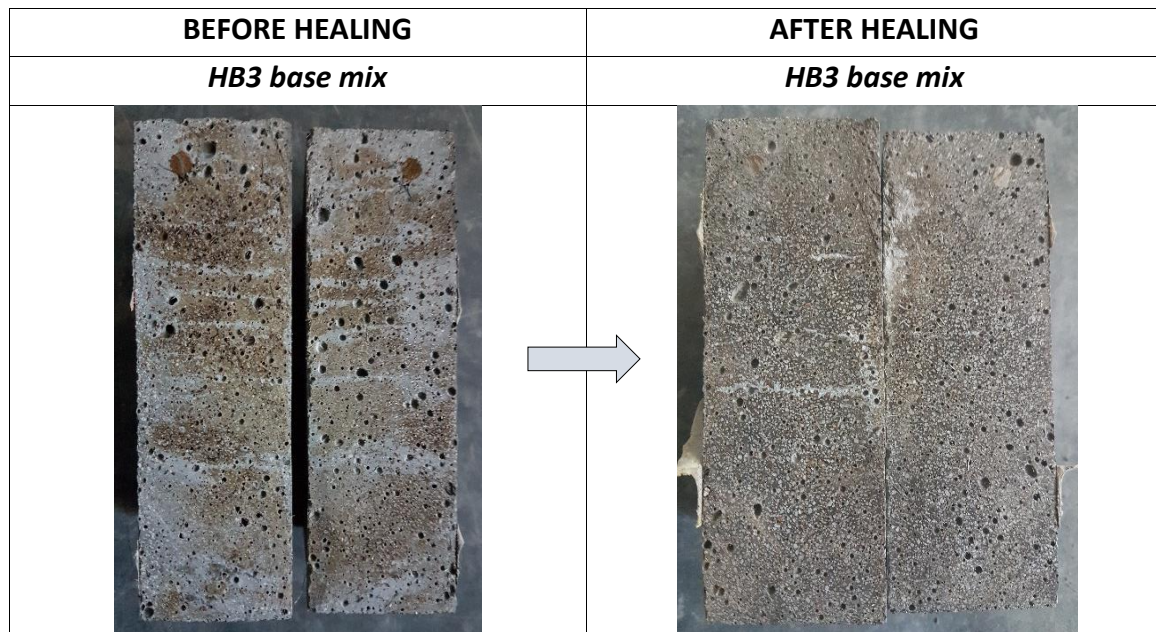
Figure 4–28. Comparison between chloride penetration in HB3 before and after the healing exposure

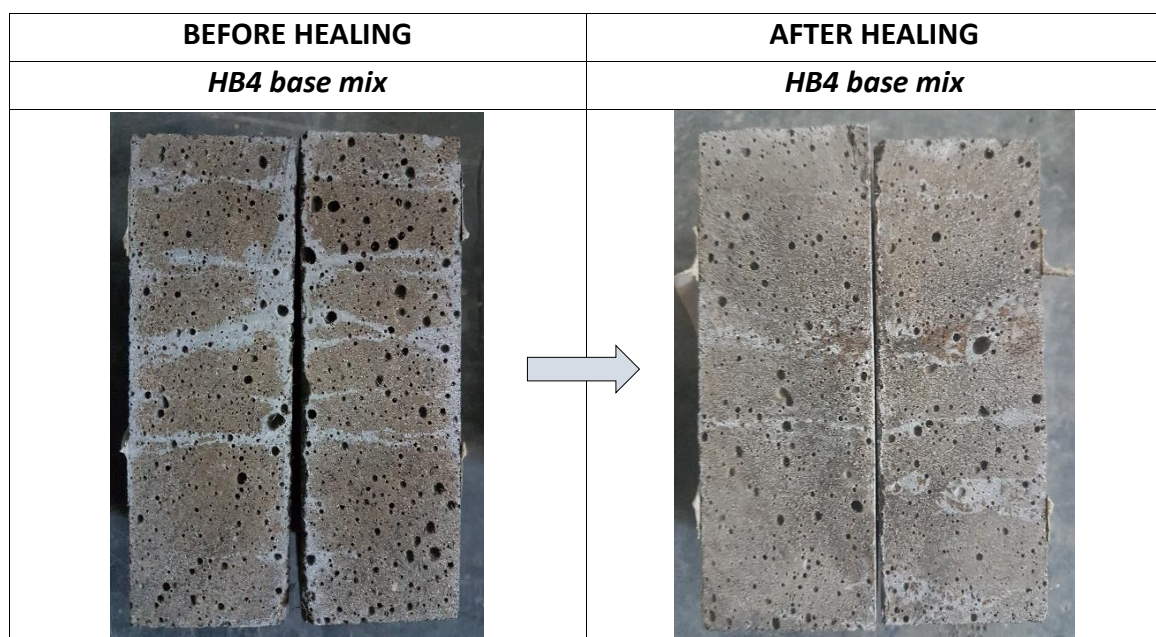
Figure 4–29. Comparison between chloride penetration in HB4 before and after the healing exposure

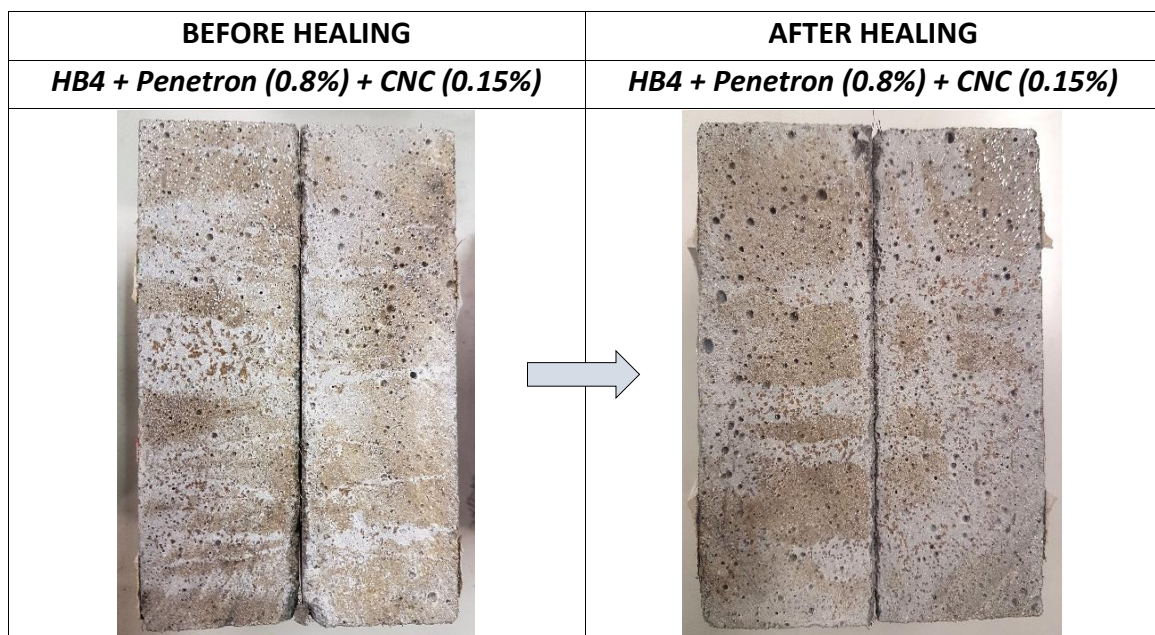
Figure 4–33. Comparison between chloride penetration in HB4 with addition of Penetron (0.8%) and Cellulose Nano-Crystal before and after the healing exposure

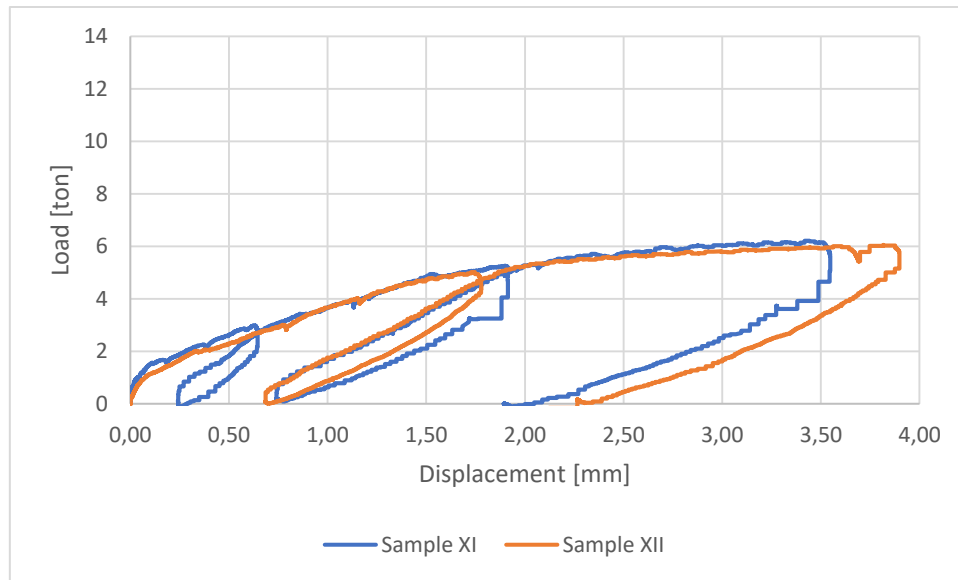
Figure 0-1. Load-displacement graph H0
