**Bridge Failures Case Studies in India  
(2016-2019)**

**By  
Raghavendra Rajendran**

**A thesis submitted in partial fulfilment of the requirements for the  
Master of science in Civil Engineering  
School of Civil, Environmental and Land Management Engineering**

**October 2019**

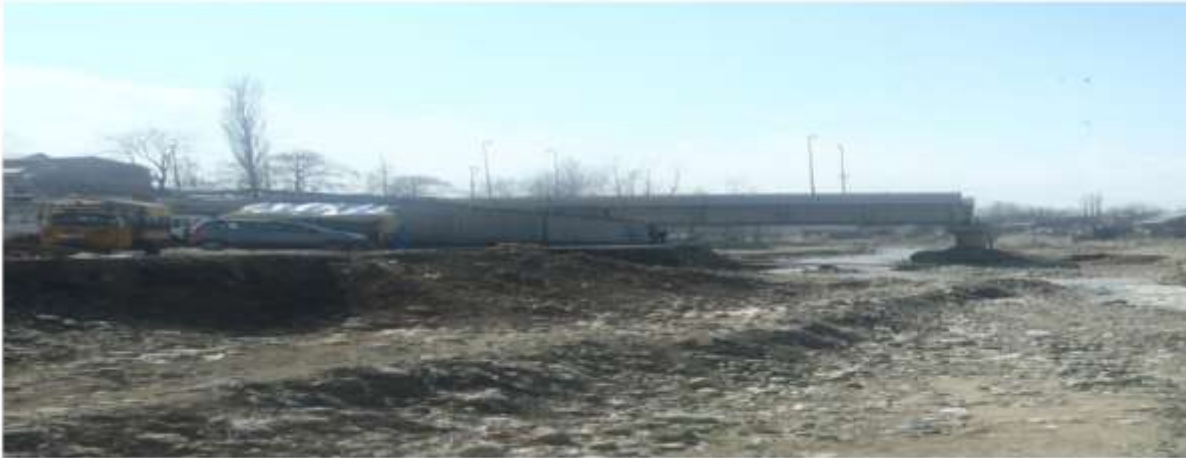
The Chadoora Bridge is located at tehsil chadoora in budgam district Kashmir, India. This bridge connects the two important tehsils. The trade, communication and public transport fully depend on this bridge. It was constructed by R and B division Kashmir in the 2001 – 2002, the bridge is a balanced cantilever bridge with Total length of the bridge is 108.3mtr. It consists of 2 Dummy abutments and Solid wall type piers RCC with circular ends having open foundation. Two Balanced Cantilever bridges each supported on two piers formed by four longitudinal precast prestressed girders with 7.5mtr carriage way.

*Figure 10 Chadoora Bridge taken after floods ( Azmat Hussain 2016)*

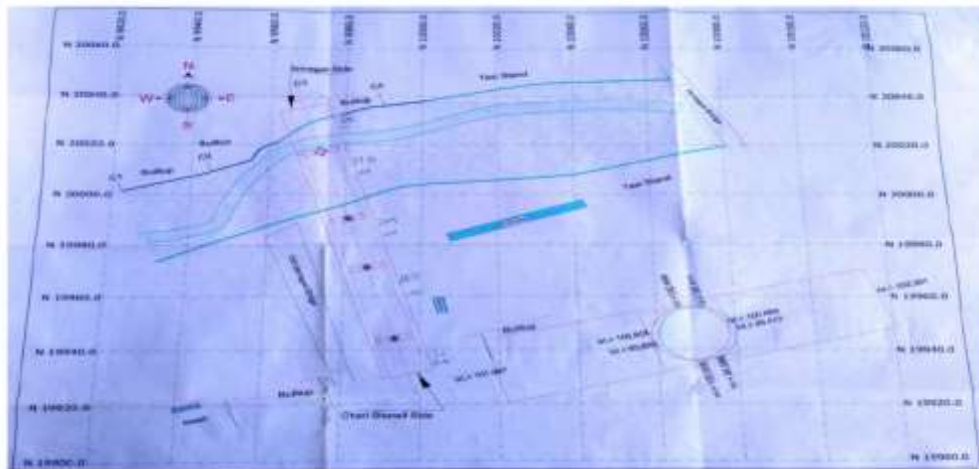
Debris changes both the geotechnical and hydraulic characteristics of a bridge. Debris accumulation in the bridge may result in substantial block in bridge opening, the waterway opening area is considerably reduced. With reduced waterway, velocity would increase, and greater scour depths would be involved, requiring deeper foundations. But after constructing the bridge, these things became negligible and lead to the failure of the bridges. Scouring around the foundation was taken place removed the fines from sand, gravel, boulder matrix. The scouring was predominant on upstream side and slightly less on the downstream side. That is why the pier first tilted towards upstream side and settled by about 30 – 40 cm. The scouring of the bridge has also taken place due to massive slides on river side of left abutment. The obvious cause of the scouring has been encroachment of almost 75% of total waterway, both on upstream and downstream side by the way of the creation of the eidgah and sumo stand respectively. The width of the eidgah and sumo stand is 71.7 mtrs. So, the total waterway was 36.6 meter only. This cause the scour of the pier.

Figure 11 The detailed site plan of the bridge (Azmat Hussain & Sumaira Jan 2016)

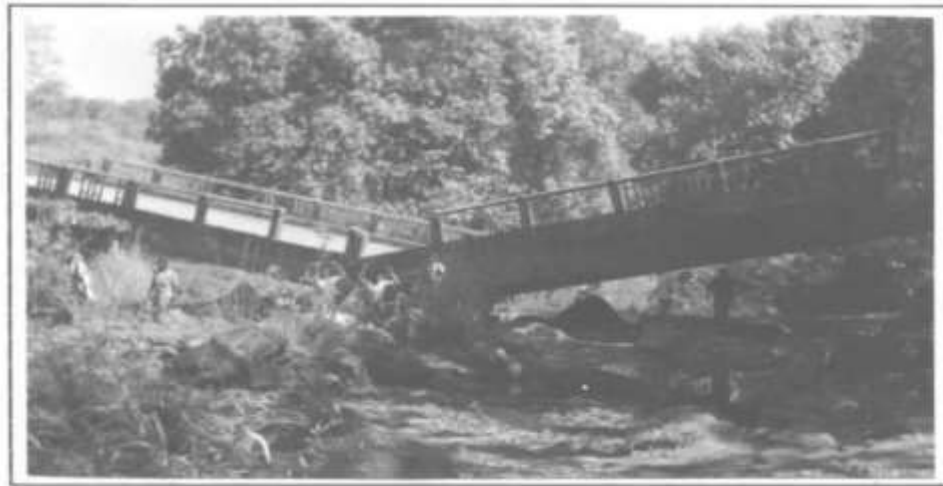
The bridge is situated in Km. 26/6 on Langi Durg Road. It was constructed in the year I 980-81. This bridge has two solid slab spans of 15.25 meters each. The substructure is of solid coarse rubble stone masonry. The base dimensions of pier foundation are 3780 mm. in traffic direction and 10080 mm. in current direction at R.L. 94.00m. The pier foundation is resting on boulder strata.

*Figure 12 Langi Durg Road Bridge (Pier Failure of Bridge and Geotechnical J. K. Jain 1998)*

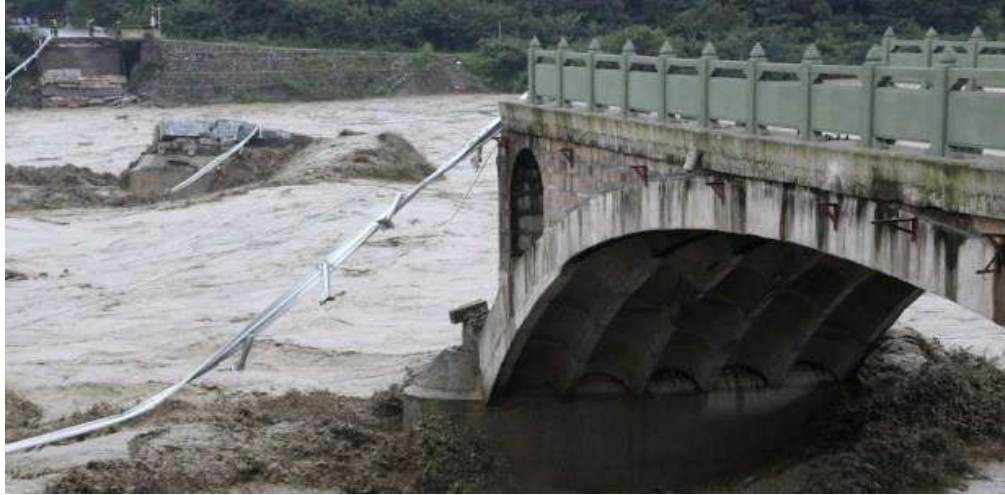
The bridge was located at distance of 460 km from New Delhi and 30 km from District Hamirpur. This is important link road which serves and connect three districts Mandi, Bilaspur and Hamirpur. This Point is considered as the center of Himachal Pradesh. On August 11, 2007 & August 12, 2007 due to heavy rain the concrete bridge got collapsed. Then with in two-year government constructed a new bridge over the site. But on August 14th, 2014 the steel bridge also got collapsed due to soil erosion from foundation. This study is important because bridge collapsed two times due to same reason i.e. scouring of foundation. Local scour around the bridge abutment is one of the most critical causes of bridge failure.

*Figure 14 Collapse of Jahu Bridge – (Jahu Bridge, Pankaj, 2018)*

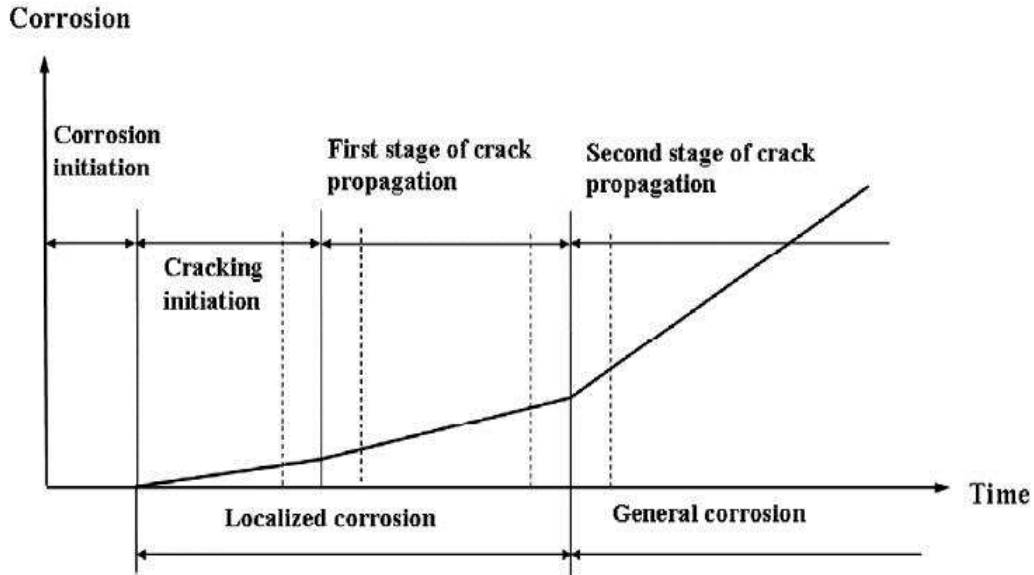
explained in terms of the corrosion damage of the surface area due to cracking, spalling, and delamination (Wryers et al. 1993). The rate of damage was identified and used for the prediction of life in case of the bridge deck.

Figure 17 Corrosion Pattern under Natural Chloride-Induced Corrosion (Zhang et al. 2010)

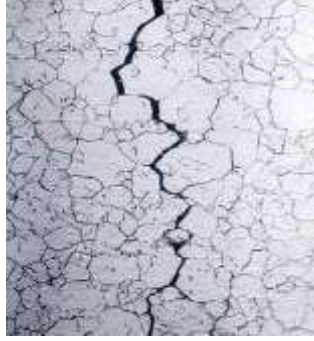
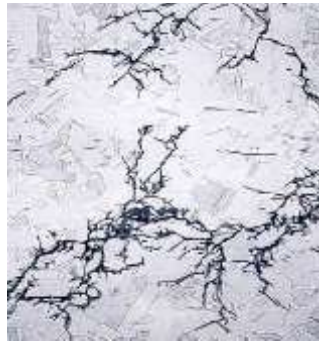
- 1) One or several microcracks are generated at the surface of the steel,
- 2) These cracks grow until they reach a certain depth and then they propagate very quickly until
- 3) It aims into the brittle failure of the wire. This failure may be enhanced by hydrogen embrittlement.

Figure 20.A Start of stress corrosion cracking. (Kamnik, April 2008)

Figure 20.B Start of stress corrosion cracking. (Kamnik, April 2008)

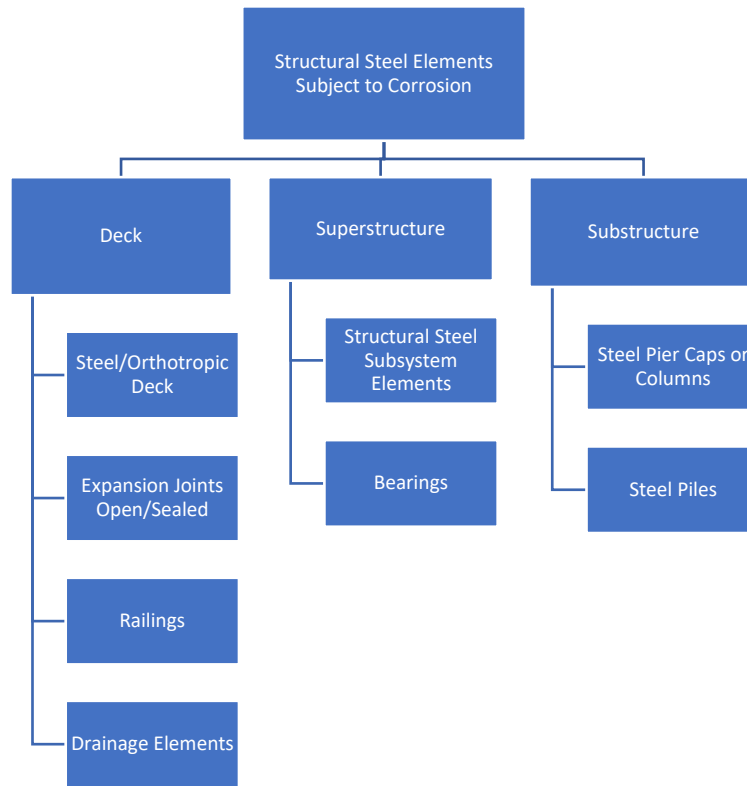
Figure 21 Structural steel elements subject to corrosion (Kamnik, April 2008)

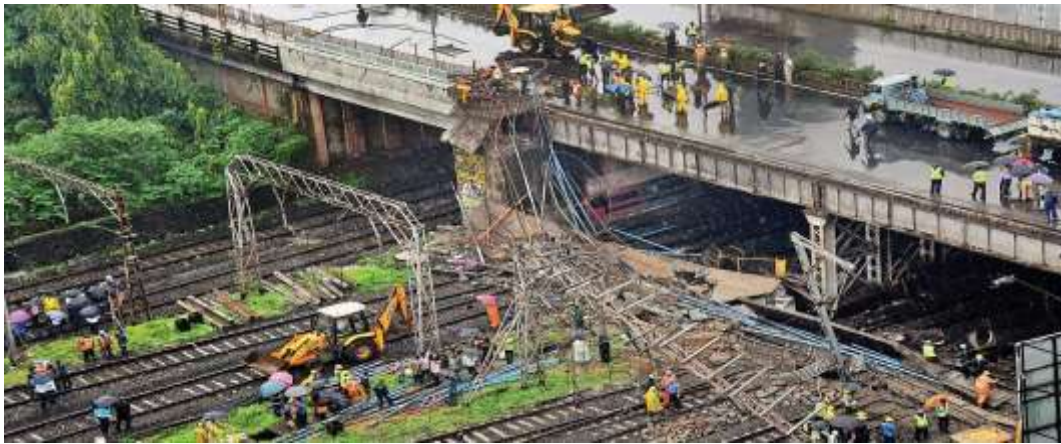
It was this extra weight of nearly 124 tones — comprising dry sand, paver blocks and cable wires — that led to the collapse.

*Figure 22 Andheri Bridge – (economictimes,2018)*

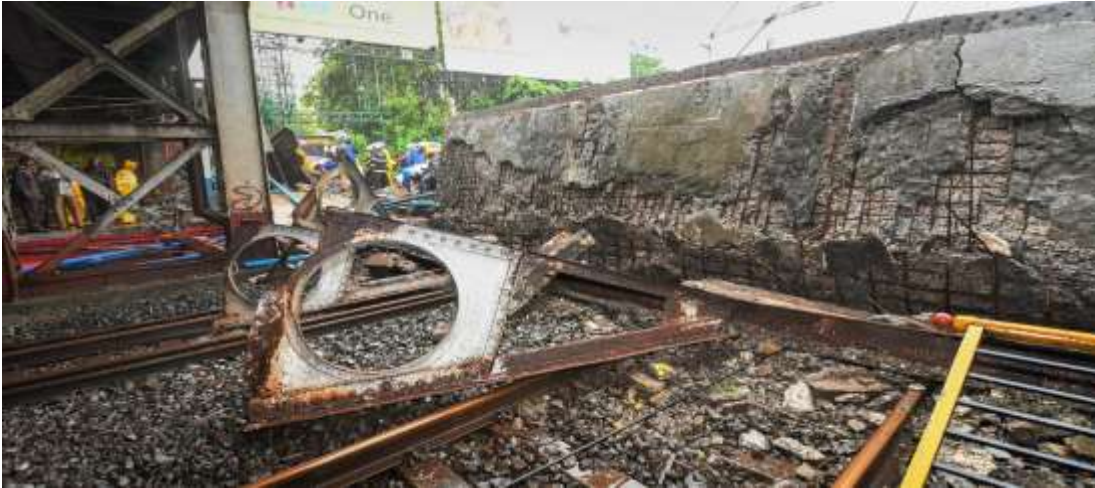
The accident occurred due to heavy/deep corrosion and pitting of cantilever steel brackets supporting the pathway resulting in thinning down of section. Also, the additional load of various cables, sand, paver blocks, etcetera, provided by the BMC without prior permission from the Western Railway, not contemplated when the bridge was designed, also contributed to its weakening.

*Figure 23 Failure due to corrosion – (economictimes,2018)*

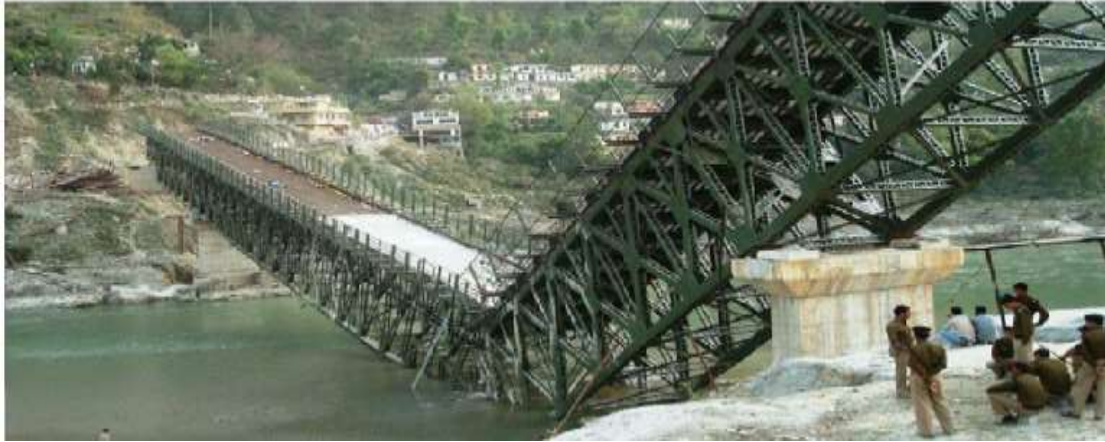
Chauras continuous deck type truss bridge failure took place during casting of the deck slab. The bridge was proposed to connect two cities is described in above section. After Placing the steel truss on two piers and two abutments, casting of deck slab was initiated from mid portion of the 110m span of the bridge towards right piers. When concrete was placed in 52.5m length from mid span of 110m towards right pier, bridge started collapse and below we will see the reason for the collapse.

Figure 30 Chauras Bridge after failure (Failure of Chauras bridge Harshad, pabitra rajan, Pramod kumar, 2014)

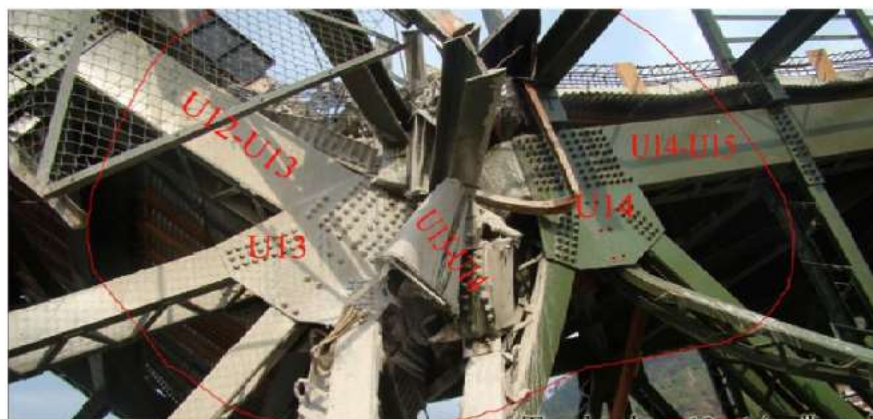
Next major fault is dimensioning and Buckling stress calculation. Buckling stresses for the buildup section ( $149.8 \text{ N/mm}^2$ ) and individual plates ( $140.0 \text{ N/mm}^2$ ) are quit close, and these strength of these are less than the actual stress developed at failure ( $173.8 \text{ N/mm}^2$ ). But it is not clear whether the local buckling at the double welded plates or buckling of the entire member U13U14 initiated the collapse.

Figure 31 Joints U13 and U14 and buckled member U13U14 (Failure of Chauras bridge Harshad, pabitra rajan, Pramod kumar, 2014)

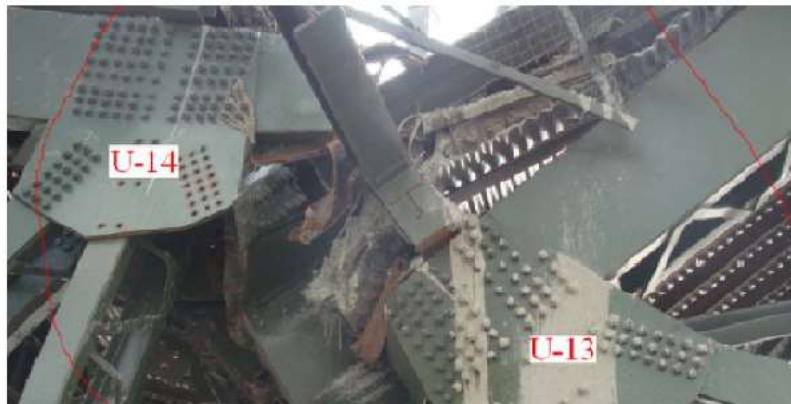
Another important factor is gusset plates, the member U18U19 did not fail even at such a high compressive stress, as it was prevented against buckling by the reverts. While gusset plate at joint U13 and U14 remained intact at high stress whereas, member U13U14 buckled and failed at a lower stress. Thus, gussets plates if connected properly to the members and prevented from buckling can take compressive or tensile stress up to ultimate strength of plate.

Figure 32 Intact gusset plat at joint U13 and U14 (Failure of Chauras bridge Harshad, pabitra rajan, Pramod kumar, 2014)

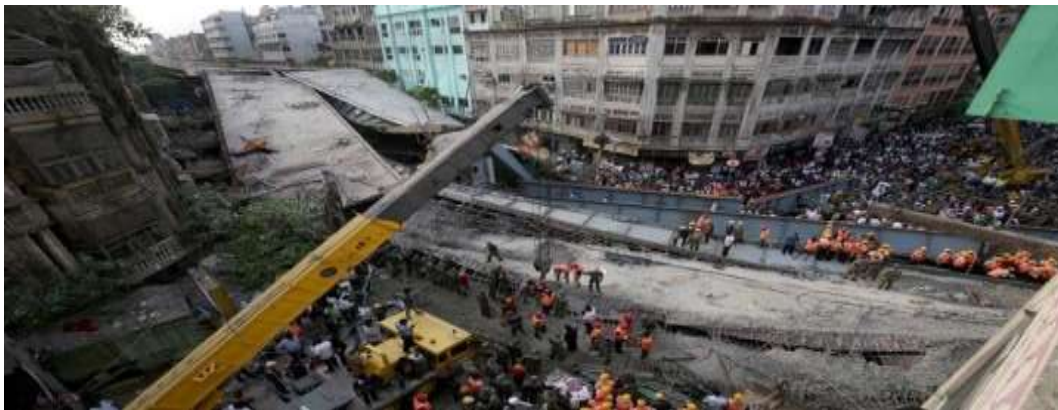
The pier 40(C) which had collapsed on 31<sup>st</sup> Mar 16 was supporting two simply spans. One side of the pier the deck slab on the carriageways were already cast. While on the other side, concreting for deck slab was done for one of the carriageways while the other carriageway slab was not cast prior to the collapse. From this it is clearly seen that cantilever Girder no.1 carried the full dead load from the deck slab on the both sides, whereas cantilever Girder no.2 carried the dead load from the deck slab on one side only. This is clearly seen from the pic source SEFI Website. It must be noted from below fig, that the concrete debris had fallen on one side whereas on the other side the bare plate girders have fallen, without having any concrete over on it.

Figure 35 After failure, Concrete Deck Slab had been Laid on one Cantilever Side only (Collapse of Kolkata flyover N.Prabhakar & N.Subramanian, 2017)

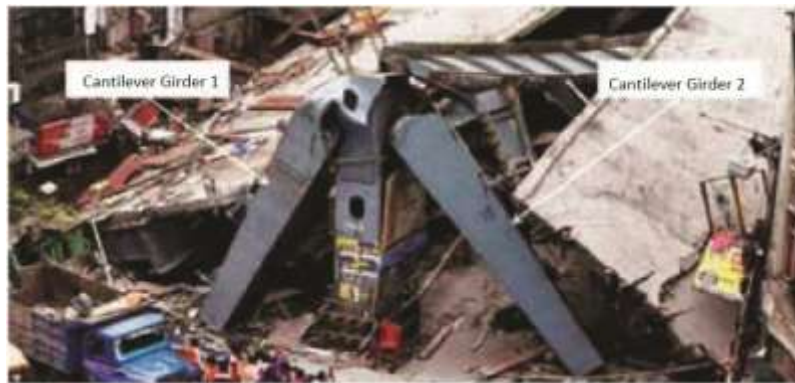
This initiated the shear failure of the side plates of the hollow cantilever beam, thus resulting in total collapse. From the Below fig, it is seen that the cantilever girder 1, had a large opening near the supporting end and a spliced connection. Opening near the support is to reduce the shear capacity of the girder while here affected the shear capacity of the beam. And another major defect was the inadequate number of bolts were used in many important locations.

Figure 37 Collapse of the two cantilever girder (Collapse of Kolkata flyover N.Prabhakar & N.Subramanian, 2014)

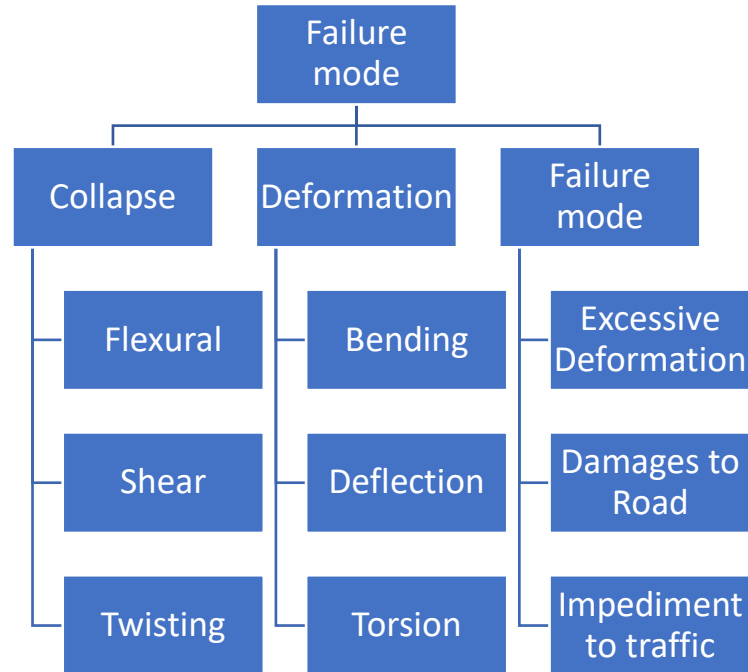
The combination of failure mode is listed below.

Figure 38 Combination of failure mode
