# Corrosive phenomena in photovoltaic and agrivoltaic structures

TESI DI LAUREA MAGISTRALE IN  
MECHANICAL ENGINEERING  
INGEGNERIA MECCANICA

Author: **Cesare Cassetti**

# Abstract

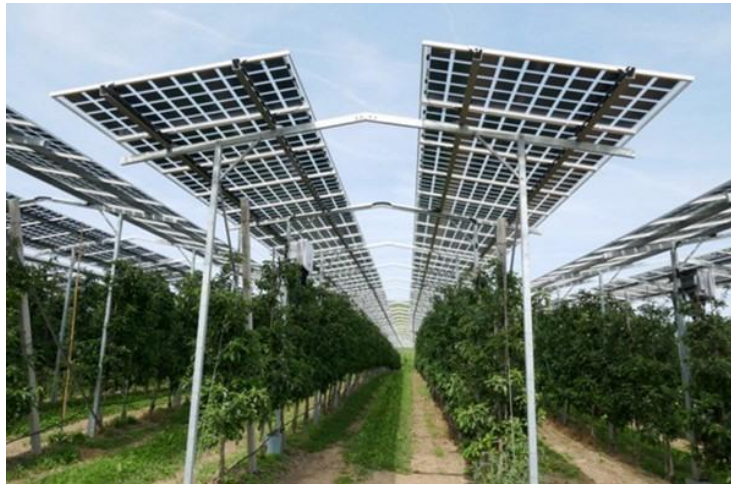
Figure 2 - Advanced AGV [8]

These systems are characterized by the mandatory implementation of a sophisticated monitoring system, which transforms the cultivated field into a data-driven environment. As detailed in the GSE operating rules, the objective is to verify the symbiotic relationship between the PV modules and the crops by tracking specific parameters over time [9]:

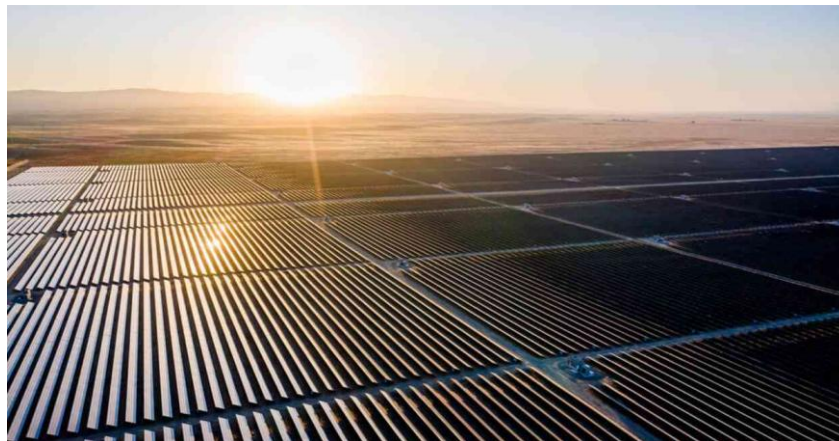
Figure 4 - Standard GMPV [12]

The fundamental distinction between standard ground-mounted photovoltaic (GMPV) plants and agrivoltaic systems lies in the philosophy of land utilization. In a conventional ground-mounted PV plant, the land is dedicated exclusively to energy generation. As highlighted in the GSE statistical report 2024, standard installations typically require substantial surface areas (approximately 1.7 hectares per MW in Italy), where the soil is often compacted or covered with gravel to suppress vegetation costs [2]. In these configurations, the spacing between module rows is strictly determined by the need to avoid mutual shading during early morning and late afternoon hours. Consequently, the land between rows remains unproductive "dead space" from an economic perspective, serving only for maintenance access.

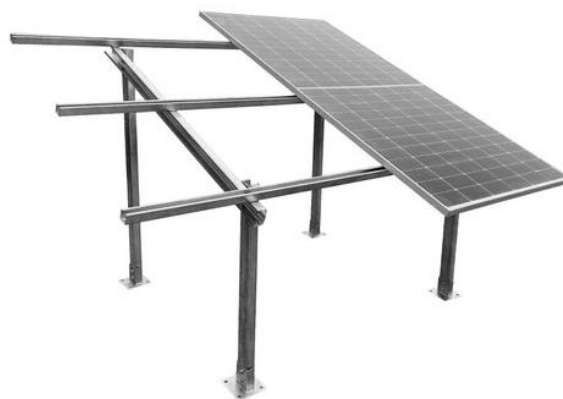
The fixed-tilt configuration characterizes the early generations of ground-mounted PV and remains a viable solution for specific applications where maintenance simplicity is paramount. In this topology, PV modules are mounted on a stationary steel racking system, typically supported by two parallel rows of piles (driven or screw piles) for every table to ensure stability against wind and snow loads. The modules, usually arranged in groups of 2, 3, or 4 in landscape or portrait orientation, are permanently oriented towards the equator (South in the Northern hemisphere) to maximize annual irradiation capture.

Figure 5 - Fixet structure type [22]

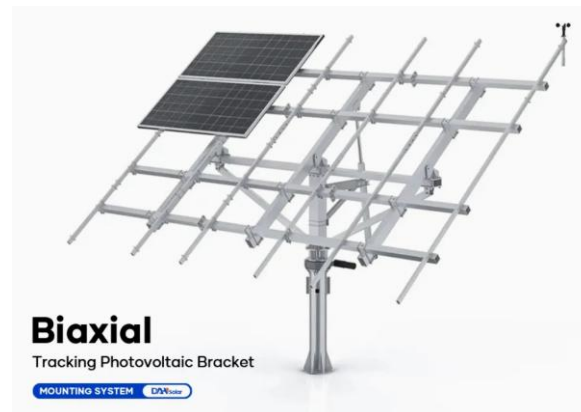
Dual-axis trackers (DAT) represent the most technologically advanced solution, capable of tracking the sun's position across both the azimuth (East-West) and zenith (elevation) axes. This capability allows the modules to maintain perfect alignment with the sun vector at all times, theoretically offering yield increases of 25-35% over fixed systems, particularly in high latitudes.

Figure 7 - Dual-axis tracker structure type [26]

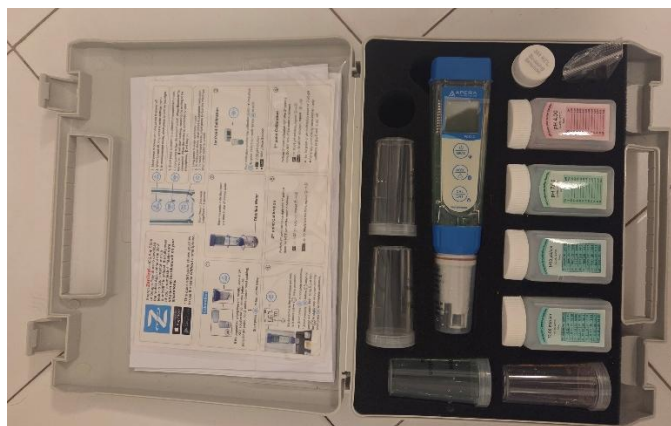
To measure the acidity and the ionic concentration of the soil extracts, an Apera PC60-Z smart multiparameter tester was utilized. This instrument is designed to measure pH, electrical conductivity, total dissolved solids and salinity simultaneously.

Figure 8 - Apera PC60-Z for pH and electrical conductivity

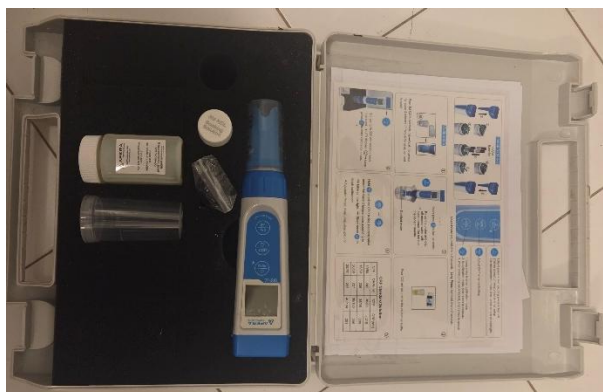
The measurement of the soil's oxidation-reduction potential, a fundamental parameter for assessing the degree of aeration and the risk of anaerobic bacterial corrosion, was conducted using an Apera ORP60 tester.

Figure 9 - Apera ORP60

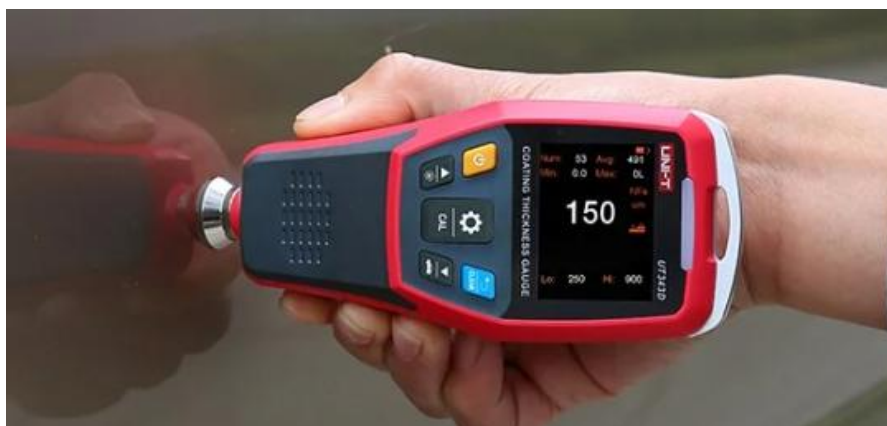
To evaluate the physical degradation of the foundations, it was necessary to quantify the remaining thickness of the protective zinc layer on the steel profiles. For this purpose, a UNI-T UT343D ultrasonic coating thickness gauge was employed.

Figure 10 - UNI-T UT343D ultrasonic coating thickness gauge [56]

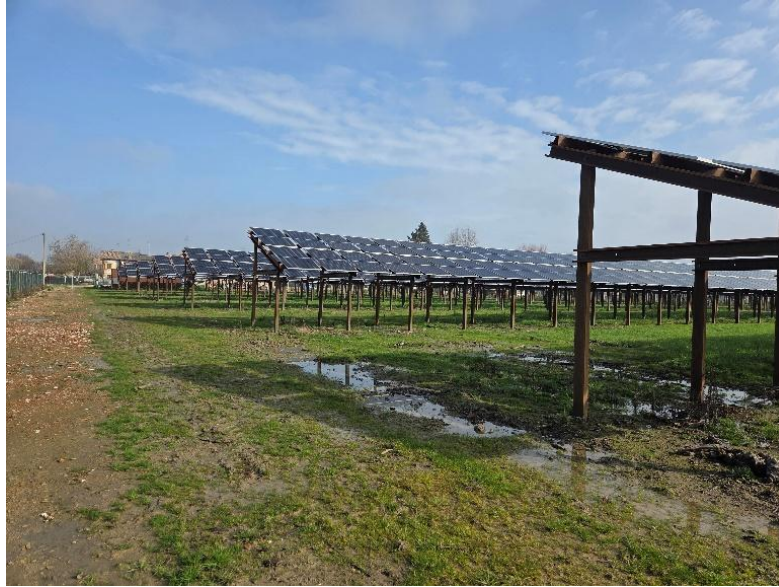
Figure 12 - Plant of Modena

The plant features an installed peak power capacity of 1940.3 kW and utilizes a fixed mounting structure. The construction phase, with specific reference to the placement of the foundation piles, was officially completed on April 1, 2025. The structural design distinguishes itself by relying entirely on unalloyed weathering steel. Specifically, Corten grade S355 was chosen for the heavily stressed vertical foundation piles, while Corten grade S235 was utilized for the lighter above-ground upper structure. The entire assembly is mechanically connected using high-grade class A2-70 stainless steel bolts. The vertical foundation supports consist of open C-shaped profiles. The geometric dimensions of this cross-section feature a primary main side of 160 mm, a width of 80 mm, and structural lips of 25 mm, maintaining a uniform material thickness of 2.5 mm throughout the profile length.

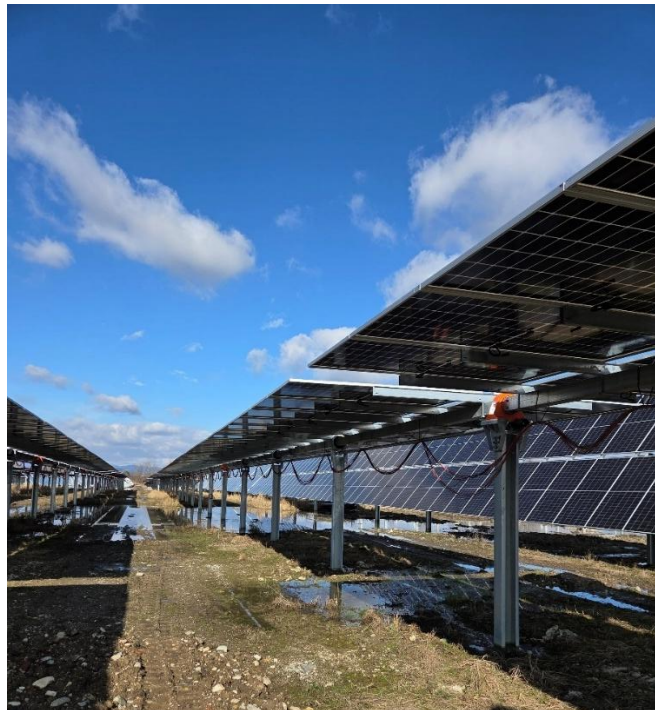
Figure 13 - Plant of Vercelli

The second installation is a massive traditional photovoltaic plant situated in the province of Vercelli, in the province of Vercelli, Piedmont. This geographical area is located at an altitude of approximately 200 m above sea level and is historically renowned for its extensive flooded rice paddies. The climate is continental and notoriously humid, heavily influenced by the dense network of agricultural irrigation canals, while remaining completely isolated from any marine influence. The plant is managed by Repower, a major international energy utility company managing significant renewable assets. The system boasts a highly significant installed peak power, totaling 19530 kW of panel capacity, and employs an advanced single-axis tracking structure to optimize solar yield.

The foundation piles were installed recently on August 1, 2025. The structural materials chosen for this site reflect a heavy-duty approach, consisting entirely of highly specified protected steel. The vertical foundation piles are manufactured from

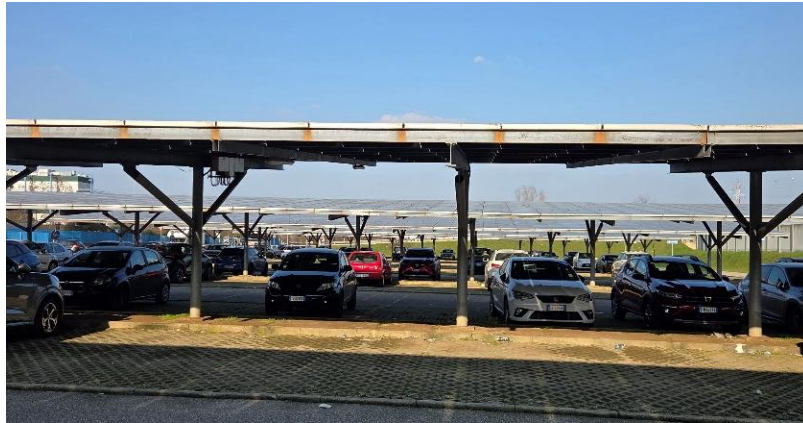
Figure 14 - Plant of Pavia

The plant has an installed peak power capacity of 1179 kW and was constructed historically around January 1, 2013. The system features a fixed structural layout completely manufactured from hot-dip galvanized steel. Although the exact original steel composition is not specifically documented in the available historical records, engineering standards of the time suggest it is presumed to be structural grade S235 or S275. The primary vertical columns have a large circular hollow section with an external diameter of 180 mm. Field estimation indicated that the hot-dip galvanization applied has a starting average thickness of approximately 90  $\mu\text{m}$ .

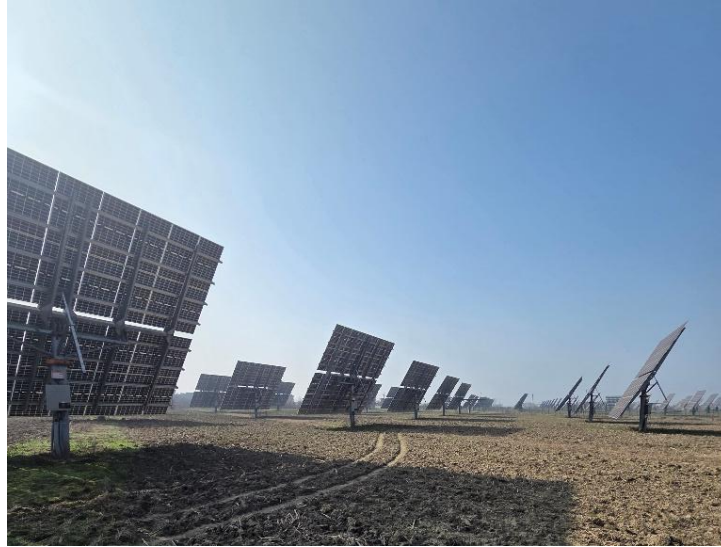
Figure 15 - Plant of Rovigo

The original construction of the foundations and support structures dates back to January 1, 2013. Originally featuring an installed peak power of 5650 kW, the plant underwent a massive repowering process in 2021. This substantial technical intervention included the complete replacement of the photovoltaic panels, increasing the total installed peak power to an impressive 7440 kW. This structural repowering implies a clear operational intention by the utility company to extend the functional use of the existing metallic support framework far into the future, significantly beyond its original depreciation schedule.

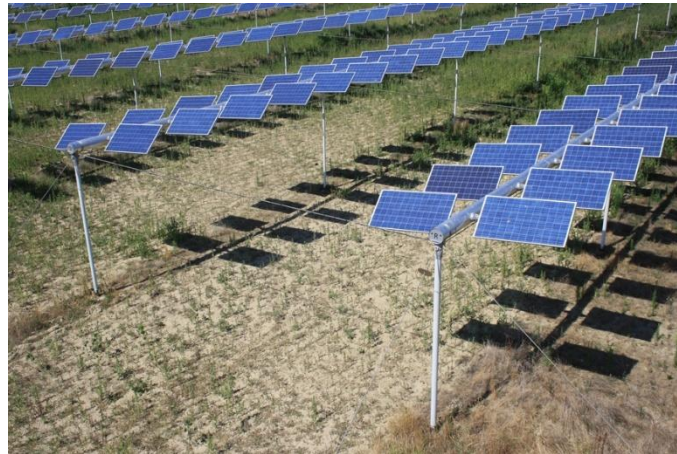
Figure 16 - Plant of Castelvetro [68]

Constructed on January 1, 2011, the plant features an installed peak power of 1293.6 kW utilizing a highly elevated dual-axis solar tracking architecture. The structural framework relies on a specialized multi-layer component system. This consists of an initial hot-dip galvanization layer, presenting an average measured thickness of 90  $\mu\text{m}$ , which is further completely enveloped by an industrial paint layer. The specific layers and paint composition remains strictly undocumented. The main vertical columns feature a standard circular hollow section with an external diameter of 200 mm.

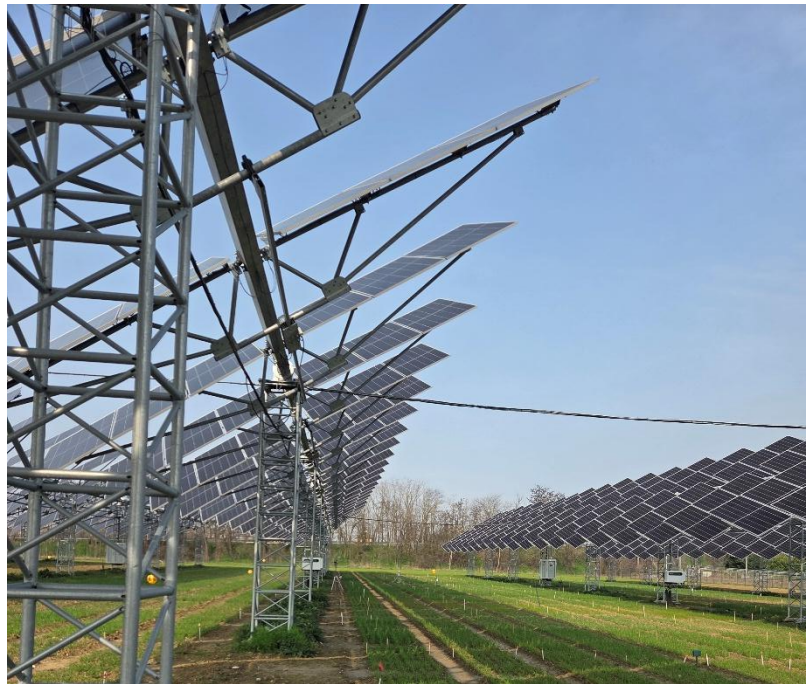
Figure 17 - Plant of Piacenza

The foundation piles were officially constructed on June 1, 2024. The structure utilizes a distinctly different, highly specialized engineering approach compared to the traditional single-pole sites, acting essentially as a structural evolution of the patents developed by Remtec. The framework consists of a complex tubular truss structure entirely manufactured from hot-dip galvanized steel, presenting an average zinc coating thickness of 90  $\mu\text{m}$  across the accessible members. Instead of relying on a single central column or concrete plinths, this system utilizes an anchored foundation consisting of four distinct underground screw piles for each base, each with a diameter of 100 mm, driven deeply down to 4 m into the soil. Above ground, this transitions

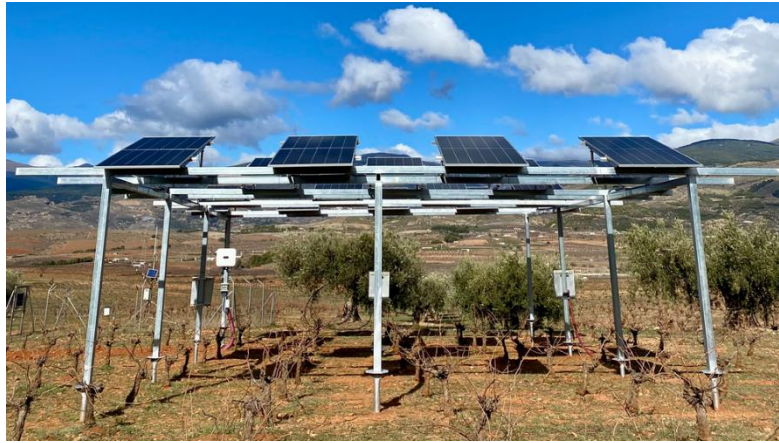
Figure 19 - Plant of Almeria [69]

It is a highly specialized, small-scale system with a minimal installed peak power of 10.8 kW, utilizing a fixed mounting framework whose structural supports were installed on January 1, 2025. The entire supporting structure is manufactured exclusively from hot-dip galvanized steel, featuring an average zinc coating thickness of 45  $\mu\text{m}$ . The vertical support piles are characterized by a precise square tubular section, with a side length of 75 mm and a relatively thin material thickness of 2 mm. The foundations are realized by directly driving these galvanized square piles into the dry ground by ramming, completely avoiding the use of any concrete plinths. The depth and specific state of the local groundwater table at this location are not visually detectable from the surface and remain entirely unknown.

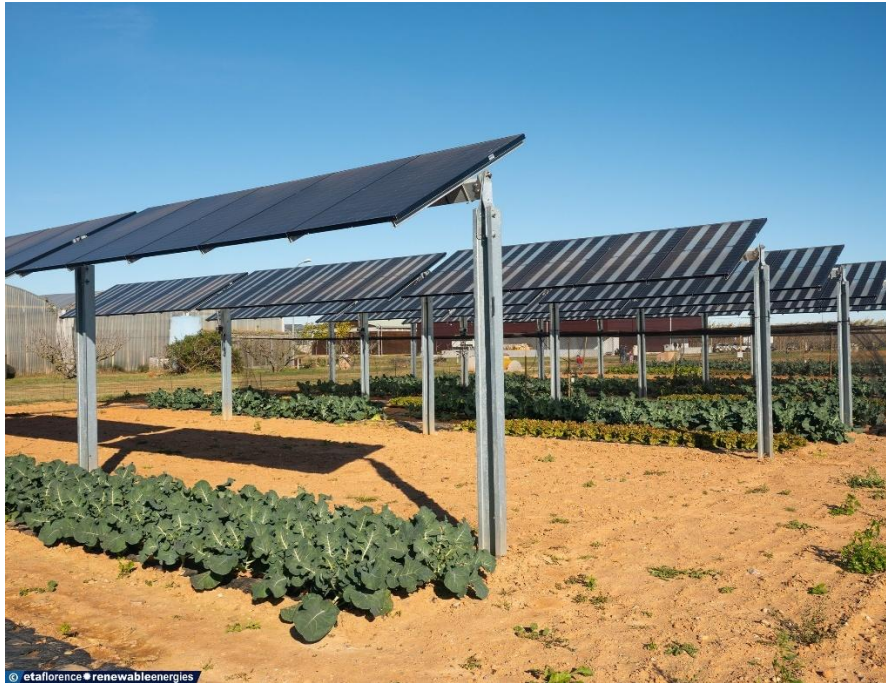
Figure 20 - Plant of Barcelona [70]

It is an active agrivoltaic plant with a total installed peak power of 47.2 kW of panels, employing an advanced dynamic single-axis solar tracker specifically configured to maximize light interception while balancing the shading over the crops below. The foundation structure was officially installed into the agricultural soil on January 1, 2025. The entire structural framework is constructed from high-quality hot-dip galvanized steel. Notably, the zinc coating thickness measured at this specific coastal site is highly substantial, averaging an impressive 90  $\mu\text{m}$ , a specification necessary to combat the harsh environment. The structural vertical supports utilize a standard open  $\Omega$ -shaped profile with a main side length of 210 mm and a robust material thickness of 5 mm, driven directly into the earth by mechanical pile ramming to form the foundations.

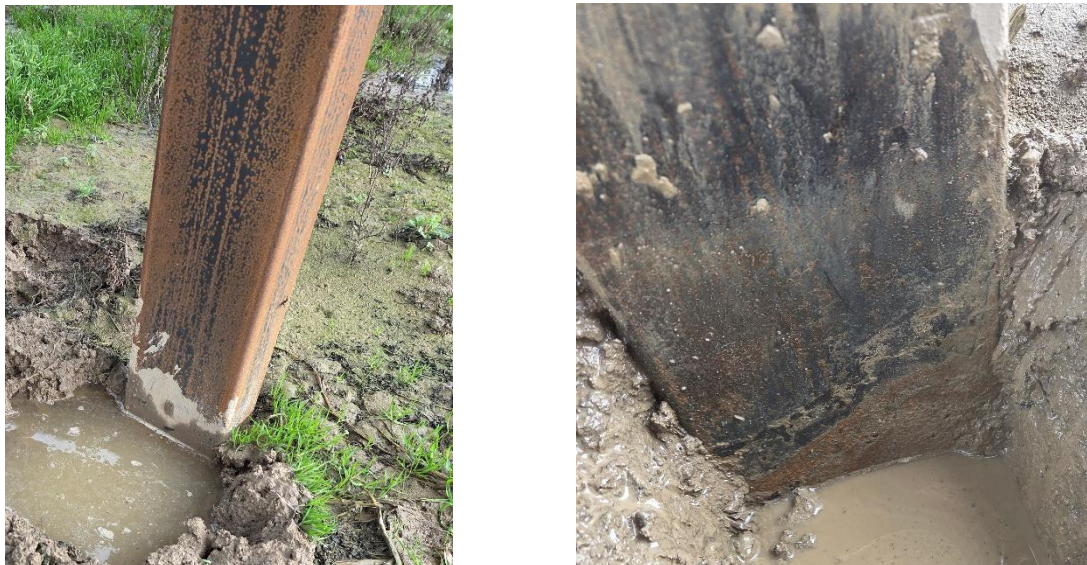
Figure 22 - Buried part of plant of Modena

The structural evaluation of this specific plant focuses on the behavior of the unalloyed weathering steel utilized for the foundation profiles. Because the installation is of entirely new construction, it currently presents the very early developmental stages of the protective Corten patina, possessing a historical tracking period of only 1 year. It was observed that the steel profiles were driven into the ground for supply reasons without the protective patina having already developed beforehand. Currently, the development of the aerial patina exhibits a reddish-orange coloration that is still relatively light, a chromatic state that is entirely coherent with the brief period of atmospheric exposure that has elapsed since construction.

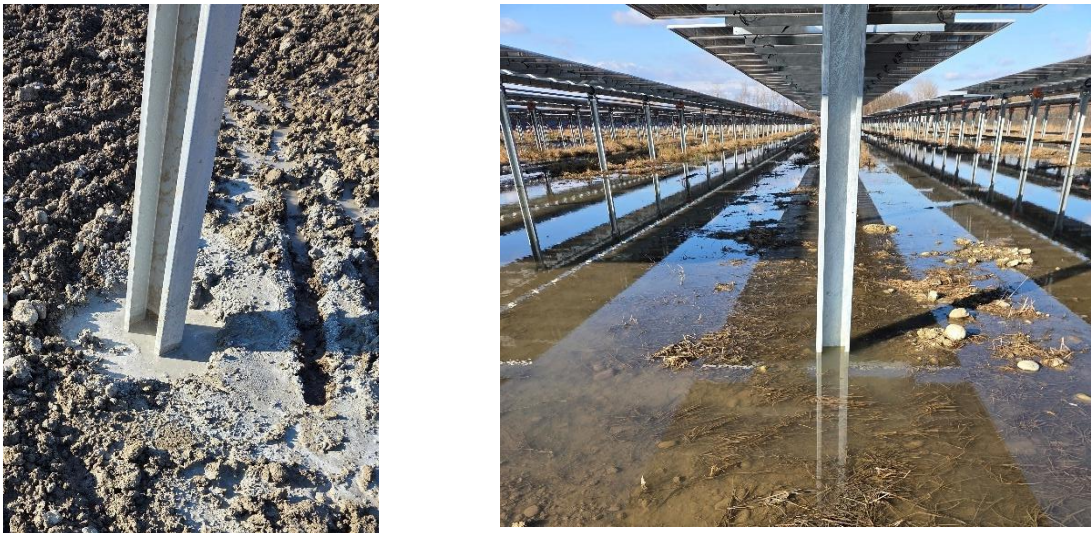
Figure 23 - Foundation part of plant of Vercelli

The structural conditions of the second investigated site are entirely dictated by its current developmental phase. Because the massive solar plant is actively under construction, the metallic foundation profiles do not present any visible signs of corrosion or structural degradation at this time. The hot-dip galvanized coating remains visually intact and pristine across the observed structural members.

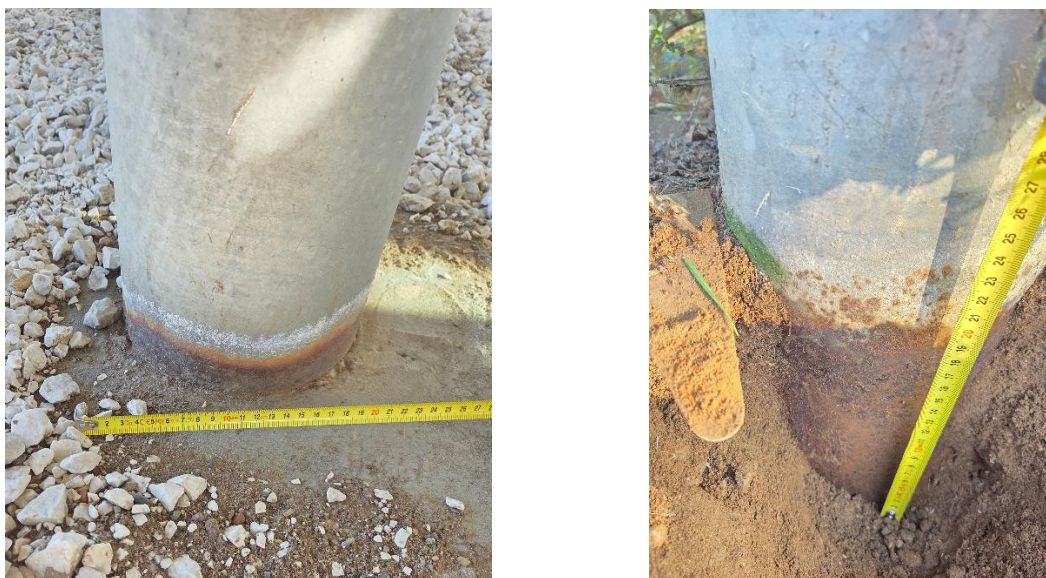
Figure 24 - Foundation and buried part of plant of Pavia

The structural condition of the university parking canopy reveals a severe state of advanced degradation. A highly aggressive corrosive ring is clearly visible approximately 7 cm above the contact line between the vertical pole and the concrete plinth. This specific localized area is affected by profound corrosion phenomena that have progressed to the point of causing active flaking of the underlying structural steel. Furthermore, there is a distinct chromatic shift in the metallic surface in the area immediately above this ring, accompanied by aggressive pitting phenomena exactly at the air-soil transition zone. The deeply buried underground portion of the poles is completely and entirely corroded. Interestingly, the foundation columns that utilize only concrete plinths without topsoil do not present these signs of corrosion, which strongly suggests that the severe degradation problem derives directly from the filling of the foundation areas with mixed soil and gravel. Additionally, in the aerial portion of the structure, specific corrosion spots are visible on the fixing beads of the solar panels, exactly corresponding to the water drainage points.

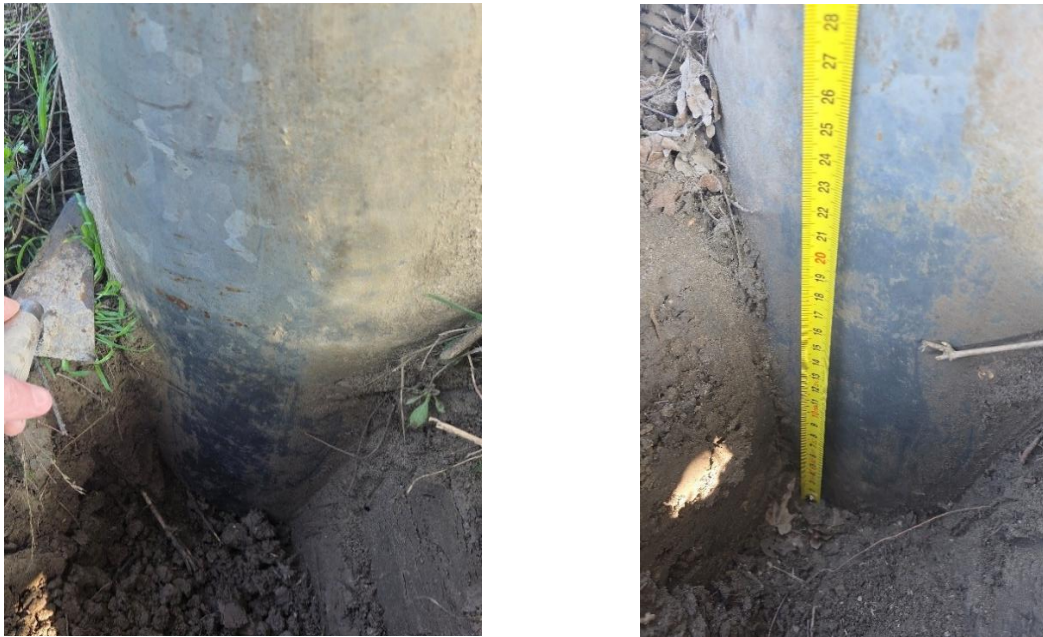
Figure 25 - Buried part of plant of Rovigo

The inspection of the foundations at this massive agricultural site revealed a surprisingly pristine structural condition. Despite the installation being decidedly old, having been originally constructed in 2013, the foundation poles do not present any visible trace of corrosion. This excellent state of preservation is consistent across the entire length of the structure, showing no signs of degradation either in the buried underground portion or in the aerial section exposed to the agricultural atmosphere.

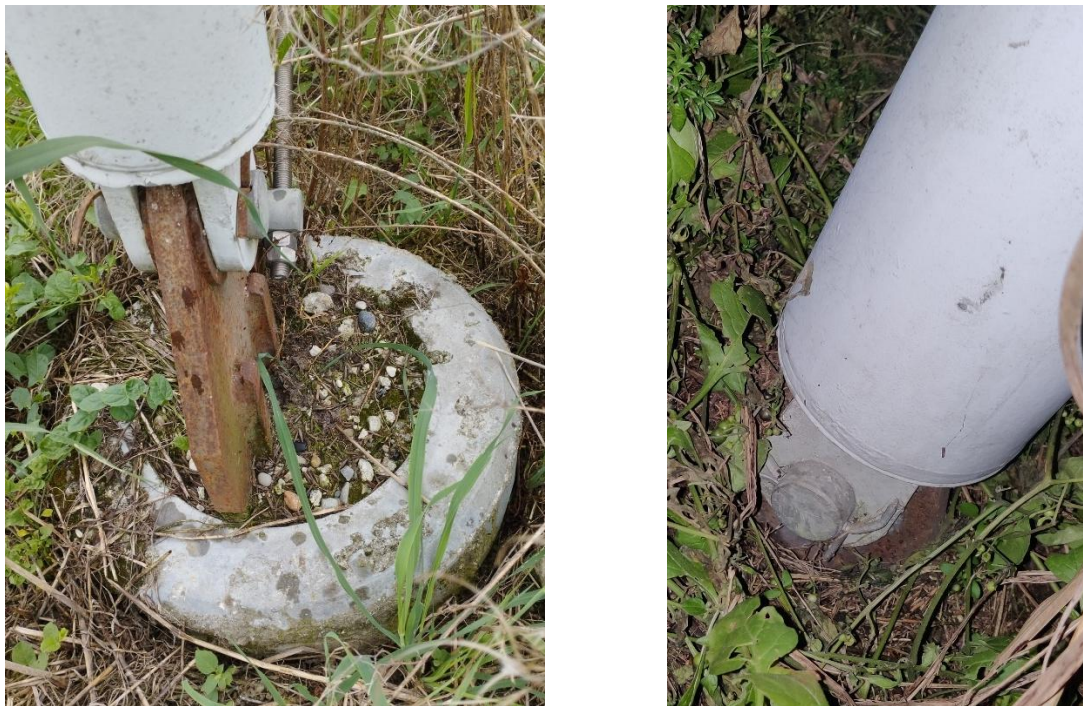
Figure 26 - Foundation of plant of Castelvetro

metal pole and the foundation matrix. At this interface, there is a connection steel joint that is now entirely corroded. Because there are no traces of thick corrosion flakes, but rather a surface porosity in the material, it is hypothesized that the zinc coating in this specific ring has only recently been completely exhausted.

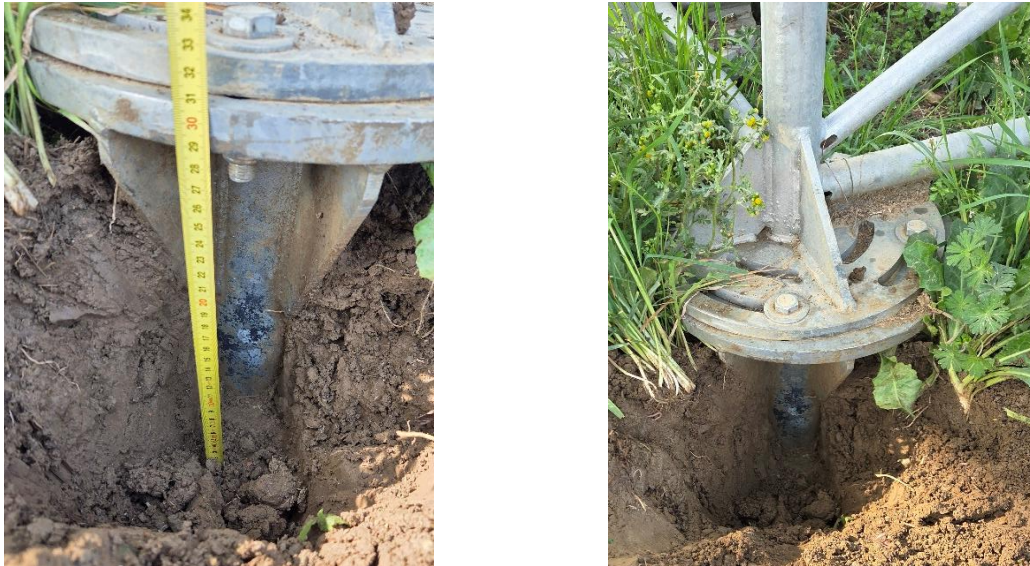
Figure 27 - Buried part of plant of Piacenza

These localized surface variations are hypothesized not attributed to environmental degradation, but are instead thought to be the physical result of the mechanical screwing process during the foundation installation, or potentially the very first microscopic signs of localized environmental attack.

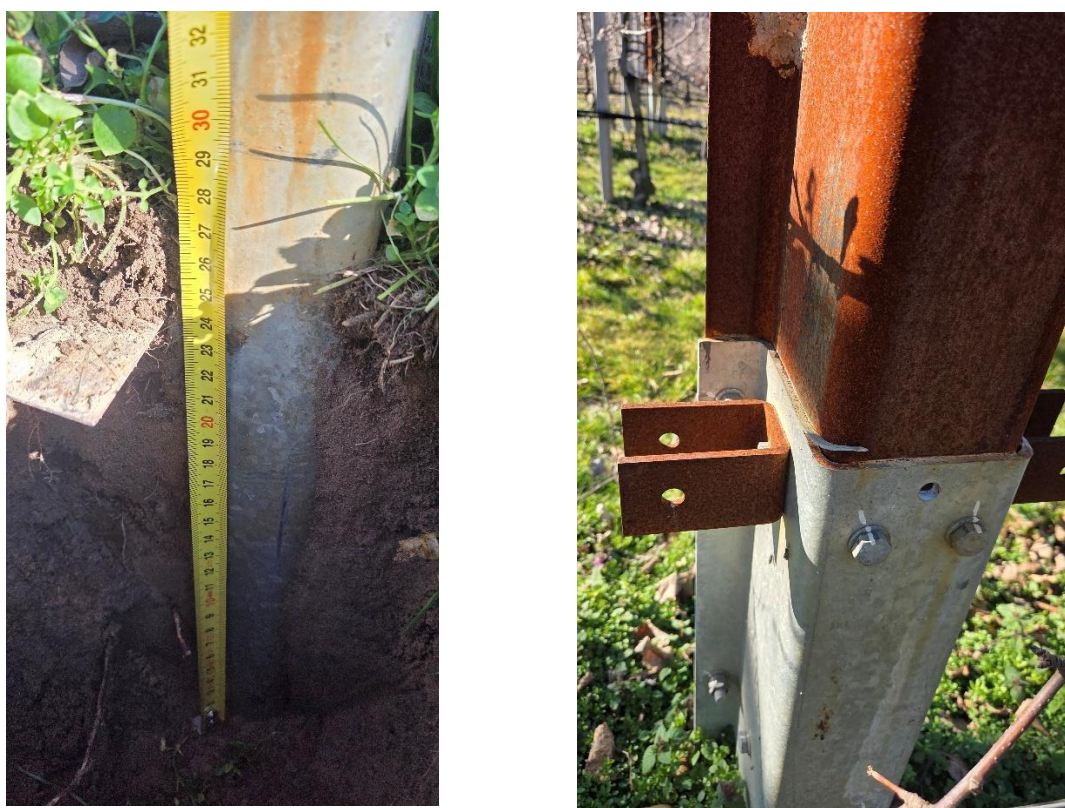
Figure 28 - Buried part and connection joint of plant of Ora

The structural evaluation of the alpine orchard installation reveals a condition largely influenced by its recent commissioning and specific material choices. Because the plant is entirely new, there is absolutely no corrosion present on the hot-dip galvanized profiles within the underground soil environment. However, a highly specific and active corrosion phenomenon was detected in the aerial portion of the structure. Specifically, early signs of corrosion are visibly developing exactly at the physical point of contact between the unalloyed Corten weathering steel superstructure and the hot-dip galvanized foundation piles. This bimetallic interface is located on the main pole, situated relatively close to the ground level.

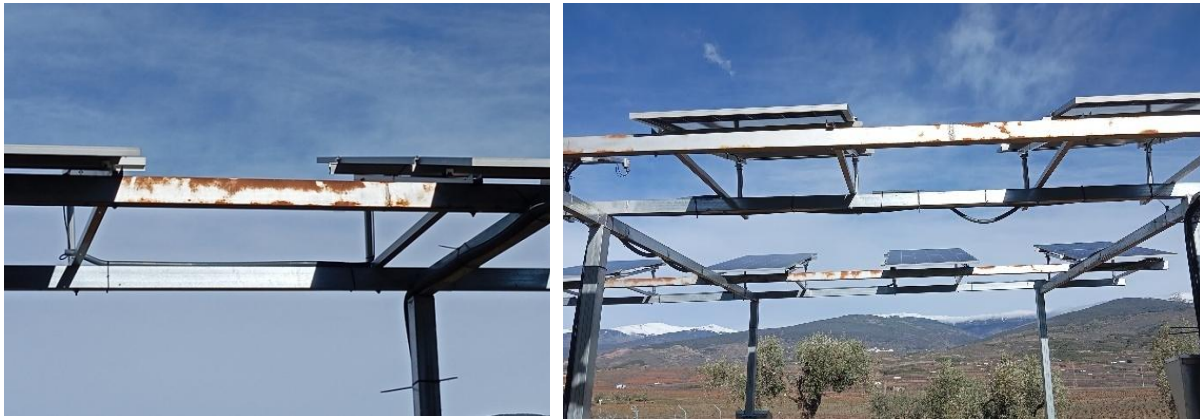
Figure 29 – Metallic frameworks of plant of Almeria

The inspection of the experimental coastal installation revealed a surprisingly severe and aggressive state of degradation, especially considering the extreme youth of the structure. Active corrosion is clearly visible across the aerial portions of the metallic framework. Following a deeper investigation into the agronomic practices of the site, this rapid deterioration was directly attributed to the heavy agricultural use of elemental sulfur and its various chemical derivatives, specifically sulfates and sulfides, which are routinely applied to the vineyard as targeted fertilizers and organic treatments.

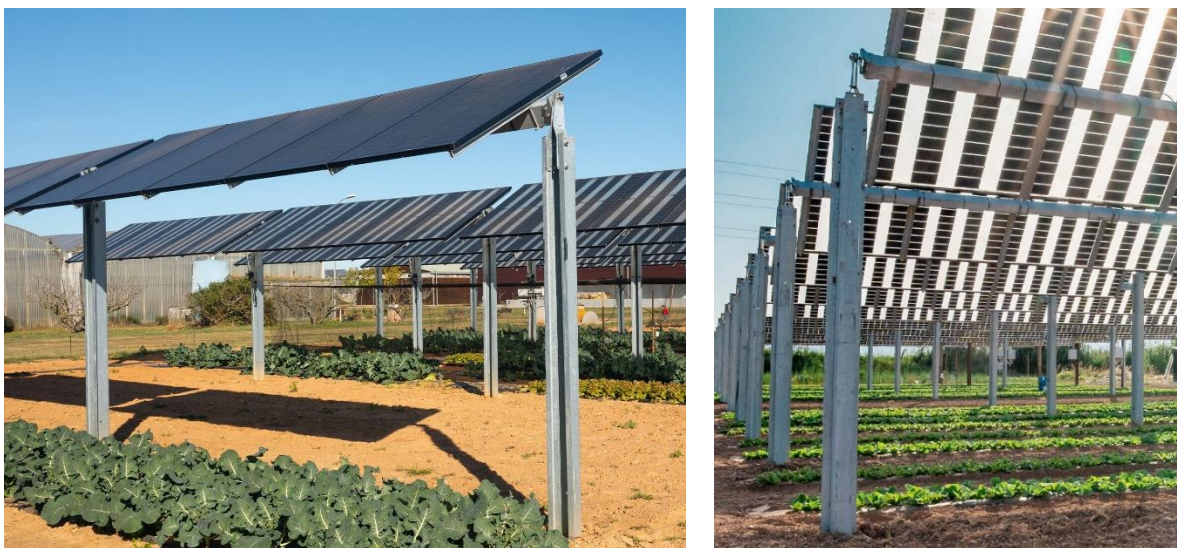
Figure 30 - Piles of plant of Barcelona

The final investigated installation, situated in the coastal metropolitan area, currently exhibits a pristine structural condition. Due to the very recent installation of the tracking framework, there is absolutely no active corrosion present on the massive hot-dip galvanized profiles. The structural surfaces remain uniform and visually uncompromised by the surrounding agricultural environment.

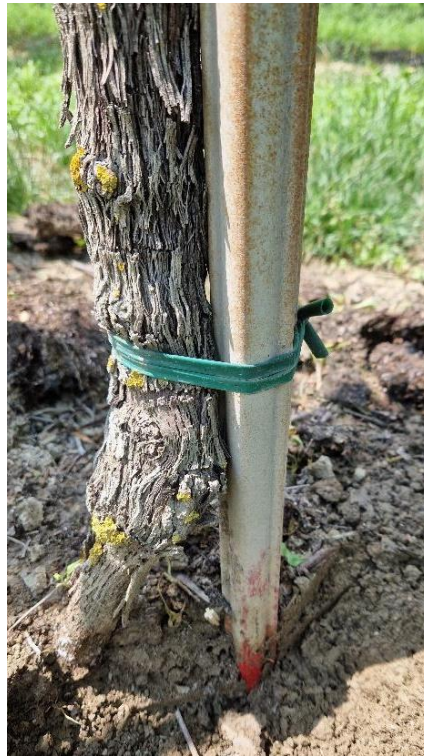
Figure 31 - Integration of structural support and grapevine [34]

The investigated vineyard poles were manufactured using a structural carbon steel substrate, specifically grade S250. To protect this steel core against the environmental elements, the profiles were coated with an advanced continuous zinc-aluminum-magnesium alloy, commercially known as Magnelis. The specific coating designation applied to these poles was ZM310. According to the technical specifications of the material, a ZM310 designation indicates a total minimum coating mass of 310 g/m<sup>2</sup> distributed across both surfaces. When converted to a linear physical dimension, this mass corresponds to a theoretical guidance value of approximately 25 µm of protective alloy per side [34].

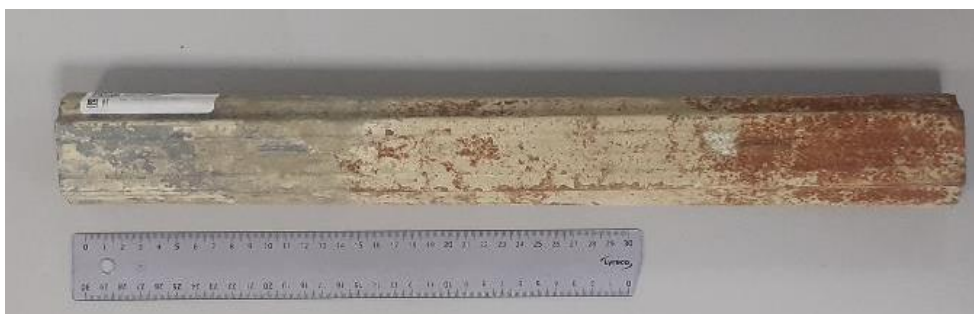
Under standard, ordinary atmospheric conditions, such as those classified as C3 medium corrosivity, manufacturer data and accelerated salt spray tests consistently demonstrate that a 25 µm zinc-aluminum-magnesium layer can easily guarantee a service life exceeding forty to fifty years without the appearance of red rust. The advanced microstructure of the alloy, characterized by a complex ternary eutectic phase containing magnesium, provides exceptional barrier properties and a highly effective self-healing effect on cut edges in open-air environments [34].

Figure 32 - Visual assessment of corrosion and rust distribution on a vineyard post specimen [34]

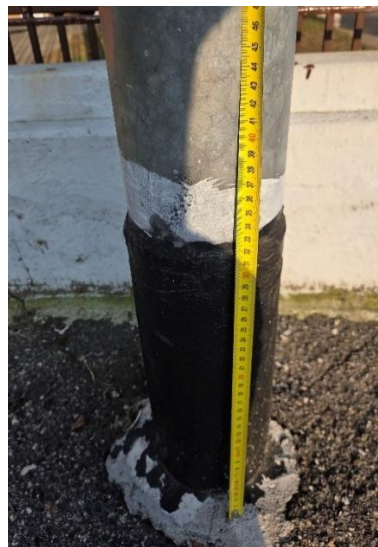
Figure 37 – Bituminous protection of illumination pole

In the specific case of piles embedded in concrete foundation plinths or micropiles, the maximum vulnerability shifts precisely to the interface between the extrados of the concrete and the emerging steel. Water stagnation at this specific contact point triggers carbonation processes and sulfate attacks that destroy the passivating alkalinity of the cement, creating micro-cracks that act as incubators for chlorides and acidic moisture. This phenomenon accelerates the formation of a corrosion ring. To overcome these pathologies, corrosion engineering prescribes the implementation of passive barriers, which are dielectric coating systems designed to waterproof the interface, physically excluding the electrolyte and oxygen from the metallic surface and effectively deactivating the galvanic macro-cell [18].

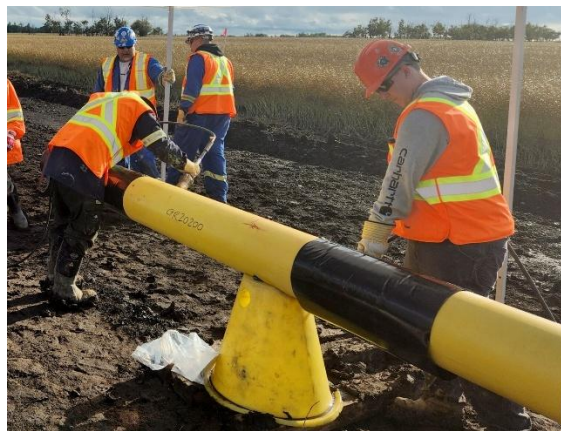
Figure 38 - shrinkable anticorrosive sleeves

The necessity to protect the ground line of metallic supports boasts a wide historical case study in civil infrastructure engineering, particularly in the public lighting and road sign sectors. Historically, the passive protection par excellence for circular lighting poles was represented by the application of hot-applied bituminous bands. Bitumen offers extraordinary hydrophobic properties and excellent chemical tolerance in both acidic and alkaline environments, isolating the metal from interstitial soil water. However, traditional bituminous coatings maintain a degree of plasticity that makes them highly susceptible to mechanical damage from impact or abrasion during the brutal operations of hydraulic ramming typical of solar construction. A single tear in the bituminous mantle concentrates the entire anodic current of the macro-cell in that small defect, triggering penetrating pitting at extreme speeds [15].
