Building Future through Preserving Past

Architectural Design Studio for Restoration and Transformation of Complex Construction Thesis 2023 July

POLITECNICO DI MILANO
School of Architecture Urban Planning Construction Engineering(AUIC)
Architectural Design Studio for Restoration and Transformation of Complex Construction

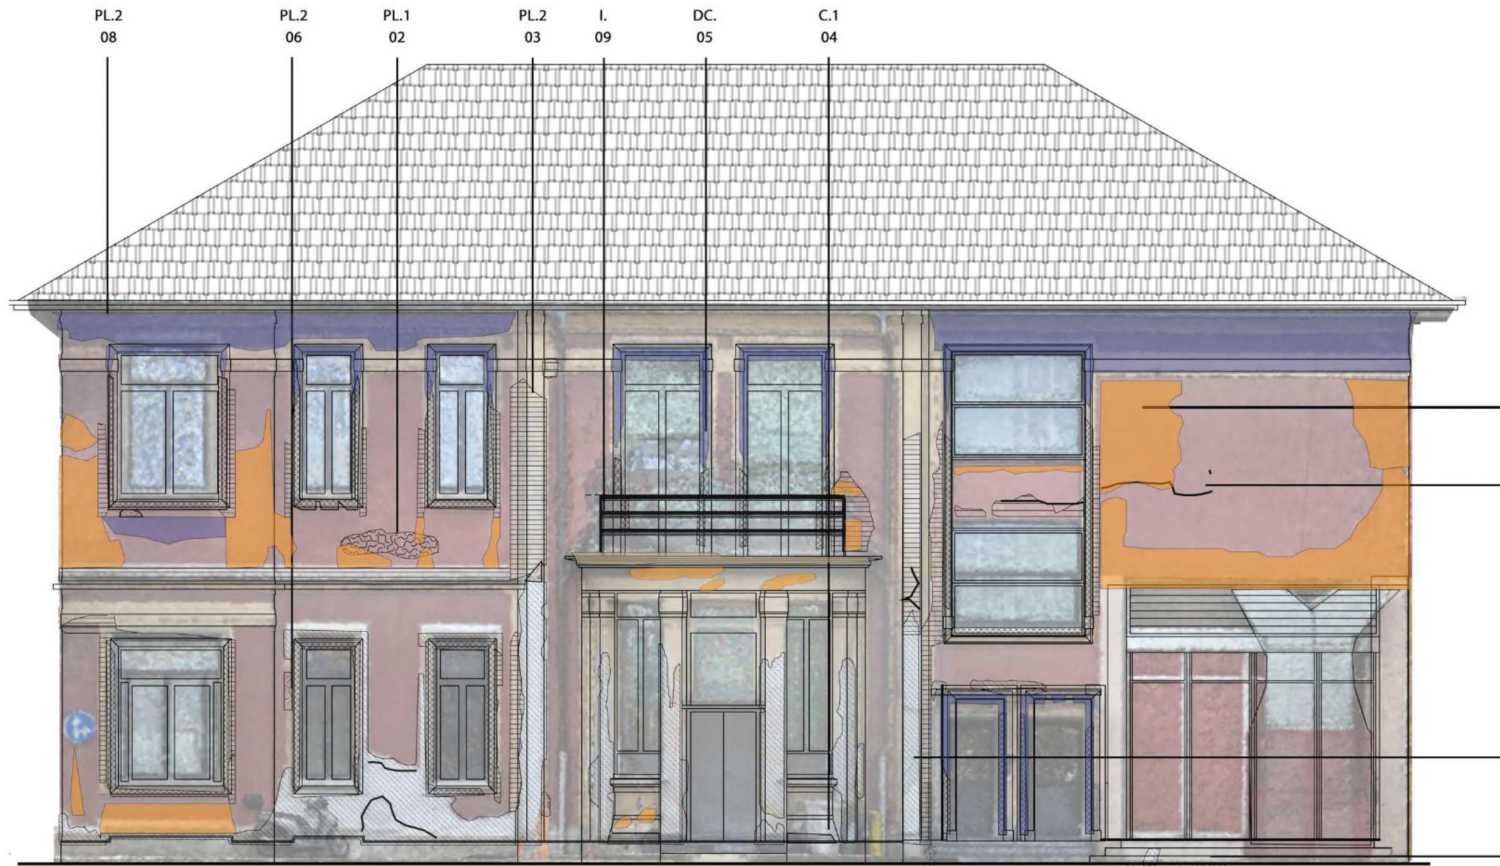
Crack & Deformation

01. Cracks

Detachment

02. Bursting

03. Peeling

04. Disintegration

Material Loss

05. Erosion

06. Missing Part

Discoloration & Deposit

07. Discoloration

08. Black Compact Deposit

09. Staining

Biocolonization

10. Alga/Moss/ Mold

Others

11. Uncompatible Interventions

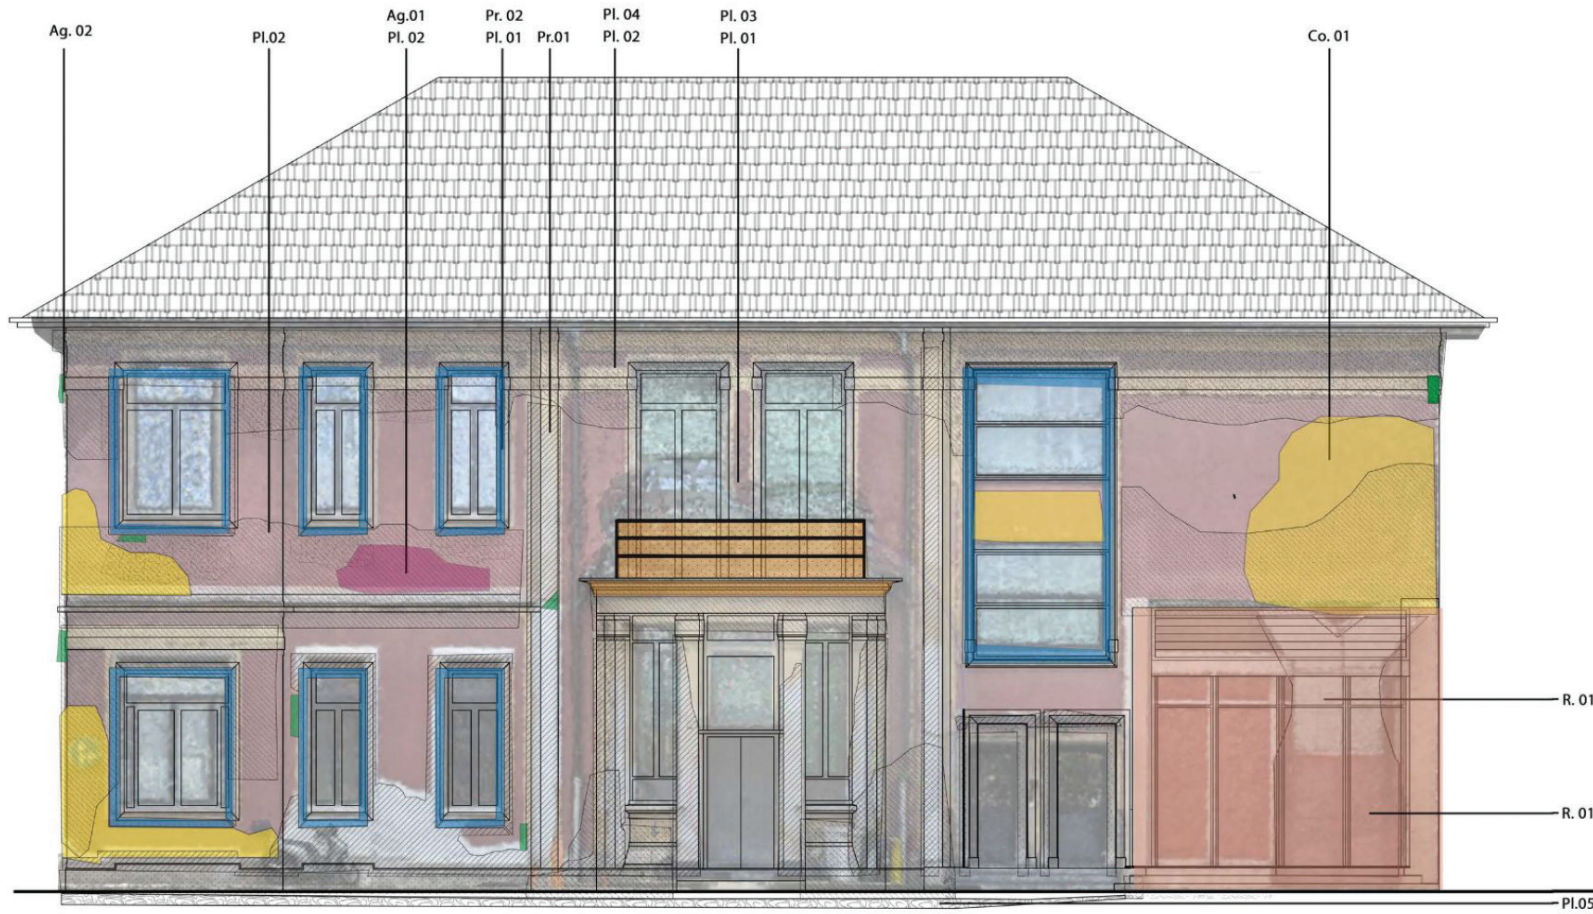
- Removal**
- R. 01 Demolition of structure
- Cleaning**
- Pl. 01 Dry Cleaning with Manual Tools
 - Pl. 02 Wet Cleaning with Atomised and Nebulized Water
 - Pl. 03 Cleaning with Chemicals
 - Pl. 04 Cleaning with Micro-sandblasting
 - Pl. 05 Cleaning with Bioxide Products
- Addition**
- Ag. 01 Lime plaster patch
 - Ag.02 Integration of stucco & molding
- Consolidation**
- Co. 01 Consolidation with Ethyl Silicate
- Protection**
- Pr. 01 Painting with Lime Plaster
 - Pr. 02 Apply Water Repellent

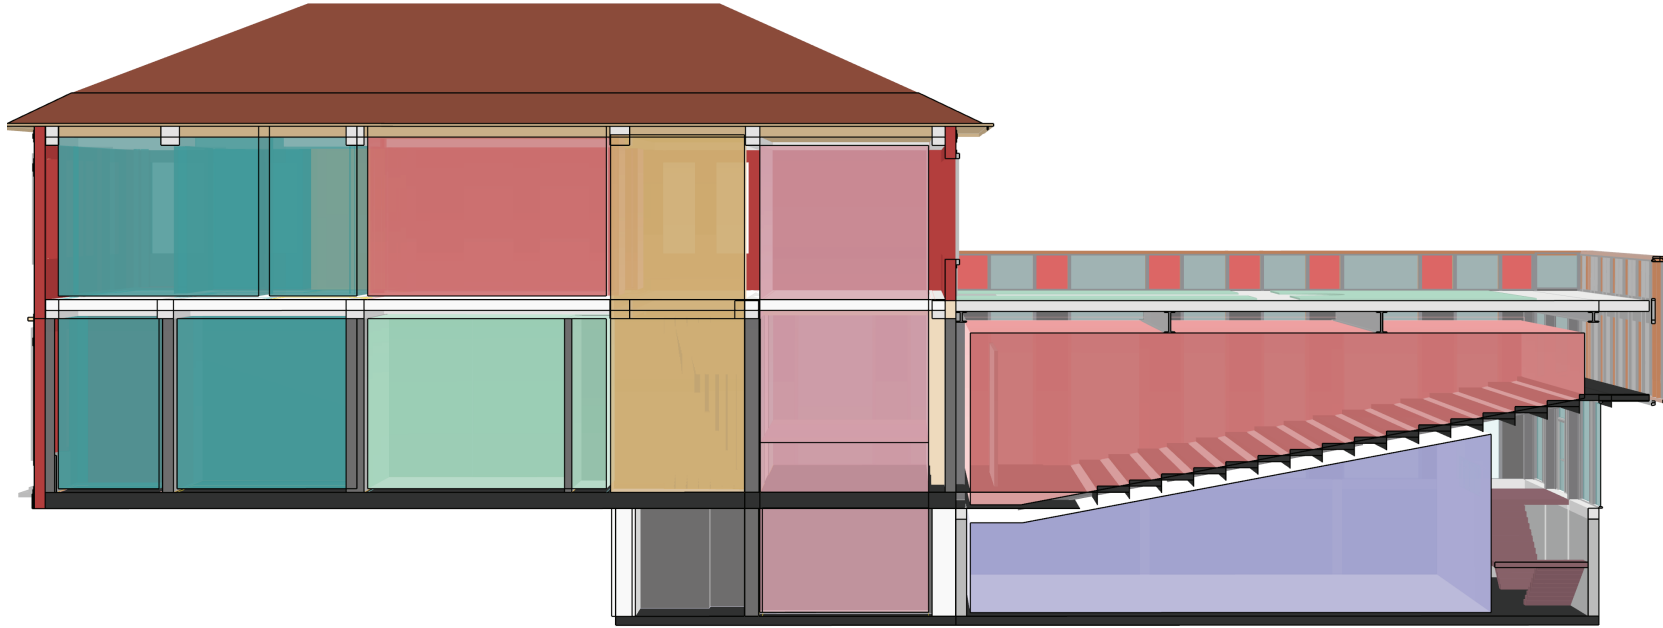
- Green Roof
- Existing Building
- Circulation
- Aula Grande
- Aula Info Grande

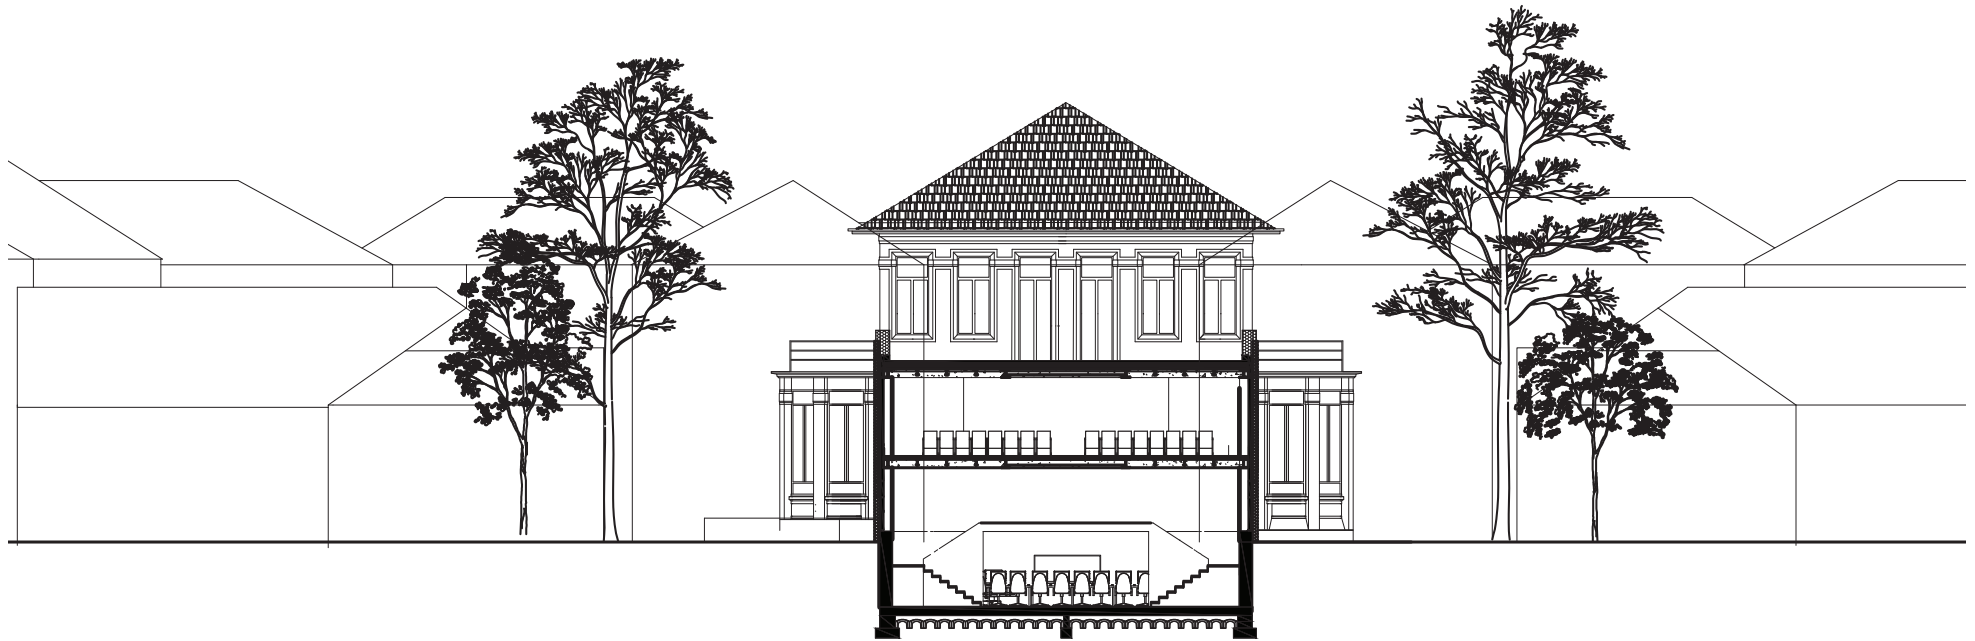
SECTION B-B 1/200

CROSS SECTION BB
additions and demolitions

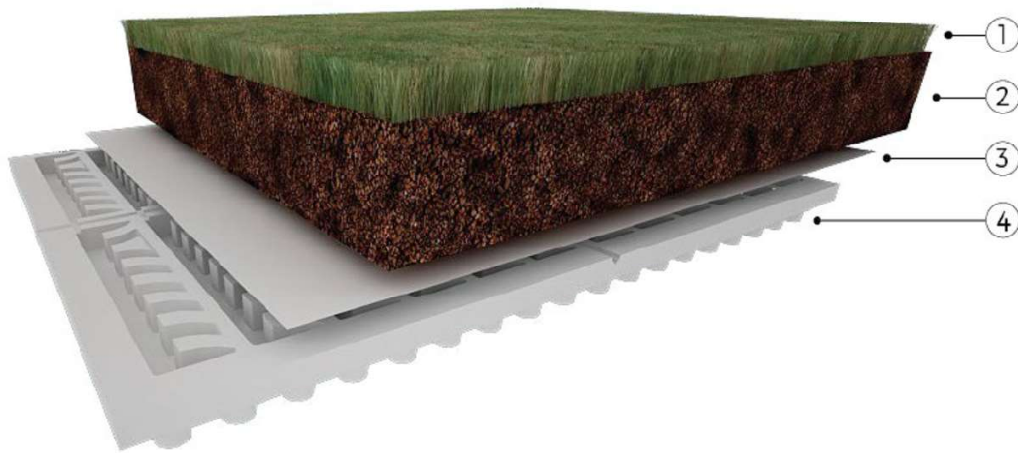
TECHNICAL DATA

Thickness of the system (without vegetation)	cm ca.	23,00
Weight when saturated (without vegetation)	kg/mq	192,00
Total amount of water for the vegetation	l/mq	69,00
Air volume at pFI	l/mq	64,50

The combination of green roof and sun shading system allows us to save of energy.
