THE STRUCTURAL INVESTIGATION

The constructive evaluation

Criticality investigation

Seismic vulnerability analysis

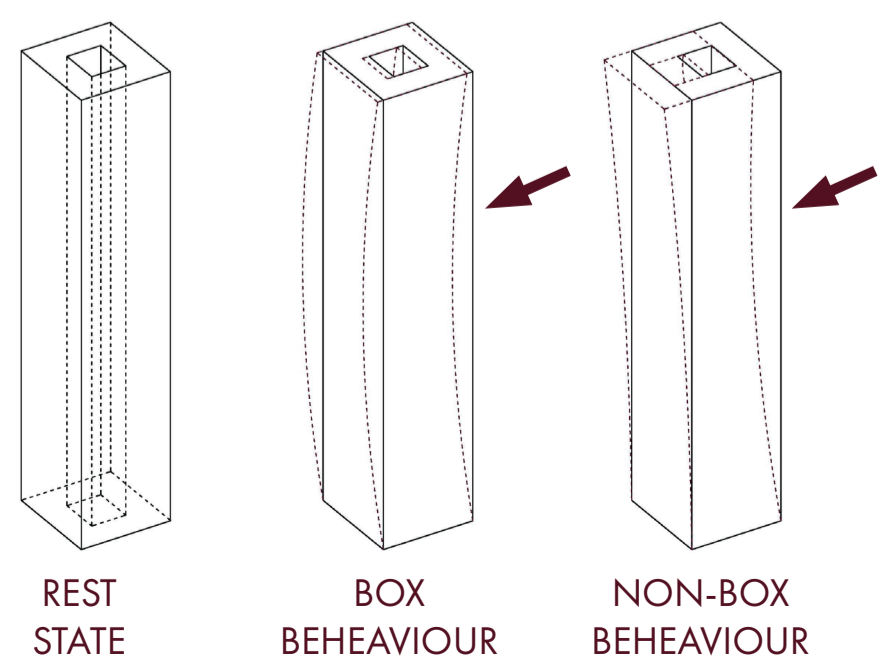
THE BOX BEHAVIOUR

Masonry, slabs and roofing, if considered stand alone, constitute a simple static scheme rather fragile. The connection of flat elements such as these, joined together by one-dimensional elements (such as slabs and arches) or spatial (such as the vault) instead to a box system characterized by a remarkable stiffness. The box behaviour of the building therefore depends not only on the quality of the individual elements that make up the structure (which is however essential) but above all on their collaboration: connections between vertical and horizontal elements play a key role in the building's response to stress.

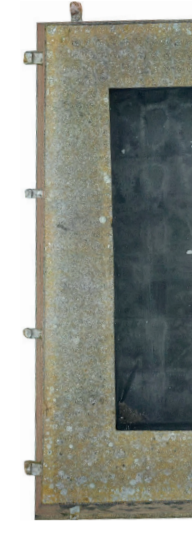
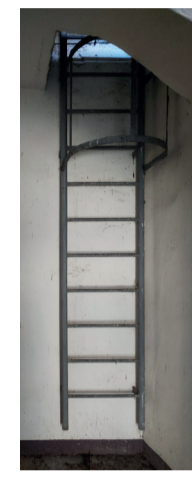
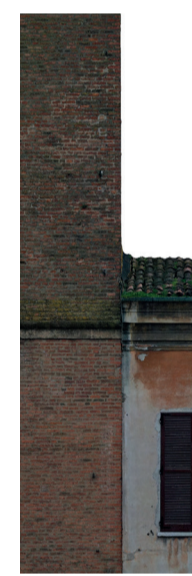
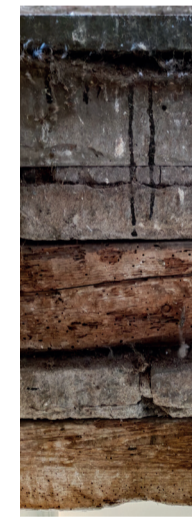
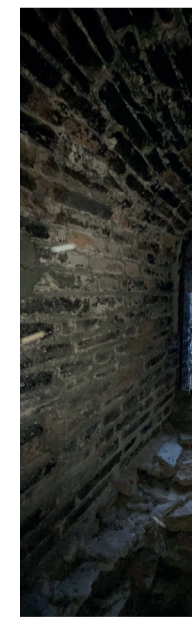
The constructive elements

In the case of the Tower, there are no weakening elements typical of the prevailing vertical architectural typology, which has undoubtedly contributed to preserving a good structural stability even of the top portion. As mentioned above, the roof is made with a vaulted brick barrel structure. It is not clear whether originally the tower had a four-pitched roof, as represented in the historical engravings, as currently there are no visible signs of this possible modification.

The Tower has no masonry stairs that are part of the original structure and for the type and function of the building itself it is assumed that they did not even exist. Of these, in fact, there is not even a visual trace on the internal masonry. Today, the vertical connections are ensured only by a structure of metal ladders added retrospectively around the 70s to replace a system of old ladders and wooden landing stages.

Currently it has 4 floors made around the end of the 60's/early 70's. These are steel structures with a thickness of about 15cm that assume the function of landing. They are very rarely subjected to stress. In this specific case, the structural role of the floors is reduced in conformation, since not originally integrated into the masonry structure, although it contributes to act as an additional element of connection between the walls of the Tower and therefore constraint in the box behavior assumed by the whole in case of stress.

The Tower has 4 vaulted ceilings, to divide the spaces of the basement, the ground floor, the first floor and the remaining free chimney. To these is also added the cover, also made with a barrel vault. From the relief of the floor of the first level, sectioned by the trap door from which you can access the free space above, you can deduce that these are brick vaults alternating with wooden joists, topped by a floor in steel, of the average variable overall thickness of about 50cm.

The Tower consists of solid brick walls fixed with lime mortar 2.5m thick at the base and then gradually thinner as you climb upwards, with a loss of about 20cm on each side distributed over the entire height (37.4m) and not perceptible. The walls are made up of bricks almost regular characterized by mixtures and granularity substantially inhomogeneous, alternating with joints of mortar mostly homogeneous. For the response that the masonry in question has had to the stresses suffered over time it can be defined masonry of excellent quality.

The Tower presents (as can be deduced from the historical drawings of relief recovered and from the data collected during the geognostic surveys of the 90s) of the foundations with stone steps that extend below the floor for about 6m and widen with respect to the encumbrance of the tower above ground of about 1.6m.

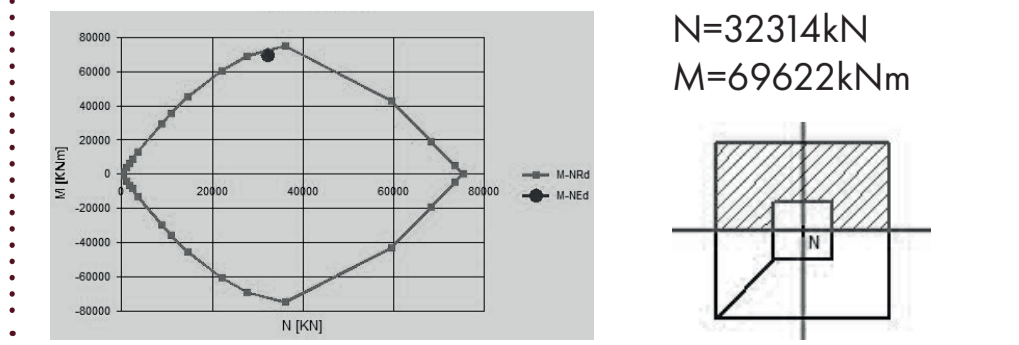
SLV	0,1	N(z)	25869		Sezione	N(N)
		T(z)	2796			0
		M(z)	69622	Z=0		32314
			49209	Z=7.3		1
			2574			2
			49209	Z=7.3		3
			30416	Z=14.6		4
			2130			5
			30416	Z=14.6		
			14864	Z=21.9		
			6533			
			1464			
			14864	Z=21.9		
			4175	Z=29.2		
			0			
			564			
			4175	Z=29.2		
			0	Z=36.6

Considering a value fd = 1.51 as calculated by a regulatory procedure, the most stressed section, i.e. the one at the base, is verified at the SLV:
