Department of Civil and Environmental Engineering
Ph. D. in Structural Seismic and Geotechnical Engineering

**Seismic Response and Strengthening of
Flat Slab Buildings**

Doctoral dissertation of:
Teresa Netti

XXXIII Cycle - MAY 2021

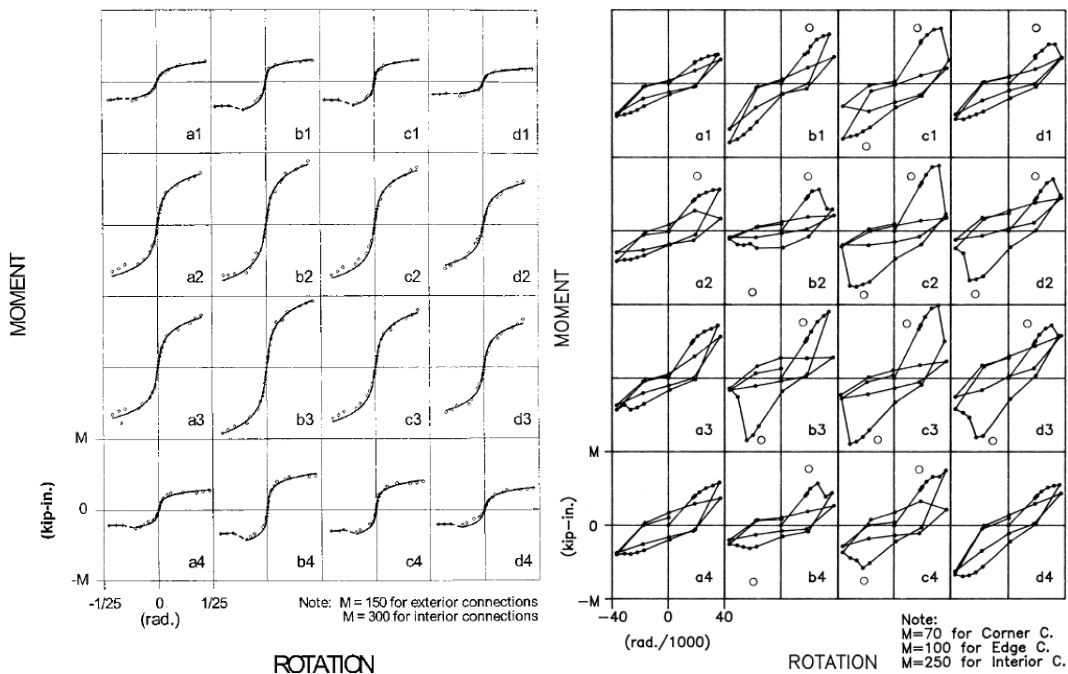
Figure 2.4 Moment-rotation curves [10], [11].

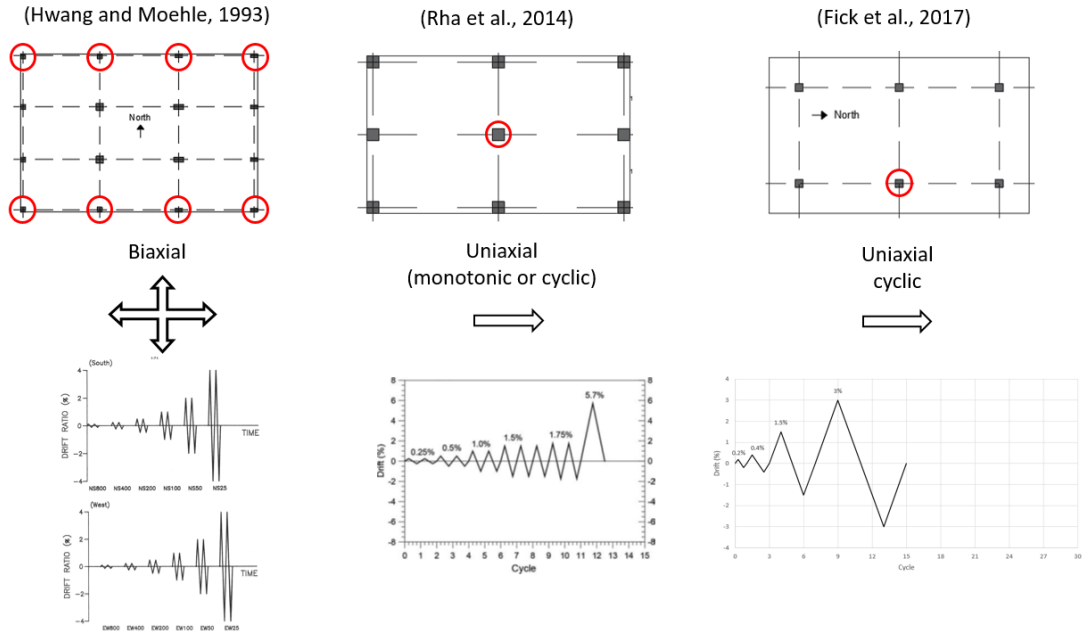
Figure 2.17 Geometry, load application and first connections failed for the flat slab floors and multi-storey frame experiments.

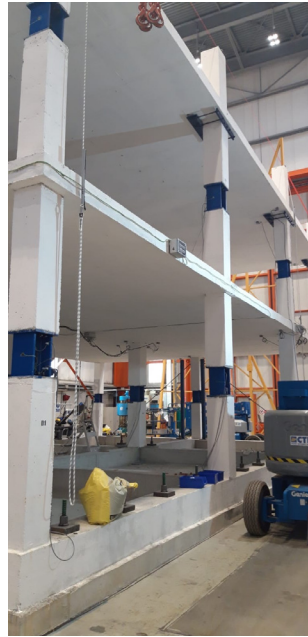
Figure 3.9 Steel stub in the columns.

steel stub for internal force and moments' measurement in the columns of each floor of the structure (Figure 3.9).

The columns are 3.2 m in height between each slab, the central stub is 0.5 m long, the cross sections are square with a dimension of 0.4 m for the internal column typology, 0.35 m for the edge typology and 0.3 m for the corner typology.

The choice of the cross section and dimensions of the internal stubs has been made in order to provide the same stiffness as that of the concrete cross-section.

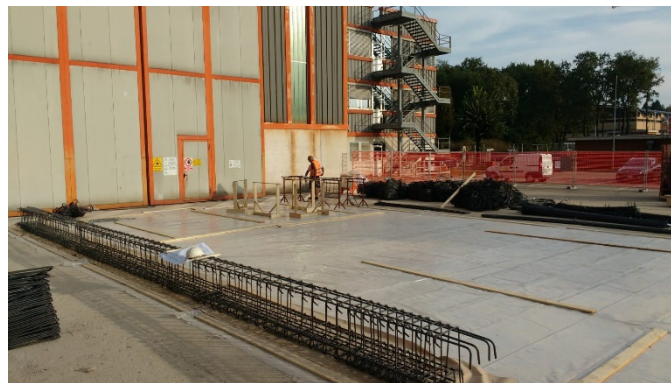
Figure 4.3 Plastic sheet under the structure.

The structure was built over plastic sheeting, to facilitate the lifting and transfer of the structure to the inside and then the outside of the laboratory.

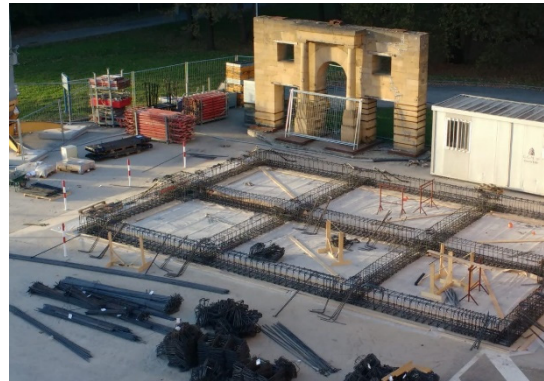
Figure 4.4 Foundation slab.

The work began with the preparation of the foundation slab and connecting beams between neighbouring columns, in accordance with common requirements for buildings in earthquake-prone areas. The connecting beams have also been used to accommodate the lifting systems and to provide stiff ribs during the transportation phases.

Some threaded metal bushing was inserted within the slab reinforcement of the 1st and the 2nd floors for bolting HE metal beams used to connect actuators.

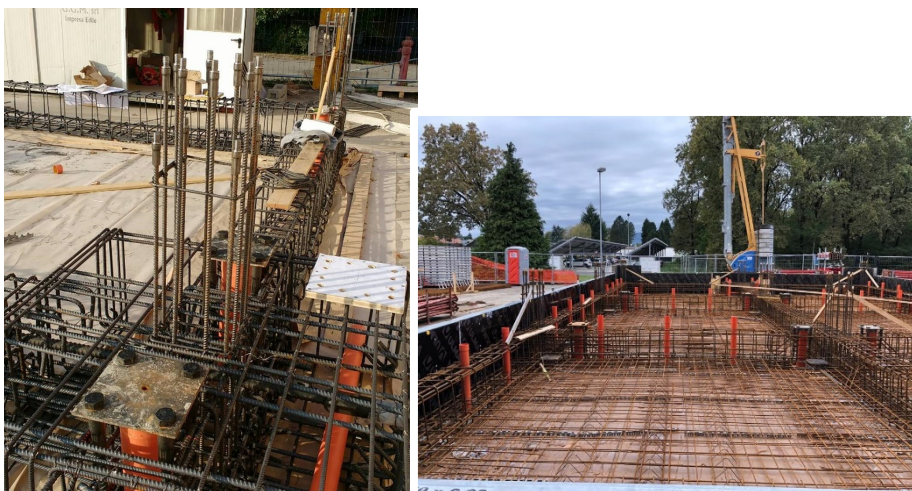
Figure 4.5 Rebars and plastic tubes detail.

Rebars with threaded couplers were inserted into the foundations as column reinforcement and, afterwards, to connect the measuring devices (load cells). Plastic (PVC) tubes were inserted to install the lifting jacks and other tubes were used to fasten the mock-up to the strong floor. The connections were placed at different heights to prevent the couplers from being all on the same plane.

The column reinforcements were installed using the positioning jigs due to the very low clearance of the load cell mounting holes.

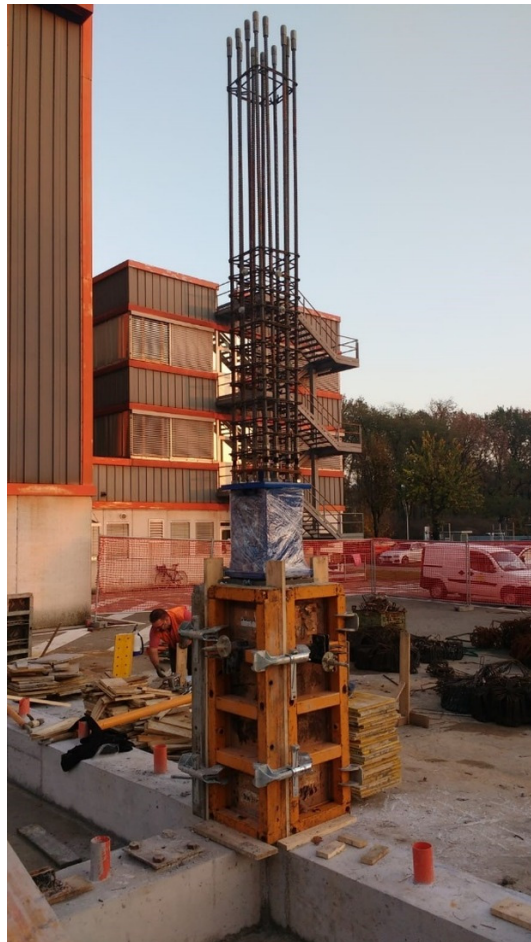
Figure 4.6 Column details: reinforcement, load cell and formwork.

The load cells were protected by a plastic film to preserve the surfaces.

A gap of 2 cm was left underneath each load cell, which was subsequently filled by non-shrinkage mortar poured into special holes in the load cell bases. In this way a perfect contact was ensured between the steel surface of the cell and the top of the concrete casting was ensured. The casting of the upper half of the column, between the top of the load cell and the floor slab of the upper floor, was carried out without any special measures.

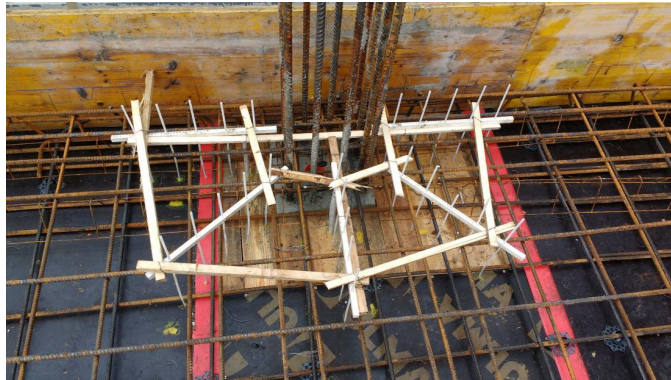
Figure 4.9 Plastic tubes positioning in the slab-column connections that will be strengthening.

The second phase of the test campaign envisaged the strengthening of the 1st floor slab by the use of post-installed threaded bars bolted on both sides of the slab. A rebar scanner correctly located existing rebars making the application effective. While this technique is valid for ordinary applications, it is less accurate and slower when performed in a laboratory environment, where interference from measuring devices must also be considered. To this purpose small pre-holes were required to ensure the positioning and verticality of drilled holes, in order to avoid any interference with the longitudinal rebar and measuring devices. Small plastic tubes (4 mm diameter) were fitted into some nails, inserted into the formwork where the pre-holes were to be made. All the nails were then removed together with the formwork.

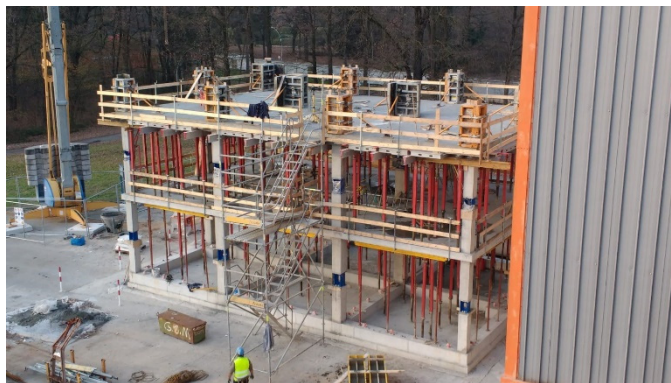
Figure 4.10 Props and safety measure for all the structure.

The formworks used for the 1st floor, were then reutilised on for the 2nd. Leaving only the props until the end of the curing time, for least 28 days.

After the curing time (at least 28 days) all the props were removed and safety devices were installed to allow the workers to safely operate inside the structure.

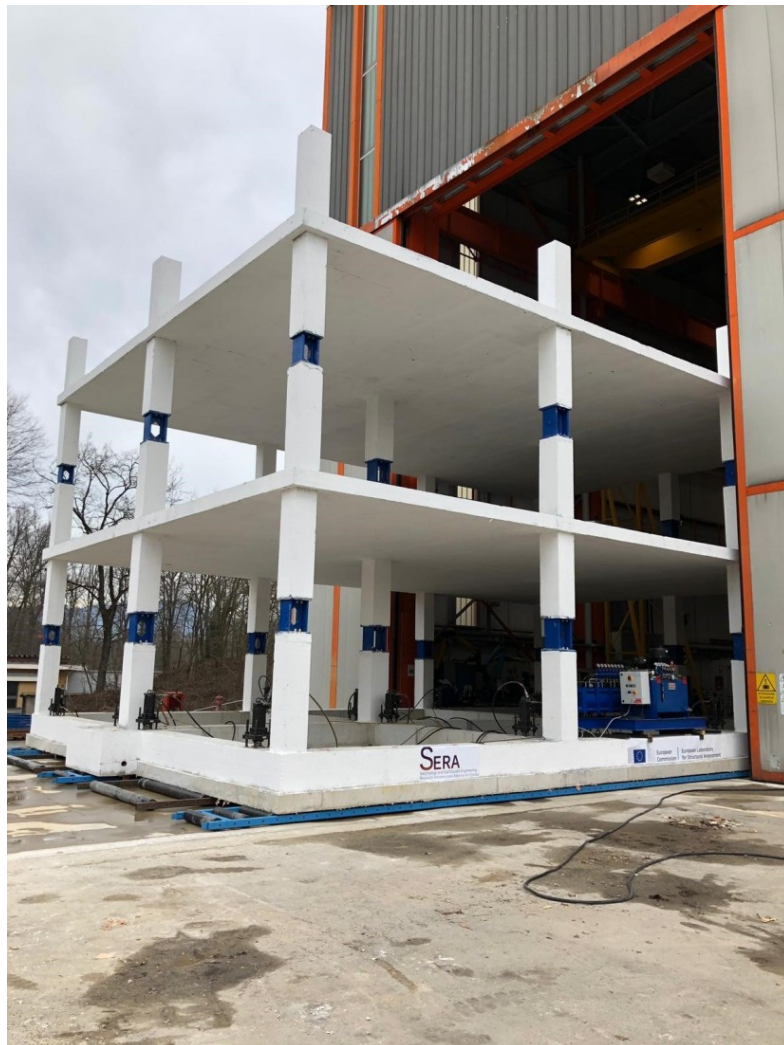
Figure 4.12 Transportation of the specimen through the ELSA laboratory door.

After construction, the specimen was transported to the interior of the laboratory. The specimen was raised by means of 16 hydraulic jacks working at equal oil flow to prevent any rotation or misalignment of the base. A roller surface was placed underneath the specimen, which was then lowered and hauled to its final destination in front of the reaction wall, then fixed to the floor by means of DYWIDAG threaded bars. The roller was designed to work at the elastic limit in order to compensate the irregularities of the floor without transmitting significant deformation to the upper level of the structure.

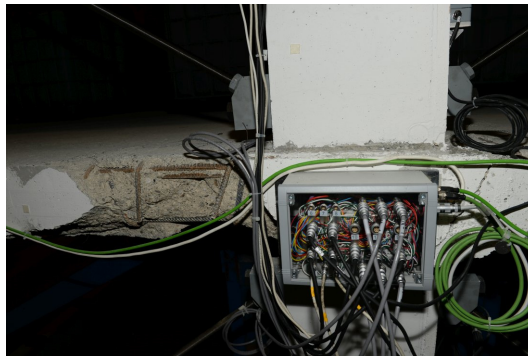
Figure 4.16 Data acquisition box.

With this new system, each actuator is provided with a slave control module that maintains the analogue part of the system close to the actuator. Each slave is then connected with just two cables, an EtherCAT and a power supply, creating the control network. The ElsaREC data acquisition system has been designed with the same philosophy of the control system, by creating a series of slave data acquisition boxes (Figure 4.16) that provide the conditioning and the digitalization of sensors routinely used during the ELSA experimentation; (linear encoders, linear potentiometers, magnetostrictive sensors, inclinometers, strain gages and load cells).

In the case of large scale tests, sensors are grouped for spatial location and connected to a tailored slave box that conditions-digitalizes different type of sensors while keeping the analogue cabling lengths to a minimum. The boxes are simply connected with a robust data bus and a single power supply cable to a centralized Master Unit that has access at any time to all the available data.

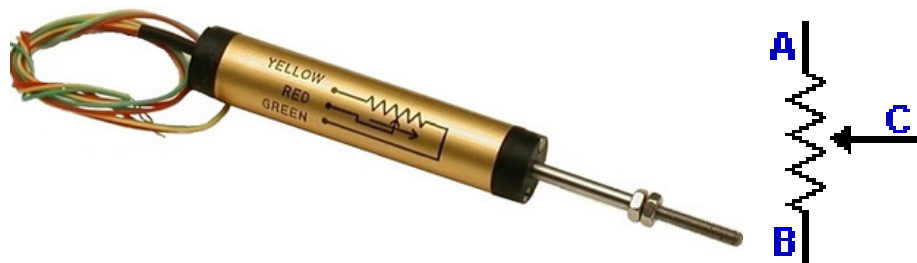
Figure 4.17 a) COD transducer b) Schematize of a potentiometer.

The COD transducer is a potentiometer, a linear displacement transducer. The potentiometers are measuring devices that use an electrical circuit with a variable resistance, and in output give an analogical signal proportionate to the measured displacement.

The analogical signal is defined by the position of the handle (C) that specifies the electric resistance given from the terminal (A, B).

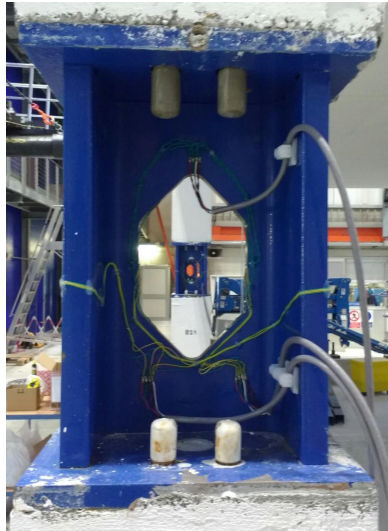
Figure 4.22 Load Cell.

The load cells were of three types, small, medium and large in function of the column typology where positioned, respectively: corner, edge and internally.

The measured quantities are strains in the flanges and along the sides of the hexagonal hole, and were derived successively to obtain the shear, moment and axial forces. The notch is motivated by the need to increase the strains in the web and provide more accurate measurements.

The end plates are connected to the central stub by bolts and to the RC column with threaded bars. The threads remain within the members due to the shape of the HEM profile. The stiffness of the plates approximates a rigid behaviour and improves the transmission of the normal stresses from steel stub to the concrete.

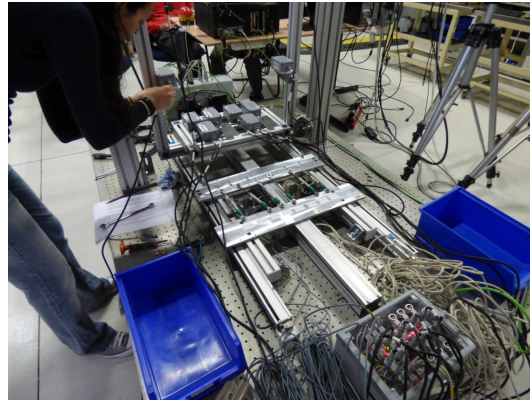
Figure 4.23 Sensors disposition for the calibration of box 1.

To represent the conclusion of the testing, only the results obtained with the box 1 are here reported. In this box, there were ten inclinometers and six displacement transducers.

For each typology of sensors, the calibration campaign was divided into two phases; the first one with the aim to determine the sensors sensitivity (for the box 1, a9 for the inclinometer and a10 for the displacement transducer) the second one to finalise the calibration (for the box 1, a11 for the displacement transducer and a12 for the inclinometer).

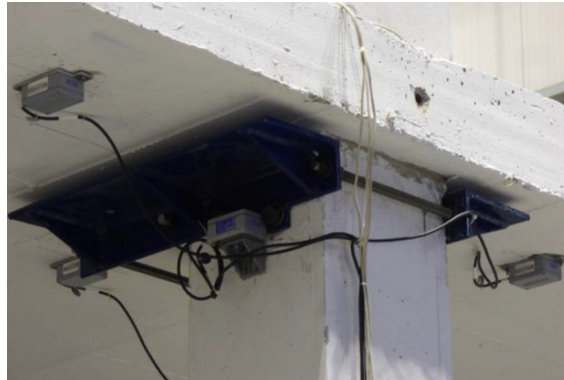
Figure 4.54 Inclinometer positioning and safety system.

A series of prepared extension cables and chemical anchors were collocated on which to mount the sensors on the structure (Figure 4.54). Lastly, sensors were cabled to the acquisition boxes.

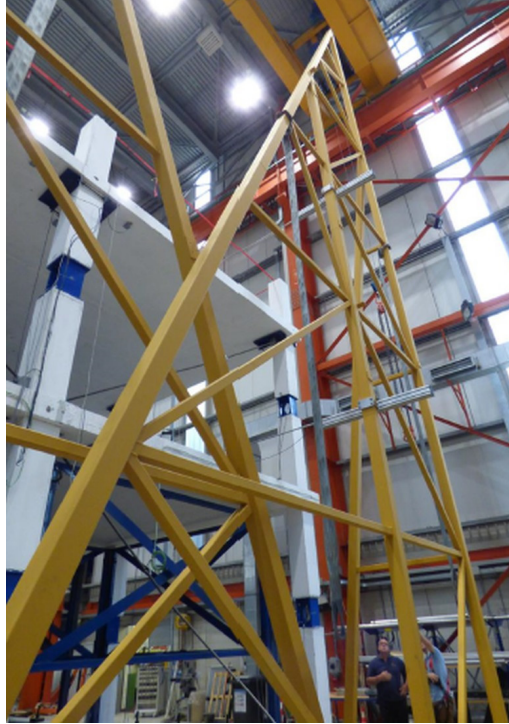
Figure 4.56 Anti-torsion safety system.

The first was an anti-torsion safety system (Figure 4.56), a safety bracing along the short West and East side of the structure (A and D). This system was to prevent the specimen from undergoing excessive torsion during the test (resulting from

unforeseen accidents in the control system or during the removal of the damaged specimen from the laboratory).

Algorithms that prevent the excessive drift difference of two actuators on each floor already controlled the torsion of the mock-up.

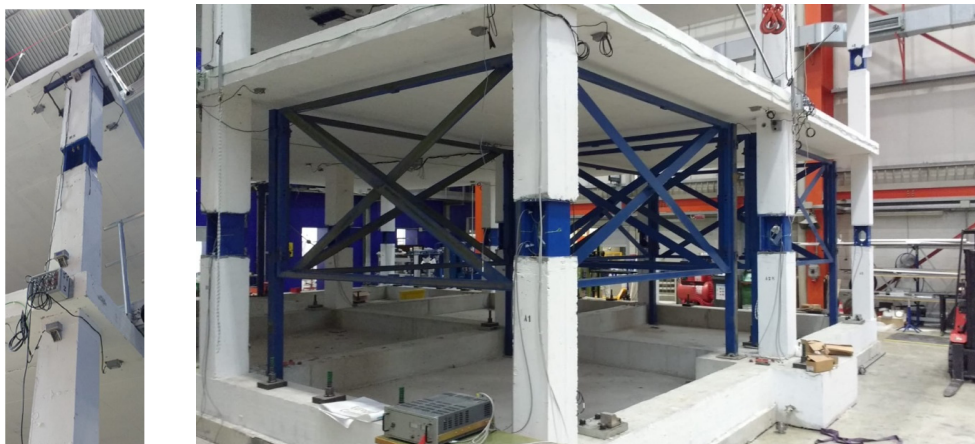
Figure 4.57 Safety measures, a) capitals at 1st floor and b) props on ground floor.

The other two fall protection systems that completed the passive safety measures regarded the possible collapse of the 2nd floor or of some connections to collapse. They consisted of props on the lower floor (Figure 4.57 b) and metal capitals on the upper floor (Figure 4.57 a).

In case of necessity, the benefits of these two safety measures would be realised during the transportation of the structure from the laboratory and when it was dismantled, for the protection of the workers.

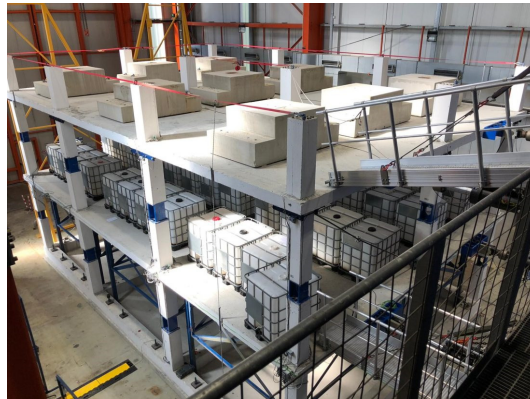
Figure 4.58 Safety measures related to the safety of the ELSA laboratory staff.

A second set of safety measures is related to the safety of the ELSA laboratory staff. It included safety lines and access to the floors using footbridges, and fixed ropes.

All these systems were designed to be activated only in case of emergency, while they did not alter the structural behaviour of the mock-up under normal conditions.

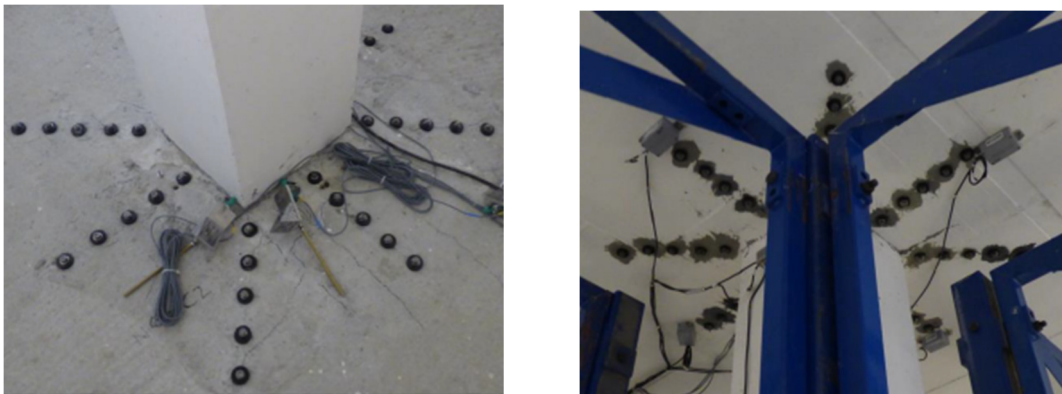
Figure 4.68 Repair of the central column on the 1st floor.

Threaded bars (8.8 steel grade) with 10 mm diameter were installed, with rigid circular washers having an external diameter of 40 mm and 10 mm thickness. Nuts on both sides enabled the pre-loading of each bolt, ensuring the efficiency of the post-installed fastening (Figure 4.68).

Once test B1 was concluded, water tanks were removed from the first floor, both for practical reasons related to the installation, in order to reproduce the removal of non-structural loads, as would have been the praxis in an intervention on a real building. The slabs were drilled, following the pre-holes, the lower surface was smoothed using an epoxy resin to allow the lower washer to sit on a plane, and the bolts were installed and tightened with a torque wrench to apply a preload of 10 kN.

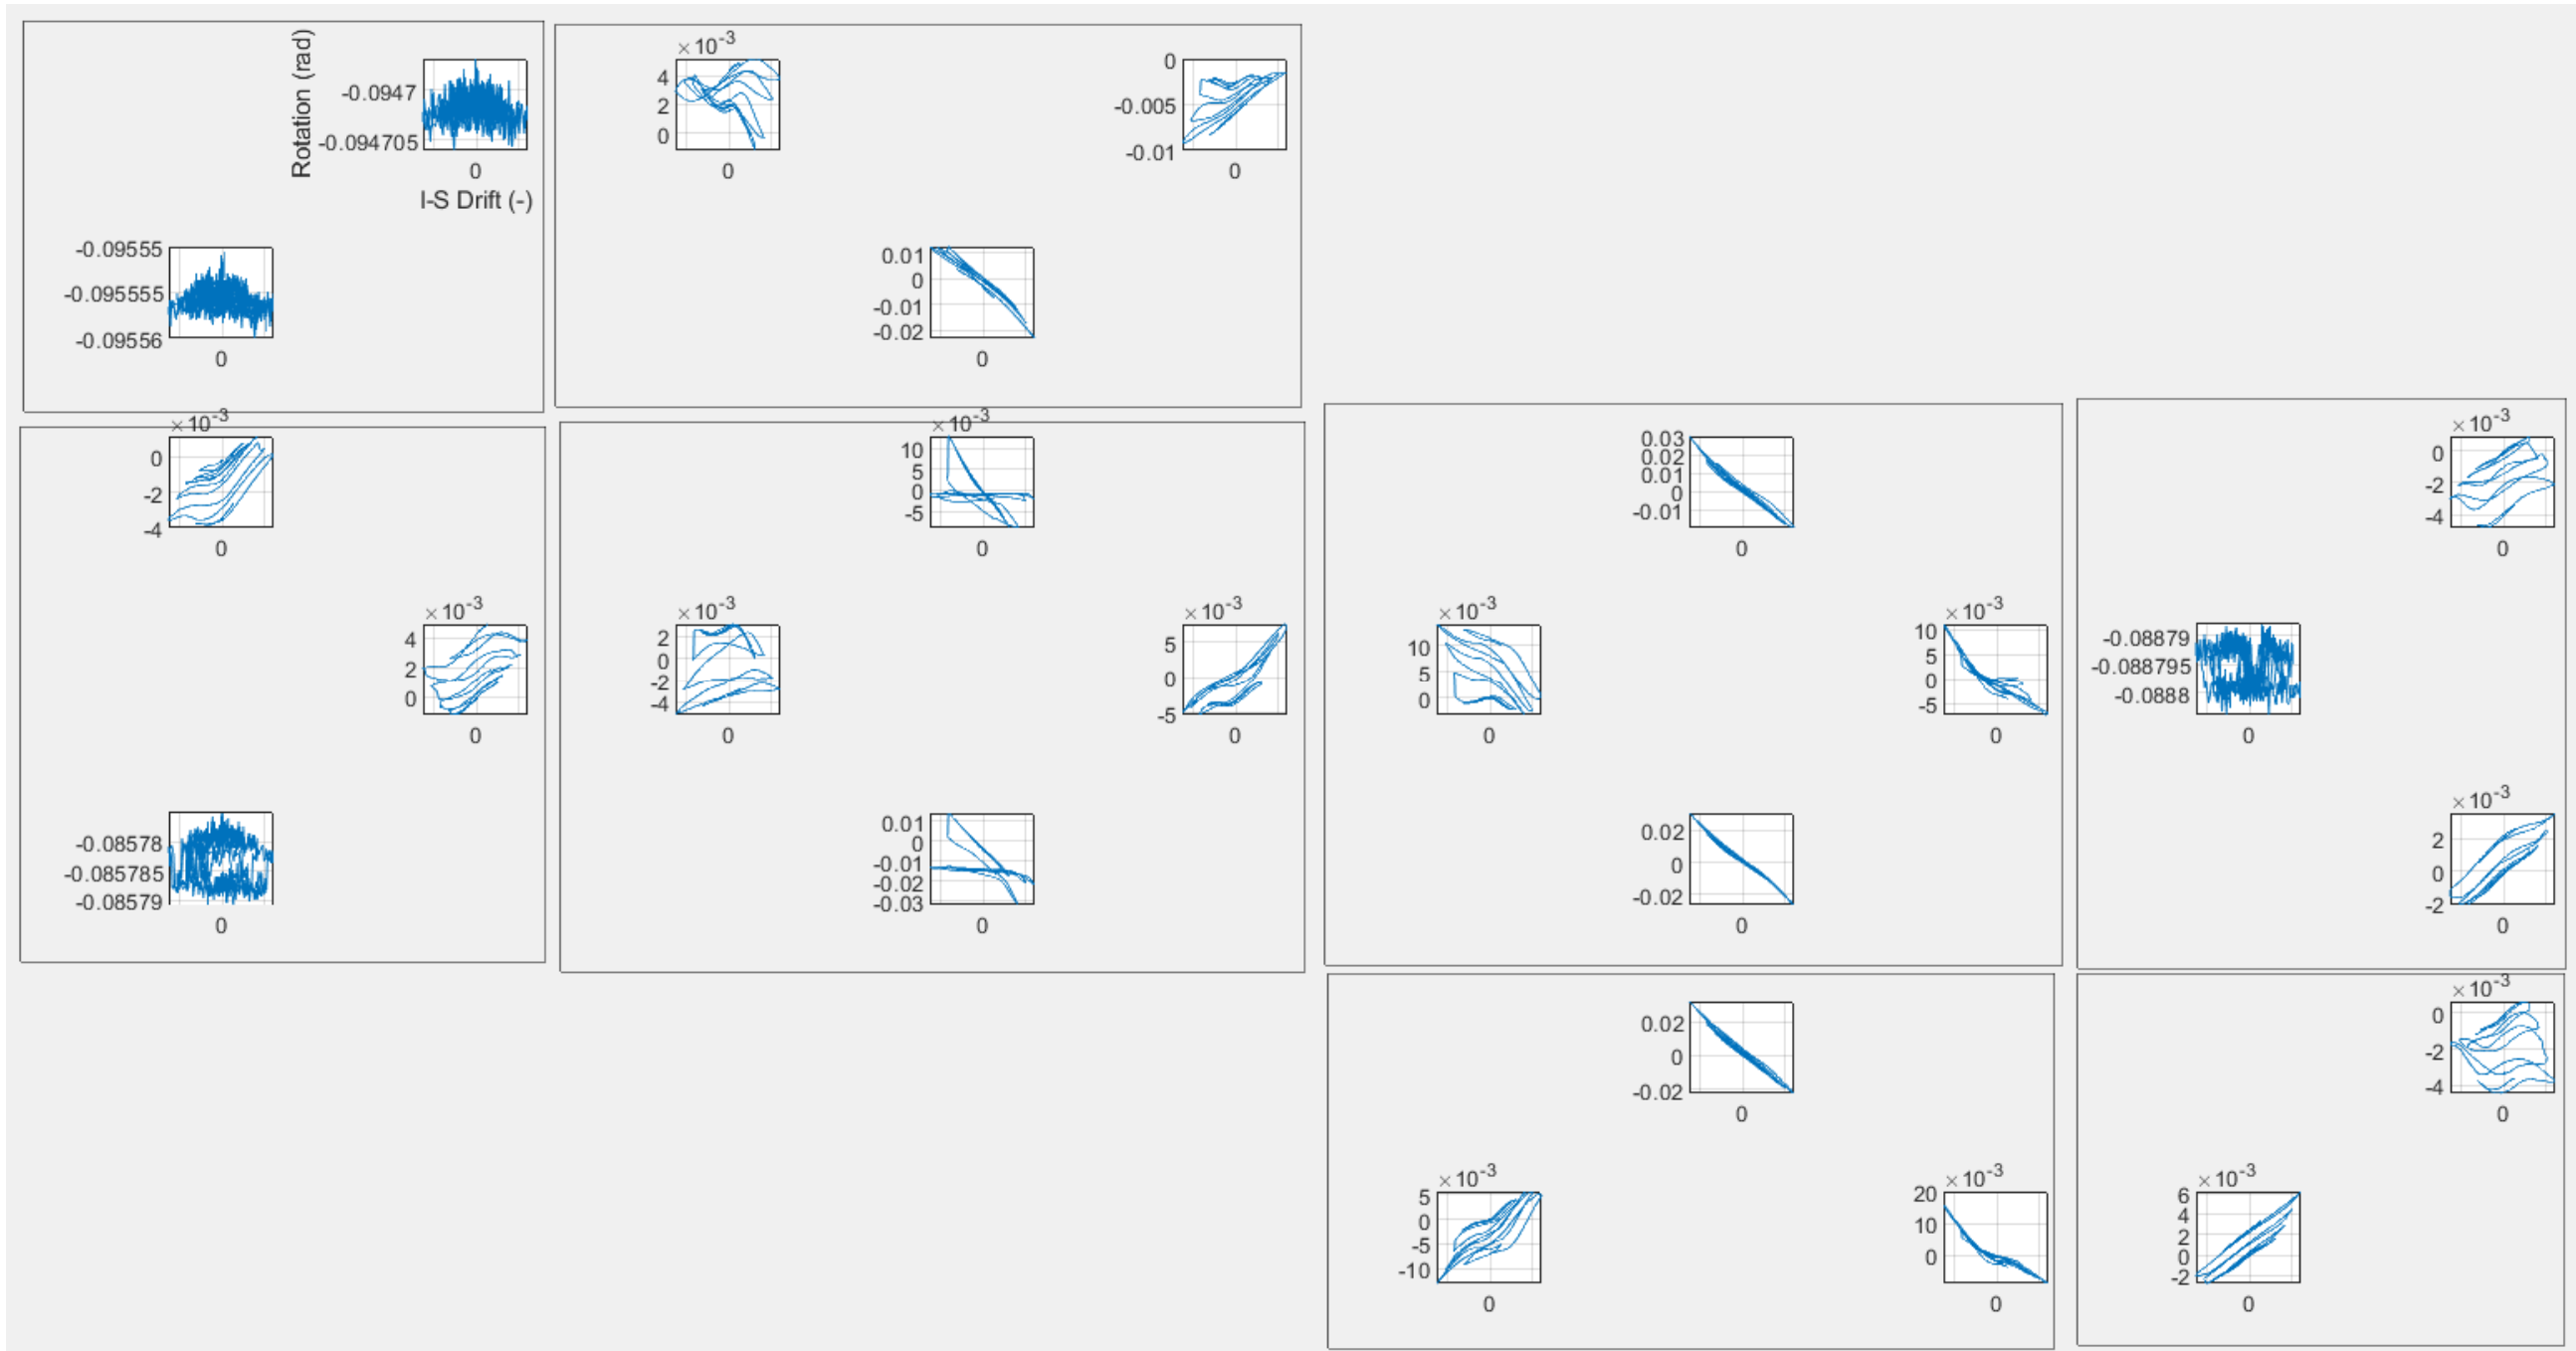
Figure 5.17 Slab rotation vs inter-storey drift ratio from each sensors in the 1st floor, test Cyc-2.

For sensors in the slabs the relationship between the inter-storey drift and the rotation (Figure 5.17 and Figure 5.18) appears non-linear, with some exceptions; whereas for the columns this relationship is linear in all the sensors (Figure 5.19 and Figure 5.20) indicating that the columns remained elastic during the tests. For the slab sensors in both floors (Figure 5.17 and Figure 5.18) it is possible to observe a difference in the measurements to one order of magnitude, between the ones located in the North-South directions and the ones in the West-East, this it was different from the sensors in the columns on both floors (Figure 5.19 and Figure 5.20) which all recorded values of similar magnitude. The same behaviour is observed in both the seismic and the cyclic test.

Figure 5.17 and Figure 5.18 report the rotation versus the inter-storey drift ratio of each sensors in the slabs and Figure 5.19 and Figure 5.20 report the rotation versus the inter-storey drift ratio of each sensor on the columns.

The sensors around each column are outlined with a rectangle. Each rectangle indicates the slab-column connection in the position that it has in the slab. Not all the slab-column connections have been instrumented, so the rectangle for the four lateral connections (A3, B3, C1 and D1) was omitted (see Figure 5.16 for the instrumented connections). Inside each rectangle, the graph of the detected measure is reported. Each graph indicates the position of the sensor that took the reading (see Figure 5.16 for the sensors position).

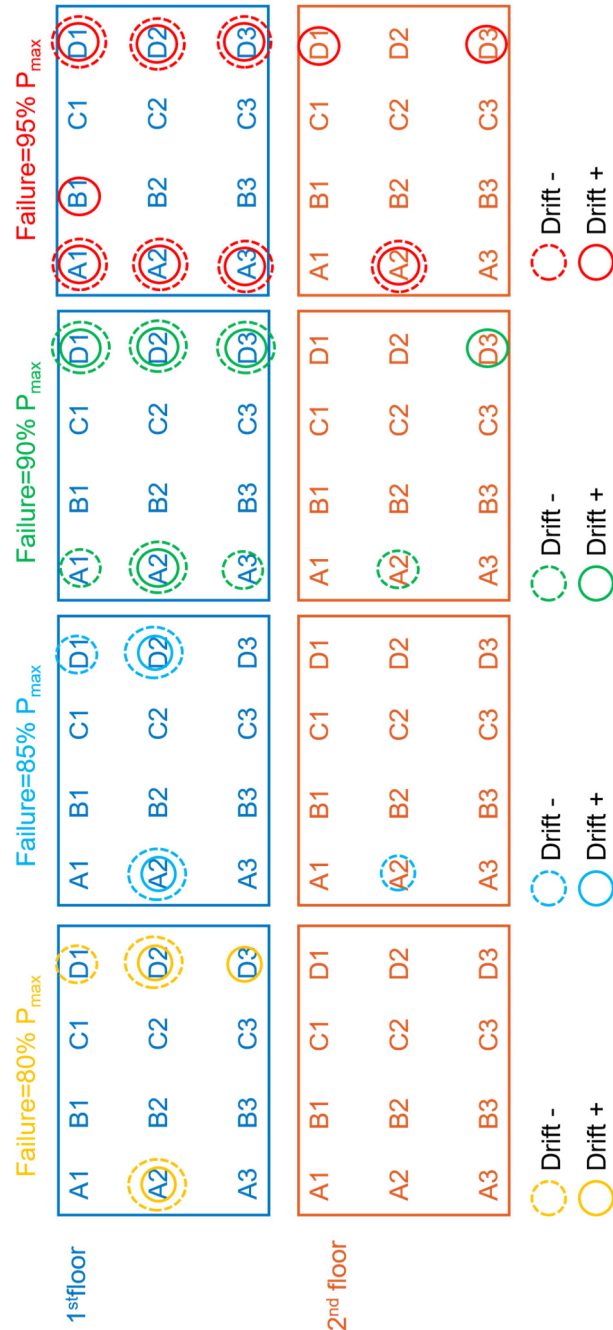
Figure 7.30 Connections failure for the analysed percentages of drop of the loading resistance, Test Cyc-1 (f02). Circled is the failed connection. Negative drift: westward loading, positive drift, eastward loading.

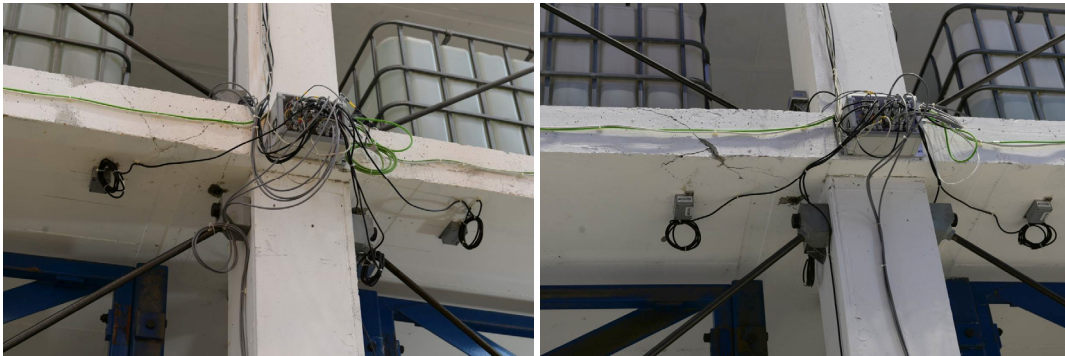
After the drift value of 1.5% the two lateral connection located at the centre of the short side A2 (east) and the D2 (west) on the 1st floor and along the vertical surface of the side of the slab (Figure 7.36) started to show significant damage. The cracks formed are of torsion and shear typologies.

Figure 7.36 a) A2 and b) D2 connections after the 1.5% drift, tests Cyc-1 (f02).

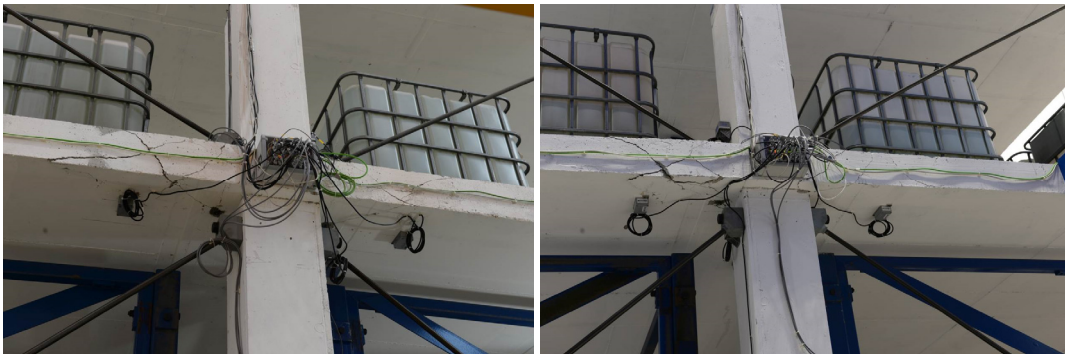
At a drift value of 2%, in the same connections, the cracks opened wider.

Figure 7.37 a) A2 and b) D2 connections after the 2% drift, tests Cyc-1 (f02).

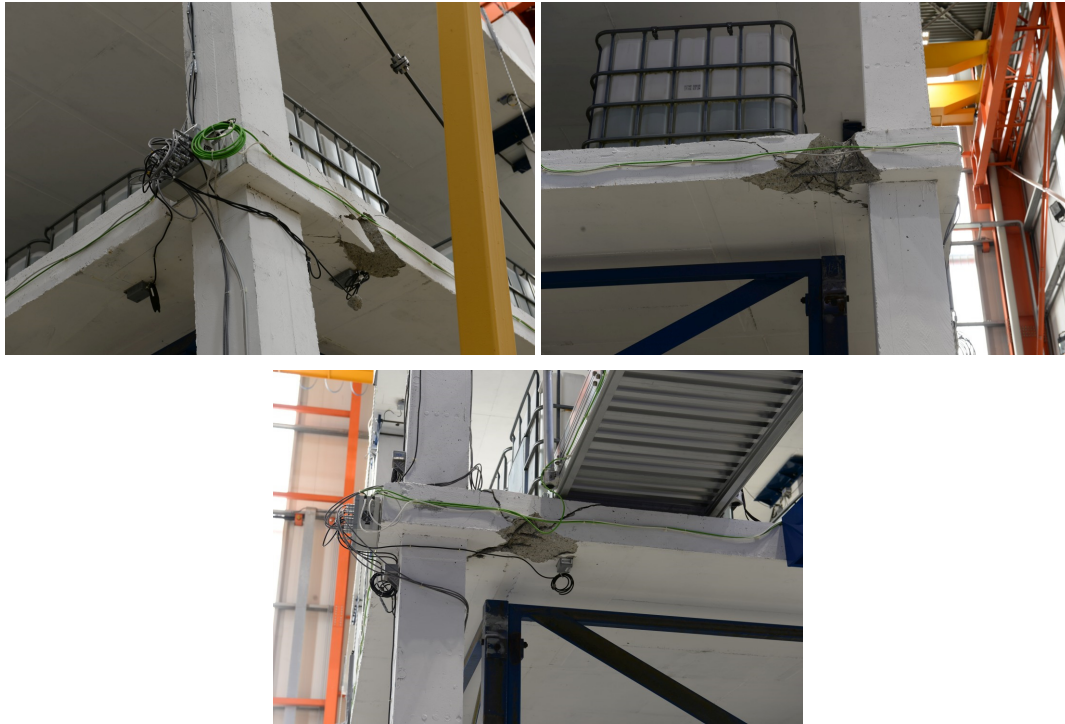
Figure 7.38 a) A1, b) D1 and c) D3 connections after the 2.5% drift, tests B1 (f02).

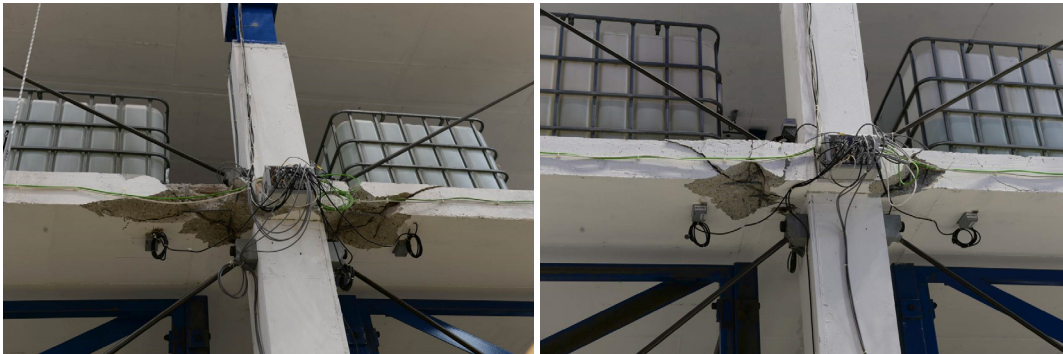
The previous two, A2 and D2 reported a greater level of damage (Figure 7.39). At 2.5% drift, the concrete was expelled reporting serious damage which evidenced the importance of the integrity reinforcement.

Figure 7.39 a) A2 and b) D2 connections after the 2.5% drift, tests B1 (f02).

By comparing the two most damaged connections at the end of the first cyclic test, it is possible to note that the failure mode present on the side of both is a combination of punching shear (Figure 7.40) and torsion (Figure 7.39).

- The connections in the alignments A and D were those that showed the most damage (Figure 7.38 and Figure 7.39). The edge connection D2 in the 1st floor was the first to punch, for an inter-storey drift ratio of 1.5%. The design of the specimen was executed with the aim of reflecting as far as possible the common design mode for European structures as prescribed in EC8 [1]. For this reason, the reinforcement detailing on the edge of the slab was executed with a simple bending of the bars without hook. This caused damaged to the slab edge;

- From the connections in the short side (alignments A in Figure 7.38 and D in Figure 7.39) the efficiency of the integrity reinforcement is made clear. Two bottom bars in each direction were placed at each connection, following the EC2 [4]. This reinforcement was sufficient to avoid the collapse of the slab. From the edge connections in Figure 7.38 it is also possible to observe the catenary effect of the top reinforcement;

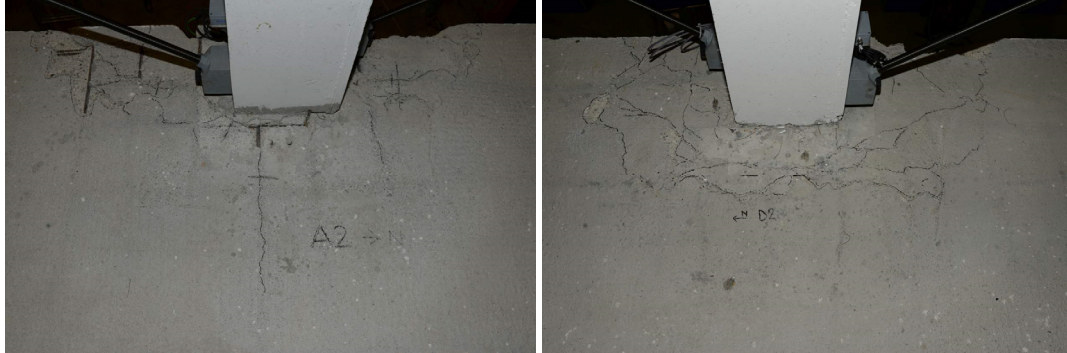
Figure 7.40 a shows that a sliding crack opened in A2 on the East face, at the interface with column, without the formation of a punching cone. The typical punching cracks are observed in connection D2 on the opposite side of the slab. The difference can be interpreted with the different reinforcement layout. The following section will

deepen into the analysis of these phenomena on the basis of the slab thickness variation measurements, related to cracking.

Figure 7.40 a) A2 and b) D2 slab-column connections after the 2.5% drift, tests B1 (f02).

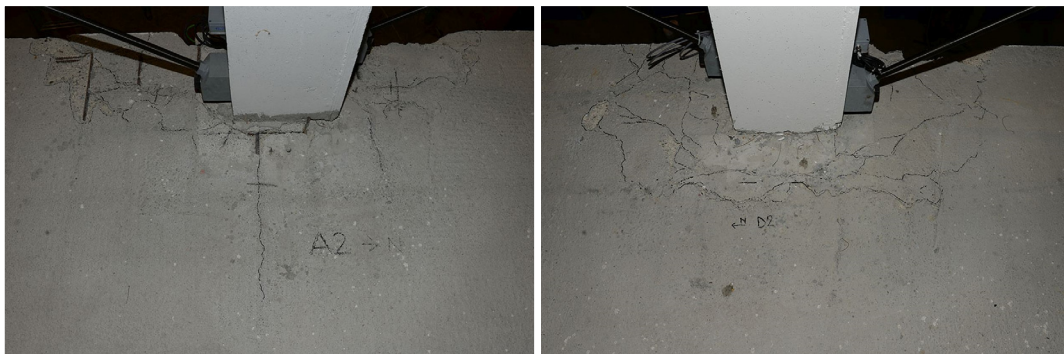
The crack diffusion on the two floors (Figure 7.44 and Figure 7.45) was very similar. Especially for the A2 connection (Figure 7.44 a and Figure 7.45 a), some cracks were evidenced in the same position on both floors with the addition of the diagonal one from the edge of the column, only clearly visible only on that of the 2nd floor.

Regarding the D2 connection (Figure 7.44 b and Figure 7.45 b), on the 1st floor the crack pattern appeared more irregular and widespread than on the 2nd one.

Figure 7.44 Damage in the slab-column connections, 1st floor a) A2, b) D2.

In all the connections, the sensors recorded similar patterns except for the A2 and D2 where the three different sensors each recorded a different pattern. For the connections A2 and D2, some visual comparison is given in Figure 7.44 and Figure 7.45.

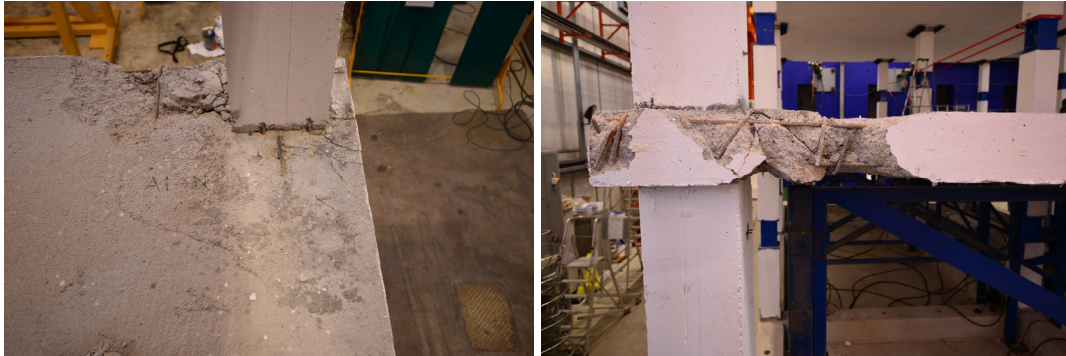
Figure 8.23 A1 connection after test Cyc-2 (g04), a) slab-column connection, b) slab east side.

The most damaged connections on the 1st floor were on the short west side, the two corners A1 (Figure 8.23) and A3 (Figure 8.24) and the edge A2 (Figure 8.25). On the opposite (east) side, the corner D1 (Figure 8.26) and the lateral D2 (Figure 8.27) resulted to be most damaged.

From a deeper analysis of the cracks that opened in the connections and on the side of the slab, it was possible to note that all the connections in the alignments A and D reported a mixed failure mode with flexural and punching cracks. The formation of a the punching cone in the slab around the column was observed in most of the corner and edge connections (from Figure 8.23 to Figure 8.27). A summary of the failure mode observed in each of the failed connections is reported in Table 8.22. all these connections were on the 1st floor, without shear reinforcement.

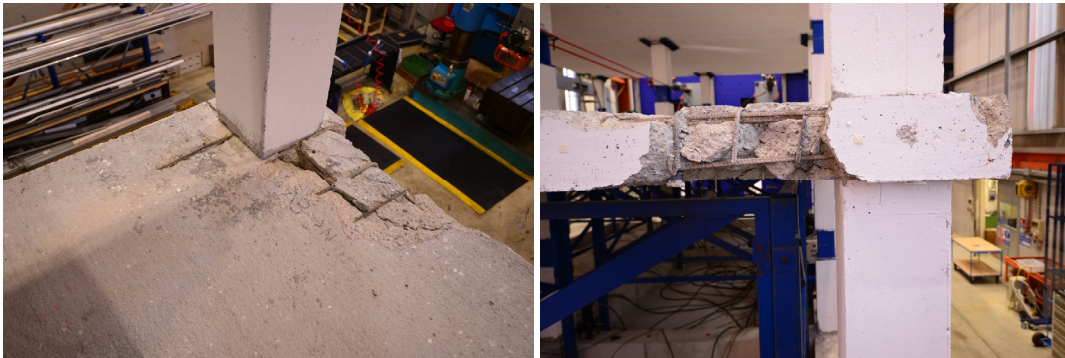
Figure 8.24 A3 connection after test Cyc-2 (g04), a) slab-column connection, b) slab west side.

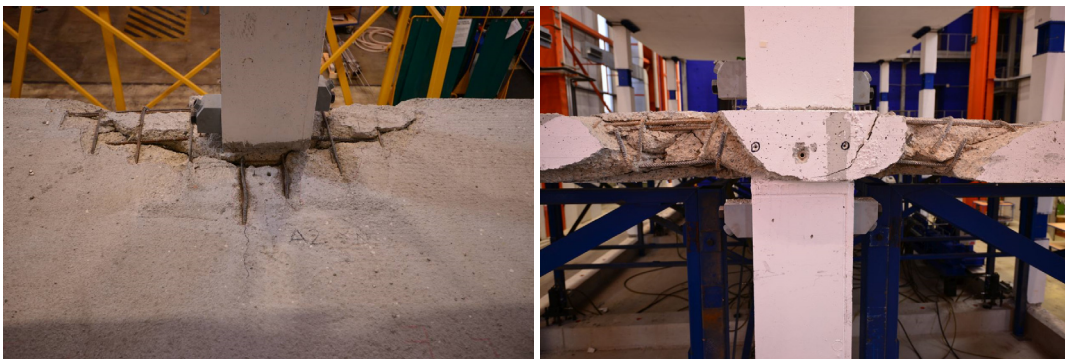
Figure 8.25 A2 connection after test Cyc-2 (g04), a) slab-column connection, b) slab west side.

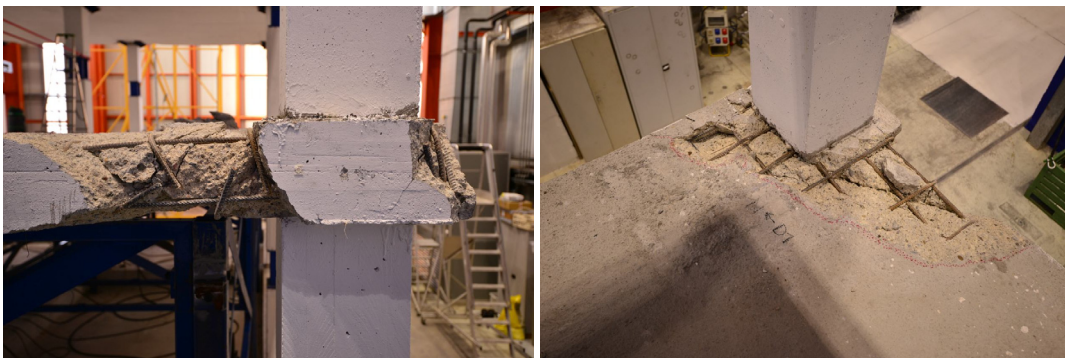
Figure 8.26 D1 connection after test Cyc-2 (g04), a) slab west side, b) slab-column connection.

From Figure 8.26 a, it is possible to see the longitudinal reinforcement detail of the slab.

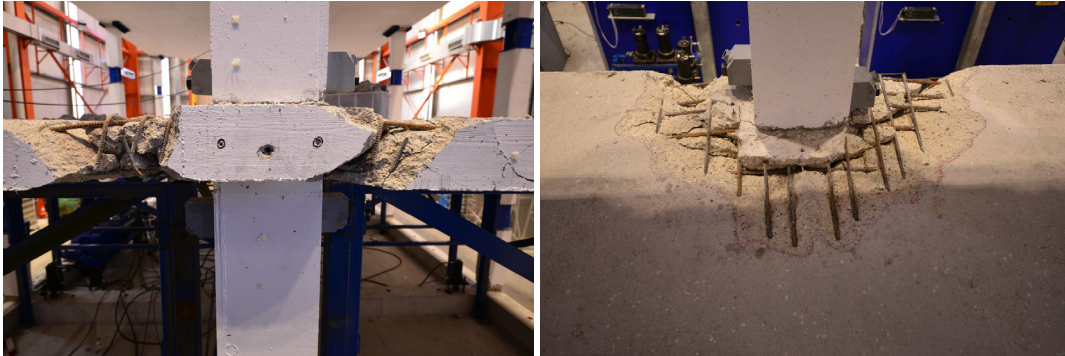
Figure 8.27 D2 connection after test Cyc-2 (g04), a) slab east side, b) slab-column connection.

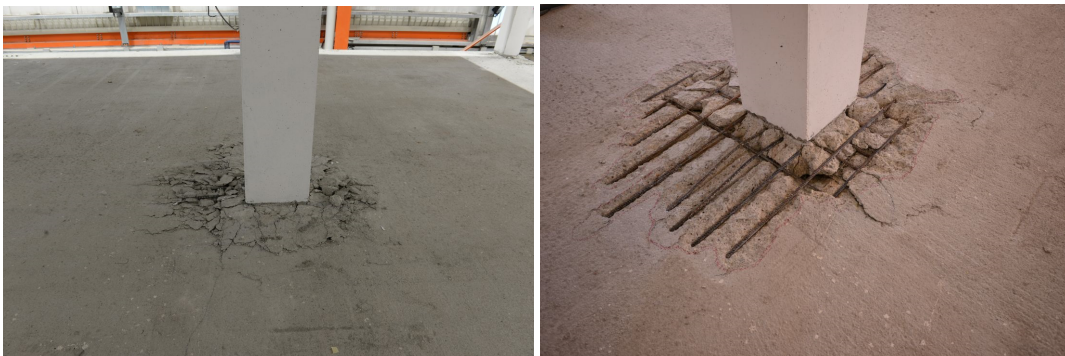
As it is possible to see in Figure 8.28, during the test the B2 connection punched and this was one of the causes of the onset of a the global load reduction.

Figure 8.28 B2 connection after test Cyc-2 (g04) a) north-south direction before the removal of the damaged concrete pieces and b) east-west direction after the removal of the damaged concrete pieces.

The internal B2 connection was the only one punched with brittle failure (Figure

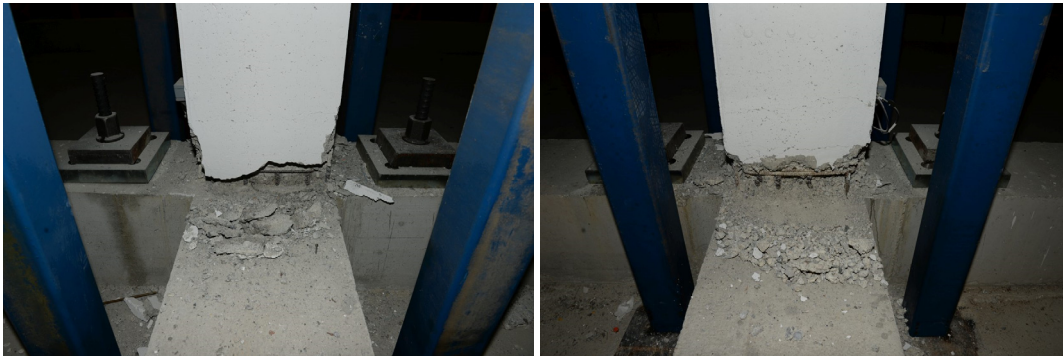
At the end of the test, after compression buckling, the breaking of the longitudinal reinforcement at the base of the column in the B2 connection (Figure 8.30) was observed. The reinforcement of the columns limited the cracking of these members, that would have increased the ultimate drift.

Figure 8.30 Base column connection B2 a) east and b) west, test Cyc-2 (g04).

No cracks appeared in the column heights but the internal columns B2 and C2 reported a significant failure at the base. These damages are reported in Figure 8.30.

The B2 was the same column that punched in the slab-column connections on the 1st floor during the cyclic test Cyc-1 for an inter-storey drift of 4% in negative. At the end of the test, after compression buckling, breaking of the longitudinal reinforcement at the base of the column in the B2 connection (Figure 8.30 a) was observed. The reinforcement of the columns limited the cracking of these members that would have increased the ultimate drift.

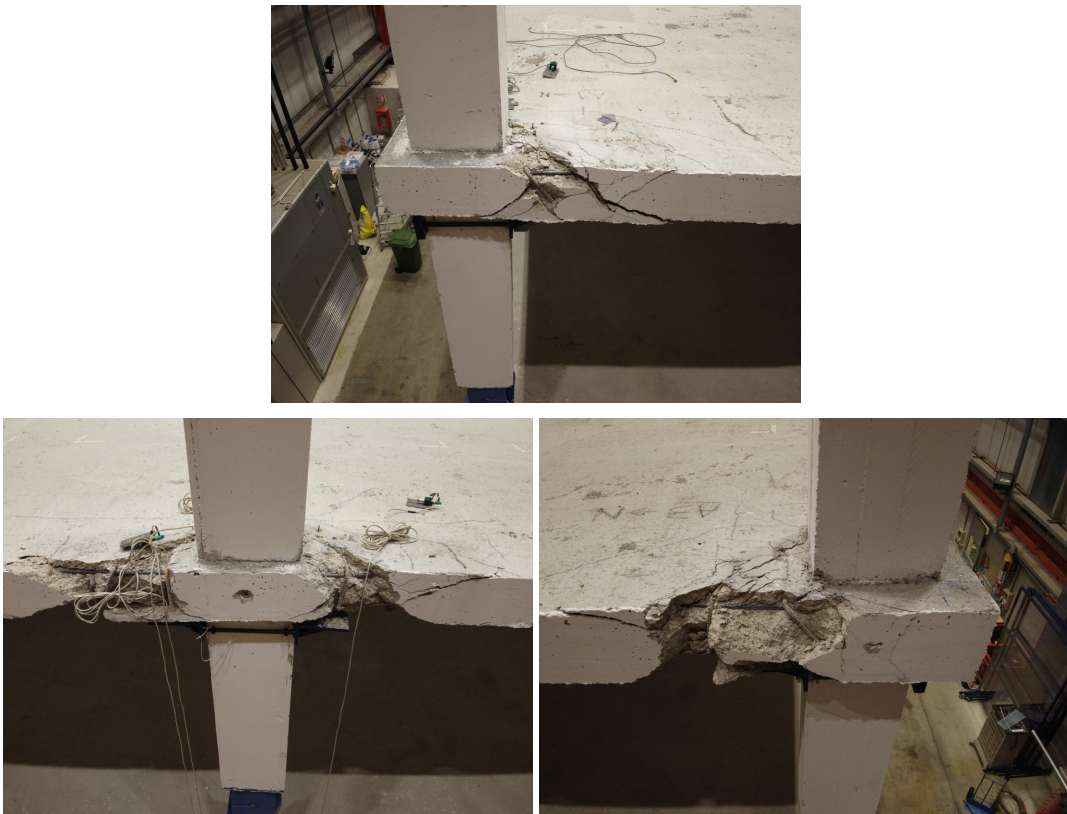
Figure 8.31 Damage in the A alignment in the 2nd floor, a) A1, b) A2, c) A3.
