Department of Civil and Environmental Engineering
Ph. D. in Structural Seismic and Geotechnical Engineering

**Seismic Response and Strengthening of
Flat Slab Buildings**

Doctoral dissertation of:
Teresa Netti

XXXIII Cycle - MAY 2021

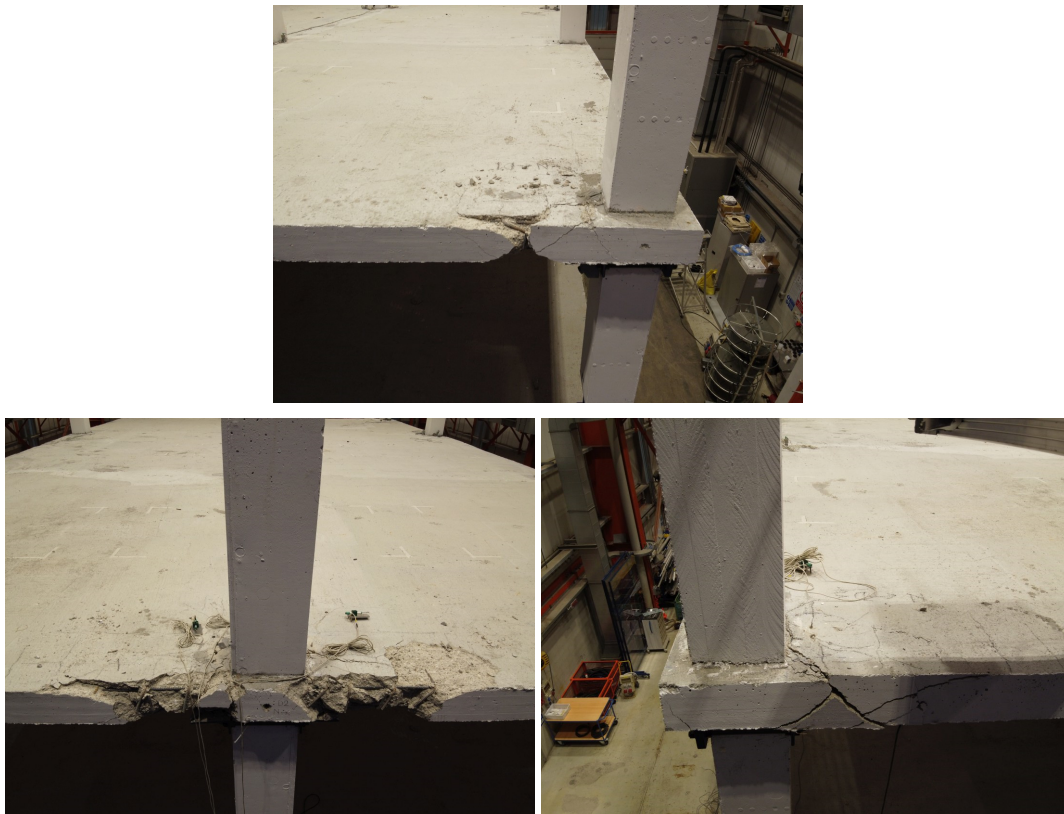
Figure 8.32 Damage in the D alignment in the 2nd floor, a) D1, b) D2, c) D3.

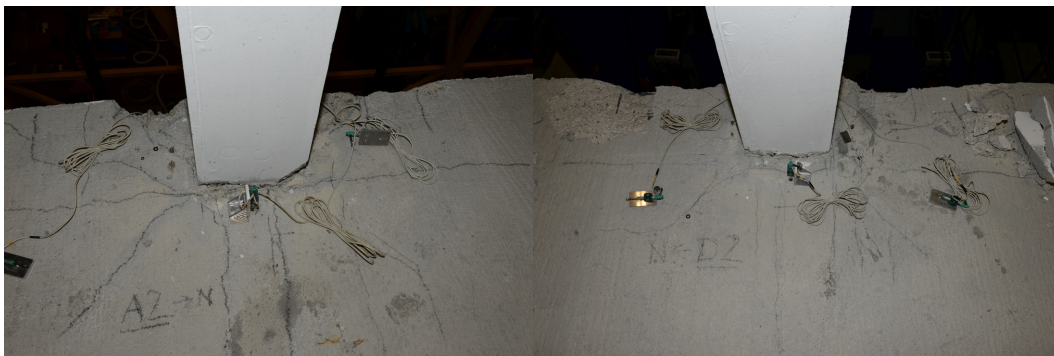
On the upper surface, radial cracking together with torsion cracking with some cover spalling were observed also on the east and west sides of the slab (Figure 8.33).

Figure 8.33 Cracking in 2nd floor, connections a) A2 west side and, b) D2 east side.

On the whole, very severe damage showed on the A and D edges of the 2nd floor; the images shown above are all relative to conditions after a drift of 6% was reached.

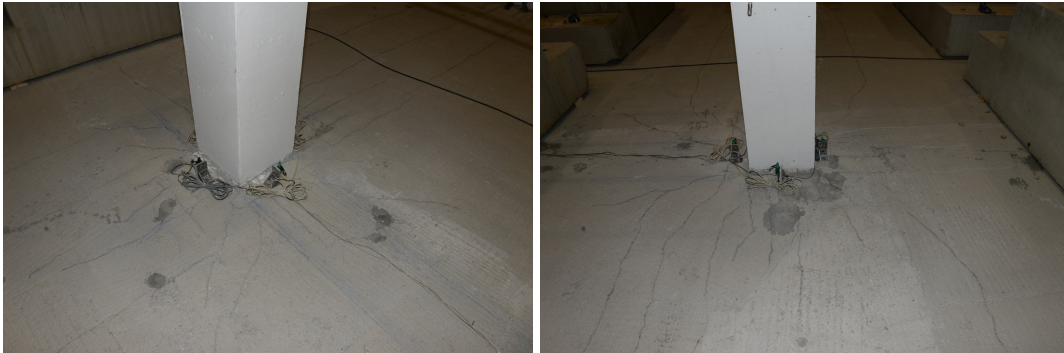
The slab-column connections on the North and South side (lines 1 and 3, intersections with B and C) reported damage due to torsion with some cover spalling on the upper surface, while flexural cracks showed on the vertical face of the slab edge. In the internal and in the connections located on the side of the structure parallel to the loading application, radial cracking was observed (Figure 8.34).

Figure 8.34 Radial cracking in the internal connections on the 2nd floor a) B2, b) C2.

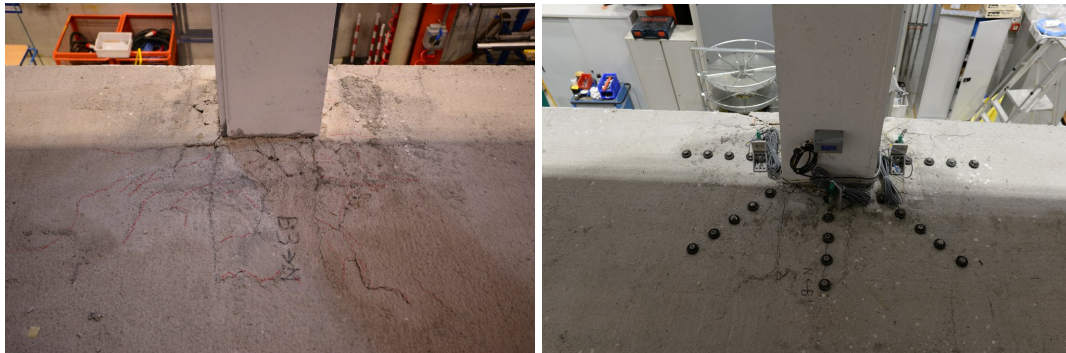
Failure was not observed in either of the two analysed connections (Figure 8.37 and Figure 8.38 a and b).

Figure 8.38 Connections a) B3 unstrengthen and b) B1 strengthened.

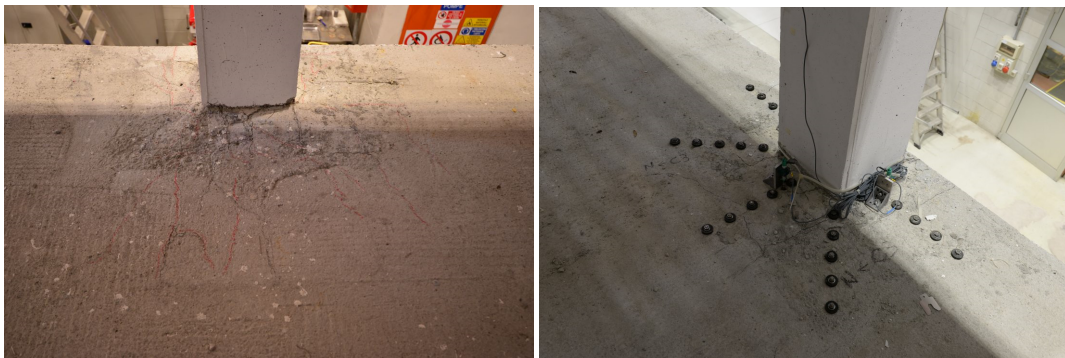
In this comparison, the two analysed connections show a similar trend in the ductility analysis with maximum values of unbalanced moment closer than the comparison between B3 and B1. Failure was not observed in either of the two analysed connections independently from the presence of the strengthening (Figure 8.41 and Figure 8.42 a and b). The effect of the strengthening can be seen only for the absence of any strength deterioration in C3, whereas C1 showed a slight reduction of the unbalanced moment after the peak.

Figure 8.42 Connections a) C1 unstrengthened and b) C3 strengthened.

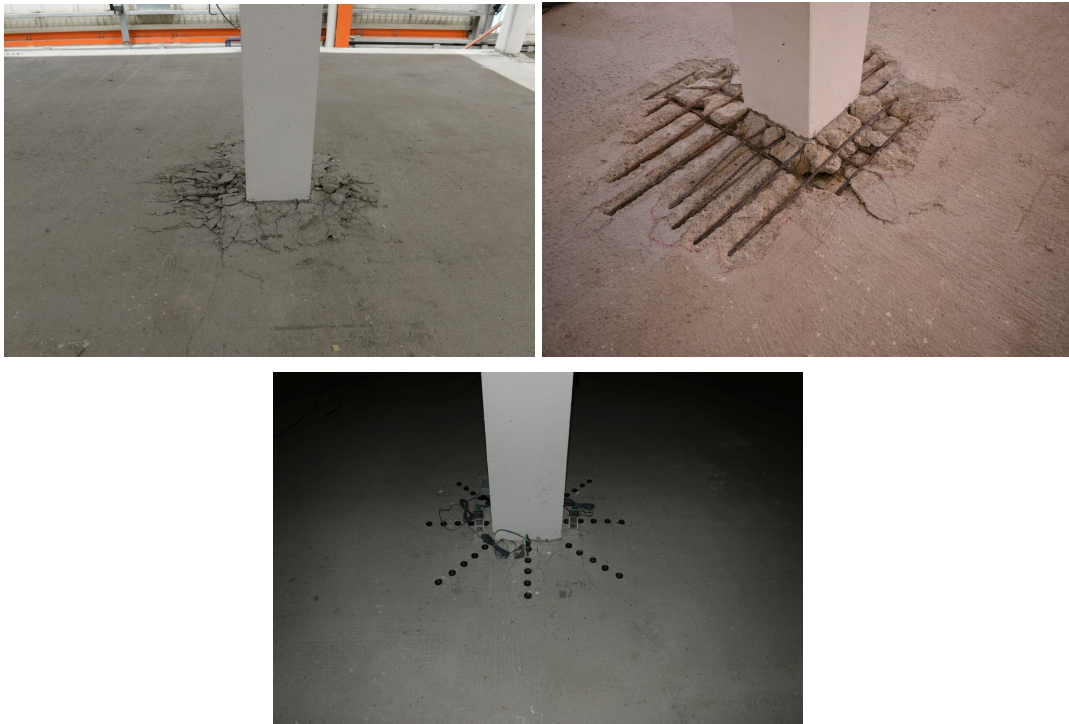
Figure 8.45 B2 a) before and b) after the removal of the damaged concrete pieces and c) C2 connections at the end of the test CYC-2 (g04).

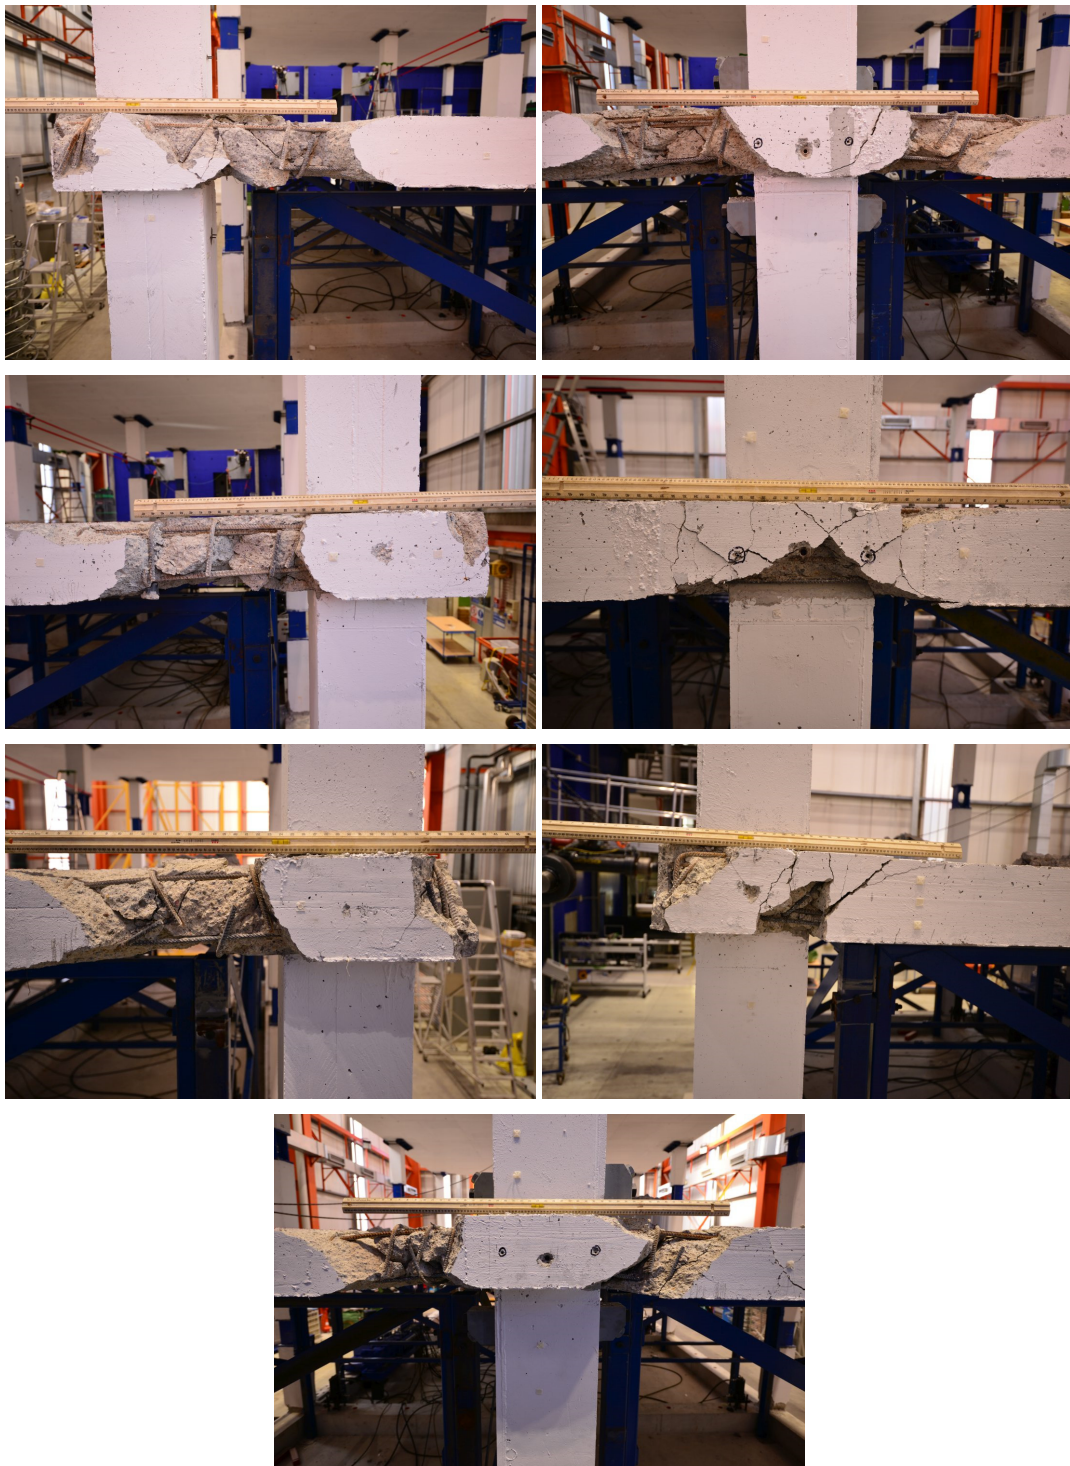
Figure 9.2 1st floor slab edge damage, connections, clockwise direction a) A1, b) A2, c) A3, d) B1, e) D1 east, f) D1 north, g) D2 at the end of the experimental campaign.

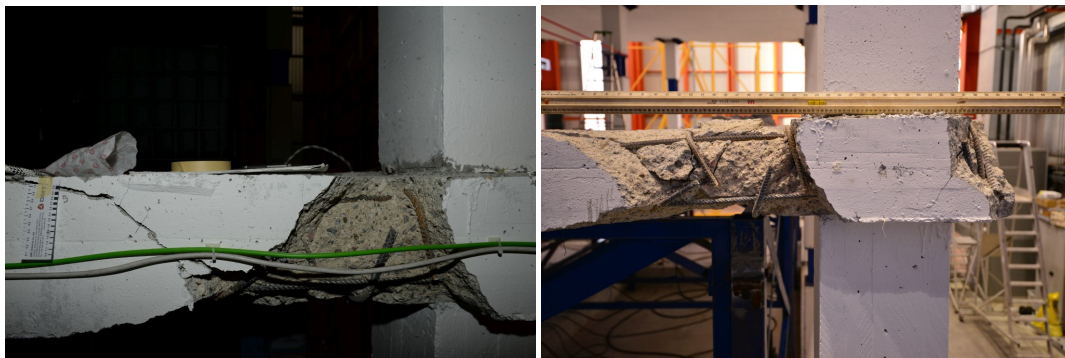
Observing the D1 east connection at the end of the first cyclic test in Figure 9.11 it can be seen that this caused the damage of the edge (Figure 9.11 a). In literature to date, it was the first time that it was possible to observe this detail

This design detailing is quite common in the real slab buildings in Europe.

Figure 9.11 SlabSTRESS D1 east after test a) Cyc-1 and b) Cyc-2.

All the connections in the two short sides of the slab were too damaged to be repaired. Due to this and safety reasons, added vertical loading (water tanks) in these connections was removed and also some of the sensors.

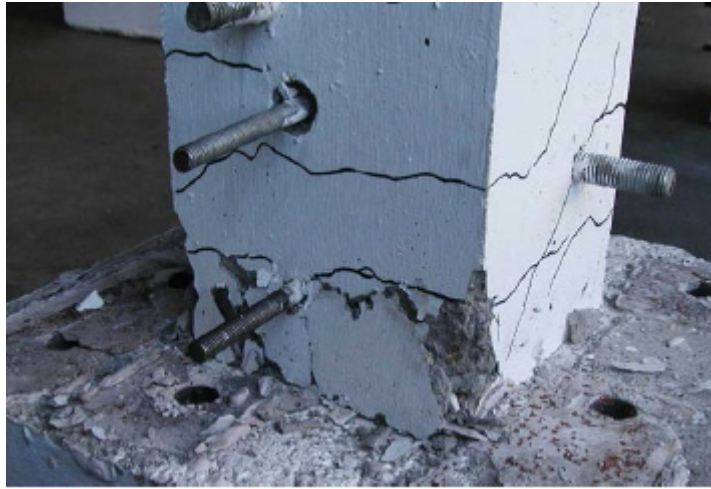
They observed a nonlinear response with yielding of slab reinforcement, yielding at column bases, and punching at slab-column connections for both specimens, reinforced-concrete slab-column frame (RC) and post-tensioned slab-column frame (PT) (Figure 9.10). They also reported the formation of hinge in some connections with loss of moment transfer strength.

Figure 9.17 Kang and Wallace, 2004 [5] damage at the column base of the RC specimen.

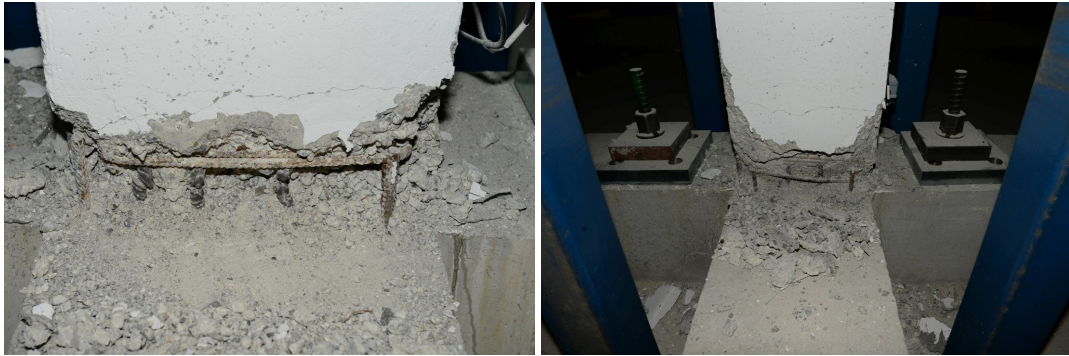
No cracks appeared in the column heights but the internal columns B2 and C2 reported a significant failure at the base. These damages are reported in Figure 8.30.

Figure 9.19 SlabSTRESS base column connection a) B2 west and b) C2 east.

The B2 was the same column that punched in the slab-column connections on the 1st floor during the cyclic test Cyc-1 for an inter-storey drift of 4% in negative. At the end of the test, after compression buckling, breaking of the longitudinal reinforcement at the base of the column in the B2 connection (Figure 8.30 a) was observed. The reinforcement of the columns limited the cracking of these members that would have increased the ultimate drift.

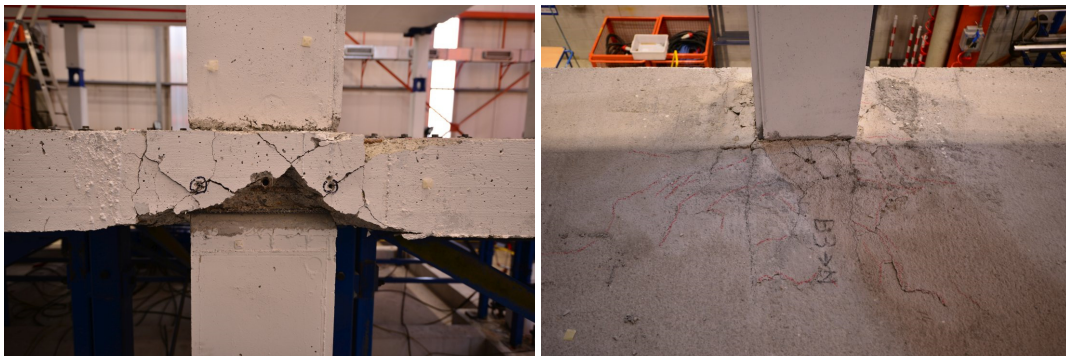
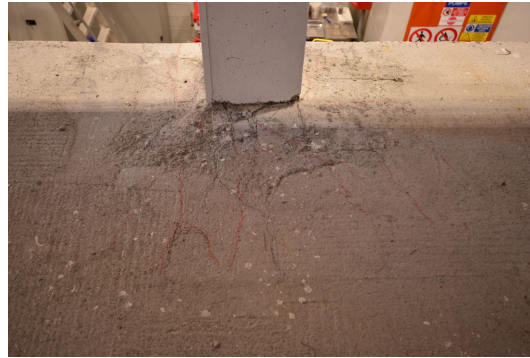
with Figure 9.33 and from Table 8.11, it is possible to see that the lateral connections in the side parallel to the loading applications reported flexural cracks of limited entity.

Figure 9.33 SlabSTRESS 1st floor slab damage, edge parallel to lateral load direction, connection a) B1 north, b) B3 and c) C3.

It can be concluded that SlabSTRESS shared the same type of damage on edge connections, though with more severe cracking influenced by the detail of the reinforcement. This type of damage shows both with uniaxial loading perpendicular to the edge and biaxial loading. If the loading is parallel to the edge, the damage is much lower. The SlabSTRESS result is confirmed by ductility calculations as well.

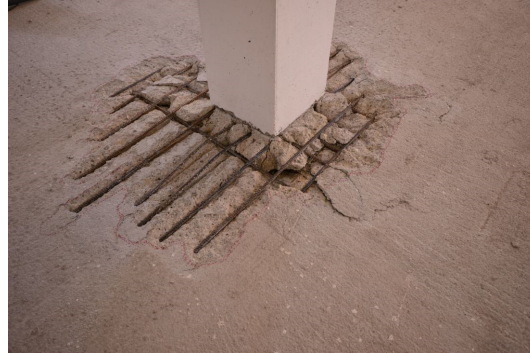
The SlabSTRESS internal punching occurred in the internal connections for an inter-storey drift ratio of 4.1%. In addition, the buckling of the longitudinal compressed

reinforcement was observed on the east side of the punched connection B2 near the column (Figure 9.37).

Figure 9.37 SlabSTRESS B2 connection east-west direction after the removal of damaged concrete pieces.

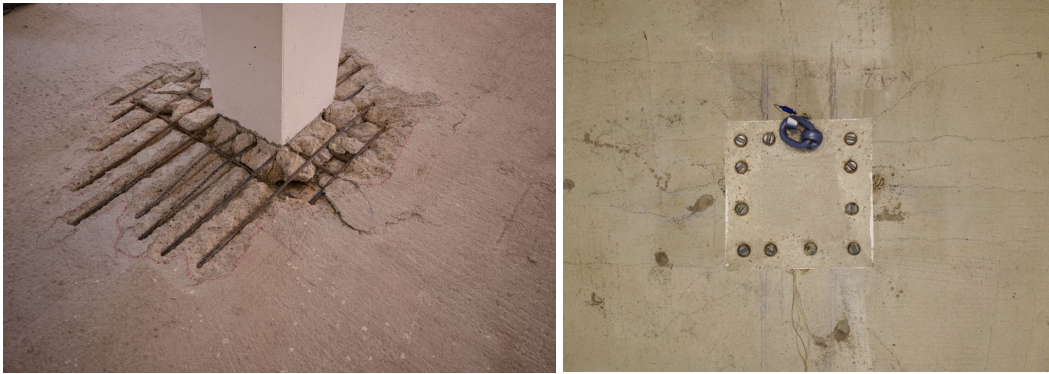
The use of shear reinforcement reduced the intensity of damage, preventing the slab punching (Figure 9.43) and dropping (Figure 9.44 a) observed in specimens without shear reinforcement.

Figure 9.43 B2 connection a) 1st floor, b) 2nd floor.

Although there were differences between the two tests (see Table 9.2), the recorded damage was similar. The internal connections of both test with shear reinforcement (Figure 9.41 a for Kang and Wallace, 2004 [5] and Figure 9.43 b for SlabSTRESS) showed cracking that extended from the column section without any punching. Similarly, in the edge connections, the presence of shear reinforcement contributed to decreasing the spread of cracking and prevented the slab from partly dropping. Only some cover spalling was reported (Figure 9.41 b for Kang and Wallace, 2004 [5] and Figure 9.44 b for SlabSTRESS).

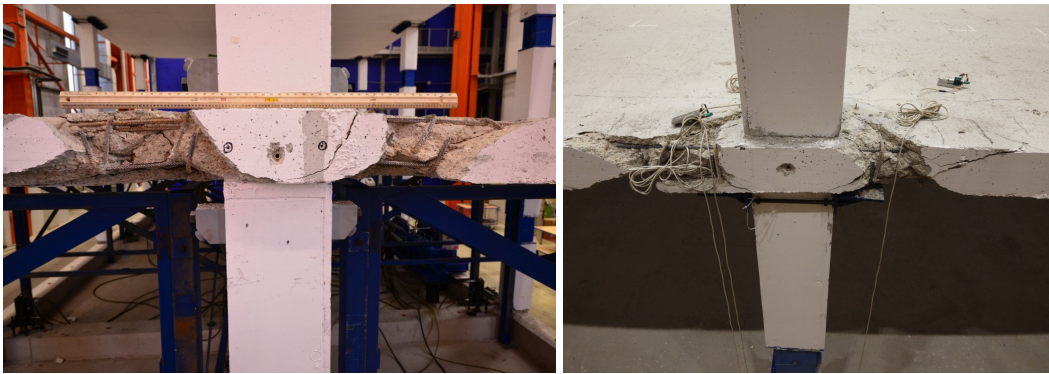
Figure 9.44 A2 connection a) 1st floor, b) 2nd floor.

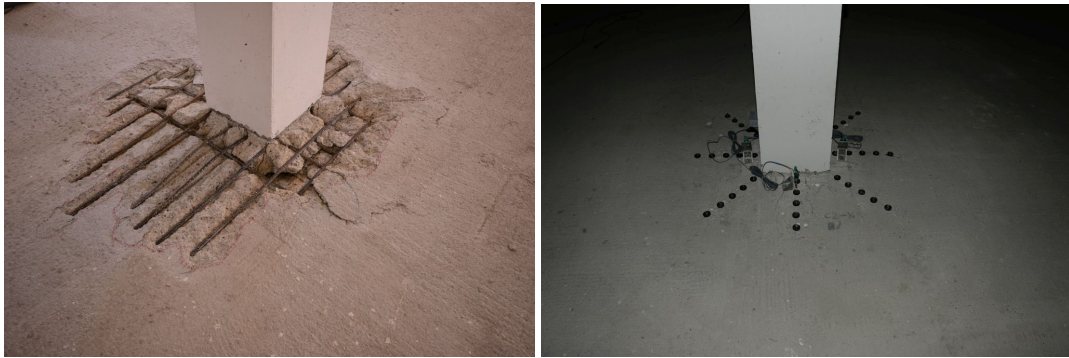
reported greater damage compared to the connections with shear reinforcement. Similarly, in SlabSTRESS the strengthening avoided punching failure for combined gravity and lateral loading. As it is possible to see from Figure 9.51 a brittle punching occurred in the internal connection B2 (Figure 9.51 a) while the similar connection C2 was strengthened (Figure 9.51 b) and resisted to the end of the test without failure.

Figure 9.51 SlabSTRESS internal connections a) B2 un-strengthened and b) C2 strengthened.

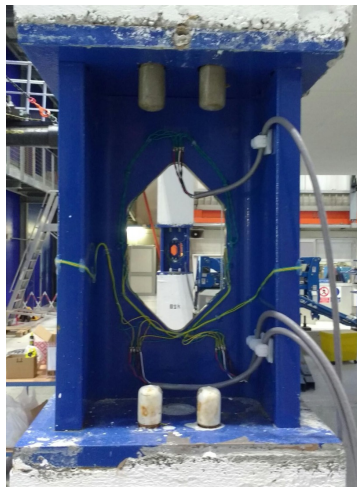
SlabSTRESS was the first experiment on a two storey flat-plate frame in which the columns' internal forces (shear force, axial force and bending moment) were measured, on both floors, with a system designed *ad hoc* (Figure 9.53). The collected data was acquired with very accurate sensors that guarantee the validity of the results.

Figure 9.53 Load cell in SlabSTRESS.

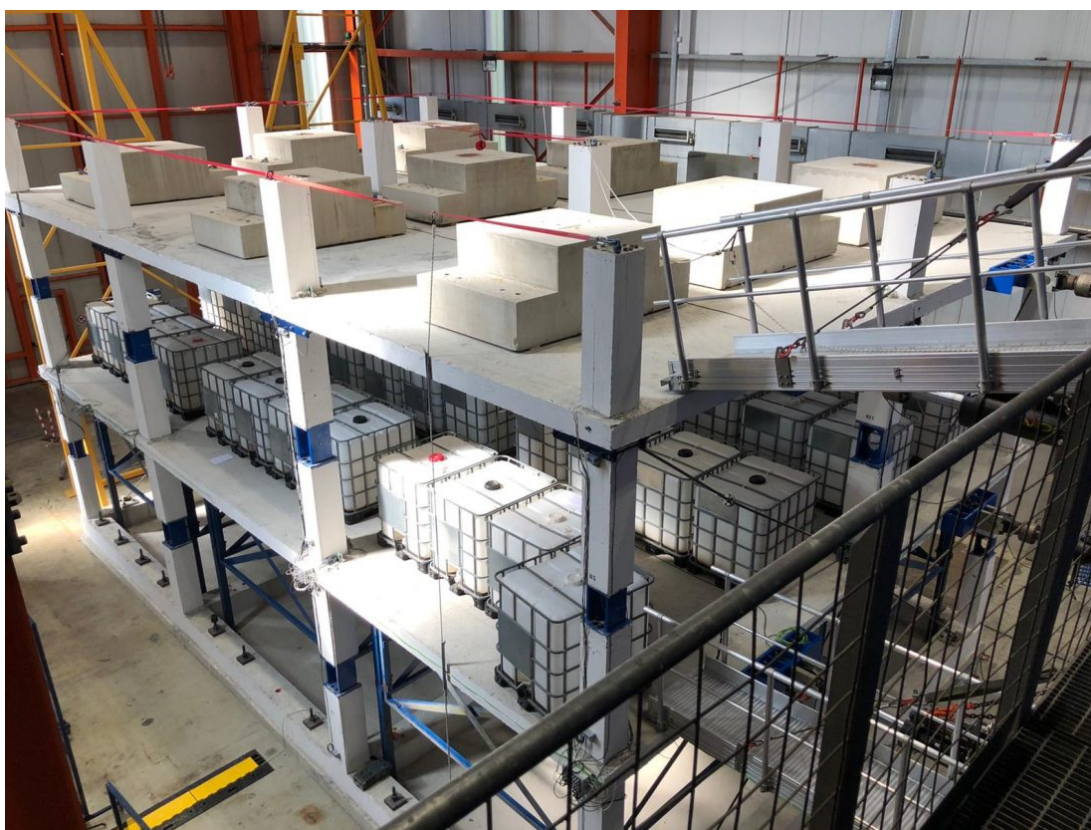
The loads typology consists of water tanks on the 1st floor and concrete blocks on the 2nd floor.

Figure 11.19 Loads different typologies.

The loads differ in each experiments for disposition, size and typology.
