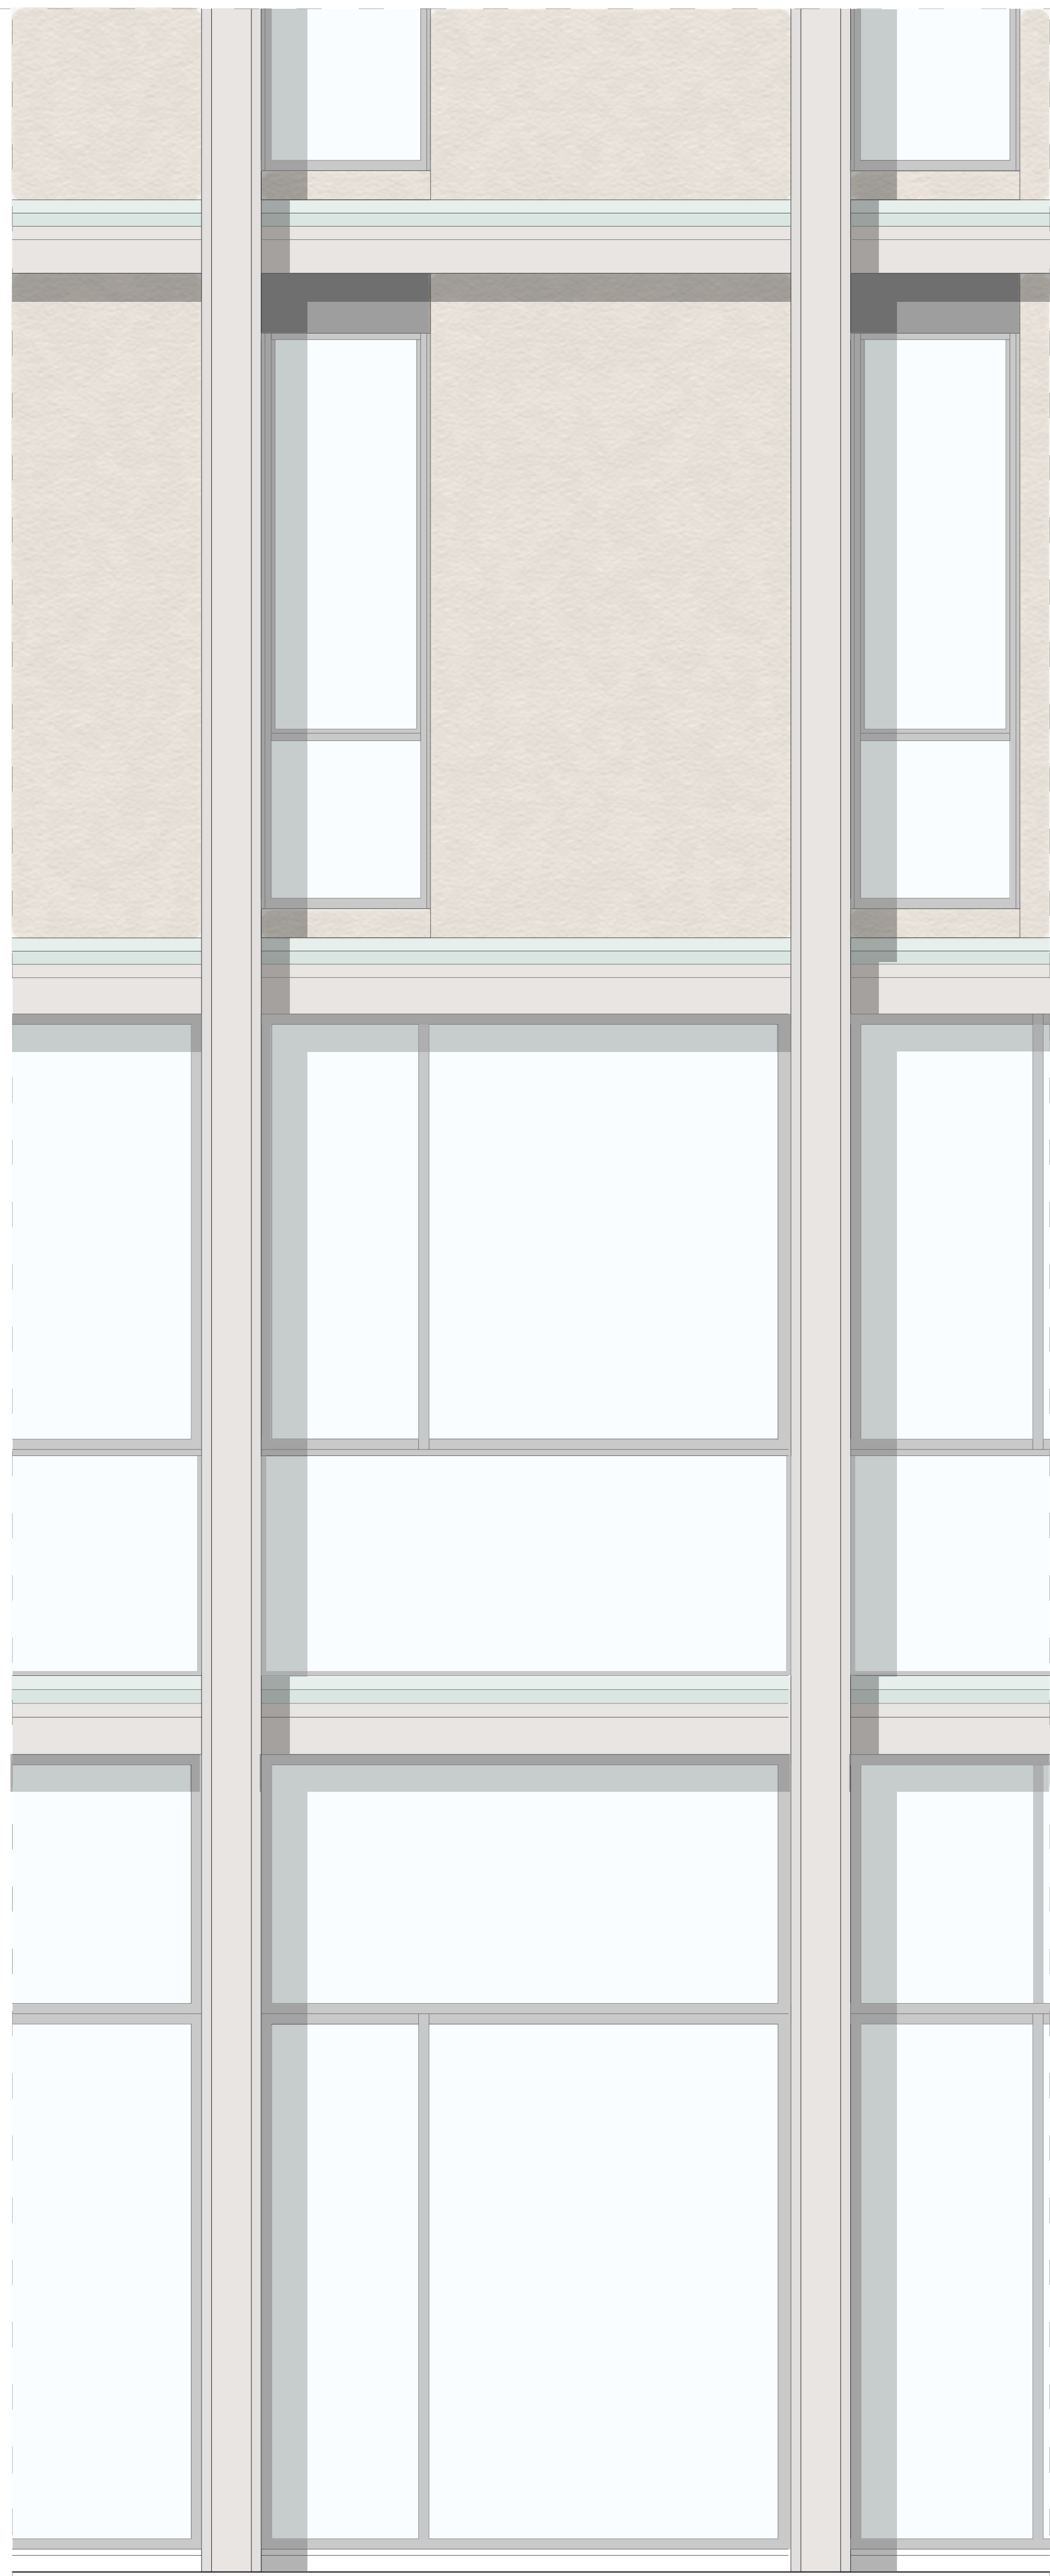
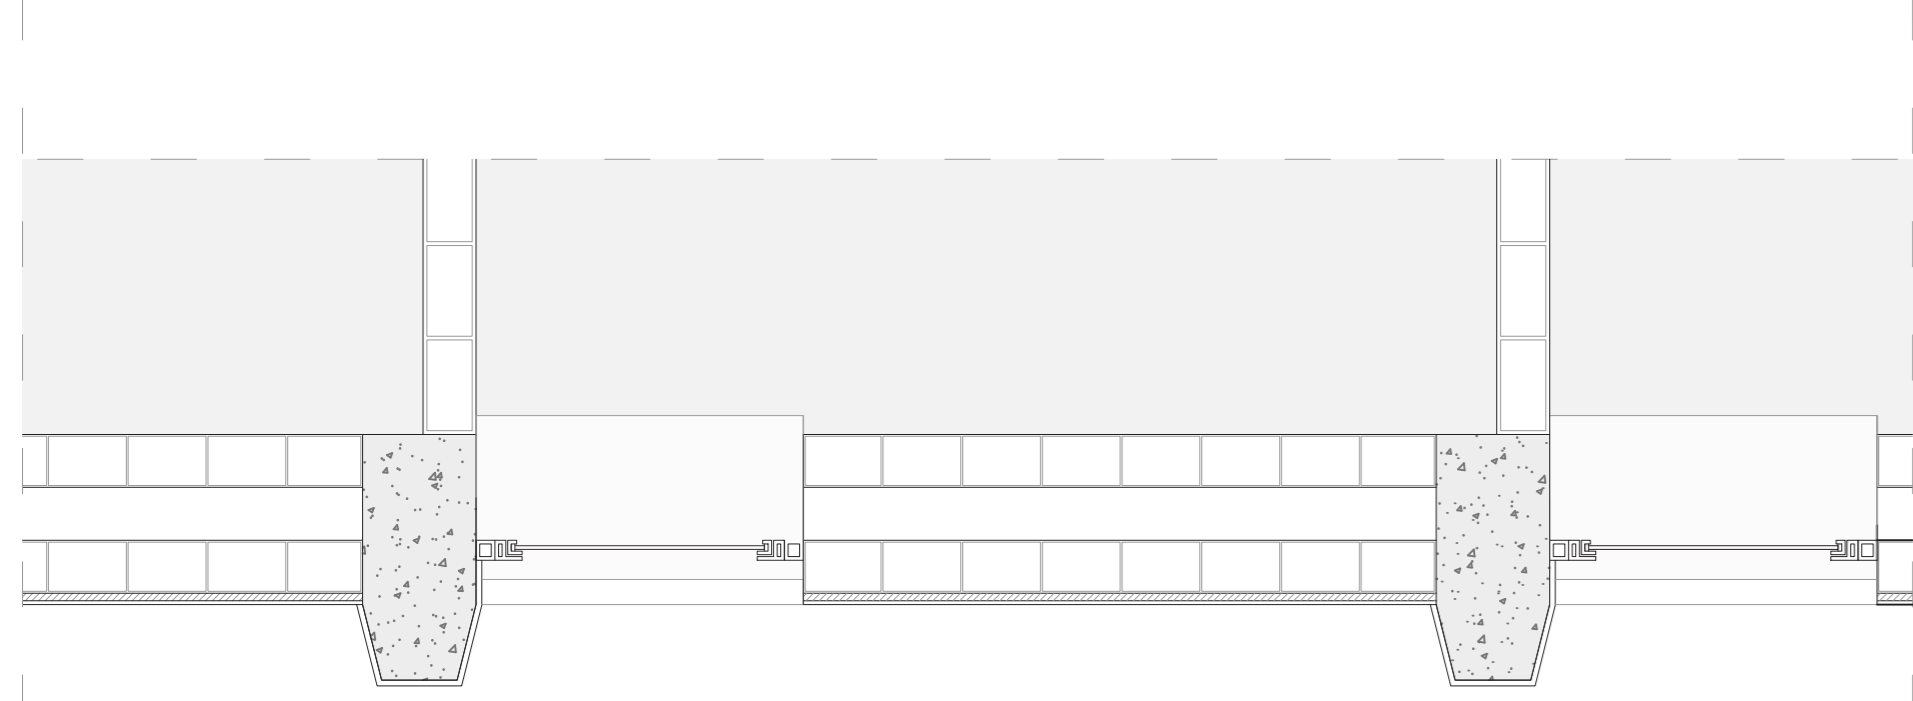
Typical span of the Convitto in elevation and plan (survey situation)
SCALE 1:20

- Level 1: detachment of plaster
- Level 2: presence of cracks
- Level 3: presence of exposed rebars
