2003
Methodology: The intervention, with special emphasis on facades, follows the phases of:
- Historical and stylistic research.
- Decay analysis.
- Remedial intervention
- Design of a rooftop addition for each of the buildings.

Aharonovitch street is located in the core of the Central White City, in the Zone A and right under UNESCO protection.

Area of Intervention

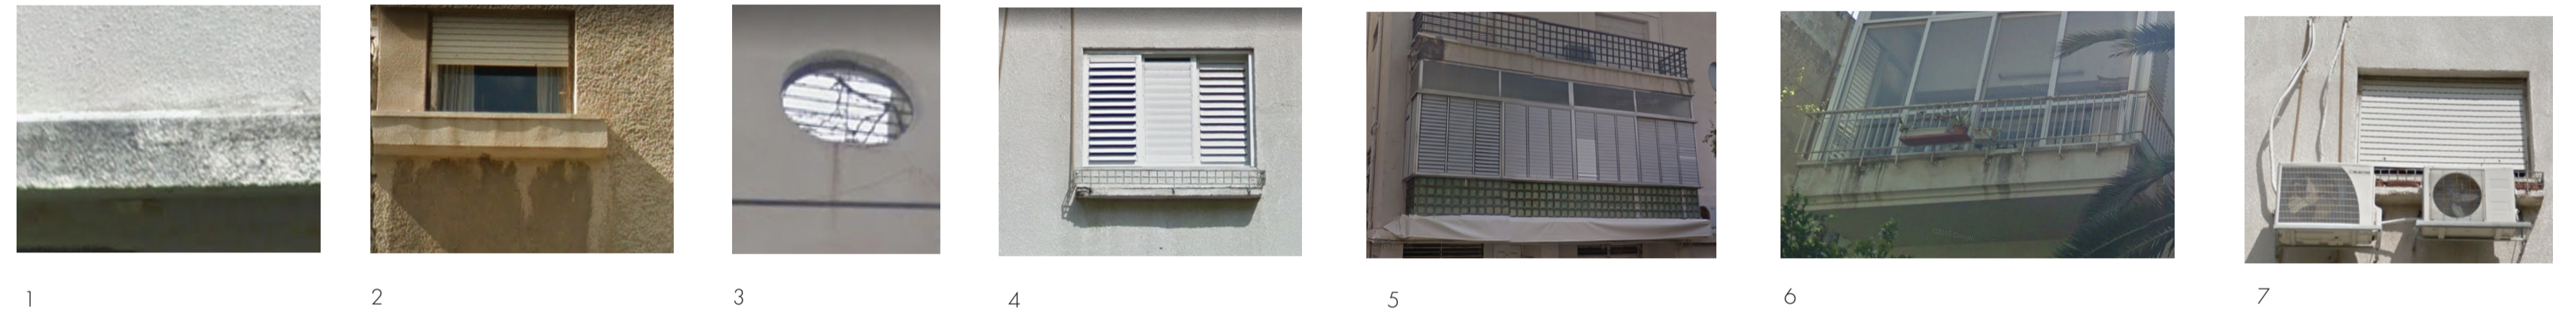
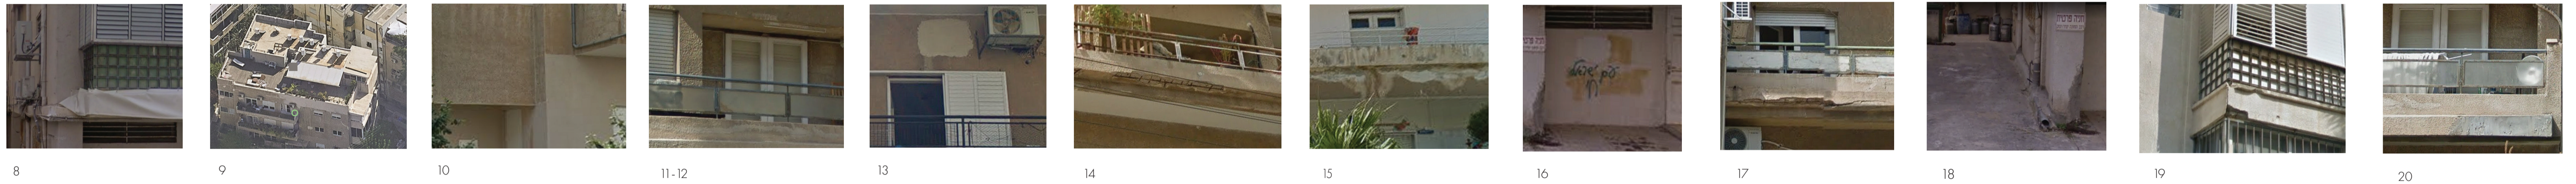
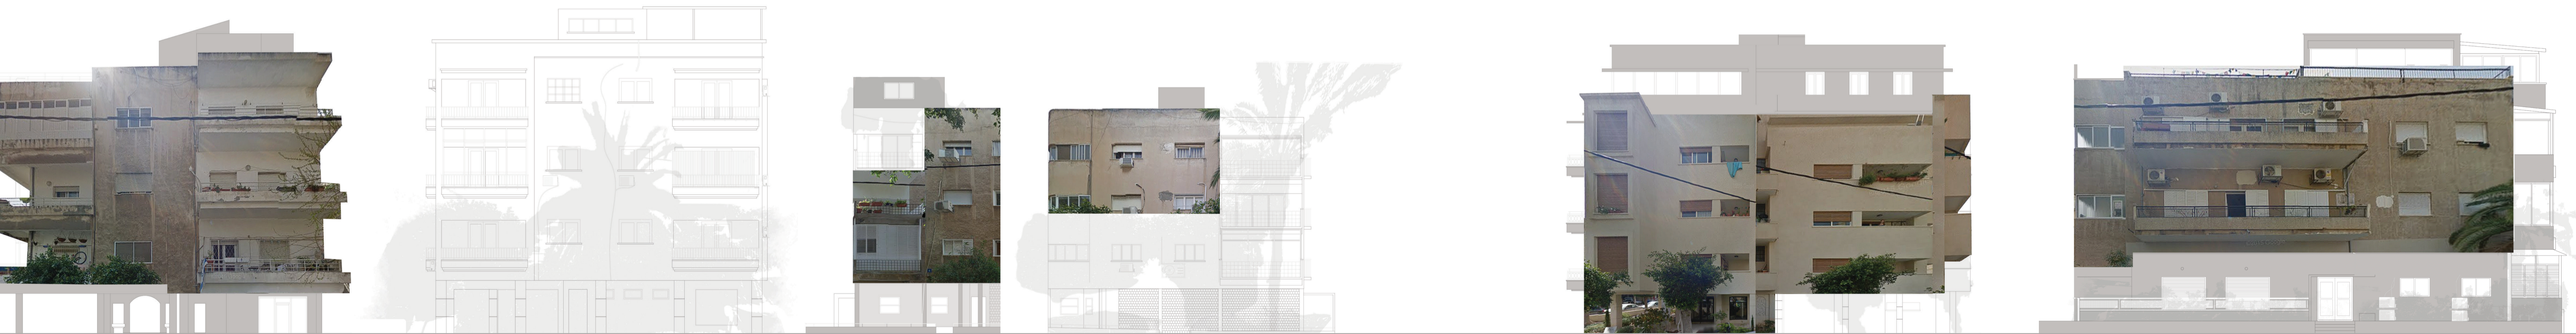
SOUTH SIDE 10 8 6 4 2

- _Buildings 7, 8, 6, currently covered by vegetation.
 - _Building 9, already restored and covered by vegetation. Its intervention for the rooftop will be reconsidered.
 - _Building 11, already restored. Eventhough, Its intervention will be reconsidered
- In general, the buildings present a similar decay condition, with anomalies that vary in frequency.

- _Climatic conditions and lack of regular maintenance are the highest contributing causes of decay.
- _The need for new residential units and more comfortable habitational conditions is evident and it has been solved without rightful advice.
- _There is a high degree of negligence towards the architectural object and its values.

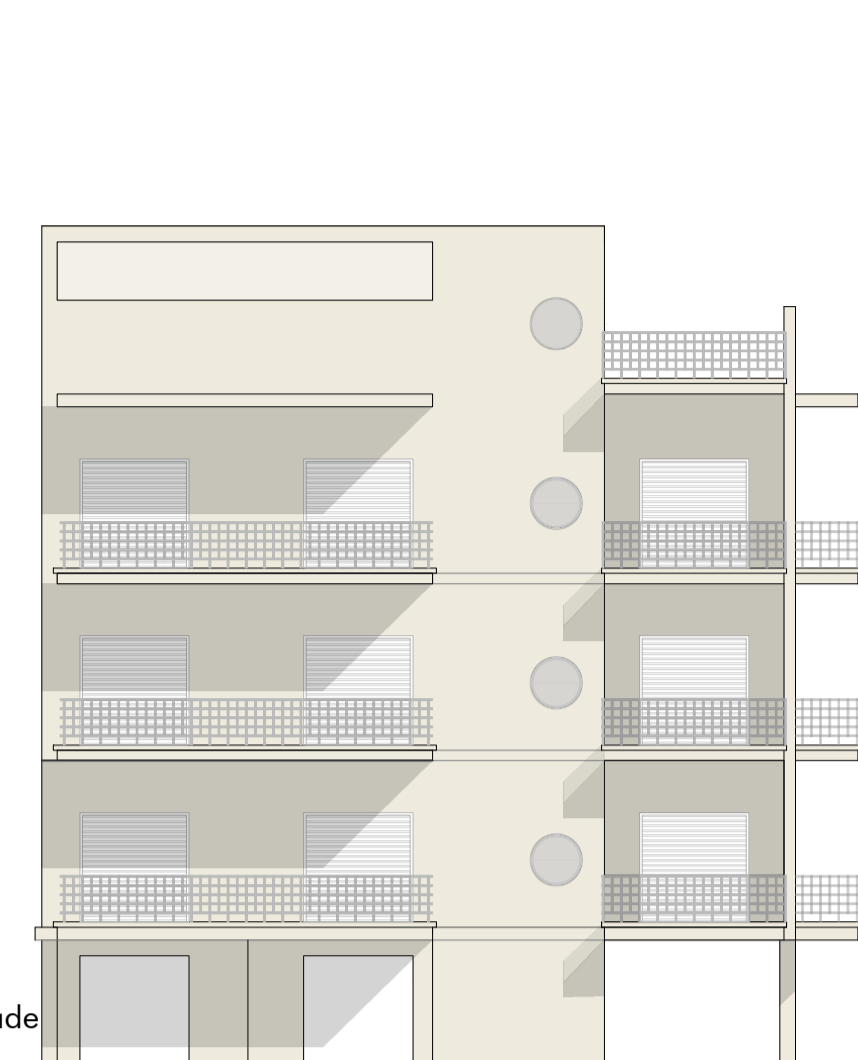
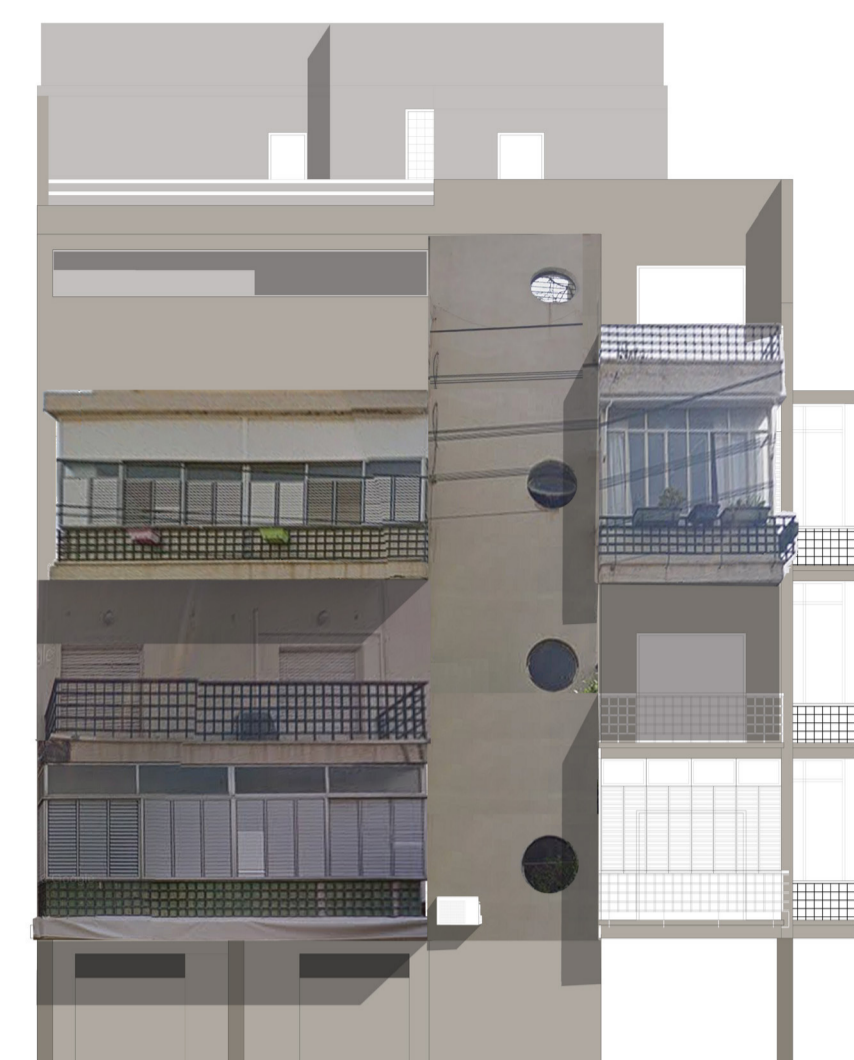
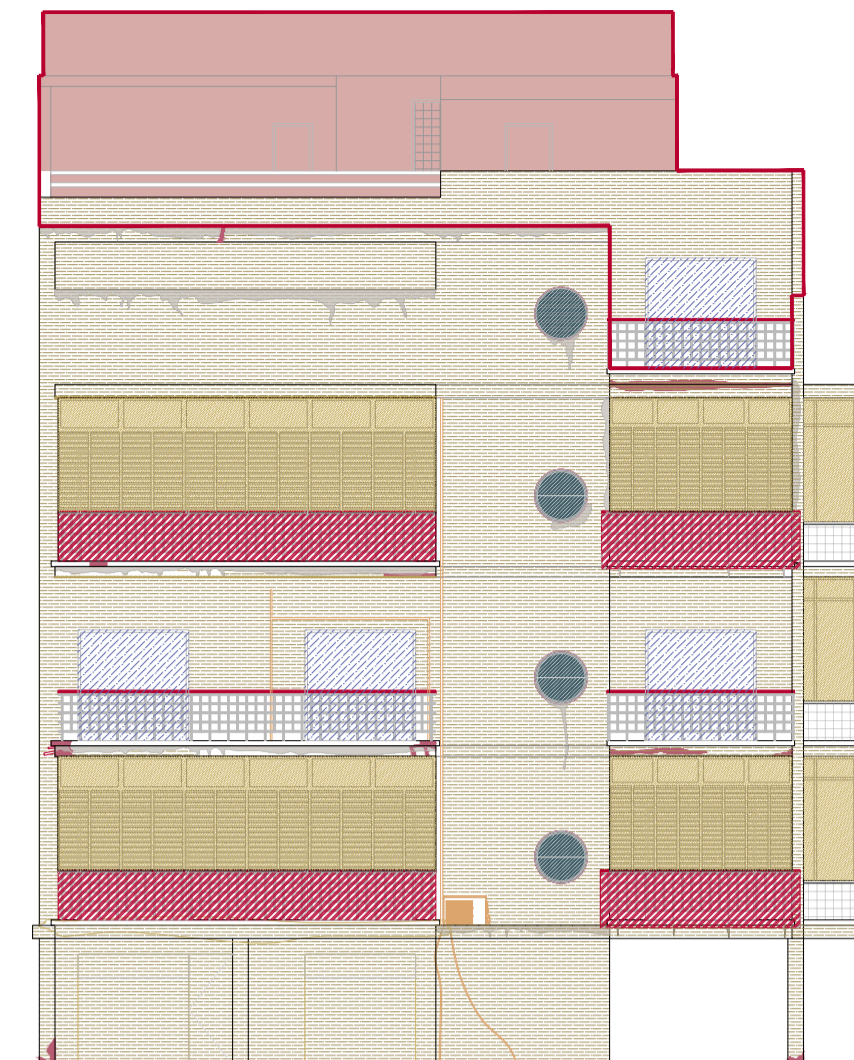
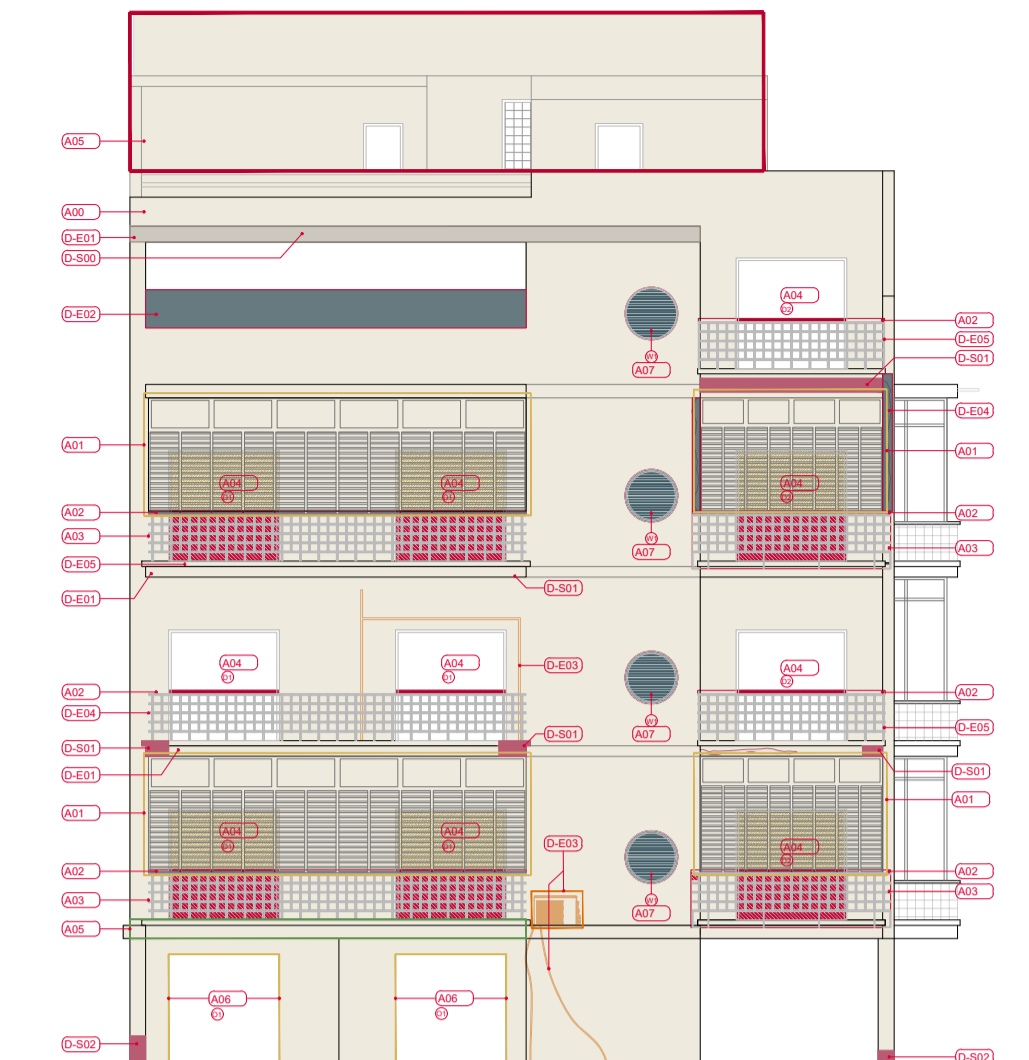
B. 1
West facade

Decay analysis

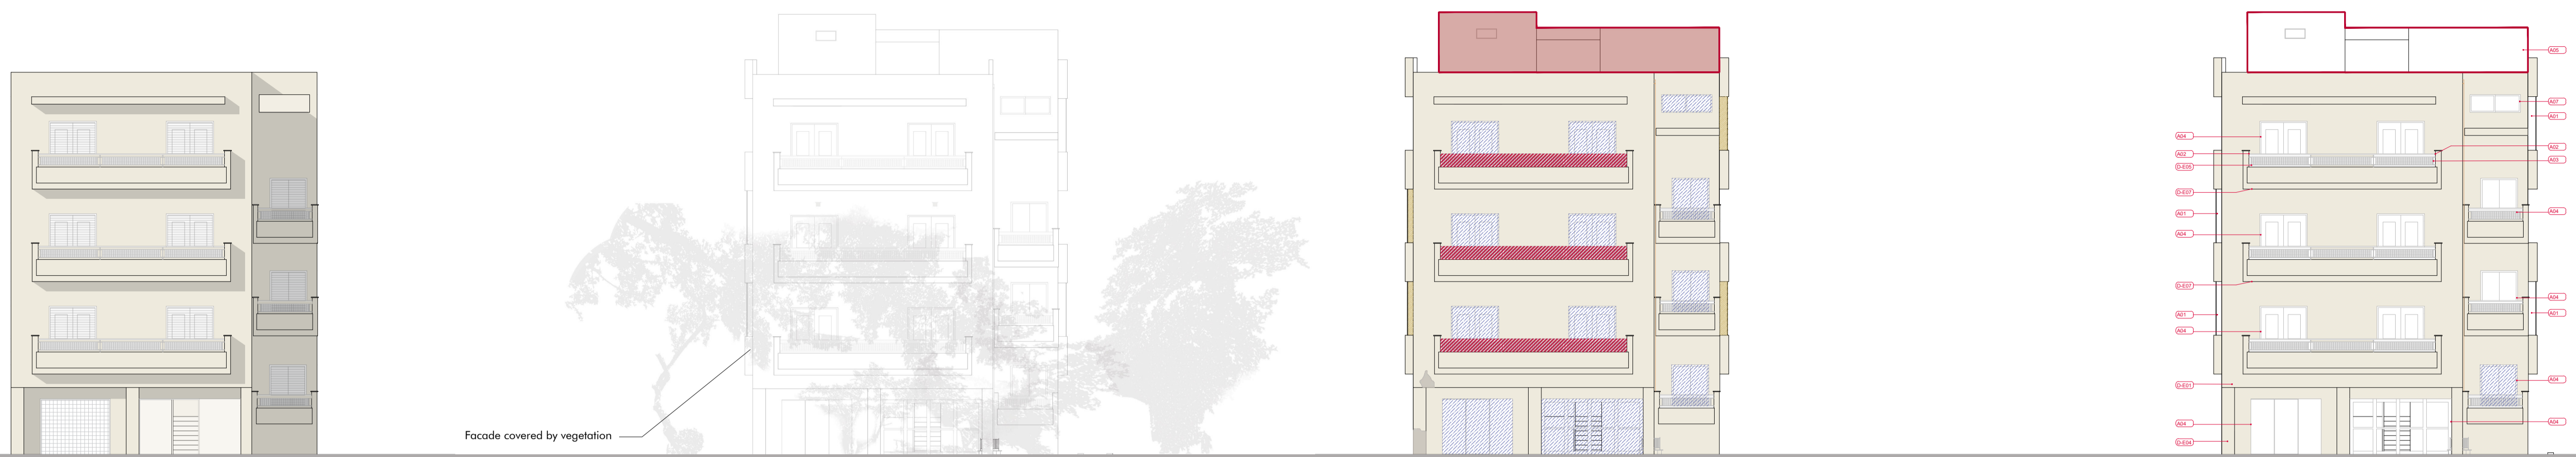
B. 9

Decay analysis

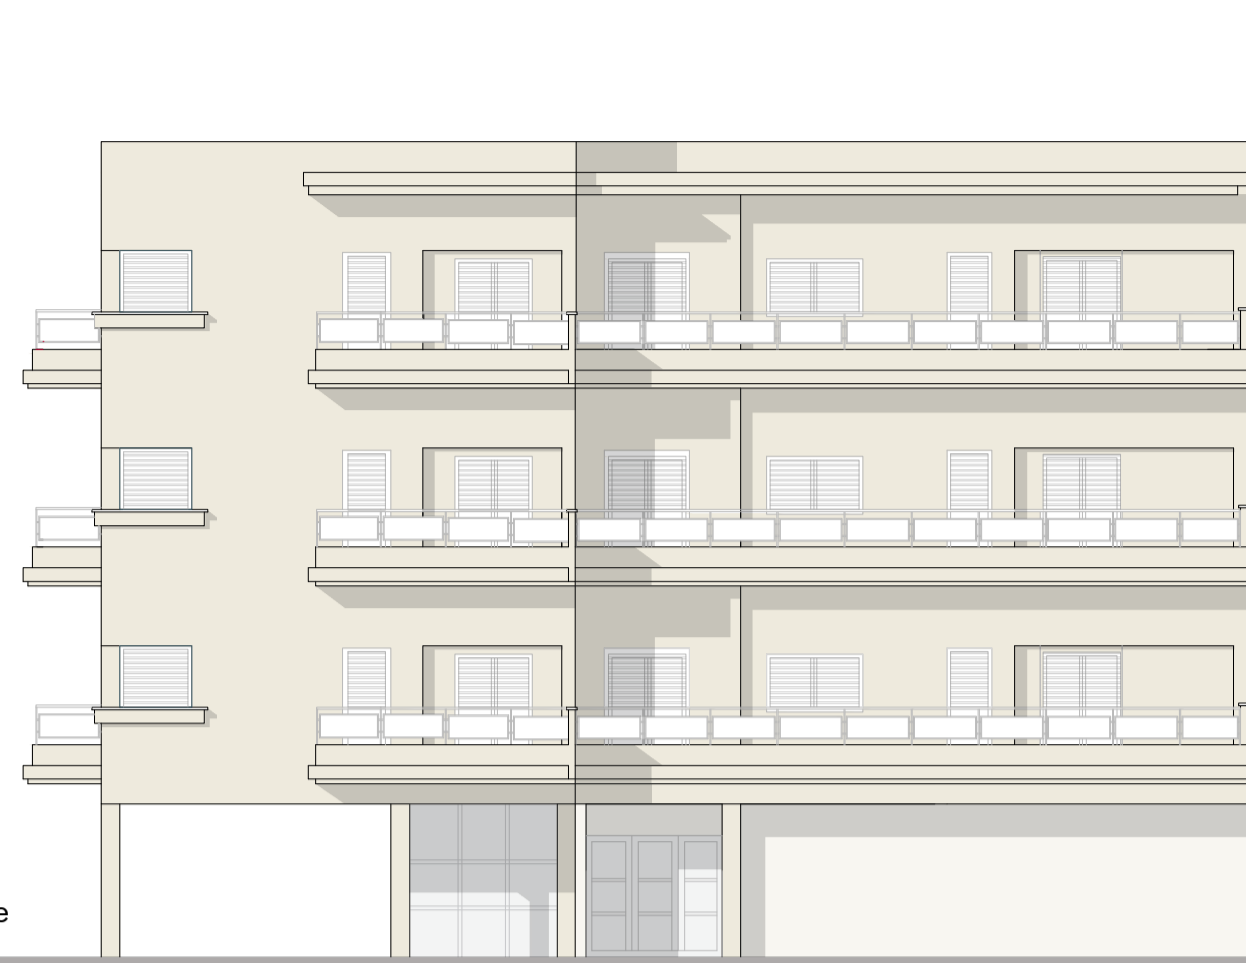
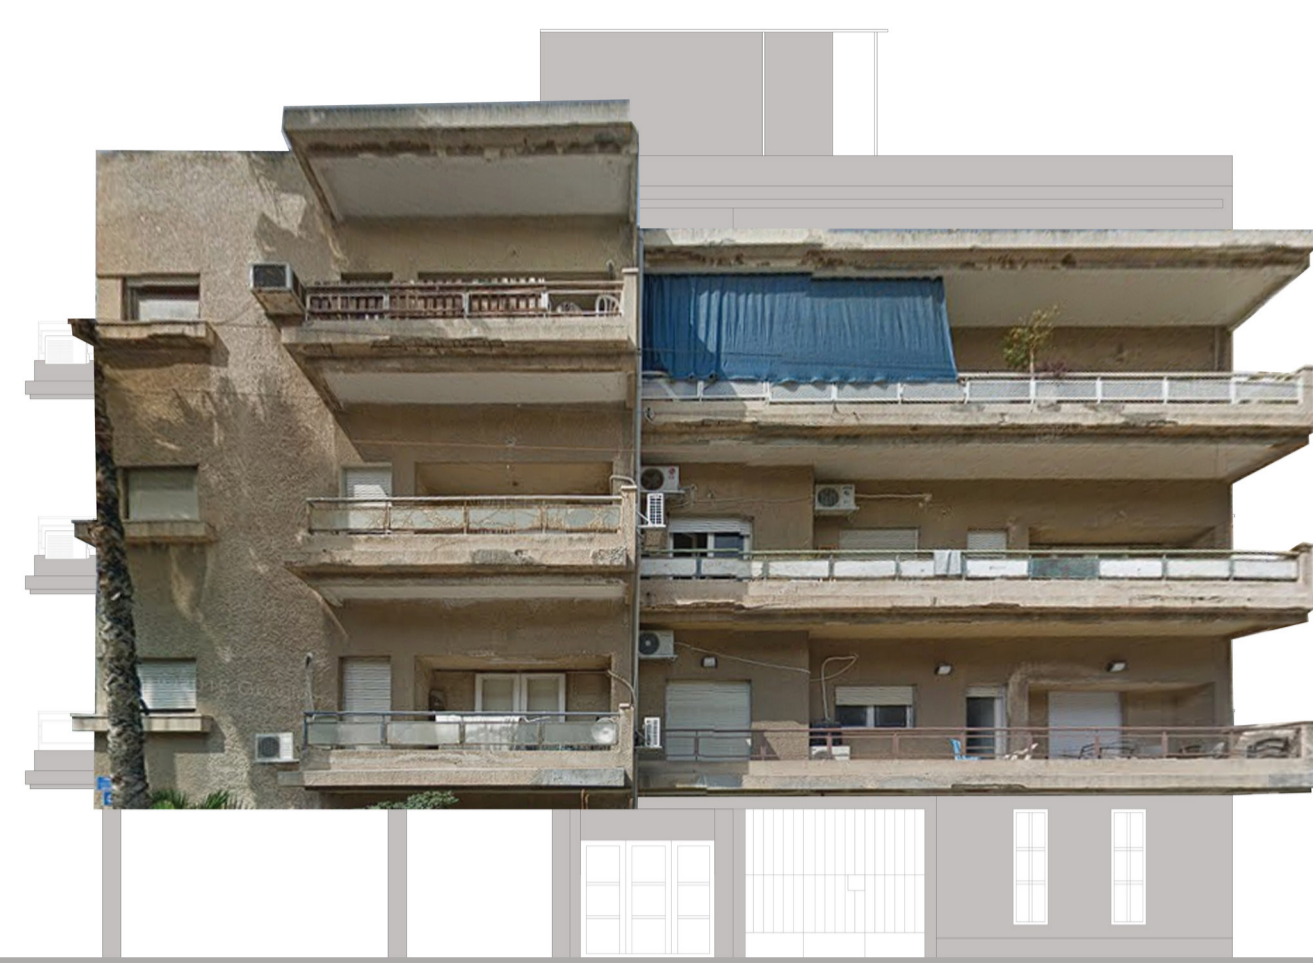
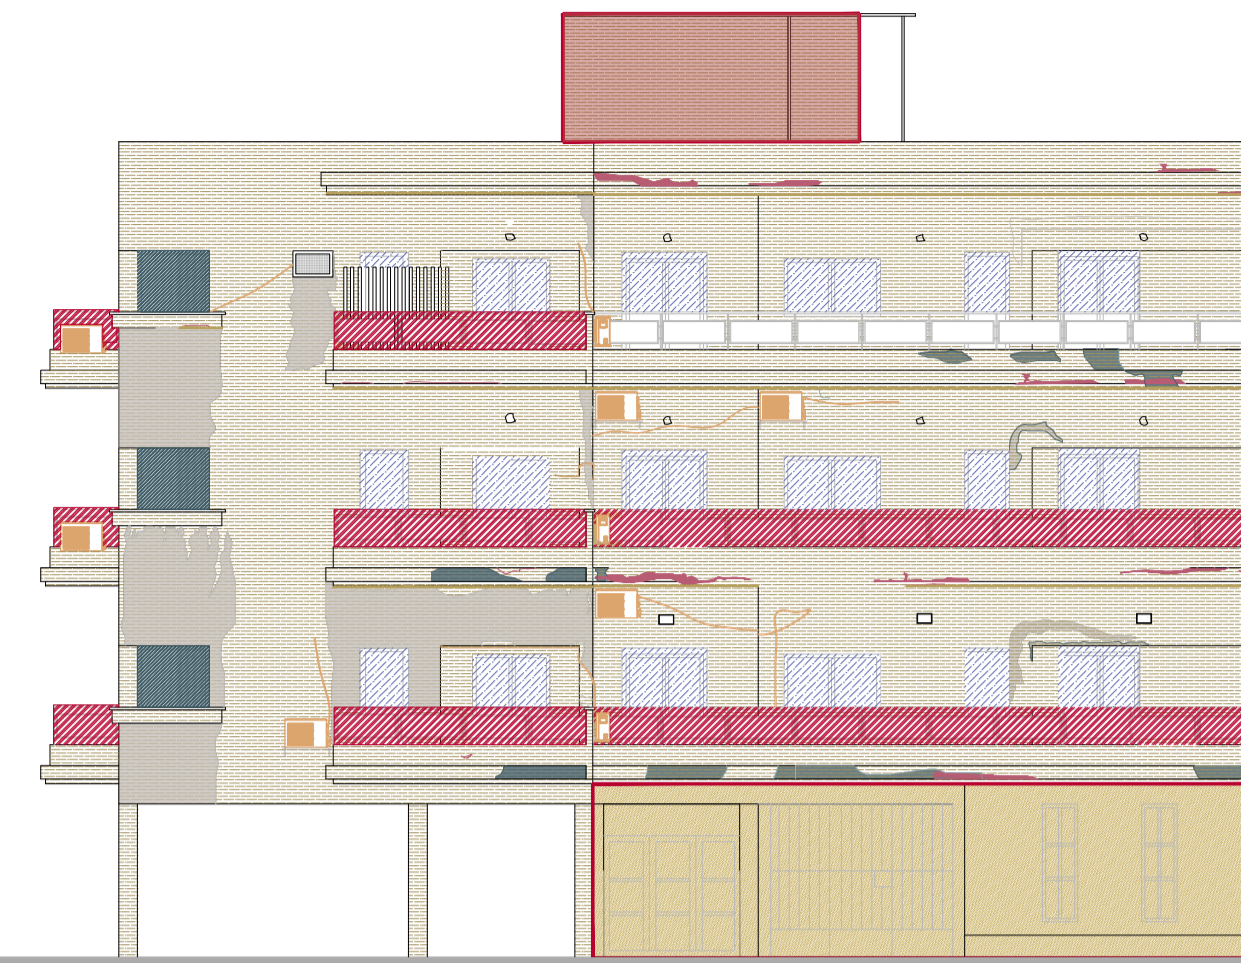
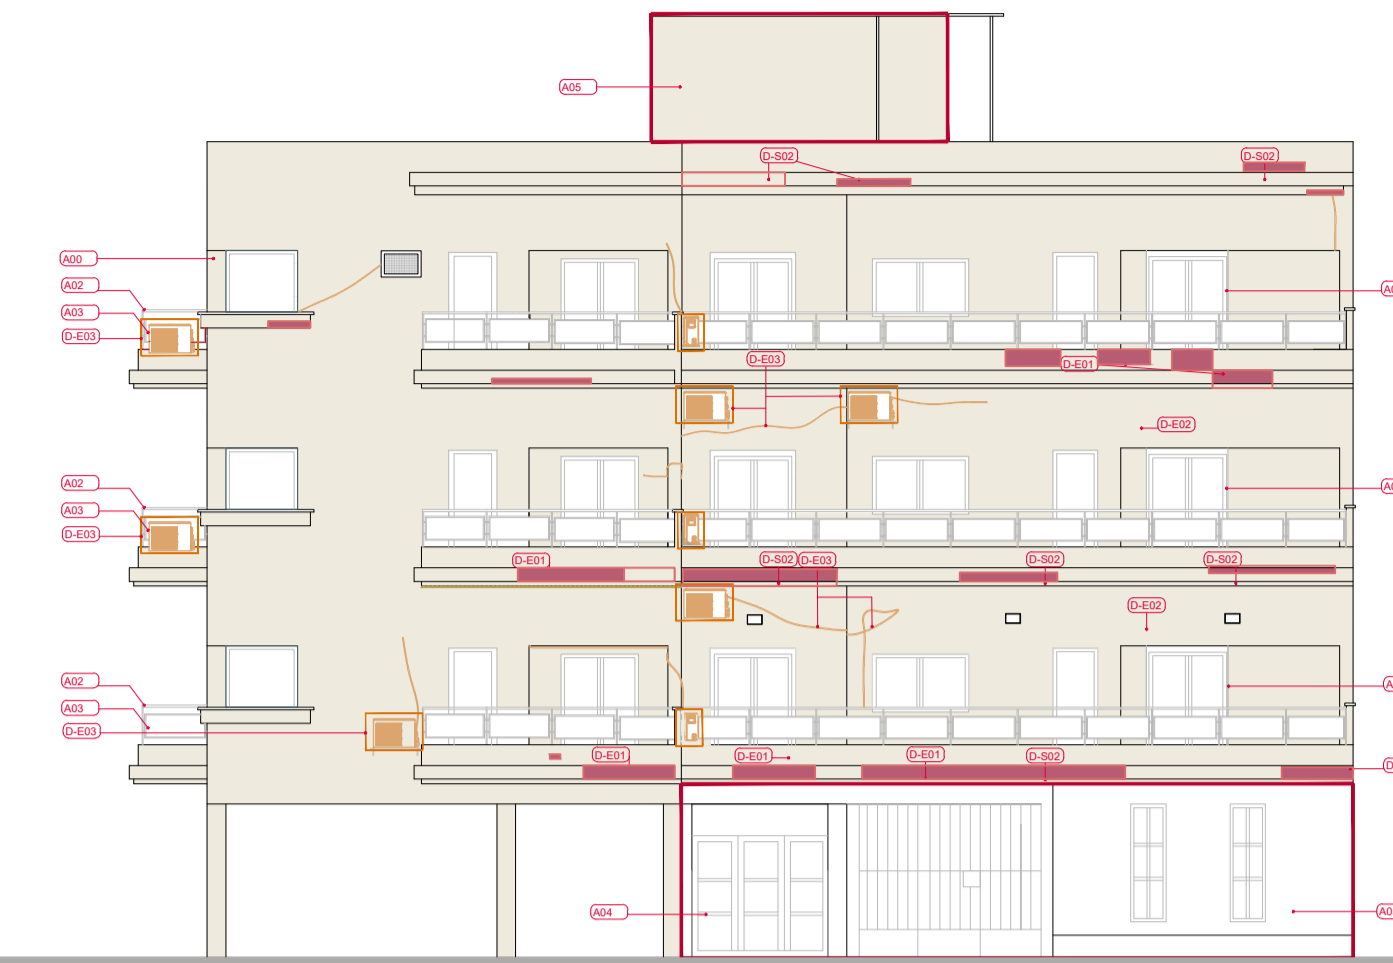
B. 13
East facade

Decay analysis

Remedial intervention

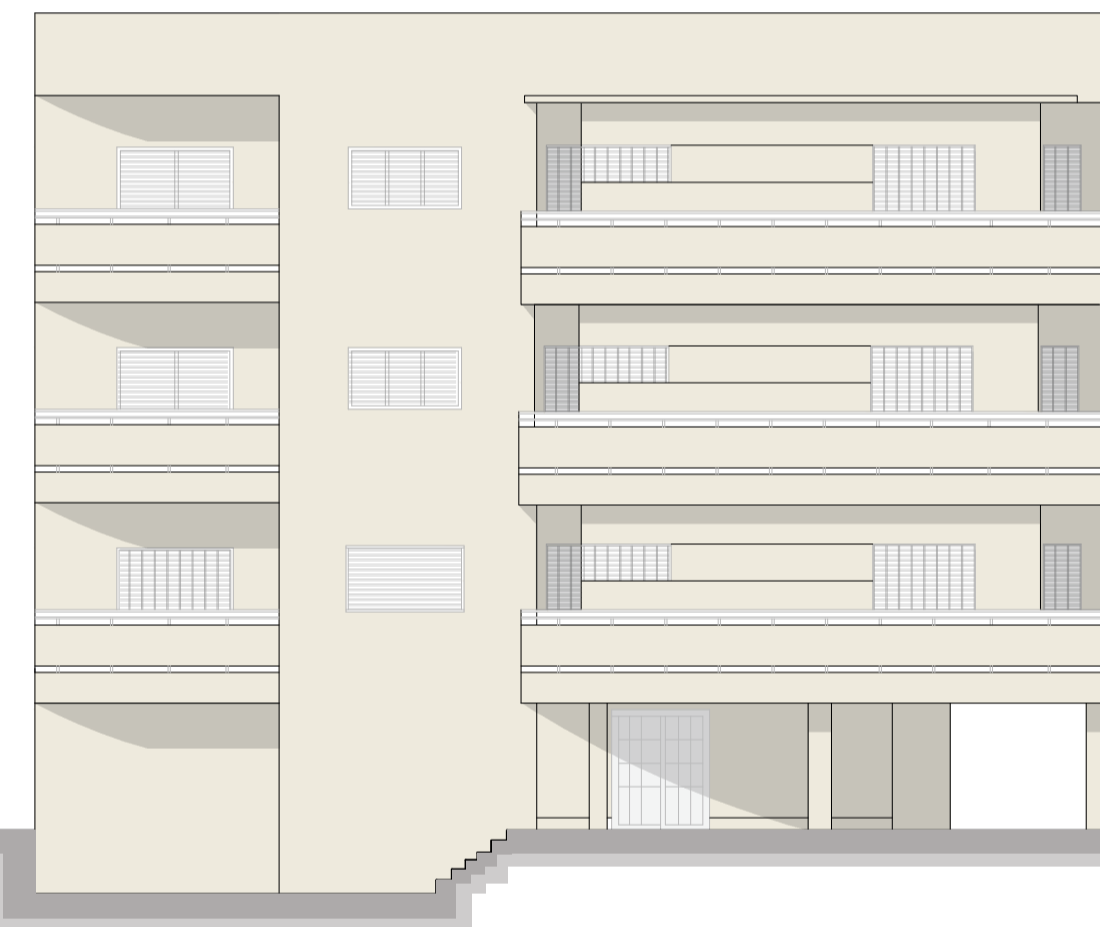
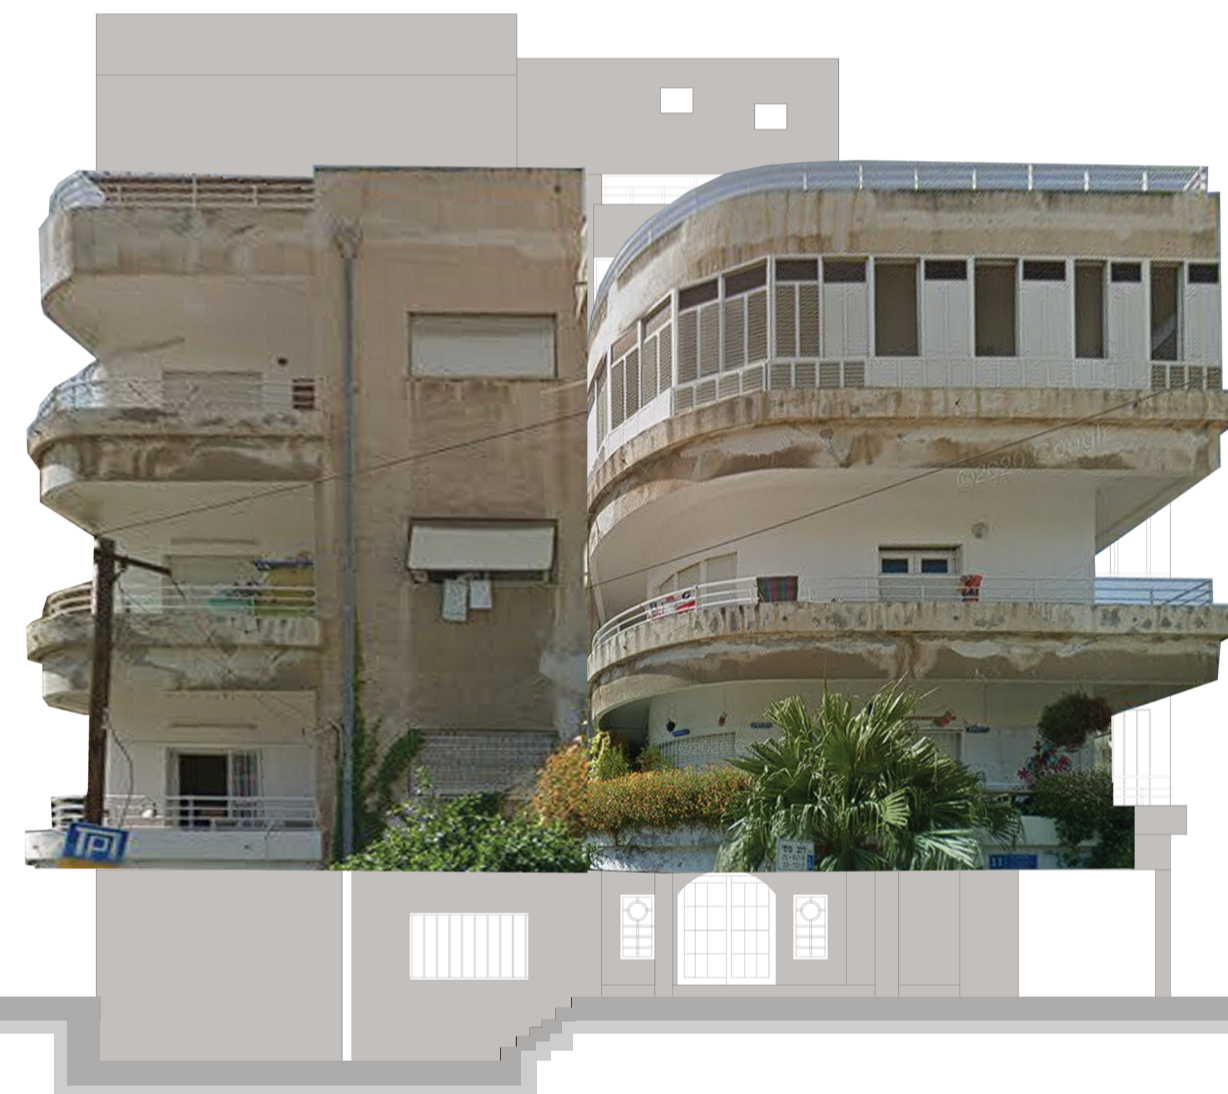
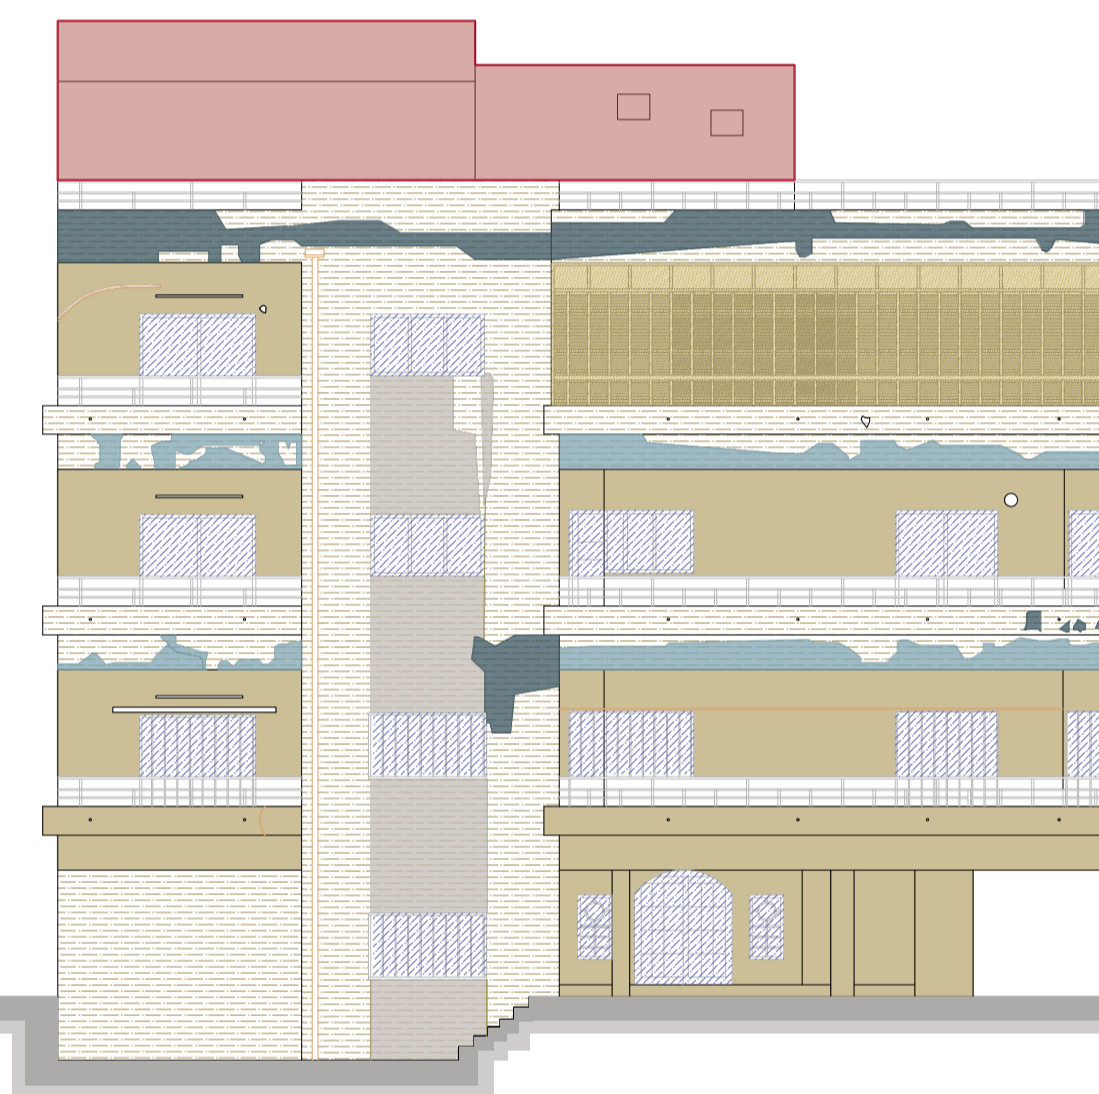
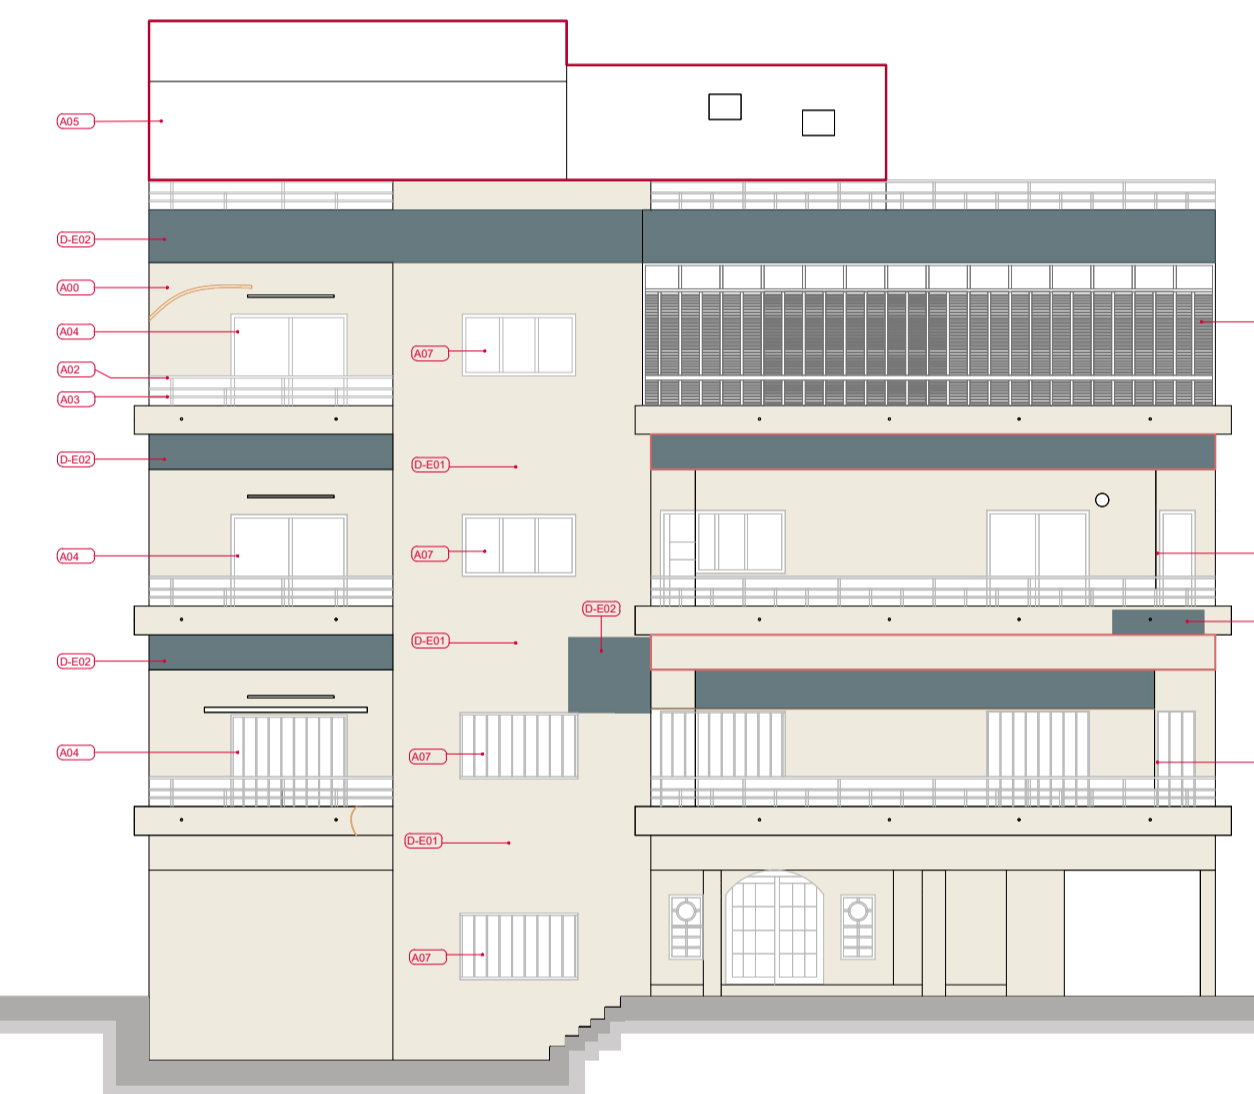
B. 10
East facade

Incoherent surface treatments - plastering & painting done as upkeep/repairation works causing variation by color/texture/aesthetic congruency

Decay - weathering of plastering & painting due to lack of maintenance

Decay - weathering of plastering & painting due to occupant activities - water seepage/faulty constructions/damages from interventions

Decay - weathering of plastering & painting due to natural causes of water seepage/exposure to sun/heat

Decay - metal - railings rusted/damaged due to external conditions

Decay - windows - glass stained and metal rusted due to exposure to external conditions

Decay - structural - damaged structural members - column/slab/beam due to exposure to outdoor conditions/aging/human interventions

Improper installation of different shading and windows in openings

Decay - wood - handrails rotten/disintegrated due to outdoor conditions

A00 Wall surface - sanded and repainted to original color by design.
A01 Aluminum enclosure to be removed
A02 Handrail to be inserted with improvisation to withstand current weathering conditions
A03 Railing to be refurbished as per original design and painted with protective coat
A04 Door to be replaced to original detail by frame & shutter
A05 Additional structures for awning/pergolas/shading devices to be removed

D-E06 Wall and door built into the opening to be demolished and finished as per original elevation
D-E07 Window to be refurbished with new glazing and improvised frames
D-E01 Slab surface decay due to staining by water and metal elements to be cleaned and repainted
D-E02 Wall surface decay due to staining by water - add coping on top surface with drip-mould detail
D-E03 Service equipment to be removed
D-E04 Wall mounted conduits to be concealed
Mismatch in plastering during intervention - to be sanded, textured, painted to original finish

D-E05 Railing deterioration - natural causes - to be replaced & painted to original finish
D-E06 Window sill - marble & railing detail to be redone and rectified to original state
D-E07 Ceiling surface - paint exfoliation due to natural decay and structural issues - to be investigated-plastered-painted
D-S00 Structural beam crack to be inspected and remedied through additional reinforcement
D-S01 Structural column - external disintegration to be recast with structural concrete
D-S02 Structural slab to be chipped, reinforcement to be inspected and recast

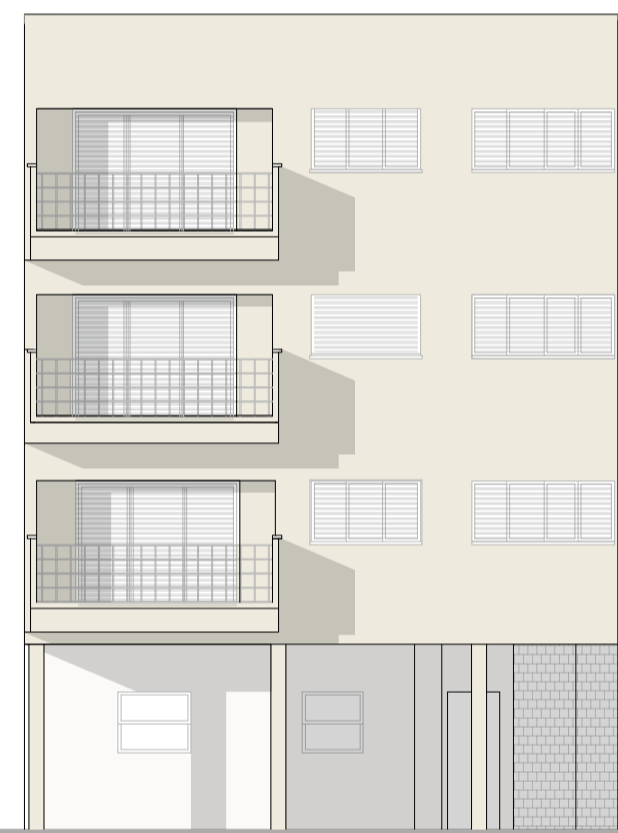
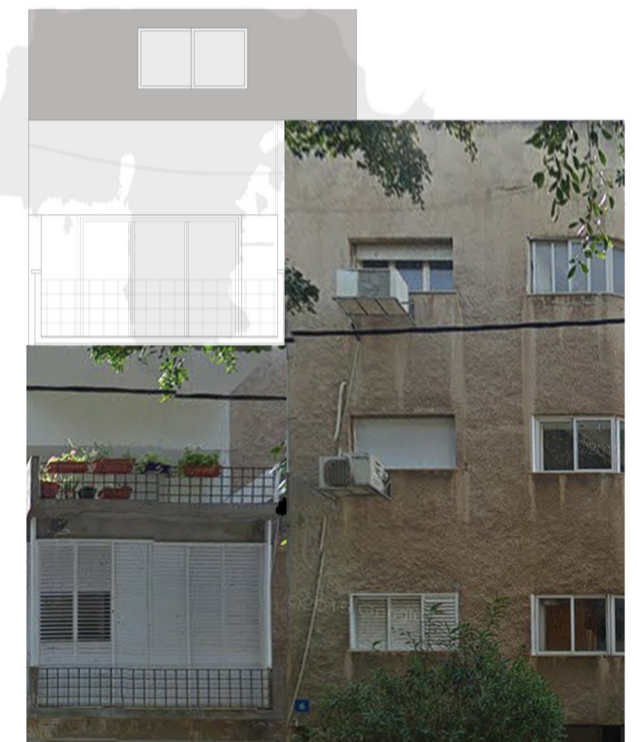
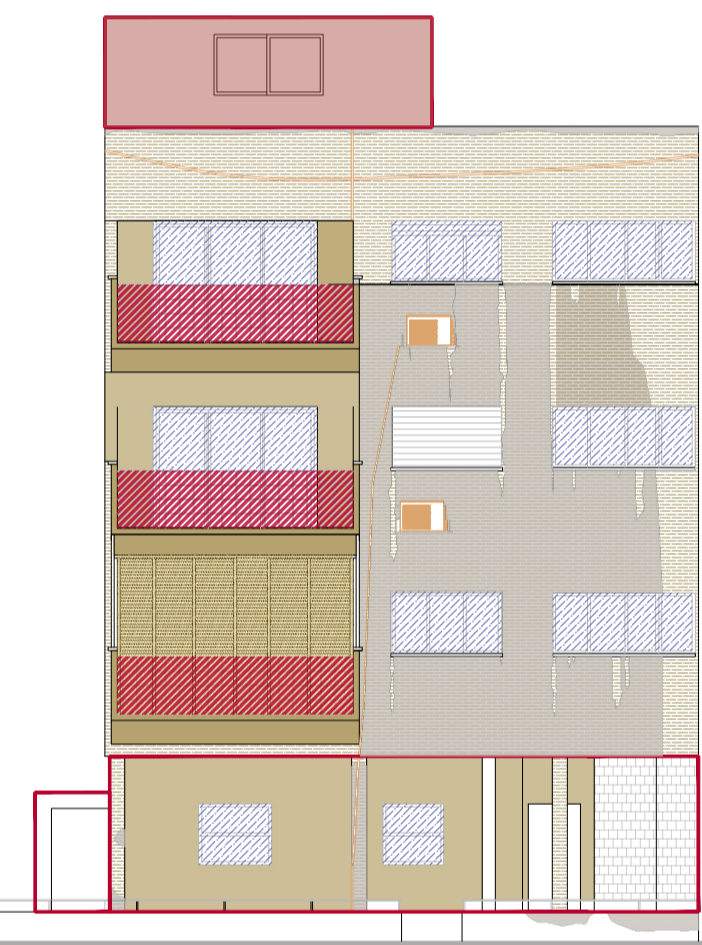
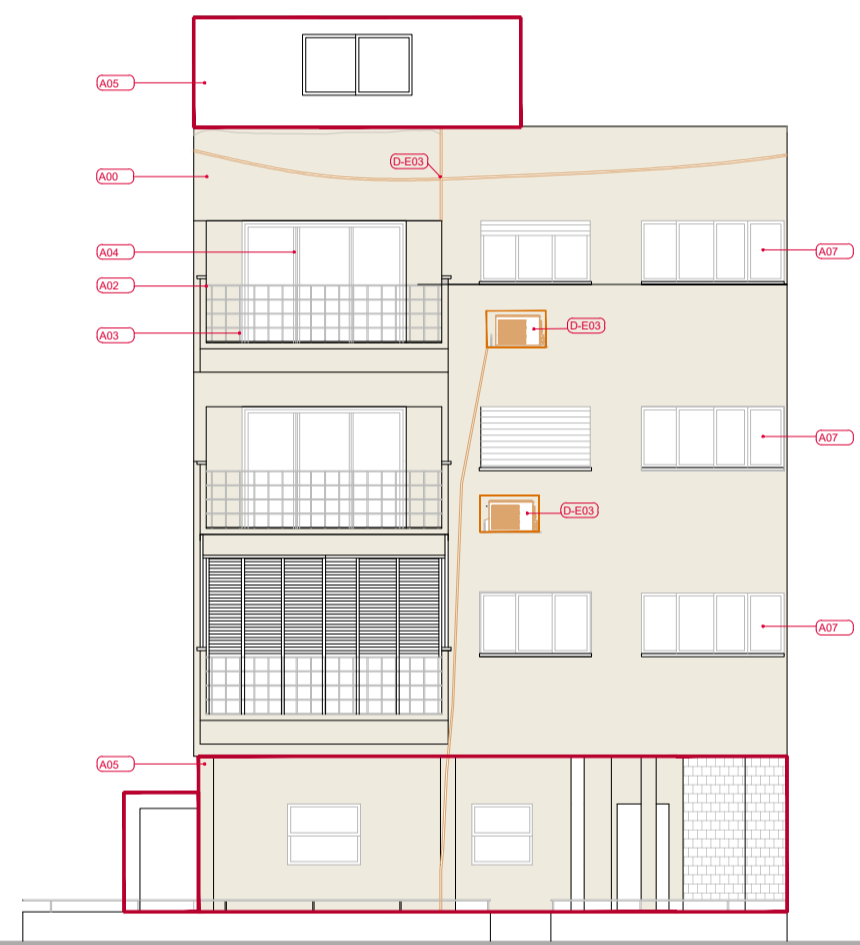
B. 6

- Incoherent surface treatments - plastering & painting done as upkeep/repair works causing variation by color/texture/aesthetic congruency
- Incoherent additions - windows, doors & blinds - that have been modified/added/removed diverging from the original design

- Decay - weathering of plastering & painting due to lack of maintenance
- Decay - weathering of plastering & painting due to occupant activities - water seepage/faulty constructions/damages from interventions

- Decay - weathering of plastering & painting due to natural causes of water seepage/exposure to sun/heat
- Decay - metal - railings rusted/damaged due to external conditions

- Decay - windows - glass stained and metal rusted due to exposure to external conditions
- Decay - structural - damaged structural members - column/slab/beam due to exposure to outdoor conditions/aging/human interventions

- Improper installation of different shading and windows in openings
- Incoherent additions - exposed elements for plumbing/electrical/HVAC services
- Decay - wood - handrails rotten/disintegrated due to outdoor conditions

- A00 Wall surface - sanded and repainted to original color by design.
- A01 Aluminum enclosure to be removed
- A02 Handrail to be inserted with improvisation to withstand current weathering conditions
- A03 Railing to be refurbished as per original design and painted with protective coat
- A04 Door to be replaced to original detail by frame & shutter
- A05 Additional structures for awning/pergolas/shading devices to be removed

- D-E01 Slab surface decay due to staining by water and metal elements to be cleaned and repainted
- D-E02 Wall surface decay due to staining by water - add coping on top surface with drip-mould detail

- D-S00 Railing deterioration - natural causes - to be replaced & painted to original finish
- D-S01 Window sill - marble & railing detail to be redone and rectified to original state

- D-S02 Ceiling surface - paint delamination due to natural decay and structural issues - to be investigated-plastered-painted
- D-S00 Wall surface decay due to staining by water - to be investigated-plastered-painted

- D-S01 Structural beam crack to be inspected and remedied through additional reinforcement
- D-S02 Structural column - external disintegration to be recast with structural concrete

- D-S02 Structural slab to be chipped, reinforcement to be inspected and recast
