2003
Methodology: The intervention, with special emphasis on facades, follows the phases of:
- Historical and stylistic research.
- Decay analysis.
- Remedial intervention
- Design of a rooftop addition for each of the buildings.

Aharonovitch street is located in the core of the Central White City, in the Zone A and right under UNESCO protection.

Area of Intervention

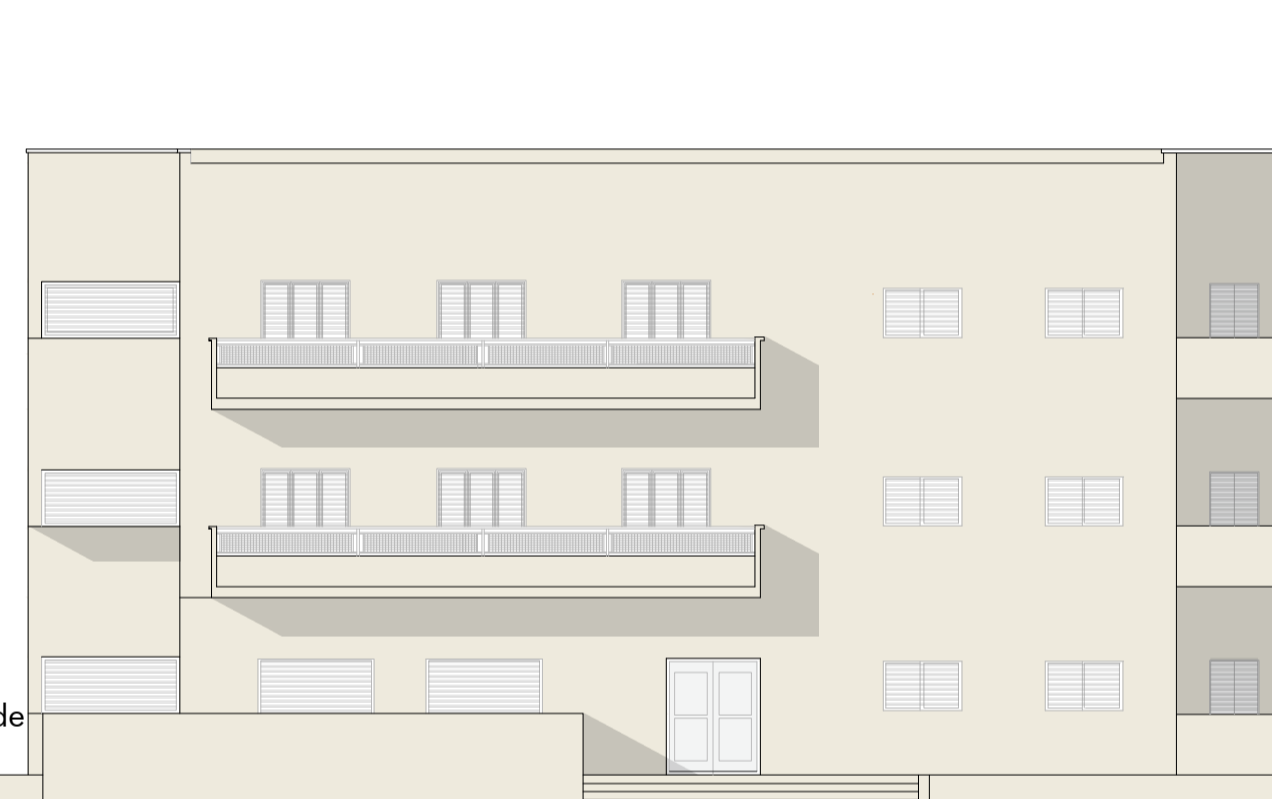
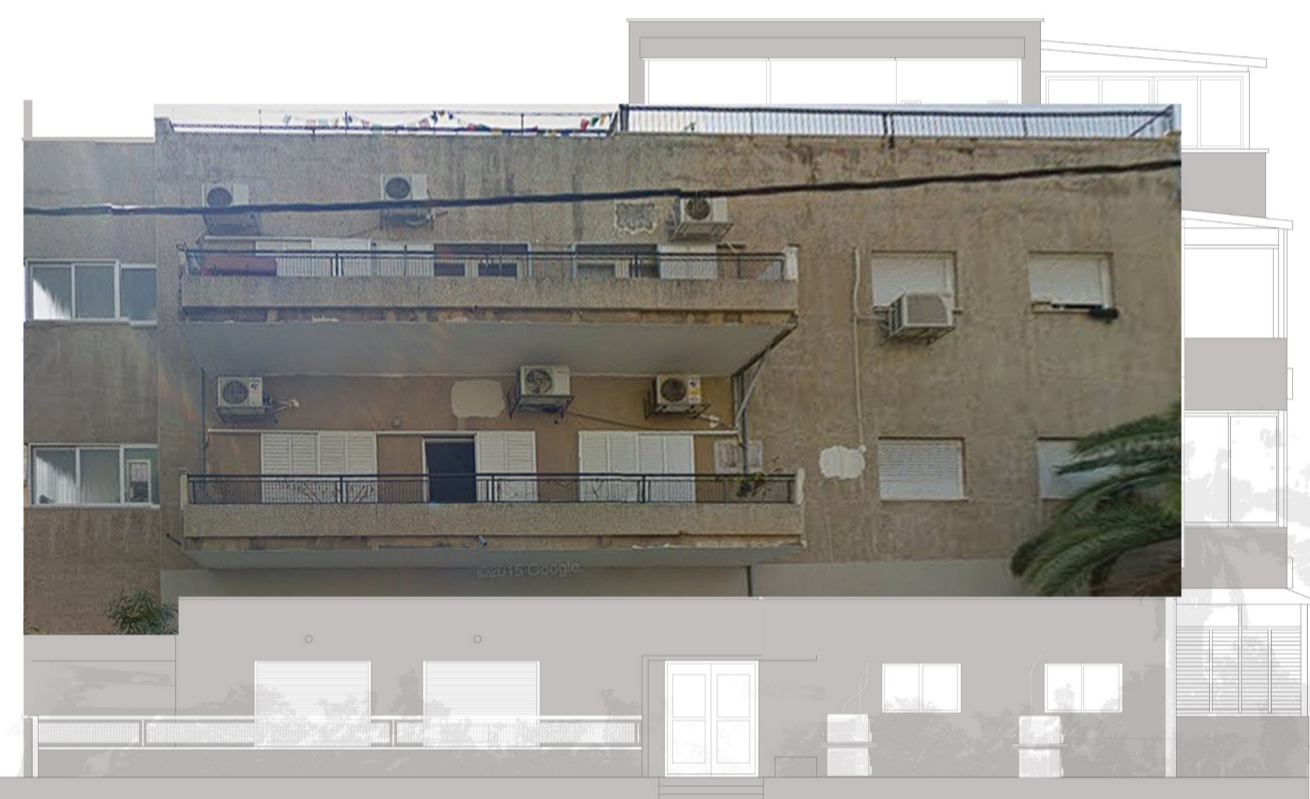
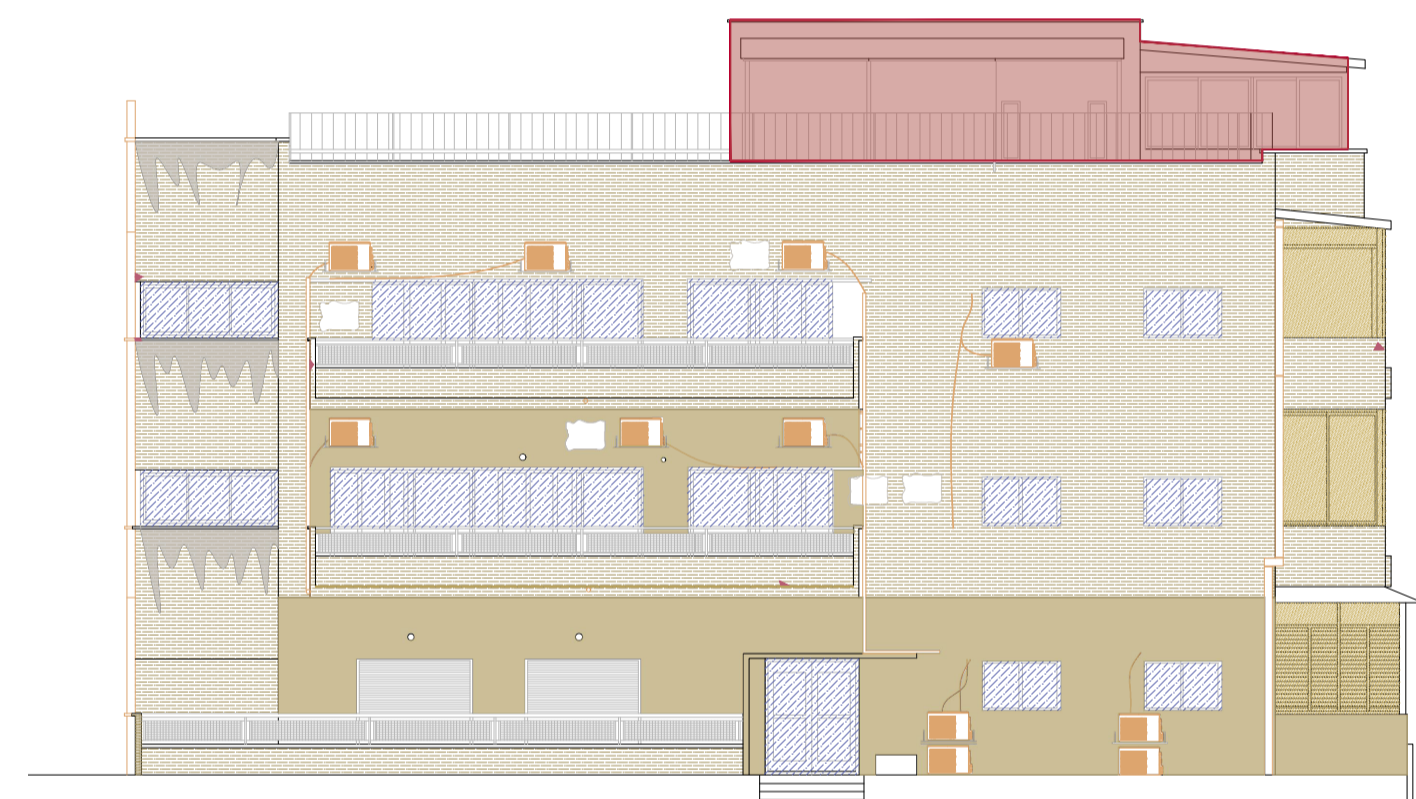
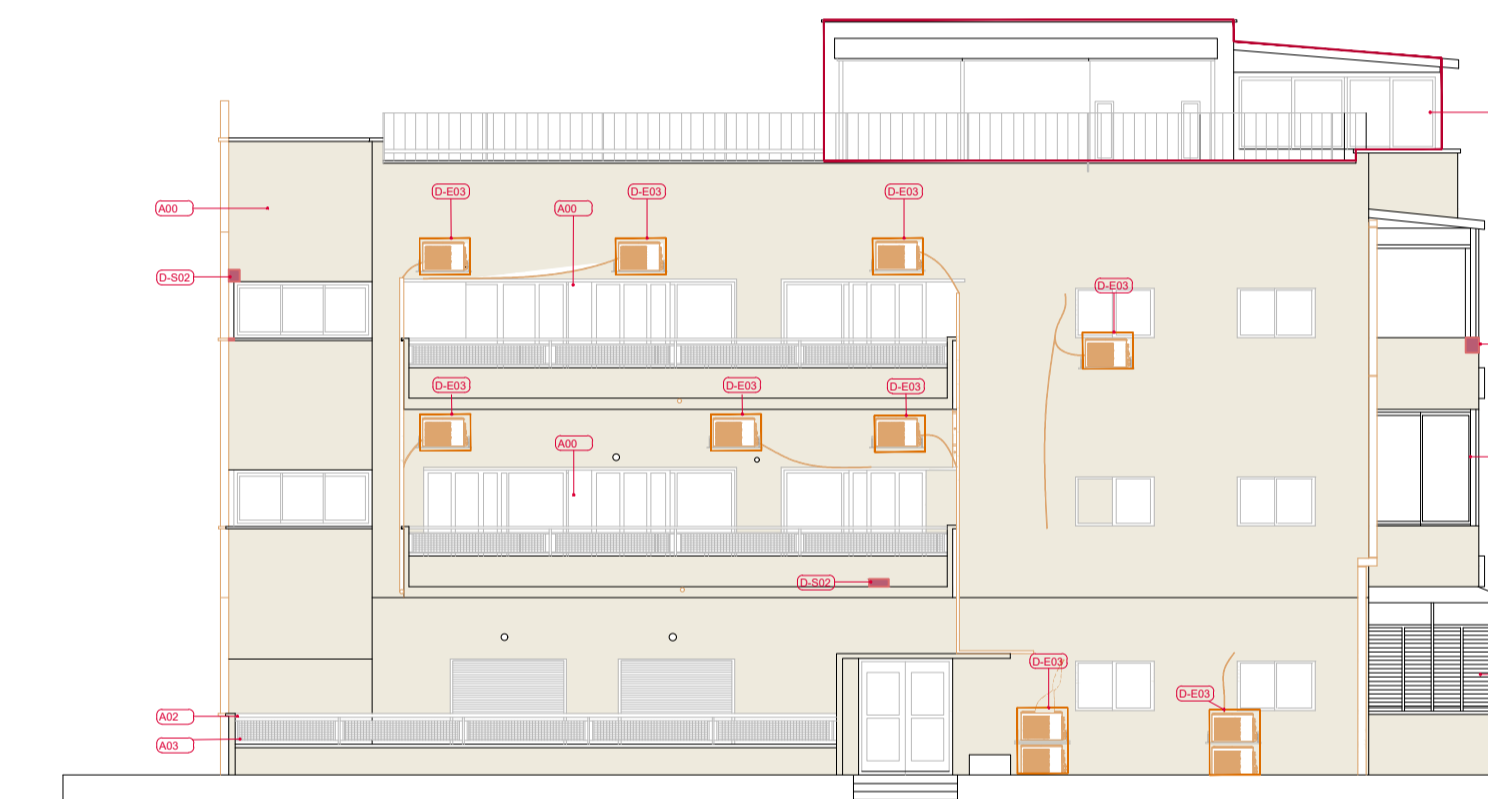
B. 2
South facade

- Incoherent surface treatments - plastering & painting done as upkeep/repairation works causing variation by color/texture/aesthetic congruency
- Incoherent additions - windows, doors & blinds - that have been modified/added/removed diverging from the original design

- Decay - weathering of plastering & painting due to lack of maintenance
- Decay - weathering of plastering & painting due to occupant activities - water seepage/faulty constructions/damages from interventions
