WHY

SEQUENCES:

-CURRENT SITUATION -DECAY PATTERN IDENTIFICATION - CONSERVATION INTERVENTIONS - DEMOLITIONS & ADDITIONS - RESULT

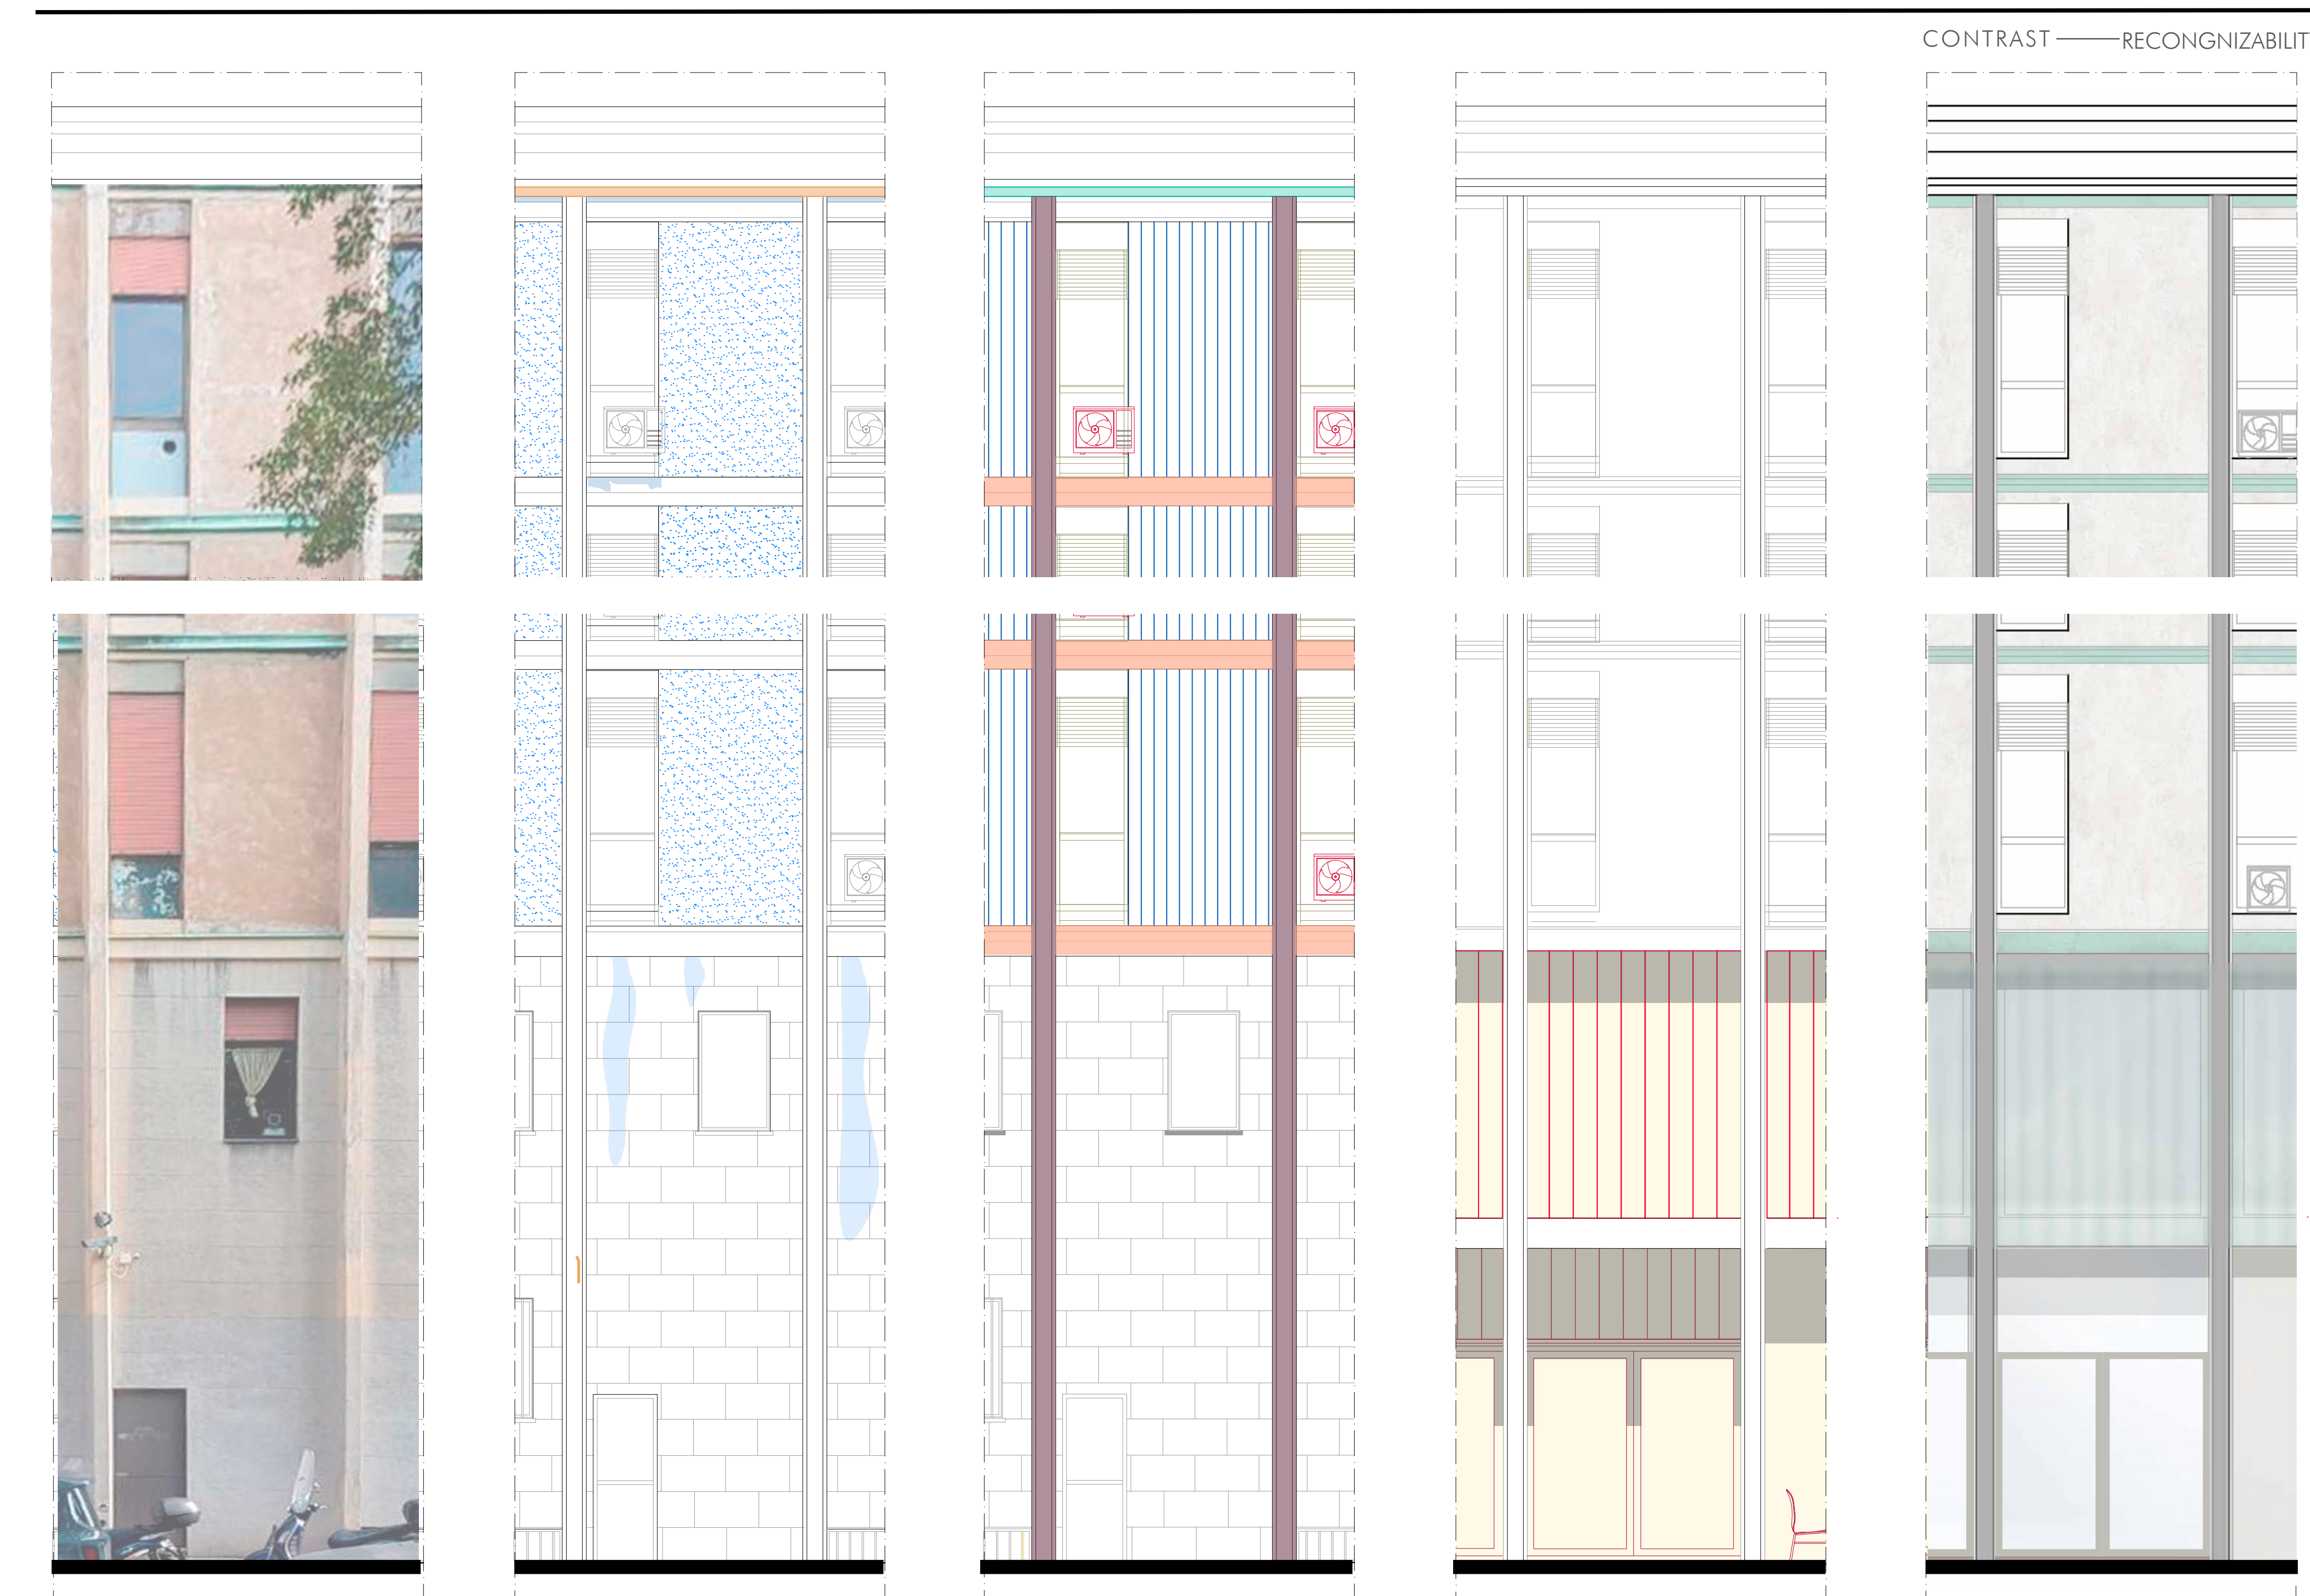
ENCrustation - SOILING		CONSolidation AND CLEANING OF PLASTER		DEMOLITION
	DISCOLOURATION - BLEACH		CONSolidation OF ROOF EAVES		ADDITION
	CRACKS		WASHING AND GENTLE WET-SAND BLASTING		
			CLEANING OF SOILING AND APPLICATION OF PROTECTIVE COATING		
			CLEANING OF YELLOW-ISH PAINT AND CONSOLIDATION		
			SUBSTITUTION OF WINDOW FRAMES		
			REMOVAL OF OLD SERVICES FROM THE FAÇADE

1 Consolidation of Roof Eaves
 • Re-design of the rain-water drainage system, so as to fit also the old system with the one of the newly added volumes;
 • Consolidation on roof eaves via crack filling with cement mortar injection;
 • Coating of roof eaves with a new homogeneous layer of render as well as a protective coating.

3 Consolidation and Cleaning
 • Washing off the facade;
 • Gentle Wet Sand Blasting of the façade;
 • Cement mortar injections to the spider-webbing cracks on mortar;
 • Application of a silicate system protective product
 • Silicification on the coating material with the substrate

4 Gentle cleaning
 • low-pressure wet abrasive cleaning;
 • Protective coating for the patina to prevent tarnish and fading.

5 Consolidation and Cleaning
 • Gentle Wet Sand Blasting of the partial
 • yellowish painting layer on the pillars
 • cement mortar filling of the superficial cracks
