POLITECNICO DI MILANO

Facoltà di Ingegneria Edile - Architettura
Corso di laurea magistrale in Ingegneria dei Sistemi Edilizi

Seismic performance of bridges during Canterbury earthquakes

Maria BRANDO Matr. 751083

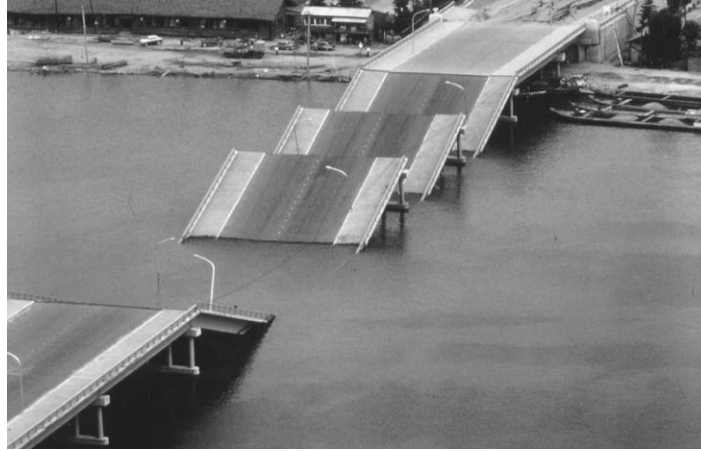
The collapse of the Showa Bridge in the 1964 Niigata earthquake demonstrates one result of the unseating of simple spans (Figure 1.1).

Figure 1.1. *Showa Bridge collapse in 1964 Niigata earthquake.*

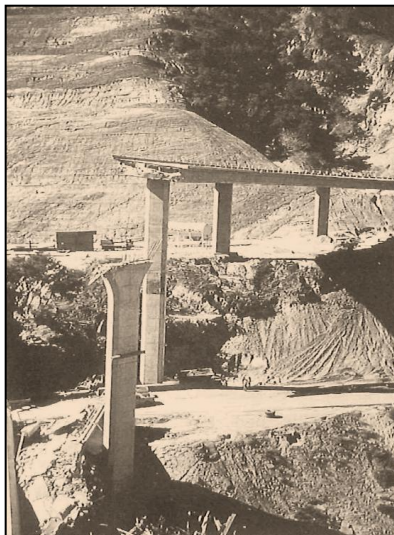
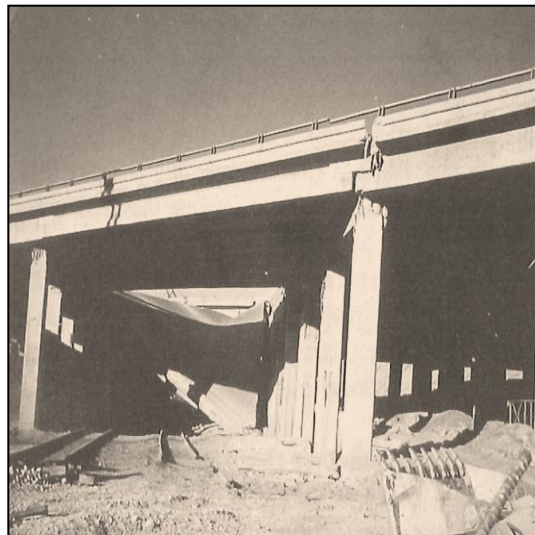
Figure 1.2 shows two examples damage from the 1971 San Fernando earthquake [6]. In Figure 1.2a is shown a span collapse: although linkage restrainer bolts were provided across the movement joints in this bridge, they had insufficient strength to restrain the longitudinal relative movement. In the case shown in Figure 1.2b a simply supported span has unseated due to excessive relative displacement between adjacent bents. The support lines are skewed to the bridge axis, and it has been observed that skewed spans develop larger displacements than right spans, as a consequence of a tendency for the skew span to rotate in the direction of decreasing skew, thus tending to drop off the supports at the acute corners. In Figure 1.3, Figure 1.4 and Figure 1.5 are shown other examples of span failure in recent famous earthquakes.

Figure 1.2. *Damage from 1971 San Fernando earthquake: a) Span Collapse; b) Unseating (simple span, skew) [7]*

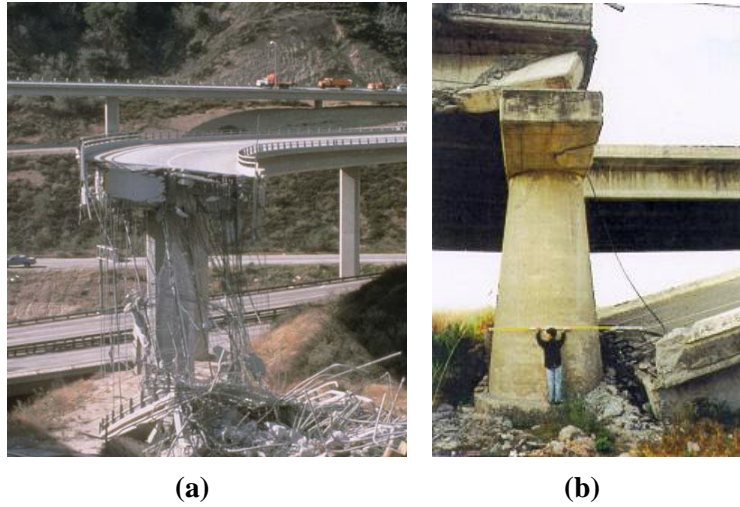
Figure 1.3. *a) Span collapses at the Golden State-Antelope Valley interchange collectors, 1994 Northridge earthquake [8], b) Fallen Beam due to Superstructure Movement in the Longitudinal Direction in Taiwan Chi Chi Earthquake, 1999 [9]*

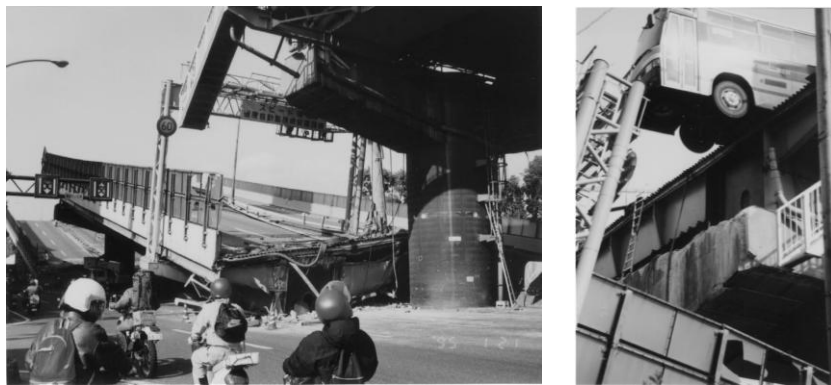
Figure 1.4. *Example of collapsed span as a result of insufficient support length, 1995 Kobe earthquake [10]*

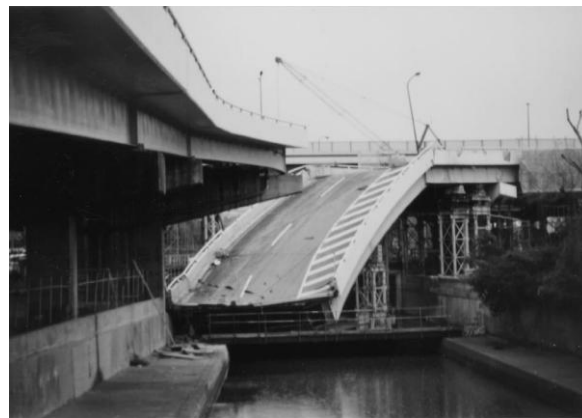
Figure 1.5. *Example of damaged bearing and collapsed span, 1995 Kobe earthquake [10]*

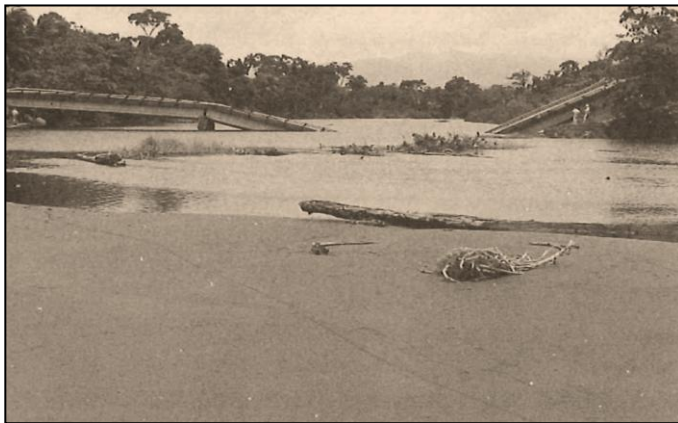
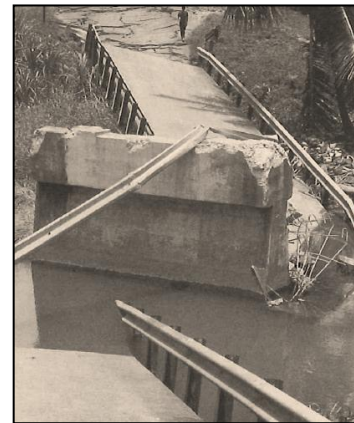
Bridges with simply supported spans are particularly susceptible to span failure resulting from liquefaction, an example is shown in Figure 1.7 a-b from the 1990 Costa Rica earthquake. The supports of the bridge were skewed at about 30° to the transverse axis, and the spans were thrown off the internal support in the direction of decreasing skew.

Figure 1.7. a) Liquefaction failure, Rio Viscaya bridge, 1990 Costa Rica earthquake b) Liquefaction failure, Rio Viscaya bridge, 1990 Costa Rica earthquake [7]

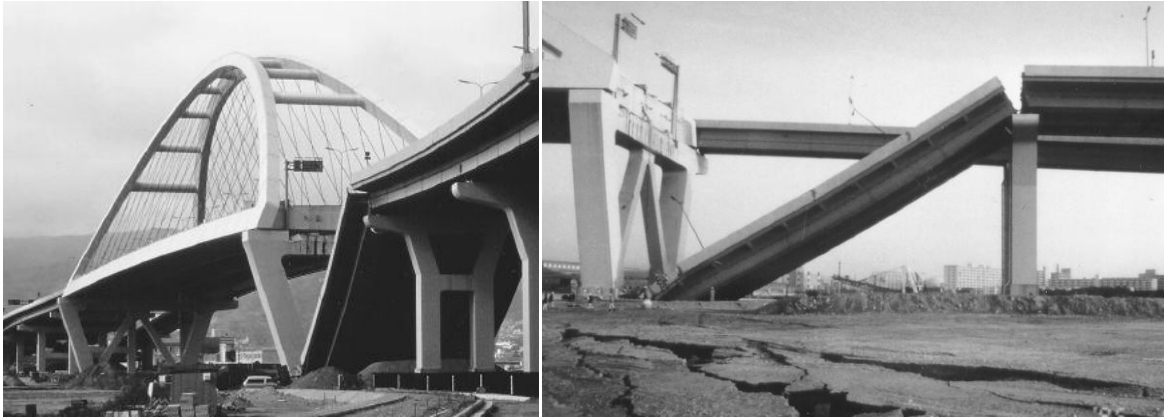
Another example is the unseating of simply supported link span, from the 1995 Kobe earthquake, shown in Figure 1.8, caused from the failure of the tension-link restrainers connecting the link span to the arch support. Slumping and liquefaction at the site caused large movements of the arch bridge support resulting in unseating of the span.

Figure 1.8. *Unseating of simply supported link span, Nishinomiya-ko bridge, Kobe earthquake*

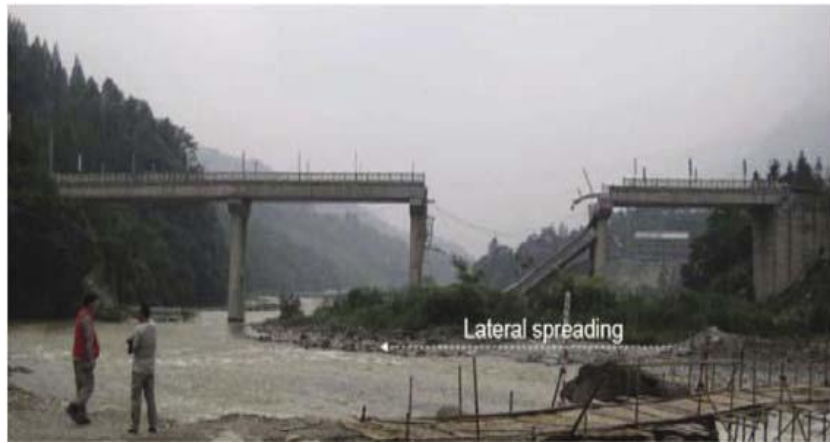
Lateral spreading of the soil caused also the failure of Gaoyuan Bridge span in 2008 Wenchuan earthquake (Figure 1.9).

Figure 1.9. *Gaoyuan Bridge nearby fault trace, 2008 Wenchuan earthquake [11]*

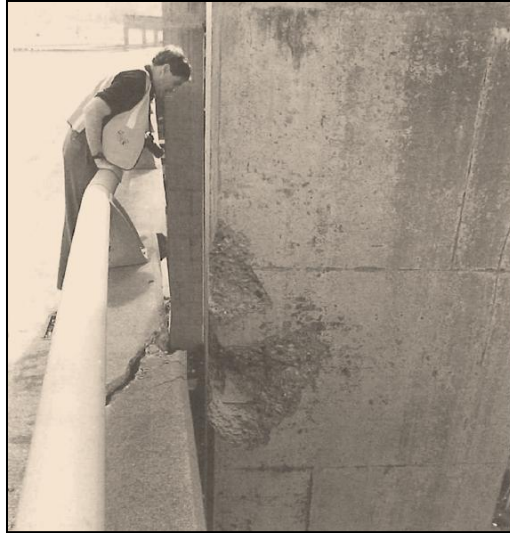
Impact forces from pounding of bridge components can be very high, causing amplification of member shear forces with increased probability of brittle shear failure, as shown in Figure 1.10. In the 1989 Loma Prieta earthquake at the China Basin/Southern viaduct section of I-280 in San Francisco, there was a 150 mm separation between the lower roadway and columns independently supporting an upper-level deck proved inadequate.

Figure 1.10. *Pounding of I-280 China Basin/Southern viaduct, 1989 Loma Prieta earthquake [7]*

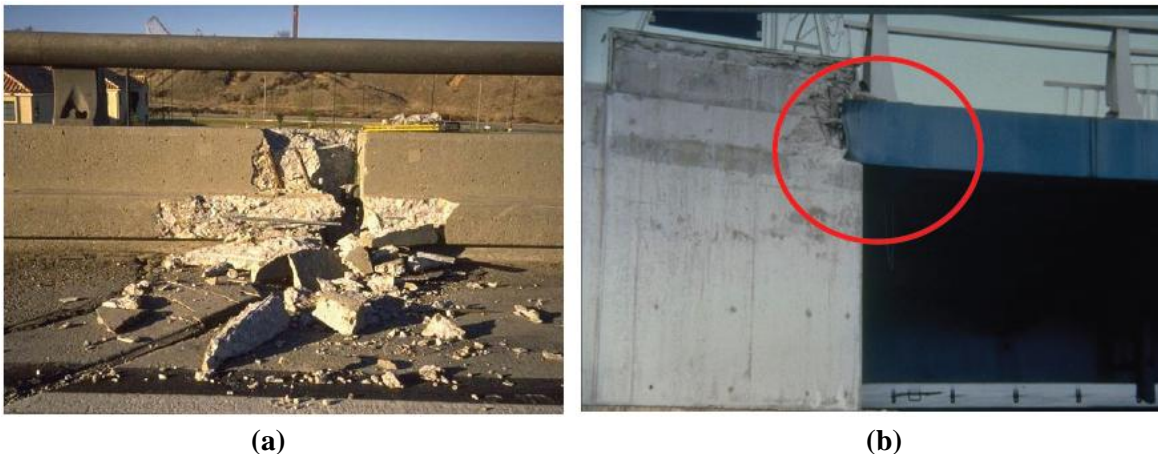
Other minor pounding damage resulting in spalling of concrete and possible buckling of steel bars are shown in Figure 1.11.

Figure 1.11. *Pounding damage: (a) between adjacent spans at the Interstate-5 at Santa Clara River in Los Angeles County during the 1994 Northridge earthquake and (b) at the abutment of a bridge near Nishinomiya Port in the 1995 Kobe earthquake [8]*

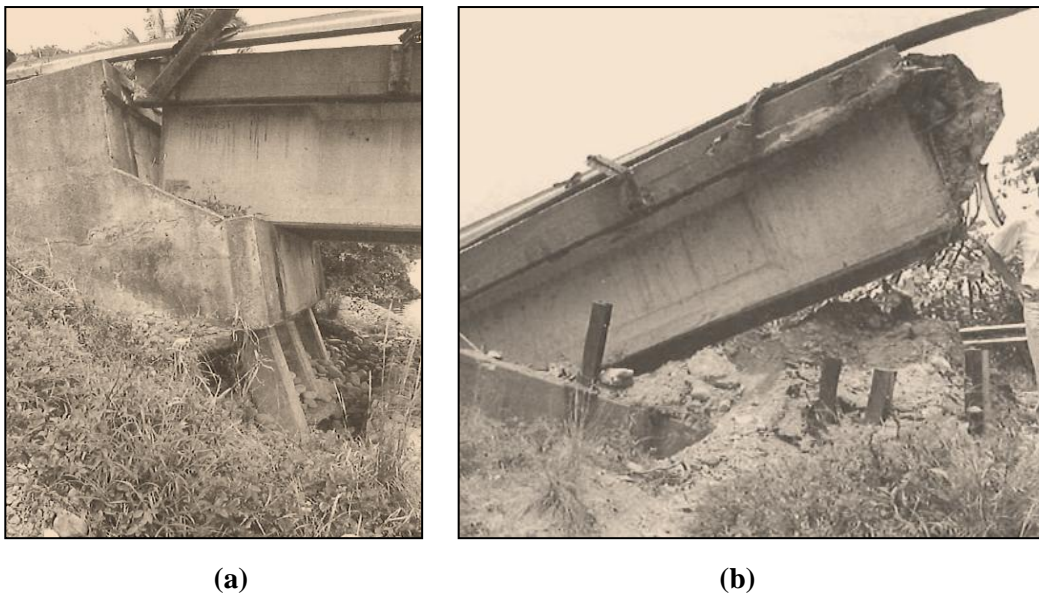
Figure 1.13 show examples of abutment failure from the 1990 Costa Rica earthquake. The bridge shown in Figure 1.13a had severe slumping and a 9° rotation of one abutment, resulting in a lateral and shear displacement of the pile tops of about 660 mm and in flexural and shear failure of the supporting piles. An extreme case of abutment back wall damage is shown in Figure 1.13b: this bridge pushed its end span through and over the abutment, when an internal pier collapsed and rotated, because of liquefying sand. Total collapse is uncommon and generally related to other causes.

Figure 1.13. *Damage to the abutment in 1990 Costa Rica Earthquake: a) abutment slumping and rotation, Rio Banano Bridge; b) abutment failure due to passive pressure, Rio Vascaya bridge [7]*

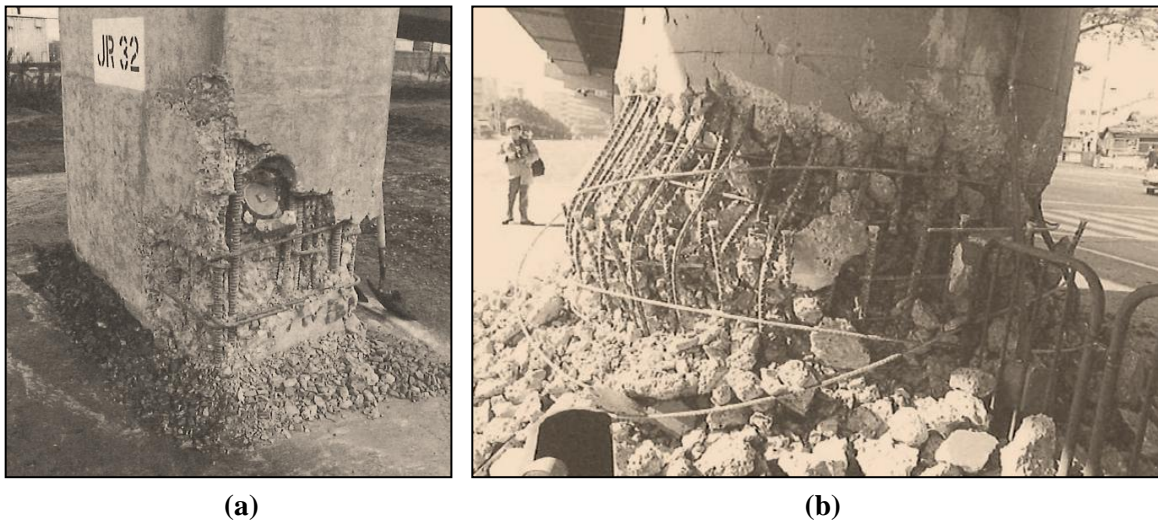
Column longitudinal reinforcement was often lap spliced immediately above the foundation. Tests indicate that lap-splice length as short as 20 bar diameters, commonly used for Californian bridges designed prior 1971, is insufficient to enable the flexural strength of the column [12]. Figure 1.14a shows damage to the base of a column, attributable to lap-slice bond failure, which occurred in the 1989 Loma Prieta earthquake [3]. Inadequate flexural strength may also occur as result of butt welding of longitudinal reinforcement close to maximum moment locations (at the base of the piers). An example is given in Figure 1.14b where is shown flexural failure of a column of the Hanshin expressway in the 1995 Kobe earthquake [13], caused by failure of a large number of butt welds at the same location, dose to the column base.

Figure 1.14. Bond failure of lap splices at column base, 1989 Loma Prieta earthquake [7]

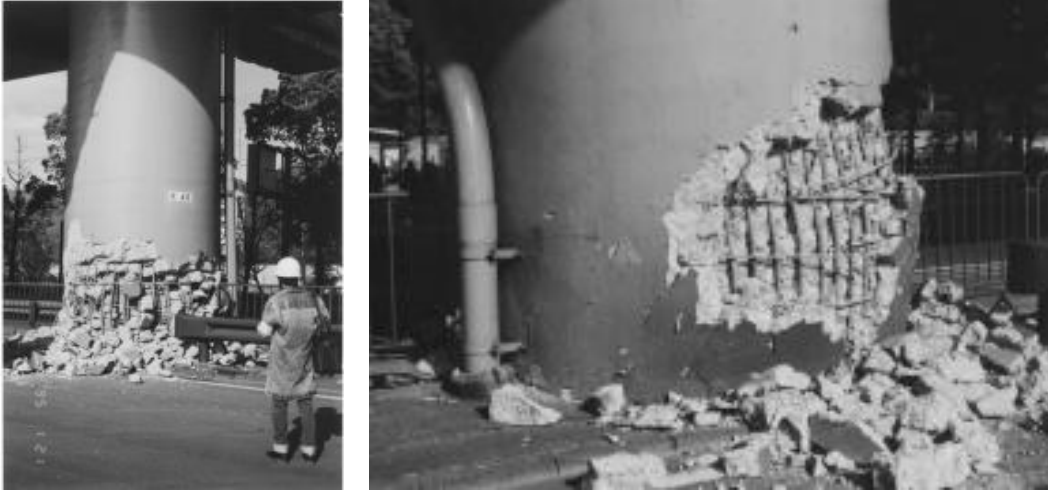
To survive intense seismic attack, structures must possess ductility, that is the property of being able to deform through several cycles of displacements much larger than the yield displacement, without significant strength degradation. At displacement ductility levels of about 2 to 3, concrete compression strains in the plastic hinge regions exceed the unconfined compression strain capacity, and spalling of the cover concrete occurs. Unless the core concrete is well confined by close-spaced transverse hoops or spirals, crushing rapidly extends into the core, the longitudinal reinforcement buckles, and rapid strength degradation occurs, resulting eventually in an inability to support gravity load. This behavior may be accelerated when transverse reinforcement is lap spliced in the cover concrete, as is common with older bridges. Figure 1.15 shows an example of flexural plastic hinge failures in Kobe earthquake, 1995.

Figure 1.15. *Two examples of flexural failure due to lack of confinement at bottom of reinforced concrete piers supporting a steel superstructure, 1995 Kobe Earthquake [10]*

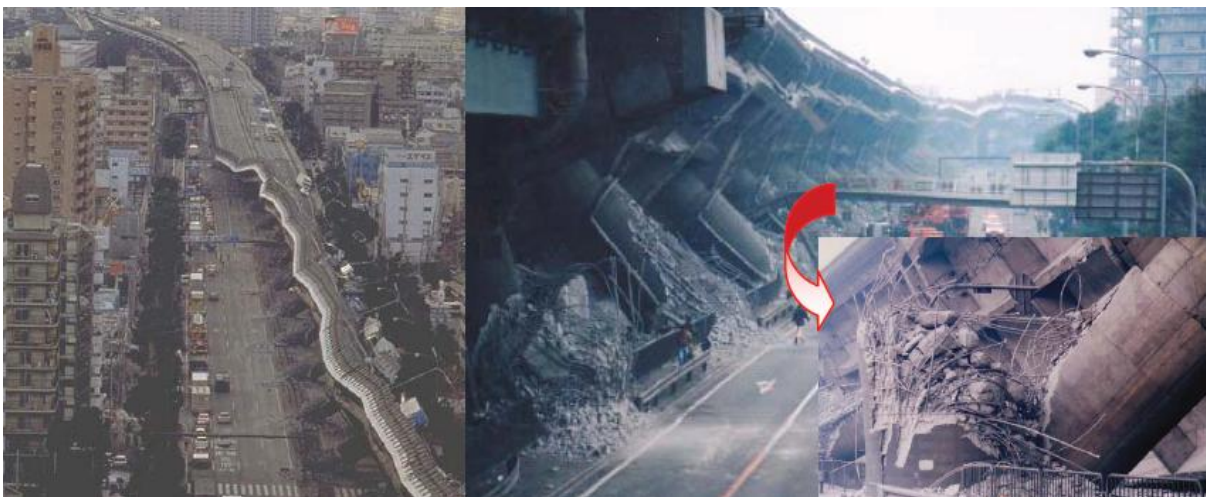
A number of bridge in Japan developed flexure-shear failures at column midheight during 1982 Urahawa-ohi [14] and 1995 Kobe [13] earthquakes, as result of premature termination of the column longitudinal reinforcement. Bar termination was based on the design moment envelope, without accounting for the effects of tension shift due to diagonal shear cracking and this deficiency was exacerbated by the provision of a short development length of bars lap spliced at this location. Failure of the 18 columns of the collapsed section of the Hanshin expressway in the 1995 Kobe earthquake (Figure 1.16) was initiated by premature termination of 33% of the column longitudinal reinforcement at 20% of the column height. This forced the plastic hinge to form above the base, where it could not benefit from confinement provided by the strong footing, which was essential for survival of the columns, since very little confinement was provided.

Figure 1.16. *Flexural failure above column base of columns of the Hanshin expressway, due to premature termination of longitudinal reinforcement and inadequate confinement in the 1995 Kobe earthquake [8]*

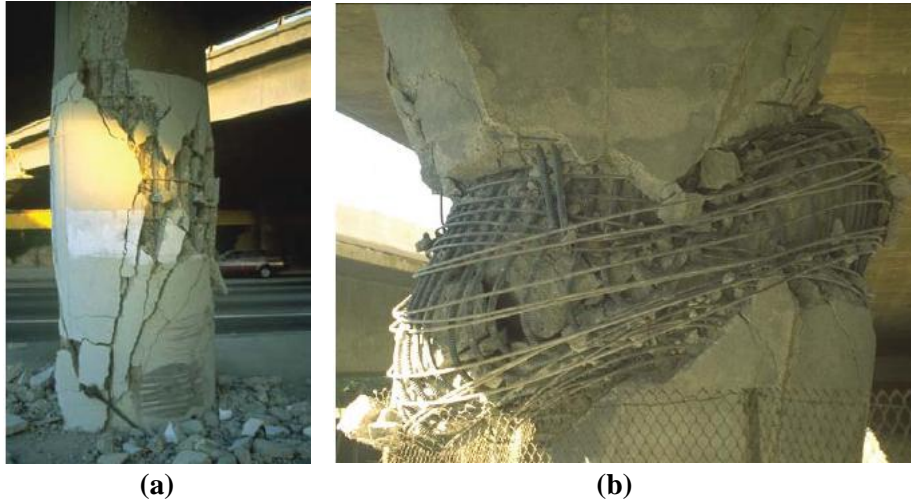
In Figure 1.17 damage from San Fernando Earthquake are presented. Figure 1.17a shows the typical brittle failure when flexural strength exceeds shear strength. No indication that the plastic hinging developed at the base of the pier is noticed. On the other hand, in the pier in Figure 1.17b no damage occurred in the mid region, but at the top developed a plastic hinge giving rise to shear failure within the hinge region. This leads to an important observation: as a consequence of a reduction in aggregate interlock shear transfer in plastic hinges, shear strength in plastic hinge regions is less than in other part of the element.

(a) (b)
Figure 1.17. Shear failure within (a) and outside (b) the plastic hinge region in San Fernando Mission Blvd-Gothic Avenue Bridge and I-10 Freeway at Venice Blvd, respectively, during the 1994 Northridge earthquake [8]

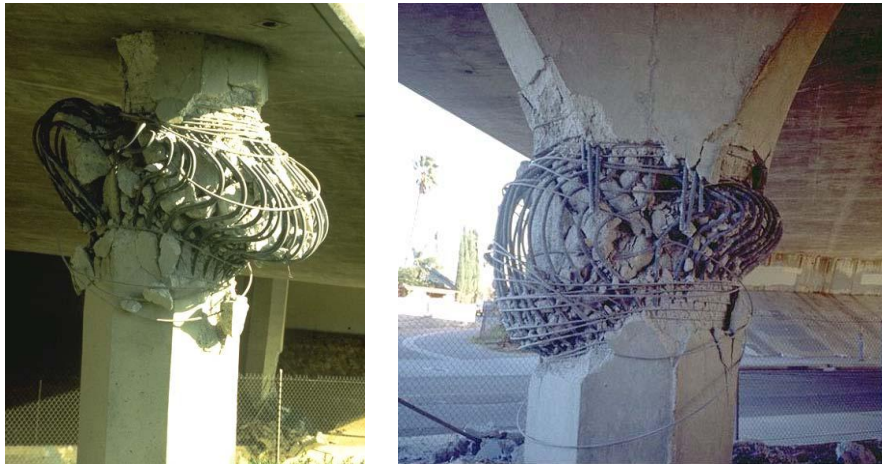
The cause of failure of six of the seven bridge structures that failed in 1994 Northridge earthquake has been attributed to column shear failures [16]. The rupture of transverse reinforcement cause the loss of the structural integrity of the column, that thus fail under gravity loads. Examples of column collapse caused by shear failures are shown in Figure 1.18.

Figure 1.18. Confinement failure at bridge pier top, 1994 Northridge earthquake [8]

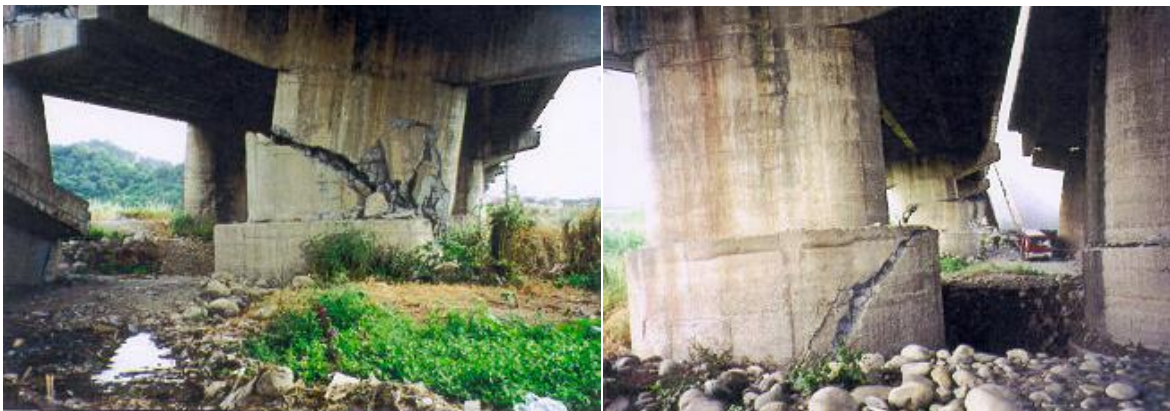
After the Chi-Chi earthquake, Wushi bridge was severely damaged and the road was closed [9]. Under horizontal vibration, substantial shear cracks showed on the southbound hammerhead concrete pier (Figure 1.19).

Figure 1.19. Wushi Bridge, shear failure of piers P2S and P3N, 1999 Taiwan earthquake [9]

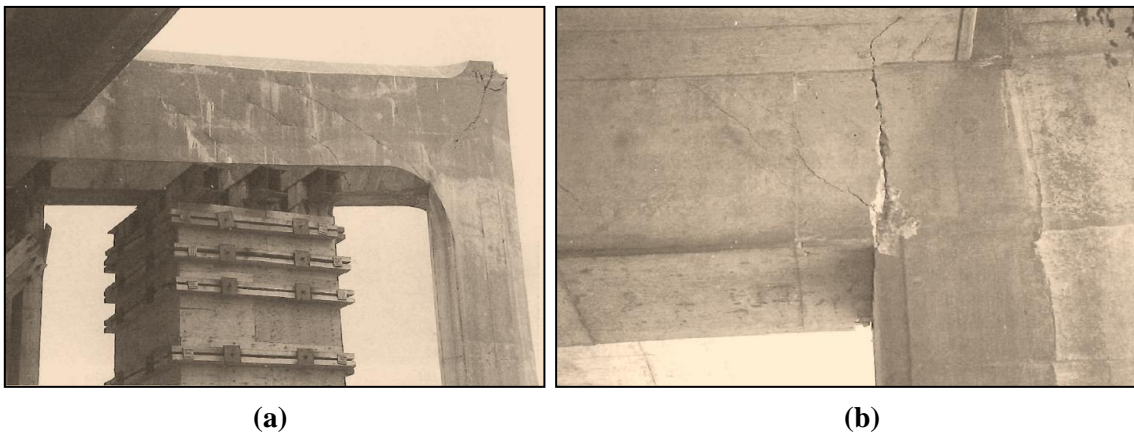
Figure 1.20 shows two examples of damage to cap beam during the 1989 Loma Prieta earthquake. In Figure 1.20a is illustrated the damage to outrigger cap beams: the flexural cracks resulting from negative moments under combined gravity load and seismic force, were steeply inclined under the influence of shear. Figure 1.20b shows the growth of a flexural crack formed at the inner face of a column as a result of the inadequate anchorage provided by the 900-mm development length of 18 bars into the joint region.

Figure 1.20. a) Abutment slumping and rotation failure, Rio Bananito bridge, 1990 Costa Rica earthquake⁴; b) Cap beam positive moment cracks at inner column face, 1989 Loma Prieta earthquake [7]

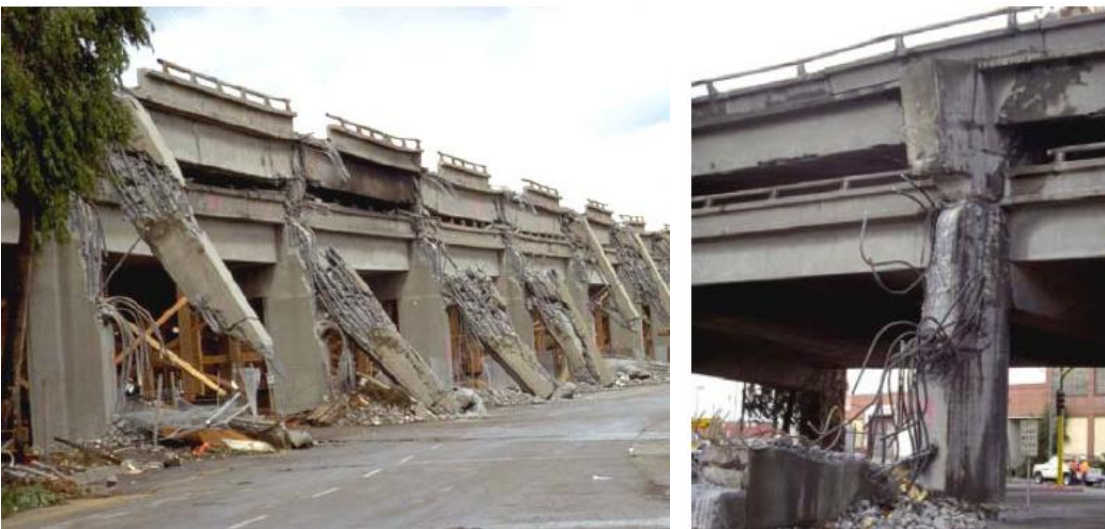
Figure 1.21. Sliding shear at top columns of the Cypress viaduct in the 1989 Loma Prieta earthquake [8]

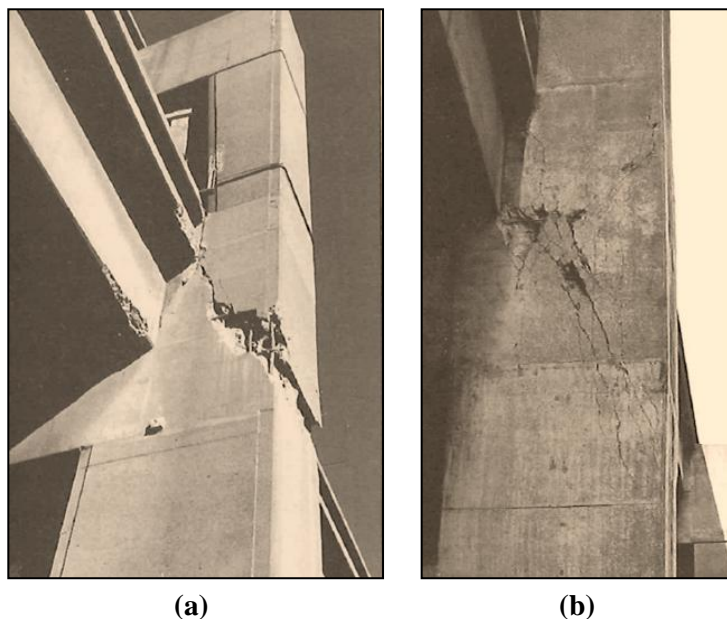
Shear failure may strike also the connections. In fact the transfer of forces through connections results in horizontal and vertical joint shear forces. This problem was taken under consideration specially after the 1989 Loma Prieta earthquake which caused shear problems in the connection between cap beams and columns. It has been uncommon for these shear forces to be considered in bridge design, and until recently properly design joint shear reinforcement was almost never provided. Without this reinforcement joint shear failure may occur, as evidenced by the diagonal cracking of the joint region of a Cypress viaduct bent and by the crack pattern in the joint region of a bent of the Embarcadero viaduct depicted in Figure 1.22.

Figure 1.22. Joint shear failure, 1989 Loma Prieta earthquake, I-480 viaduct and Embarcadero viaduct [7]

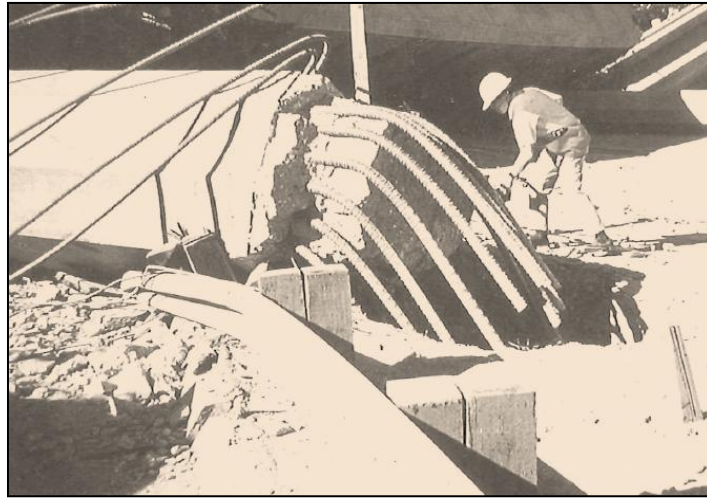
Figure 1.23. *Pullout failure, 1971 San Fernando earthquake [7]*

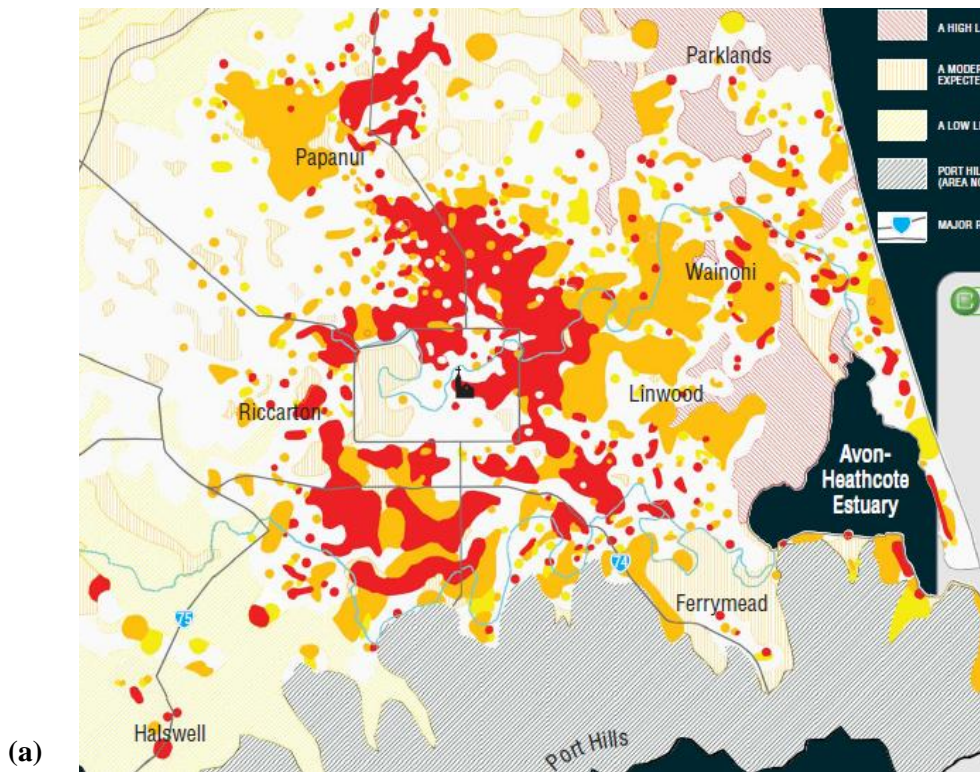
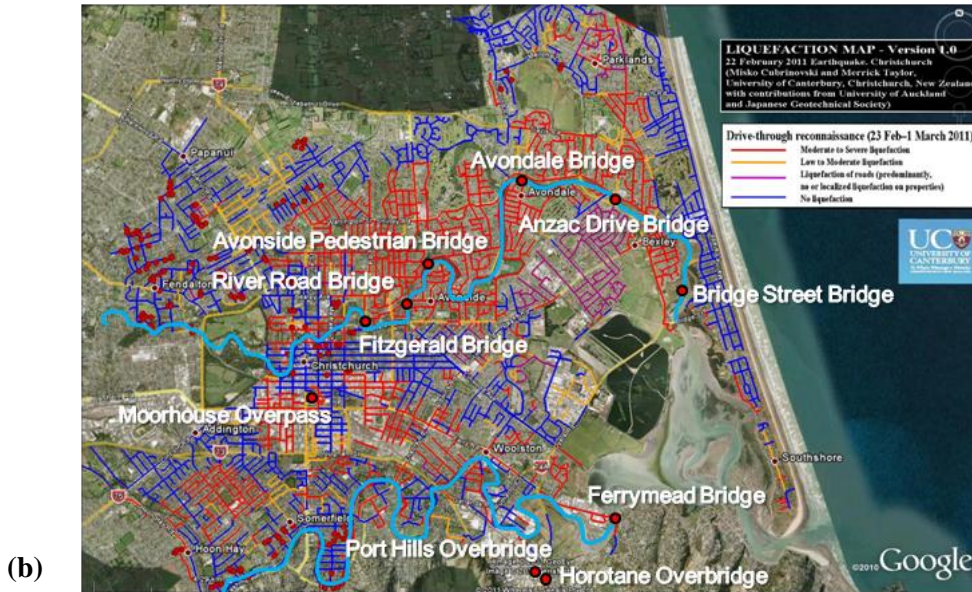
Figure 2.5. Comparison of predicted and observed liquefaction potential for Christchurch: a) prediction of liquefaction potential for a low ground water level where red and orange are the areas with high and medium susceptibility to liquefaction [Environment Canterbury, 2000c.]; b) Liquefaction potential hazard map of Canterbury region as of 10/12/2004 (ECAN)

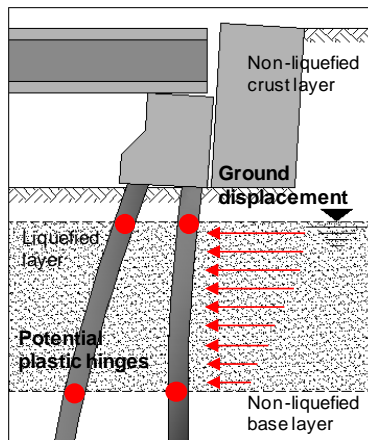
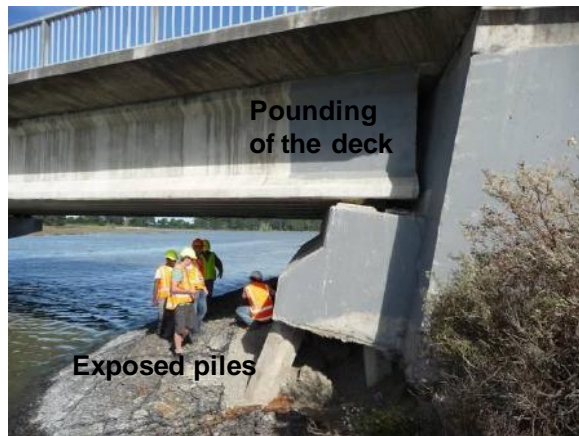
Abutments presented two different damage types, residual displacements/rotations of substructure and damage to the structure (cracks, concrete crushing and spalling), both caused by lateral spreading of the approaches and river-banks. One commonly observed effect of lateral spreading on bridges was the tendency for the abutments to rotate backwards toward the riverbanks or converge inwards, meaning that the bridge superstructure acted as a rigid strut while the foundations

underwent forced rotations or movements in the direction of lateral ground flow (Figure 2.7a). This effect was most prevalent on bridges with deep abutments or closely spaced abutment piles. These types of abutments are in contrast to the current design philosophy [21] for lateral spreading banks that uses a shallow beam type abutment, and a small number of deep piles. These are designed to allow the laterally spreading slope to spill past the abutment.

Figure 2.7. Damage at the abutments: a) Sketch of the forces acting on abutments and foundations in undeformed condition; b) Back rotated abutments of Fitzgerald Bridge [Courtesy of OPUS]; c) Back rotated abutments of Bridge Street Bridge [Photo by M. Bruneau]; d) Damaged abutments of Avondale Road Bridge [Courtesy of OPUS]

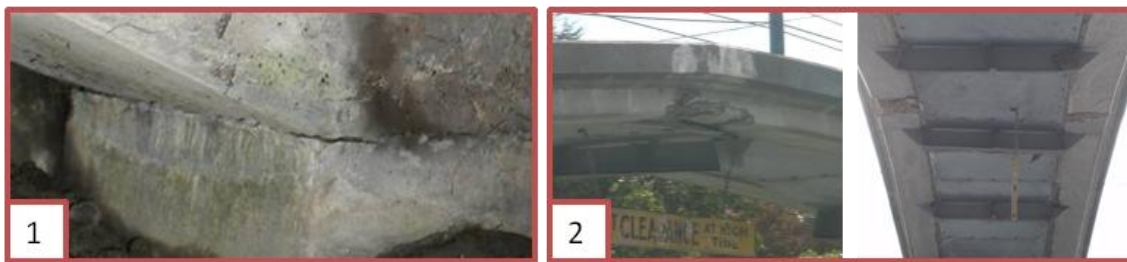
After September 4, 2010, Dallington and Porritt Park Pedestrian Bridges had visible damage to their abutments. At the Dallington Pedestrian Bridge ($-43^{\circ} 31' 4.39''$, $172^{\circ} 40' 37.30''$), briefly named Snell bridge (Figure 2.15a), a post-tensioned double flanged concrete arch deck, a horizontal crack split the entire abutment at each end of the bridge (Figure 2.15b). During the Darfield earthquake, a three pinned arch formed in response to lateral spreading. In the 2011 event, the superstructure continued to deform at mid-span where the previous plastic hinge formed (Figure 2.15, detail 2), spalling concrete cover under negative bending and deforming the superstructure in torsion about the longitudinal axis of the bridge. In concrete bridges with flat decks, such as pre-cast panels or cast-in-situ slabs, a compressive load passing through the deck is unlikely to cause a hinge to form as it did in this case. This is because there is no lever-arm between the point of application of the compressive force at the river banks, and at the point of resistance at the centre of the bridge, therefore there is no moment demand. The Dallington Pedestrian Bridge had a lever arm due to the arch form, so there is a moment demand, and a weak point at the centre where the section is skinniest, thus leading to the plastic hinge formation that was observed. The same bridge also exhibited severe damage to the pile caps of the abutment on the side of the river that was subjected to extensive lateral spreading (Figure 2.15, detail 1). The crack was widened to enable inspection of the underlying reinforcement, so it was not as large as the figure illustrates. Fortunately, the bridge has been retrofitted more than ten years ago, since it acts also as a “utility” bridge, carrying two 65kW power cables. Additional details on this bridge can be found in [27].

Figure 2.15. a) Overall view of the Snell Place Footbridge with indication of the three-hinge arch mechanism [Photo by A. Palermo]; b) Plastic hinge formation at the mid span [Photo by M. Le Heux]; c) Close up view of the plastic hinge at mid span from the side [Photo by A. Kivell] and from the bottom [Photo by M. Le Heux]; b) Damage to abutment: close up of the crack [Photo by M. Le Heux]

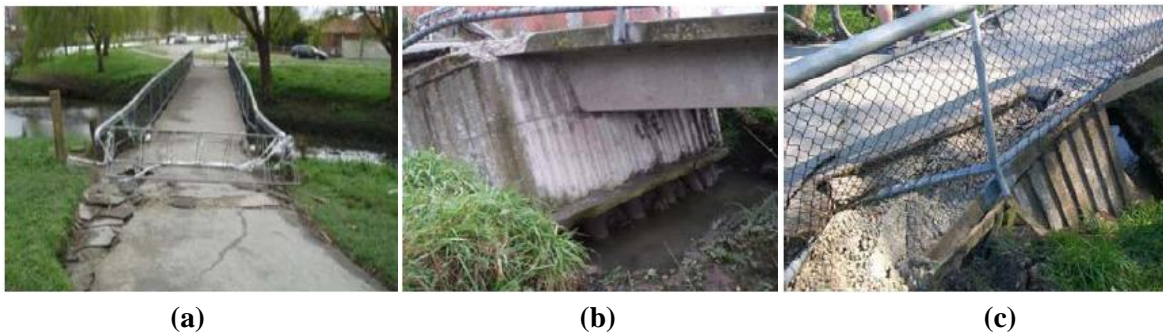
The other case, Porritt Park Pedestrian Bridge ($-43^{\circ} 30' 52.25''$, $172^{\circ} 40' 58.71''$) (Figure 2.16a), experienced large rotation and translation of the south abutment. This abutment sits on six small piles approximately 200 mm in diameter (Figure 2.16b). It is likely that the piles do not extend very deep and as such, they provided minimal lateral stiffness to the system, only serving to increase the surface area the soil wedge interacted with, exacerbating the problem. This rotation resulted in extensive cracking at the abutment face, as well as hinging at the deck-abutment connection. Rotation imposed on the bridge by the abutment also led to a plastic hinge forming in the double tee beam at 1.5 beam diameters from the abutment (Figure 2.16c). This distance is a likely point at which joint reinforcement was curtailed. After the June 13 2011 aftershocks the deck lost bearing support resulting in collapse. After the Christchurch event, significant damage developed in the Fifield Terrace Footbridge ($-43^{\circ} 33' 18.83''$, $172^{\circ} 39' 33.89''$) superstructure, which rotated about the vertical plane (Figure 2.17a). The point of weakness in the deck was where the steel studs linking the pier to the superstructure were situated, which would have likely been compounded by rotation of the piers. The deformation was so large that the rectangular hollow steel section at the extremity of the deck ruptured through its weld (Figure 2.17b). A significant rotation of steel piers was also visible after this event (Figure 2.17c).

Figure 2.16. Porritt Park Pedestrian Bridge: a) End view [Photo courtesy of OPUS International Ltd]; b) Backward rotation of abutment and exposure of piles [Photo courtesy of OPUS International Ltd]; c) Repairing damage to approach and river bank lateral spreading [Photo by L. Hogan]

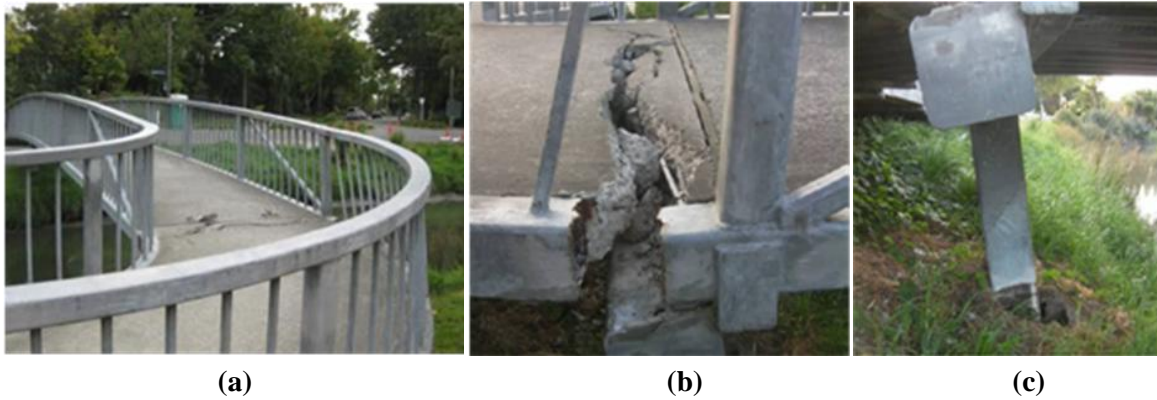
Pedestrian bridges experienced similar damage to road bridges during both earthquakes. However, due to their relatively small deck stiffness, compressive forces as a result of lateral spreading, i.e. “strut effect” and settlement of the river banks buckled most of the bridges during the Darfield earthquake, with further damage following the Christchurch earthquake. Figure 2.15, Figure 2.15 and Figure 2.17 show some of the most damaged pedestrian bridges after the latter event.

Figure 2.17. Overall view of some damaged pedestrian bridges after February 22, 2011. a) Dallington Bridge (Snell Place); b) Porritt Park Bridge; c) Fifield Terrace Bridge.

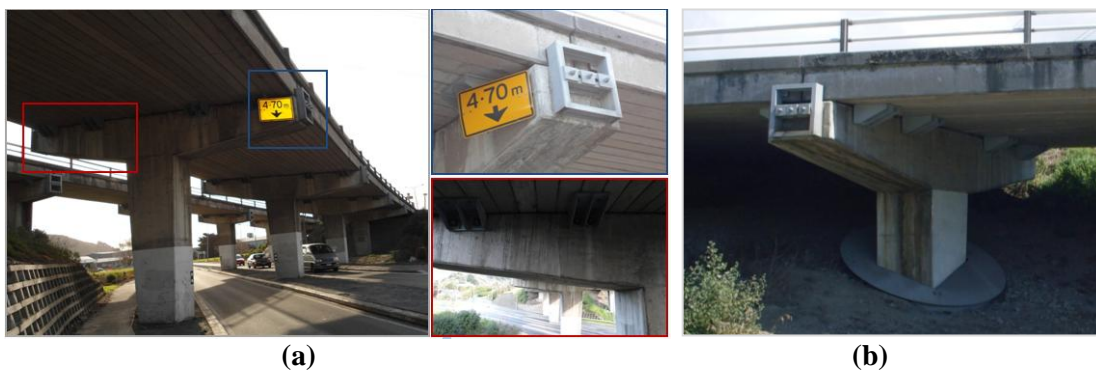
New shear keys fixed to the faces of the abutments and piers provide resistance to transverse loads and prevent sliding of the superstructure on the inclined pier caps in an earthquake event (Figure 4.2a). The spans were originally held down to the abutments and piers with 12 mm diameter dowels anchored into the infill concrete between the log beams. They were also linked by longitudinal 12 mm diameter bars anchored into the infill concrete. The new shear keys and linkage bolts provide a large increase to the resistance of the original linkage system which was considered inadequate for current design loads.

Circular steel shrouds were added at one pier column on each bridge where they passed through a significant depth of soil on the abutment slopes (Figure 4.2b). The pier annulus was constructed to prevent soil restraint to the pier which may have cause undesired plastic hinging due to ground motion in the transverse direction. The soil restraint shortens the effective length of the column, in what is known as a ‘captive-column’ effect.

Figure 4.2. Retrofit solutions fitted to the bridge (a) Shear keys and pier linkages; (b) Circular steel shroud

The Overpass bridges have been recently, in 2009, retrofitted by fixing fabricated steel shear keys to the underside of the beams at both the abutments and piers to resist longitudinal earthquake loads. Linkage rods were fitted between brackets located on either side of the piers by drilling through the tops of the piers to form a tight linkage between adjacent spans. The down-stand of the brackets prevents relative movement between the spans and the piers. Linkage at the abutments was provided by rods extending between the brackets and the soil face of the abutment seating beams.

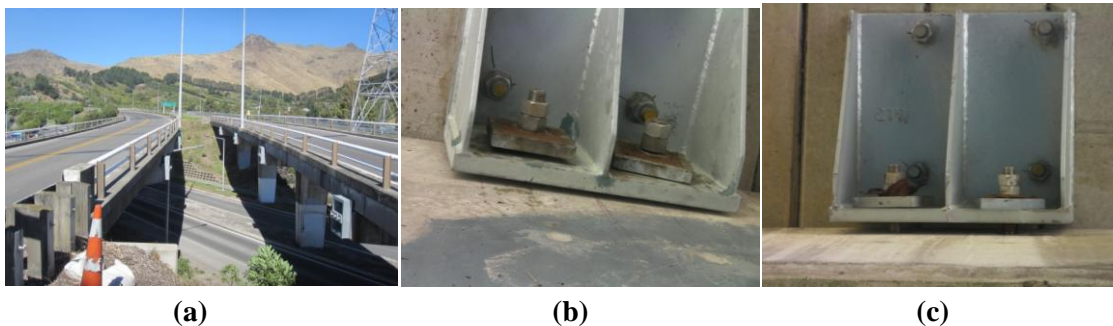
Superstructure of Port Hills bridge didn't suffer damage after the Lyttelton earthquake. No cracks developed meaning that the deck behaved elastically during the seismic excitation (Figure 4.3a). Figure 4.3b-c show the good performance of the recent retrofitting: links between the spans rotated and elongated but they were able to keep the spans connected. The nominal 10 mm gaps between the new shear keys and the abutment face at the south-east abutment of the No 1 Bridge closed up with no clearance on two of the four keys.

Figure 4.3. (a) Overall view of bridge superstructure; (b) Rotation of the bolts; (c) Elongation of the links between the spans

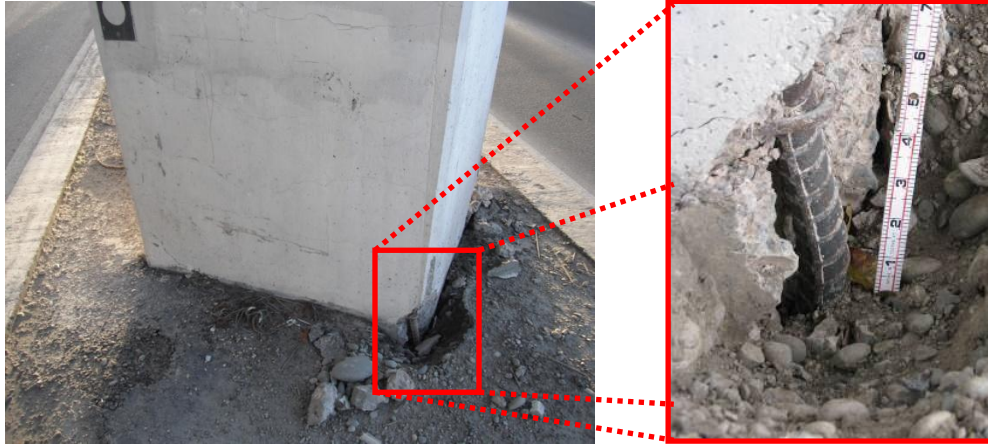
In the Christchurch earthquake the bridge sustained damage to the central pier with the formation of a plastic hinge at its base and two of the corner reinforcing bars buckling over a length of 150 mm cracking and spalling of the concrete occurred around the base of the pier, exposing the reinforcing steel (Figure 4.4). Flexural cracking developed also in the lower halves of the other pier stems except those adjacent to the abutments, and some settlement of the approach pavement. Soil gapping at ground level occurred at the faces of most of the pier stems with separation cracks up to 15 mm wide. This damage was induced by ground shaking which activated the transverse response of the bridge and apparently came with the second aftershock soon after the main quake.

Figure 4.4. Damaged pier of Port Hills overbridge: detail of buckled reinforcing steel at the base of the pier

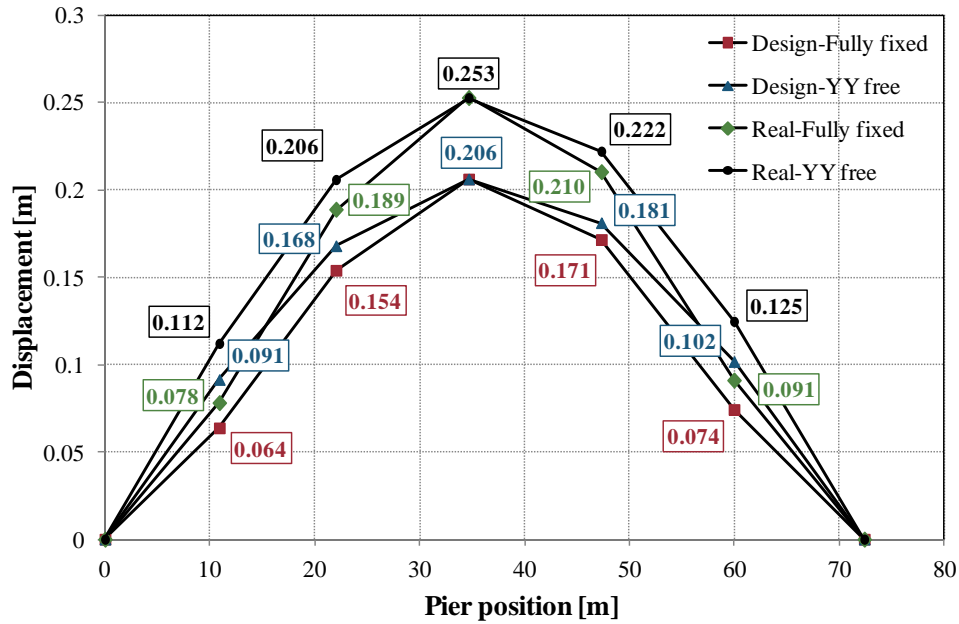
Figure 4.12. Displacement profile of each model

The graphic shows that the peak displacement reached by the pier D is the same, in both prototype, for the fully fixed and for the free rotation around y-y axis case. Moreover, it's interesting to notice that, changing over from design to actual properties, the maximum displacement increase in just 5 cm.

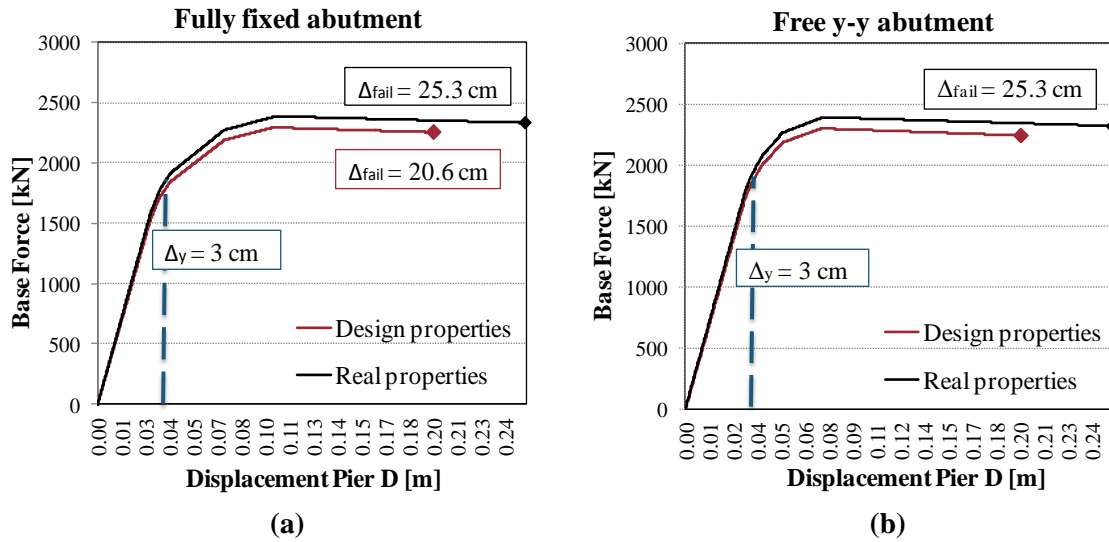
Figure 4.13. Pushover curves of the central pier for different material properties and for the two configuration of the model: (a) with fully fixed abutment and (b) with the deck free to rotate around the y-y axis.

$$\mu_{design} = \frac{\Delta_{\varepsilon c=0.064}}{\Delta_y} = \frac{0.14}{0.03} = 4.75$$

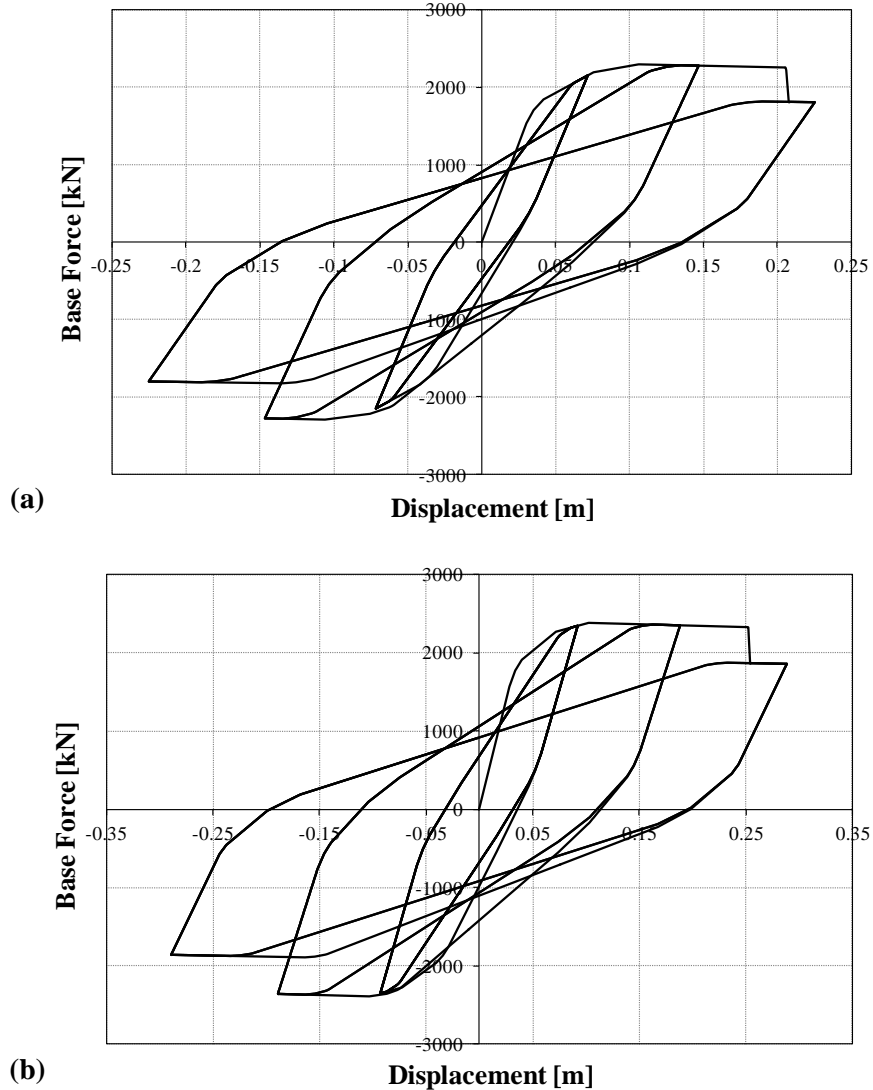
In order to anticipate the performance of the structure, the assessment was complemented with a push pull analysis to evaluate the dissipative behavior of the bridge. The structure is subjected to increasing levels of force until the collapse. The Figure 4.14 shows the result of the analysis: the total envelope of the curve match the static pushover curve and the underlying area correspond to the dissipate energy of the system.

Figure 4.14. Push pull curves of the central pier for (a) design and (b) actual properties
