POLITECNICO DI MILANO

Facoltà di Ingegneria Edile - Architettura
Corso di laurea magistrale in Ingegneria dei Sistemi Edilizi

Seismic performance of bridges during Canterbury earthquakes

Maria BRANDO Matr. 751083

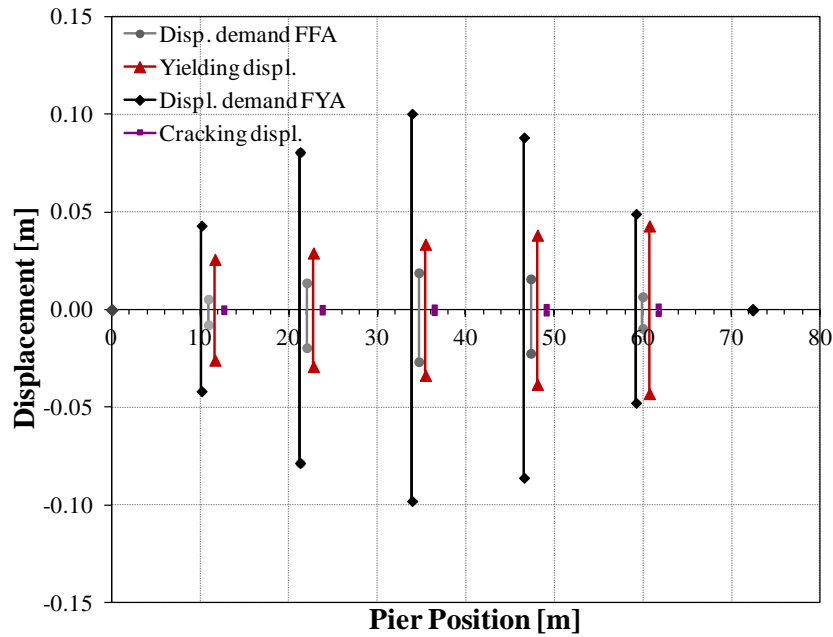
X	Δ_{max}	Δ_{min}	ϕ_y	H	Δ_y		
Piers	m	m	m	m ⁻¹	m ²	m		
B	10.90	0.0430	-0.0417	0.0023	5.85	0.0258	yielded	yielded
C	22.02	0.0806	-0.0785	0.0023	6.13	0.0291	yielded	yielded
D	34.67	0.1003	-0.0979	0.0024	6.45	0.0336	yielded	yielded
E	47.32	0.0882	-0.0860	0.0025	6.77	0.0382	yielded	yielded
F	59.97	0.0490	-0.0477	0.0026	7.09	0.0429	yielded	yielded

Figure 4.27. Comparison between the displacements of the structure of the two configurations (FFA and FYA) and the yielding ones, with records from HVSC.

Some observation can be made at this point of the analysis. First of all in all the cases displacements exceed the cracking point. This is consistent with field observations but at the same time do not allow to identify the model and the records which better simulate the real performance of the structure during the Christchurch Earthquake. Graphics show that the bridge remains in the elastic range in both the configurations when subjected to records from CMHS and CCCC. The only one case in which the yield displacement is exceeded is when the deck is free to rotate around the vertical axis and ground motion records from HVSC act on the structure. Signals of the formation of plastic hinges after the earthquake were observed. Results seem to suggest that the connection next to the abutment is not totally fixed and that the ground motion suffered from the structure was stronger than the ones recorded at CMHS and CCCC stations. It's nevertheless true that this results are obtained without considering the vertical component of the earthquake, that can influence the performance of the bridge as its contribution was very important, with values of acceleration never recorded before. Results obtained with the actual properties are not reported since the differences are in the order of the 5%.

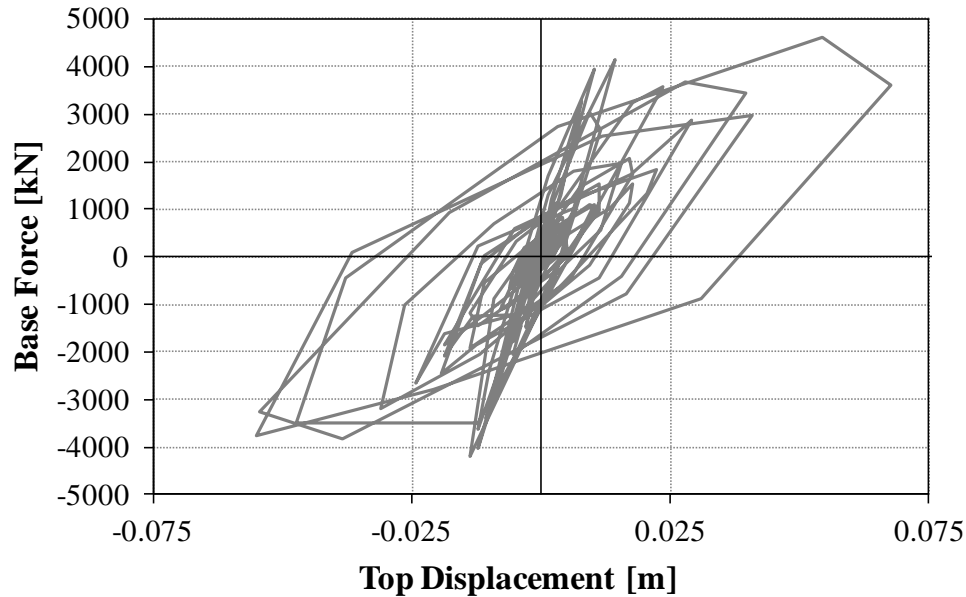
Figure 4.33. Base shear vs top displacement of the central pier (Pier D) when subjected to HVSC records.

Results show that the bridge performed well remaining in the elastic range when subjected to CCCC and CMHS records (with vertical acceleration of 0.8g). Nevertheless, the observed damage showed the inelastic behavior of the central piers, even if the overall performance was better than expected from the high spectral acceleration values. This inconsistency can be due to the distance of the stations from the bridge and the epicenter; even if the soil conditions were assumed to be similar, the PGA recorded at this station is expected to be smaller than that felt at the bridge site. A good correspondence between the numerical analyses and the reality is found subjecting the structure to the HVSC records. However, the “real” axial load variation in the bridge was probably smaller since accelerations of HVSC incorporate seismic amplification effects. Figure 4.32 shows that the displacement demand for the model with fully fixed abutment (FFA) is lower than the displacement at the yield of the base section of the piers. On the contrary, the model with the superstructure pinned around the y-y axis (FYA) develops plastic hinges at the bottom, with top displacements greater than the yielding ones. The real response of the bridge is hence likely to have been more similar to the response evaluated by the second “limit case” model. In fact, since the bridge is prefabricated with post-installed mechanical connections, the fully fixed model overestimates the stiffness of the retrofit linkages.

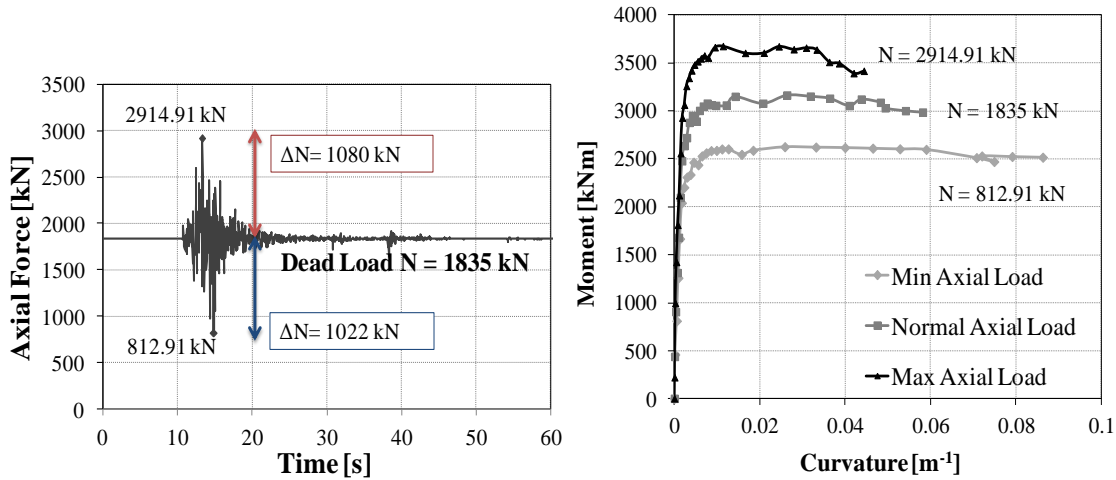
Figure 4.34. (a) Time history of the axial force loading the central pier (Pier D) when subjected to CMHS records. (b) Evolution of the moment-curvature with varying axial force.

The vertical accelerations recorded at the CMHS station induce a moderate variation of the axial force on the pier D. The moment curvature relationship change as shown in Figure 4.34b: the yielding moment in the column increases by 15% compared to the static case when subjected to the maximum axial load, otherwise decrease by 19%. On the other hand on the curvature ductility there's the opposite effect: in the first case (maximum axial load) there is a decrease of 25%, in the second case (minimum axial load) there's an increase of the 56%.

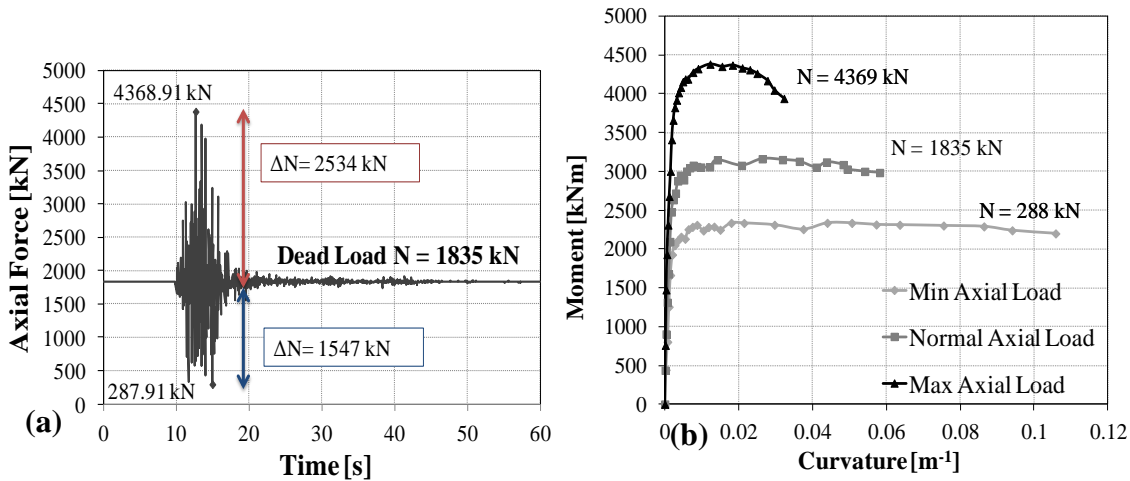
Figure 4.35. (a) Time history of the axial force loading the central pier (Pier D) when subjected to HVSC records. (b) Evolution of the moment-curvature with varying axial force.

When subjected to HVSC records instead, the moment capacity and curvature ductility in the pier D is drastically changed. When the axial load variation caused by the earthquake sums to the static load there is an increment of 38.60 % in the moment capacity but a reduction of 49.24% curvature

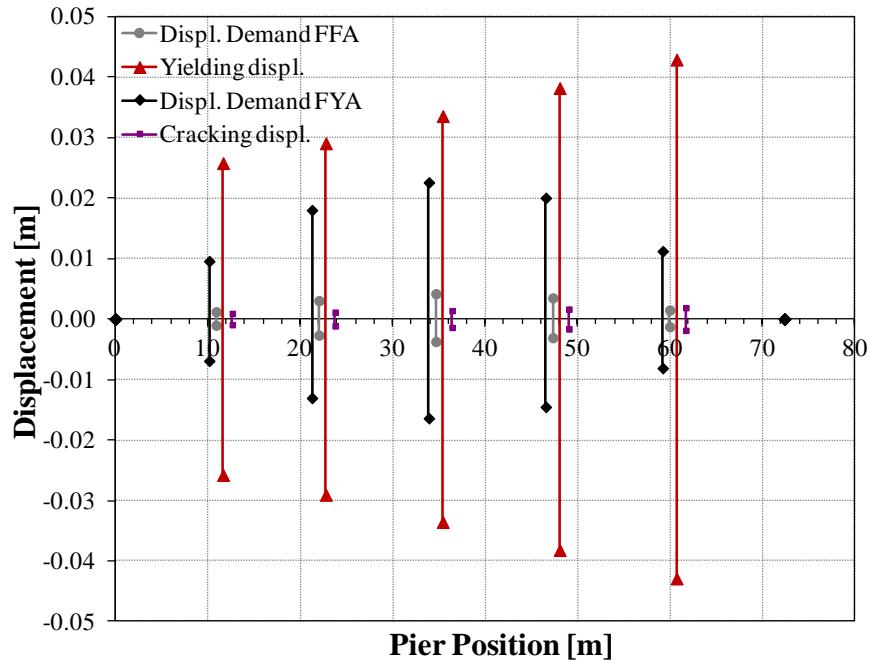
Figure 4.38. Comparison between the displacements of the structure of the two configurations (FFA and FYA) and the yielding ones, with records from HVSC.

The numerical results show that the bridge performed well during the Darfield event, with displacements lower than the one at the yield even when subjected to the ground motion from

HVSC. This confirm that even if the Lyttelton Earthquake was lower in terms of magnitude than the Darfield one, the damage was greater because the PGA recorded was more important.

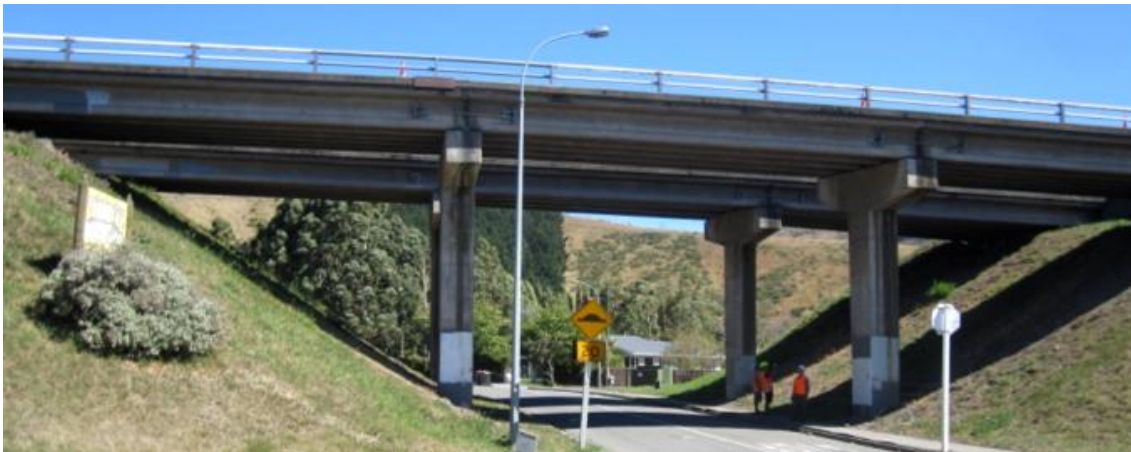
Figure 5.1. *Overall view of Horotane Valley Overpass.*

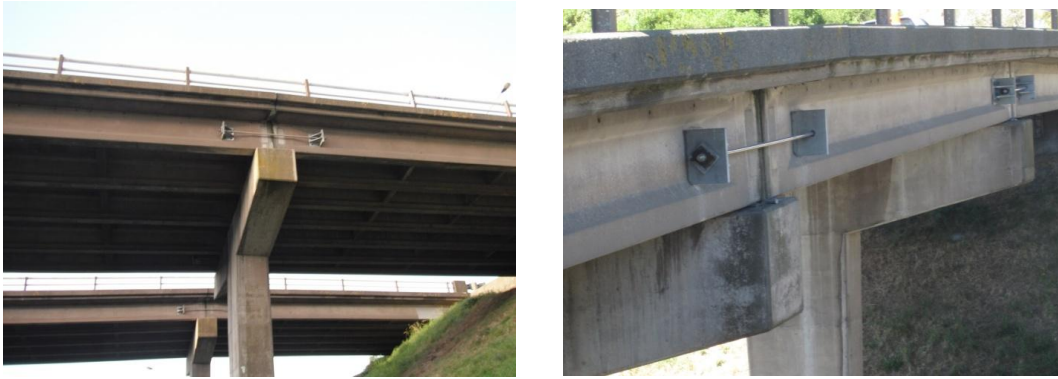
Since this overpass was recently retrofitted, it didn't suffer of any structural damage after the Darfield earthquake. Retrofits were designed to link spans together and to the abutments in order to create an "integral cast-in-place bridge" concept (Figure 5.2). The performance of Horotane Overbridge, like other bridges in the region witnessed the effectiveness of the retrofit programs undertaken by Transfund New Zealand in the past. In fact, the bridge was able to service traffic soon after the earthquake.

Figure 5.2. Steel linkages between spans after the retrofit program.

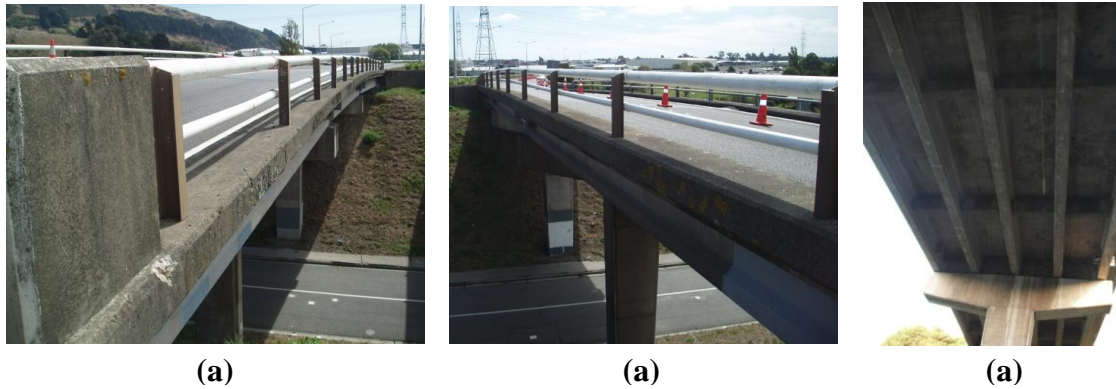
The deck and beam elements of the bridge exhibited little damage following the Lyttelton earthquake. No cracking to bridge pavement was observed throughout the length of the deck (Figure 5.3a-b). No flexural cracking of the beams was observed neither (Figure 5.3c). The ties between spans and at the abutments also elongated and pulled out. Additionally, 60% of the bolts that attached the soffit of the precast concrete beams to the abutment seat extension had sheared off. While initially alarming, this failure of the retrofit bolts highlights the necessity of bridge retrofits. If these spans had not been tied together and the seats not extended it is quite likely the spans would have collapsed.

Figure 5.3. (a-b) General view of the superstructure and (c) deck soffit of the bridge

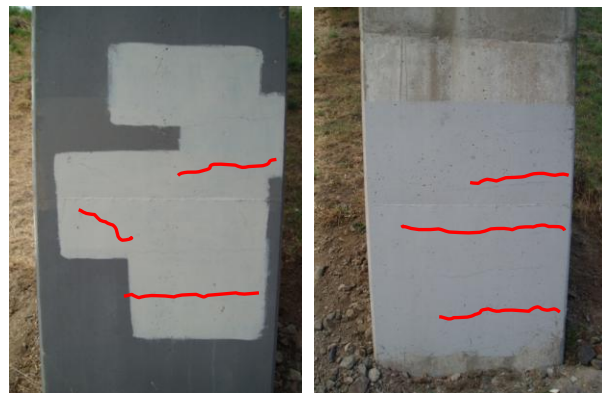
Following the Christchurch earthquake, fine horizontal cracking was observed on the lower half of all four piers (Figure 5.4). Crack widths were up to 0.2 mm and the cracks were located between about 500 to 2600 mm above ground level. The cracks were more pronounced on the column faces nearest to the roadway under the bridge. Measured distances between the bases of the piers indicated that these spacings had shortened by 200 mm on the No 1 Bridge and 260 mm on the No 2 Bridge.

Figure 5.4. Flexural cracked piers

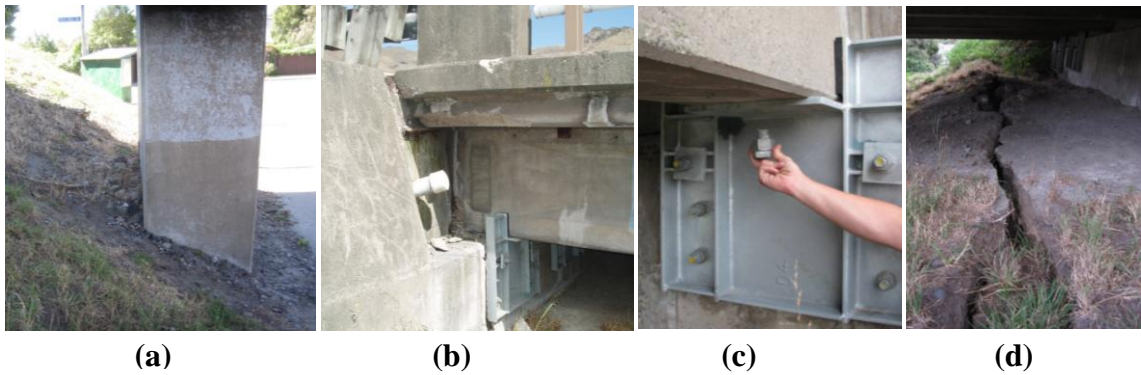
The Horotane Overbridge suffered abutment damage and a small slope failure of the embankments (Figure 5.5a). The East end of the No 2 Bridge displaced horizontally about 100 mm in a southwards direction. This resulted in severe vertical cracking at the junction between the abutment seating and the abutment wall between the two bridges. There was minor spalling at the ends of beams where they were seated on the abutments (Figure 5.5b).

All four abutments appeared to have moved forward by up to 20 mm. Cracking and movement of abutments developed outwards perpendicular to the bridge axis. A significant transverse crack 10cm wide and 60cm deep opened up at the top of the South-East slope that was continuous across the width of the bridge (Figure 5.5d). A transverse scarp also developed near the toe of the 13m long slope, extending across the width of the bridge between the bridge columns. The movement of the abutments caused even the shearing of two of the bolts on the new linkage brackets (loaded in shear) at the west abutment of the No 1 Bridge. Bolts on the new linkage brackets also sheared on both abutments of the No 2 Bridge (Figure 5.5c).

Figure 5.5. Damage at the abutments: a) Slope failure; b) Flexural cracking (c) Sheared bolt at the abutment retrofit; (d) Transversal crack at the top of the South-East slope

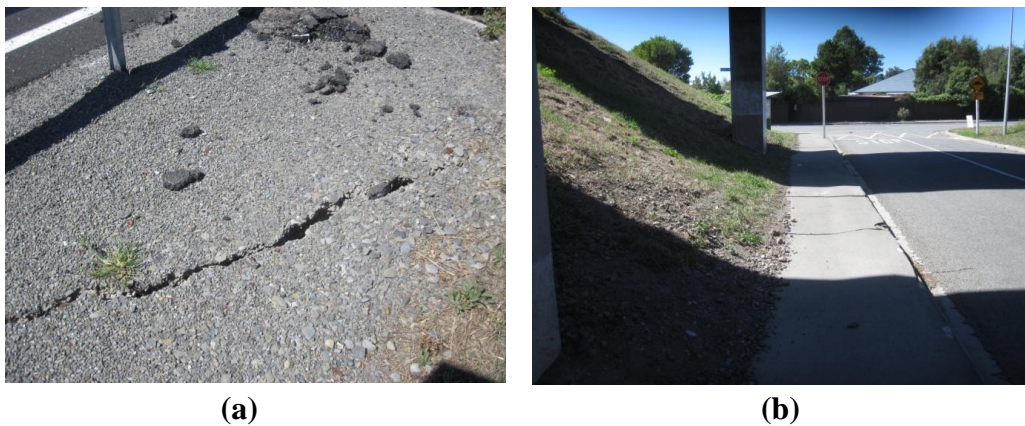
There was significant differential settlement between the approach pavements and the abutments of both bridges as evidenced by repairs to the asphaltic concrete pavement near the abutments. The approach roadway kerbs were damaged in several locations by compression against the abutments resulting from forward movement of the backfill. Buckling of the guardrails and shearing of their connection bolts occurred at several of the joints between the approach guardrails and the bridge end posts.

Figure 5.6. a) Cracks on the top of the embankment; b) Cracks in the pavement under the bridge

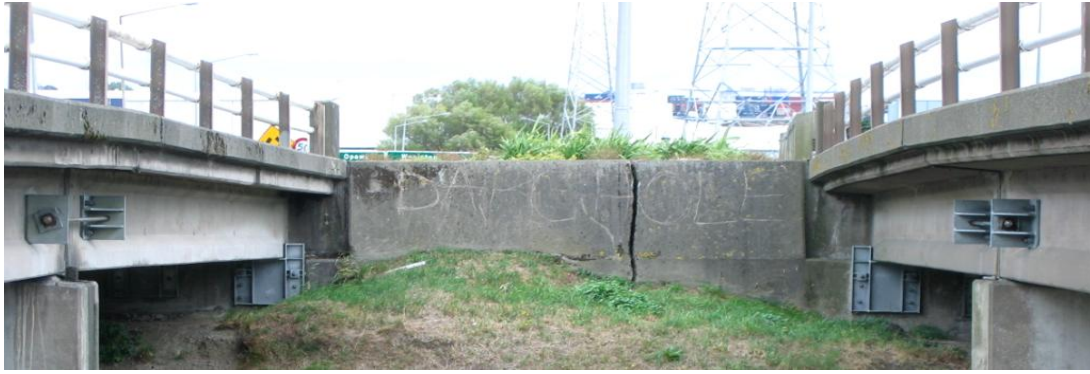
The North-West abutments had settled by about 60 mm: a transverse crack was developed at the top of the North-West slope near the concrete abutment, however this was not continuous across the slope.

Figure 5.10. Transverse crack at the northwest abutment

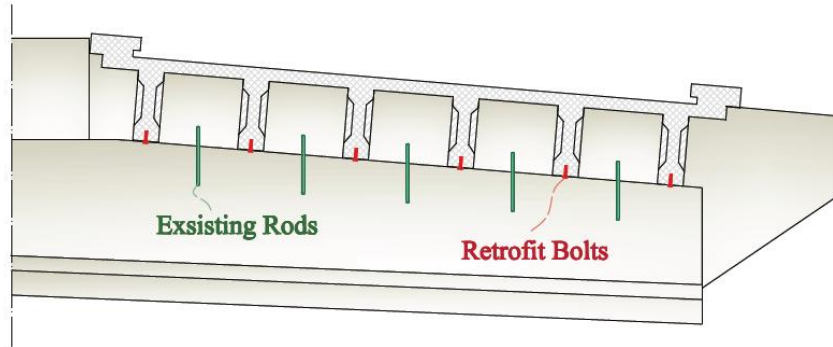
The permanent displacement accumulated is much greater than the previous one, and this is understandable. In fact an earthquake of equal magnitude but with a more peaky character would be expected to lead to displacements considerably in excess of those predicted for CMHS records [51]. As already told in the overview of damages, the movement of the abutments caused shearing of two of the bolts on the new linkage brackets (loaded in shear) at the west abutment of the No 1 Bridge. This happened as, taking into account the flexibility of the beam rubber bearings on both the abutments and the piers, and the linkage bolts at the abutments, it was estimated that the abutments were very much stiffer than the piers in the longitudinal direction and would initially have resisted most of the longitudinal earthquake loads. These are due to the combination of the ground motion and the permanent displacement resulting from the slope failure. To estimate the quantity of the loads taken by the vertical bolts, the connection between the deck and the abutments will be represented by two multi-spring elements: one for the existing holding down dowel connecting the diaphragm to the abutment, and the other one for the strengthening rods put into the bottom of the

Figure 5.29. Frontal view of the West abutment of No 1 Bridge.

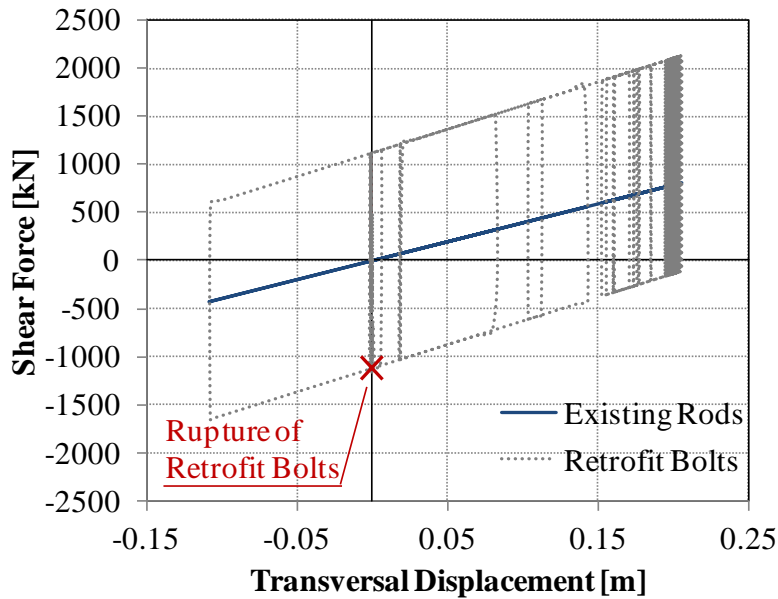
Results of the analysis are shown in Figure 5.32: adopting an elasto-plastic rule to represent the behaviour of the bolts, it's possible to pick out the brittle failure of retrofit bolts, as expected from a shear failure, at ~1120 kN. It has been chosen to represent in the graphic all the hysteretic cycles (dotted line), even if the rule does not represent the real behaviour of the element, only to better identify the time of the rupture during all the seism simulation. This can be seen more clearly in Figure 5.33 where in the shear force time history is indicated the instant when the shear failure occurs (~11 s). In Figure 5.32 is shown also the behaviour of the existing bolts, that, because of the lower stiffness, absorb a shear force much smaller than the retrofit, remaining in the elastic range.

Figure 5.32. Shear vs transversal displacement of retrofit bolts and existing rods, with the indication of the shear failure of the retrofit bolts.

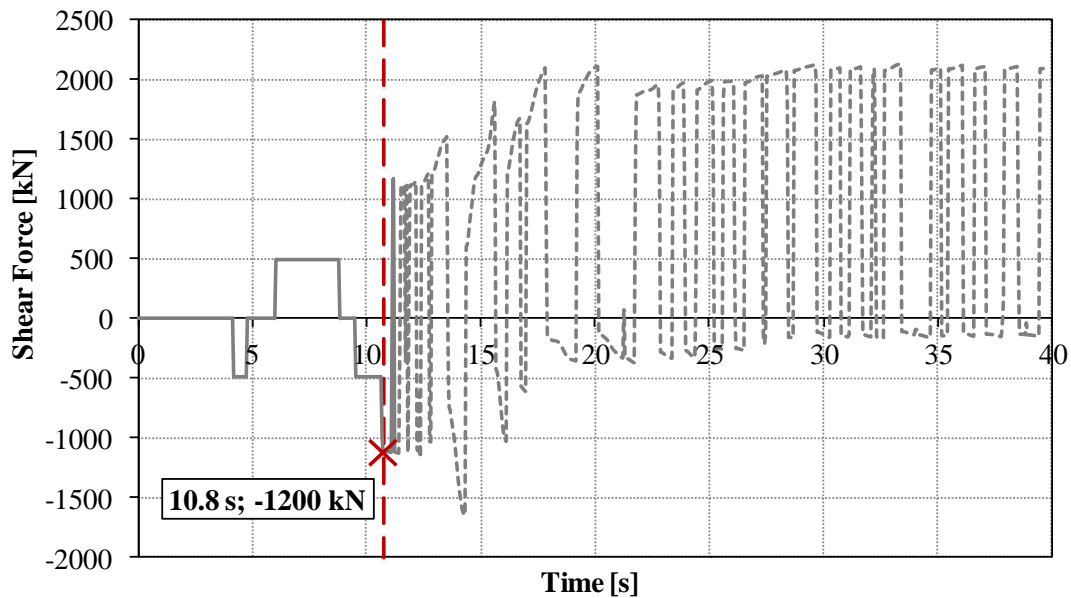
Figure 5.33. Time History of the Shear Force acting on retrofit bolts, with the indication of the breaking point.

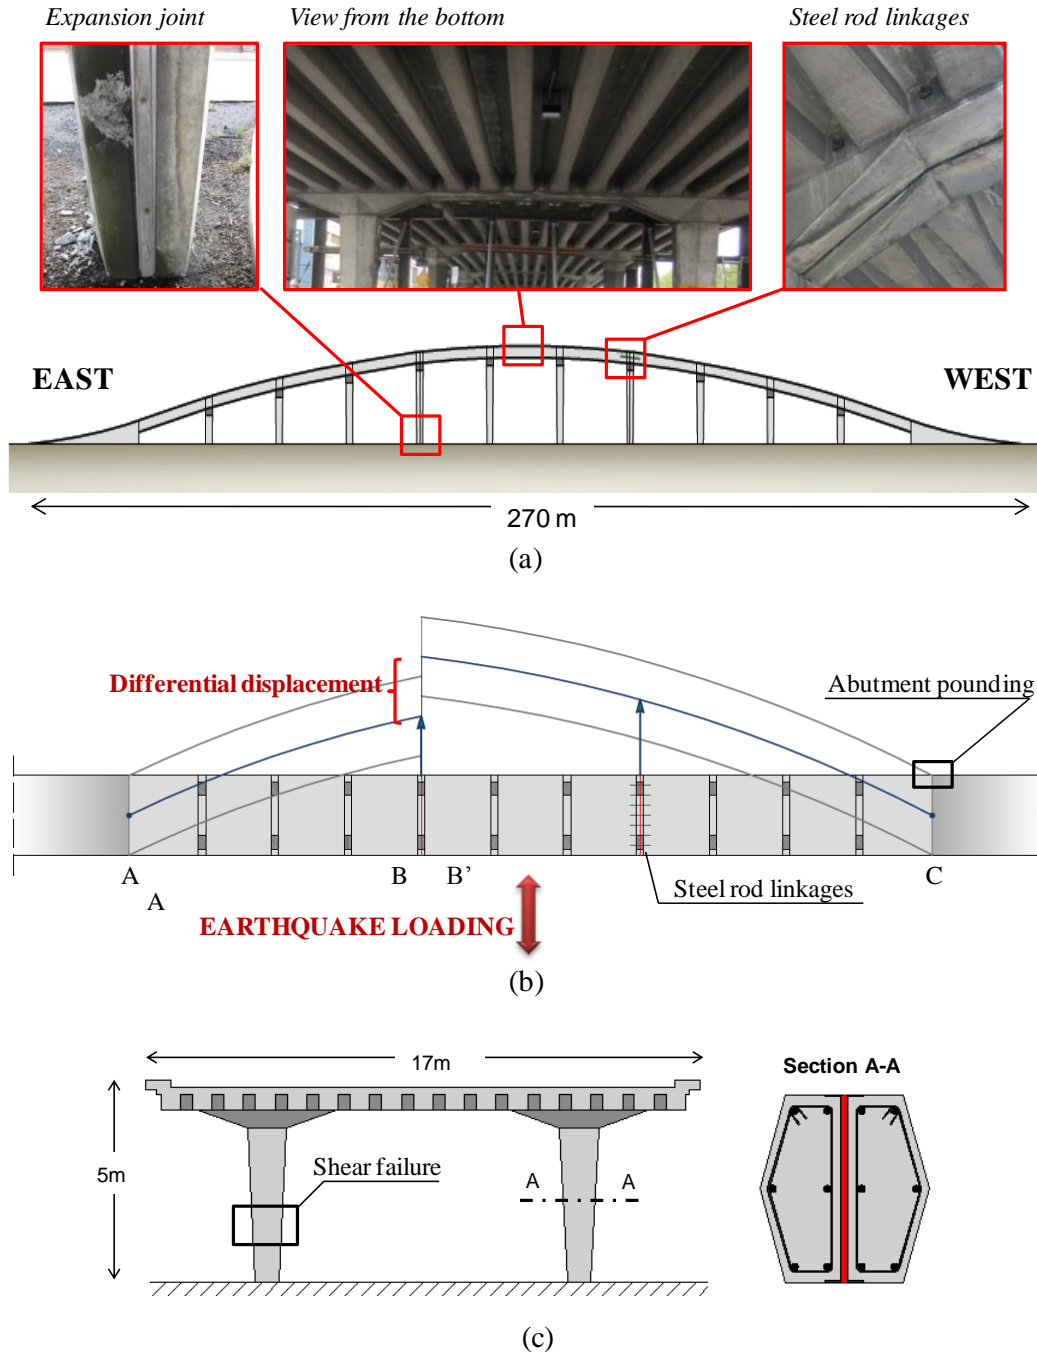
The overall performance of the structure was unsatisfactory with significant shear cracking and buckling of the split piers below the eastern expansion joint (Pier 7). The mechanism of damage is shown in Figure 6.4b-c. This damage affected the vertical load carrying capacity of the structure along with the lateral capacity. As a result of this damage, the bridge was closed following the February earthquake for over 5 weeks (reopened: 31st March, 2011) while strengthening works were undertaken. This caused vehicle traffic to be restricted to a single lane in both directions either side of the over bridge. A summary of the extent of damage is given in Table 6.1.

Figure 6.4 a) Sketch of the bridge elevation with location of the expansion joints and steel rod linkages b) Sketch of the bridge plan view and qualitative displacement profile under transversal loading; c) Sketch of the typical transverse pier elevation and transversal section of piers with expansion joints;

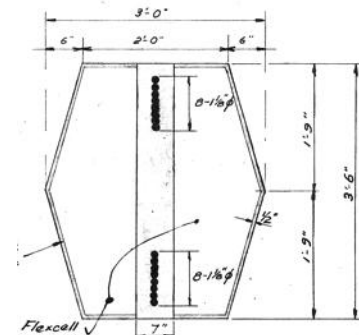
The south column exhibited fine vertical cracks at the top of the southern face. This is due to the configuration of the moment connection at the top of the column, shown in Figure 6.7. In fact is possible to notice that the width of the compression concrete at the joint (7" = ~180 mm) roughly corresponds to the distance between the vertical cracks. These cracks are on a shear plane from the compressive forces at the connection caused from transverse movement. Fine horizontal cracking at approximately 700 mm from the top of the north column on the southeast faces was also noted.

Figure 6.7. Detail of the transverse moment connection

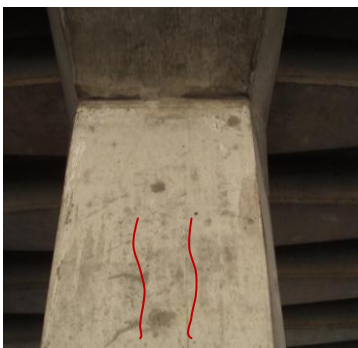
Pier 3

Figure 6.8. Pier 3, south column, fine vertical cracks at the top and horizontal flexural cracks.

The south column exhibited fine vertical cracks at the top of the southern most face similar to that on pier 2. On the same column fine horizontal flexural cracks were noted on the south face approximately 1.3 m from the top. It's worthwhile that the high tensile steel bars used for the pinned connections have a development length that ends at approximately 1.1 m from the top of the column. For this reason it is believed that these bars were providing some flexural tensile capacity during the transverse/vertical ground motions. The south column is shown in Figure 6.8. The north column had fine horizontal cracks on the

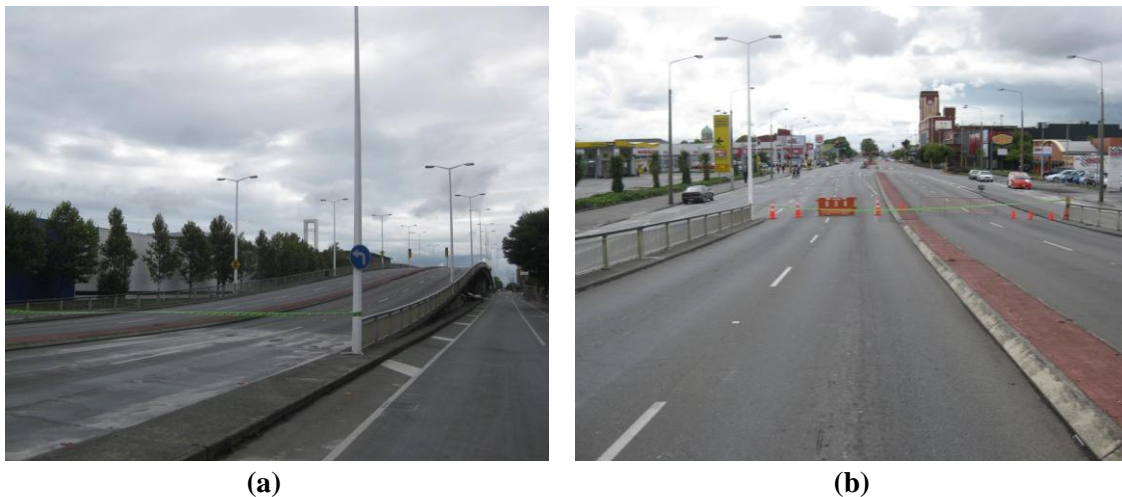
The surrounding land did not suffer any major damage. The pavement was subject to minimal damage but was in an operational condition at the time of inspection though had become uneven due to liquefaction. Liquefaction did not cause any major damage the structure though it impact on the behaviour underlying soil in the shaking is likely to have altered the ground motion that the bridge experienced. There has not been any lateral spreading with no nearby watercourses.

Figure 6.12. *View of the bridge (a) from the west side and (b) from the east side.*

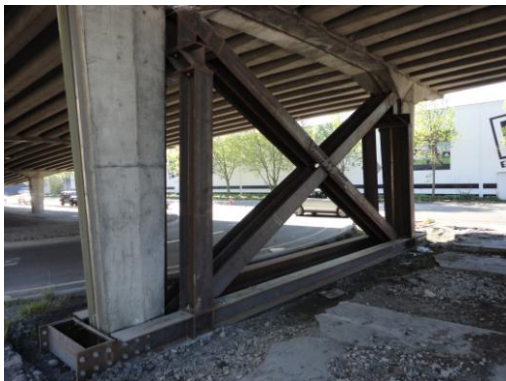
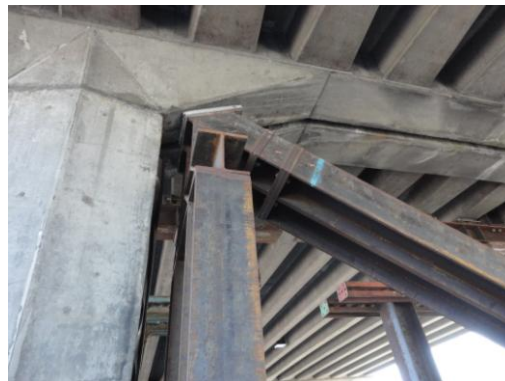
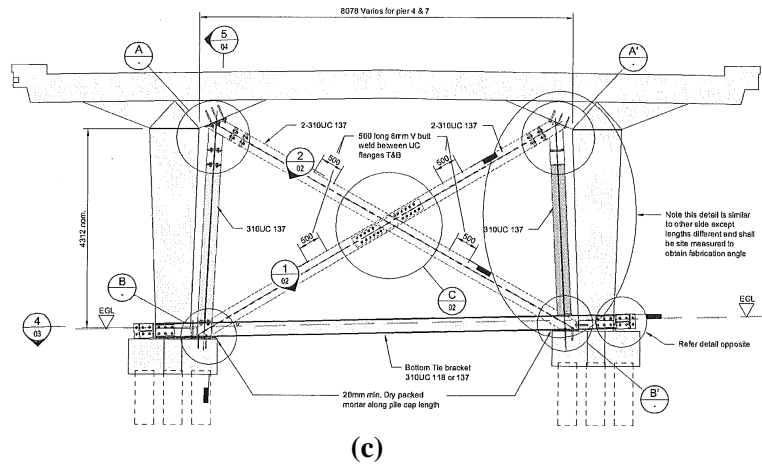
Piers 4 & 7 were identified as positions of weakness, especially in the transversal direction. To improve the transversal capacity of the damaged structure Opus International Consultants Limited[©] elected to construct dual cross-bracing units at each of the piers (Figure 6.14a). These were straddled the piers and used doubled up 310UC137 steel sections to act as a diagonal bracing system. Full drawing of the repair can be found in the document ‘R702 Moorhouse Avenue Overbridge, Earthquake Strengthening and Seismic Strengthening Report’ by Opus International Consultants Limited[©] (Figure 6.14c) .

Figure 6.14. (a) Transverse bracing system implemented at Pier 4 & 7 (b) Detail of the connection between the steel beams (c) Detail of the retrofit work from the drawings (Opus International Consultants Limited).

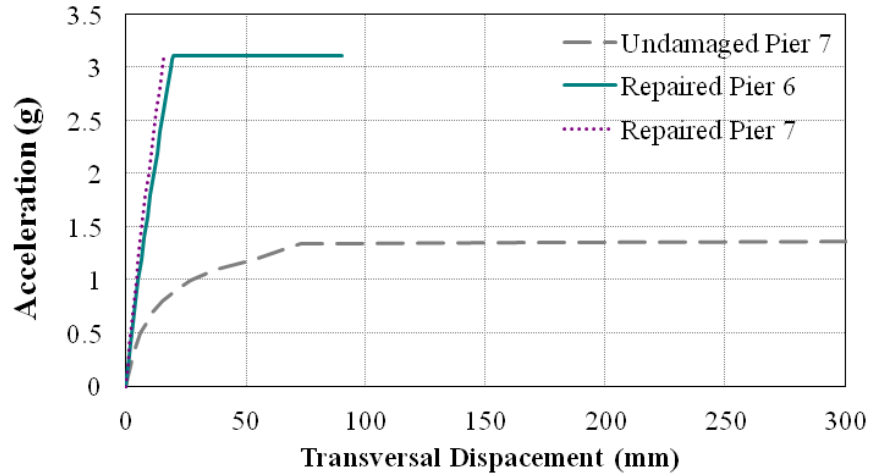
Within Figure 6.17 undamaged pushover analysis is accompanied by pushover analysis of the repaired structure. Inclusion of steel cross-bracing greatly increased the repaired structure's stiffness which can be seen by the relationship between displacement at pier 7 where bracing is located. Inclusion of bracing induces a change in location of the ultimate failure mechanism to pier 6, one of the fixed base piers in the central section of the bridge. Failure occurs at over 3.0g (3.0w_d) due to

shear in the pier frame legs. While shear is not a desirable failure mechanism, failure occurs far above any current design levels.

Figure 6.17. Pushover analysis of undamaged and repaired condition, investigating transversal displacement of Piers 6 and 7.

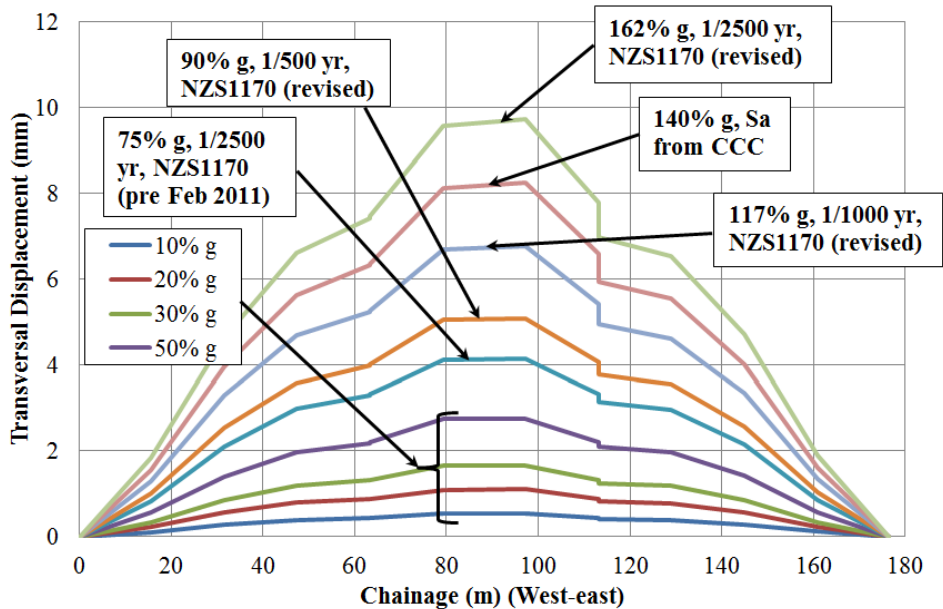
Figure 6.18. Pushover analysis on the structure in its repaired condition displacement in the transversal direction.

Pushover analyses were undertaken on the structure in its undamaged and repaired condition as shown in Figure 6.17 and Figure 6.18. From these figures it can be seen that repairs made to strengthen the structure following the February 2011 event have a significant influence on the level of deformation.

Figure 6.18 shows the transversal displacement profile of the structure under various levels of loading. It can be seen that the inclusion of cross-bracing units tied the structure together giving a more symmetric profile with only a minor difference in deformation at pier 7. The inclusion of cross bracing also stiffened and strengthened the structure. Using modal analysis (Table 6.2) it can be seen that this in turn decreased the natural period of the structure which might be expected to increase accelerations, though in NZS1170.5 [21] the structure remains in the plateau region of the design spectra, thus having a minimal effect on design base shear.

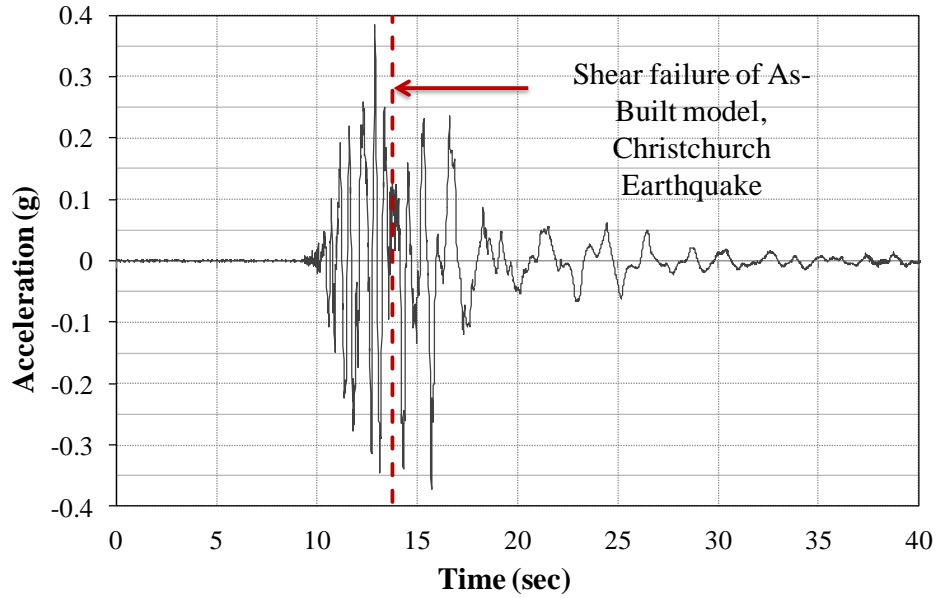
Figure 6.19. Ground Motion measured at Catholic Cathedral College (CCCC) with the indication of the instant in which the shear failure happened according to the numerical analyses.

Shear failure of Pier 7 occurred in the As-Built model after ~14 s when subjected to the Christchurch earthquake as expected (Figure 6.19). The failure of Pier 7 during the analysis meant that the full analysis could not be carried out, meaning the true peak displacement and shear force of the As-Built model may not have been obtained. No failure occurred in any of the other tests, indicating that the repair and retrofit methods were effective in preventing failure of the bridge.

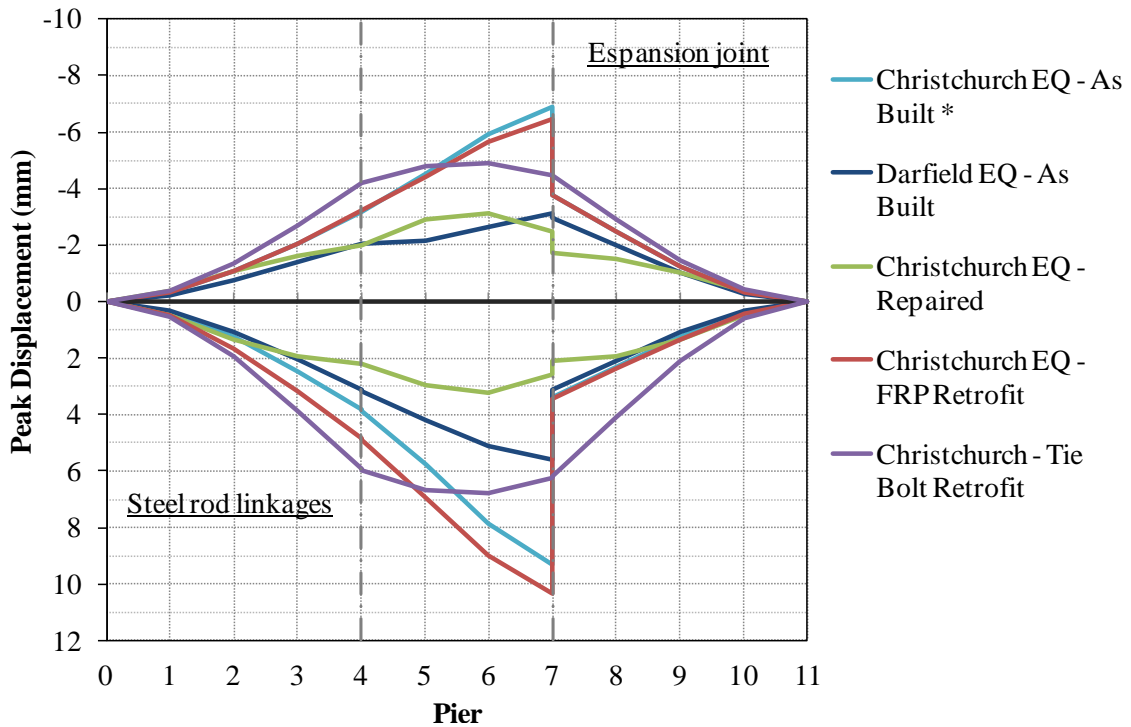
Figure 6.20. Displacement profile of each model when subjected to CCCC records.

Table 6.4 gives a summary of results from the analysis showing the peak displacement, drift and shear force that occurred at Pier 7. Pier 7 was chosen for comparison as it was the pier that underwent the largest deformations in the As-Built models and is also the pier that exhibited the most damage in the detailed damage assessment. Figure 6.20 shows the peak displacement profiles of each model.

The displacement profiles show a larger peak displacement in the south direction than the north direction which is consistent with the damage to the west abutment in which spalling occurred on the southern side of the abutment, but not the northern side (Figure 6.20).
