POLITECNICO DI MILANO

The Role of Structural Homogeneity
in Seismically Active Historical Centers of Abruzzo

Castel del Monte, Castelvechio di Calvisio, Santo Stefano di Sessanio, Villa Santa Lucia degli Abruzzi

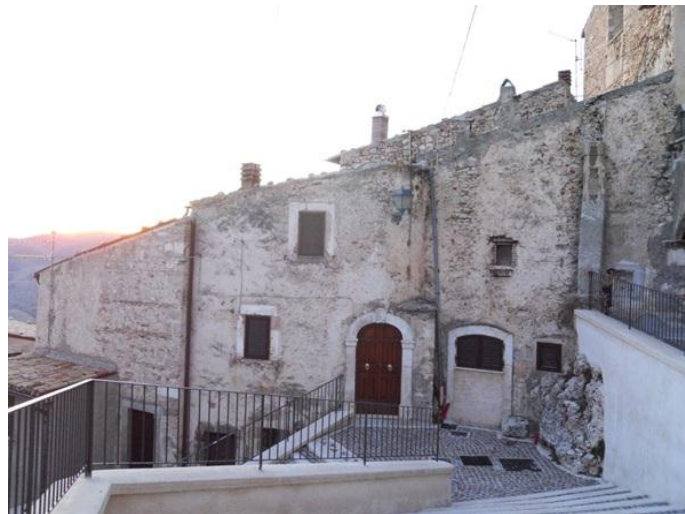
Figure 2.11 Perpendicular Example

the Baronia collective, ruins showed a tendency to being built perpendicular to the elevation curves although this was not always the case. Seen above are the two orientations to the elevation curves present in Castel del Monte. In addition, there are several structures that while categorized in one of the two aforementioned categories, they are in fact oriented between 0 and 90 degrees to the elevation curves. These are the least favorable of the orientations. In these cases, the propensity for collapse is the most extreme, due to increased torsion movement of a structure in this condition.

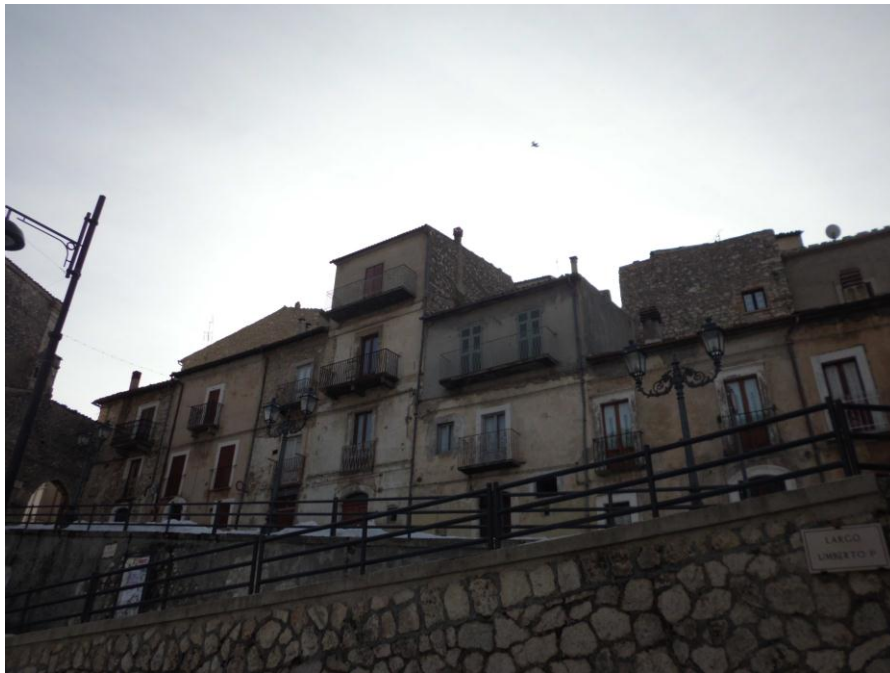
Figure 2.12 Example of a tower in aggregate CdM 008

Castel del Monte, of all of the villages of Baronia, has some of the more extreme examples of height differences in individual aggregates. As seen in the attached table, in many cases the building heights shift within the aggregate, corresponding to the changing elevation curves. In addition there are several cases of towers within an aggregate that are much taller than their surrounding structures. This is the case for the tower in aggregate CdM 008. While this tower is not severe in nature, the

lack of homogeneity regarding the building heights within the individual aggregate creates an

increased propensity for collapse in the case of a seismic event. As seen throughout Castel del Monte, in many cases structures that are not physically adjacent to one another or even in the same aggregate, are connected through non-structural elements such as arches or “sporti”. These elements can create minor cracks, but in general they are considered to be successful anti-seismic elements that help to separate structures of differing heights. This therefore minimizes the chance of partial or complete damage due to the

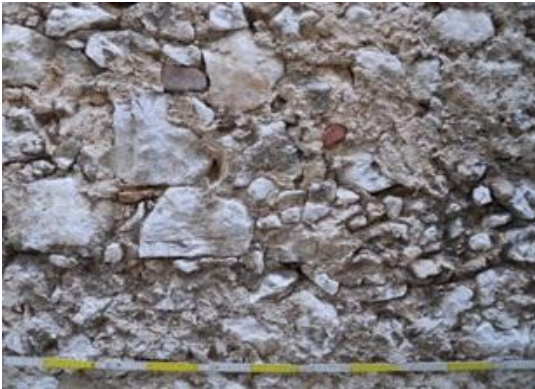
Figure 2.14 Masonry Elevation – Typology 1

referred to as masonry typology number one. This is the lowest quality of masonry present in Castel del Monte. After plaster covered buildings, masonry typology one is the most common, making up 32 percent of the existing buildings within the historic center. As seen in the photos above, in Castel del Monte, this particular masonry typology is defined by its lack of regularity, both in the formation of horizontal rows as well as individual stone sizes. This quality of masonry is common in hillside communities across the Abruzzo region. Due to the access of irregular stones in the region as well available cheap construction labor, this particular typology was extremely cost efficient.

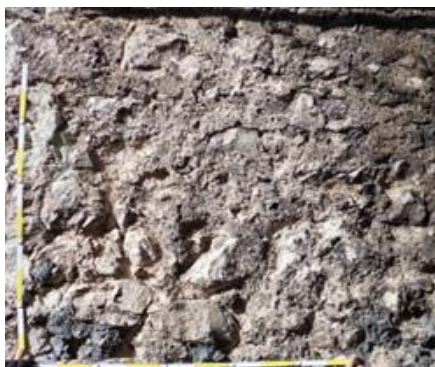
2.25 Parallel Orientation – Masonry 1 – Photo

its elevation masonry composition. It is important to note the varying stone sizes in the elevation diagram and photo on the last page. This characteristic can create irregular unit movements in the

case of a seismic event and thus accelerate the collapse mechanisms of the masonry. This is why the individual analysis of an aggregate as a whole is extremely important when considering structural vulnerability in the case of a seismic event. While all of the aforementioned examples are considered to be masonry typology one, their individual makeup can vary drastically.

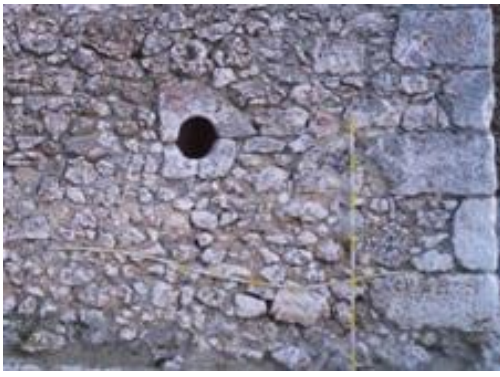
Figure 2.33 Tower- Masonry 2 - Photo

The first example comes from the tower building typology, specifically from aggregate CdM Tower. Due to its importance as the gate of the historical center, the masonry quality was given more importance than typical residential structures. As seen in the elevation photo and diagram below, the individual stones are still irregular but there is a stronger presence of horizontal rows than is seen in

the case of masonry typology one. In addition, corner stones within the structure tend to be more prominent in size and of higher quality. As seen in the two examples below, the buildings of this

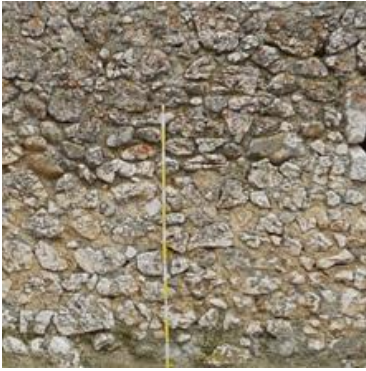
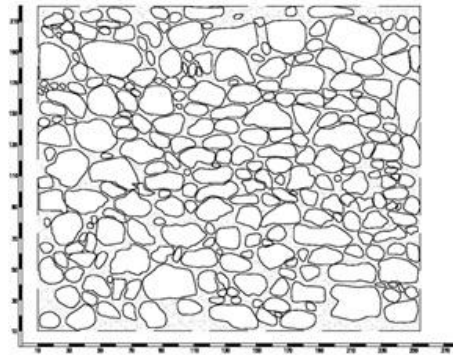
There are also several examples of masonry typology two throughout the typical row houses of Castel del Monte, seen in both those oriented parallel and perpendicular to the elevation curves. In the example below, seen in aggregate CdM 010, the masonry does not have perfectly horizontal rows but unlike masonry typology one, there is a strong horizontality. However there are no present vertical systems as will be seen in the case of masonry typology three. As seen in the photo on the next page, masonry typology two is generally present in taller buildings, presumably of higher social

2.38 Parallel Orientation – Masonry 2 – Photo

2.39 Parallel Orientation – Masonry 2 - Diagram

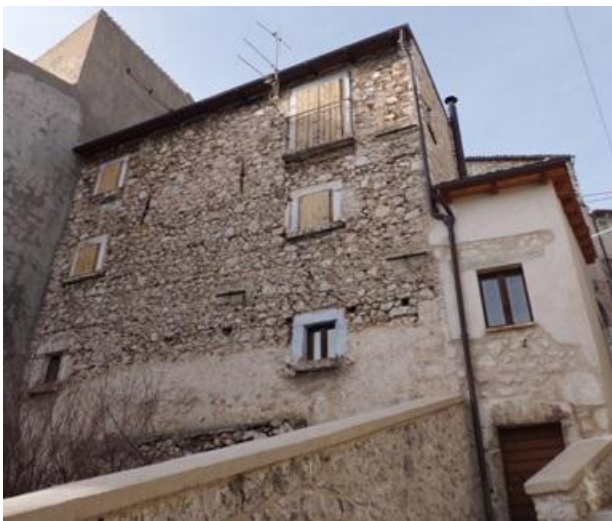
Figure 2.40 South Façade (Aggregate CdM 020)

curves. While the stones present in this masonry are more regular in size, they still strongly differ, which is an important factor to consider in the case of a seismic event that would affect the structure.

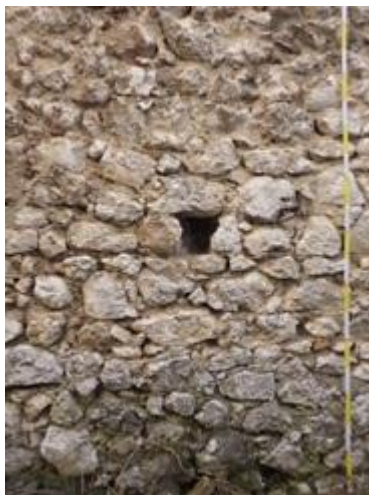
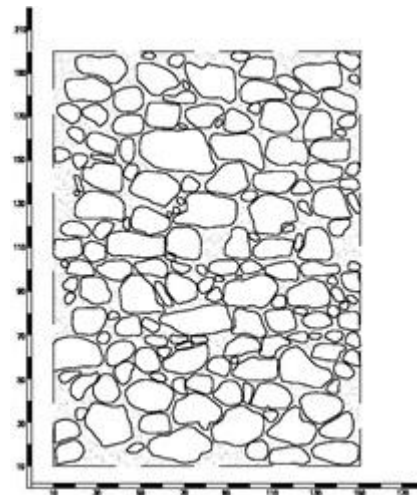
is seen below, in aggregate CdM 014, the quality of masonry is high regarding the individual

2.41 Perpendicular - Masonry 2 – Photo

2.42 Perpendicular – Masonry 2 – Diagram

stones. Again, as is a characteristic of masonry typology two, there is a presence of horizontality

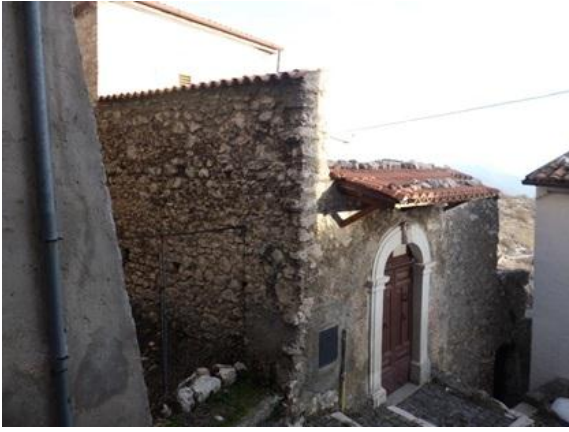
2.43 *Front West Façade (Aggregate Cdm 014)*

regarding stone size as well as a higher quality stone as well. However the lack of mortar leaves the masonry vulnerable to human and environment related factors that can damage the structure. There is again no presence of vertical alignments but the masonry is still one of a higher quality than many within the category of masonry typology two.

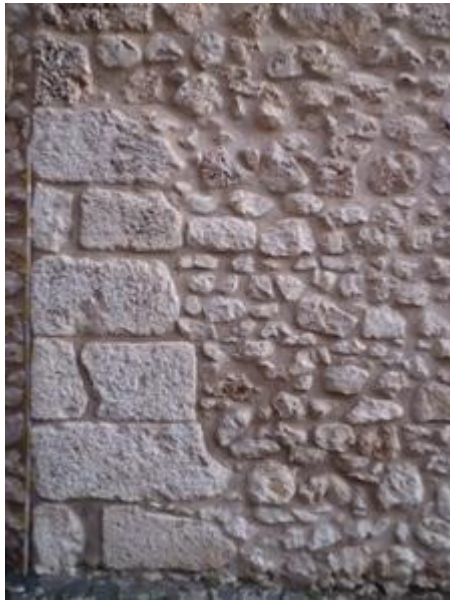
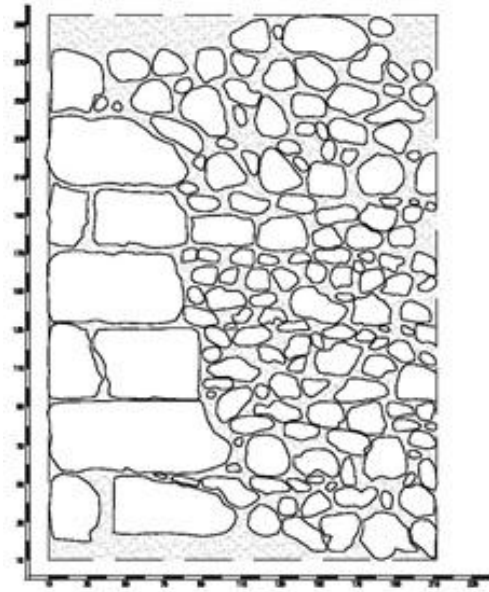
It is in a good state of preservation, most likely due to the importance of the structure to the local society. Similar to the two aforementioned masonry typologies, the typology is located throughout Castel del Monte, present only in the building typology of churches. As seen in the example, in the aggregate CdM Church 2, masonry typology three is present in the Madonna del Suffragio church in

2.46 Church – Masonry 3 – Photo

2.47 Church – Masonry 3 – Diagram

the South of the historical center. There is a strong horizontal presence, forming coherent horizontal rows, more clearly defined than in masonry typology one and two. While there is no concrete vertical structure as seen in present day masonry structures, there is a subtle vertical structure which aids in

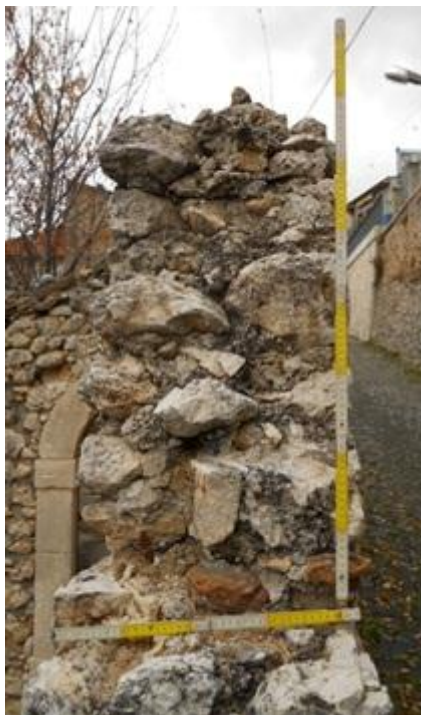
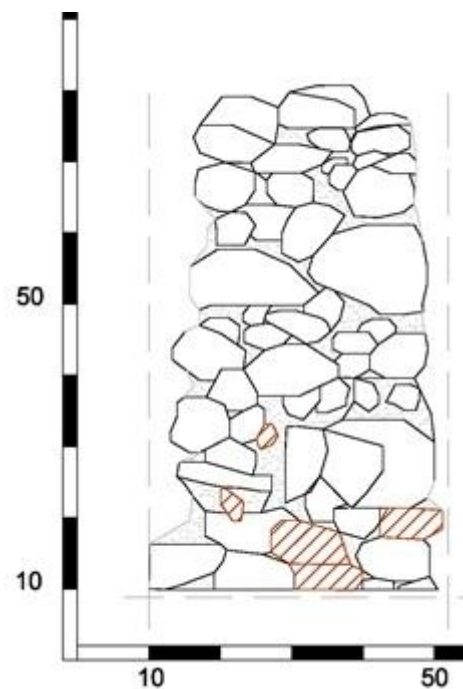
2.49 Section Photo (Aggregate: Not Applicable) 2.50 Section Diagram (Aggregate: Not Applicable)

This first ruin to be discussed is that outside of the historical center. The following analysis will be based on the assumption that the wall section analyzed is representative of the overall masonry of the structure. Upon initial observation, it is clear that the masonry has been assembled with a certain effectiveness. This fact is in line with other information gained from observed analysis. Despite the small size of the section under examination, it can be deduced that the masonry is comprised of two leaves with a thickness of 40 centimeters. Both leaves are made up stones of either medium or large size with the presence of some larger stones that provide clamping between the adjacent elements. There is also the important presence of limestone wedges that provide a more

cohesive structural connection. Within the section, the mortar is still in good condition with a firm

consistency. The aggregates within the section are larger than the visible mortar on the surface, composed instead of very fine gravel of angular shape and light gray color. Within the section there were no voids that could have possibly compromised the structural stability of the wall. Following

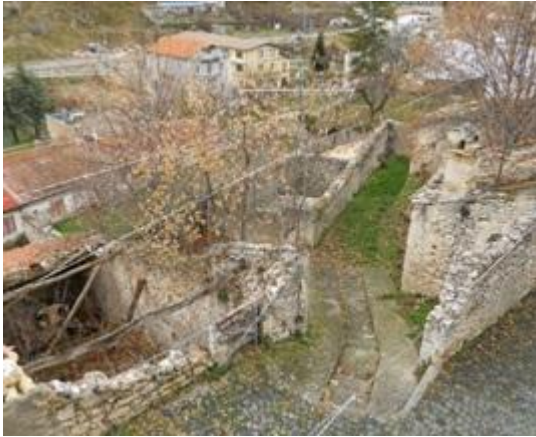
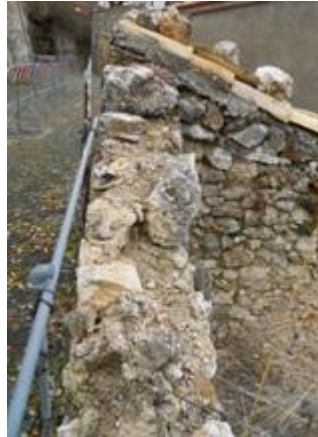
Figure 2.51 Overall Ruins - Photo

Figure 2.52 Overall Ruins - Photo

RELUIS modifications, the section is composed of irregularly formed masonry stones (regarding dimensions and materials). In this particular example, it can be deduced that the masonry had little to no influence on the collapse of the structure. However it is important to note that this conclusion is based on the limited evidence available and can be considered simply an assumption without further information or details.

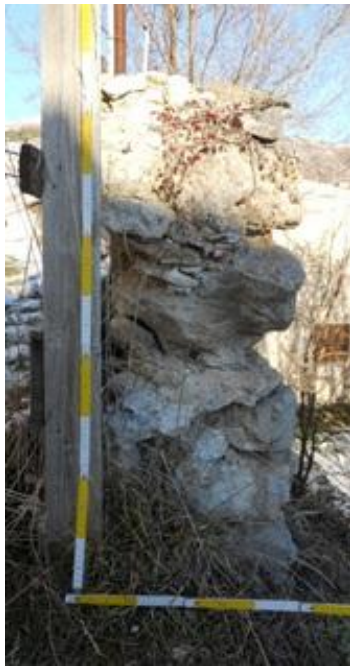
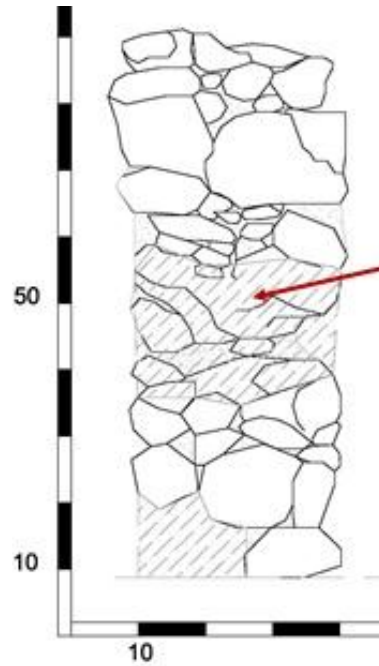
2.53 Section Photo (Aggregate CdM 115)

2.54 Section Diagram (Aggregate CdM 115)

larger connecting stones, indicated by the red arrow in the diagram above, on the right. Also it is

important to note the presence of limestone wedges that connect that increase the structural stability of the section. The mortar within the section is in good condition and is of firm consistency. The aggregates are larger than the visible mortar on the surface, which are instead of

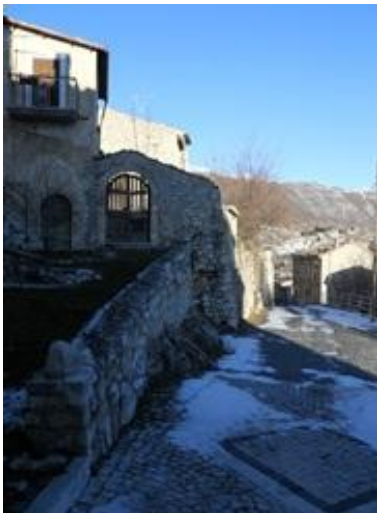
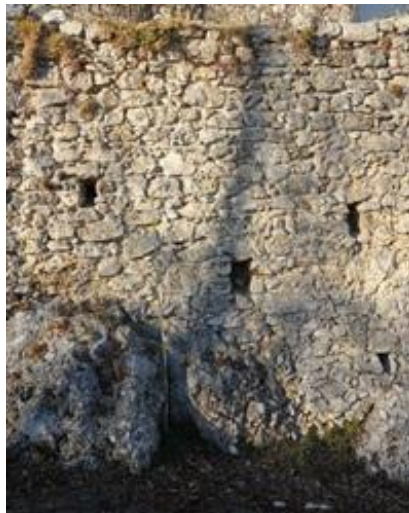
2.55 Overall Ruins - Photo

2.56 Ruins Elevation - Photo

Due to a lack of information available, it is impossible to conclude the cause of collapse based solely on analyzing the masonry section of the ruins, however the quality of the masonry can be

noted. In the case of both analyzed section, the quality of masonry was low or medium (regarding the three masonry typologies present in Castel del Monte), but was assembled with a certain effectiveness and knowledge of construction and anti-seismic design. The lack of evidence of masonry failure suggests that the quality of masonry in Castel del Monte, even the quality of the lowest masonry typology one, is still structurally reliable regarding its vulnerability to seismic events. This then puts all other elements involved as a possible factor in the collapse of these two previously discussed structures or the possible future collapse risk of the still standing structures within the historic center. It is also important to note that both structures are oriented parallel to the elevation curves.

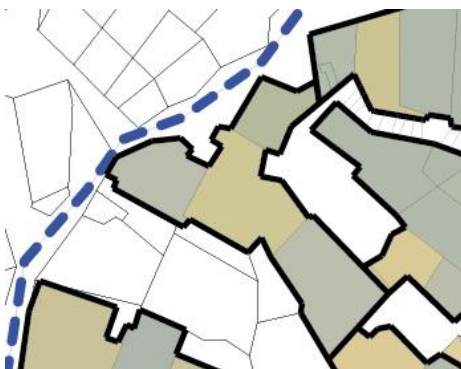
2.58 Collective Homogeneity

As seen in the collective homogeneity analysis below, overall the aggregate is extremely homogeneous. The aggregate is made of four connected buildings, all of which are structurally diverse with the four factors taken into consideration for the collective homogeneity analysis. In addition, the plan of the aggregate as well as the individual structures is extremely

irregular. This adds to the overall vulnerability of the aggregate in the case of a seismic event. As seen in the separate diagrams above, the Northern most structure of the aggregate is the least

homogenous, regarding the overall aggregate. It is the only structure within the aggregate that is oriented perpendicular to the elevation curves. In addition, it is also composed of a different masonry typology than the other half of the structures within the aggregate. This diversity of a single element suggests this particular building was added to the aggregate after its initial construction. Additions do not necessarily imply vulnerability, but when they are constructed without considering the existing construction typologies in place, as is the case in this particular aggregate, they can risk the structural stability of the entire aggregate in the case of a seismic event. Beyond this particular structure, the aggregate is fairly homogeneous, especially with regards to the building heights that are all equal.

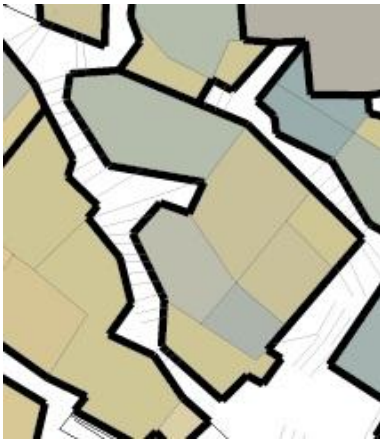
2.65 *Collective Homogeneity*

conjecture. The entire aggregate is oriented parallel to the elevation curves. However the aggregate lacks in homogeneity in both masonry typology and building heights. There are seven total structures within the aggregate. In the case of the building heights, almost all of the buildings are touching at least one other structure within the aggregate with a height difference of two stories. In addition, one of the structures on the South-East of the aggregate

has tower like characteristics, which could lead to potential collapse mechanisms. Regarding the

masonry typology, three different typologies are present and located throughout the aggregate. In the case of a seismic, this could lead to the separate structures within the aggregate reacting in different manners, which is only amplified by the extreme differences in height within the aggregate. Overall this aggregate can be considered extremely vulnerable in the case of a seismic event, especially with its proximity to San Marco church.

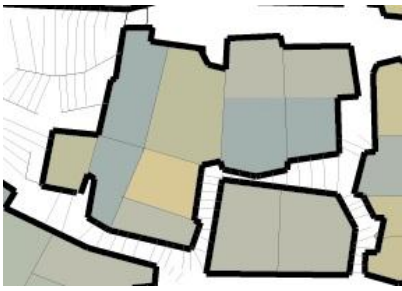
2.70 *Collective Homogeneity*

The third negative example comes again from the Central-North portion of the historical center, in the form of aggregate CdM 002. The aggregate is formed by eight separate structures. This negative example is unique due to the fact that the masonry throughout the aggregate is entirely uniform, which suggests a recent restoration. However regarding the remaining three factors considered for the collective homogeneity analysis, the aggregate functions as two separate units. Half of the aggregate is oriented perpendicular to the elevation curves, while the other half is

oriented parallel. In addition, the structures in the aggregate are taller on the half of the aggregate that is uphill, while the other half that is downhill is shorter. This is a common construction characteristic within both Castel del Monte and other hillside villages. This type of structural scheme requires addition buttresses

and tie rods to avoid the common collapse mechanism of out of plane wall overturning. This

aggregate is extremely vulnerable to this particular collapse. Therefore this example is very important when considering the overall vulnerability of the village, specifically discussed later in this thesis.

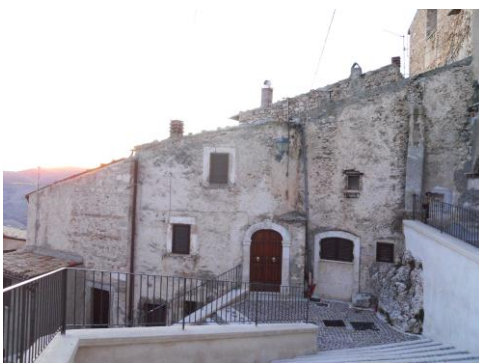
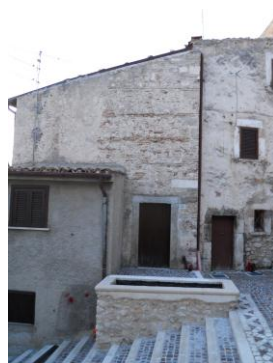
2.77 *Photo of aggregate CdM 001*

2.78 *Photo of CdM 001*

the San Marco church, aggregate Church. This negative example of structural homogeneity is found in aggregate CdM 001. Similar to the previous example of structural

irregular in both plan and elevation. In addition, considering the collective homogeneity analysis, the aggregate, made of six separate structures, is lacking in structural homogeneity regarding all four of the considered factors. The center of the structure is oriented parallel to the elevation curves while

the two end sections are oriented perpendicular. This could reveal that both the end sections were additions after the initial construction phase and therefore vulnerable to collapse, away from the center portion of the aggregate. The aggregate is fairly homogeneous regarding the masonry

as well as the possible out of plan wall turning of the downhill facades. In order to diminish the vulnerabilities to collapse present in the aggregate, several structural renovations are essential, including the addition of buttresses on the Southern facades as well as stronger connections between the three separate portions of the aggregate. These interventions will prevent substantial damages both to the aggregate as well as the adjacent church in the event of future seismic activity.

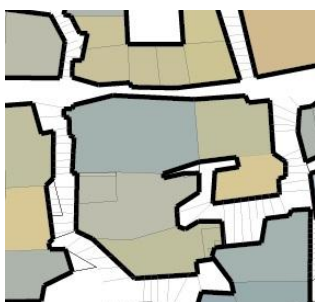
2.88 Collective Homogeneity

the elevation curves, the aggregate is completely homogeneous. The masonry typology and building heights are homogeneous in all four of the buildings within the aggregate. The largest concern is the sectional separations within the aggregate and different orientations to the elevation curves. In both cases, the addition of buttresses and stronger

connections between the buildings are integral in avoiding future collapse mechanisms or major damages in the case of a seismic event.

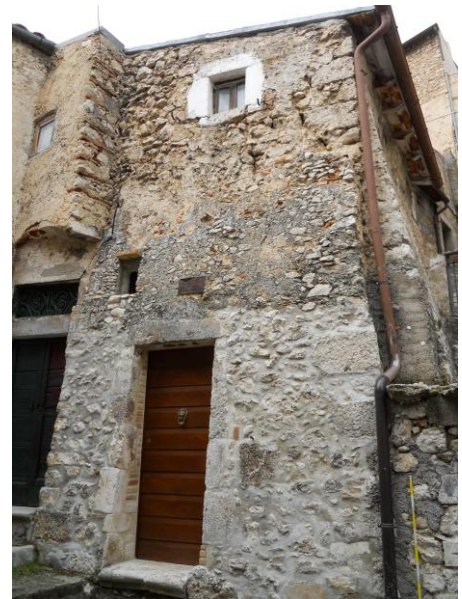
2.94 Photo of aggregate CdM 036

this aggregate has been added to and renovated on multiple occasions since its original construction.

of the aggregate is oriented parallel to the elevation curves while the Northern portion, consisting of three separate buildings, is oriented perpendicular as seen in the diagrams below. The heights of the aggregate vary significantly, with a tower like structure at the South-East corner of the aggregate. In addition, the masonry typology consists of three separate types. The North-East corner of the aggregate is covered in plaster, which implies a recent restoration of the structural

masonry. The North-West corner however is composed of masonry typology one, while the entire Southern portion is made up of masonry typology two. This also implies the addition of an piece to the Southern portion of the aggregate. Overall the aggregate, regarding renovations, needs the

addition of both plaster covering for the exposed masonry as well as tie rods in order to better the

connections between the individual units of the aggregate. These interventions will not only help to minimize the effects of decay on the structural masonry, but also deter the out of plane actions of the Southern wall, in the case of a seismic event.

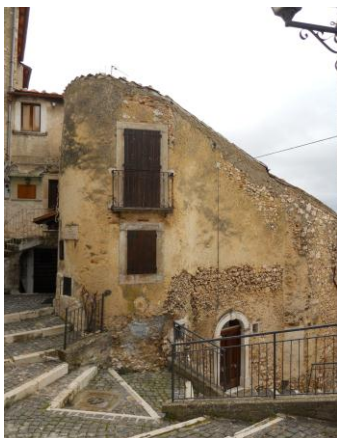
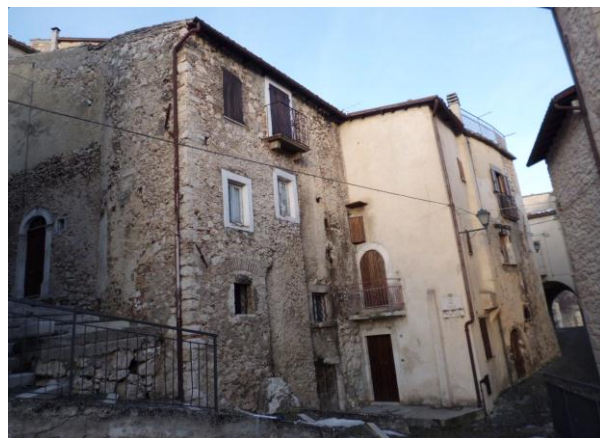
2.109 South-East Elevation of Aggregate

2.110 North-East Elevation of Aggregate

collective homogeneity analysis, further observation implies several stages of renovations and additions that failed to respect the existing masonry and construction typology. Similar to many of the previous negative examples of structural homogeneity, the aggregate is extremely irregular in plan. The entire aggregate is oriented perpendicular to the elevation curves. While being oriented

aggregate. The largest risk, regarding structural vulnerabilities in seismic events, is the masonry typology of the aggregate. There are three different masonry typologies present in the aggregate and several are present in single units of the aggregate. As seen in the photos

the aggregate have been added over the years, mixing several masonry typologies in single units.

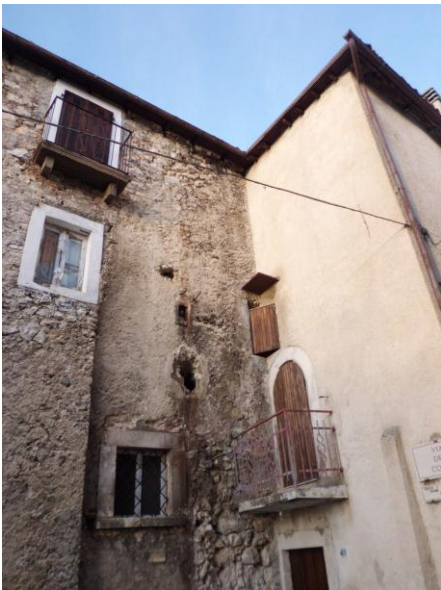
2.125 Negative Opening Example No.1

example number one, there are several structural flaws considering the location of the openings. In general, the openings are extremely close to one another. In addition, there is an opening in the corner which destroys the continuity of the vertical structure, increasing the likeliness of shear

failure. Examples two and three are further examples of openings being placed too close to one another, thus compromising the structure of the wall. The positive examples seen to the left utilize openings placed far apart as well as being placed somewhat off

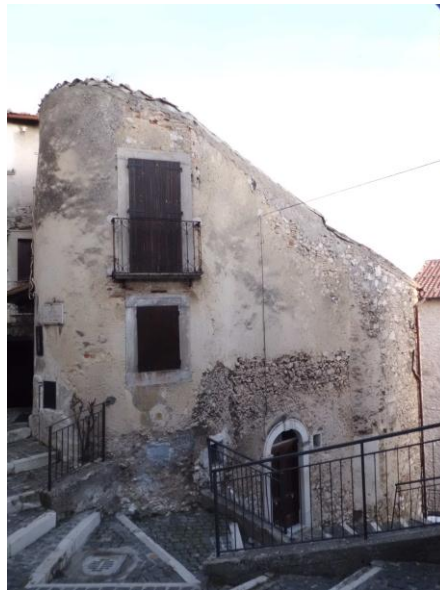
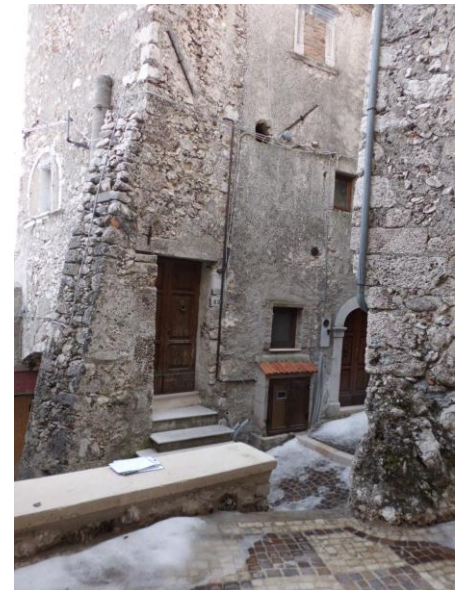
2.126 Negative Example No.2

2.127 Negative Example No.3

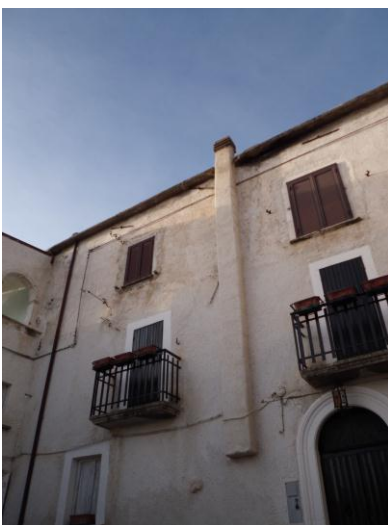
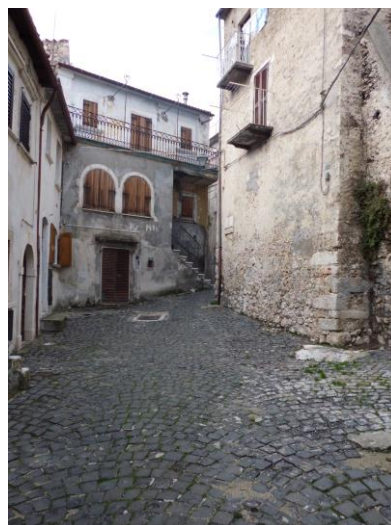
2.128 Positive Example No.1

2.129 Positive Example No.2

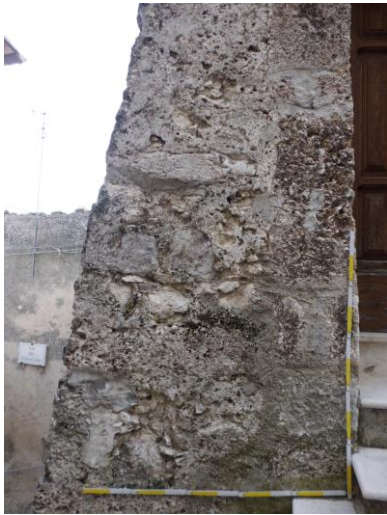
2.130 Example of Buttress in CdM

Castel del Monte, similar to the other three villages within the Baronia collective, has both buttresses and tie rods placed throughout the entire historical center. As seen in the attached “Permanent Interventions” map, the structural interventions in some cases are both present in a single structure. The effects of these interventions either separately or together are described in the

introduction. Both are essential in structural interventions in seismic events but only when they are used properly. In the case of Castel del Monte, the types of buttresses and tie rods are typical in nature.

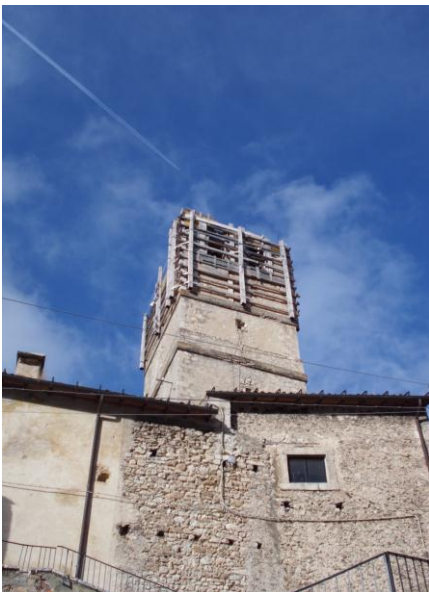
2.134 Damaged in Castel del Monte

no terrain feature in the area that amplifies the force of a seismic event. The worst area for damages was seen at the San Marco church as well as the attached aggregate that is a part of the historical boundary wall of the city. This area is extremely vulnerable, which has been previously discussed in the "Building Typology" section. The only major structural damage, the tower of the San Marco church, is a part of this region with a majority of the buildings sustaining level E damage. As seen in the photo to the left, the tower suffered moderate structural damage

including cracks and small collapsed pieces. The damages sustained are typical of tower structures in seismic areas and the temporary wooden grid intervention is common to prevent the collapse mechanism of wall overturning.

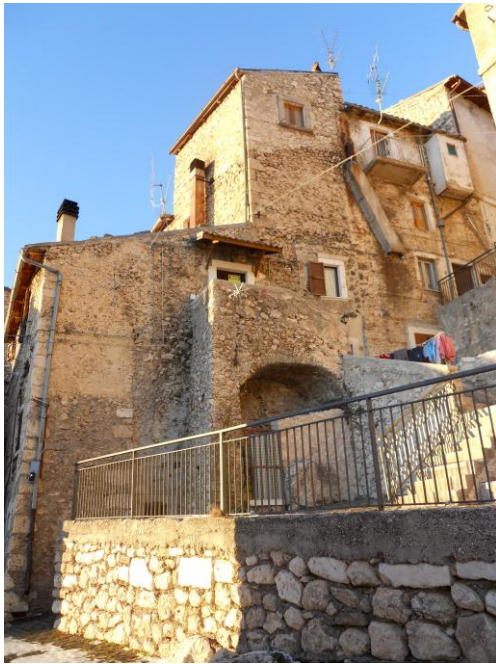
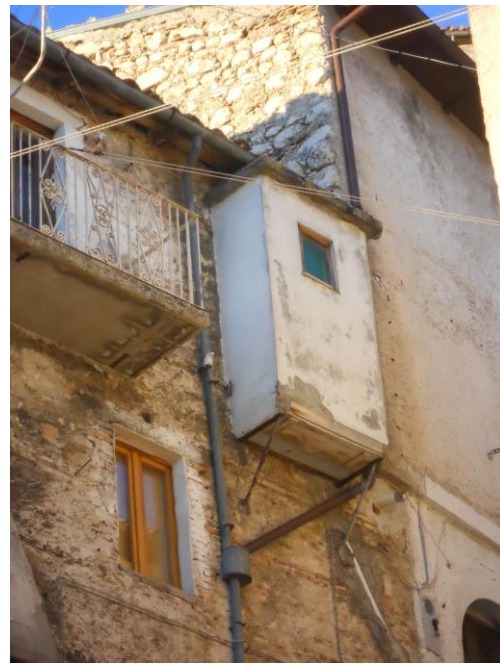
Figure 2.135 Aggregate CdM 013

The first example of one of the more vulnerable aggregates is found in the heart of the historic center, near the San Marco church, specifically in aggregate CdM 013. This example, as all

of the examples chosen for further analysis in the vulnerability conclusion, was also chosen as one of the previously discussed negative examples. This example has been chosen for several reasons. First

and foremost this aggregate was chosen due to the fact that two of the six structures are inhabited.

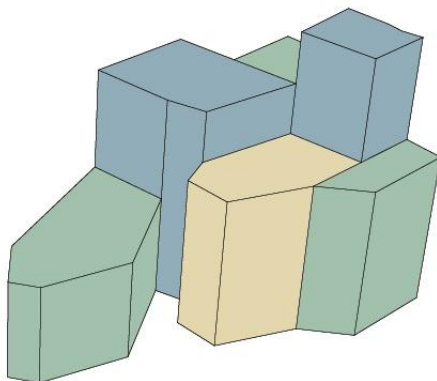
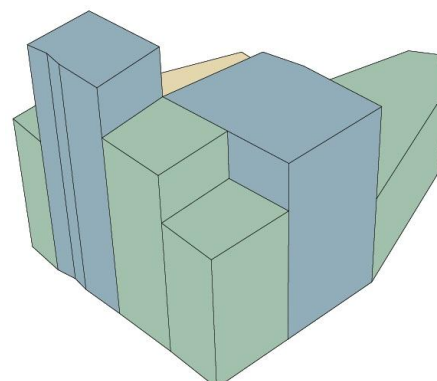
Figure 2.137 Aggregate CdM 013 Model

In addition, as previously mentioned, this aggregate has been determined to be negative regarding its collective homogeneity. As seen in the models above, the aggregate is extremely irregular regarding the building heights and masonry typology composition. There were also damages in the aggregate after the 2009 L'Aquila seismic event and not all of the structures within the aggregate have permanent structural interventions in place. As seen in both figures 2.135 and 2.136, there is also irregularity in both additions to the structures as well as openings. Openings have been placed too close to structural elements such as the roof or corners. Also additions, such as bathrooms have been added as cantilevers to the original structure which is extremely vulnerable to collapse in the case of a seismic event due to the uneven mass distribution. It is also important to note the extreme changes of the aggregate over time, with elements of different masonry composition, has contributed to the determination of this particular aggregate as a high priority level. Regarding a future for this aggregate, there are several restoration options available. First and foremost, additional permanent and temporary structural interventions need to be added to better control the reactions between the irregular units within the aggregate. These interventions should specifically be placed in vulnerable areas such as fulcrum points between two attached structures of different heights as well as in locations such as the cantilever addition seen in figure 2.136. In addition, any damages sustained during the most recent seismic event of 2009 need to be thoroughly analyzed and resolved to better protect the inhabitants of the aggregate.

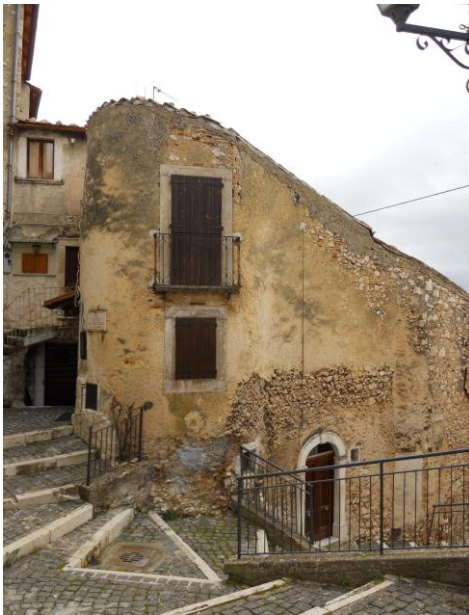
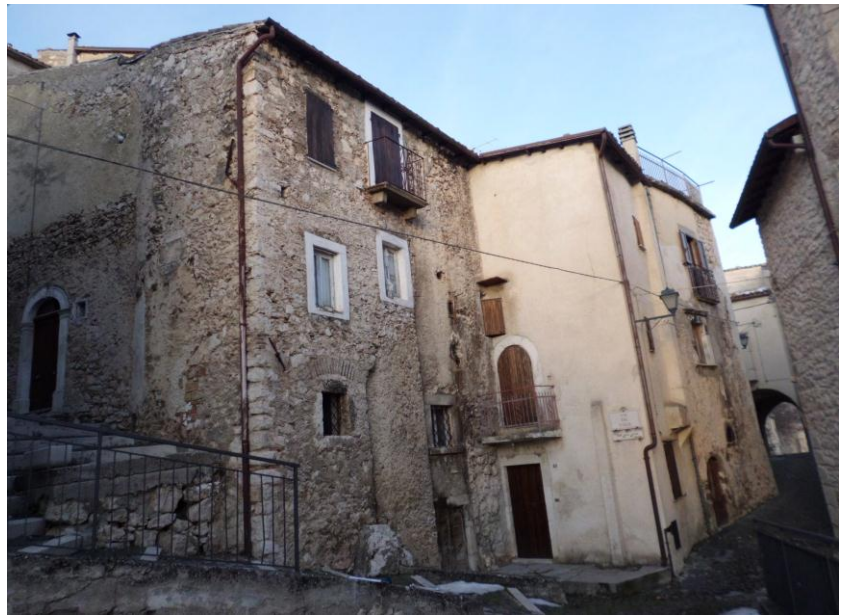
Figure 2.139 Aggregate CdM 101

The second example of a high priority structure is found in the historical center, specifically in aggregate CdM 101. This example has been previously discussed as one of the negative examples within Castel del Monte. This aggregate has been chosen for several reasons, the first of which is that one of the six structures within the aggregate is currently inhabited. In addition, as previously mentioned, the aggregate has been considered to be negative regarding its overall collective homogeneity. This particular aggregate is extremely irregular in both masonry typology composition and the building heights of the individual units within the aggregate. The aggregate is also irregular in

both plan and elevation. There were also damages in the aggregate after the 2009 L'Aquila seismic event and not all of the structures within the aggregate have permanent structural interventions in

place. As seen in both figures 2.139 and 2.140 there is also irregularity in both additions to the structures as well as openings. Openings have been placed too close to structural elements such as the roof or corners. Regarding a future for this aggregate, there are several restoration options available. Additional permanent and temporary structural interventions need to be added to better control the reactions between the irregular units within the aggregate. These interventions should specifically be placed in vulnerable areas such as fulcrum points between two attached structures of different heights. In addition, any damages sustained during the most recent seismic event of 2009 need to be thoroughly analyzed and resolved to better protect the inhabitants of the aggregate.

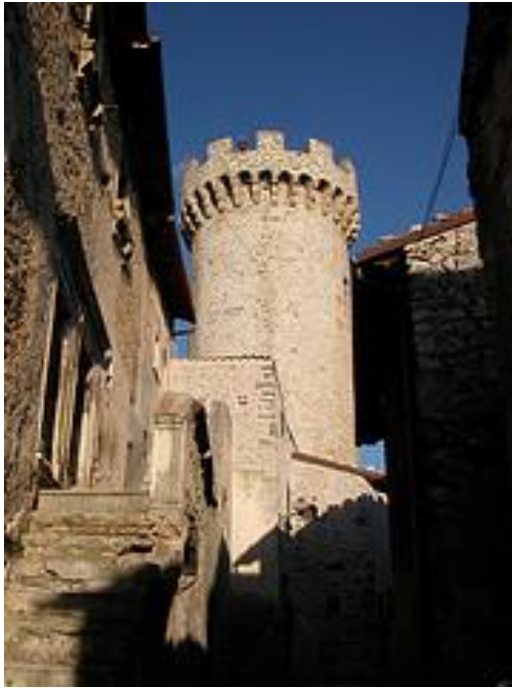
Figure 3.2 Tower of Medicea – Pre Seismic

Santo Stefano has also recently come into popularity due to the effects of the 2009 L'Aquila earthquake on the village. One of the village's churches, the 17th Century Church of Madonna del Lago, lost most of its front façade and suffered severe roof damages. In addition, the village lost the symbol of the city, the Medicea tower, which collapsed due to the seismic event. As will be discussed in further detail in the "Permanent Intervention" section, it is believed that the collapse of the prized tower was due to 20th Century renovations. These renovations aimed at replacing the structure of the tower's observation platform. The original structure was a wooden deck but was replaced in the restoration process by a deck made of reinforced concrete. This renovation thus made the tower top heavy and in the case of the 2009 seismic event, made the period of movement of the tower much higher thus leading to its collapse. The cost, determined immediately following the collapse, of the

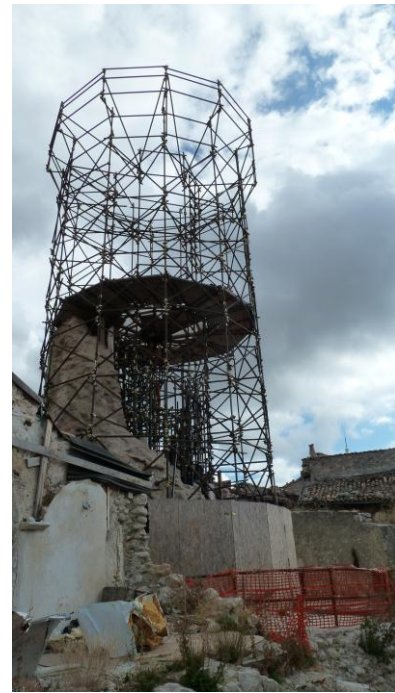
Figure 3.3 Post Seismic

post-seismic restoration of the tower has been estimated to be one million euros, for an intervention process of over two years. This tower has been used in many studies concerning the restoration of the L'Aquila region, following the 2009 earthquake.

Therefore the restoration and rebuilding process of the Medicea tower is of high priority. The approximate cost of the restoration has been set at one million euro and should last approximately two years to complete the intervention. Currently, as seen in figure 3.14.2a, temporary scaffolding has been set in place, however substantial restorative or structural work has yet to begin. This particular tower will be an important point when considering the use of the limited public funds for restoration within the Baronia collective. While the

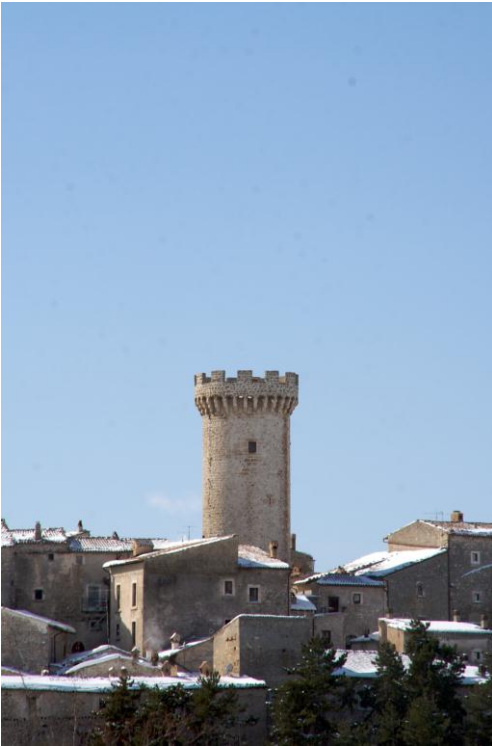
Figure 3.8 Pre-Seismic Medicea Tower

The fourth and final tower in Santo Stefano di Sessanio, as previously mentioned, is the tower of Medicea. The tower was built in the initial construction of the village and became a symbol of Santo Stefano di Sessanio before its eventual collapse in 2009. The tower survived several major and minor seismic events over its extensive life time and only suffered collapse after a 20th century structural restoration. This restoration replaced the original wooden viewing deck with a reinforced concrete version. The addition of reinforced concrete failed to respect the existing construction as well as the existing structural mechanics of the tower. The addition of the heavier viewing deck

created a top heavy effect to the tower. When the seismic event struck in 2009, the tower, with a much heavier deck, reacted to the seismic event with more momentum and therefore experienced an exaggerated period of movement. These new structural dynamics would be too much for the masonry structure to take in the case of a seismic event and led to its eventual collapse. This renovation will be further discussed in the “Permanent Interventions” section.

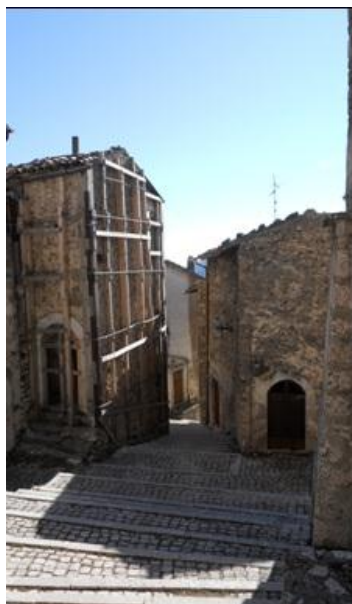
Figure 3.12 Unknown Aggregate

the Baronia collective, a connection between buildings oriented perpendicular to the elevation curves with partially or completely collapsed structures has been observed. While this is just an on-site

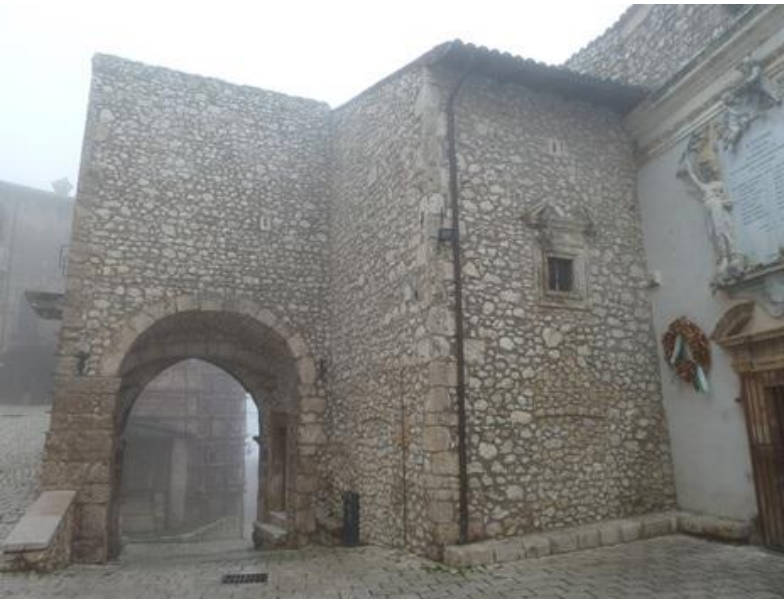
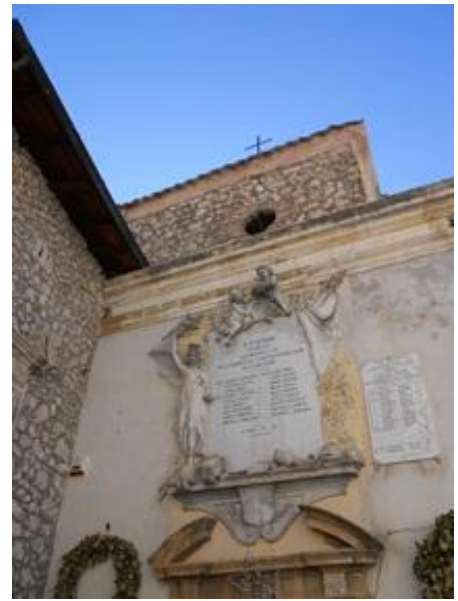
There are three churches or religious structures present in Santo Stefano di Sessanio, all of which are located within the original historical center. The first example is found in aggregate SSS 047. This particular church is situated within the historical defensive boundary wall, surrounding the original historical center of Santo Stefano di Sessanio. The church is irregular in plan as well as in mass distribution due to its varying heights. During the most recent seismic event of 2009, the church sustained little to no damages. Similar to many churches with the region of Abruzzo, this church, although constructed with higher quality materials, is extremely vulnerable to seismic activity. Renaissance or Roman churches are characterized by large vaults and high ceilings. In

In addition, they are popular in use due to their cultural and social importance within Italy. Despite their higher construction standards, as is the case of this particular church, permanent structural interventions are recommended in order to minimize damage to the cultural patrimony of the village as well as to minimize the casualties in the case of the next seismic event to come. Luckily, this church has a rectangular façade, which can help to minimize the common out of plane wall overturning in church facades.

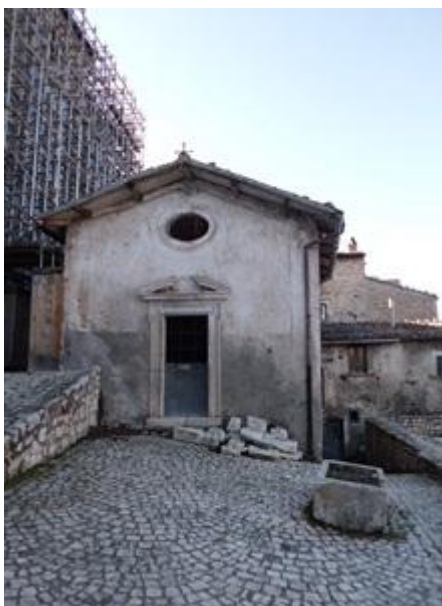
Figure 3.17 SSS 014 Front East

The second example of a church or religious structure within Santo Stefano di Sessanio comes from aggregate SSS 014. This religious structure is rare within the Baronia collective due to its inclusion within an aggregate. As seen in the image to the left, the aggregate to which the church is

connected is currently under restoration due to minor damage after the 2009 earthquake. The church is the smallest of the three present in Santo Stefano di Sessanio. Similar to the other churches in the area, the church is composed of high quality masonry as well as created using higher construction standards. This church is less vulnerable than the other two present in the village due to its extreme regularity, small stature and lack of vaults. However this church is not isolated and is therefore vulnerable to the influences of the aggregate in which it is

located. Therefore any recommended structural interventions would be regarding its connection to the buildings within its aggregate.

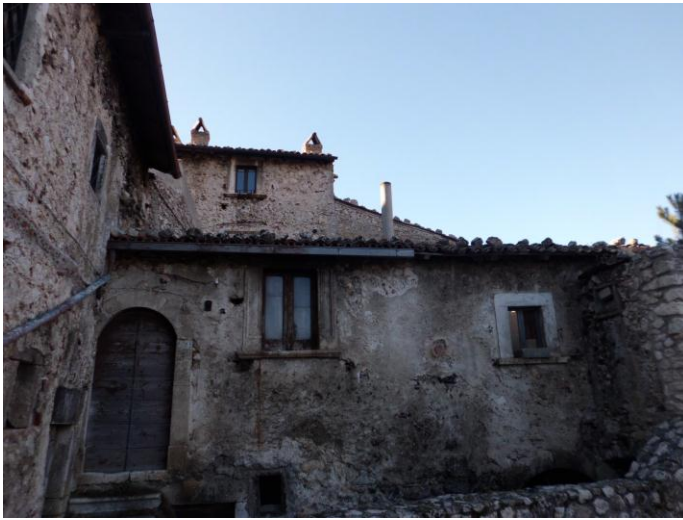
Figure 3.22 Aggregate SSS 014

Masonry typology one is present in several of the structures categorized as in the historical building wall house building typology. The example to be examined comes from aggregate SSS 014. This particular aggregate is located within the historical center. All of the structures within the structure are currently of private use and uninhabited. As seen in the photo below of the overall aggregate, the structure is composed of structures of varying height. In addition, the building within the aggregate have not been used in a substantial amount of time. This is the case with several

structures in Santo Stefano di Sessanio. In most cases, structures composed of masonry typology one were originally covered in a plaster covering in order to protect the masonry structure below. As seen in the figures below, the masonry typology one present in this particular aggregate also was once covered in plaster. However the plaster

has begun to decay and is revealing the masonry typology below. This slight decay of the plaster

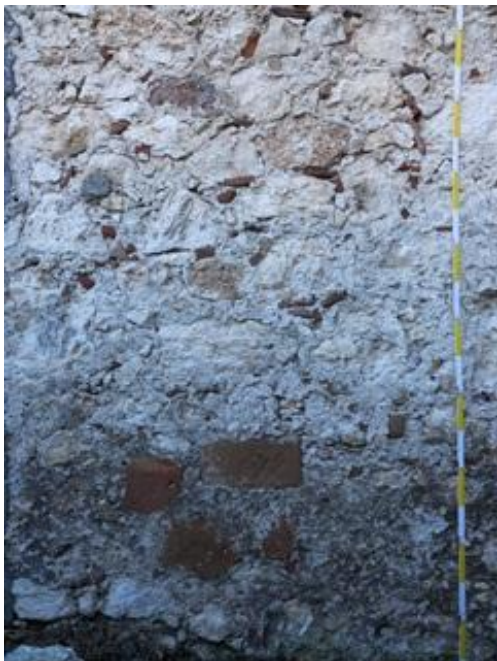
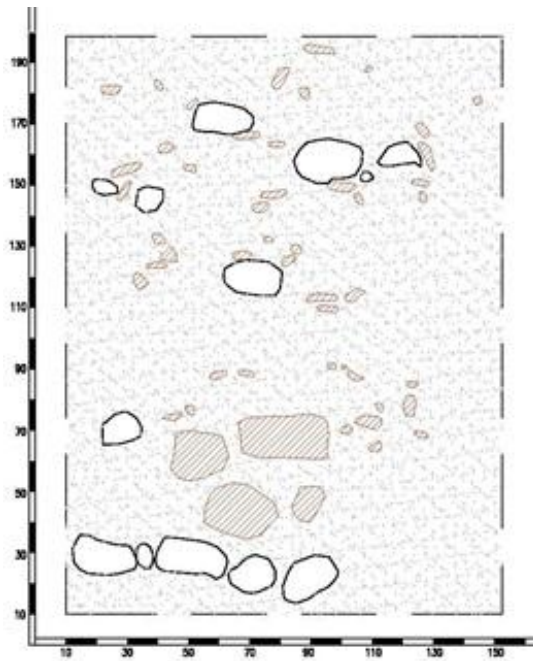
Figure 3.23 Typology 1 Historical Boundary Wall

Figure 3.24 Typology 1 Historical Boundary Wall

cover implies a recent restoration or renovation, due to the fact that the original structure was built

when the city of Santo Stefano di Sessanio was initially constructed. As visible in the photos and masonry analysis above, there are no distinctive horizontal or vertical structures within the masonry which is what categorizes the masonry as the lowest quality present in Santo Stefano di Sessanio. However it is important to note that this structure has survived hundreds of seismic events and should not be considered structural insufficient regarding the masonry typology.
