POLITECNICO DI MILANO

The Role of Structural Homogeneity
in Seismically Active Historical Centers of Abruzzo

Castel del Monte, Castelvechio di Calvisio, Santo Stefano di Sessanio, Villa Santa Lucia degli Abruzzi

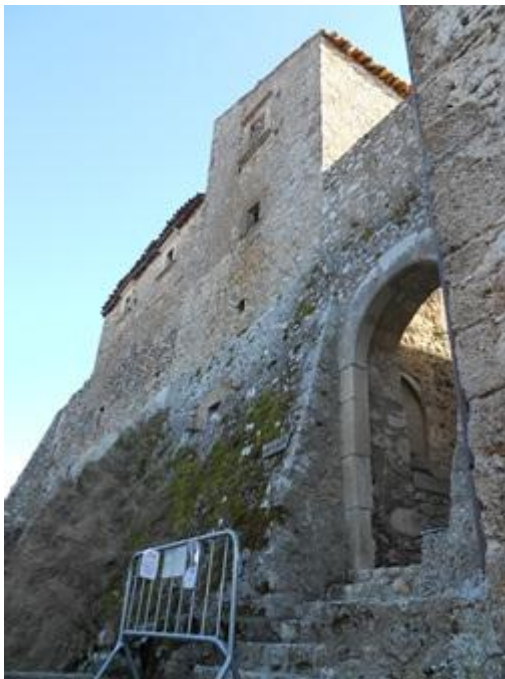
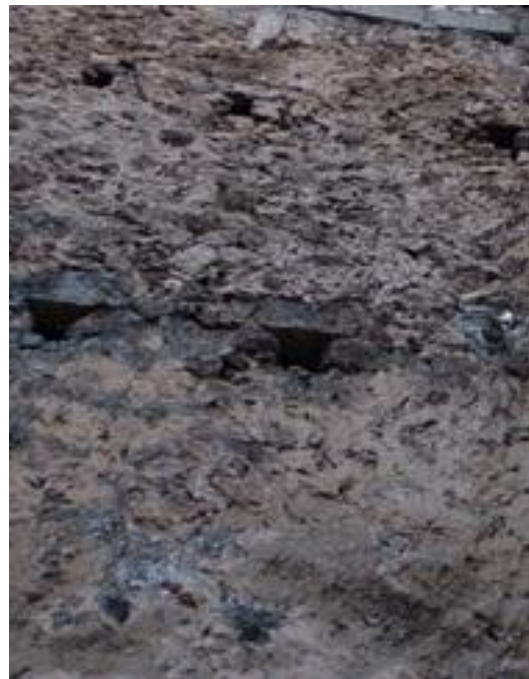
Figure 3.25 Aggregate SSS 017

Figure 3.26 Typology 1 Tower House

017. This example is located within the historical center, attached to the historical boundary wall. This aggregate is also located adjacent to the tower of Medicea. This particular aggregate is currently of private use, with all of the buildings currently uninhabited. The structure also originally had a plaster covering of the masonry structure but, as seen in the photos above, it has been decayed over time revealing masonry typology one as the primary structure. This particular example of masonry typology one is of a higher quality, with a slight presence of horizontal rows of the bricks. This higher quality of the masonry is due to the social importance of the historical boundary wall of the historical center. This wall overall was created using higher quality stones as well as a higher

construction quality. However the overall formation of the structure can still be considered to be masonry typology one.

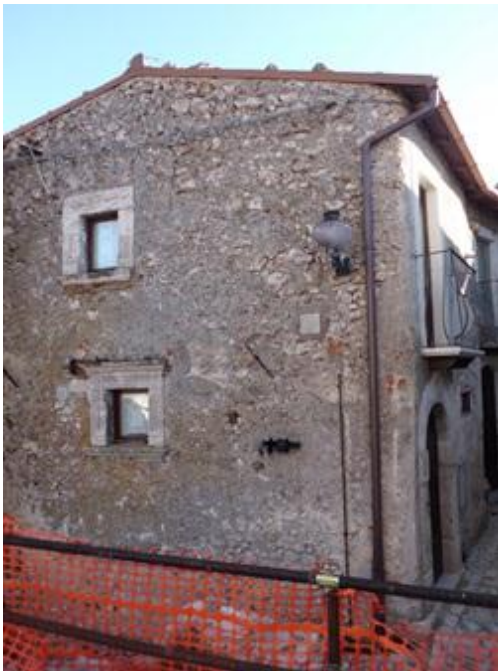
Figure 3.27 Aggregate SSS 001

SSS 001. This particular aggregate is located within the historical center of the village. In addition, the aggregate is currently of combined public and private use. The single building within the aggregate of private use is the only structure within the aggregate that is currently inhabited. As seen in the photo to the left, the aggregate is composed of structures of similar heights and has several forms of permanent structural interventions. The masonry typology present is highly visible due to a high level of decay of the protective plaster cover. Again the masonry lacks any

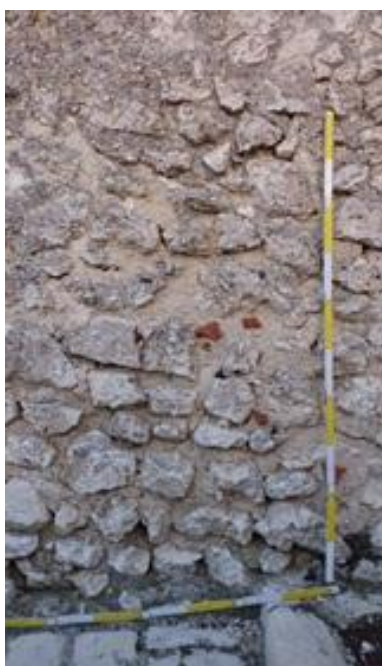
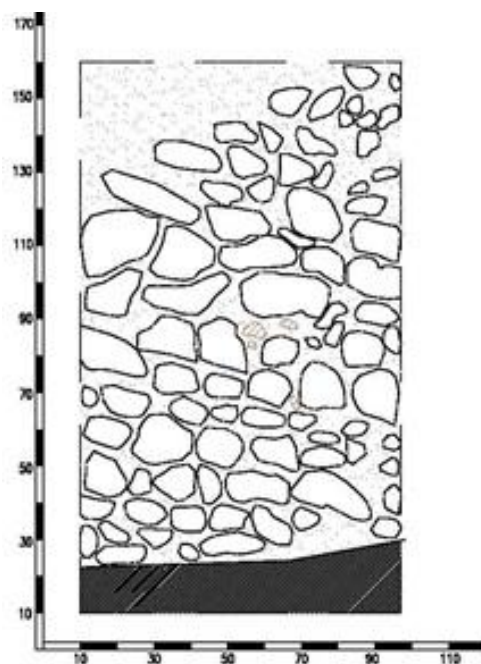
Figure 3.28 Typology 1 Parallel

Figure 3.29 Typology 1 Parallel

consistent horizontal or vertical structures. The overall composition of the masonry is structural stability but is still the lowest quality masonry typology within Santo Stefano di Sessanio. The irregularity of the stones, clearly visible in the attached masonry analysis figures is evidence of the fact that the masonry stones come from the surrounding area, which was the most economical choice when the village was originally constructed. This is one of the better examples of masonry typology one within Santo Stefano di Sessanio due to the quantity and consistency of the masonry stones within the structure.

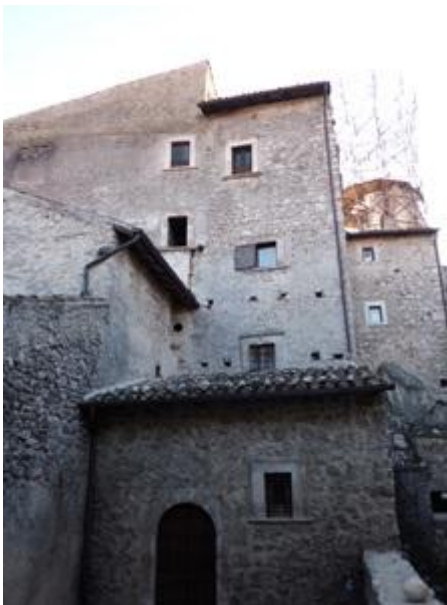
Figure 3.30 Aggregate SSS 016

aggregate is located within the historical center but is unattached to the historical boundary wall. The aggregate is composed of five structures, all of which are both privately owned and currently uninhabited. In addition, as seen in the photo to the left, the aggregate is composed of several buildings of varying heights. The structure in question is composed of masonry typology one with a plaster covering that has experienced substantial decay, revealing the structural masonry typology present. Similar to the previous example of

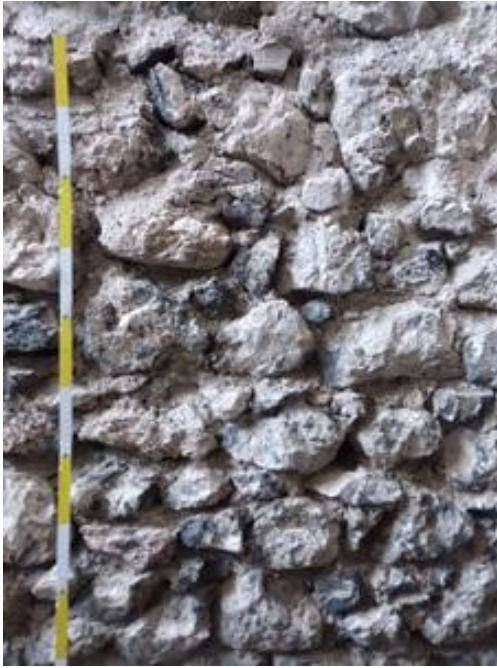
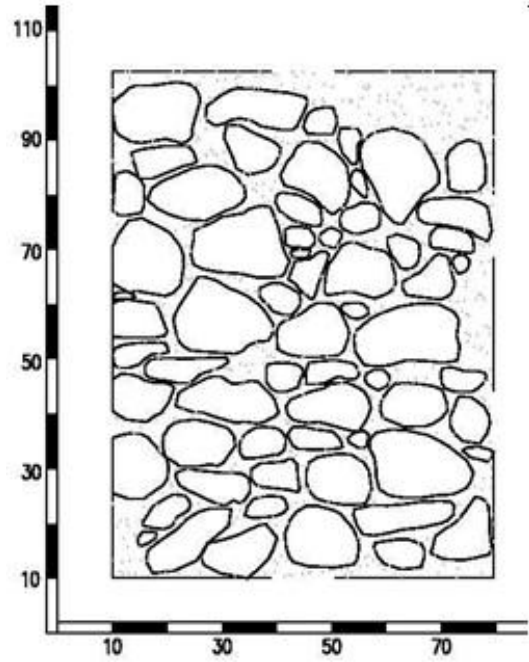
Figure 3.31 Typology 1 Perpendicular

Figure 3.32 Typology 1 Perpendicular

characteristics of this masonry example to note are the varying sizes of stones used in the masonry, as well as the properly spaced distances between each of the stones. In addition, despite the loss of the plaster cover, the masonry still maintains a large amount of mortar, helping to stabilize the masonry in the case of a seismic event. Of all the examples of masonry typology one within Santo Stefano di Sessanio, this is one of the higher qualities examples.

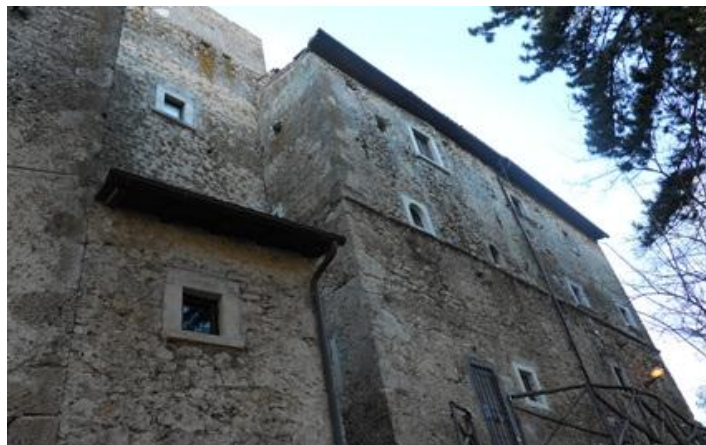
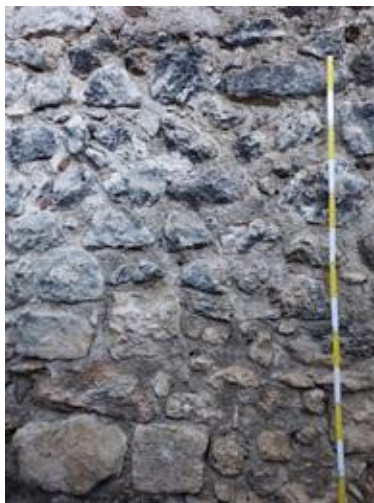
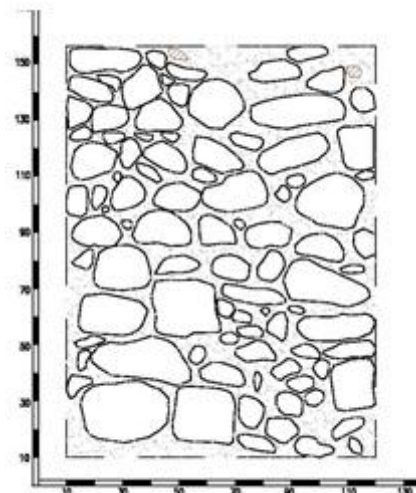
Figure 3.35 Aggregate SSS 017

Figure 3.36 Typology 2 Historical Boundary Wall

Figure 3.37 Typology 2 Historical Boundary Wall

masonry analysis above, there are very few traces of the once existent plaster covering of the masonry, which has now almost entirely decayed away. The revealed masonry has a subtle presence of horizontal rows of stones. The masonry is also of higher quality due to the proper spacing between stones as well as the varying sizes of the stone which provide a stronger structural stability. Due to the massive heights of the structures within the historical boundary wall, the masonry typology becomes extremely important regarding the structure's vulnerability in the case of a seismic event. The structure is also supported with the addition of buttresses in order to prevent the out-of-plane wall overturning tendencies of taller structures such as those within this particular aggregate. It is however important to note that the masonry typology, while of higher quality, is a single element when considering the overall vulnerability of both a single building as well as an aggregate.

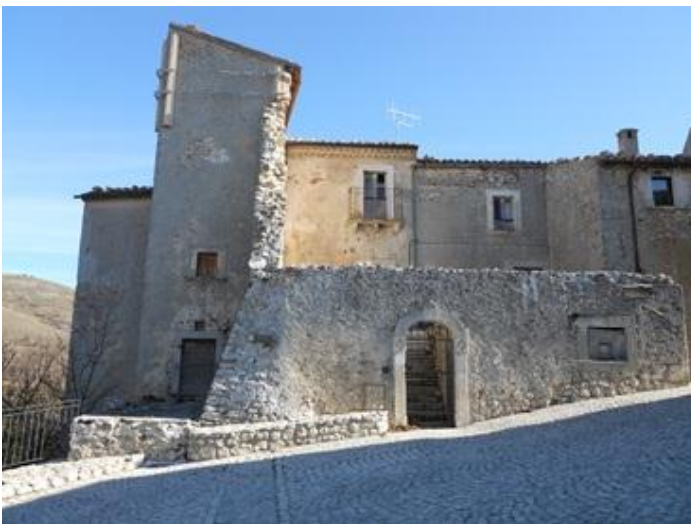
Figure 3.38 Typology 2 Historical Boundary Wall

wall. The entire aggregate is currently privately owned as well as being uninhabited. The structure under analysis is partially collapsed and therefore has provided the rare opportunity of observing the masonry typology two in section. The wall is a typical exam of masonry typology two, with the presence of horizontal rows

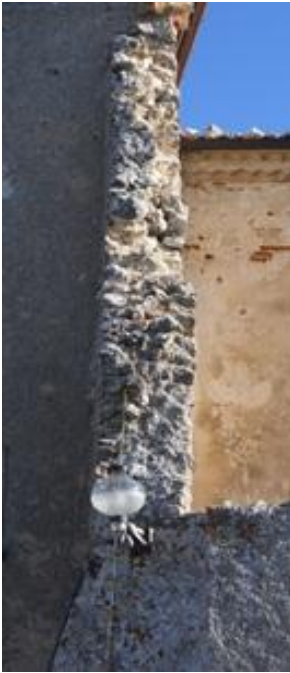
Figure 3.39 Typology 2

as well as higher quality stones, placed properly apart. As seen in the photo below of the masonry section, the section is composed of two structural leaves. Based on observational analysis alone, there appears to be poor connection between the two leaves of the section. In addition, there appear to be little to no large stones that span the entire width of the section. This is important to note

because a lack of connection between leaves in a masonry section can produce several types of damages as well as potential collapse mechanisms. These characteristics are important to note due to the lack of thorough structural information provided through the observation analysis of exposed masonry on the structure's façade. In order to thoroughly analysis the masonry structure, both structural exams and samples would have be taken from the site. However in this case, the sectional view is a fairly accurate assessment of the structural faults present in this particular example of masonry typology two. The second building typology in which masonry

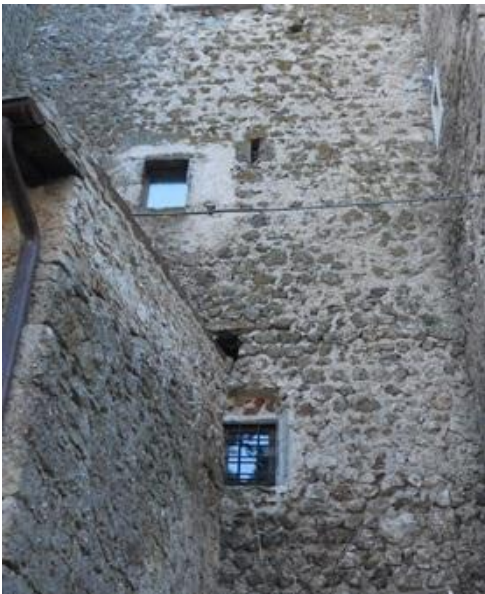
Figure 3.40 Aggregate SSS 017

well as uninhabited. While no elevation analysis was available, even in the photo to the left, the masonry typology is clear. There is a substantial presence of horizontal rows of the stones as well as a high quality of stones both regarding cut and shape. Masonry typology two is strongly defined by its regularity in form and higher quality construction. Again, structures within the historical boundary were generally given more structural importance due to their social place within the village. While there is a small presence of a plaster

covering, most of this protection from the elements for the masonry has decayed. This implies a restoration within the lifetime of the structure, if not recently. This is to be expected given the social standing of the tower within the historical boundary well.

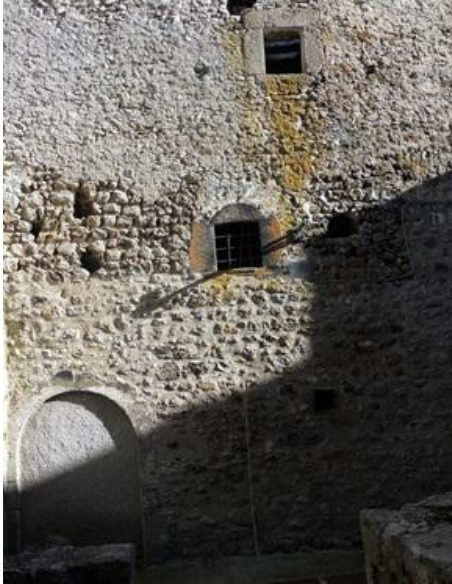
Figure 3.41 Aggregate SSS 013

aggregate, three are structurally composed of masonry typology two, one of the most of any single aggregate. This example has almost no evidence of the once existent plaster cover and therefore is extremely accessible regarding observational analysis. As is seen in the attached figures of the masonry analysis, the masonry composition is extreme regular, with a subtly visible presence of horizontal rows. In addition, the masonry typology is composed of stones of varying sizes that are properly placed apart. The quality of the masonry is

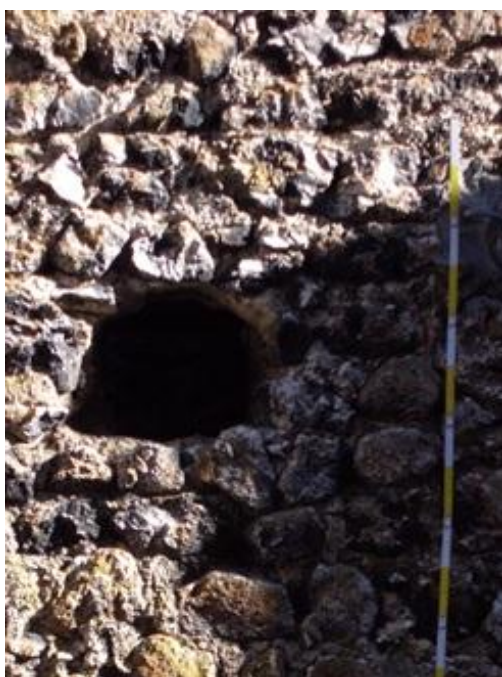
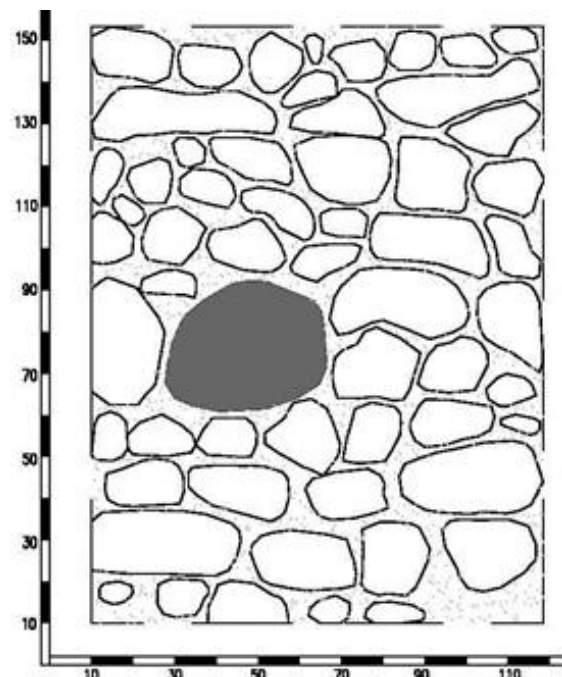
particular aggregate is also extremely important considering the varying sizes of the separate structures within the aggregate. Another strong consideration in choosing this specific example was the amount of openings within the façade of the structure. This the elevation example analyzed is taken at one of these opening. As is seen in the masonry analysis below, the opening is a fluid

Figure 3.42 Typology 2 Parallel

Figure 3.43 Typology 2 Parallel

element within the masonry structure. The opening fails to interrupt the rhythm of the masonry. This is important to note considering the structural importance of openings within a masonry structure. This will be further discussed in the Openings section 3.10. In this particular masonry sample, it is also important to note the size of the stones. These stones are the typical size of stones found in the surrounding region. These stones are of high quality and have been constructed with high quality, which is expected for structures within the historical center of the village. This choice of stone was also considered to be economical due to the lack of transportation costs.

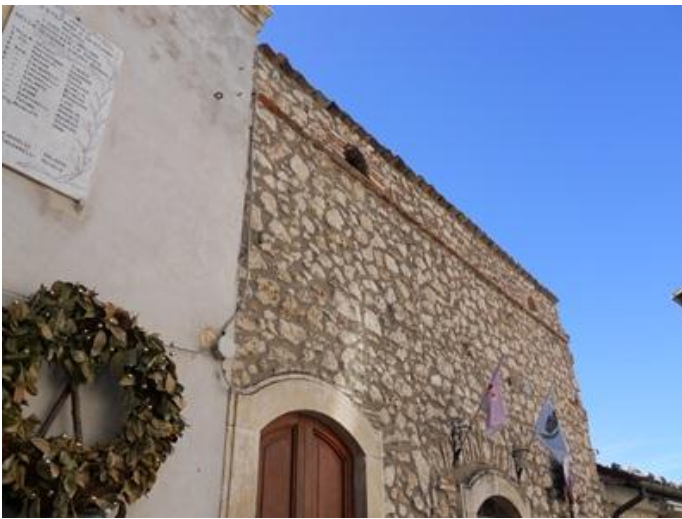
Figure 3.46 Aggregate SSS 047

There is no plaster cover present to protect the bricks and there is no evidence to suggest that there was a cover at one time. This appears to be an aesthetical choice. In addition, it is important to note the varying sizes of the masonry stones as well as the proper spacing between each stone element.

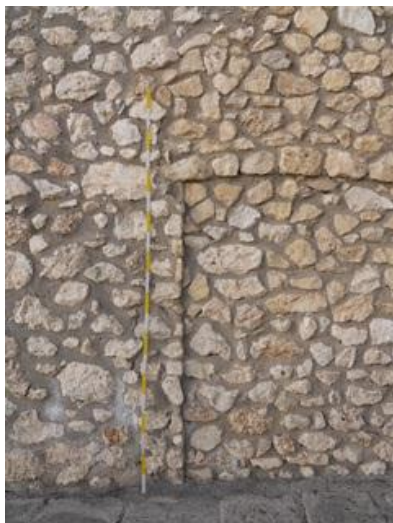
Due to the social importance of both churches and religious structures in both Santo Stefano di Sessanio as well as the rest of the Baronia communities, these structures are of the highest masonry and construction quality. However while these structures are composed of more structurally sound masonry, they are extremely vulnerable.

Figure 3.47 Typology 3 Church

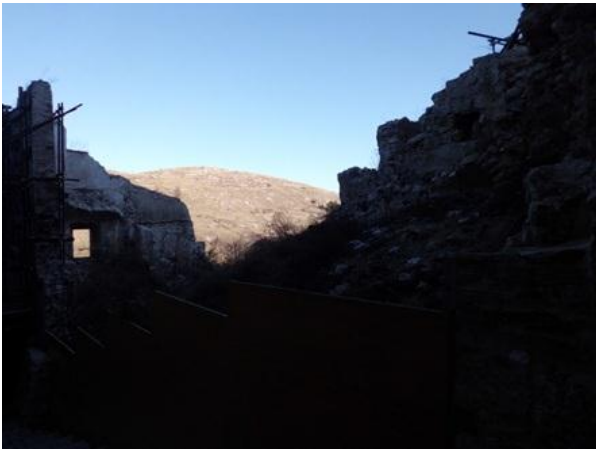
Figure 3.49 Aggregate SSS 018

The first example of a ruin comes from within the historical center. The ruin is located in aggregate SSS 018. This particular ruin suffered total collapse, with several structures within the

Aggregate suffering at the least partial collapse. Based on observations it is possible to conclude that the original aggregate lacked homogeneity in height. This may have played a role in the eventual collapse of the two structures within the aggregate.

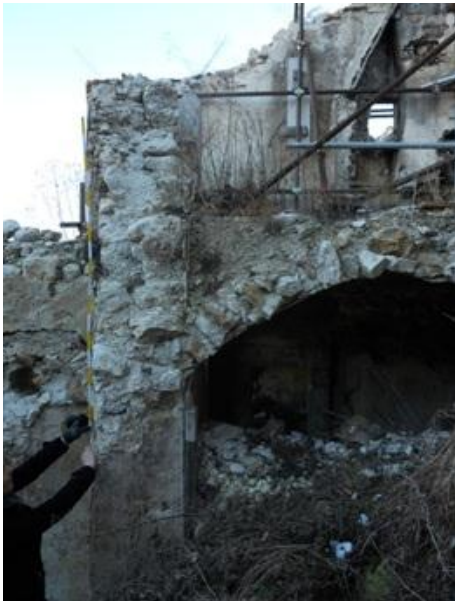
Figure 3.52 Section 1

Observation analysis of the sections within the ruins have been used to determine the quality of the primary masonry structures. This analysis will be based on the assumption that the wall sections analyzed are representative of the overall masonry of the structure. Upon initial observation, it is clear that the masonry has been assembled with a little effectiveness. This fact is in line with other information gained from observed analysis. Despite the small size of the sections under examination, the overall masonry composition can be deduced. Section 1 uses a two leaf system, both in the wall and vault sections. The wall section appears to have very few connecting stones to connect the two leaves together. The second section however appears to be composed of either two

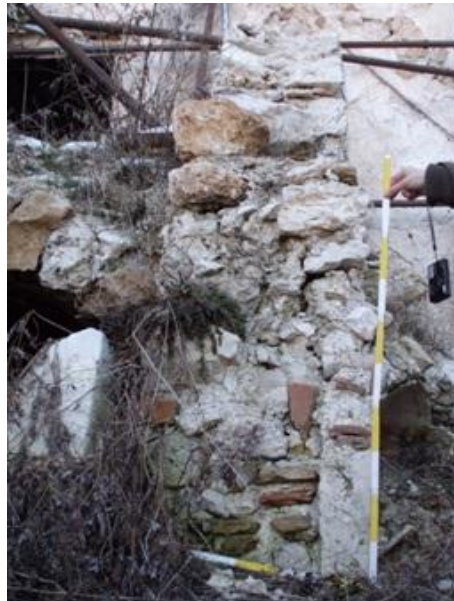
Figure 3.53 Section 2

or three leaves, with the presence of a few larger stones meant to hold the two sides of the wall section together. The third and final section is, based on observational analysis, composed of three leaves. In this case, the section is composed almost entirely of smaller stones and lacks any larger stones within the wall structures. It is important to note that these sections are extremely difficult to analyze on a solely observational analysis method, therefore these conclusions should be considered only temporary preliminary analysis

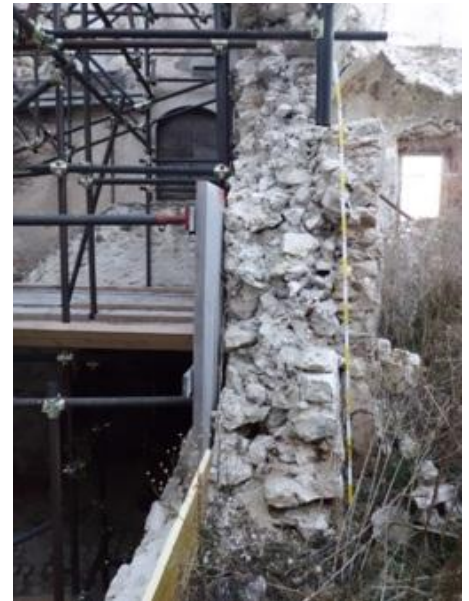
Figure 3.54 Section 3

until extensive future analysis can be completed both on-site and off-site in a laboratory. However it is important to note that even in observational analysis, the masonry sections are structurally flawed in several regards, which may have played a role in the eventual collapse of the two structures within the aggregate. In addition, both structures have been notable composed of the lowest masonry quality within Santo Stefano di Sessanio, masonry typology one.

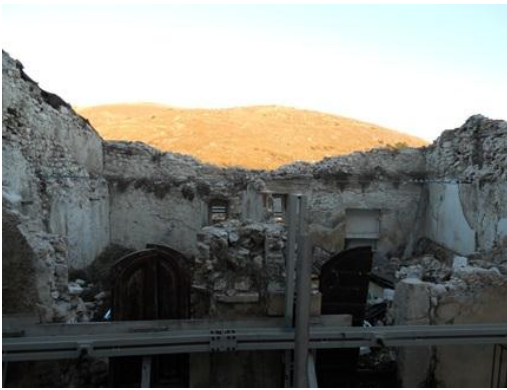
Figure 3.55 Aggregate SSS 020

The second example of ruins within Santo Stefano di Sessanio is located extremely close to the first example. This is an important point to note due to their close vicinity, foundation or terrain conditions could have been influential in the two separate aggregates' collapses, however that is solely conjecture without further analysis. This second example is located in aggregate SSS 020. The aggregate is composed of a single structure which, despite the addition of permanent structural interventions such as tie rods, experience total collapse. As seen in the photo to the left, the structure

lost its entire roof as well as a majority of the interior and exterior walls. As seen in the figure, there is currently a temporary structural intervention in place in order to minimize the collapse mechanisms as well as to avoid damages to the surround structures or street way. This ruin is important to note due to the existence of damages

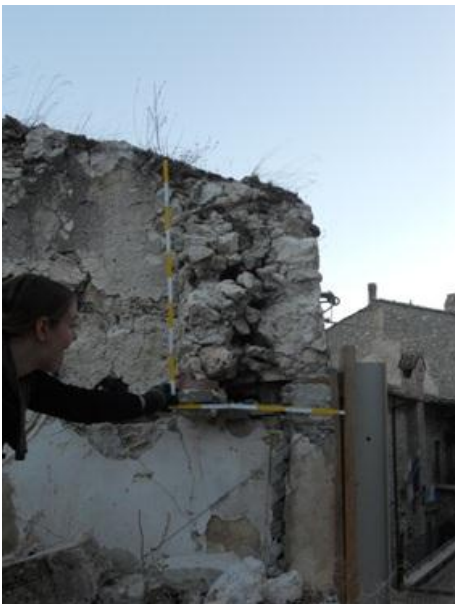
3.56 Ruins Section 1

caused by the use of tie rods, this will be further discussed in the temporary interventions section 3.11. As seen in the figure of the section to the left, the wall section appears to be composed of three leaves, the outermost of which is primarily a plaster cover. The inner two leaves are notable due to

the use of extremely small stone masonry elements as well as the lack of larger stones connecting the leaves together. These stones that span the entire width of a masonry section are critical in the structural stability of a masonry section.

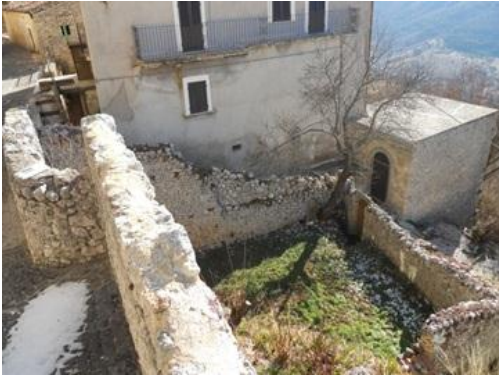
Figure 3.57 Aggregate SSS 038

The third and final example of a ruin in Santo Stefano di Sessanio is located outside of the historical center. The ruin is located within aggregate SSS 038. This aggregate consists of two structures both of which are currently ruins. Due to the high amount of vegetation present in both sites, their collapses can be considered not recent events. As seen in the photo analysis to the left, it is extremely difficult to determine both the masonry quality as well as the cause of the collapse. Due to a lack of access within the site of the ruins, sectional analysis was impossible. However based on

extremely limited observational analysis, several preliminary conclusions can be made. The first and most important of these conclusions is the collapse mechanisms that appear to be present in the ruins. The structural failure is clearly related to the degradation of the masonry, which appears to have suffered shear failure. The view of the

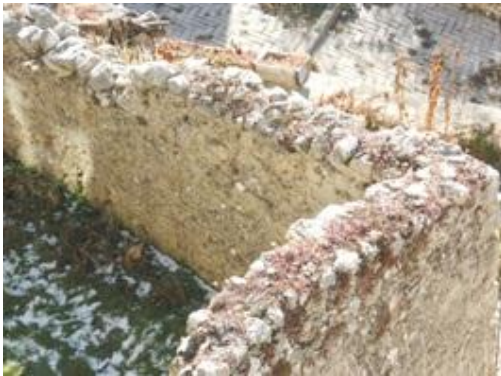
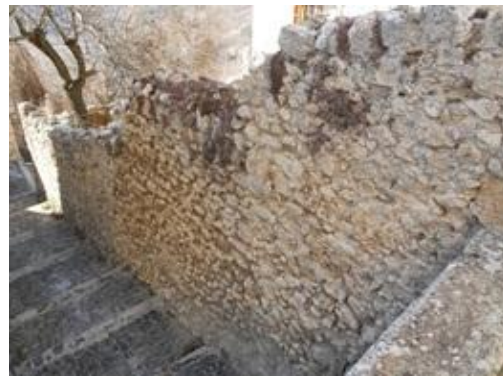
masonry sections from a distance suggests a two leaf system with the presence of larger stones to

better connect the sides of the wall section. However due to the lack of a plaster cover and what appears to be the lack of mortar, the connection of the individual elements could have played a role in the collapse. Again, this conclusion is only preliminary and must be verified with further thorough analysis of the masonry present to verify the preliminary observational claim.

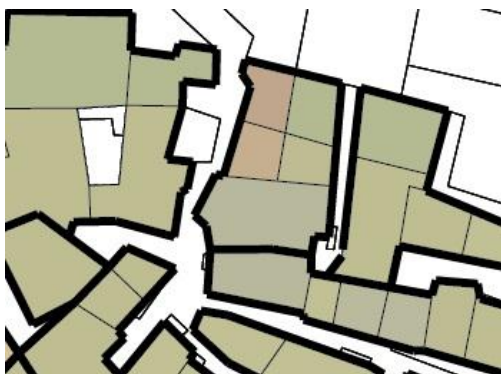
Figure 3.62 Collective Homogeneity Analysis

However the aggregate is considered to be a negative example of collective homogeneity due to the

presence of historical boundary within half of the aggregate. This creates an exaggerated height disparity from the Northern portion of the aggregate to the Southern. As is expected, the buildings within the aggregate, within the defensive wall, are much higher than

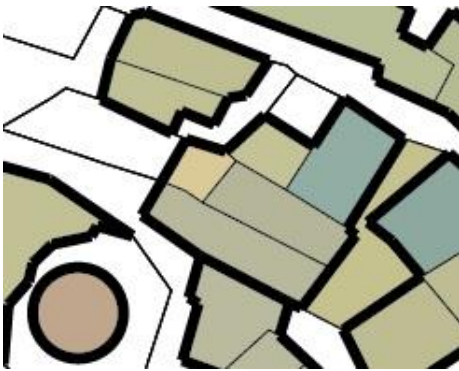
Figure 3.69 Homogeneity Analysis

SSS 016, located within the historical center of Santo Stefano di Sessanio. This particular example is fairly regular in plan, however is significantly lacking in homogeneity in the four major structural factors considered in the collective homogeneity analysis. Regarding building typology, all of the structures within the aggregate are oriented parallel to the elevation curves, with the exception of

one structure which is oriented perpendicular to the elevation curves. The greatest disparity regarding collective structural homogeneity is seen in the factors of building height and masonry typology. There is one tower-like structure within the aggregate, as well as several differing heights for the individual structures. Many adjacent structures differ in height by two or

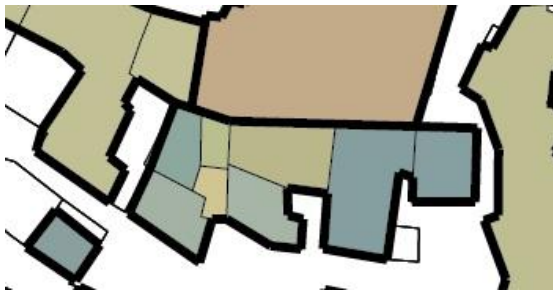
Figure 3.76 Collective Homogeneity Analysis

parallel to the elevation curves. This creates a vulnerable structural mechanisms within the aggregate

due to the differing tendencies of movement during aseismic event of the separate structures. In addition, the heights of the individual structures vary substantially, in some cases as much as by two or three stories between adjacent structures. Finally, there are

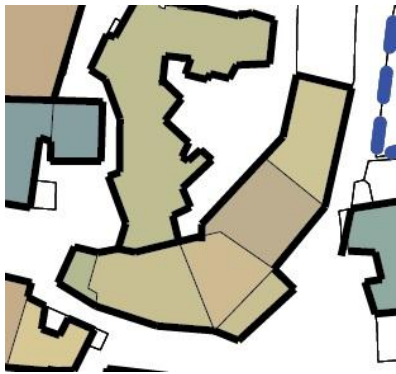
Figure 3.83 Homogeneity Analysis

parallel to the elevation curves. In addition, the entire aggregate is characterized under the building typology of the historical boundary wall, with the exception of one structure which is characterized as a

tower house. The lack of homogeneity of this aggregate is the most present in the building heights as well as in the masonry typologies. The heights within the aggregate vary by no more than one story, but increase in height from the Northern portion of the aggregate to the Southern. Regarding the masonry typology, the aggregate is composed of three different masonry typologies, including masonry

typology one, masonry typology three and the plaster cover typology. While this aggregate lacks in homogeneity, very little structural intervention is necessary. The most vulnerable portion of the aggregate is the tower house. In this case, additional support and reinforced connections between the tower and the adjacent structures would be necessary as well to ensure proper structural reactions in the case of a seismic event.

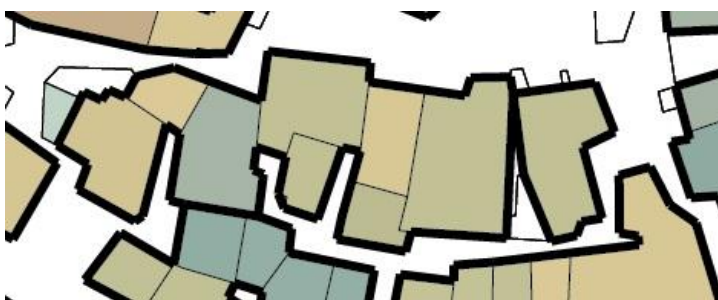
Figure 3.90 Collective Homogeneity Analysis

The majority of the structures within the aggregate are of similar heights, with the exception of a two structures that are more than two stories higher than their adjacent structures. Finally, the lack of

homogeneity is seen the most in the makeup of the masonry typology. While the aggregate is composed of only two different masonry typologies, including masonry typology one and plaster

This is caused by several structures additions added since the original construction. Thus any restorative effort should be focused on improving the connection of additions to the original units.

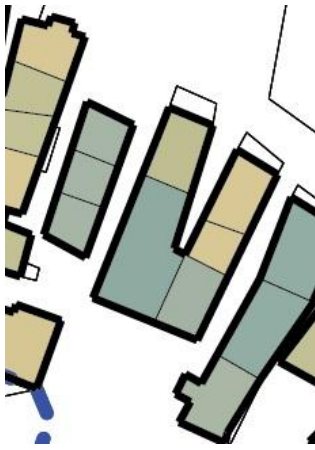
Figure 3.97 Homogeneity

045 primarily considered to be a negative example of collective structural homogeneity is the fact that the aggregate functions as two separate sections regarding several of the primary four structural factors. The Southern portion of the aggregate is oriented perpendicular to the elevation curves, while the Northern portion is oriented perpendicular to the elevation curves. This division of the aggregate is also seen in the building heights. Half of the aggregate is one story higher than the other half. Finally, the masonry typology of the aggregate is composed of two different

typologies, including masonry typology one and plaster covering. While the lack of collective homogeneity is not extreme in any of the four structural factors, the aggregate is considered to be a negative example due to the overall differences between the two portions of the aggregate. Any restorative effort should be directed at the improved connection between these two portions in order to prevent any negative effects a seismic event, due to their irregularity from one portion of the unit to the other.

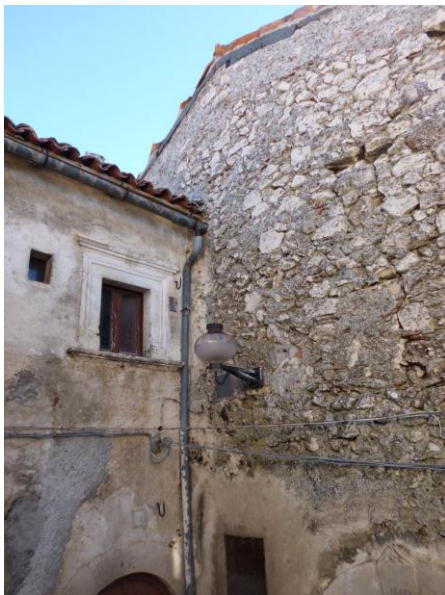
3.109 *Negative Openings*

This first negative example is found in aggregate SSS 001. In this particular case, the placement of the opening is unfavorable for several reasons. The first issue is the vicinity of several

openings to one another. As seen with the window and smaller opening on the upper floor, they are placed extremely close to one another which puts the structure between them in a vulnerable position. Also seen on the ground floor in the bottom of the image are two doors who are also extremely close to one another, this weakens the structure between, which in this case is highly dangerous due to the placement of the corner element. The second issue with these opening placements is their vicinity to the corner. Corners or other

major structural elements should be continuous and not broken up by the placement of an opening or similar puncture in the surface of the façade.

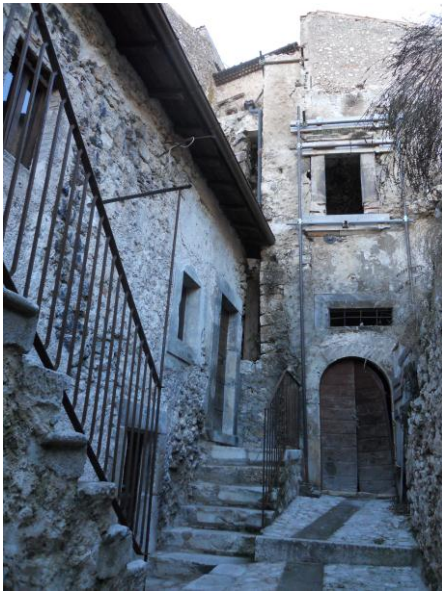
Figure 3.110 Negative Opening

The second negative example within Santo Stefano di Sessanio is found in the aggregate SSS 019. In this case, the placement of the openings creates substantial structural instability. As seen in the photo, addition temporary structural interventions have been put into place to avoid further damages. Damages have ensued in this case due to the improper placement of openings within the façade. First and foremost, the openings are located too close to the present structural corner element. This not only hinders the structural stability of the corner but of the openings as well. In

addition, the structure between the openings and the corner has also been compromised. The second deficiency with the placement of the openings in this structure is that they are immediately on top of one another. This vertical connection can naturally producing several potential collapse mechanisms, specifically the out-of-plane wall overturning between the present openings. In this case, despite the structural strength of the primary structure of the building, the building's overall stability has been challenged due to the placement of openings.

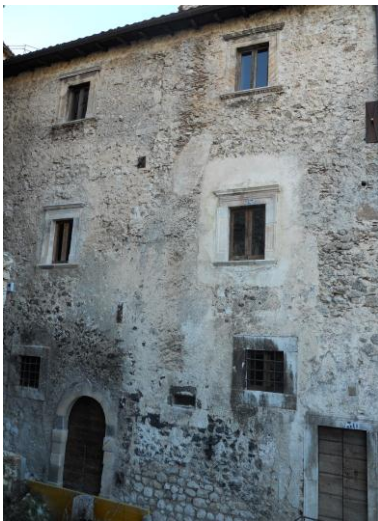
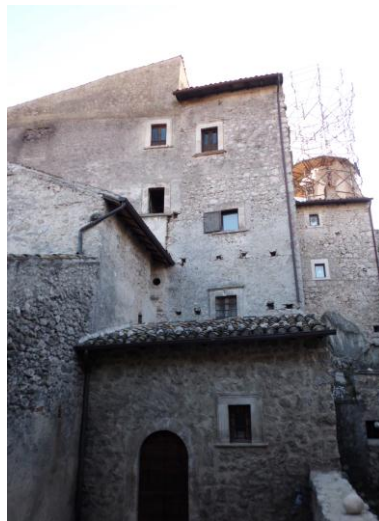
Despite the presence of several negative examples of openings with Santo Stefano di Sessanio. The majority of the structures within the village showcase positive examples of openings. The two positive examples to be discussed are found in aggregates SSS 002 and aggregate SSS016 respectively. These particular structures are positive examples of opening placements due to the lack of a vertical instability created by stacking the windows. Instead, as seen in both examples, the

openings are staggered from one story to the next. In addition, both structures have their openings placed at a proper distance from all major structural elements including the roof, columns and corners.

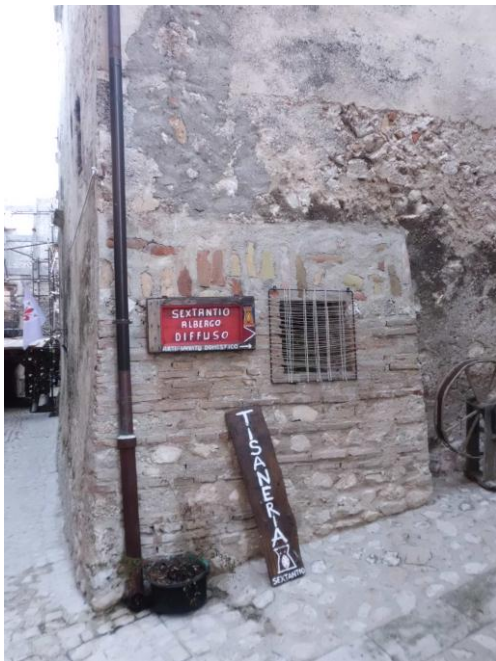
Figure 3.113 Partial Buttress

Sessanio. There are also several structures within the village with buttresses in place, specifically in the historical center. As seen in figures 3.11a and 3.11b, there are two different typologies of buttresses present within Santo Stefano di Sessanio. The first typology is a partial buttress that only

partial covers the height of the wall being supported. Typically this typology of buttress was not present in the original construction, but instead added later due to the need for additional structural support. The second typology however, the complete buttress, spans the height of the entire supported wall. The example, seen in figure 3.11b, is located within the historical boundary wall and was therefore a part of the original construction. This is typically the case for complete buttresses. It is important to note that due to the size of the buttress structure and the narrow streets within Santo Stefano di Sessanio, in many conditions within the historical center of the village, the addition of a complete buttress is impossible after the initial construction. In this case, either tie rods can be utilized, or partial buttresses, if the space allows for such a structural addition.

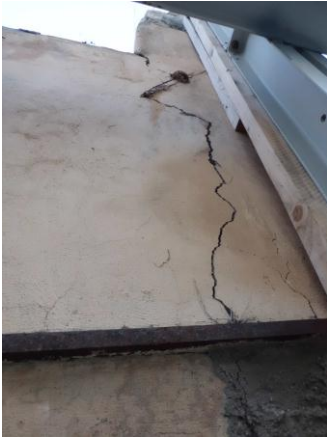
Figure 3.119 Tie Rod Crack

thesis. There are two general categories for tie rods, the first being a bar tie rod, as seen in figures 3.11c and 3.11d. The second category is of plate tie rods, as seen in figure 3.11e and 3.11f. In general, plate tie rods can be considered less damaging to the surface of the structure, while bar tie rods have a tendency of puncturing the surface, although this is only in rare occasions. Tie rods are an extremely efficient strengthening tool in seismic areas, however their placement and tensioning must be considered thoroughly. The example seen in figure 3.11g is found in the ruins of aggregate SSS 020. In this particular case, the tie rod was tensioned too strongly and was the cause of a crack within the structural façade. This crack can have devastating effects because it can produce a lack of

connection between the load bearing walls and also increase the likelihood of out-of-plane wall overturning. It is important to note however that damages due to tie rods are rare. In general, both the placement and implementation of tie rods, within both Santo Stefano di Sessanio as well as the other villages within the Baronia collective, are efficient. There is a clear history of construction knowledge specific to masonry within seismically active historical centers.

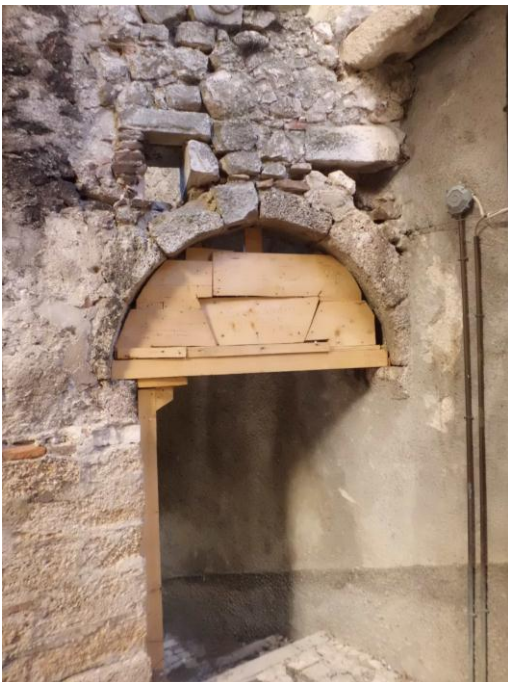
Figure 3.121 Arch Support Intervention

The first typology of temporary structural interventions present in Santo Stefano di Sessanio is that of the arch/opening support intervention, which is the most common temporary intervention within the Baronia collective. The first example is an arch support intervention, located beneath a “sporto” between aggregates SSS 001 and SSS 068. Both of these aggregates are located within the

historical center, unattached from the historical boundary wall. This particular arch support intervention has several flaws. First and foremost, the intervention touches the existing arch unevenly, thus creating increased stress within the vulnerable masonry arch. In addition, the right side of the intervention is supported by the same wall as the arch, thus unnecessarily increasing the load of the structural member. However it is important to note that this particular intervention does allow for circulation

access beneath the arch. A large more structurally sound temporary intervention would have to prohibit access underneath the arch, due to the limited space available. However this particular intervention could be of a higher quality, better supported the given arch while minimizing the collapse mechanisms already in place in the arch and the supporting walls.

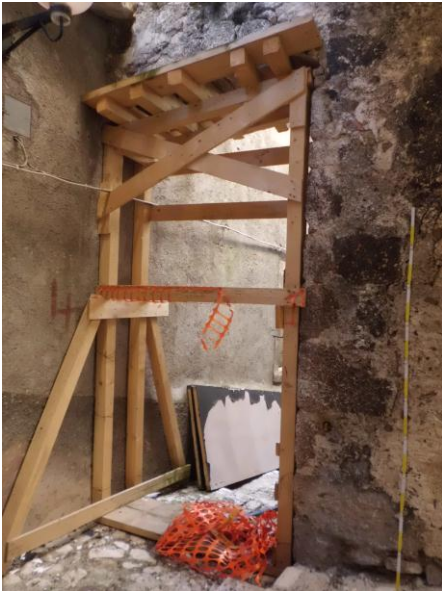
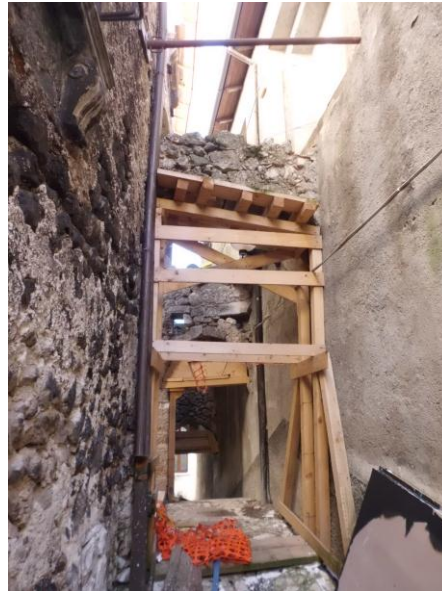
Figure 3.123 Opening Support

The second example of an arch/opening support intervention in Santo Stefano di Sessanio is located within aggregate SSS 065. This particular example is specifically an opening support intervention, as seen in the figures below. This intervention allows for passage beneath the opening

while still properly supporting the opening, preventing future damage. It is important to not the way in which the opening support intervention interacts with the masonry. In this case, the *Figure 3.122* intervention's force upon

the masonry is separated by five wood planks. This formation aids in avoiding the accumulation of stress within the supported opening. In addition, the support is not leaning or supported by the damaged masonry. Overall, this is an effective temporary wooden structural intervention.

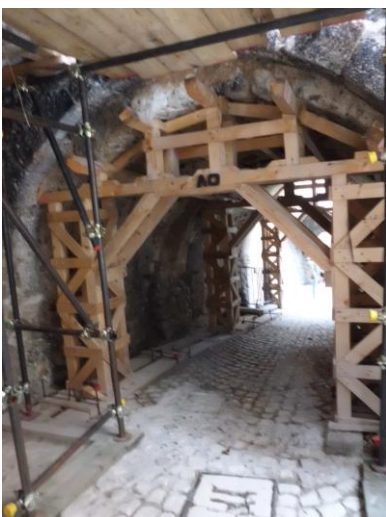
Figure 3.124 Arch Support

The third and best example of an arch support intervention is located beneath a “sporto” in aggregate SSS 019. The intervention is composed of high quality wood and evenly distributes the stress added to the existing arch by the addition of the temporary intervention. In addition, the

vertical support of the actually intervention is structurally efficient at accepting possible loads produced by the failure of the arch. In addition, the intervention, due to efficient spacing and placement, allows for circulation access beneath the system, which is extremely important due to the use of this particular street by the local inhabitants. As seen in the photo, the intervention interacts with the surface of the arch on seven different points, which are distributed along long horizontal wooden bars. Beneath this arch supporting

system is also a triangular shape support system which safely transfers the forces present in the arch support system to the columns of the temporary intervention. Due to the efficient use of space as well as a proper structural support system beneath the primary arch support, this example can be considered the best example of an arch/opening support intervention within SantoStefano di Sessanio. However despite the high quality of the temporary structural intervention, it is important to note that this intervention is only temporary and will need to be replaced in the near future with a thorough permanent structural intervention.

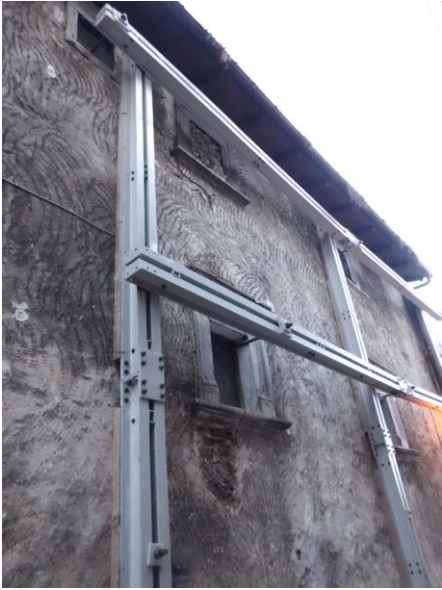
Figure 3.126 Surface Rendering

The third and final typology of temporary structural interventions to be discussed in Santo Stefano di Sessanio is surface rendering interventions. The first example is located in aggregate SSS

017, which is located within the historical center along the historical boundary wall. These interventions are typically made from steel, as is the case in this example. Similar to the wooden grid or tie interventions, this typology of temporary intervention aids in minimizing the effects of the collapse mechanism of out-of-plane wall overturning. This typology however is typically placed in the façade of the structure facing the narrow street way. Due to the use of steel instead of wood, the intervention has the propensity to last longer, however they still we need to

eventually be replaced with permanent structural interventions that prohibit the possible collapse mechanisms within the façade.

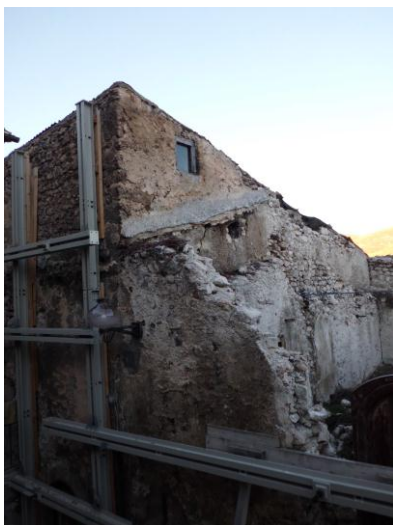
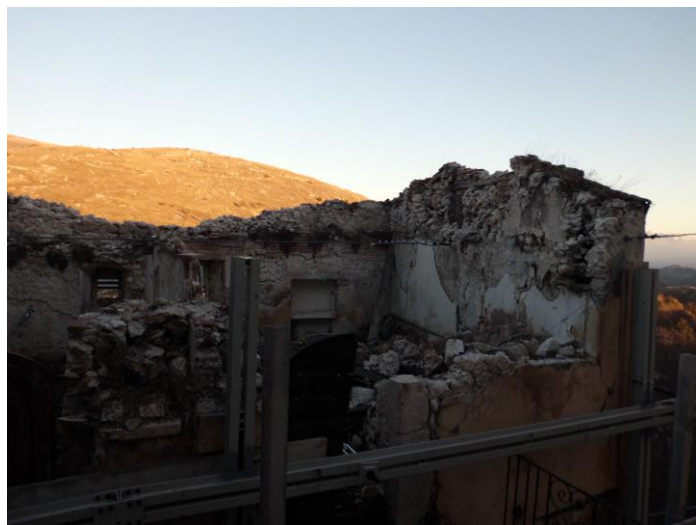
Another example of a surface rendering intervention is found in the aggregate SSS 020. This particular example is important to note due to the fact that the building in question is in ruin. As mentioned in the previous example of surface rendering, the intervention is located on the single

façade oriented towards the narrow street. The date of the implementation of the intervention is unknown, however it is presumed that this intervention was put in place after the partial collapse of

the structure. If this is the case, the temporary intervention's primary utility is to minimize further damages, specifically out-of-place turning of the primary façade onto the usable street space. In this particular case, the temporary structural intervention can remain until the ruins are dismantled and a new structure is built in the same location. Therefore no permanent structural interventions are necessary in this example.

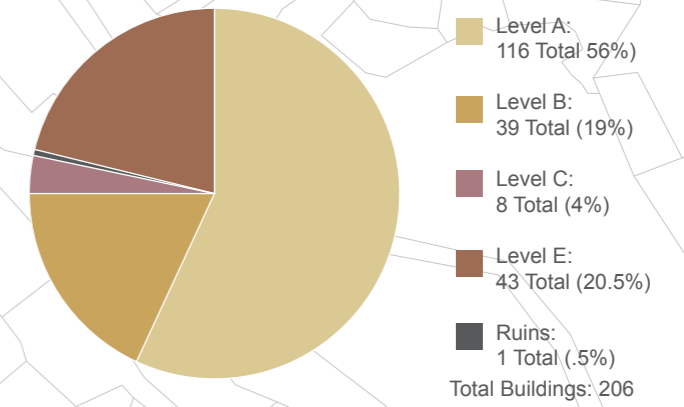
Table 3.13 Immediate Post-Seismic Damages

Considering the other villages, Santo Stefano di Sessanio had very little extreme damages. The two most notable damages including the collapse of the Medicea tower as well as severe damage to one of the churches within the historical center. The remainder of the structures experienced very little damage with 56% of the 206 buildings within the village being characterized as maintaining level A damage. However 20.5% were characterized as level E, which is defined as substantial to heavy damages. The majority of these structures were located within the historical center, however there appears to be no substantial connection between location and damage levels within Santo Stefano di Sessanio. This implies generally regular terrain characteristics throughout the village, however this has not been officially verified.

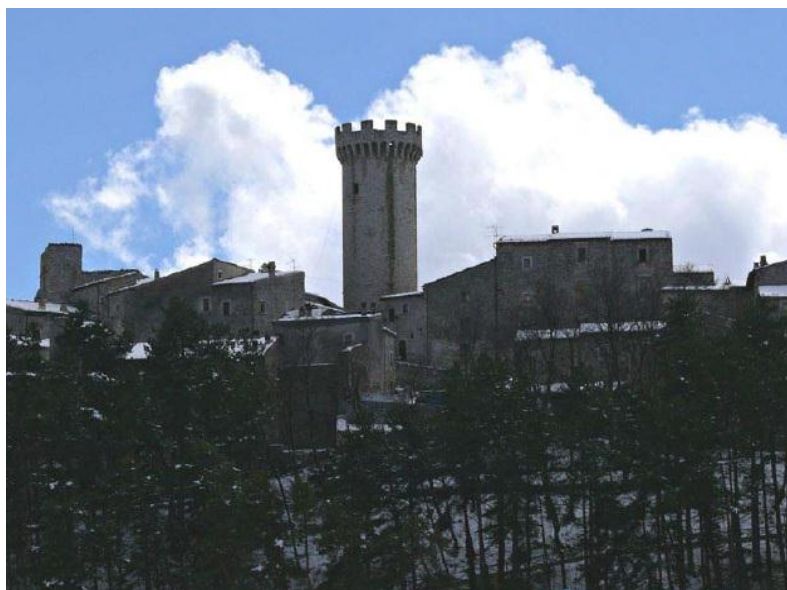
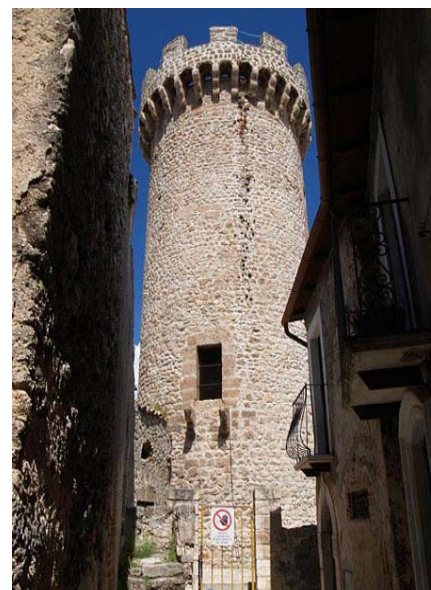
Santo Stefano, of the four village discussed in this thesis, suffered the worst patrimonial loss due to the 2009 seismic event. The symbol of the village, the Medicea tower, collapsed due to the earthquake. However it is important to note the role that a twentieth century structural restoration played in the eventual collapse of the tower. The tower was initially constructed approximately in the
