POLITECNICO DI MILANO

The Role of Structural Homogeneity
in Seismically Active Historical Centers of Abruzzo

Castel del Monte, Castelvechio di Calvisio, Santo Stefano di Sessanio, Villa Santa Lucia degli Abruzzi

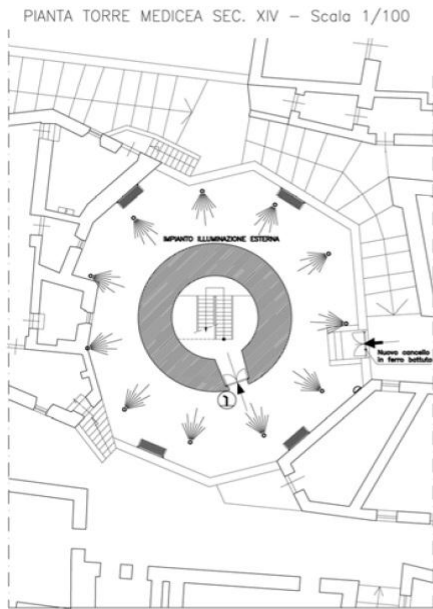
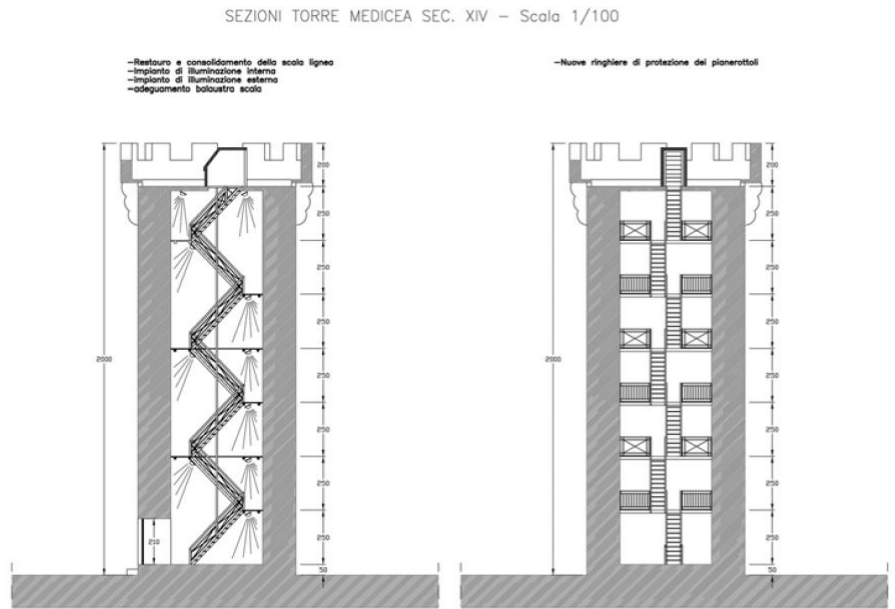
from the Medici family, who founded the village in the fourteenth century. The tower is isolated, unlike the other towers present in Santo Stefano di Sessanio. The original tower was characterized by an overall height of 18 meters, and an internal and external diameter of 4 and 5 meters

respectively. In addition, the tower was originally constructed with four interior wooden slabs, the fourth and highest being an observational platform. The masonry, before the collapse, was considered not resistant to traction but of high quality. The circular section of the tower also guaranteed a conventional mechanical efficiency that provided no evidence of a possible structural vulnerability. While there was some decay within the interior wooden slabs, the tower had survived thousands of seismic events during its more than six hundred year lifetime, until the implementation of a twentieth century restoration that led to the total collapse of the structure in April of 2009.

thickness of 15 cm and steel reinforcement bars ranging in diameter from 10-12 mm. In general, the restoration can be considered an additional element to the tower that failed to respect the materials, weight or structural dynamics of the tower.

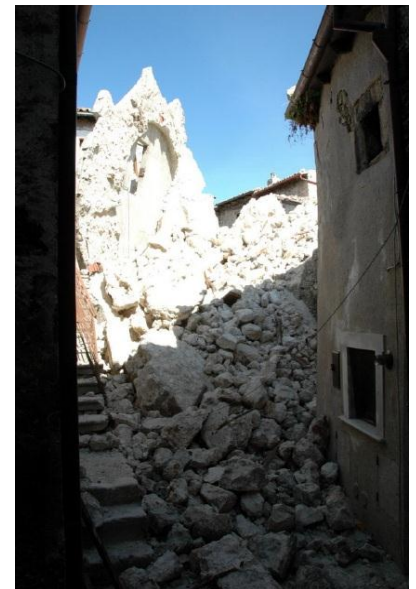
Figure 3.134 Medicea Tower

On April 6th, 2009, an earthquake struck the area of L'Aquila, approximately 30 kilometers from Santo Stefano di Sessanio. The seismic event led to minor damages throughout the village and produced the motion that would destroy the Medicea tower. After substantial lateral movements due to the seismic event, the tower completely collapsed and damaged several of the surrounding structures as well. After extensive analysis, it was determined that the masonry structure failed in crushing due to an extremely high loading. This was determined to be due to the reinforced concrete slab, added in the most recent renovation of the twentieth century. The top-heavy quality of the

tower due to this restoration create an off balance structure, which aiding in amplifying the period of movement of the tower, initiated by the seismic event. In addition, these conclusions are supported by the state of the reinforce concrete slab post collapse. The slab remained in a single piece due to its high weight of 6000 kg. The slab only suffered minor lesions of the surface. While the tower of Medicea may have suffered substantial damage due to the 2009 seismic event, it can be concluded with absolute certainty that the collapse of the Medicea tower was a direct effect of the restorative intervention of the twentieth century.

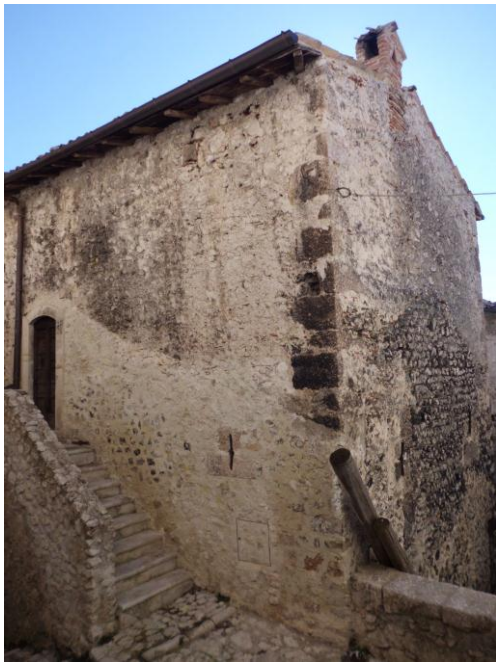
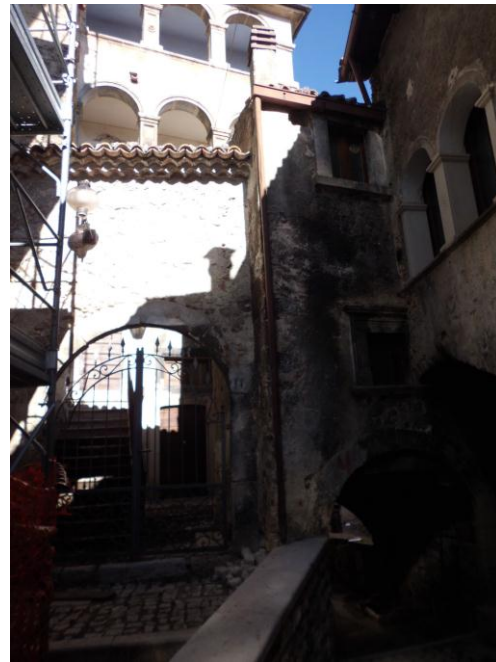
The first example of one of the more vulnerable aggregates is found in the heart of the historic center, near the San Marco church, specifically in aggregate SSS 001. This example, unlike

First and foremost this aggregate was chosen due to the fact that two of the six structures are inhabited. In addition, as previously mentioned, this aggregate has been determined to be negative regarding its collective homogeneity. As seen in the models above, the aggregate is extremely irregular regarding the building heights and masonry typology composition. There were also

damages in the aggregate after the 2009 L'Aquila seismic event and not all of the structures within the aggregate have permanent structural interventions in place. As seen in both figures 3.136 and 3.137, there is also irregularity in both additions to the structures as well as openings. Openings have been placed too close to structural elements such as the roof or corners. It is also important to note the extreme changes of the aggregate over time, with elements of different masonry composition, has contributed to the determination of this particular aggregate as a high priority level. Regarding a future for this aggregate, there are several restoration options available. First and foremost, additional permanent and temporary structural interventions need to be added to better control the reactions between the irregular units within the aggregate. These interventions should specifically be placed in vulnerable areas such as fulcrum points between two attached structures of different heights. In addition, any damages sustained during the most recent seismic event of 2009 need to be thoroughly analyzed and resolved to better protect the inhabitants of the aggregate.

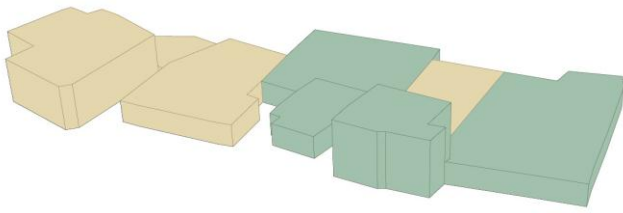
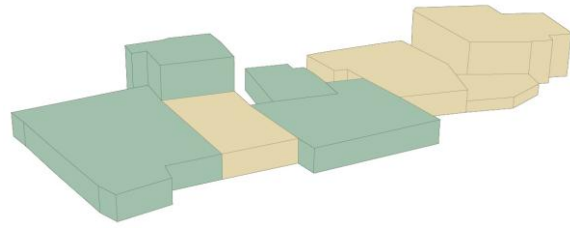
The second example of a high priority structure is found in the historical center, specifically in aggregate SSS 060. This example has been previously discussed as one of the negative examples within Santo Stefano di Sessanio. This aggregate has been chosen for several reasons, the first of which is that four of the nine structures within the aggregate are currently inhabited. In addition, as previously mentioned, the aggregate has been considered to be negative regarding its overall collective homogeneity. This particular aggregate is extremely irregular in both masonry typology composition and the building heights of the individual units within the aggregate. This aggregate is unique considering its masonry composition due to high quantity of masonry additions and restorations that failed to respect the existing structural masonry typology or homogeneity of the plan. The aggregate is also irregular in both plan and elevation. There were also damages in the aggregate after the 2009 L'Aquila seismic event and not all of the structures within the aggregate have permanent structural interventions in place. Regarding a future for this aggregate, there are several restoration options available. Additional permanent and temporary structural interventions

need to be added to better control the reactions between the irregular units within the aggregate. These interventions should specifically be placed in vulnerable areas such as fulcrum points between two attached structures of different heights. In addition, any damages sustained during the most recent seismic event of 2009 need to be thoroughly analyzed and resolved to better protect the inhabitants of the aggregate. This is especially the case in this particular aggregate due to the high amount of damages after the 2009 seismic event.

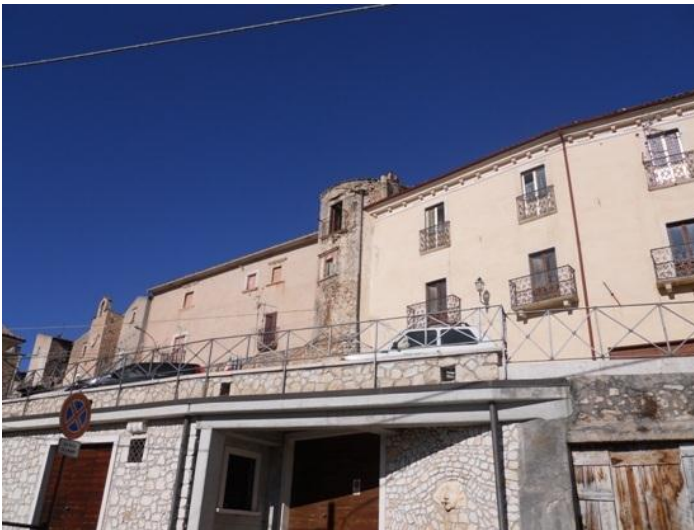
Figure 4.3 Historical Boundary Wall House

Similar to many of the other villages within the Baronia collective, Castelvechio di Calvisio is characterized by its historical boundary wall. However due to modifications of the village since its original construction, very few of the structures within the historical center are currently classified as

historical boundary wall houses. Within the entire villages, there are a total of 13 historical boundary walls present, all of which are located within the historical center. All of these examples are divided between two separate aggregates, CvC 1.17 and CvC 1.09. In the case of aggregate CvC 1.17, the entire aggregate is characterized

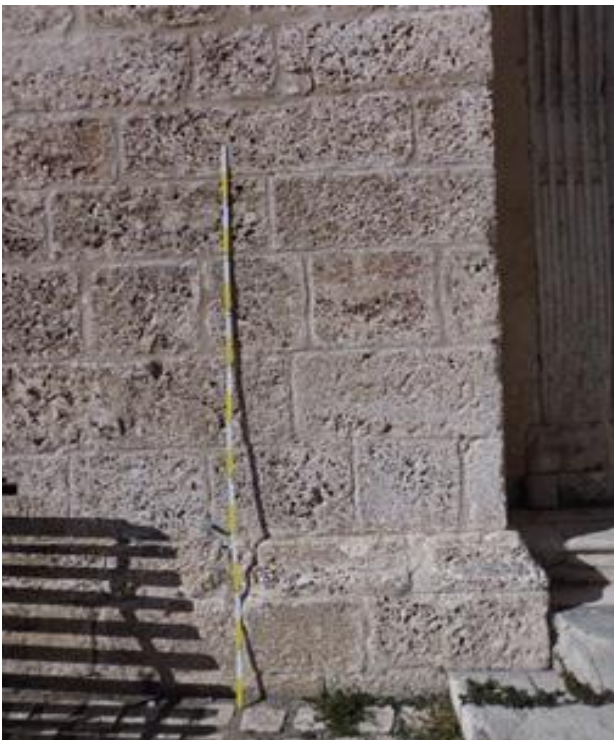
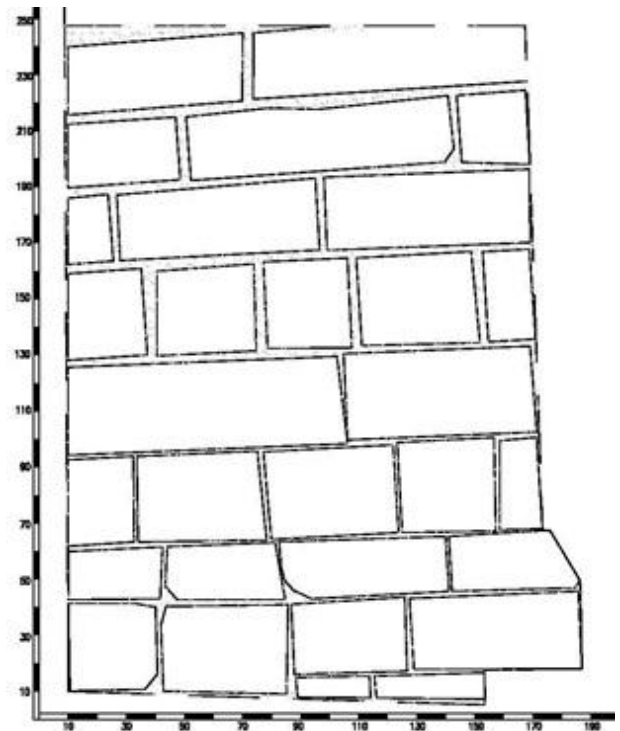
spacing between each stone. Due to the social importance of both churches and religious structures in both Csastelvechio di Calvisio as well as the remainder of the villages within the Baronia collective, these structures are of the highest masonry and construction quality. This particular

structure is composed of the highest quality version of masonry three present within the four villages discussed in this thesis. However while these church and religious structures, specifically this example, are composed of more structurally sound masonry, they are still extremely vulnerable in the

Figure 4.28 Typology 3 Church

Figure 4.29 Typology 3 Church

case of a seismic event due to their interior vaults, lack of homogeneity in building heights and propensity for out-of-plane wall overturning.

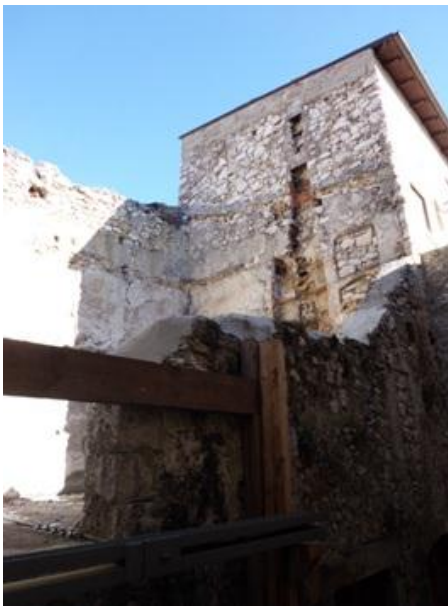
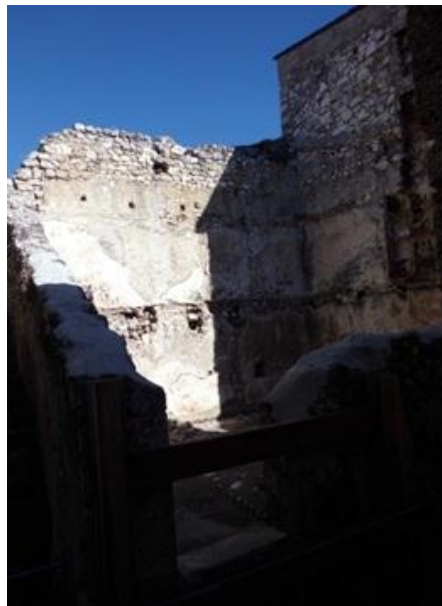
The first example of a ruin within the historical center is located in aggregate CvC 1.07. This particular aggregate lacks in structural homogeneity regarding the four primary structural elements

Figure 4.30 CvC 1.07 Ruins

Figure 4.31 CvC 1.07 Ruins

that will be discussed in the section 4.7. The ruined building in question is characterized as being composed of masonry typology one, the weakest of the masonry typologies present within

Unfortunately due to security measures in place, it was impossible to complete a more complete observational analysis of the ruins in question. However the mode of failure of the structural masonry walls does imply a failure of the strength of the masonry elements. It is important to note that this conclusion is solely conjecture and would need to be verified via more extensive analysis both on-site and in a laboratory.

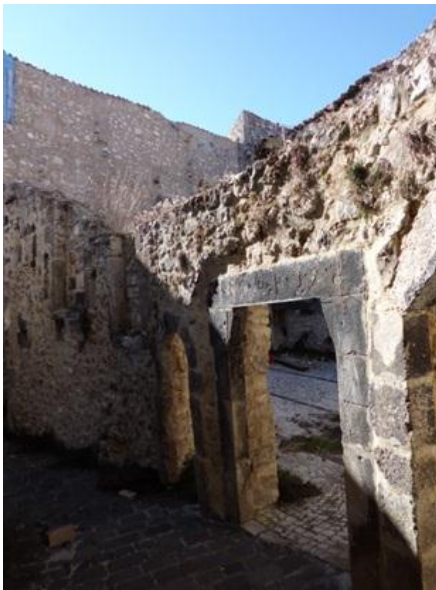
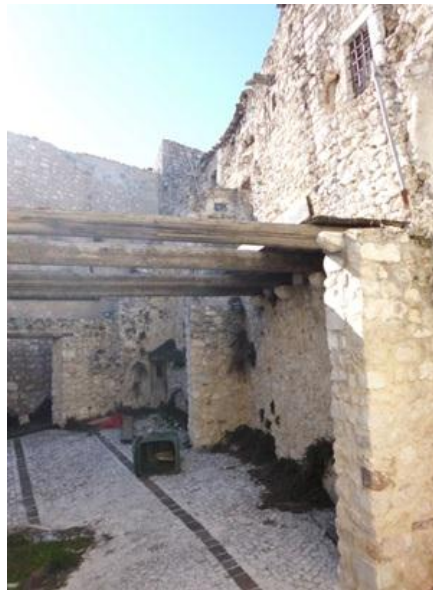
The second example of a ruin within Castelvecchio di Calvisio is, similar to the previous example, also located within the historical center of the village. Specifically this particular examples is comes from aggregate CvC 1.08. This particular aggregate is composed of five structures and lacks in structural homogeneity regarding the four primary structural factors that have been analyzed.

The building currently in ruins was structurally composed of masonry typology two. The higher

Figure 4.32 CvC 1.08 Ruins

Figure 4.33 CvC 1.08 Ruins

quality of masonry utilized as well as the observed mode of failure suggests the structure of the roof or the higher floors were the cause of the damage that led to the collapse of the entire structure. The location of vegetation and recently

added elements suggest that the collapse of the structure was not a recent event. However all of these conclusions are conjecture due to the lack of masonry sections available for thorough observational analysis. Therefore the all of these conclusion would need to be verified through further analysis both on-site and in a laboratory.

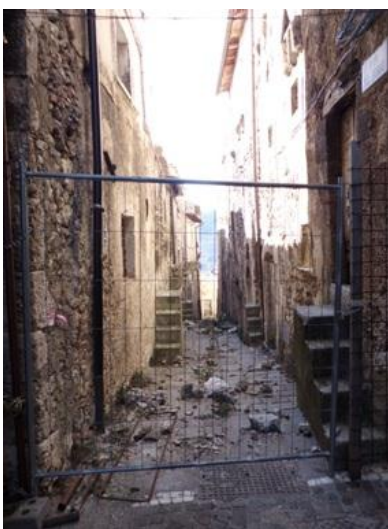
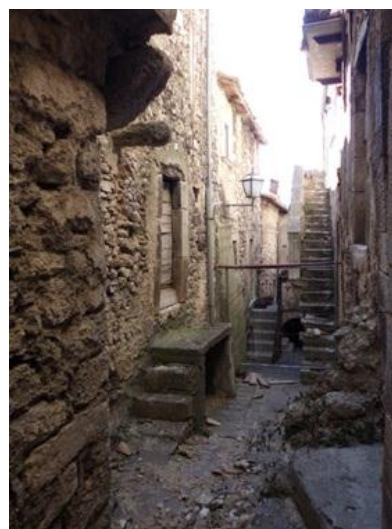
The third and final example of a ruin within the historical center of Castelvechio di Calvisio is located between two aggregates, specifically aggregates CvC 1.13 and CvC 1.14. Both of the

Figure 4.34 CvC 1.13/14 Ruins

Figure 4.35 CvC 1.13/14 Ruins

aggregates involved are irregular when considering the collective homogeneity analysis, to be introduced in section 4.7. The masonry composition of the ruin in question, which is specifically located in aggregate CvC 1.14, is masonry typology two. While this is

analysis was made impossible. Therefore any conclusions for this particular example are based solely on conjecture. Any verification of these conclusions would have to be based on further analysis both on-site and in a laboratory.

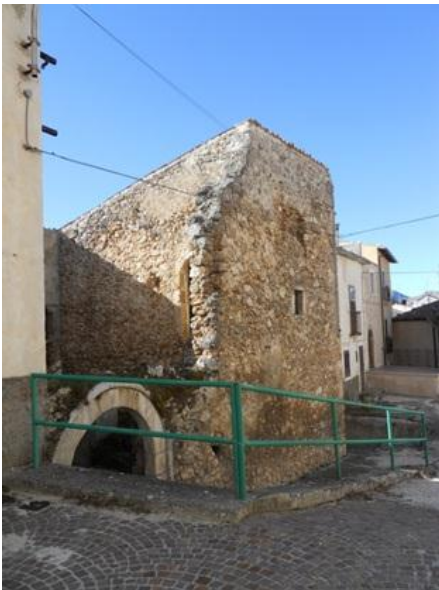
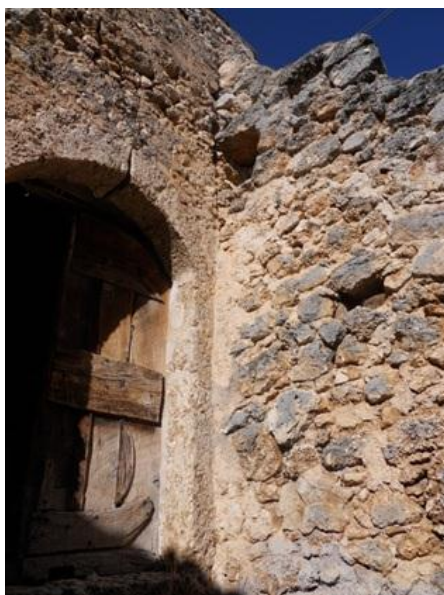
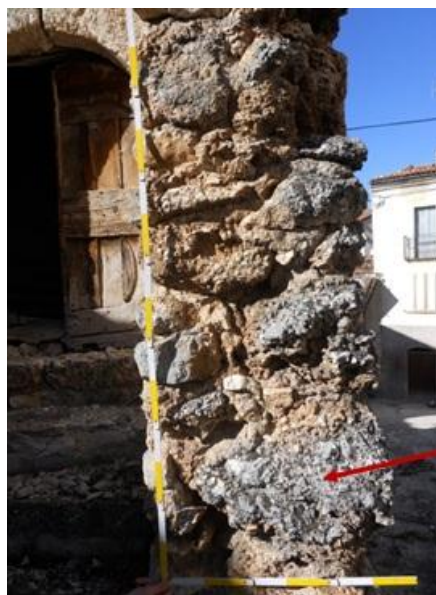
The first example outside of a ruin outside of the historical center of Castelvecchio di Calvisio is located in aggregate CvC 2.02. Due to the accessibility of the site as well as an available

Figure 4.36 Aggregate CvC 2.02

section for observational analysis, this is the best example of a ruin within the village and will therefore have the most thorough analysis. This particular aggregate lacks in homogeneity considering the four primary structural factors considered when determining the collective homogeneity of the aggregate. In addition, the masonry of the building is that of masonry typology one. When considering the wall section, seen below in figure 4.6i, it is presumed that this section is exemplary of the entire structure's masonry composition.

Initial observational analysis has indicated that the brickwork has been assembled with a certain effectiveness. Despite the size of the analyzed section, it can be deduced that the masonry is

Figure 4.37 CvC 2.02 Ruins

Figure 4.38 CvC 2.02 Ruins

comprised of two partially clamed leaves with a total thickness of 50 cm. The masonry consists of both large and medium stones, with the presence of some larger stones that connect the two leaves together to ensure a better connection

mortar used within the section is in good condition, with light gray coloration, firm consistency, with both large and small aggregates within the mortar. It is also important to note that there were no voids within the section. It can therefore be presumed that the masonry quality was not a major factor in the collapse of the structure. Again, as in the previous examples, all of these conclusions are based solely on observational analysis and would therefore need to be verified through further analysis both on-site and in a laboratory.

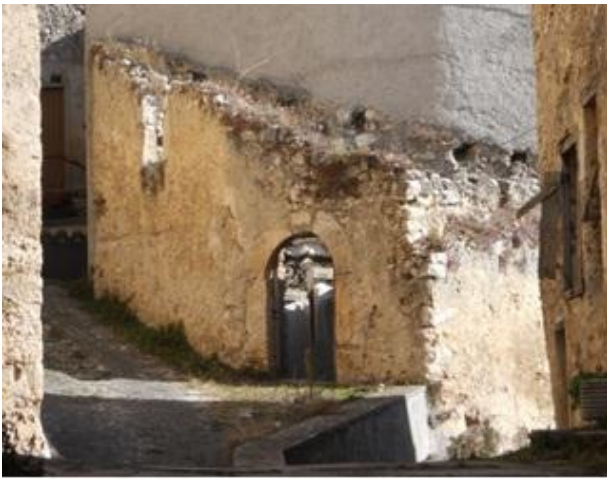
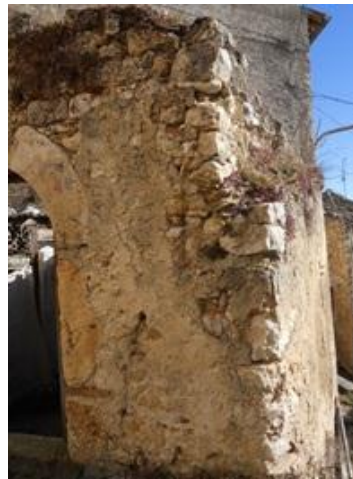
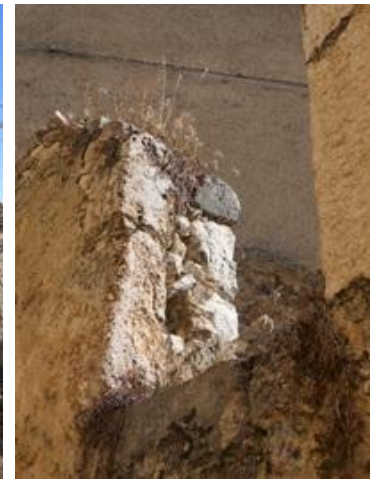
The second example of a ruin outside of the historical center of Castelvechio di Calvisio is located within aggregate CvC 2.03. This particular aggregate is fairly irregular regarding collective

Figure 4.39 CvC 2.03 Ruins

structural homogeneity and the individual ruined structure is composed of masonry typology two.

Due to the inaccessibility to the site due to security reasons, observational analysis was extremely limited. However a recent renovation, pre-collapse, that did not respect the existing masonry typology, appears to have played a part in the eventual collapse. However this again is a conclusion based solely on observations and therefore needs to be verified through further analysis.

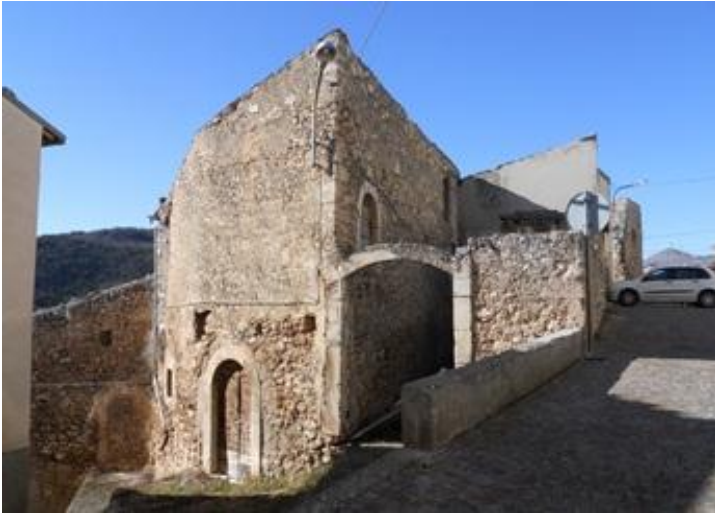
Figure 4.42 Aggregate CvC 2.07

The third example of a ruin outside of the historical center of Castelvechio di Calvisio is located within aggregate CvC 2.07. This aggregate is homogeneous regarding the four primary structural factors analyzed in order to determine the collective structural homogeneity of the aggregate. However all of the three structures within the aggregate are in ruins. In addition, all three of these structures are

composed of masonry typology one, the lowest quality masonry present in Castelvechio di Calvisio. As seen in figure 4.6m, there appears to have been an addition that failed to respect the masonry typology of the existing structure. This may have played a large role in the eventual collapse of the structure. This

conclusion is based solely on minimal observational analysis due to a lack of accessibility to the site due to security reasons. Therefore further analysis would be necessary to determine the validity of this statement.

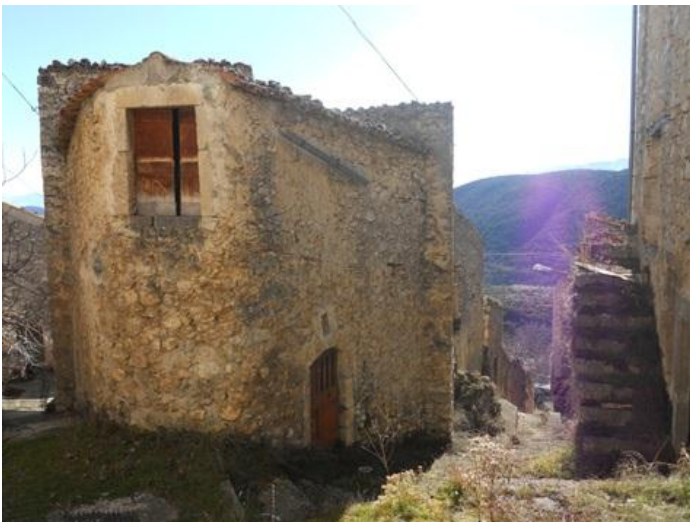
Figure 4.43 Aggregate CvC 2.13

The fourth and final example of a ruin outside of the historical center of Castelvechio di Calvisio is located in aggregate CvC 2.13. The aggregate in which this example is located in lacks in

collective homogeneity as determined through the analysis of four primary structural factors. However all six buildings within the aggregate are composed of masonry typology one, the lowest quality masonry typology present in Castelvechio di Calvisio. The collapse of the structure is concentrated solely to the upper floors,

however due to a lack of access into the site, it is difficult to determine a possible cause of the eventual collapse. Therefore, especially in this case, further analysis is required, both on-site and in a laboratory.

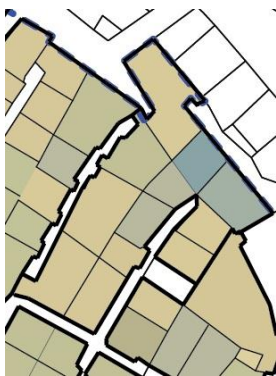
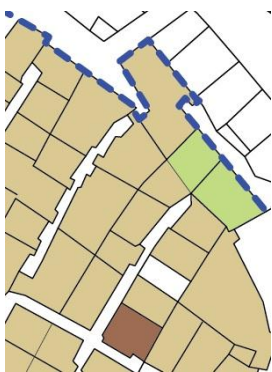
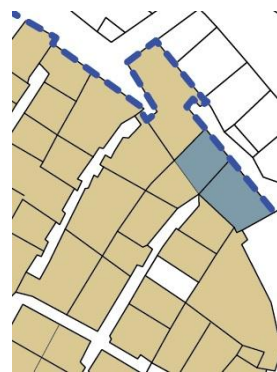
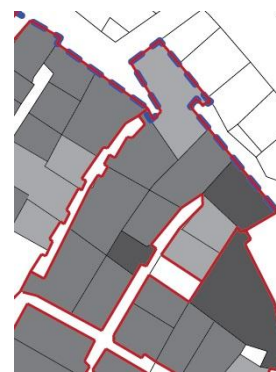
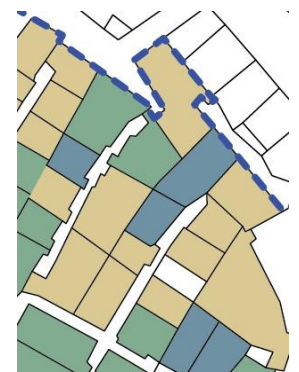
4.60 Homogeneity

The third negative example of collective structural homogeneity within the historical center of Castelvechio di Calvisio is found in aggregate CvC 1.06. There are 12 structures present within the aggregates. Of these 12 structures, all 12 are privately owned and currently only two are inhabited.

oriented perpendicular to the elevation curves. The two structures oriented perpendicular are located together on the edge of the historical center. The building heights within the aggregate are regular with no adjacent structures differing by more than a single story. The lack of homogeneity in the aggregate stems almost exclusively from the masonry typology. There are three masonry typologies present within the aggregate, including masonry

typology one, masonry typology two and plaster covered. The majority of the structures are composed of plaster covered structures. The structures with exposed masonry structures are located

on the outer most portion of the aggregate. This characteristic along with the two structures oriented perpendicular to the elevation curves render this area more vulnerable than the remainder of the

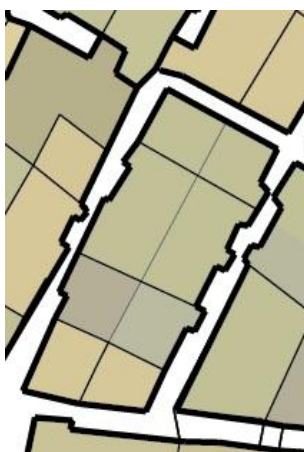
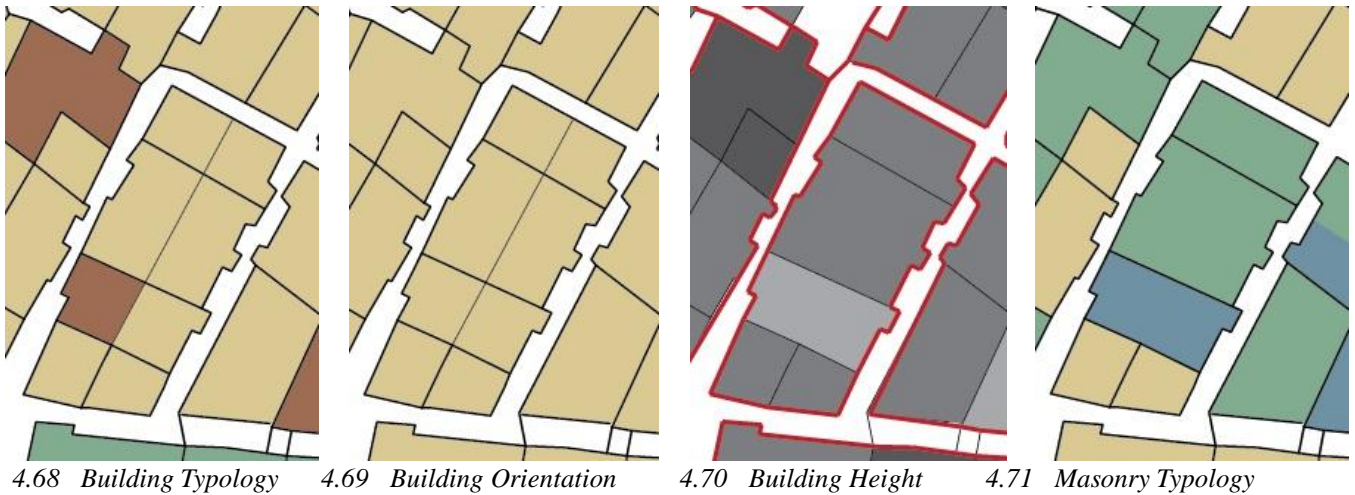
4.67 Homogeneity

currently uninhabited and one is considered to be uninhabitable. All of the buildings within the aggregate have been categorized as buildings oriented parallel to the elevation curves, with the only exception being the previously mentioned building in ruins. Regarding the building heights, the aggregate is almost completely homogeneous with the exception of one structure which is one story taller than the adjacent buildings. As seen in the previous three examples within the historical center, the lack of

homogeneity of the overall structure derives primarily from the masonry typology. The eight structures are composed of three masonry typologies, which are grouped together in three separate

groups. These typologies include masonry typology one, masonry typology two and plaster covered.

The northernmost section of the aggregate is composed of masonry typology one, the center of the aggregate is composed of two structures of masonry typology two and the Southernmost structures are plaster covered. This composition of the aggregate implies that these three sections of the aggregate have very different structural dynamics and therefore the connection between the three groups as well as the stability of the end buildings should be reinforced in the case of possible restorative work.

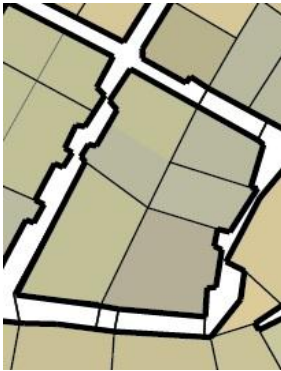
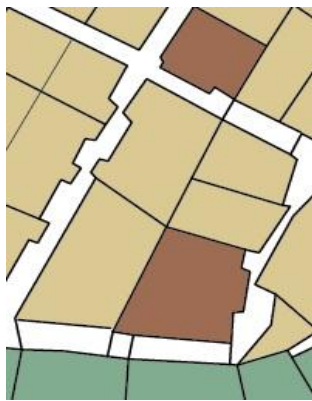
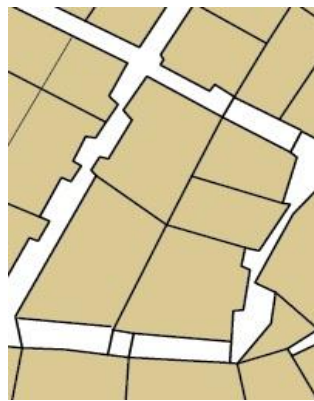
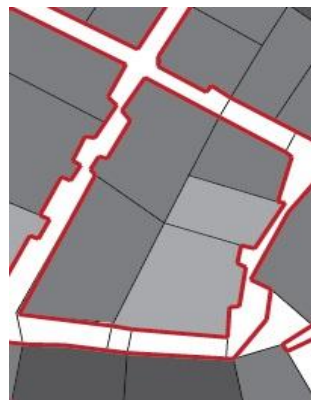
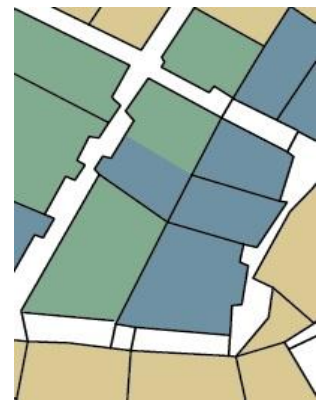
4.74 Homogeneity

only five structures. All of these five structures are privately owned and only one is currently inhabited. All of the buildings within the aggregate are classified as being buildings oriented

parallel to the elevation curves, with the exception of the one ruin within the aggregate. The overall aggregate is fairly homogeneous regarding the building heights with no adjacent structures differing by more than one story. The lack of homogeneity within the aggregate, as seen in all of the negative examples present in Castelvechio di Calvisio, derives from the masonry typology, which in this case is split into two different masonry typologies.

The two typologies present are masonry typology one, which are almost perfectly divided into two

sections in the aggregate, masonry typology one on the West side and masonry typology two on the East side. This results in very different structural dynamics for the two halves of the aggregate, thus rendering the aggregate vulnerable to several collapse mechanisms in the case of a seismic event. These mechanisms include hammering, torsion and out-of-plane wall overturning. Permanent structural interventions could help to minimize or eliminate these potential collapse mechanisms.

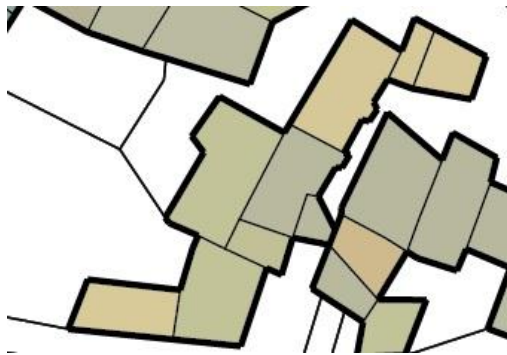
4.81 Collective Homogeneity

regular with all adjacent structures differing by no more than a single story. However it is important

to not that the aggregate has been divided into two regarding the building heights, with the taller structures lying on the Eastern side of the aggregate. The major structural factor for the lack of homogeneity within the aggregate is the masonry typology. There are three Figure

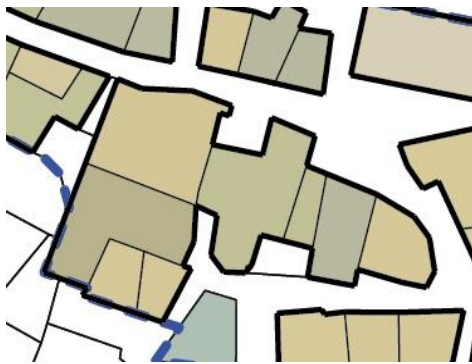
Figure 4.88 Collective Homogeneity

of one ruin. Regarding the building heights, the aggregate is almost perfectly homogeneous, with the exception of one structure that is a story taller than its adjacent structures. The lack of homogeneity in the aggregates is primarily a result of the masonry typology. There are three different typologies present in the aggregate, including masonry typology one,

masonry typology two and plaster covered. The location of these masonry typologies is irregular as well. This is important to note considering the possible collapse mechanisms related to a lack of homogeneity in the structural dynamics of an aggregate. In order to minimize these possible damages

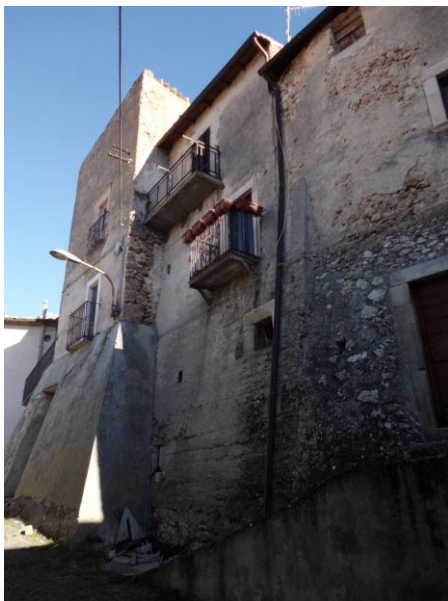
Figure 4.104 Partial Buttress

There are also several structures within the village specifically within the historical center. As seen in figures 4.11a and 4.11b, there are two different typologies of buttresses present within Castelvecchio di Calvisio. The first typology is a partial buttress that only partially covers the height of the wall being supported. Typically this typology of buttress was not present in original construction, but

instead was added later due to the need for additional structural support. The second typology however, the complete buttress, spans the height of the entire supported wall. The example, as seen in figure 4.11b, is located within the historical boundary wall and was therefore a part of the original construction. This is typically the case for complete buttresses. It is important to note that due to the size of the buttress structure and the narrow streets within the historical center of Castelvechio di Calvisio, in many conditions, the addition of a complete buttress is impossible after the initial construction. In this case, either tie rods can be utilized or partial buttresses, if the space allows for such a structural addition.

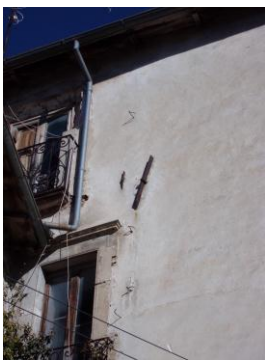
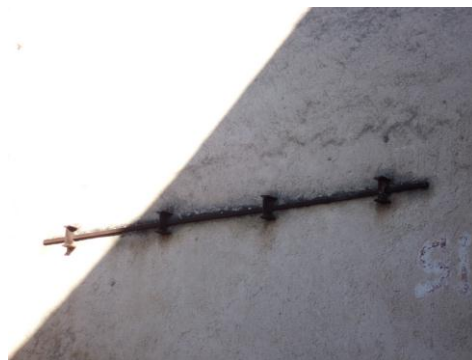
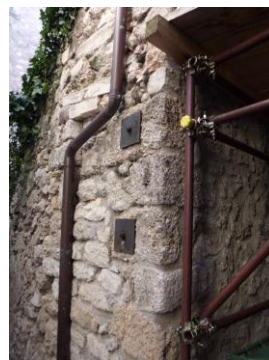
Figure 4.106 Tie Rod

the first being a bar tie rod, as seen in figures 4.11c and 4.11d. The second category is of plate tie rods, as seen in figure 4.11e and 4.11f. In general, plate tie rods can be considered less damaging to the surface of the structure, while bar tie rods have a tendency of puncturing the surface, although this is only the case in rare occasions. Tie rods are an extremely efficient strengthening tool in seismic areas, however their placement must be considered thoroughly. In general, both the placement and implementation of tie rods, within Castelvechio di Calvisio as well as the other villages within the Baronia collective, are efficient. There is a clear history of construction knowledge specific to masonry within seismically active historical centers.

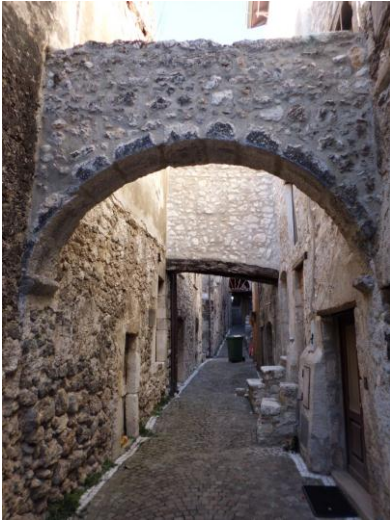
Figure 4.110 Arch

seismic protection. “Sporti” however serve a dual purpose of both anti-seismic design as well as an interior programmatic function. In both cases, the addition of an arch or “sporto” aid in separating two adjacent structures in the case of a seismic event. This separation can deter the occurrence of the

hammering between the two structures. It is important to note that high density “sporti” can create minor structural damages to the attached façade, or collapse on their own. This however is a rare occurrence and is generally only applicable for “sporti”, instead of

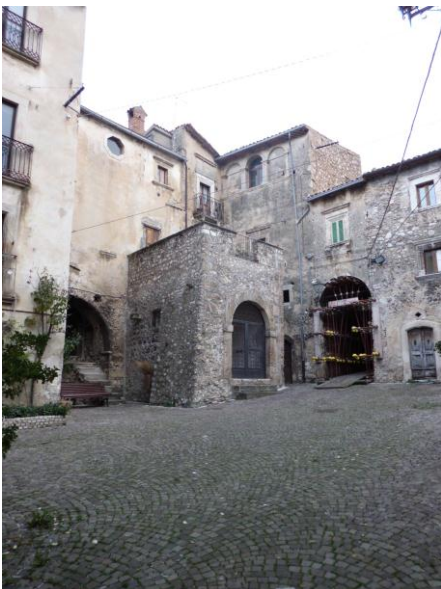
The first typology of temporary structural interventions to be discussed, present in Castelvecchio di Calvisio, is that of the arch/opening support intervention, which is the most common temporary intervention within the Baronia collective. The first example is an arch support intervention, located beneath a “sporto” between aggregates CvC 1.01 and CvC 1.16. Both are these aggregates are located within the historical center, unattached from the historical boundary wall. This particular arch support intervention is extremely effective. The intervention distributes its influence

on the “sporto” across the entire length of the arch in order to avoid the accumulation of stresses that can further the damage mechanisms in place. In addition, the intervention is supported solely by the ground and not by either of the adjacent aggregates. This placement also allows for access under the “sporto” which is preferable considering the importance of this major access way of the village. This intervention can therefore be considered quite successful and should be used as a model

Figure 4.112 Arch Support Intervention for future temporary interventions to be placed through the historical center of this village.

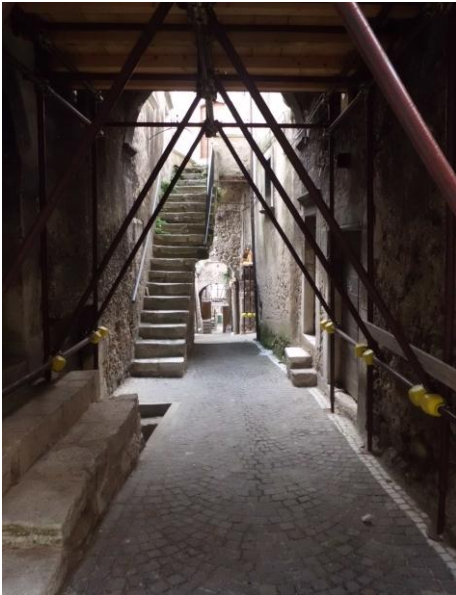
4.113 Opening Support Intervention

The second example of an arch/opening support intervention within the historical center of Castelvecchio di Calvisio is located between aggregates CvC 1.04 and CvC 1.13. Both of these

aggregates are unattached from the historical boundary wall. This particular support intervention has several flaws. The first and most important of these instabilities is that the intervention is supported by the adjacent structures' facades. This thus renders them vulnerable as well. In addition, the support system concentrates the stress of the support onto the center of the opening, thus increasing the stresses present within the opening. This example however is positive due to available access beneath the opening, allowing for continued circulation

on the major street way of the village. Overall, this intervention can be thoroughly improved to better support the opening.

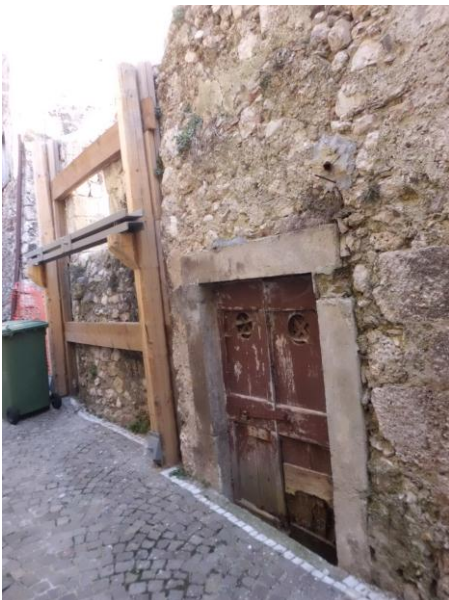
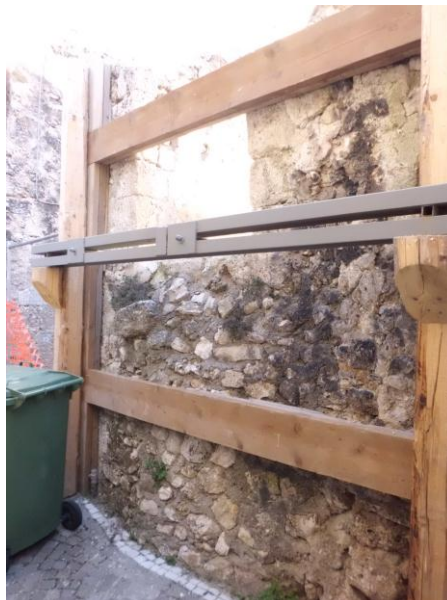
The second typology of temporary structural interventions present within the historical center of Castelvechio di Calvisio is surface rendering interventions. The example to be discussed of this particular typology of intervention is located in aggregate CvC 1.06. These interventions are typically

Figure 4.114 Surface Rendering

made from steel, however this particular case is a combination of both steel and wood. Similar to the wooden grid or tie interventions, this typology of temporary intervention aids in minimizing the effects of

the collapse mechanisms of out of plane wall overturning. This typology however is typically placed on the façade of the structure facing the narrow street way. Due to the use of steel instead of wood, the intervention has the propensity to last longer, however they still need to eventually be replace

with permanent structural interventions that prohibit the possible collapse mechanisms within the façade.

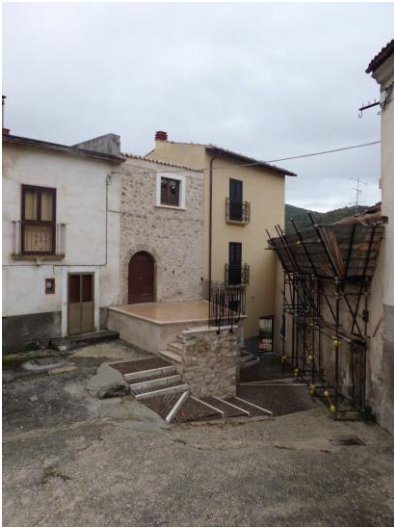
The third and last typology of temporary structural interventions present in Castelvechio di Calvisio. This is a shoring system intervention and the example to be discussed is located outside of

the historical center in aggregate CvC 2.01. This particular intervention aims at prospering up the façade of a structure as well as increasing the connection between both the façade and the roof structures. While these structures are helpful they are only temporary interventions and need to be replaced with more permanent interventions to better support the structure in question. These are appropriate interventions immediately following damage

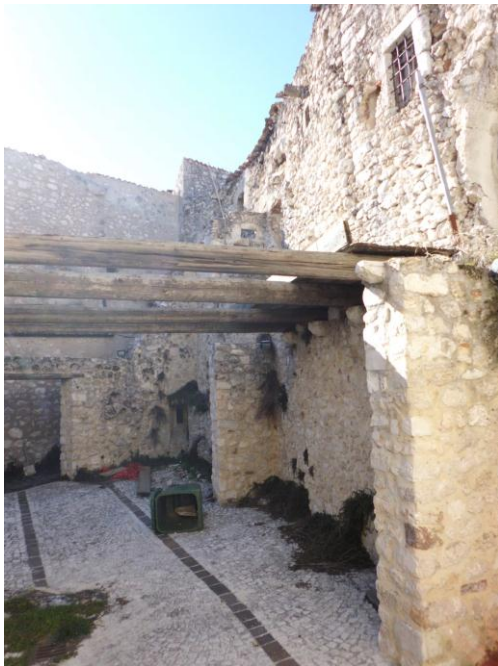
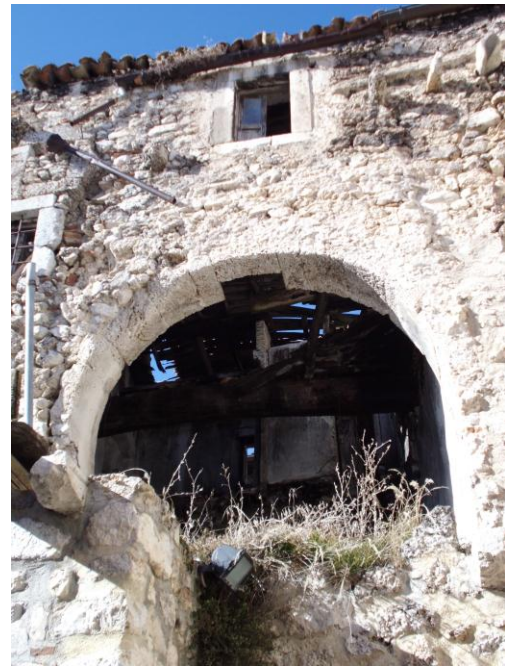
The first example of one of the more vulnerable aggregates is found in the heart of the historic center, near the San Marco church, specifically in aggregate CvC 1.08. This example, was

Figure 4.117 Aggregate CvC 1.08

determined to be negative regarding its collective homogeneity. As seen in the models above, the aggregate is extremely irregular regarding masonry typology composition and also has a ruin within the aggregate as seen in figures 4.117 and 4.118. There were also damages in the aggregate after the 2009 L'Aquila seismic event and not all of the structures within the aggregate have permanent structural interventions in place. As seen in figure 4.118, there is also irregularity in both additions to the structures as well as openings. Openings have been placed too close to structural elements such as the roof or corners. It is also important to note the extreme changes of the aggregate over time, with elements of different masonry composition, has contributed to the determination of this particular aggregate as a high priority level. Regarding a future for this aggregate, there are several restoration options available. First and foremost, additional permanent and temporary structural interventions need to be added to better control the reactions between the irregular units within the aggregate. These interventions should specifically be placed in vulnerable areas such as fulcrum points between two attached structures of different height. In addition, any damages sustained during the most recent seismic event of 2009 need to be thoroughly analyzed and resolved to better protect the inhabitants of the aggregate. It is also extremely important to resolve the existing within the aggregate due to its possibly negative effect on the surrounding structures as well as the threat it poses to the current inhabitants of both the specific aggregate as well as of all of Castelvechio di Calvisio. This aggregate also maintains "sporti" and arch connections to separate aggregates which can create partial damage to adjacent aggregates if not properly maintained, as they aren't now.

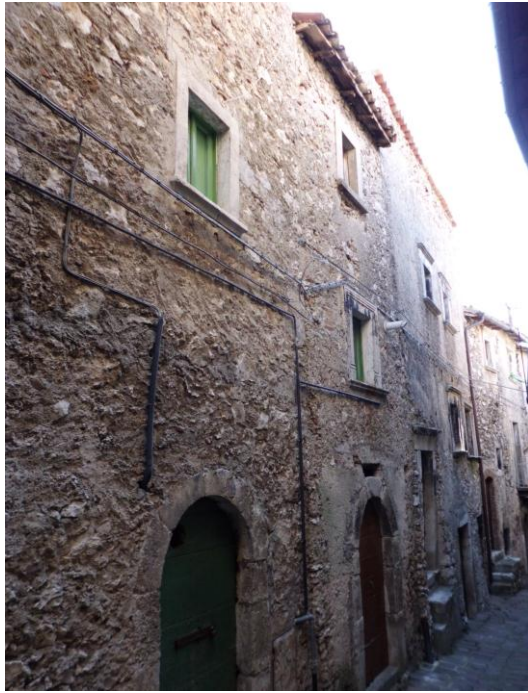
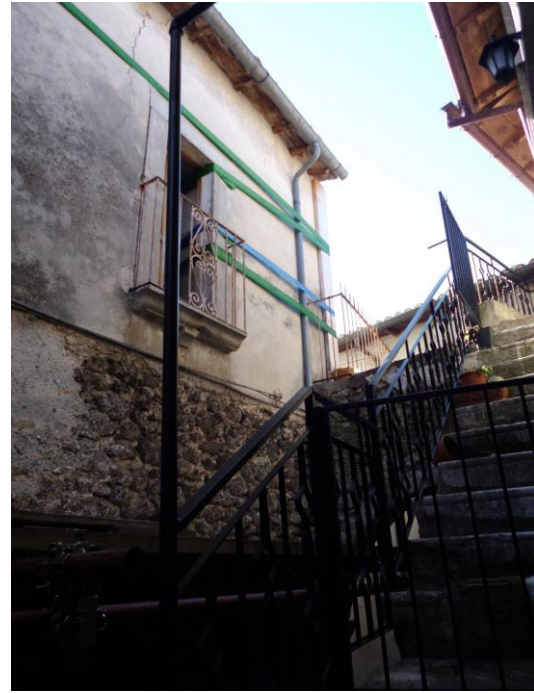
The second example of a high priority structure is found in the historical center, specifically in aggregate CvC 1.15. This aggregate has been chosen for several reasons, the first of which is that five of the nine structures within the aggregate are currently inhabited. In addition, as previously mentioned, the aggregate has been considered be negative regarding its overall collective homogeneity. This particular aggregate is extremely irregular in both masonry typology composition and the building heights of the individual units within the aggregate. The aggregate is also irregular in

Figure 4.121 Aggregate CvC 1.15

both plan and elevation. There were also extensive damages in the aggregate after the 2009 L'Aquila seismic event and not all of the structures within the aggregate have permanent structural

interventions in place. Regarding a future for this aggregate, there are several restoration options available. Additional permanent and temporary structural interventions need to be added to better control the reactions between the irregular units within the aggregate. These interventions should specifically be placed in vulnerable areas such as fulcrum points between two attached structures of different heights or between buildings of different masonry composition. In addition, any damages sustained during the most recent seismic event of 2009 need to be thoroughly analyzed and resolved to better protect the inhabitants of the aggregate.

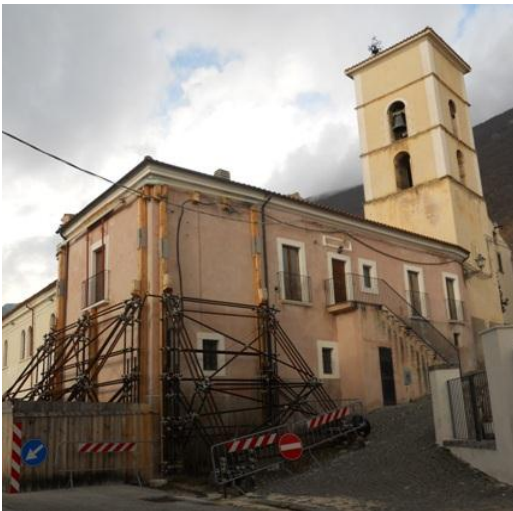
Figure 5.6 Church of Aggregate VSL 012

There is only one church or religious structure present in Villa Santa Lucia degli Abruzzi, which is located on the edge of the historical center. This example is found in aggregate VSL 012. This particular church is extremely regular in plan but irregular in elevation. Similar to many

churches within the region of Abruzzo, this church, although constructed with higher quality materials, is extremely vulnerable to seismic activity. The addition of several temporary structural interventions supports this claim. Renaissance or Roman churches are characterized by changing heights and volumes of varying sizes and shapes. In addition, they are popular in use due to their cultural and societal importance within Italy. Despite their

recommended in order to minimize damage to the cultural patrimony of the village as well as to minimize the casualties in the case of the next seismic event to come. As seen in figure 5.6 and 5.7, there are permanent structural interventions in place. However the additional of post-seismic temporary structural interventions implies a need for additional

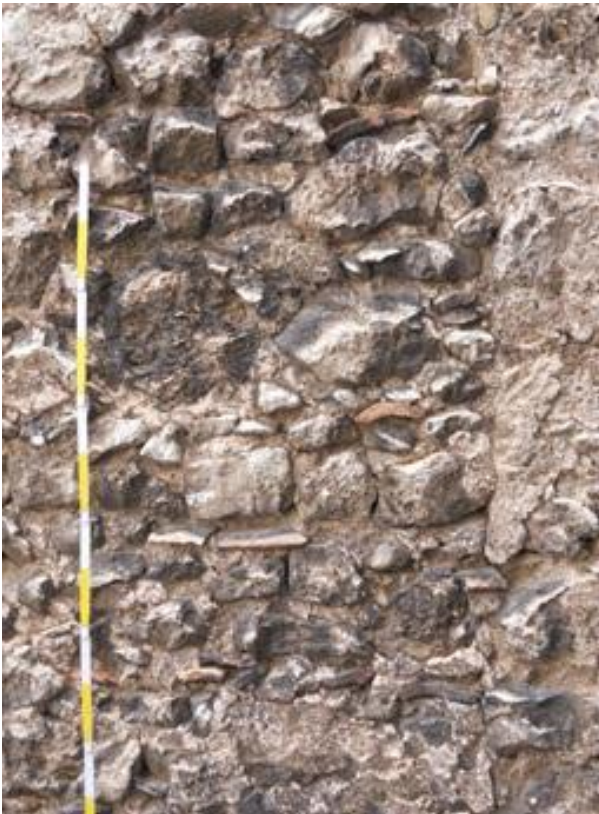
Figure 5.8 Masonry Typology One

Abruzzi. This typology, considered to the lowest quality, makes up 31 percent of the 268 structures present in the village. This particular typology is concentrated in the center of the village where it makes up the majority of the buildings. Figures 5.8 and 5.9 are two examples of this particular masonry typology present in Villa Santa Lucia degli Abruzzi. As seen in both examples above, the masonry lacks continuous horizontal bonds and have no visible vertical structural systems. This
